## Clean Water Act Section 404: Site Visit/Case Development

| Inspector Name(s) | Seika Robinson | Time In | 11:15 AM | Start Date | June 11, 2024 |
| Site Name | Hotel Media Luna | | | | |
| Site Address* | Tax Parcel 196-000-009-39 | | | | |

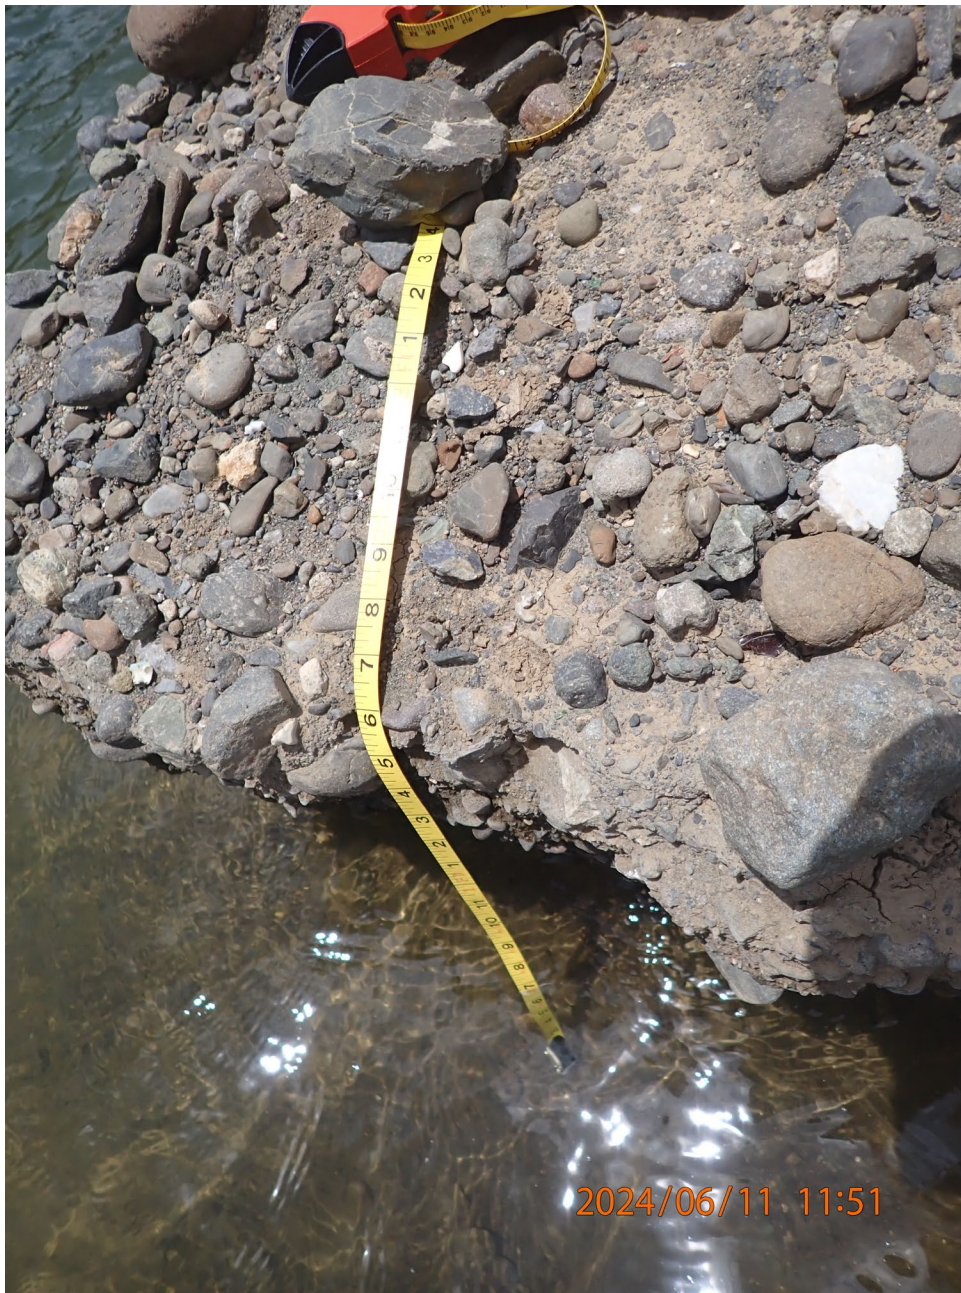
**Photo ID:** P6111021

**Description:** Within the bank of the Río de la Plata, earth moving work and fill material was observed. Approximately 18 inches of fill material as measured from the bottom of the bank.

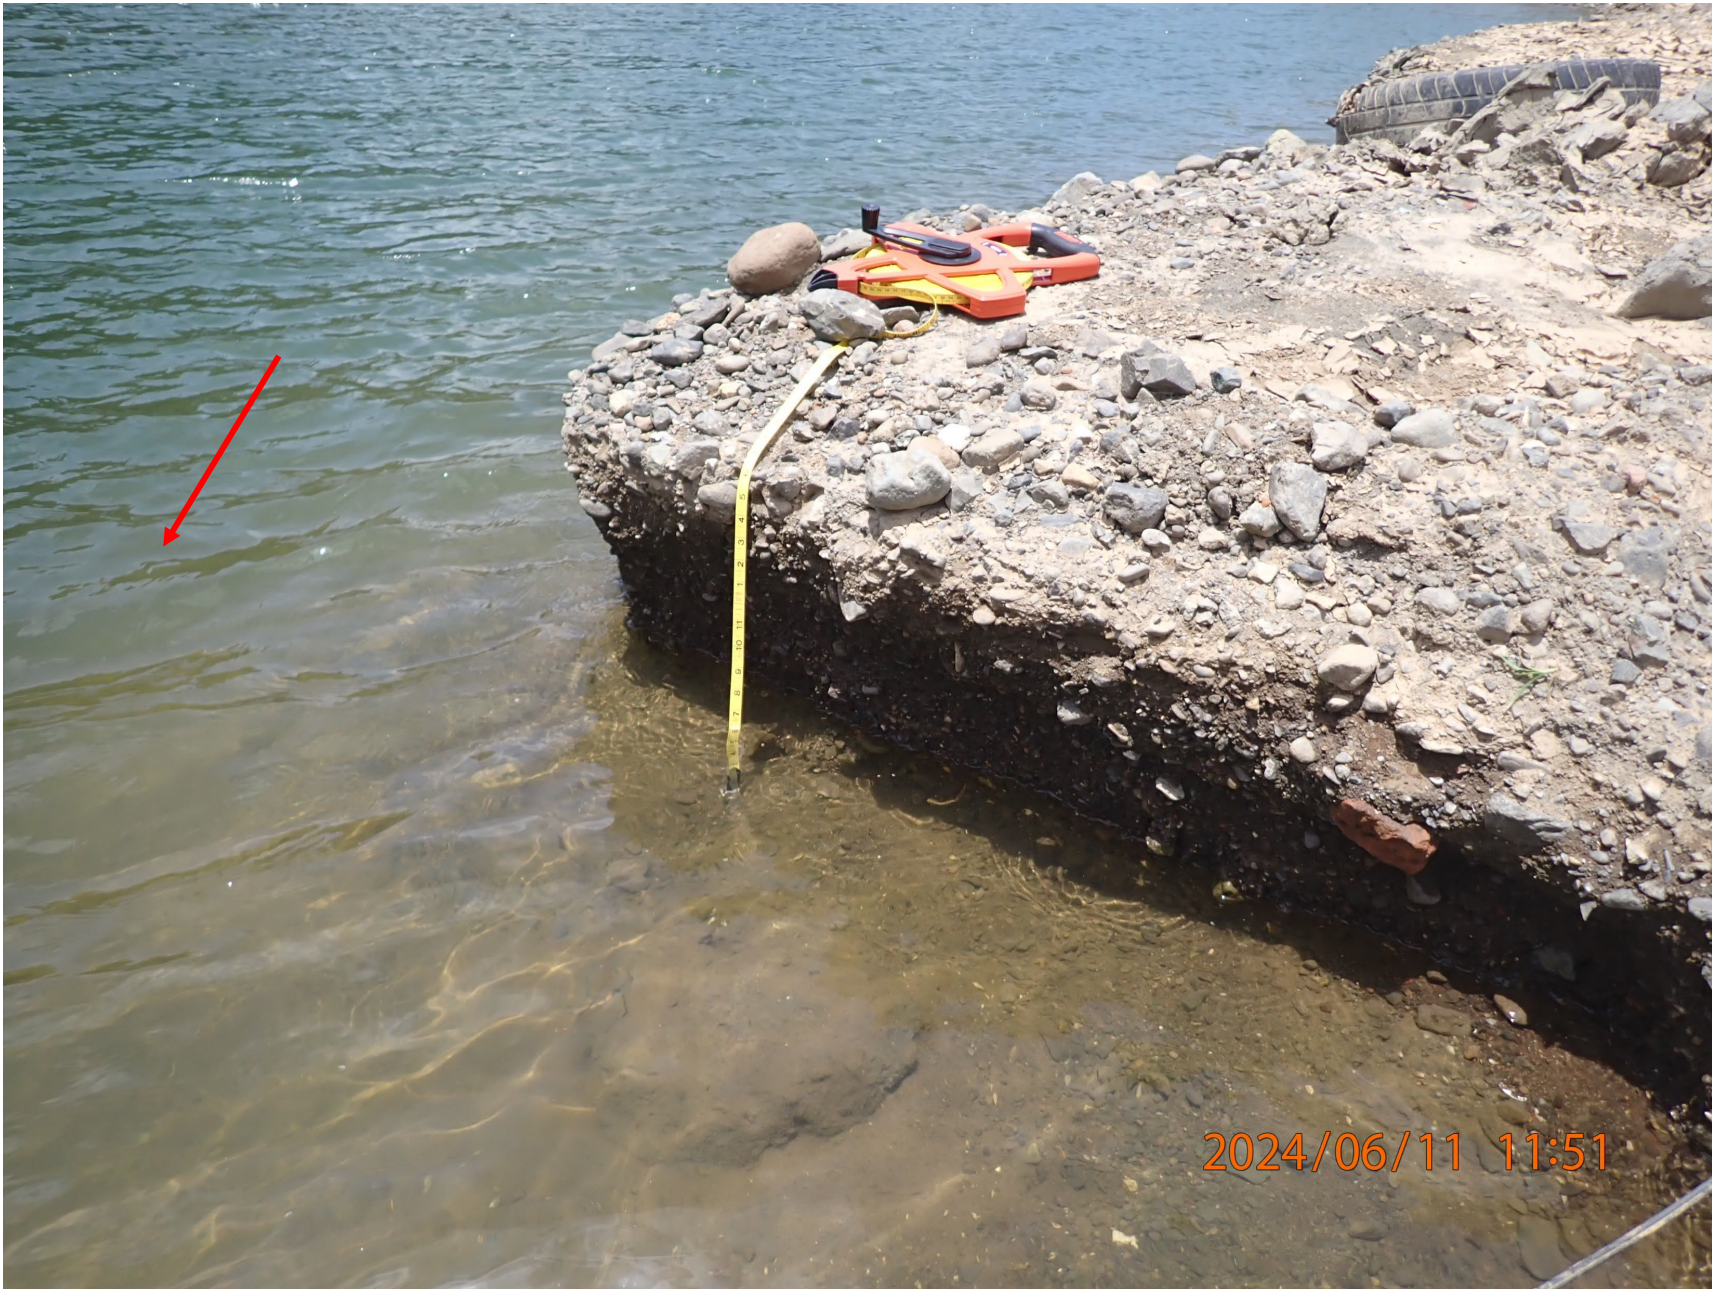
**Photo ID:** P6111022

**Description:** Within the bank of the Río de la Plata, earth moving work and fill material was observed. Approximately 18 inches of fill material as measured from the bottom of the bank.

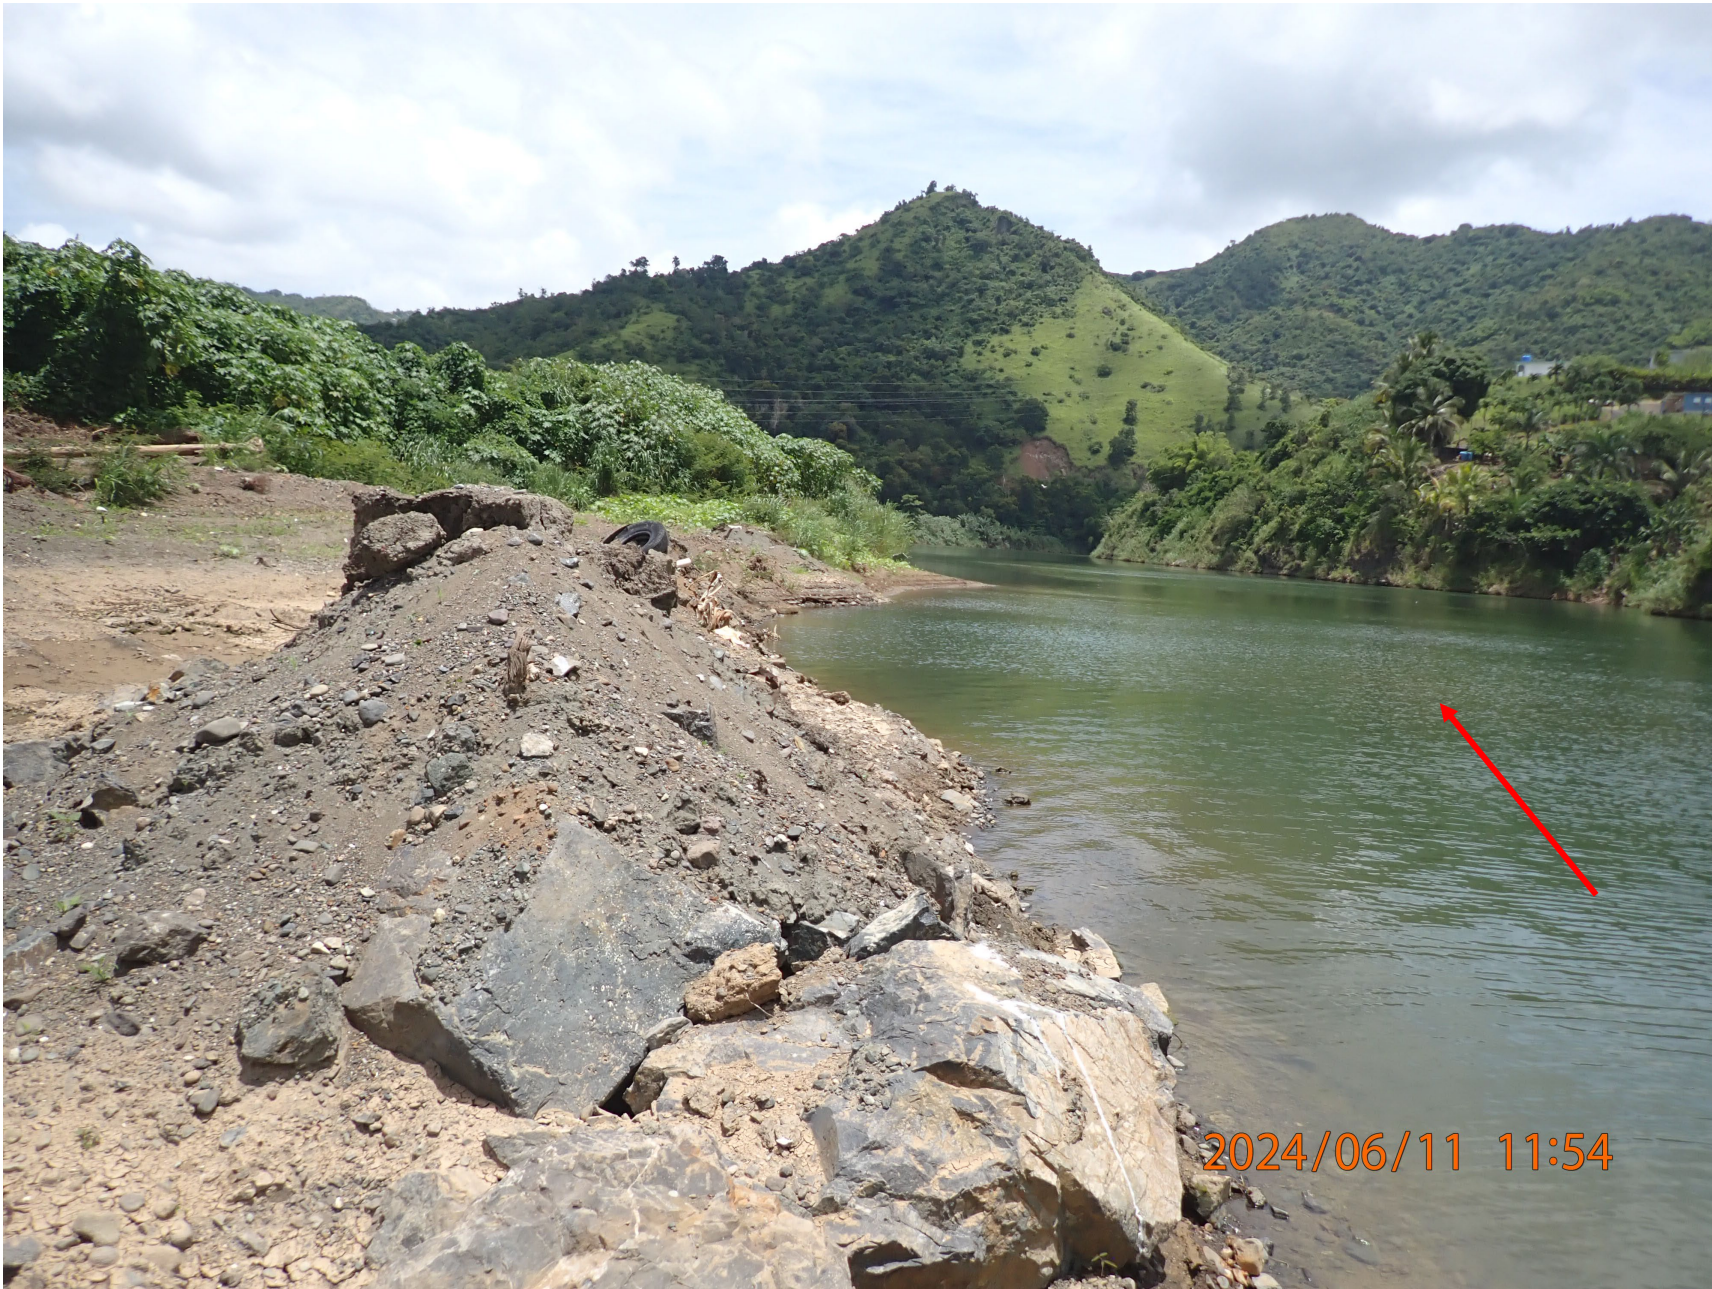
**Description:** Within the bank of the Rio de la Plata, earth moving work and fill material was observed along with trash debris.

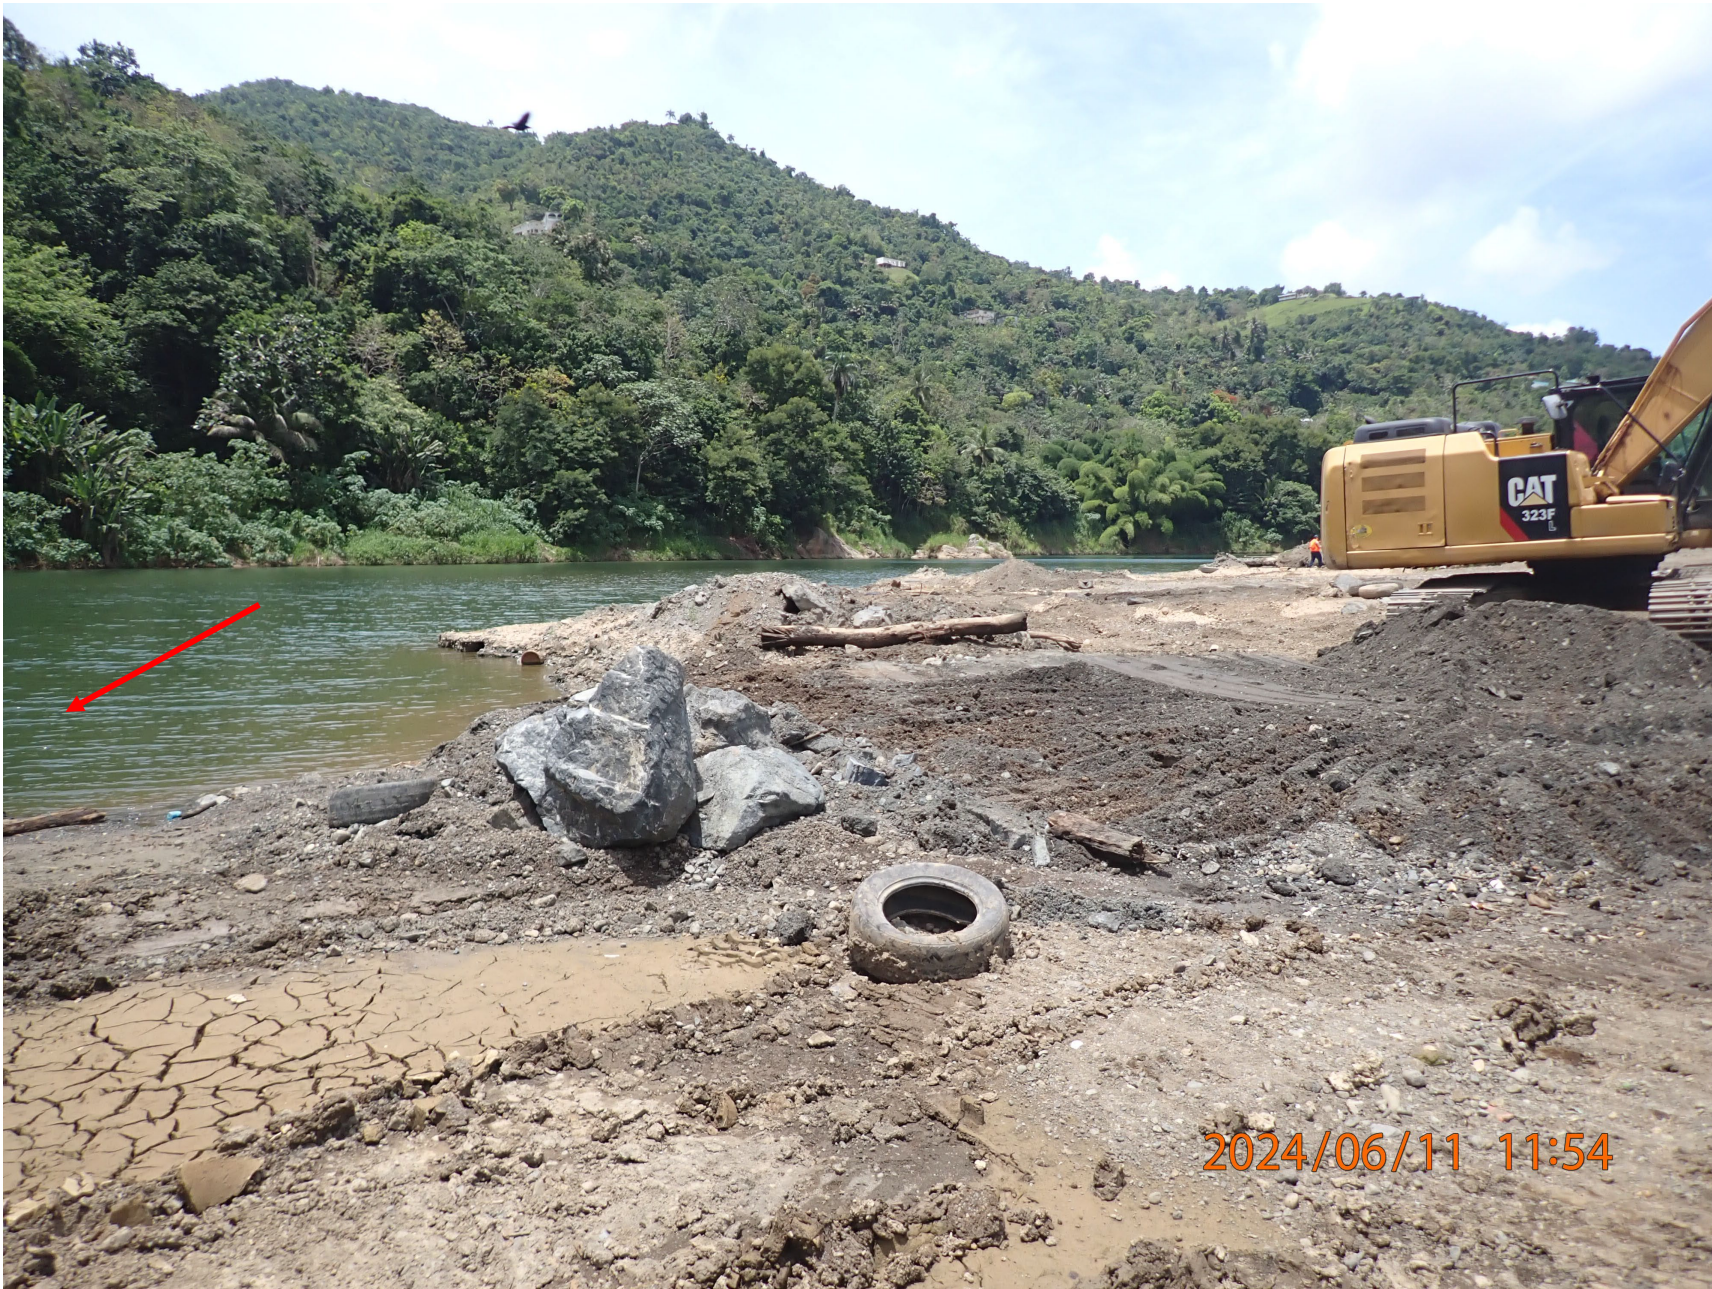
**Photo ID:** P6111026

**Description:** Within the bank of the Rio de la Plata, earth moving work and fill material was observed along with trash debris. Construction machinery was observed parked within the area where earth moving work had occurred.

Mud cracks were observed within the area of work.

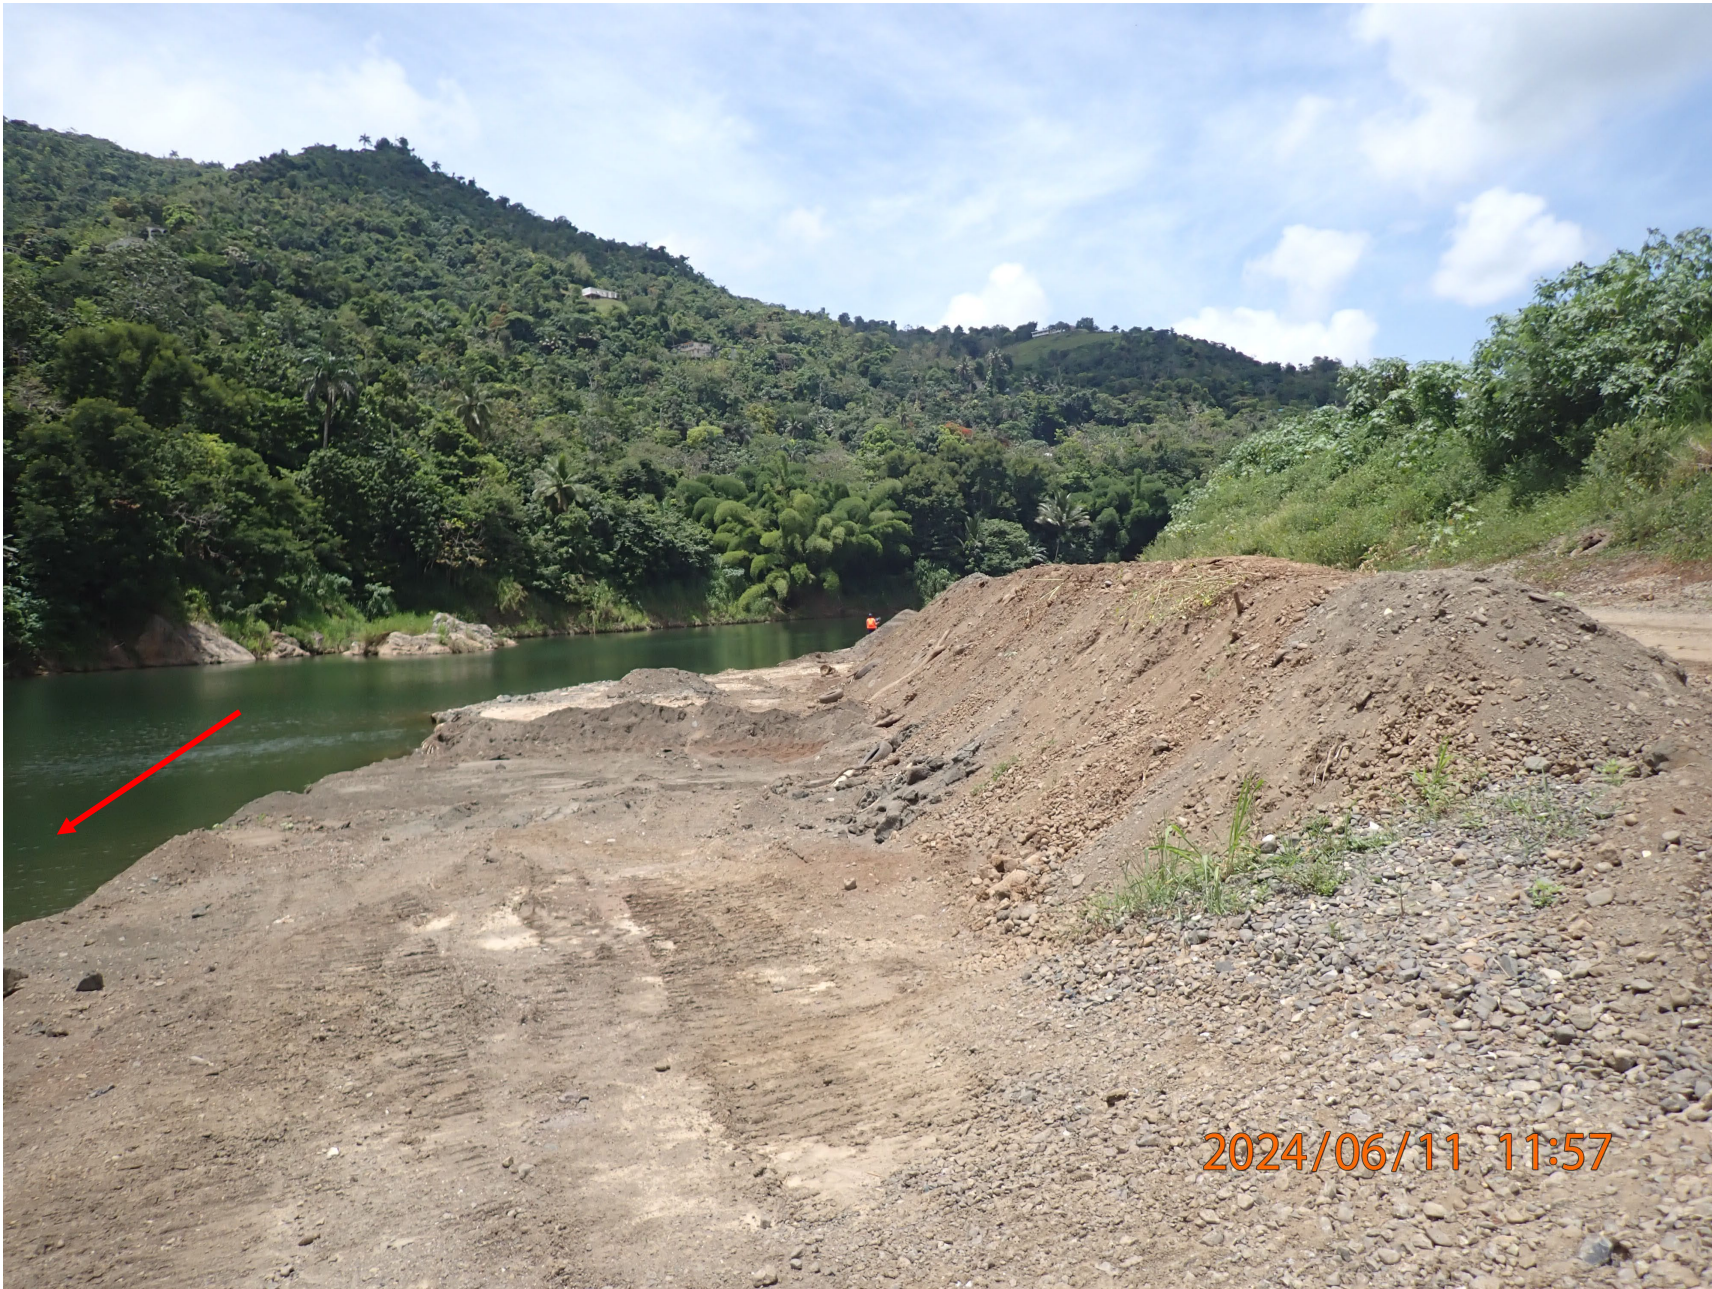
**Description:** Within the bank of the Río de la Plata, earth moving work and fill material was observed.
