Resource Conservation and Recovery Act (RCRA) Compliance Evaluation Inspection (CEI)
Plaza Provision - Guaynabo
 PRR000027847

US Environmental Protection Agency – Region 2
 Caribbean Environmental Protection Division (CEPD)
 Response and Remediation Branch (RRB)

Facility Name:		Plaza Provision - Guaynabo							
EPA ID Number:		PRR000027847							
Completion Date:		June 27, 2023							
Generator Status in Record:		Non-Notifier ¹							
RCRA Permitted:		No							
Corrective Action:		No							
Project ID		CEPD-RCRA-23-0434							
Basis for Inspection:		Core Program (COVID-19 protocols were in place while conducting this CEI) ²							
Facility Personnel:									
Name:		Title:		Email:		Phone:		Attend to:	
								OM ³ FW ⁴ DR ⁵ CM ⁶	
Mr. Oscar Rodriguez		Compliance Supervisor		orodriguez@plazaprovision.com		787-781-2070 x 1286		√ √ √ √	
EPA Personnel:									
Inspector's Name			EPA Region 2-CEPD		Enforcement Officer		phone/email		
Ms. Rosana Caballer-Cruz			EPA Region 2-CEPD		Enforcement Officer		787-977-5880/ caballer.rosana@epa.gov		
Status:		FINAL							
EPA Inspector Signature/Date		X ROSANA CABALLER-CRUZ <small>Digitally signed by ROSANA CABALLER-CRUZ Date: 2023.08.22 18:09:13

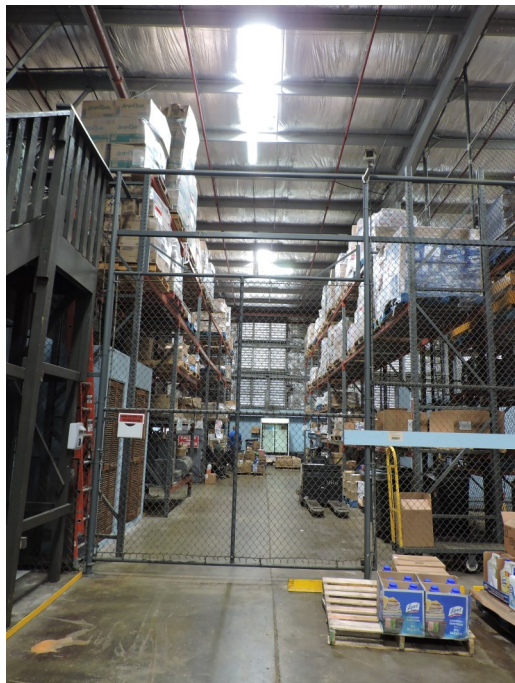
This area was already physically segregated by a cyclone fence and a lock was available (Picture

#1). At the time of the inspection, it was observed open, nevertheless, facilities representatives were inside working within this area²². The area consists of high ceilings²³ and concrete floors. Inside, four (4) metal shelves with products, such as food for human consumption, and household products,²⁴ were observed (Picture #2). According to Mr. Rodriguez, those observed within the metal shelves are the ones that would be donated, reclaimed, or dispose of (Picture #3). I asked Mr. Rodriguez about the communication devices. He replied that this area has available a mainline phone and the supervisor(s) that works within this area are allowed to carry a cell phone.

Picture 1 — Hold Area— Located inside the warehouse area, is used to store the products that would be disposed of, reclaimed, or donated by their clients. It was already physically segregated by a cyclone fence and a lock was available

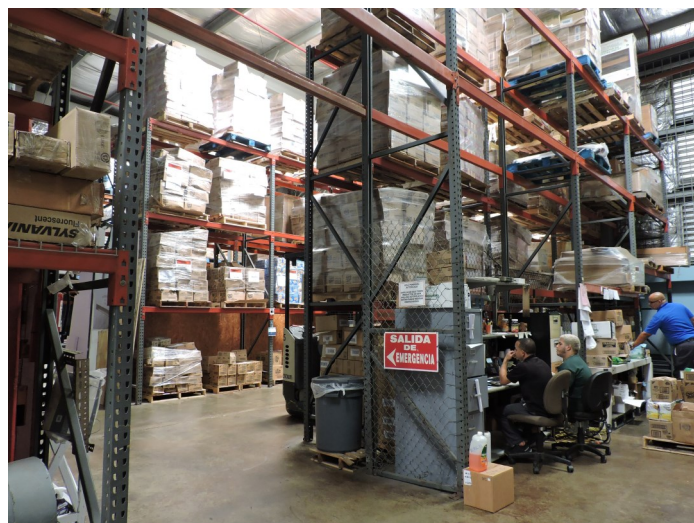
Picture 2 — Hold Area— Inside this area, four (4) metal shelves with products, such as food for human consumption, and household products, were observed

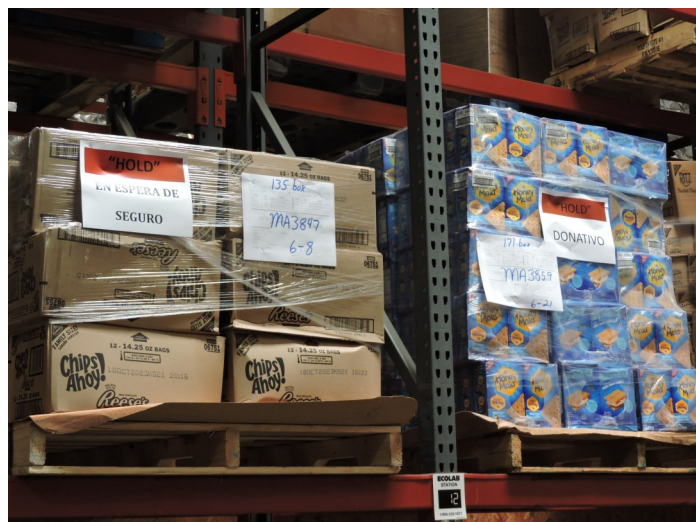
Picture 3 — Hold Area— Zoom-in picture of two (2) of the available pallets with products observed in this area.

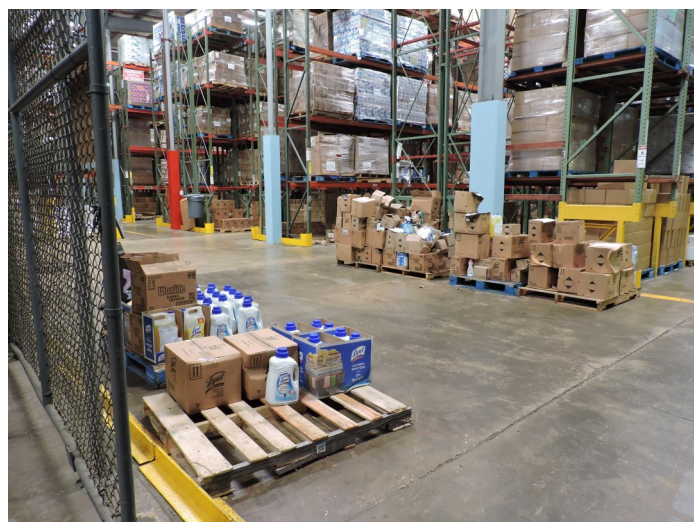
I asked Mr. Rodriguez about these damaged products. According to him, those boxes were placed at this location waiting to be processed to then be placed inside the Holding Area²⁶. At the time of the inspection, all the cardboard boxes were observed above wood panels (Picture #4). I asked him how long these open boxes were placed at this location. He replied that they were placed around 4:00 am²⁷ and would be processed during the same shift²⁸. Mr. Rodriguez told me that the final action related to the observed damaged products would be taken by the owner/client's decision. Nevertheless, he told me that possible scenarios could be donations for a non-profit organization, donations to Plaza Provision company²⁹, and the owner/client of the products could reclaim it or can de dispose of it as regular waste.

Picture 4 — Staging Area— This area was located just at the front of the Hold Area entrance. At the time of the inspection, all the cardboard boxes have damaged products and were observed above wood panels.

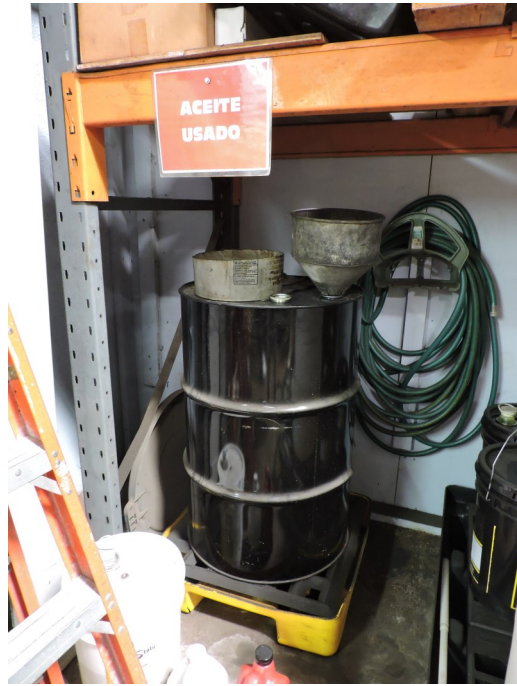
This area was already physically segregated by a cyclone fence and has a lock available. At the time of the inspection, the area was already open. Nevertheless, two (2) employees were working within this location. Inside, a 55-gallon black steel container was observed above a secondary containment. The latter appears to be in good condition, has a funnel attached to it, the area was labeled as used oil, and observed without any spill or leaks. Nevertheless, the container was not labeled as used oil (Picture #5). Also, three (3) containers were observed in front of this area. In addition, just at the side, an approximately 30-gallon yellow steel container was observed with absorbent material. Finally, I asked about the 55-gallon used oil container disposal activity frequency and the hauler company. Mr. Guadalupe told me that this container is picked up by Safety Kleen and is picked up once per year.

Used oil Label – I told them that, at the time of the inspection, the 55-gallon black steel container observed in this area was not labeled as used oil, as required by the RCRA Regulation.

At the time of the inspection, the facility failed to comply with this requirement in the Mechanical Shop Area. At this area, aka the A-1 Forklift Repairs and Services Area, a 55-gallon black steel container was not labeled as used oil.

Picture 5— Mechanical Shop Area—Here, a 55-gallon black steel container was observed above a secondary containment. At the time of the inspection, the container was not labeled as used oil.

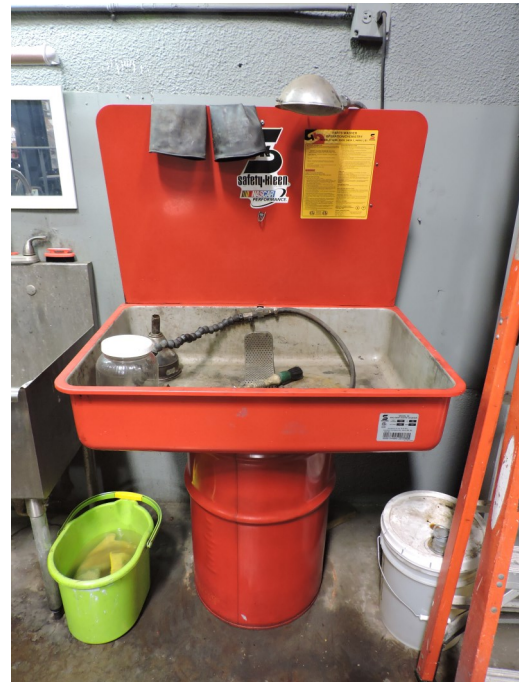
Likewise, one part washer equipment was observed. I asked Mr. Guadalupe about the latter. He told me that this unit is currently in use and the hauler company which provides hauler services for this equipment is Safety Kleen. I asked him how frequent the disposal activity is, and he replied that the part washer disposal occurs approximately every two (2) months. At the time of the CEI, the part washer was labeled, and dry, but was observed open (Picture #6).

Picture 6— Mechanical Shop Area— At the time of the inspection, a part washer was observed labeled, and dry, but it was open.

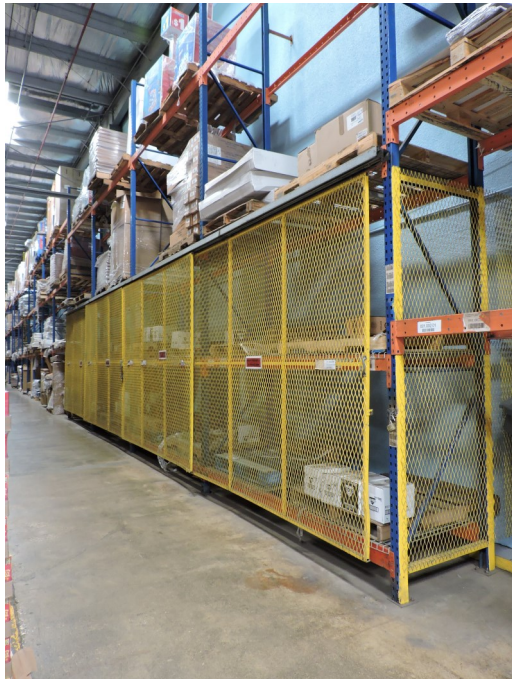
At the time of the inspection, this cage-like area was observed open (Picture #7). Mr. Rodriguez told me that it was observed open since facility representatives are currently working on dispatching products stored in this area. Although it was observed open, Mr. Rodriguez told me that this cage-like area must be closed by the end of every shift. At the time of the inspection, products were observed within this area.

Picture 7— D-CON Shelf Area—This area was located in the northwest area of the facility. It is consisting of a metal shelve cage-like area with a fence, lock and measure approximately 25 feet long.
