**UNITED STATES ENVIRONMENTAL PROTECTION AGENCY  
REGION 8  
RESOURCE CONSERVATION AND RECOVERY ACT**

**Facility Name:** Estvold Oilfield Services

**Date of Inspection:** June 8, 2022

**Type and Purpose of Inspection:** Compliance Evaluation Inspection  
RCRA Subtitle C Inspection

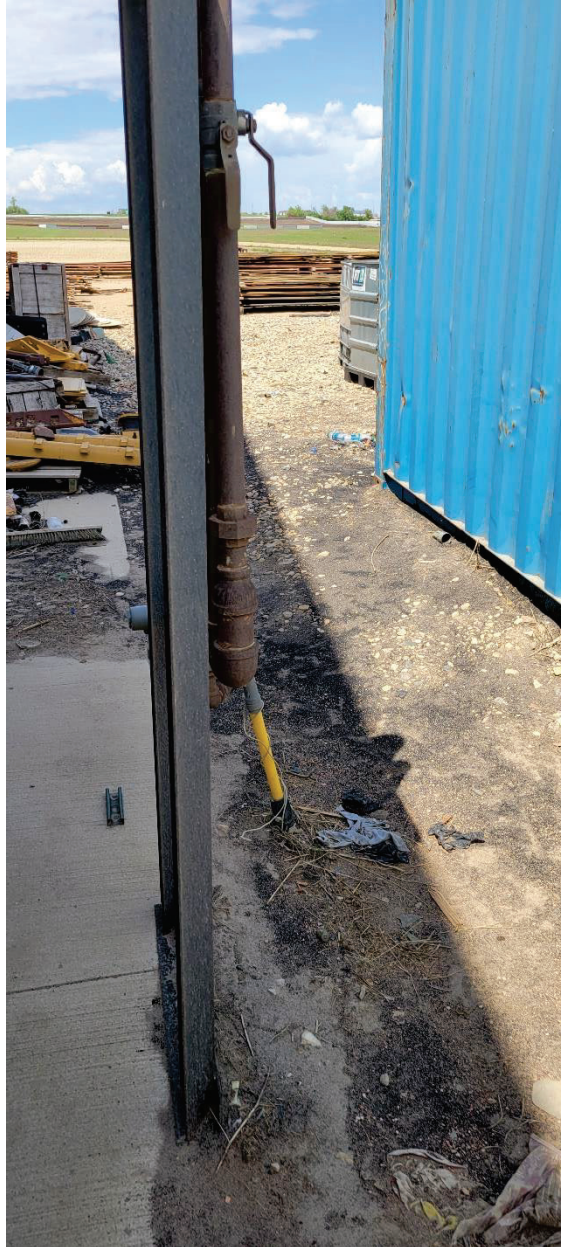
Outdoors on the east side of the north building near the wash bay, I observed paint blast media on the ground (photo #1). Mr. Borgschatz stated that he thought he had previously submitted hazardous waste determination documentation for this waste, but prior to and following the inspection I was not able to locate that documentation. Mr. Borgschatz stated that the brand of abrasive used was Black Magic Coal Slag.

Photo 1: 20220608\_145816.jpg, collected by Annette Maxwell on 6/8/2022; photo of spent blast media on the ground on the east side of the north building.

- 1) Hazardous waste determinations for:
  - a. Paint booth filters
  - b. Three totes of unknown material located on the east side of the north building
  - c. Spent paint blast media on the ground on the east side of the north building
- 2) Labeling with the words "Used Oil" on totes and containers holding used oil

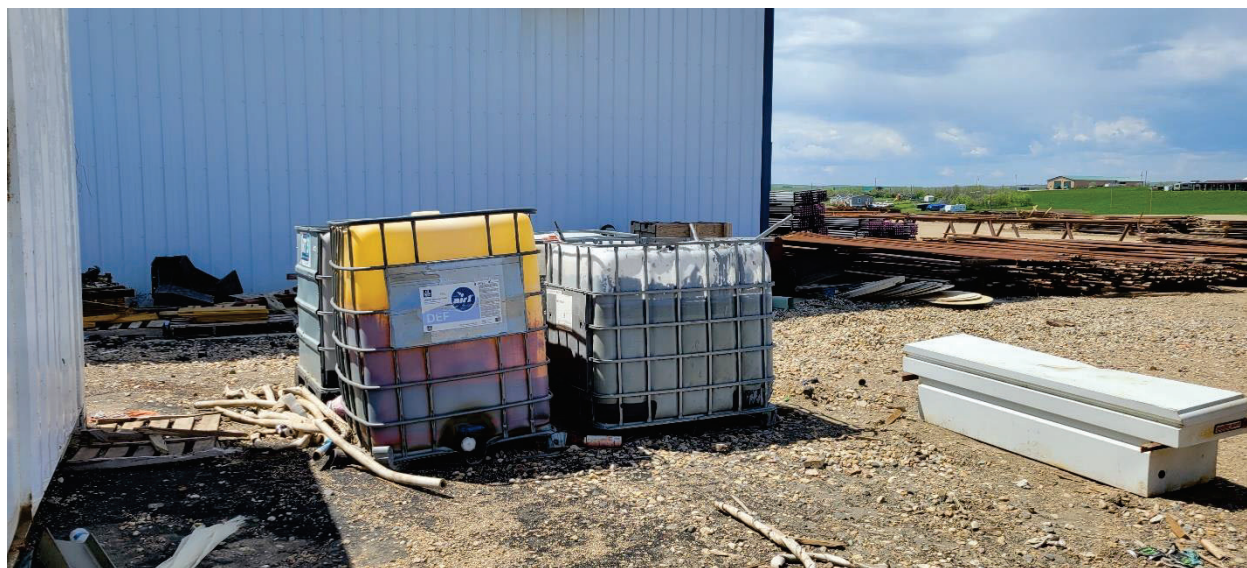
In the same area I observed four totes (photo #2), one of which Mr. Borgschatz identified as roundup herbicide awaiting use. He was not able to identify the contents of the other three totes.

Photo 2: 20220608\_150154.jpg, collected by Annette Maxwell on 6/8/2022; photo of four totes located on the east side of the north building.

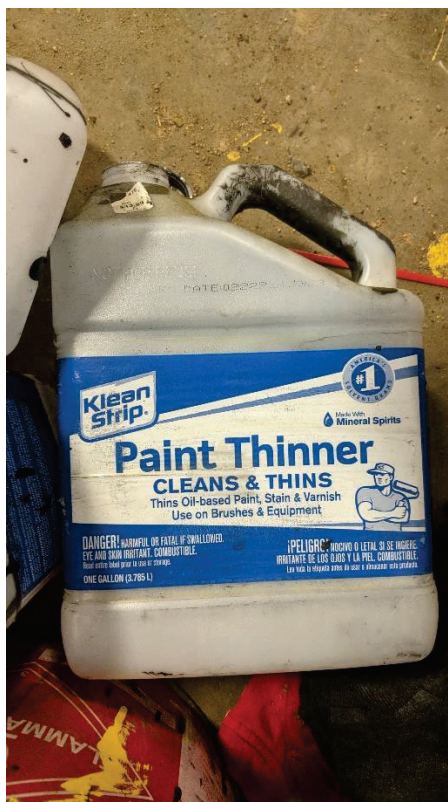
At the wash bay/paint booth, I asked whether a hazardous waste determination had been performed on the paint filters. Mr. Borgschatz was not sure of the status of a hazardous waste determination on the paint filters.

Photo 3: PXL\_20220608\_201329304.jpg, collected by Kristin McNeill on 6/8/2022; photo of an empty paint thinner container used for painting in the facility's paint booth/wash bay.

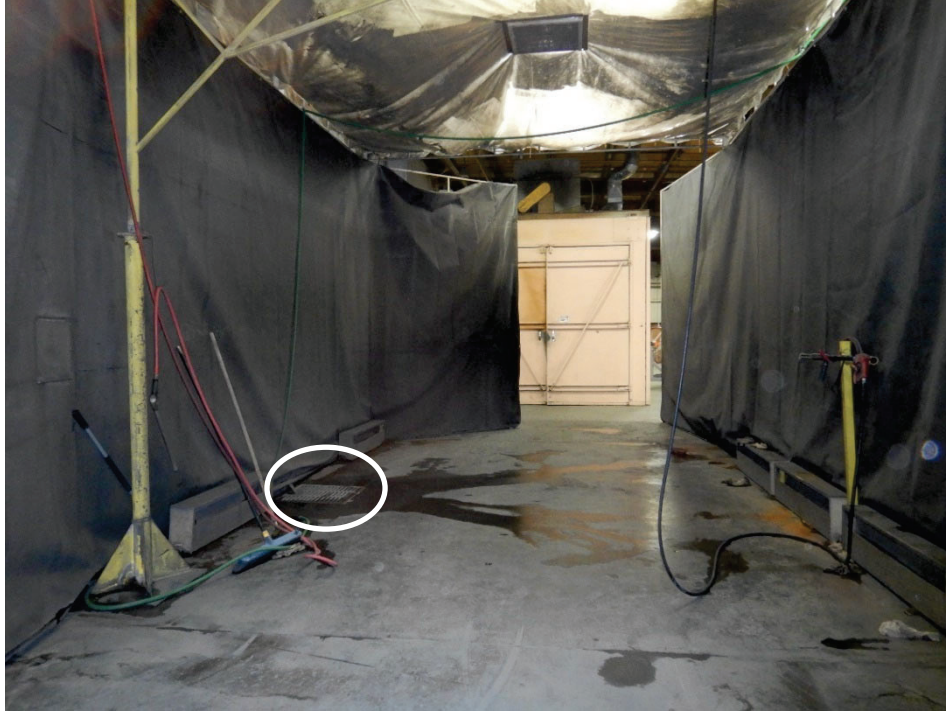
Photograph 1: View of the facility's spray booth. The sump pit (circled) is pumped to the final discharge tank.

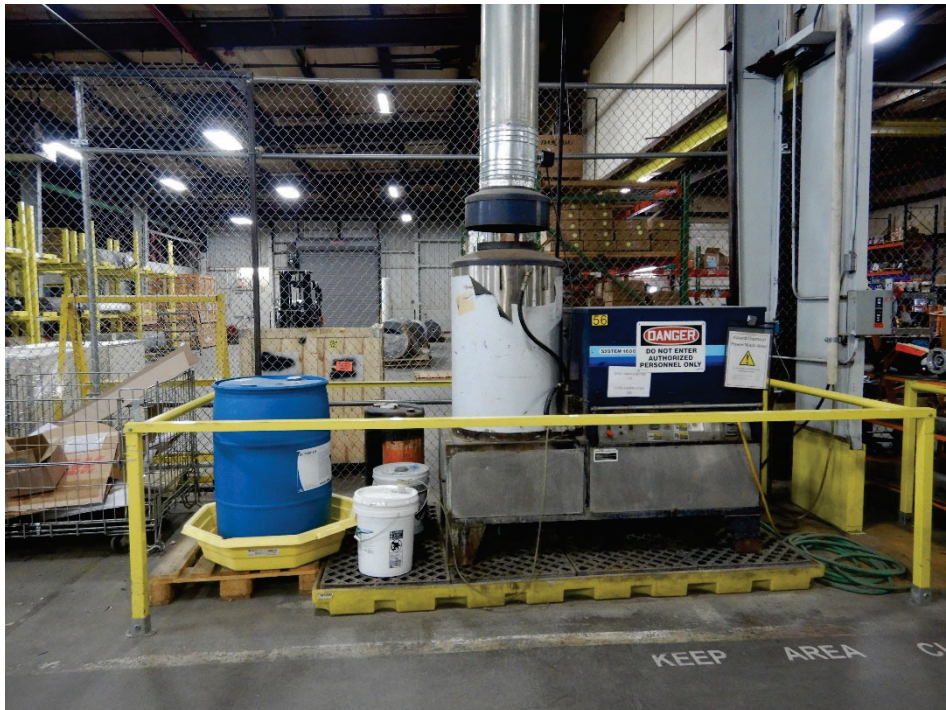
**Finding 2 – The inspection team observed chemicals stored in the parts washer area which are no longer used in the process per the facility representative.**

During the walk through, the inspection team viewed the parts washer and containment area for cleaners used in the washing stage (see Photograph 2). The facility representative noted that the blue drum is the phosphoric acid cleaner that is no longer in use. The white bucket in front of the photo is the new caustic cleaning solution that replaced the phosphoric acid cleaner.

Photograph 2: View of the parts washer and containment area for cleaners used in the washing stage. The black drum at the rear of photo is the coil cleaner. The white bucket in front of the photo is the new caustic cleaning solution that replaced the phosphoric acid cleaner.

It is recommended the phosphoric acid cleaner be removed off-site as there is no intent for it to be used in the future, as indicated by Interroll personnel.

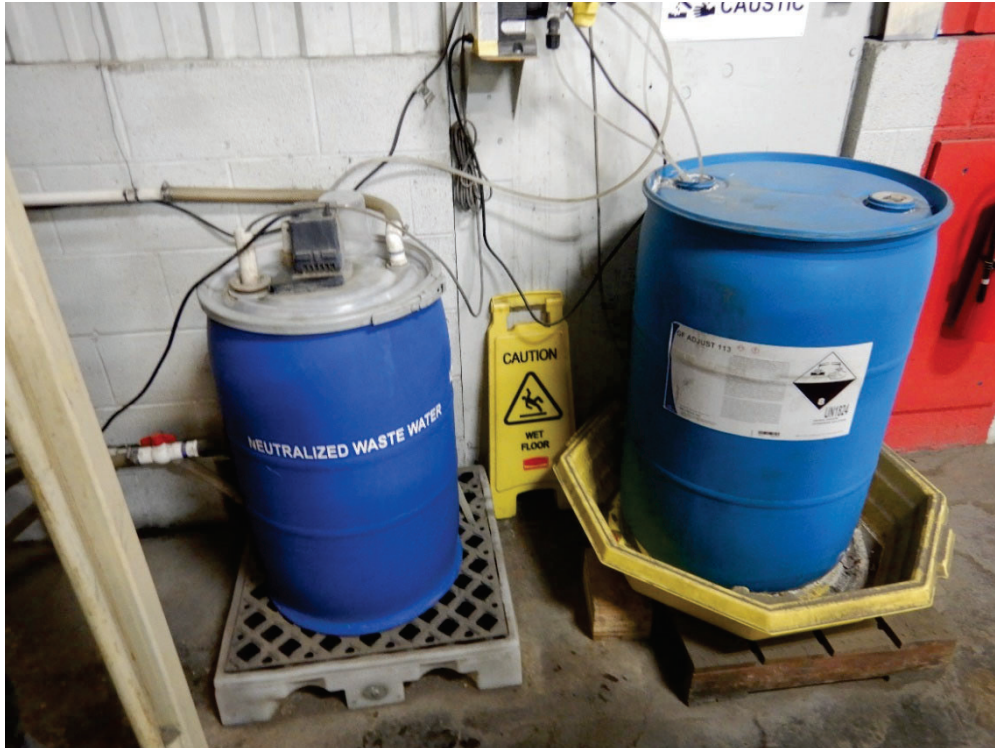
Photograph 3: The final discharge tank used for pH neutralization is on the left side of the photo. The drum at the right side of the photo is the sodium hydroxide, the pH adjustment chemical.

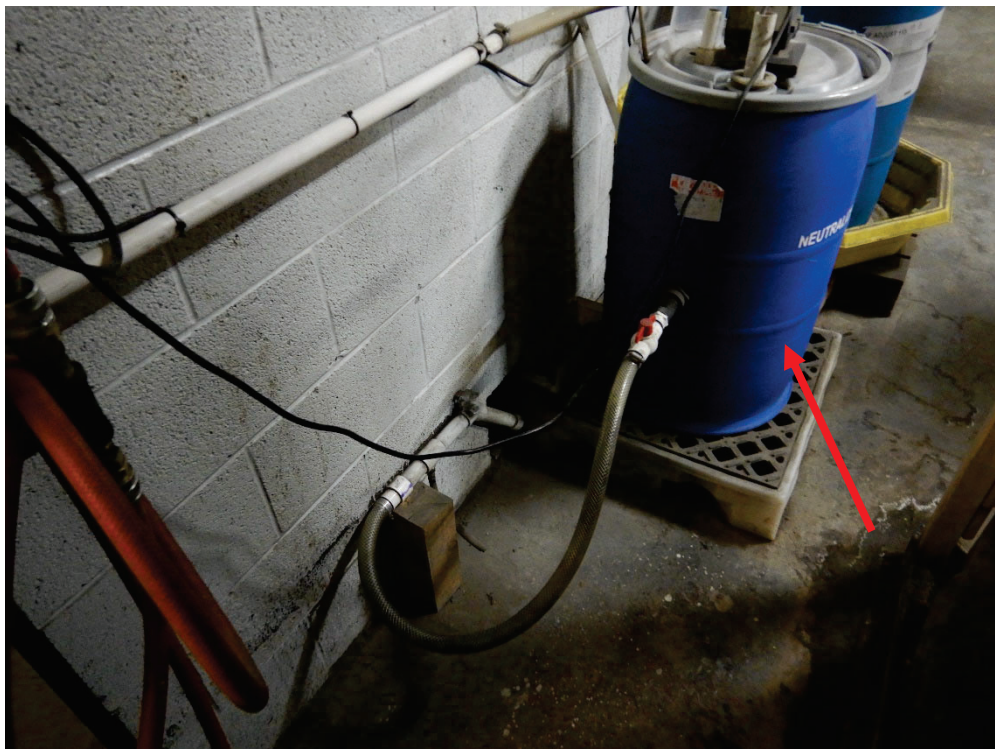
Photograph 4: Another view of the final discharge tank. Wastewater gravity flows from the tank through the hose identified by the red arrow.

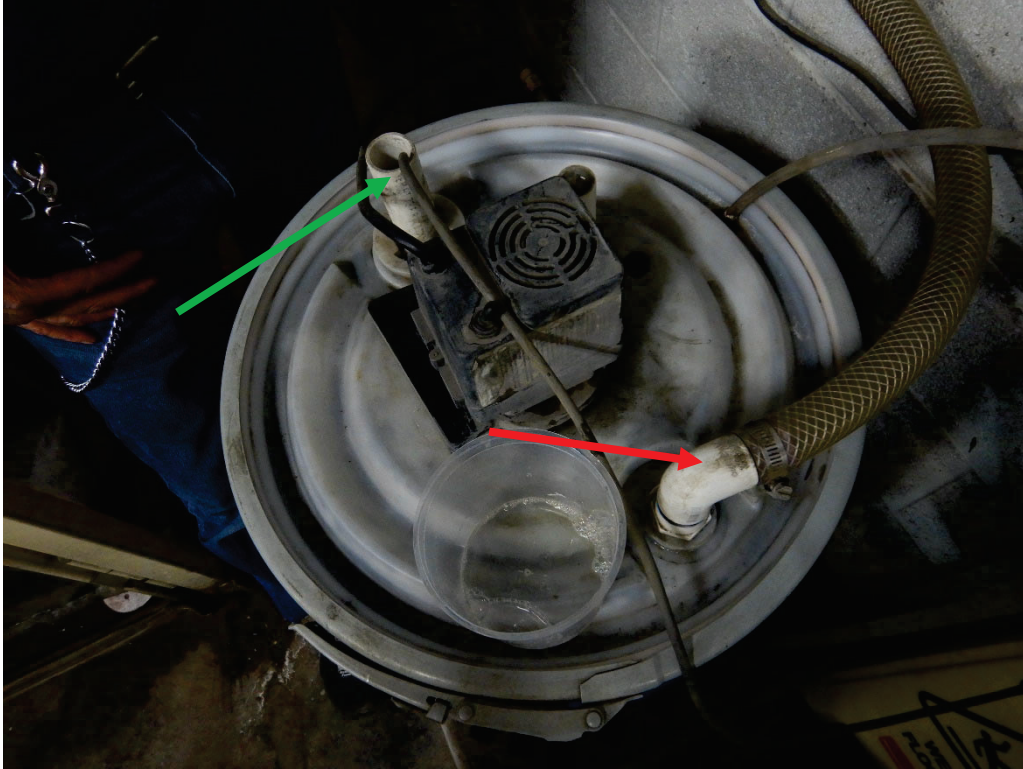
Photograph 5: A view of the top of the final discharge tank. The red arrow identifies the pipe used to convey wastewater from the final sump into the drum. The green arrow identifies the sample point.
