Re: EPA Inspection Report – Michigan Sugar Company Piling Grounds

**CLEAN WATER ACT COMPLIANCE EVALUATION INSPECTION REPORT
U.S. ENVIRONMENTAL PROTECTION AGENCY, REGION 5**

Facilities: Michigan Sugar Company – Piling Grounds of Albee, Blumfield, Breckenridge, Au Gres and Hope/Midland

Date of Inspection: March 23, 2022

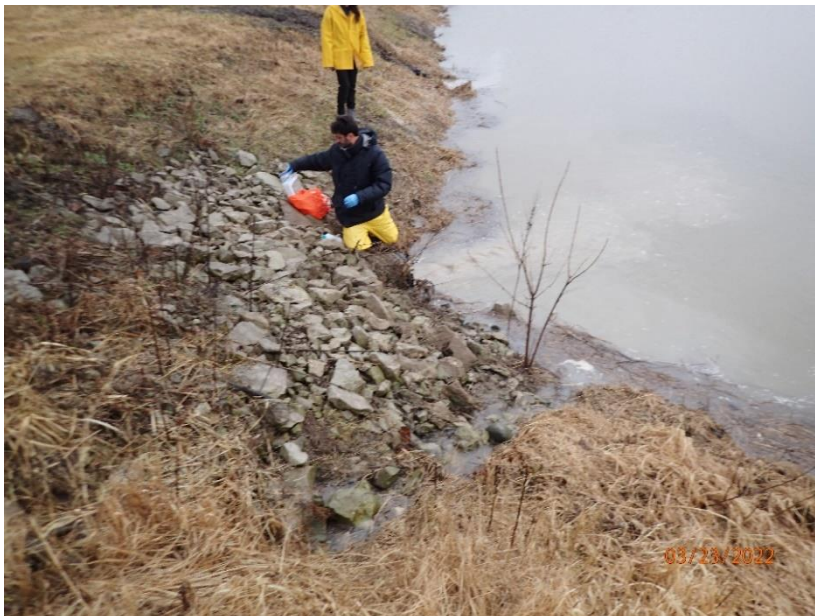
6: P3230083

Description: EPA took sample named “Albee” from the pipe that discharges stormwater from the piling ground into the pond at 8:29 A.M. EPA noted that it took six seconds to fill a one liter bottle.

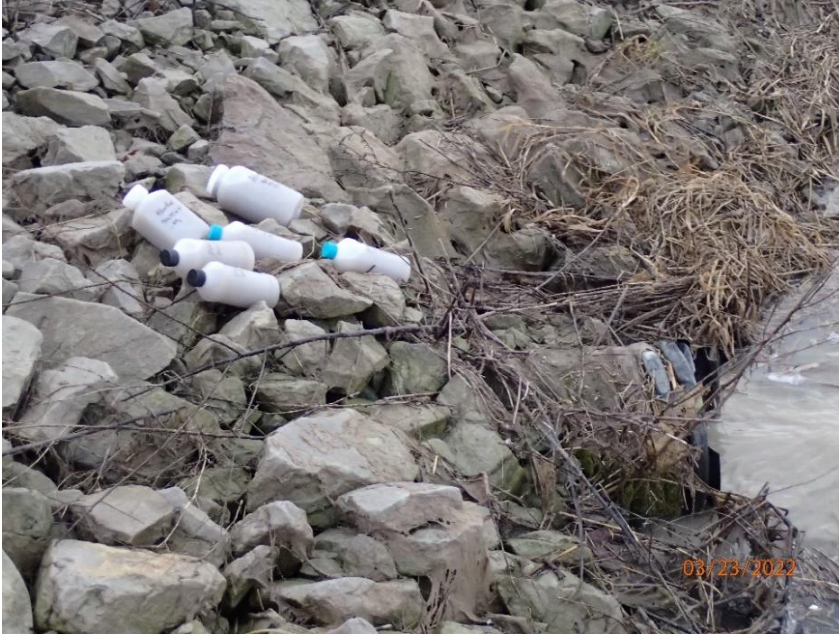
7: P3230084

Description: EPA split the samples with Michigan Sugar Company.

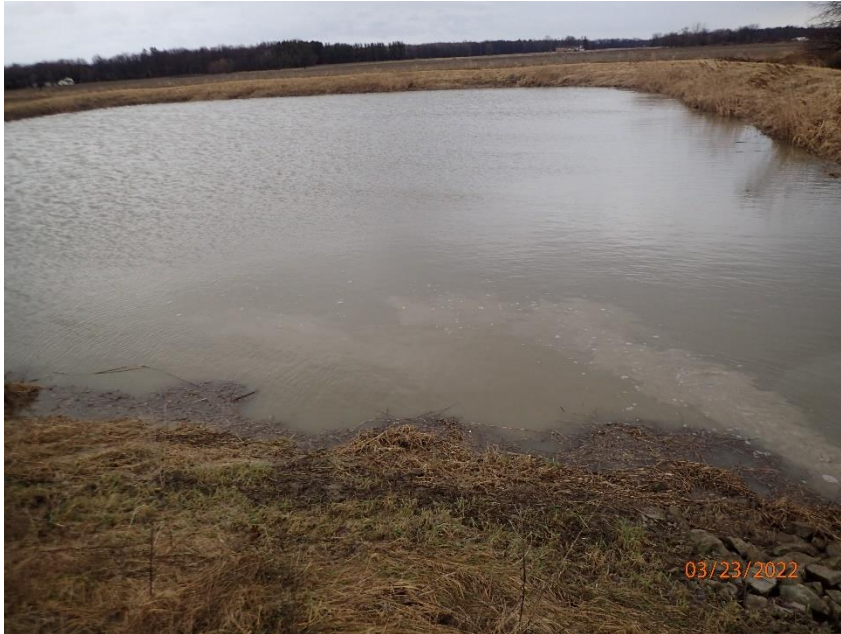
9: P3230086

Description: Note the plume into the pond from the pipe from the piling ground.

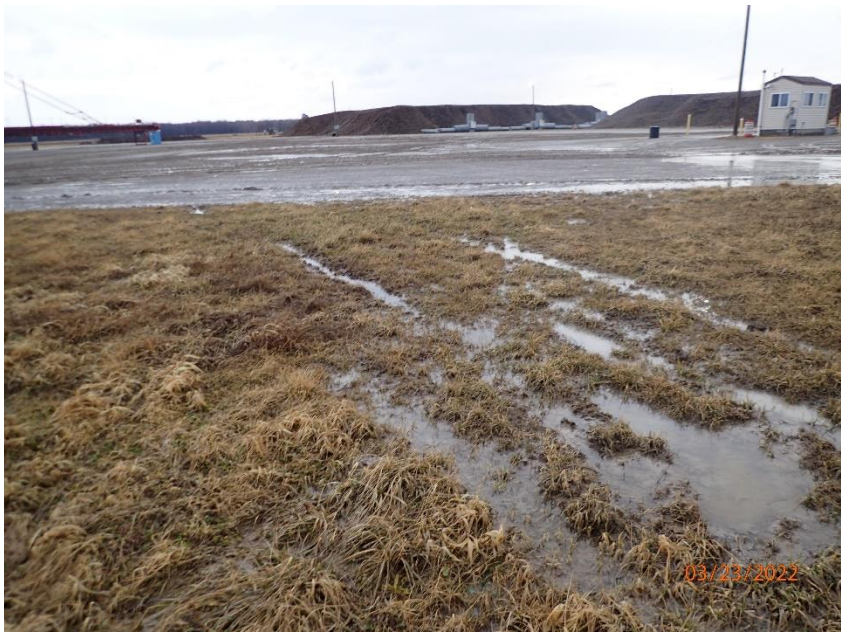
3: P3230087

Description: EPA also observed surface runoff from the piling ground to the pond.

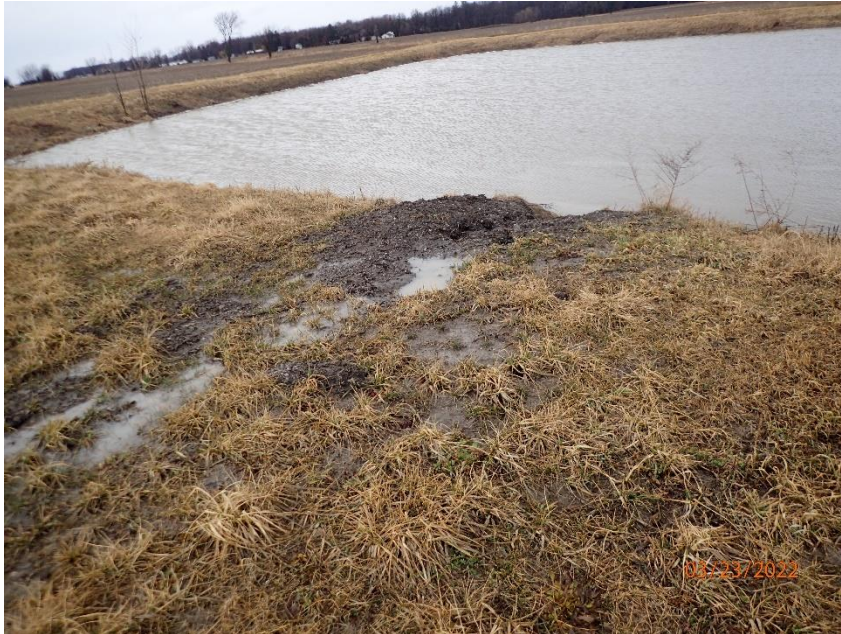
4: P3230088

Description: EPA also observed surface runoff from the piling ground to the pond.

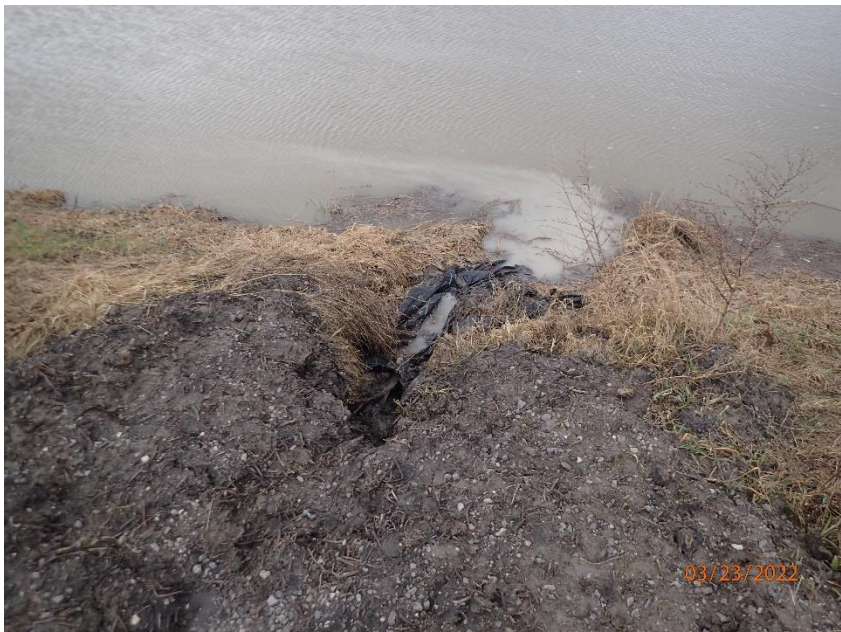
5: P3230089

Description: EPA also observed surface runoff from the piling ground to the pond.

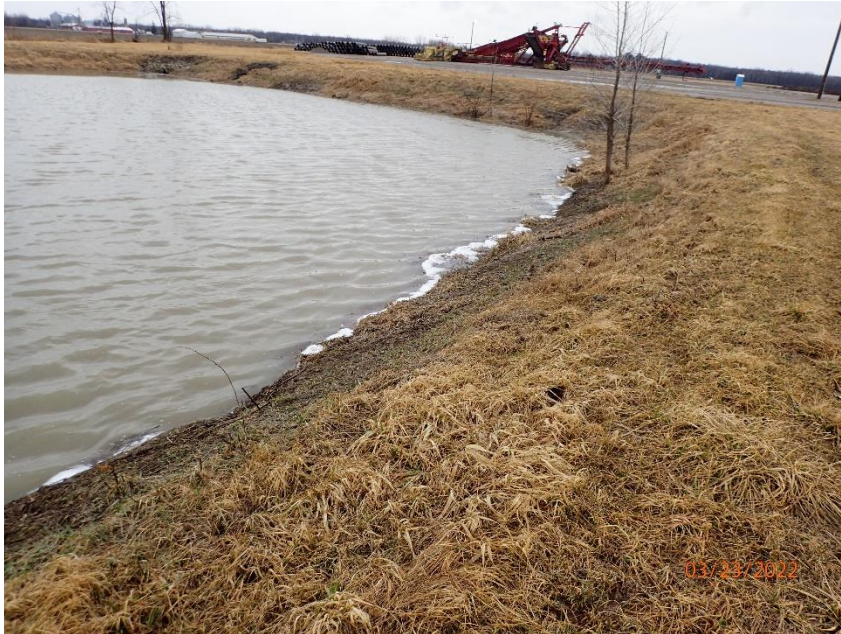
6: P3230090

Description: EPA observed foam on the edge of the pond.

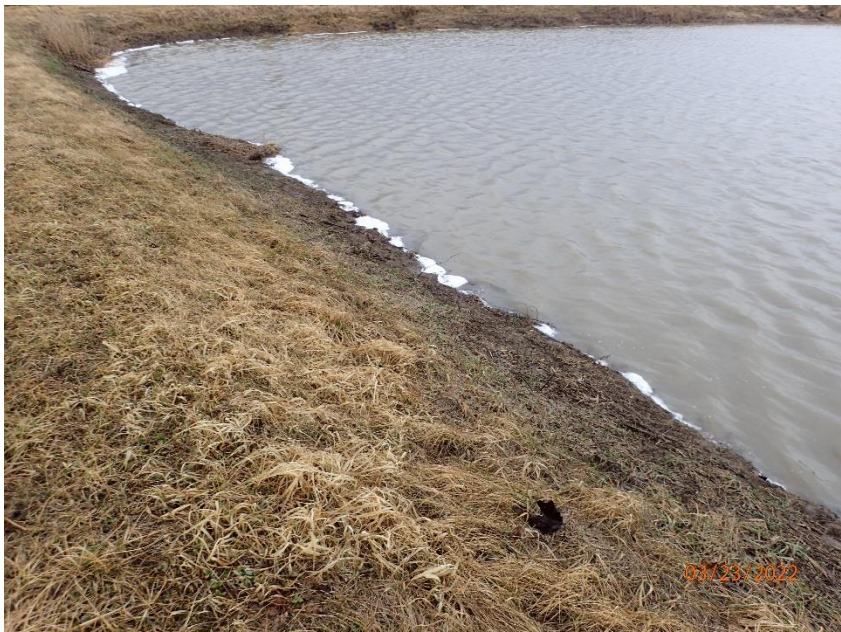
7: P3230091

Description: EPA observed foam on the edge of the pond.

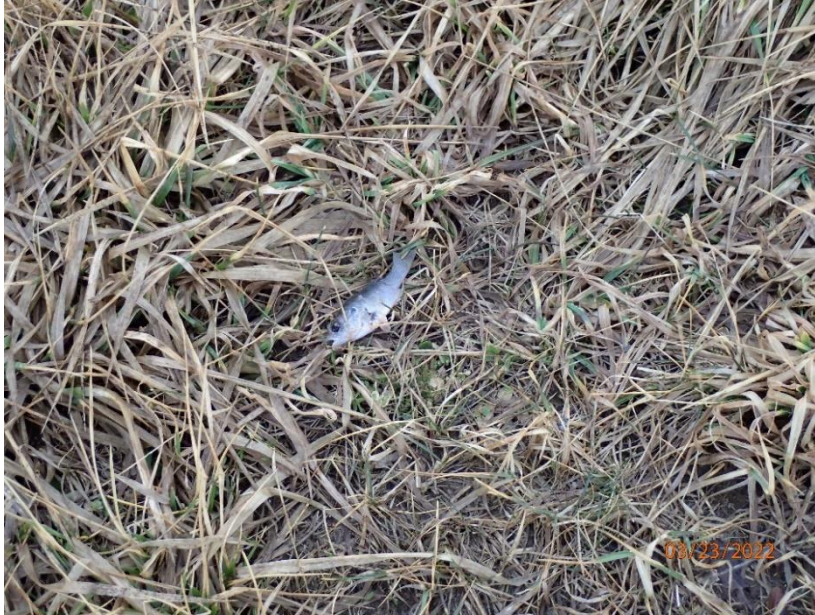
10: P3230094

Description: EPA noted dead fish on the embankment to the west of the pond.

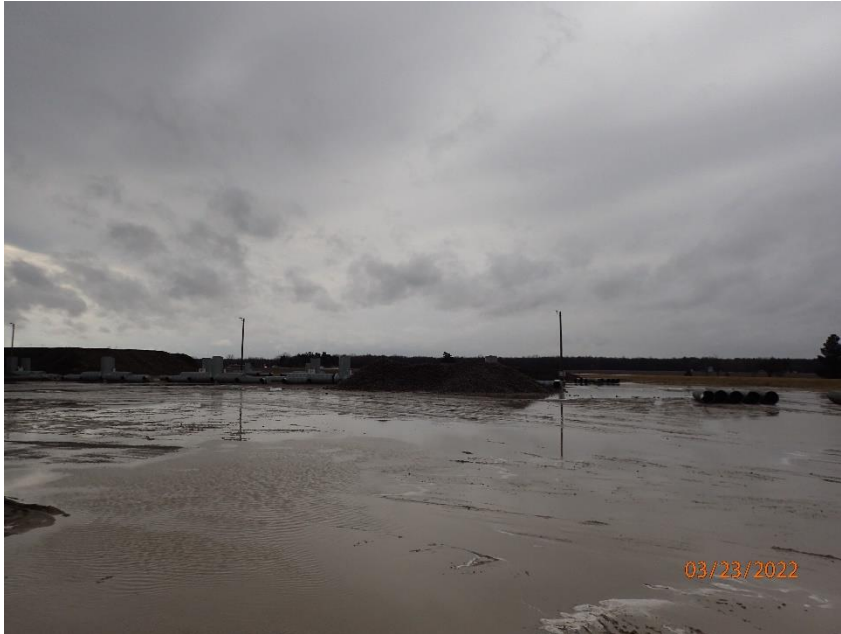
19: P3230096

Description: Precipitation that falls on the piling ground also falls on the piles of sugar beets.

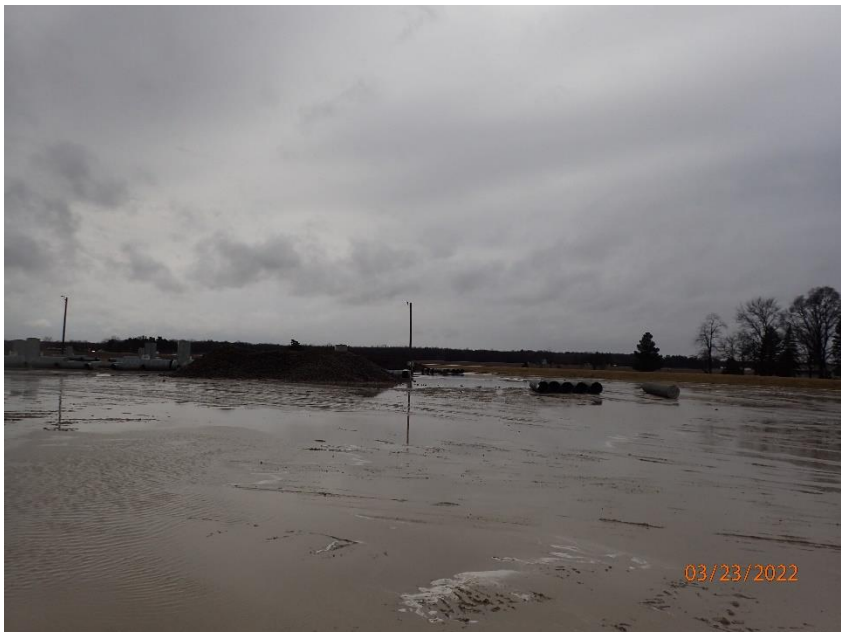
11: P3230097

Description: Precipitation that falls on the piling ground also falls on the piles of sugar beets.

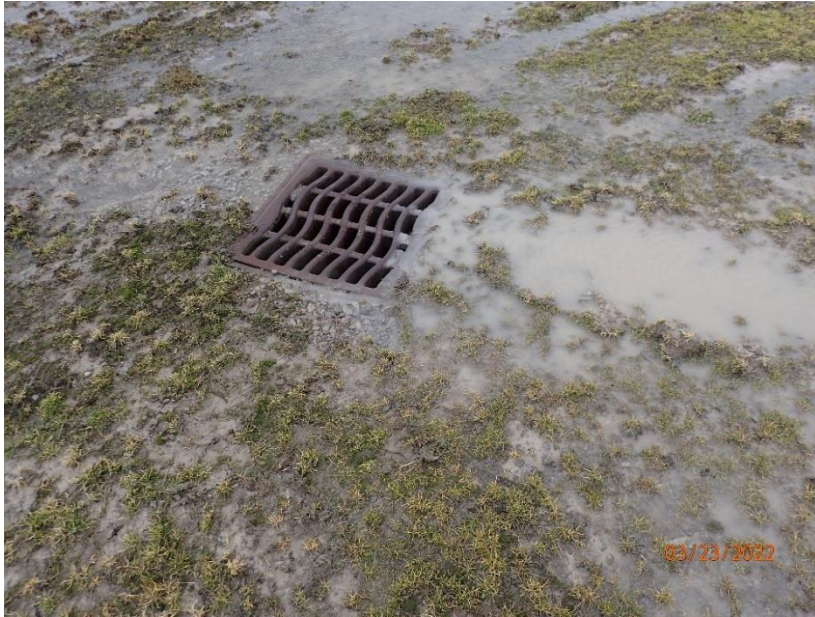
15: P3230101

Description: EPA observed the surface flow to the catch basin. This catch basin is the last one before the flow goes to the pond.

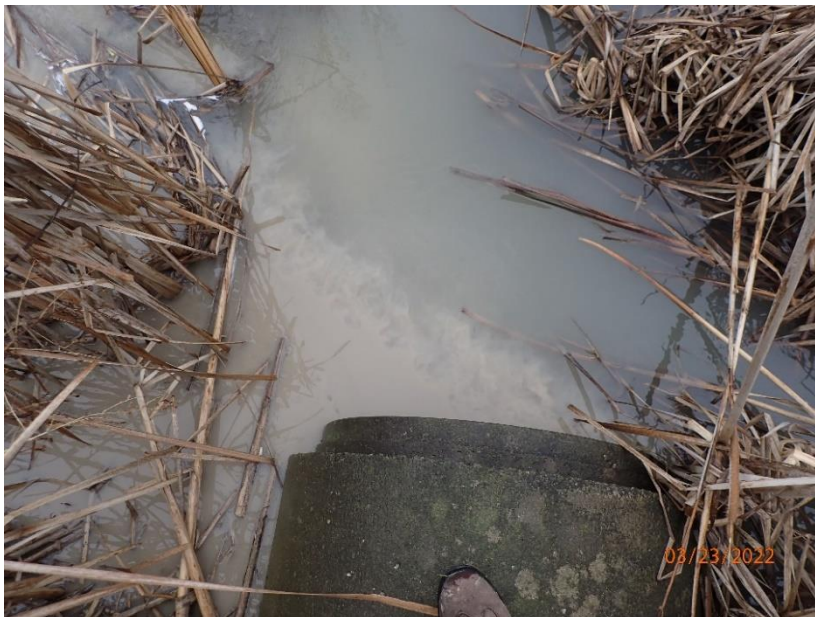
29: P3230104

Description: EPA observed a plume from the pipe from the Blumfield East Piling Ground to the pond northwest of the site.

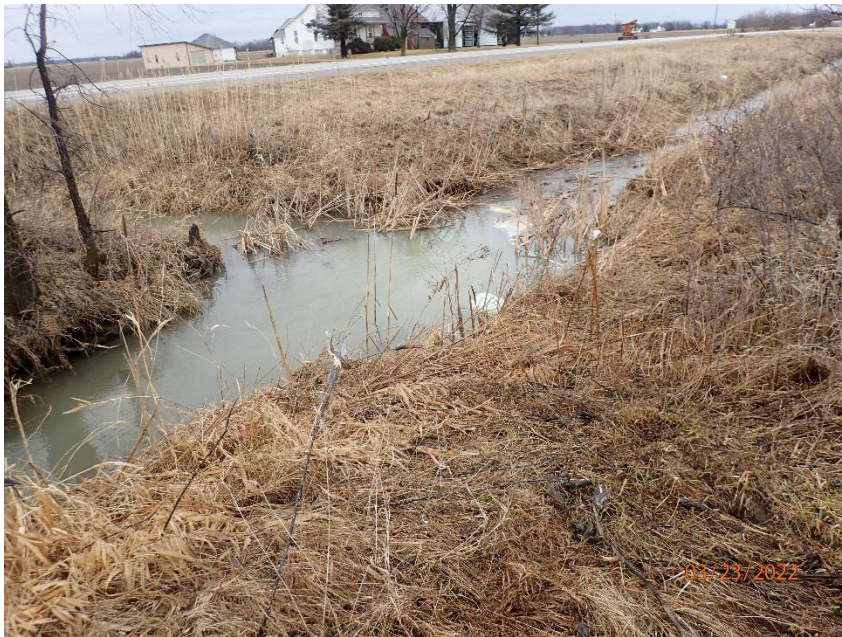
18: P3230108

Description: The pond discharges to a roadside ditch. The pipe was under water on the day of the inspection.

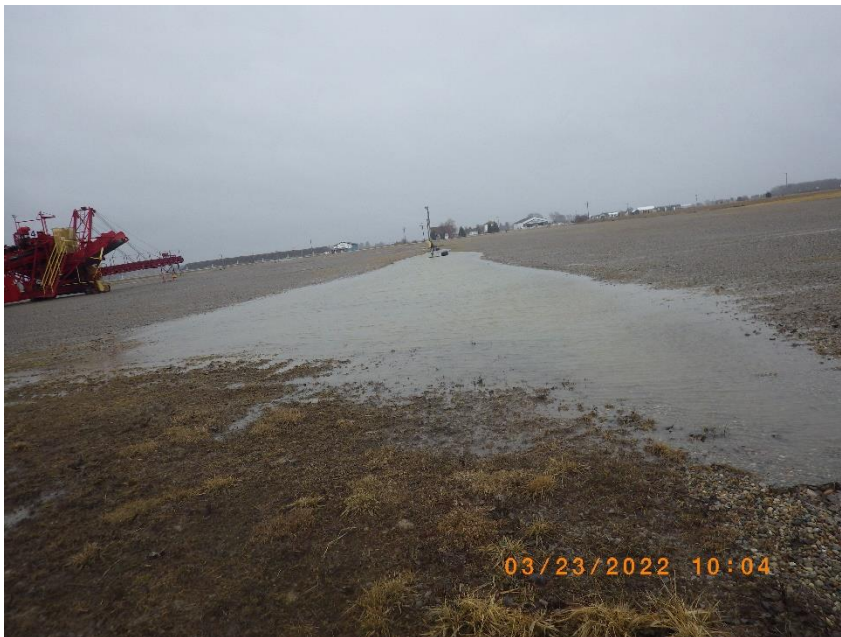
37: RIMG2490

Description: Runoff flowing west at Blumfield West piling ground.

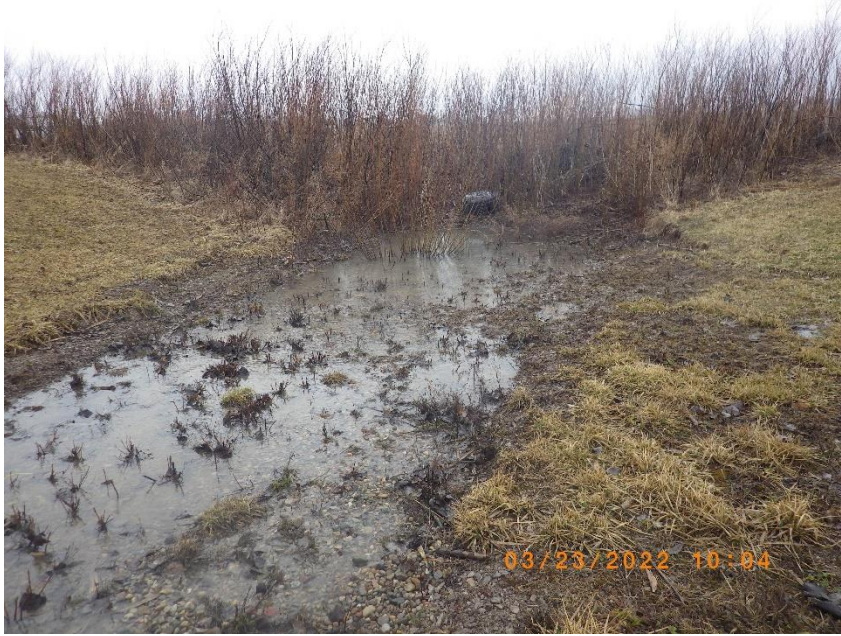
38: RIMG2491

Description: Runoff flowing west and entering a catch basin at Blumfield West piling ground.

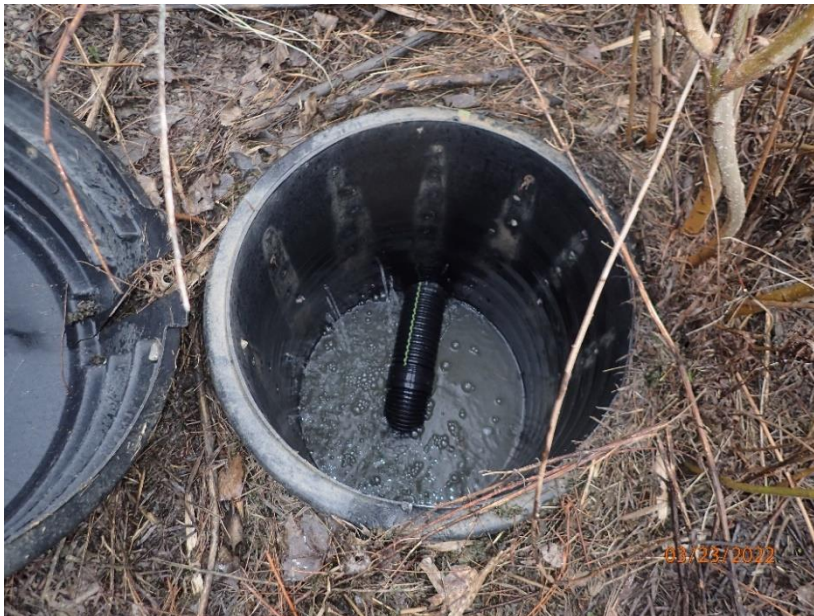
39: P3230112

Description: EPA observed water going into the catch basin on the east side of the berm on the west side of the Blumfield West Piling Ground.

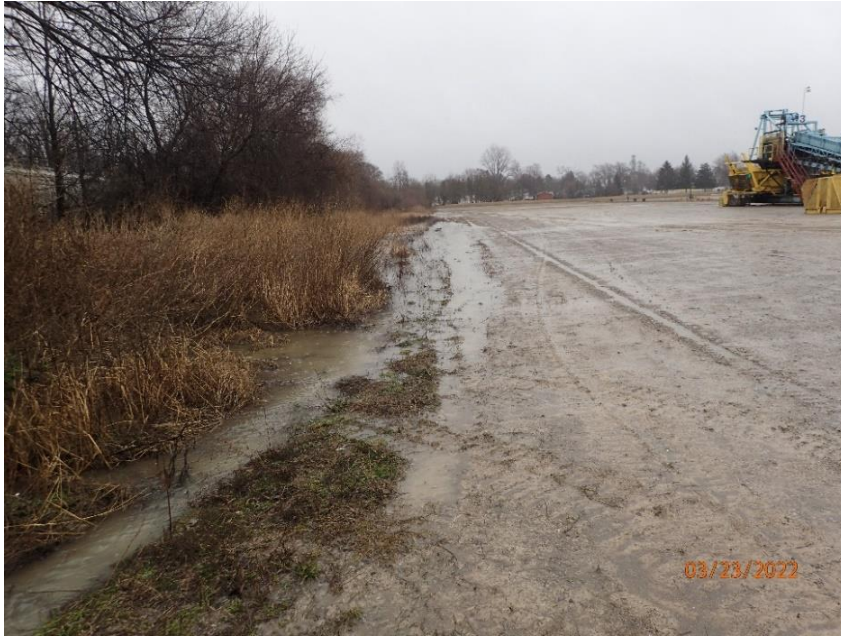
48: P3230117

Description: EPA observed the surface flow from the piling ground to the storm water structure.

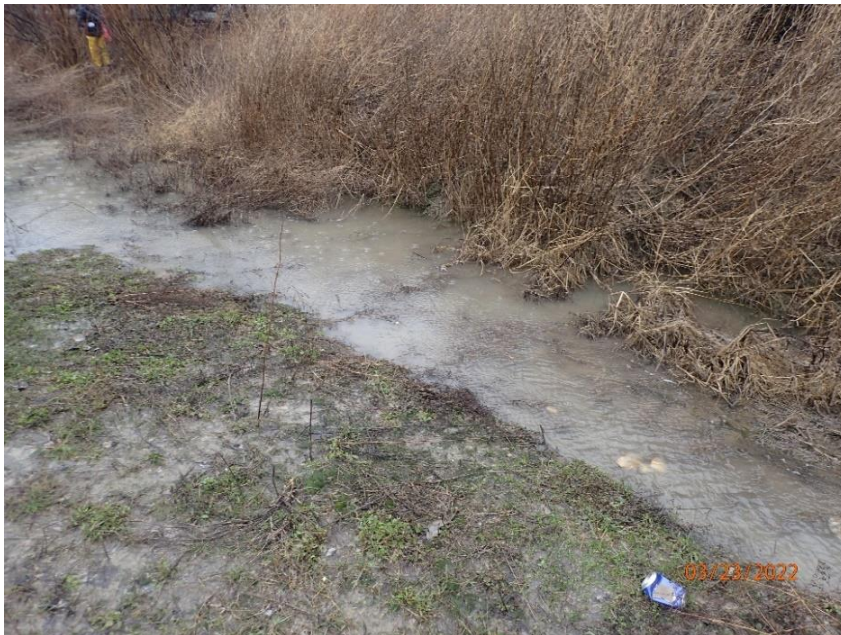
49: P3230118

Description: EPA observed the surface flow from the piling ground to the storm water structure.

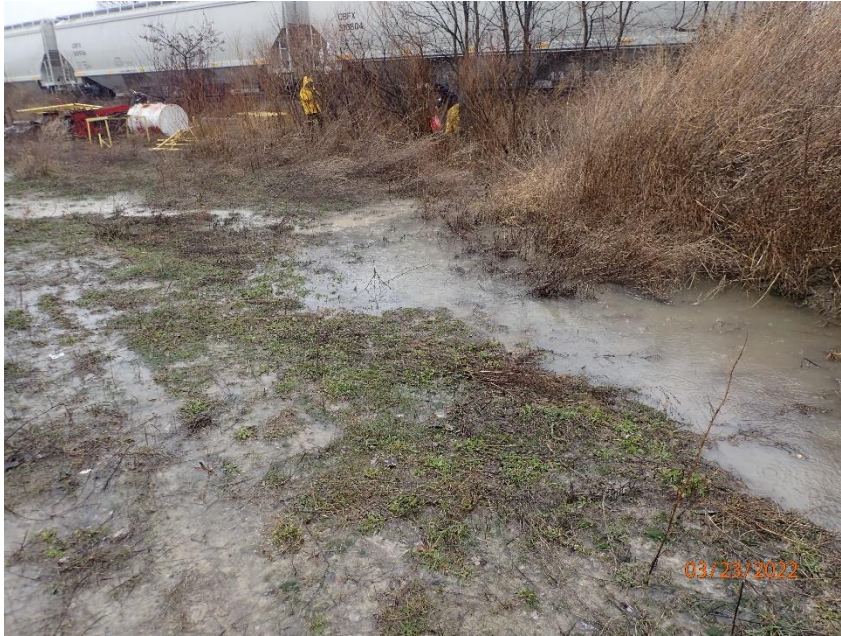
50: P3230119

Description: EPA observed the surface flow from the piling ground to the storm water structure.

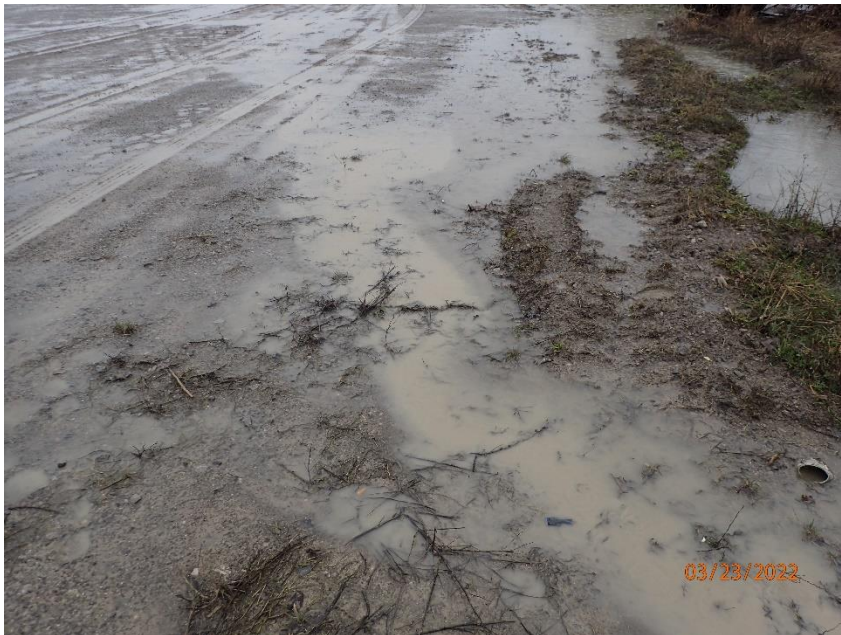
51: P3230120

Description: EPA observed the surface flow from the piling ground to the storm water structure.

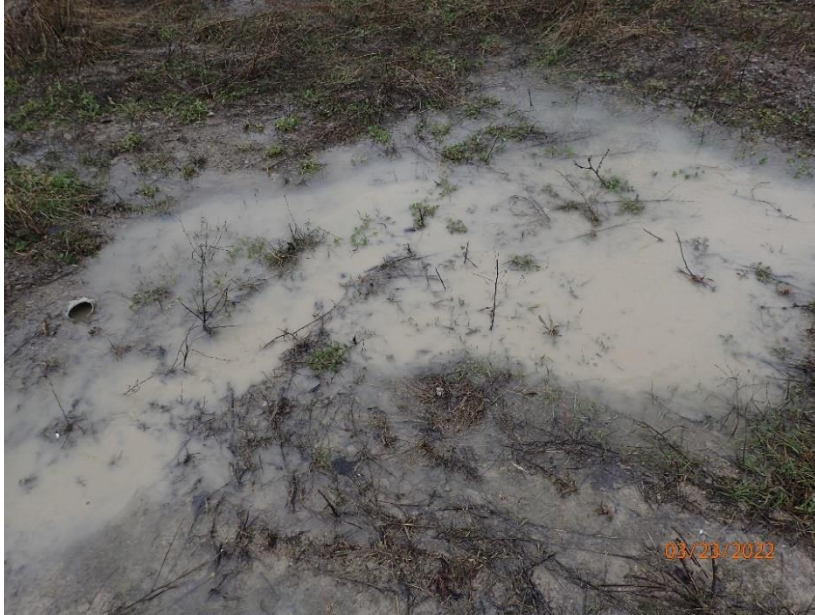
53: P3230121

Description: EPA observed the surface flow was milky and there was a plume from the piling ground.

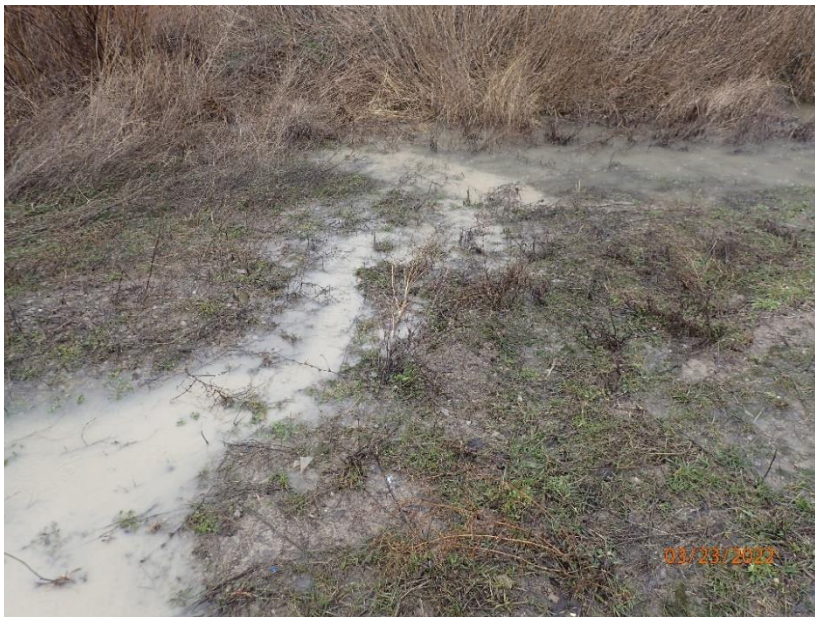
54: P3230122

Description: EPA observed the surface flow was milky and there was a plume from the piling ground.

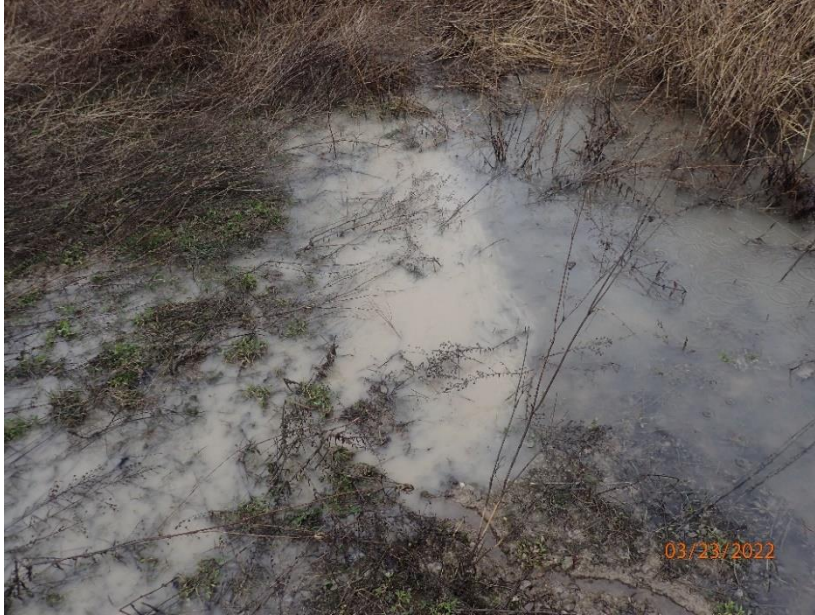
55: P3230123

Description: EPA observed the surface flow was milky and there was a plume from the piling ground.

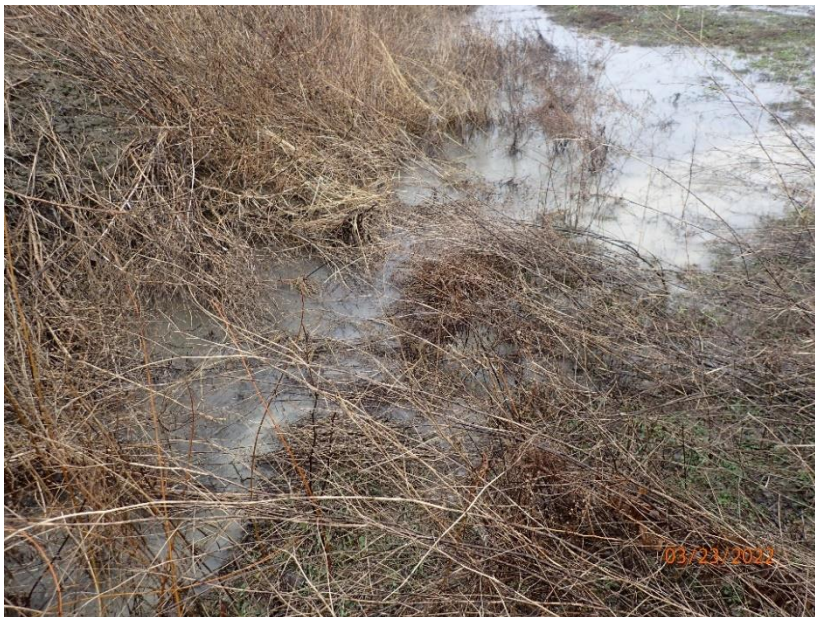
56: P3230124

Description: EPA observed the surface flow was milky and there was a plume from the piling ground.

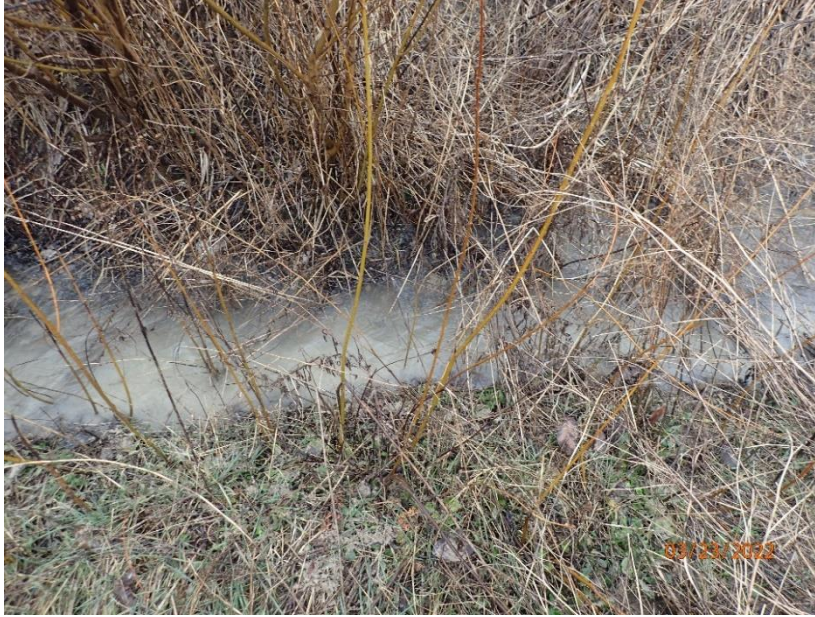
57: P3230125

Description: EPA observed the surface flow was milky and there was a plume from the piling ground.

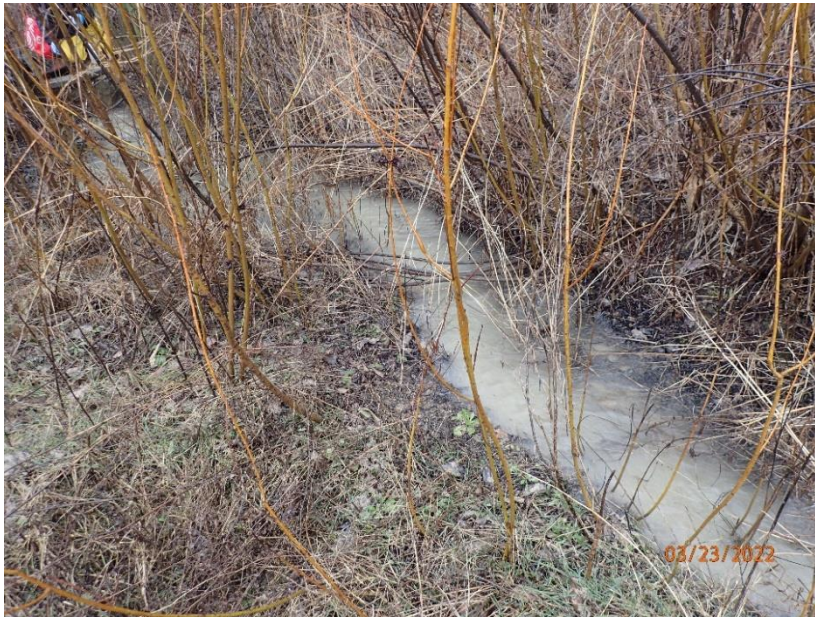
58: P3230126

Description: EPA observed the surface flow was milky and there was a plume from the piling ground.

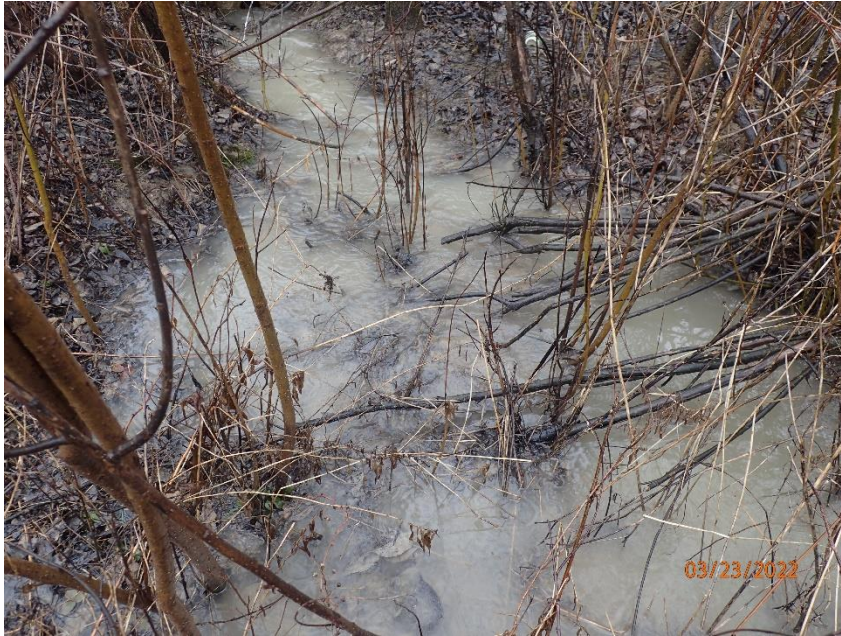
59: P3230127

Description: EPA observed the surface flow was milky and there was a plume from the piling ground.

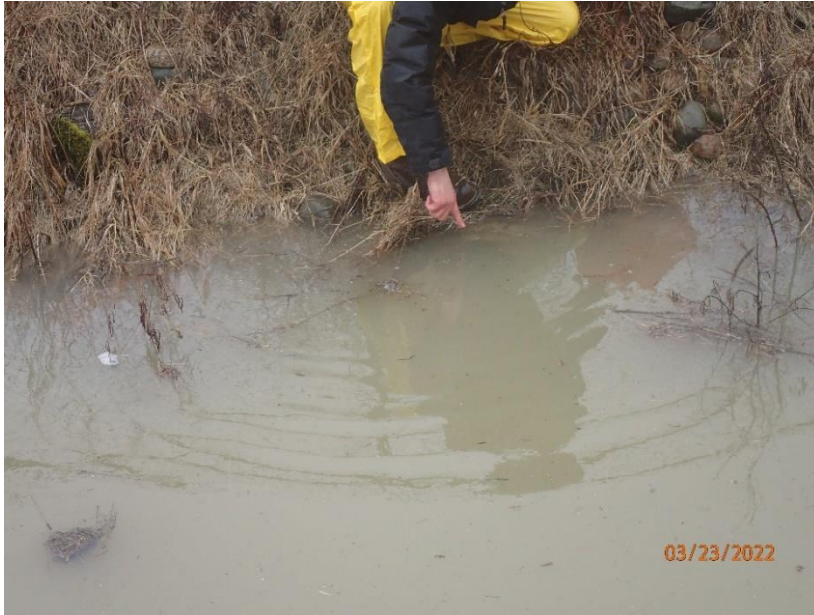
67: P3230135

Description: EPA noted where the outlet pipe to the ditch along Ransom Road was located. It was under water on the day of the inspection.

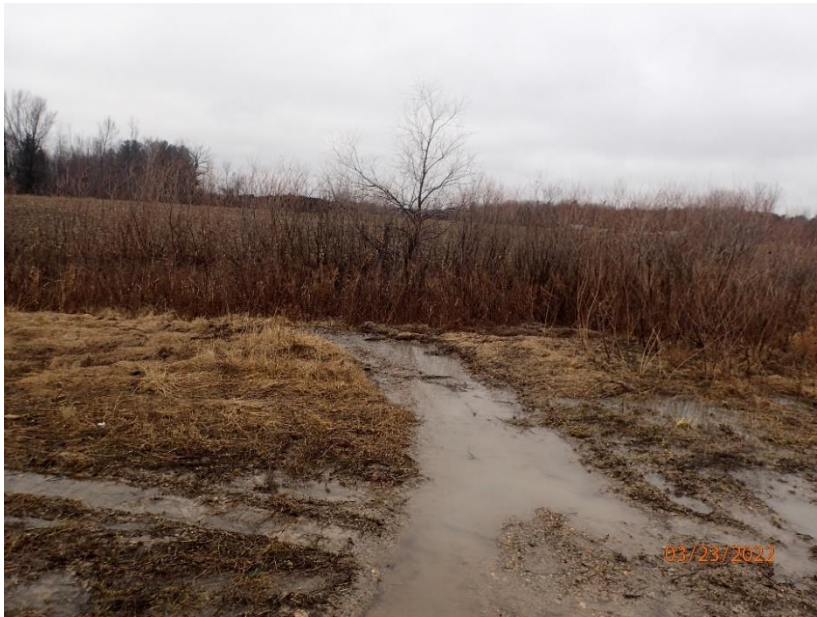
96: P3230161

Description: EPA also observed surface runoff to a ditch on the south side of the Hope/Midland Piling Ground.

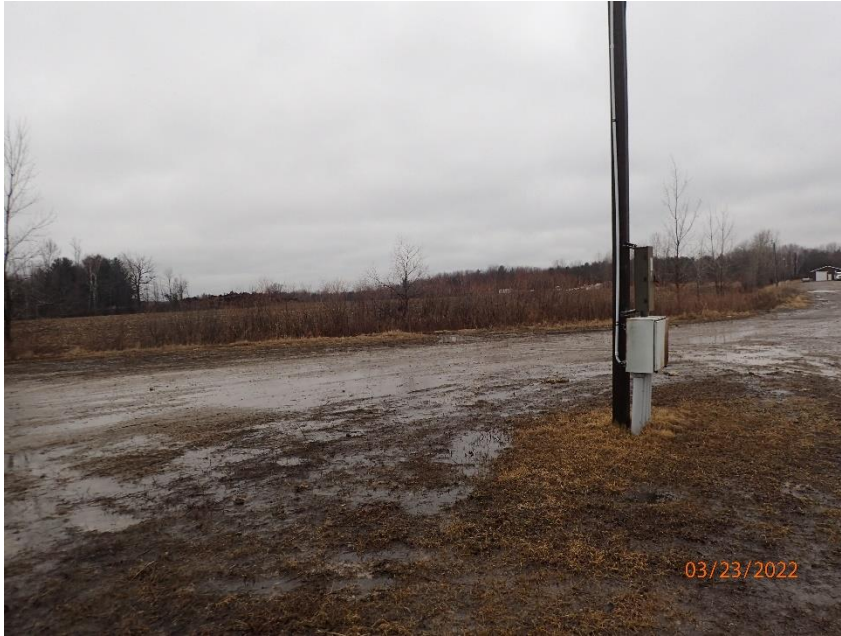
97: P3230162

Description: EPA also observed surface runoff to a ditch on the south side of the Hope/Midland Piling Ground.
