Re: EPA Inspection of Stiles and Hart Brick Company ("Stiles and Hart"), 127 Cook Street, Bridgewater, Massachusetts on September 3, 2024

**Subj:** Inspection Report  
Clean Water Act - National Pollutant Discharge Elimination System  
("NPDES")  
Stiles and Hart Brick Company

**From:** Eleanor Horvath, Inspector

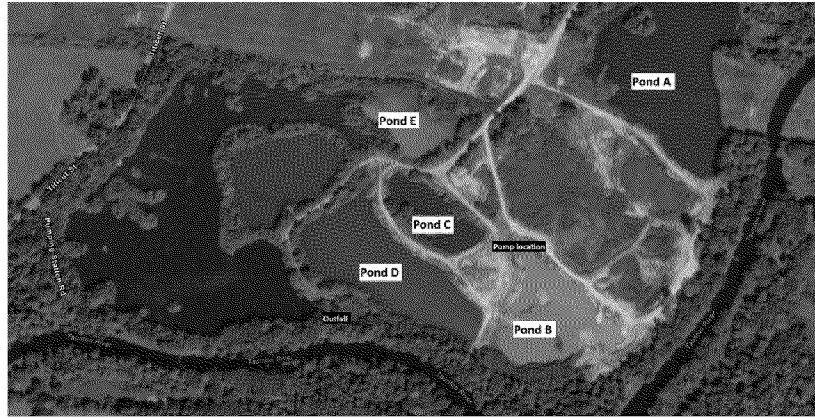
*Figure 1. Aerial image of mining areas with ponds labeled.*

From the manufacturing buildings, the inspection group walked west along a gravel roadway toward the mining ponds. The first body of water ("Pond A") was observed through dense vegetation to the south of the gravel road (*see photo 13*), approximately 0.15 miles from the buildings. Mr. Maltais described this as an old pit that was no longer used.

EPA observed a pump being used to move water from the southeasternmost pond ("Pond B"), and a diesel tank with an approximate capacity of 100 gallons associated with the pump (*see photos 4-7, 9-11*). Mr. Maltais explained that water is pumped from Pond B into an adjacent pond to the northeast ("Pond C"), from which water flows by gravity drainage through a culvert into the pond to the North ("Pond E"). Another area northeast of Pond B, south of Pond A, was entirely dry (*see photo 8 and figure 1*). This dry area is where facility representatives stated mining activities are currently being conducted. Facility representatives further explained that when mining activities are to be conducted in Pond B, water must be removed via the pump to enable the removal of clay by dragging a claw along the ground and loading the aggregated material into a dump truck.

The group walked counterclockwise around Pond D from the pump location, and observed the location where Pond E discharges on occasion into the Taunton River. Inspector Tedder observed the discharge location through very dense vegetation (see photos 1-2). Facility representatives stated that discharge into the river from Pond E usually occurs a few times per year, dependent on seasonal rainfall amounts.
