## CAA112(r) INSPECTION REPORT

| <b>Name:</b> Manor Chemical Company Inc. | |
| <b>Process:</b> NAICS Code: 422690 Other Chemical and Allied Products Wholesalers. The April 29, 2021, fire occurred in a paper adhesive mixing process. | |

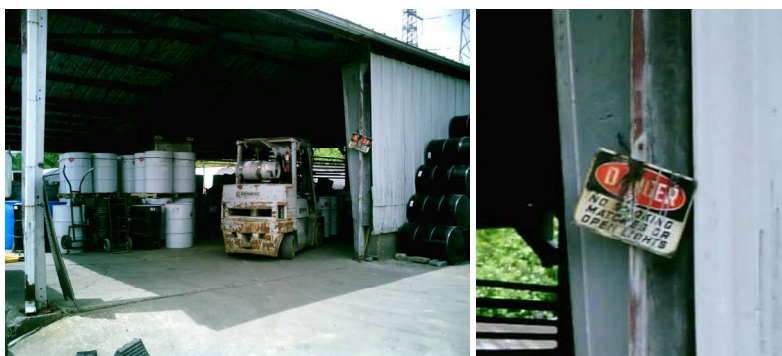
Manor appears to have recognized that flammability is a hazard at the site By: not allowing smoking onsite and labeling most chemicals with the National Fire Protection Association 704: Standard System for the Identification of the Hazards of Materials for Emergency Response hazard diamond. Seen in inspection photographs 4, 6, 8, 10, 11, and 12 (Attachment #3). Photograph 8, below, shows a flammable danger sign in the Dock area.

Figure 1: Photograph 8 – Flammable Danger sign in Dock Area

I observed a non-intrinsically safe propane powered forklift parked in the Dock area. As seen in inspection photograph 8. The taillights were open and not intrinsically safe. NFPA 70 National Electric Code defines an intrinsically safe apparatus as *“Apparatus in which all circuits are intrinsically safe.”* (NFPA 70, Article 100 Definitions).

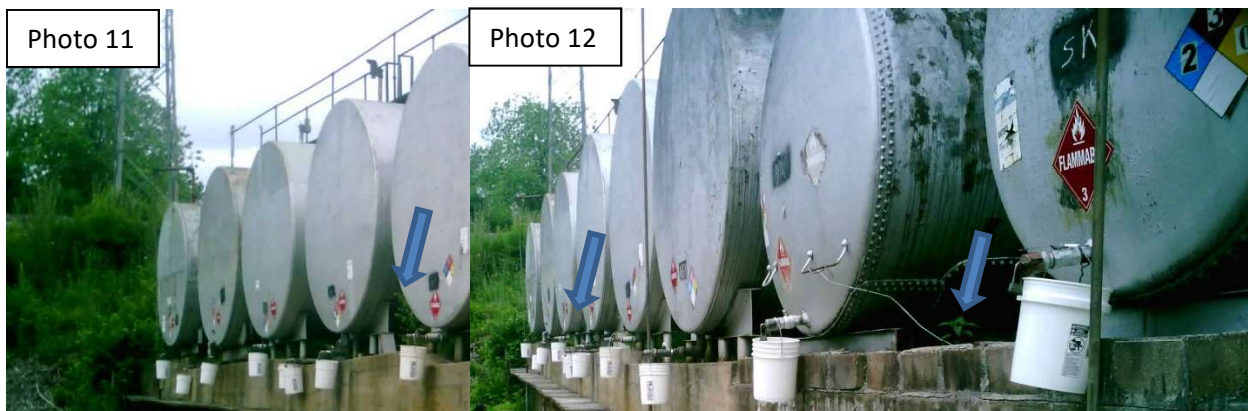
NFPA 30, 21.6.6.3 says, “Ground areas around tank storage facilities shall be kept free of weeds, trash, or other unnecessary combustible materials.” Some weeds were present near Manors bulk storage tanks as can be seen in Photographs 11 and 12. Shown below in a cropped version of photographs 11 and 12.

Figure 2: Photographs 11 & 12 – Note Weeds Between Bulk Tanks
