**UNITED STATES ENVIRONMENTAL PROTECTION AGENCY**  
**REGION 5**  
**77 WEST JACKSON BOULEVARD**  
**CHICAGO, ILLINOIS 60604**

**SUBJECT:** CLEAN WATER ACT INSPECTION REPORT  
*Fohl Village Mobile Home Park – 2500 Fohl Road S.W., Pike Township, Ohio, Stark County*

**Facility Type:** *Extended aeration treatment plant (privately-owned mobile home park)*

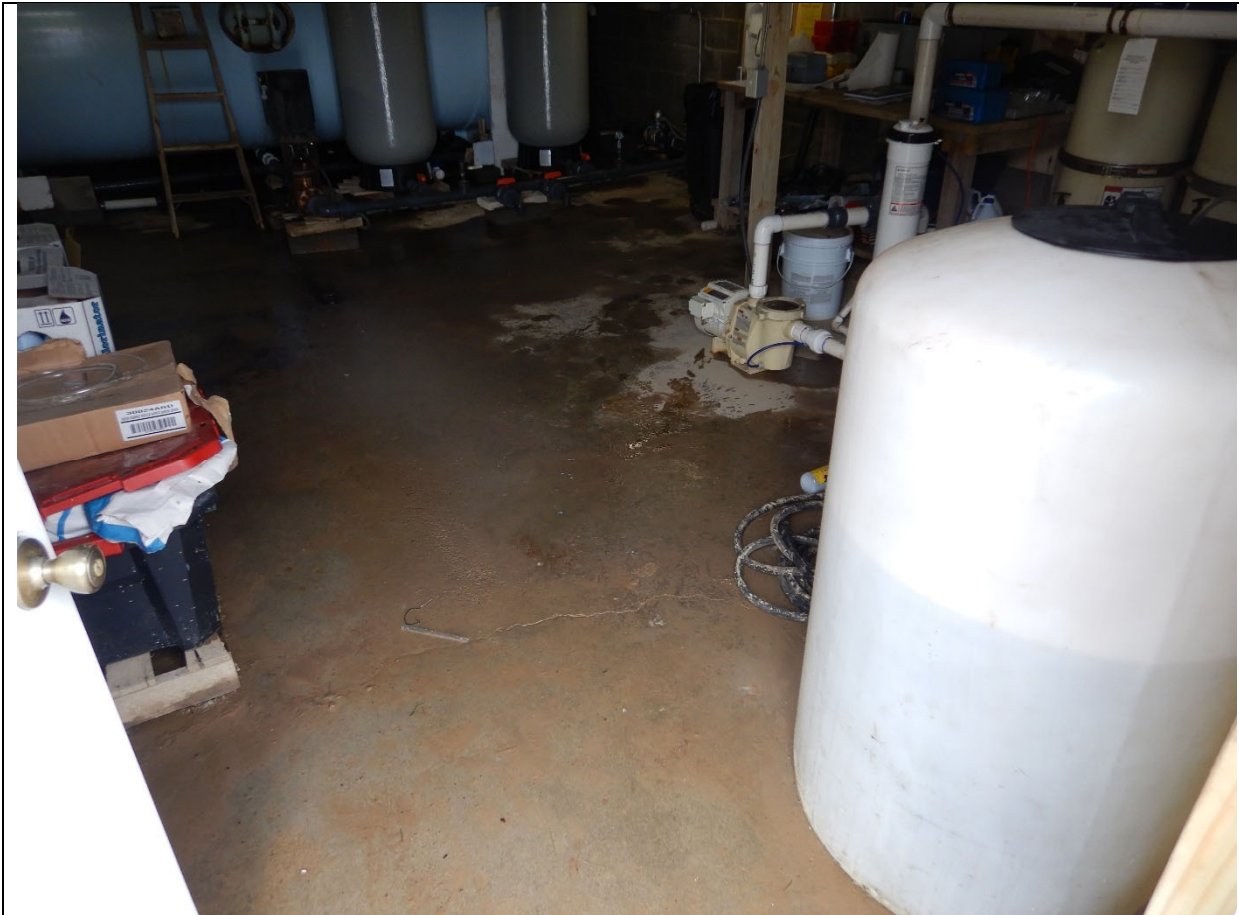
**1: DSCN1980.JPG**

There is a water treatment room for the drinking water system and the swimming pool. The room has a floor drain which drains by gravity to the sewer treatment plant. There was a plastic bulk tank with chlorine for the swimming pool as shown in photos 1 and 2. Leaks from this tank would allow chlorine to flow by gravity to the sewer treatment plant.

- a) There was no containment for a bulk tank of chlorine used for the swimming pool. Leaks from the bulk tank would flow by gravity to sewer treatment plant.*
- b) The comminutors and the alarm systems at the equalization basin were not fully functioning at the equalization basin at the time of the inspection.*
- c) Corrosion and growth on the clarifier weirs was causing uneven flow into the overflow trough. Pin flocs were visible in the clarifier and flowing over the weir.*
- d) Two of the six lamps in the UV system were burned out.*

Description: Inside the water treatment room and pool equipment room. The large white poly tank contains chlorine for the pool. There was a floor drain in this room that was connected to the sanitary sewer.

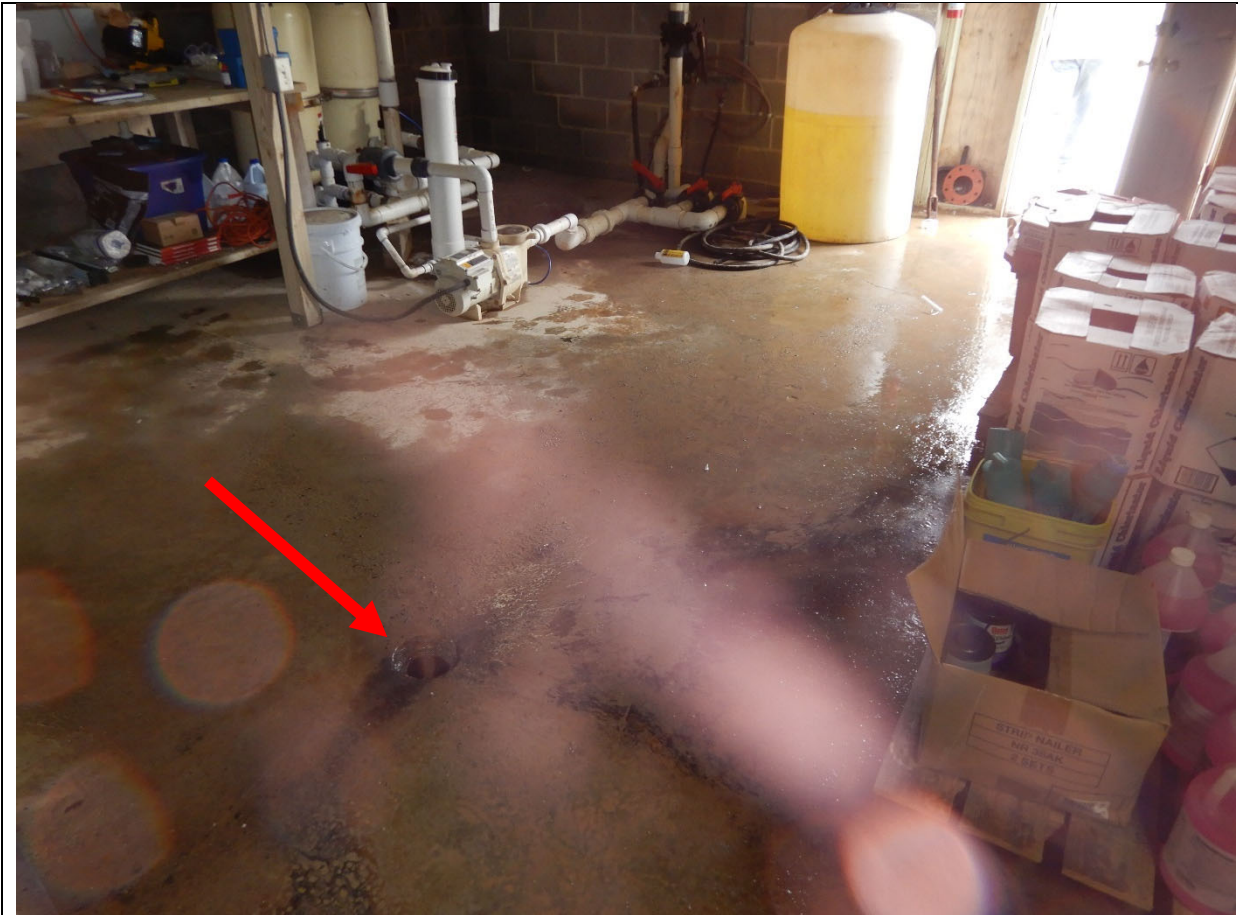
**2: DSCN1981.JPG**

**Description:** Inside the water treatment room and pool equipment room. The large white poly tank contains chlorine for the pool. There was a floor drain (marked with an arrow) in this room that was connected to the sanitary sewer.

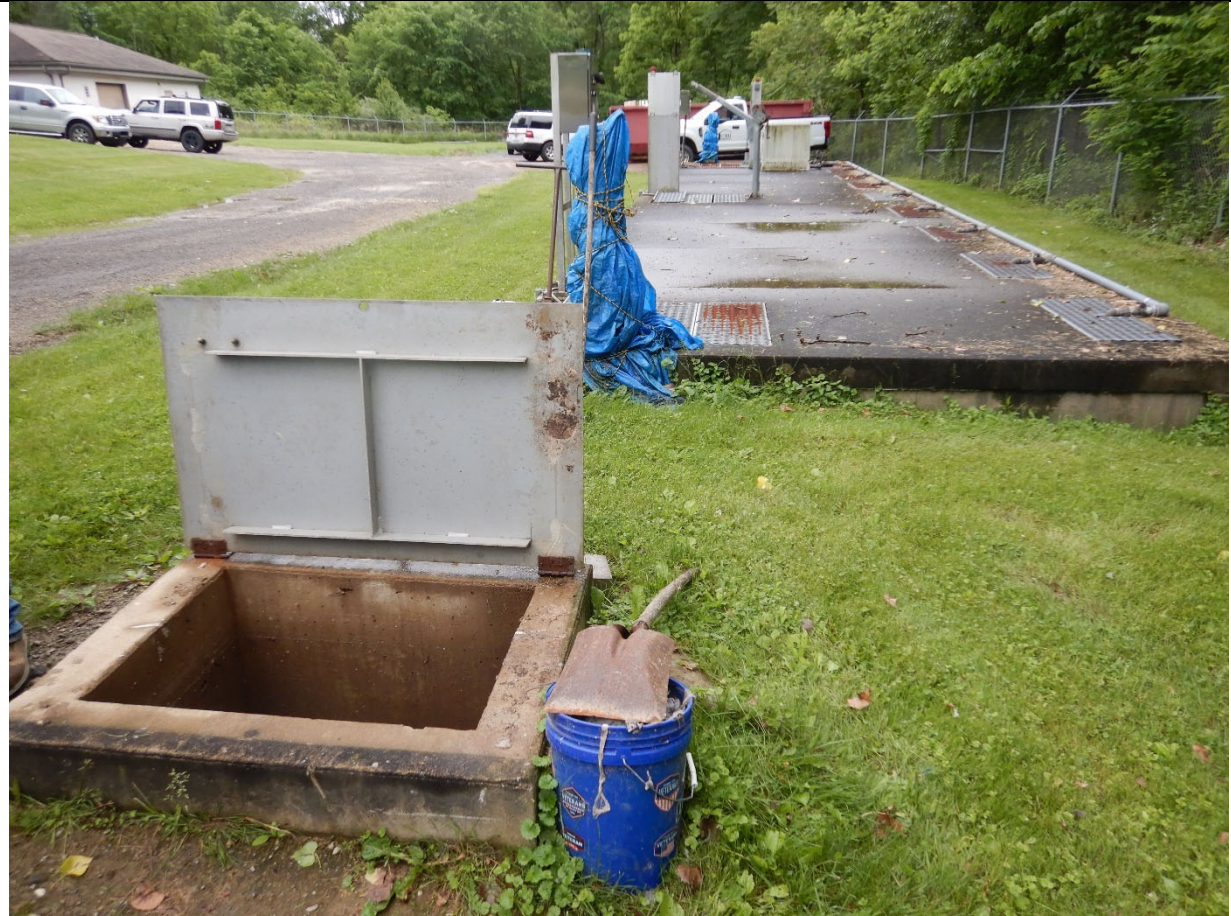
4: DSCN1983.JPG

Two comminutors, shown wrapped in blue tarps in photo 4, were out of service at the time of the inspection.

Description: At the headworks of the sewer treatment plant. The large concrete structure is an equalization basin and the equipment wrapped in blue tarps are mechanical pumps that were not in service at the time of the inspection.

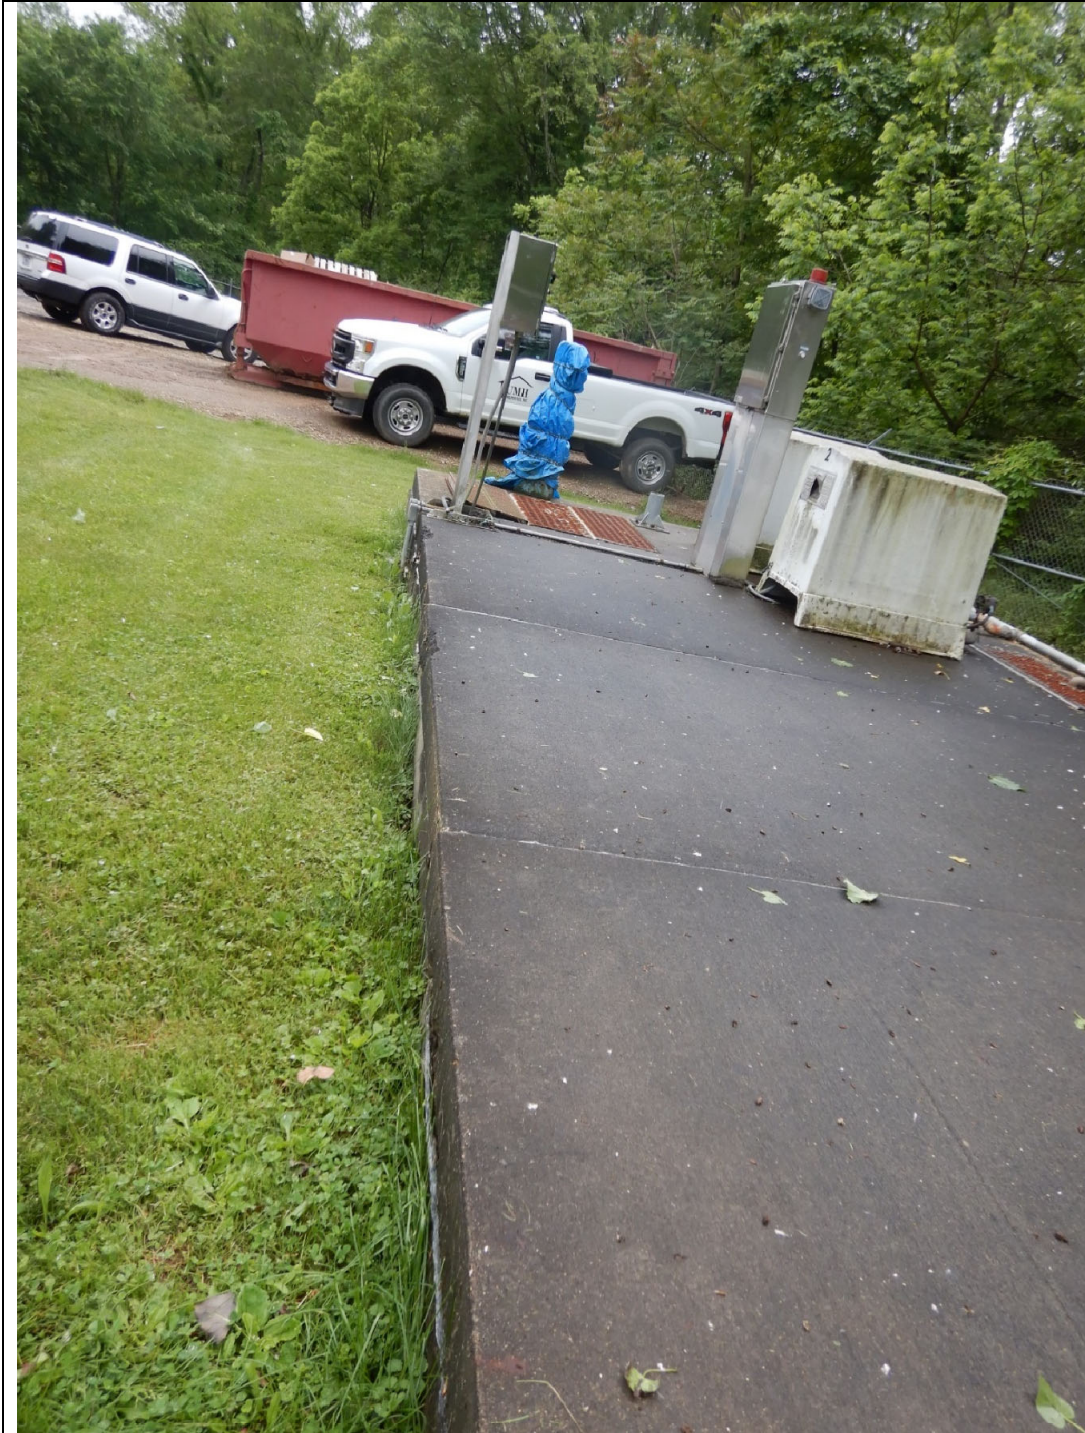
10: DSCN1989.JPG

Description: At the headworks of the sewer treatment plant. The large concrete structure is an equalization basin and the equipment wrapped in blue tarps are mechanical pumps that were not in service at the time of the inspection.

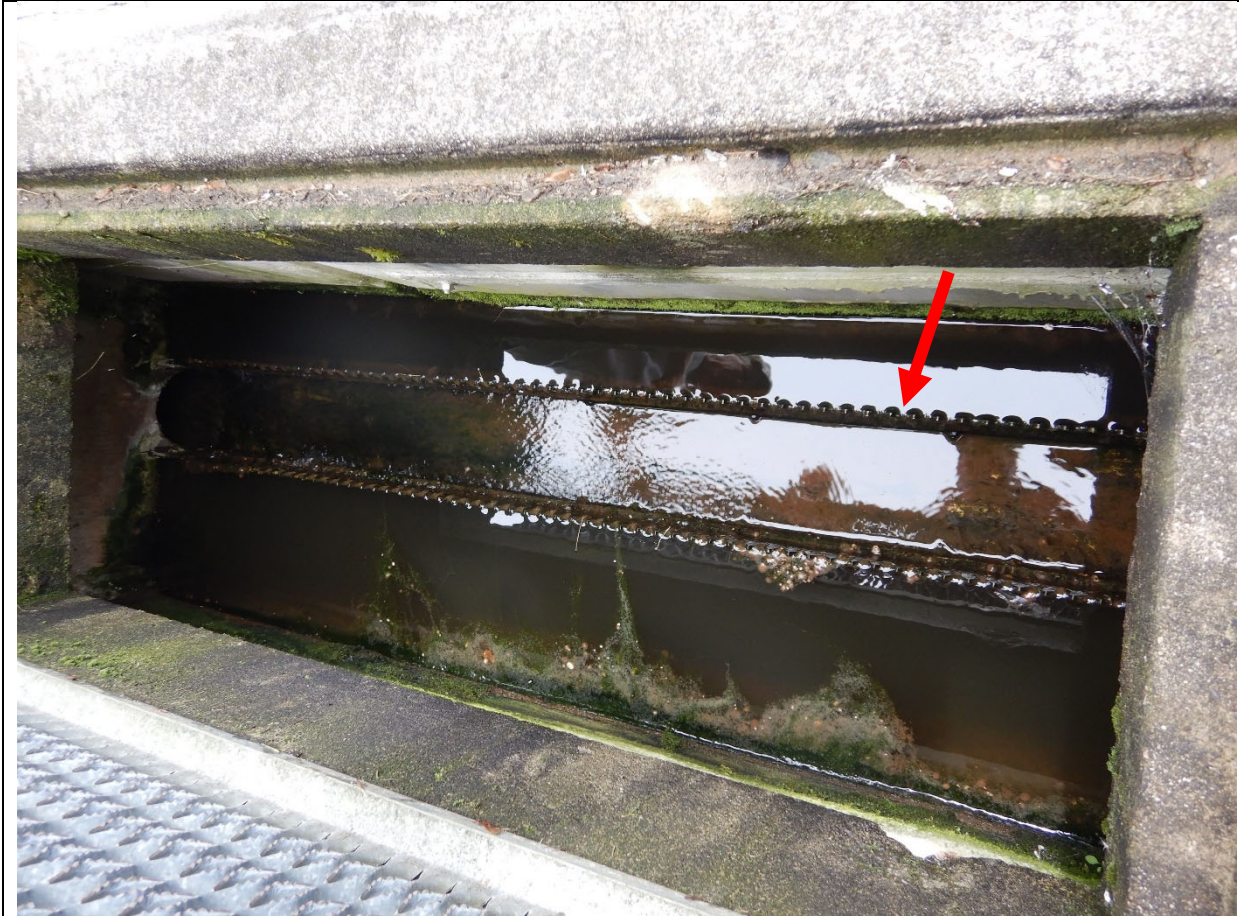
17: DSCN1996.JPG

There was growth and corrosion on the weirs in the clarifier which caused uneven flow into the overflow trough as shown in photo 17.

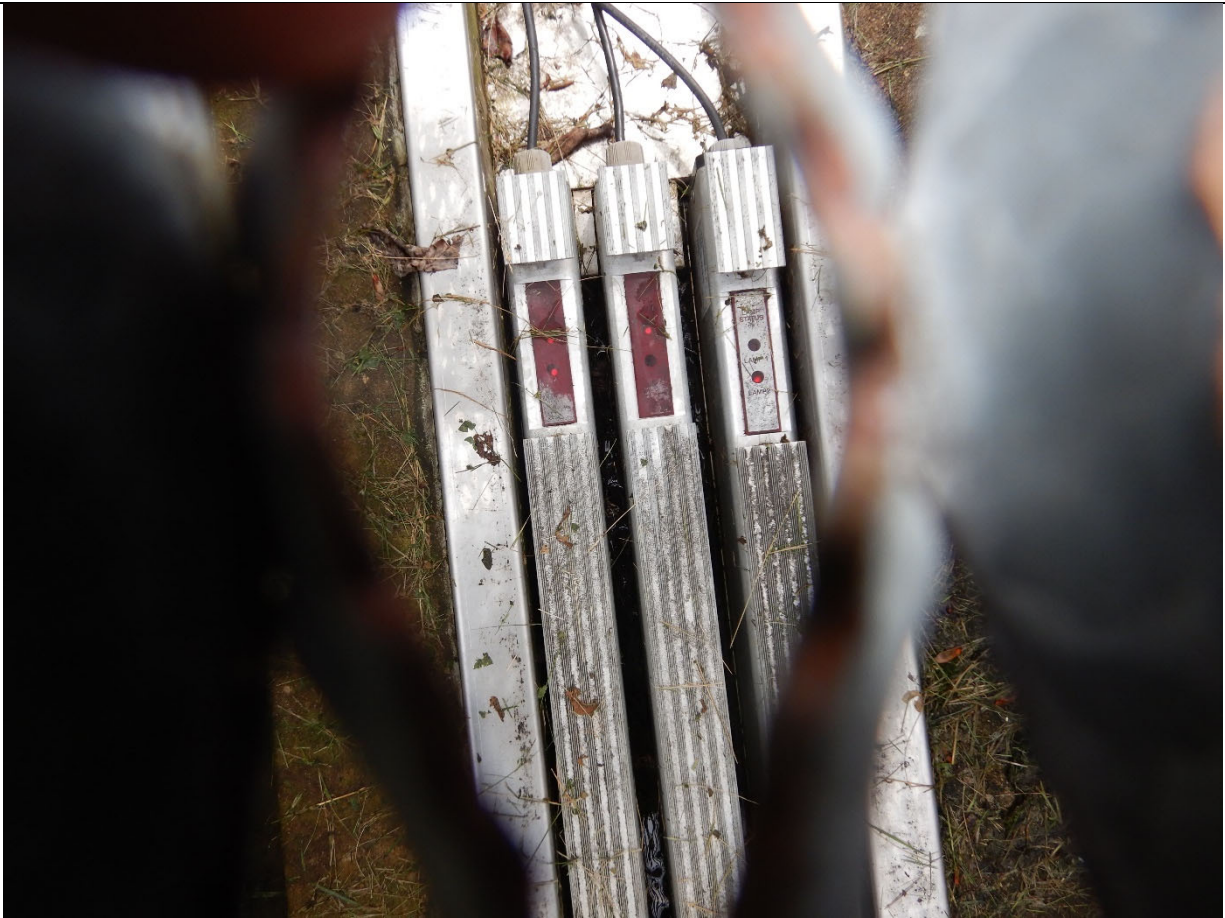
25: DSCN2004.JPG

Two of the six lamps in the UV system were burned out at the time of the inspection. See photo 25.

Description: UV system. At the time of the inspection two of the six lamps were burned out.
