**U.S. ENVIRONMENTAL PROTECTION AGENCY  
REGION 5**

**Purpose:** Pretreatment and Industrial Storm Water Compliance Evaluation Inspection

**Facility:** Poly-Wood, LLC  
1001 West Brooklyn Street  
Syracuse, IN 46567

**Date of Inspection:** May 31, 2023

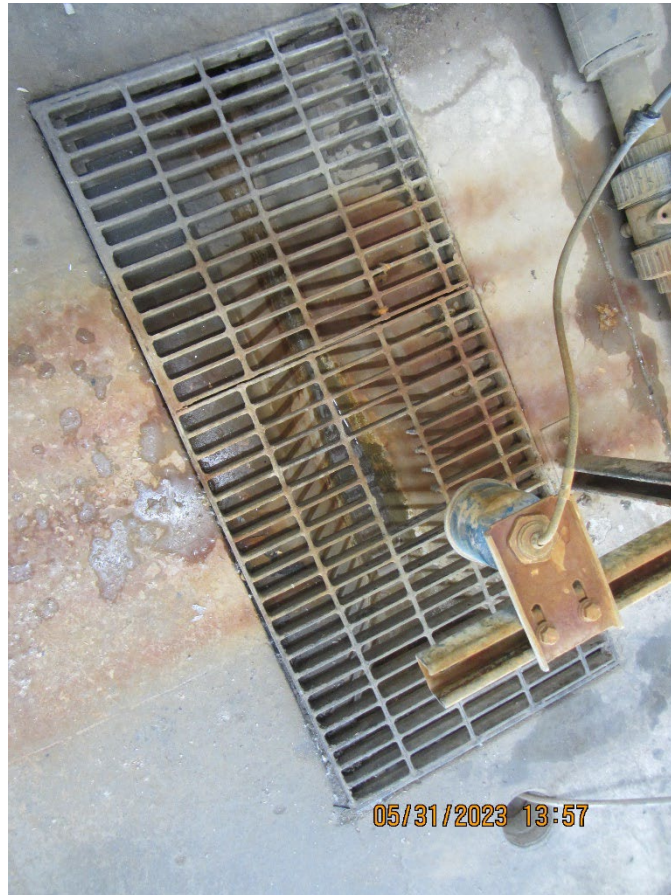
1: IMG\_0308

Description: Sampling location

Location: Powder coating line

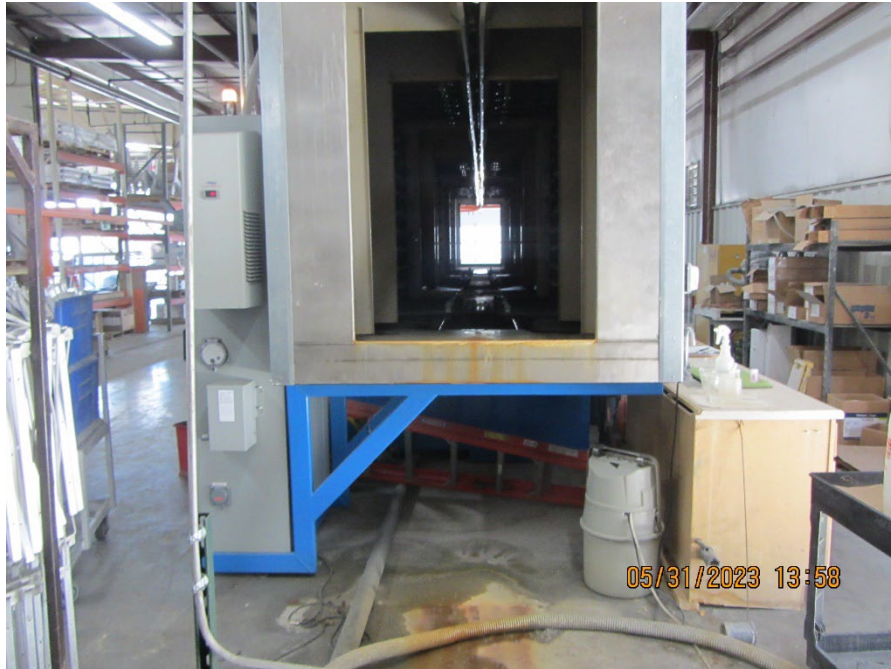
2: IMG\_0309

Description: Automated washing process

Location: Powder coating line

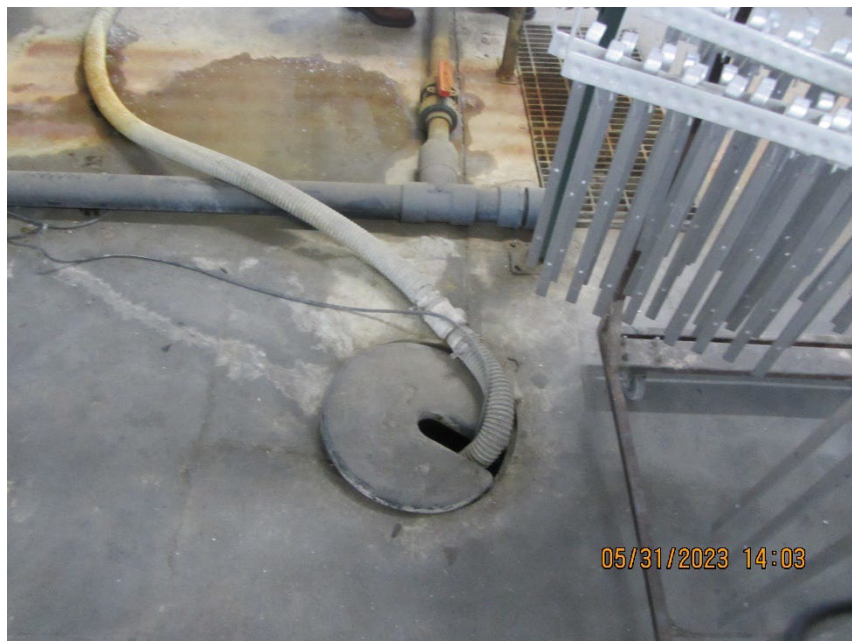
3: IMG\_0310

Description: Overflow sump.

Location: Powder coating line

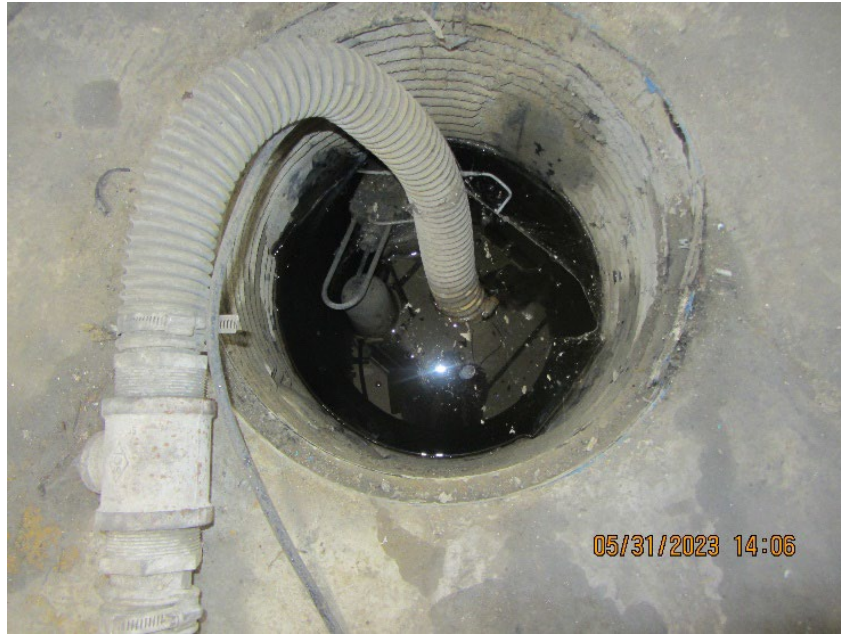
4: IMG\_0311

Description: Water inside of sump in Photo 3, which is pumped back into sampling trench.

Location: Powder coating line

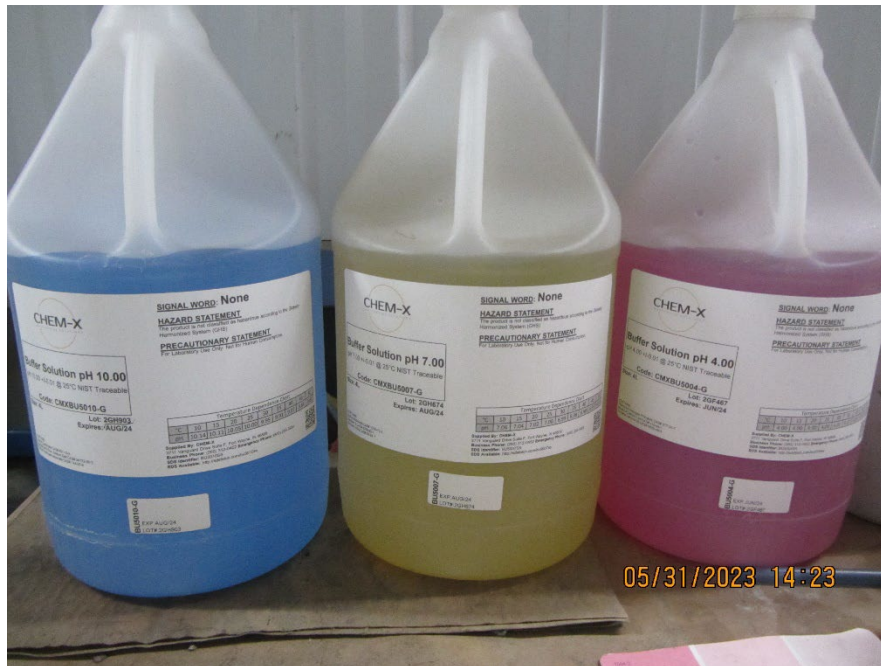
6: IMG 0313

Description: pH buffers. None are past expiration.

Location: Powder coating line

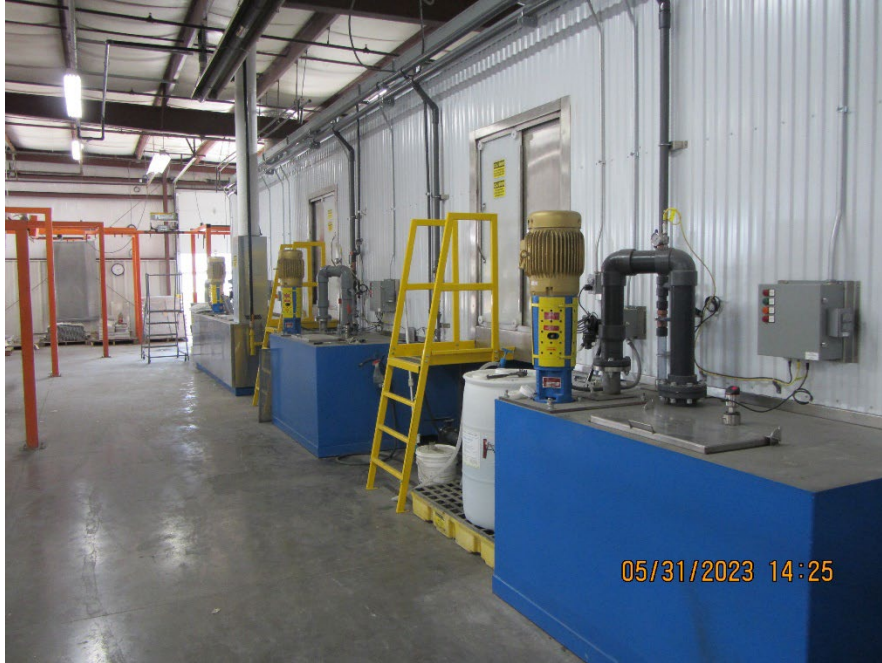
8: IMG\_0315

Description: From left to right, Stage 1 (Etch), Stage 2 (etch is rinsed off), and Stage 3 (neutralization). Stage 2 water goes to POTW; Stages 1 and 3 water is hauled off-site. Small drum between Stages 2 and 3 is for pH adjustment, and the large barrel is for conversion coating.

Location: Powder coating line

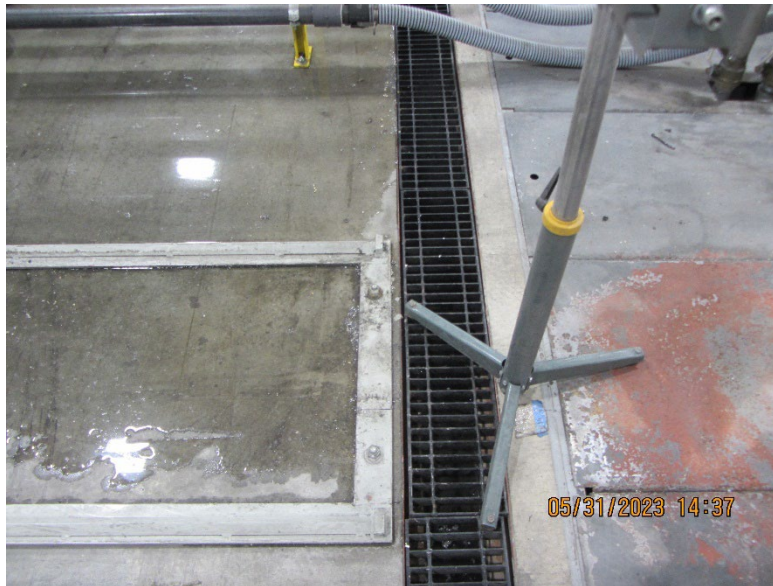
9: IMG\_0316

Description: Trench that collects water spilled from 20 extrusion lines in area

Location: Extrusion building

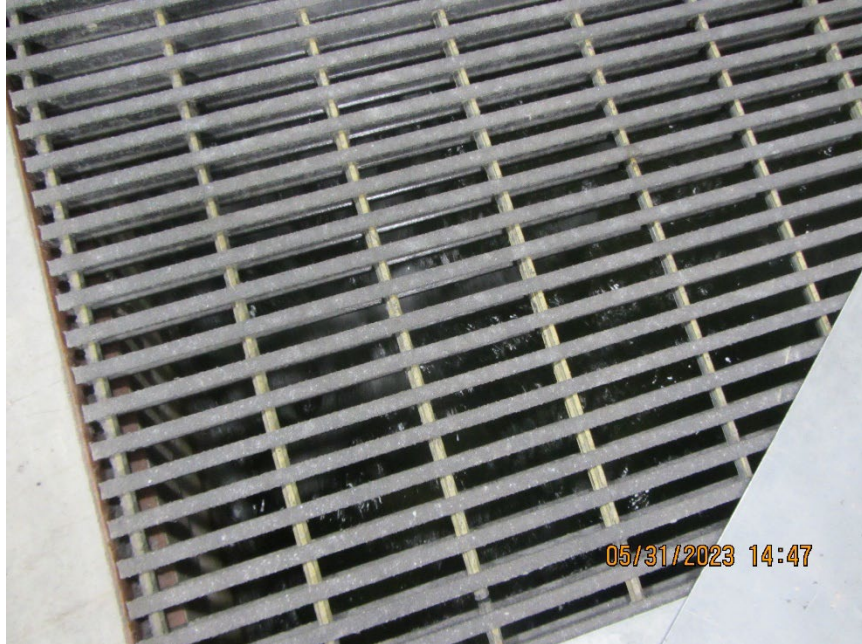
10: IMG\_0317

Description: Water below grate is recirculated through the process continuously for cooling

Location: Extrusion building

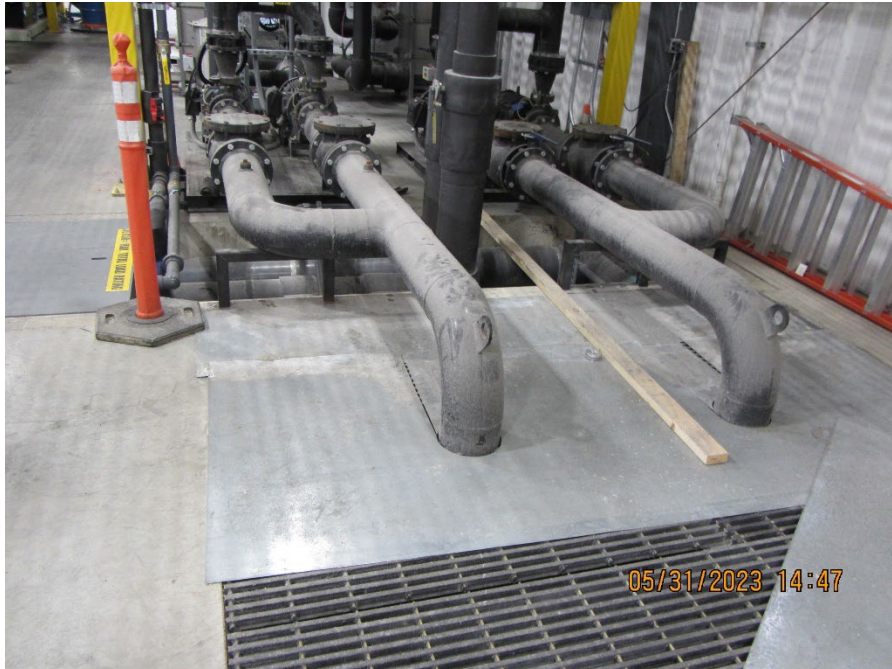
11: IMG\_0318

Description: Zoomed-out photo of the grate in Photo 10

Location: Extrusion building

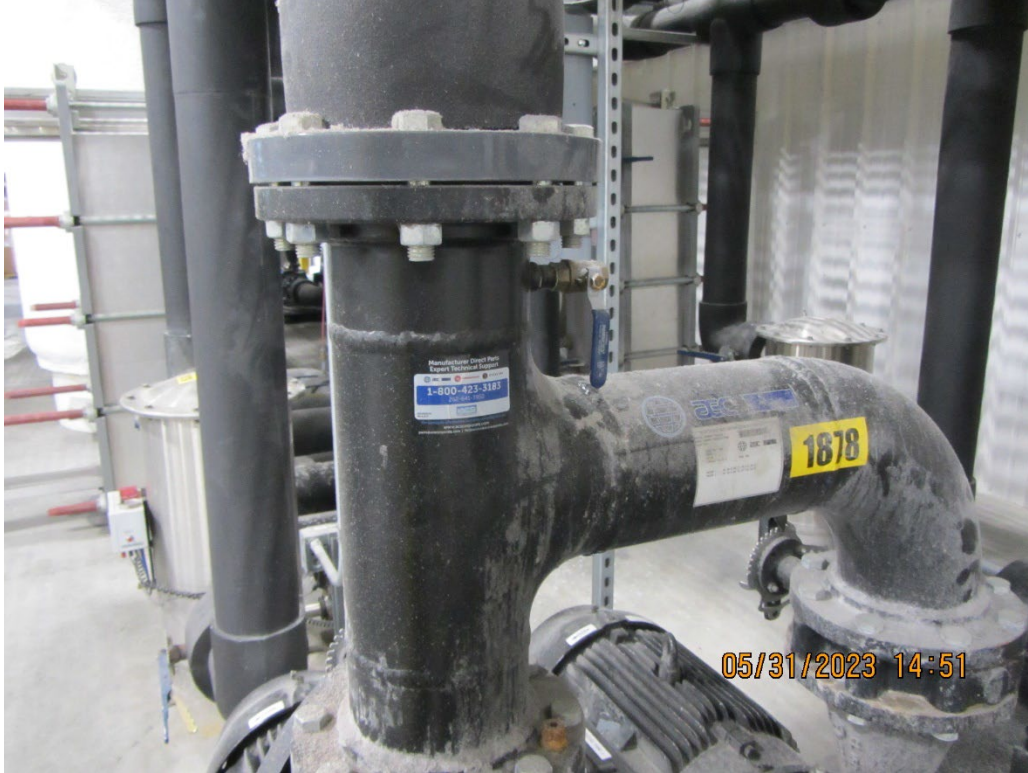
12: IMG\_0319

Description: Sampling location

Location: Extrusion building
