## Region 6 - Enforcement & Compliance Assurance Division

### INSPECTION REPORT

| Inspection Date(s): | 10/08/2024 | |
| Facility Name: | <b>Howard "B" 1 SWD Tank Battery</b> | |

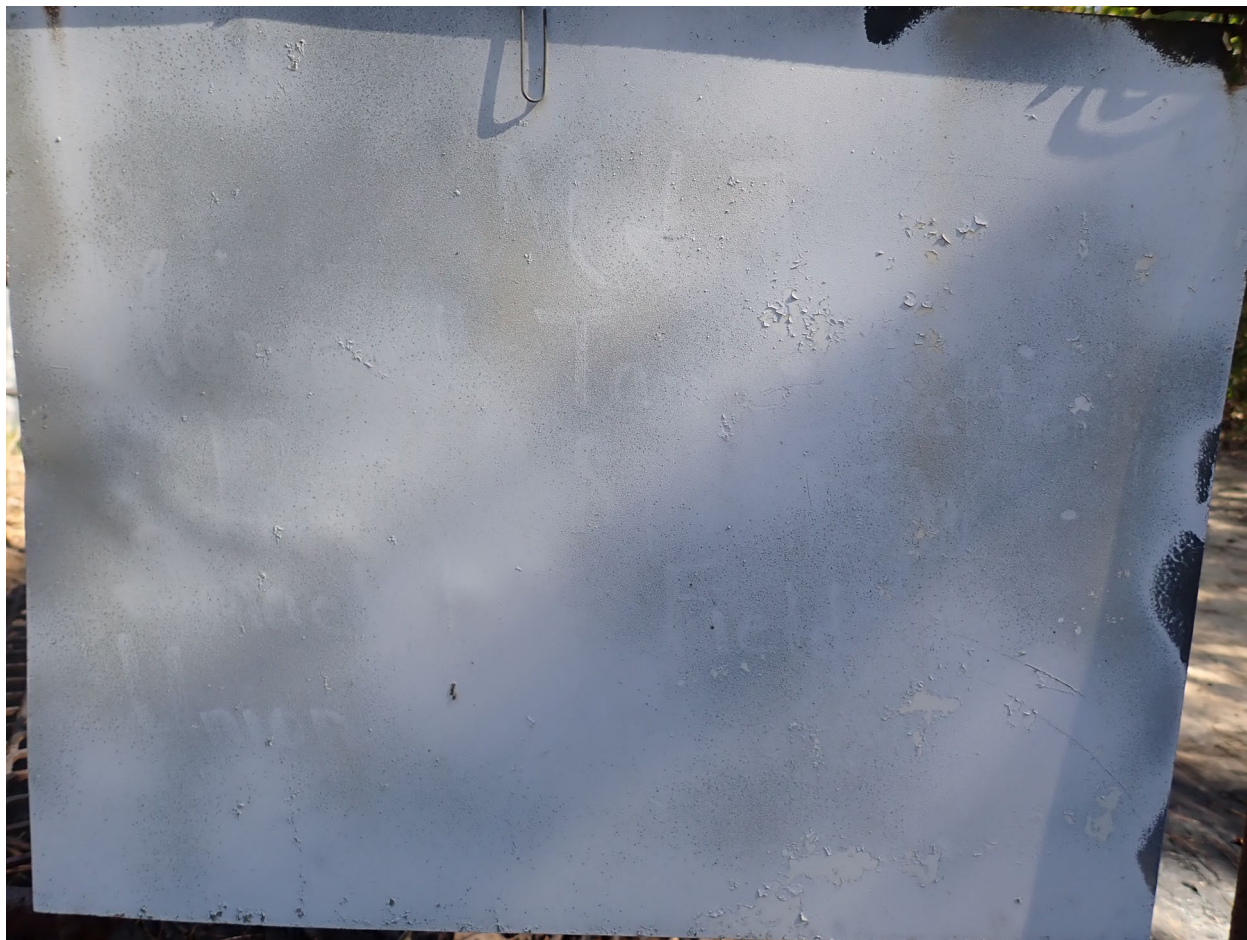
I observed the James and Mike (J&M) Eubanks – Howard "B" 1 SWD Tank Battery, signage, and associated secondary containments, storage tanks, and saltwater disposal (SWD) well; see Appendix 1 (Photographs Log), see Photo No. 1 and No. 2. For additional GPS location and photo metadata, see Appendix 1.

**Description:** Looking NW, this photo shows signage at the Howard “B” 1 SWD Tank Battery.

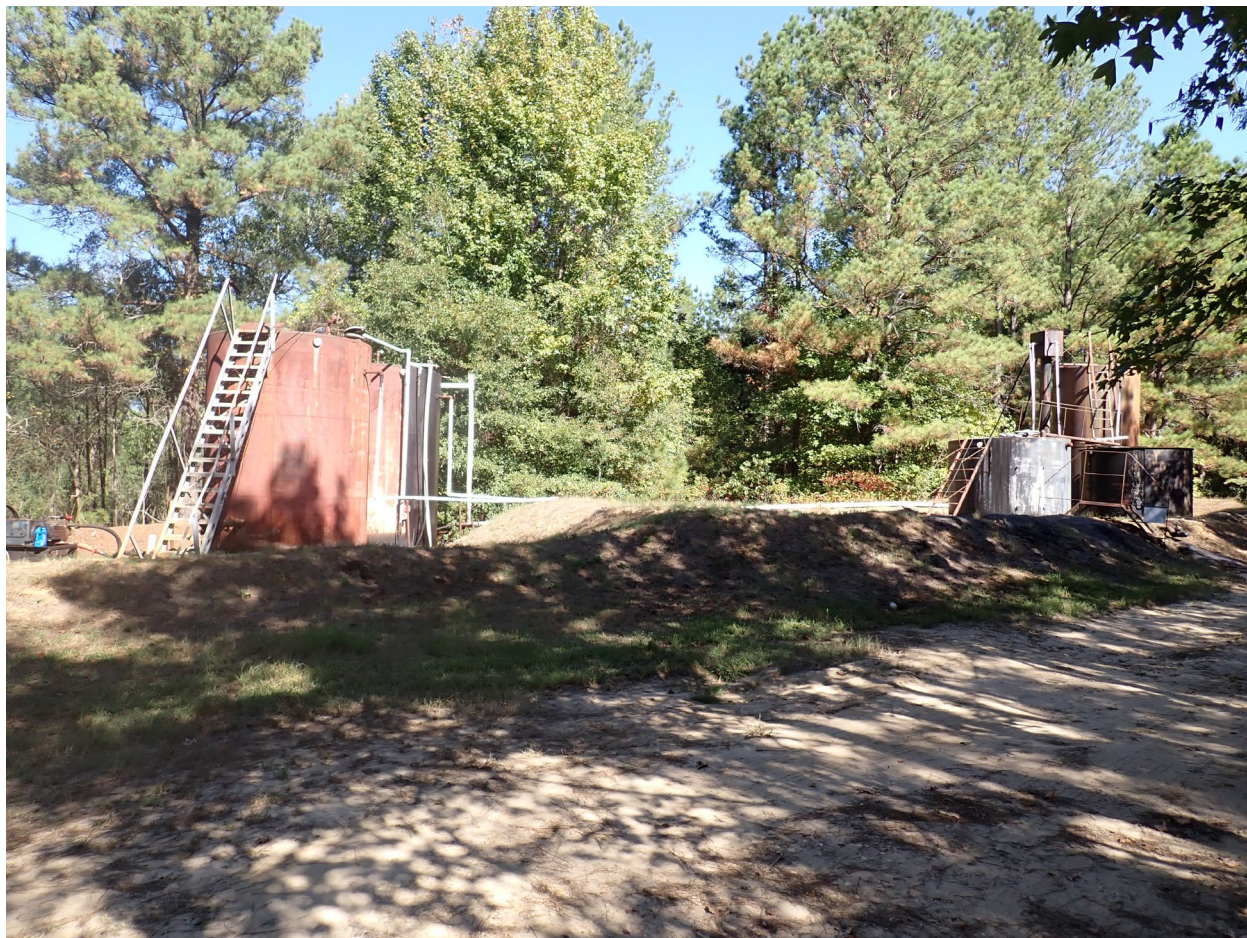
Photo No. 2

**Description:** Looking NE, this photo shows an overview of the Howard “B” 1 SWD Tank Battery.

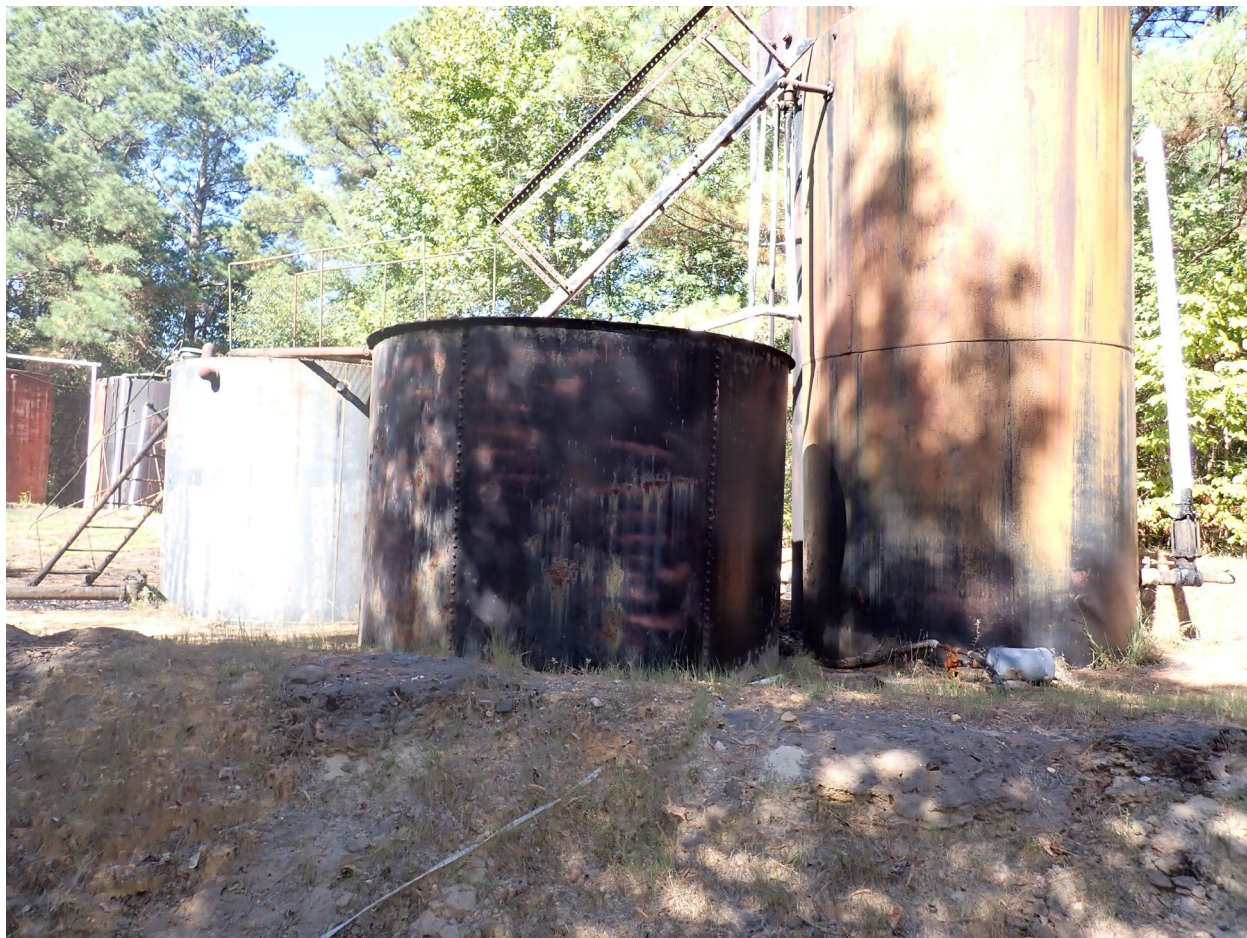
Photo No. 3

I observed one of two tank batteries (TB #1) at the facility, see Photo No. 3.

**Description:** Looking E, this photo shows an overview of one of the two tank batteries (TB) onsite; three tanks were inside containment (TB #1).

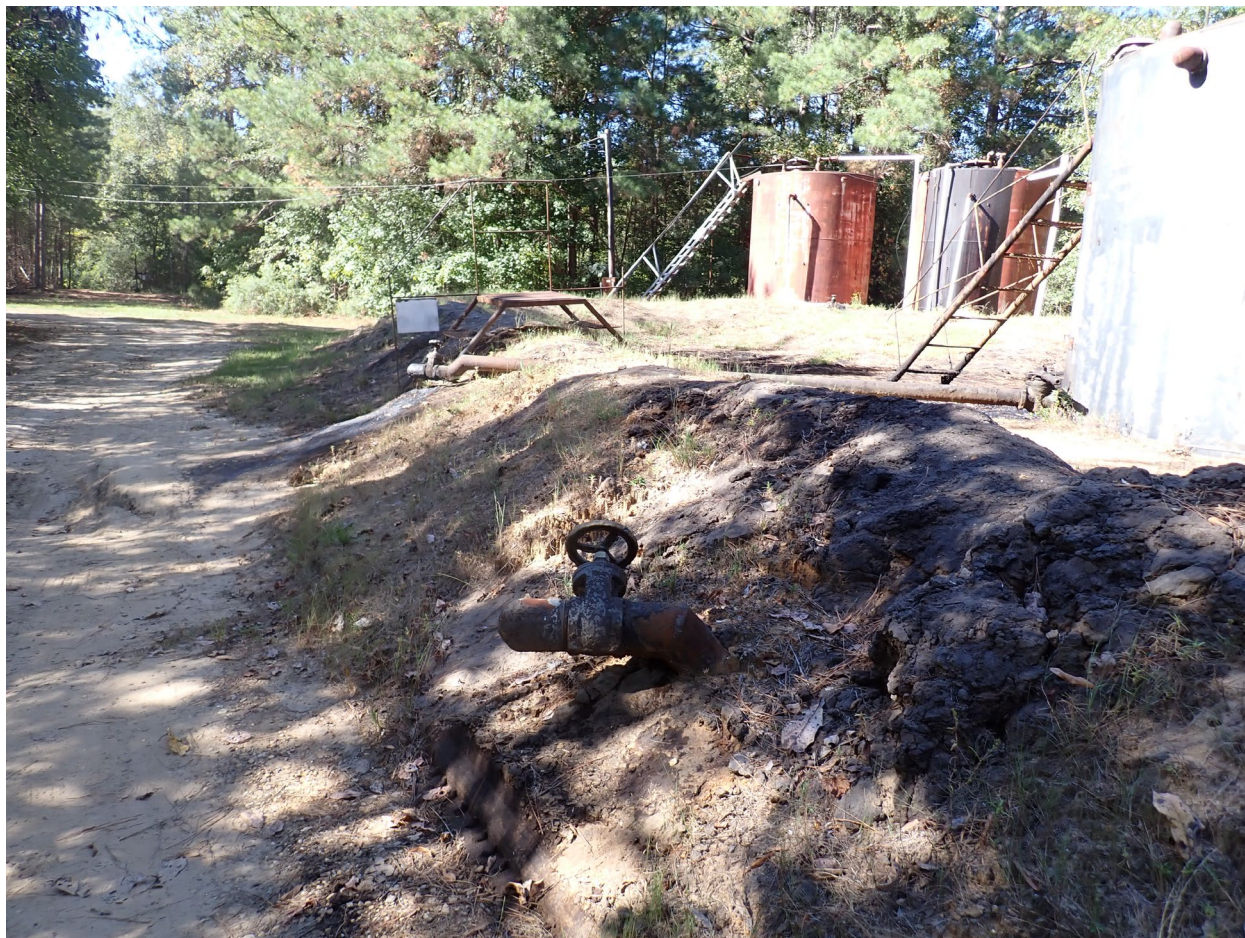
Photo No. 4

I observed production/transfer lines at TB #1 without catchment buckets, see Photo No. 4.

**Description:** Looking E-SE, this photo shows two production/transfer lines outside secondary containment with no catch buckets at valves (TB #1).

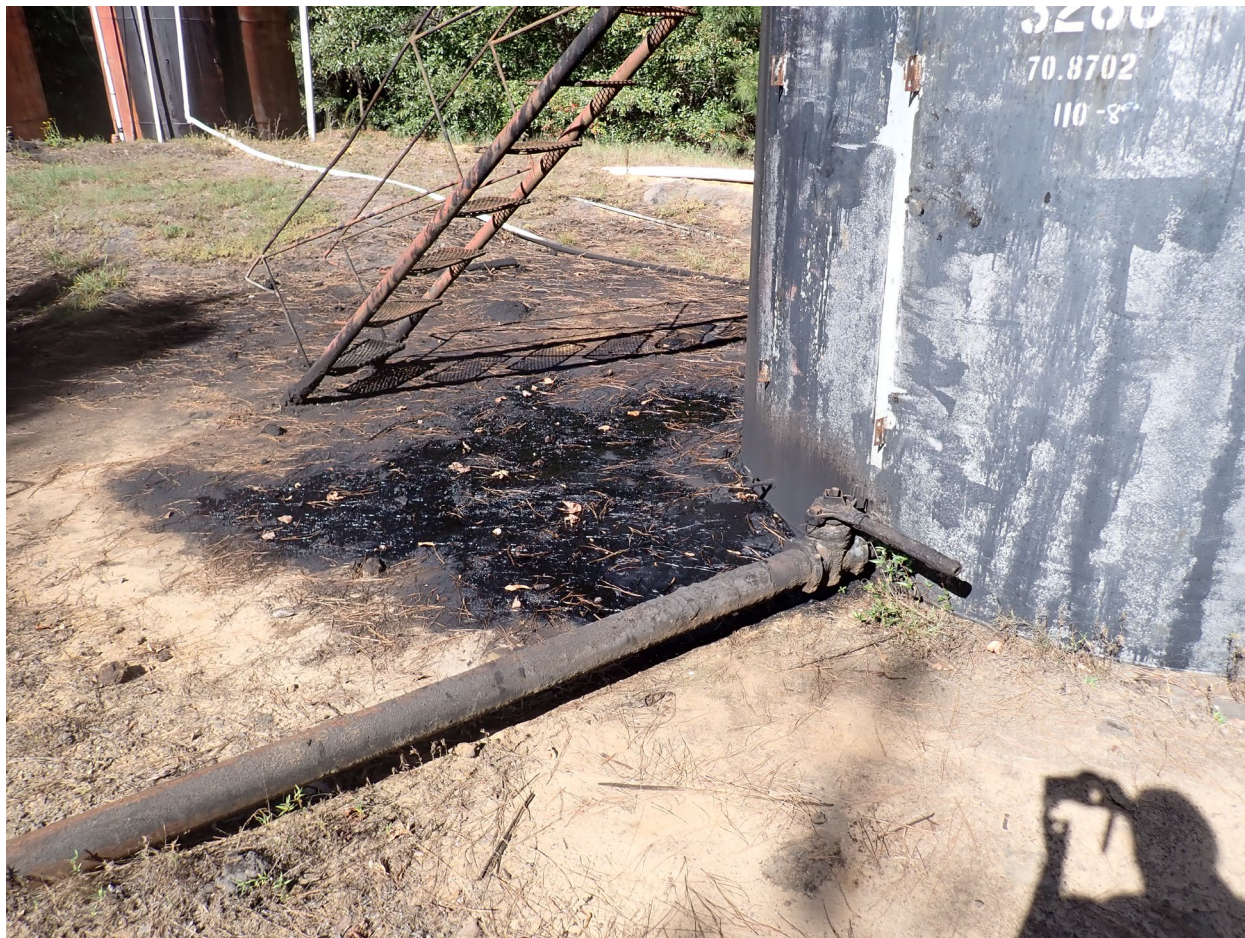
I observed active leaks of crude oil from tanks inside TB #1, see Photo No. 5 through No. 9.

**Description:** Looking E-SE, this photo shows loose oil inside secondary containment (TB #1).

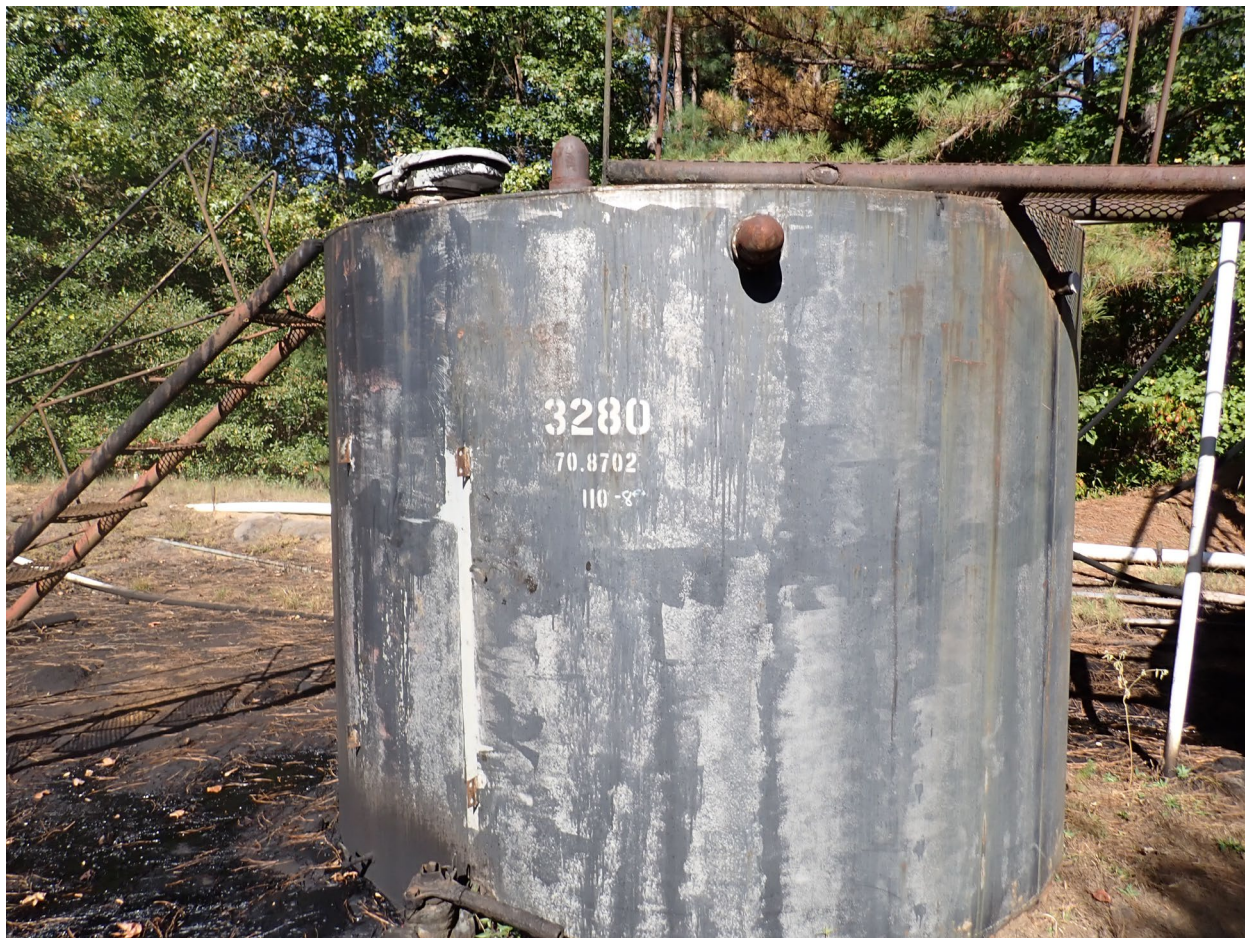
Photo No. 6

**Description:** Looking NE, this photo shows Tank 3280, from Photo No. 5, with the loose oil.

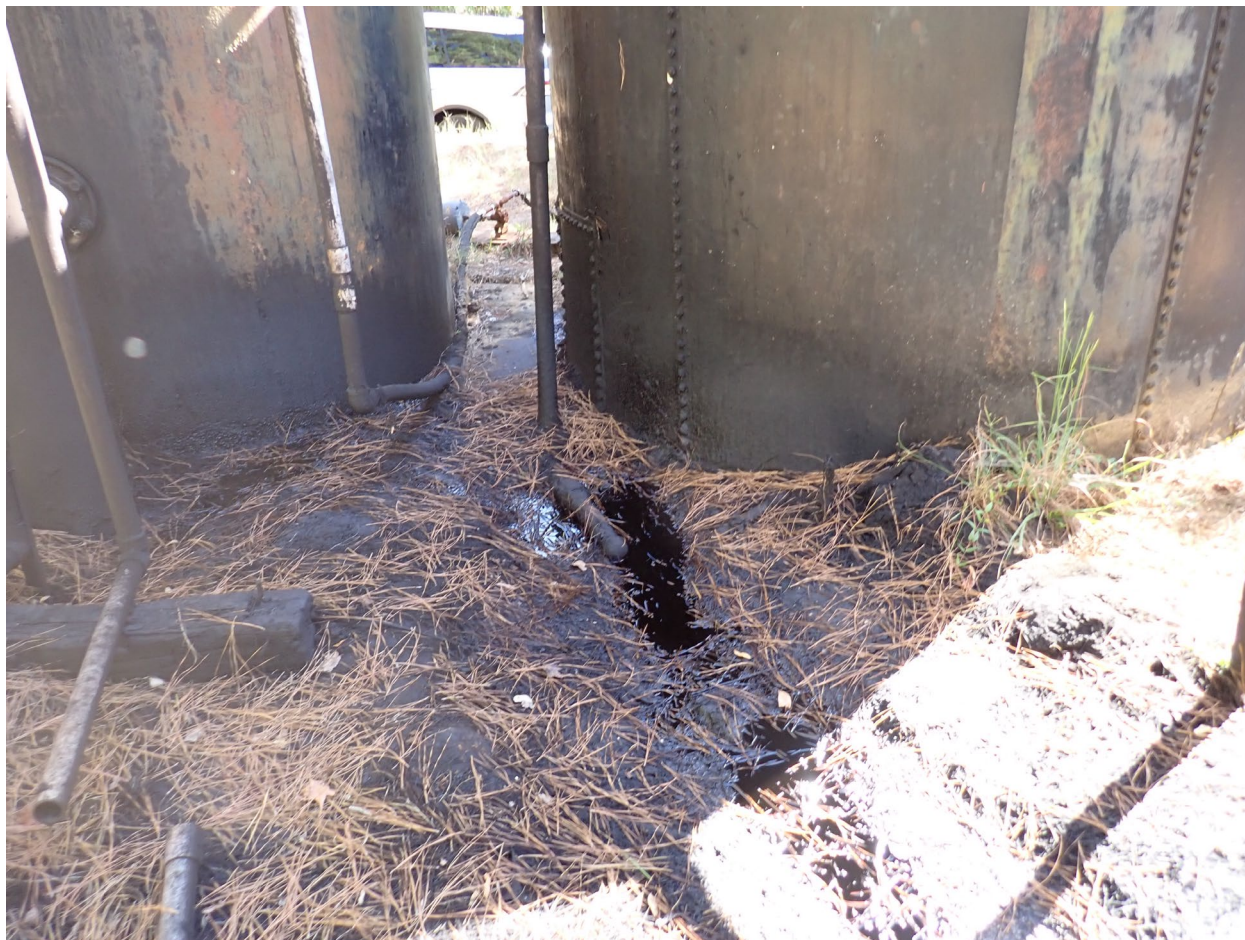
Photo No. 7

**Description:** Looking W-SW, this photo shows loose oil from an additional tank (TB #1).

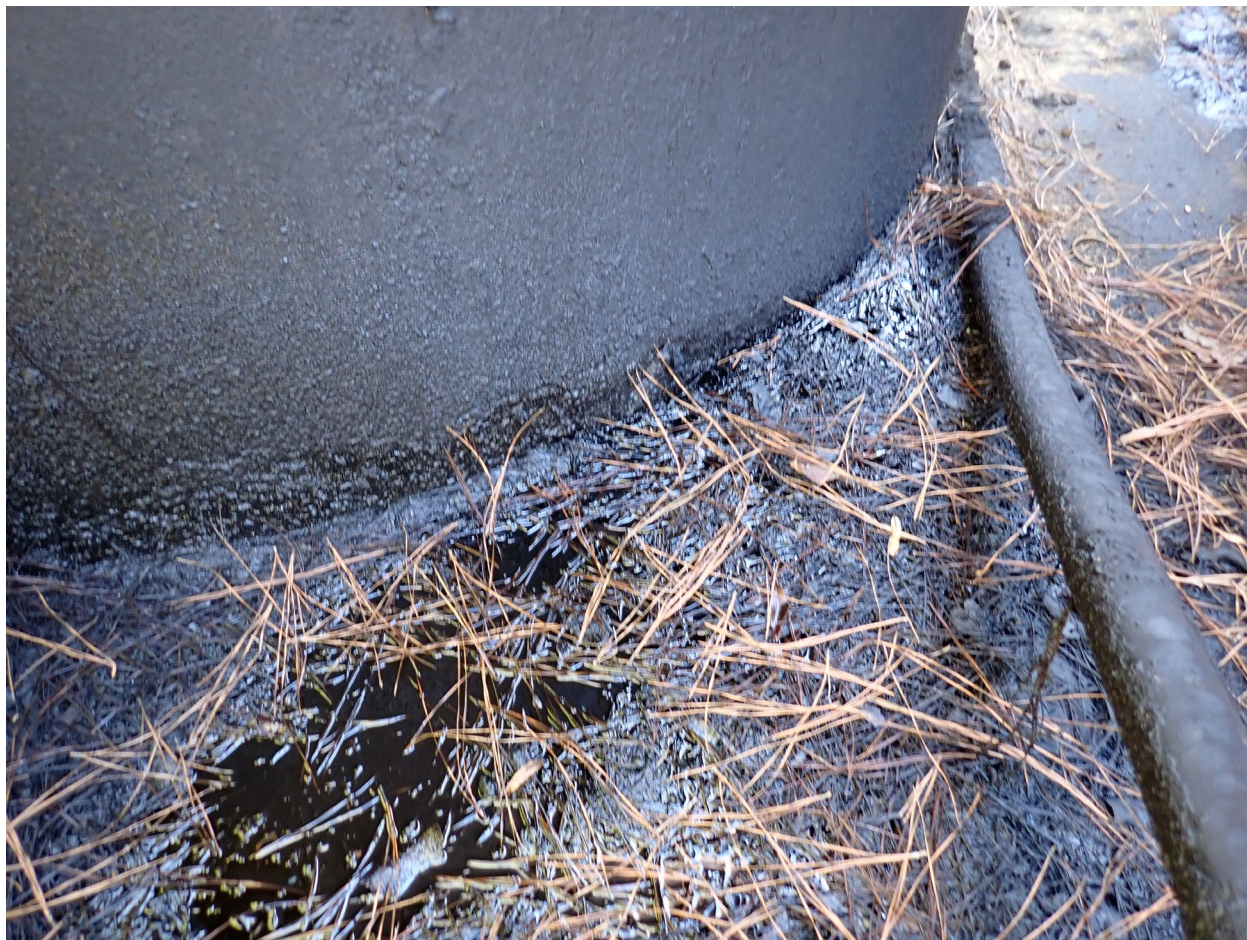
Photo No. 8

**Description:** Looking NW, this photo shows a closeup of the loose oil between the two tanks in Photo No. 7.

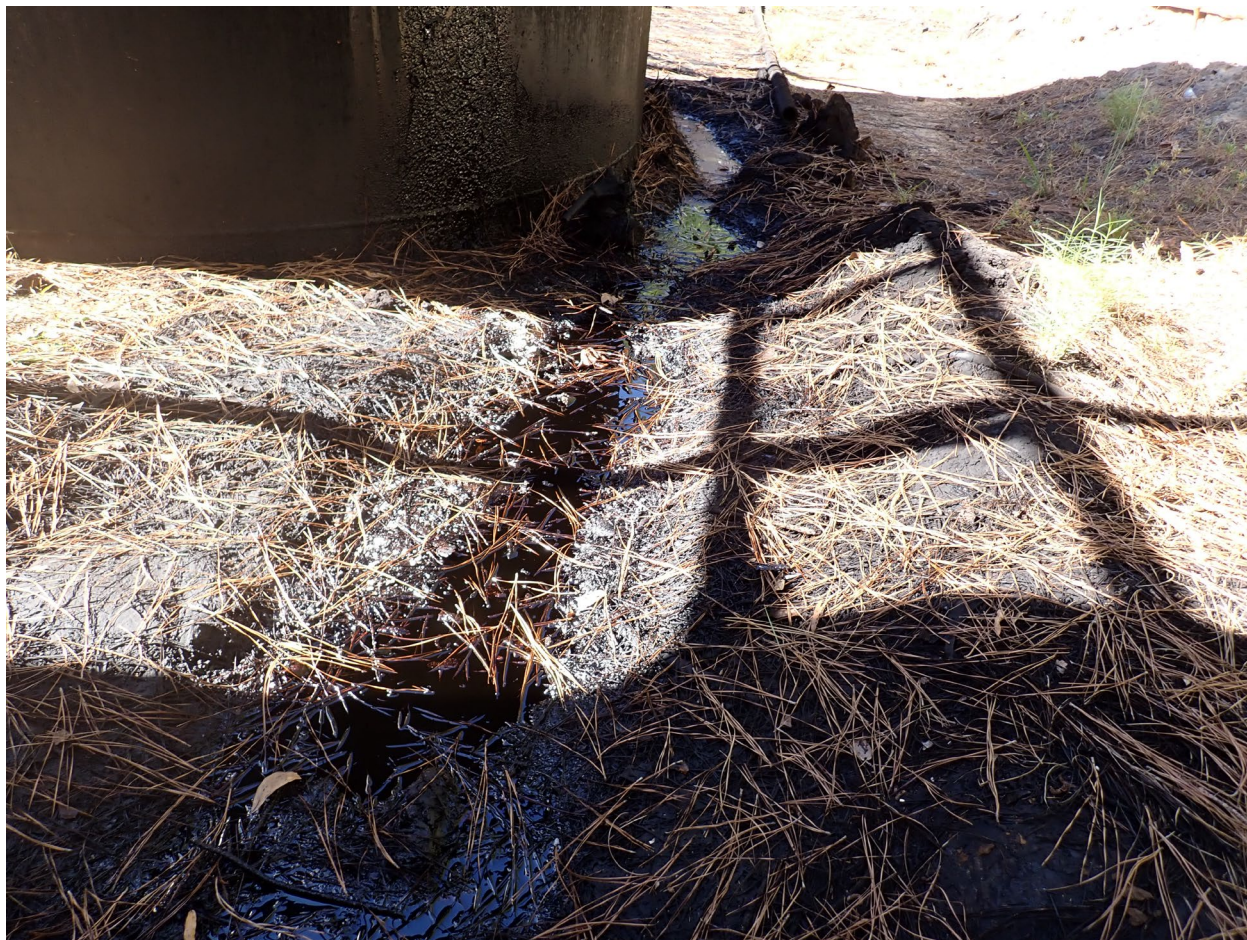
Photo No. 9

**Description:** Looking E-SE, this photo shows the flowpath for the loose oil (TB #1).

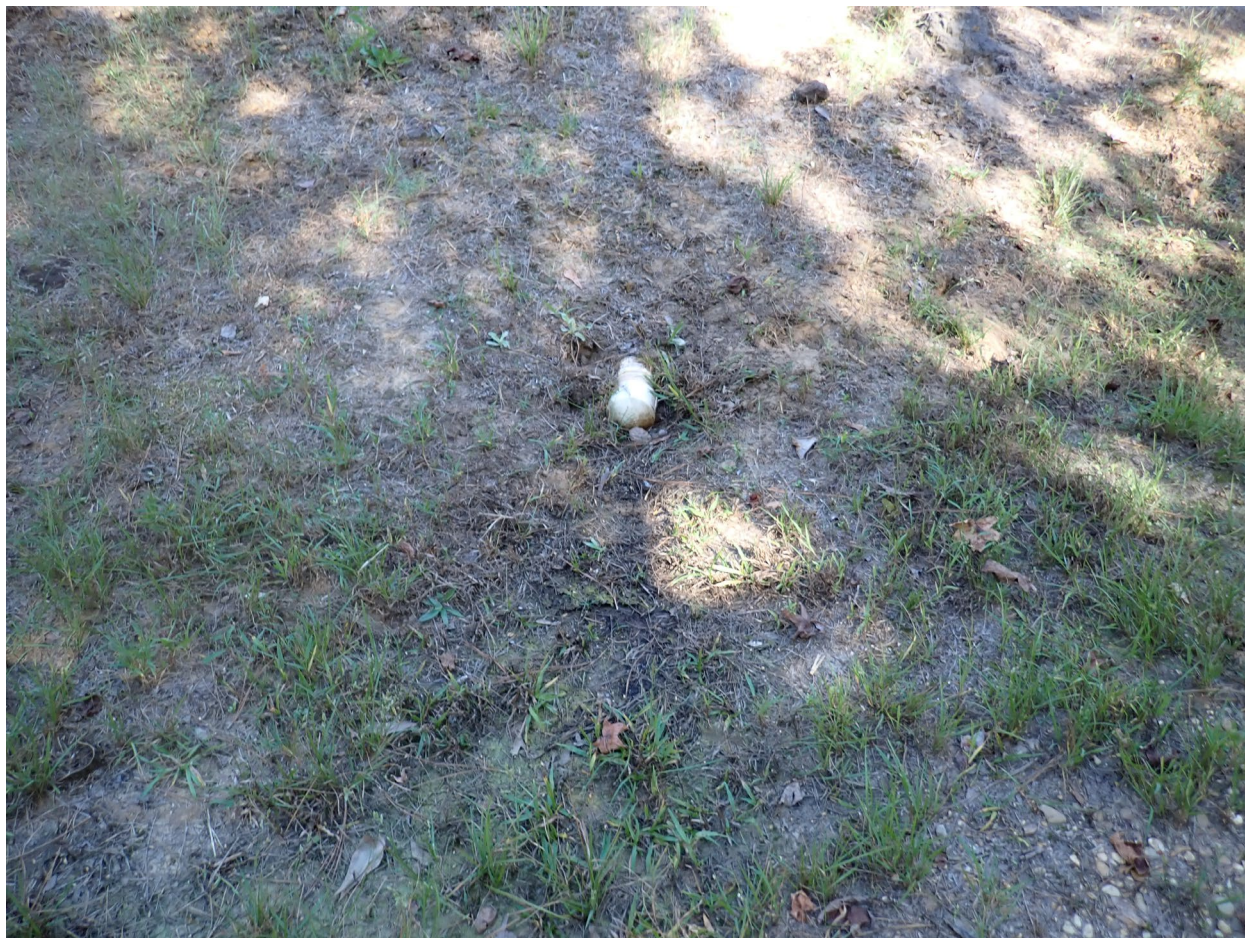
I observed the drainpipe and the cap for TB #1, see Photo No. 10 and No. 11.

**Description:** Looking N-NW, this photo shows the drainpipe for TB #1.

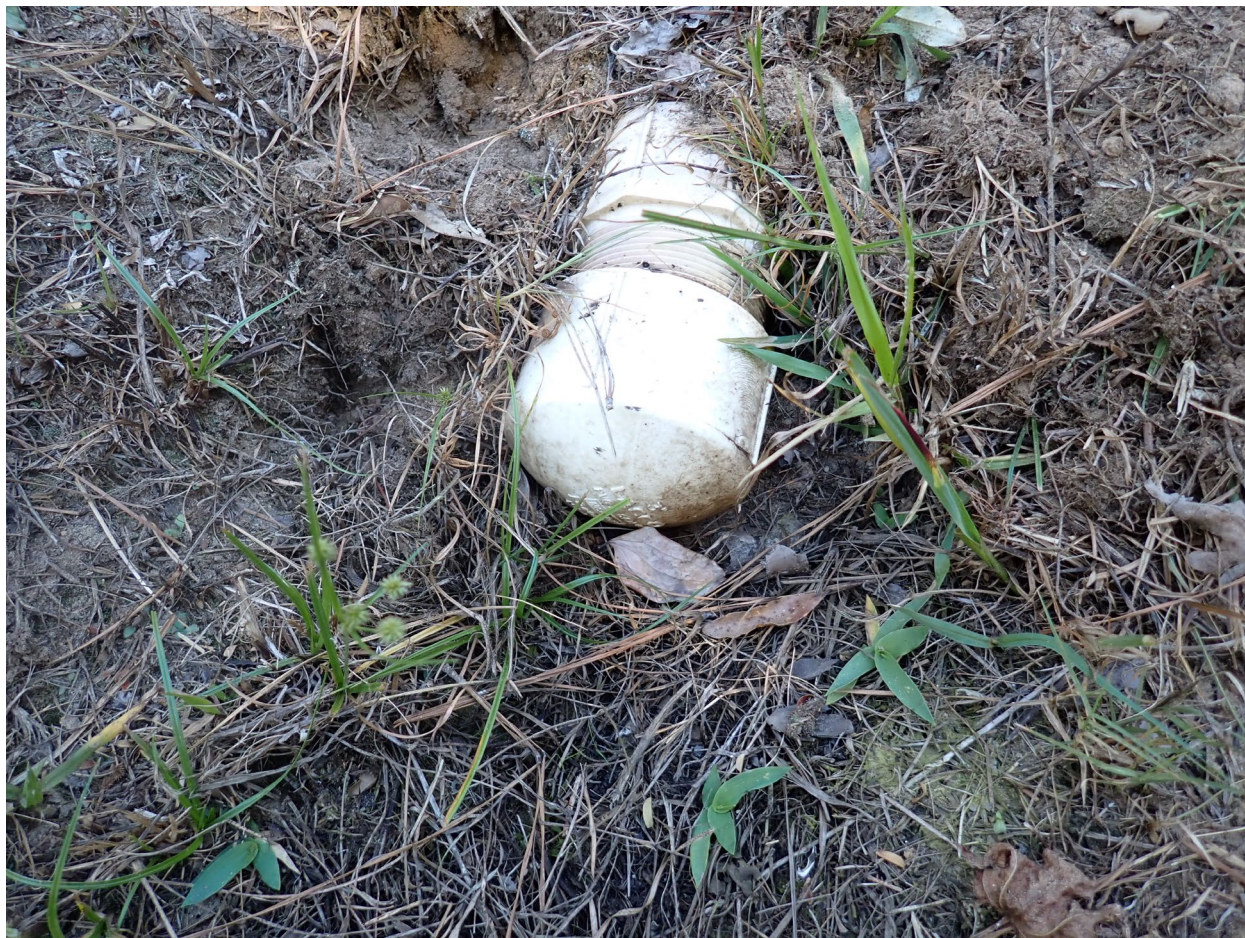
Photo No. 11

**Description:** Looking N-NE, this photo shows a closeup of the drainpipe cap from Photo No. 10; cap was loose during inspection.

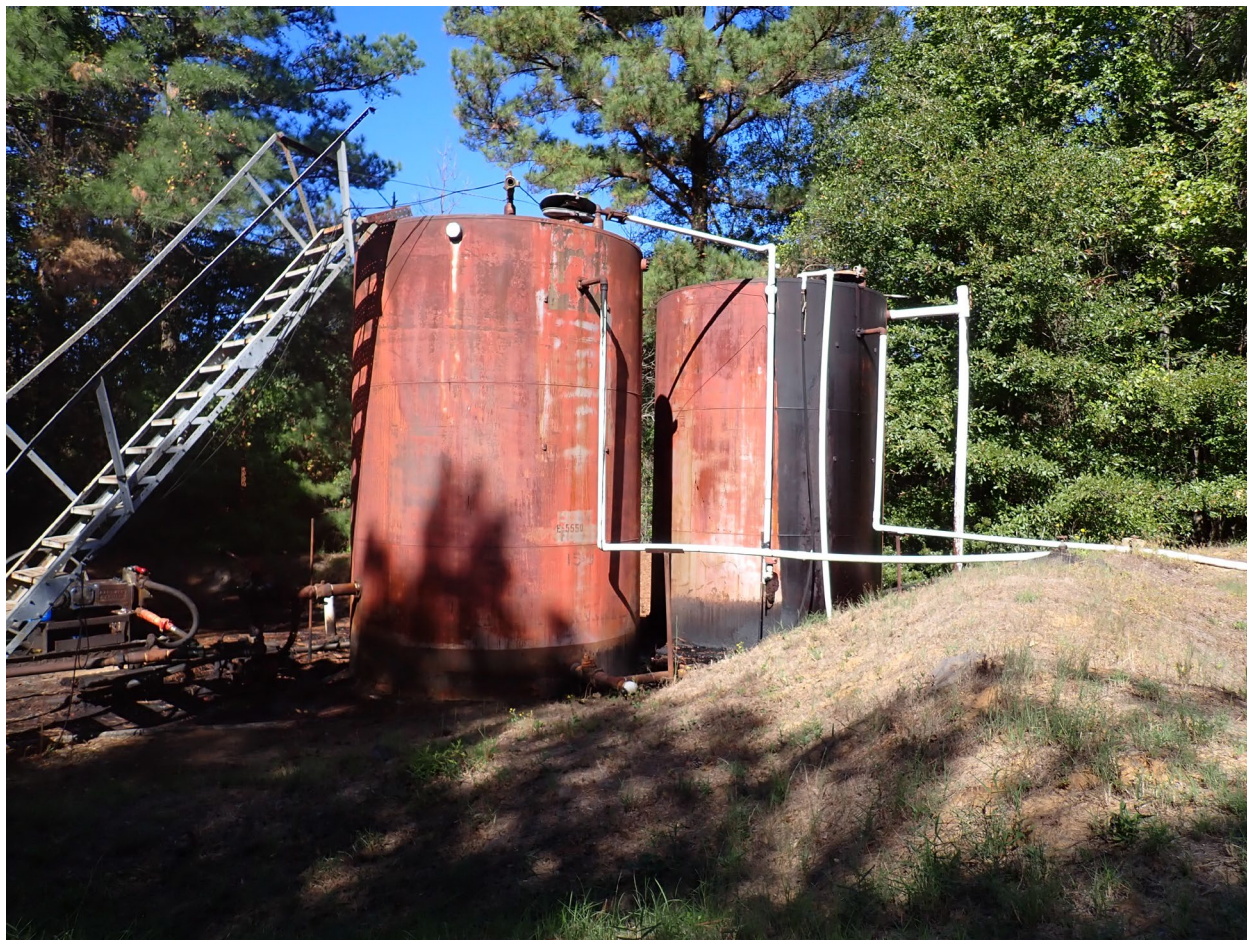
Photo No. 12

I observed two of two tank batteries (TB #2) at the facility, see Photo No. 12.

**Description:** Looking E-NE, this photo shows an overview of one of the two tank batteries (TB) onsite; two tanks were inside containment (TB #2).

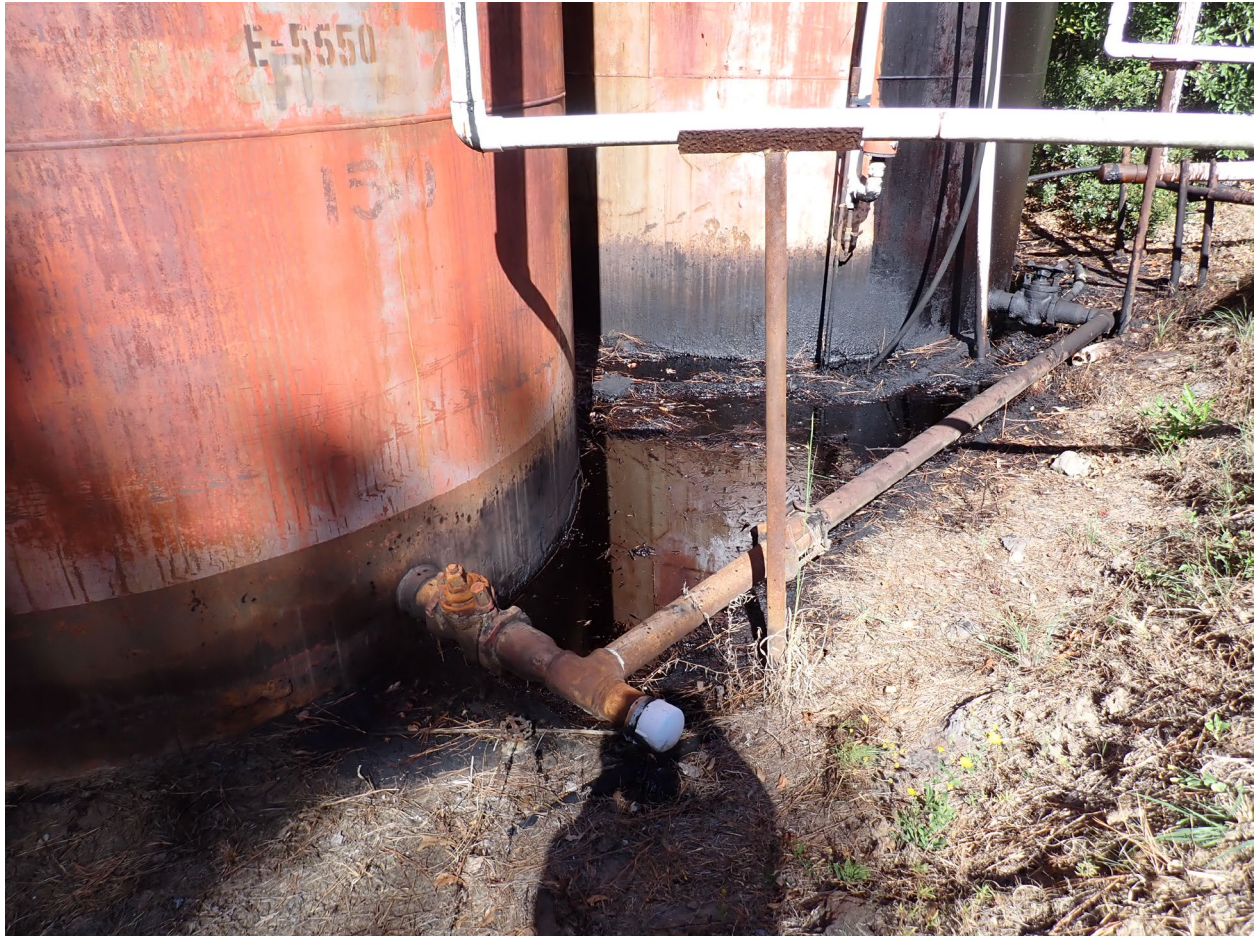
I observed loose oil inside TB #2, see Photo No. 13 and No. 15.

**Description:** Looking E-NE, this photo shows loose oil inside secondary containment (TB #2).

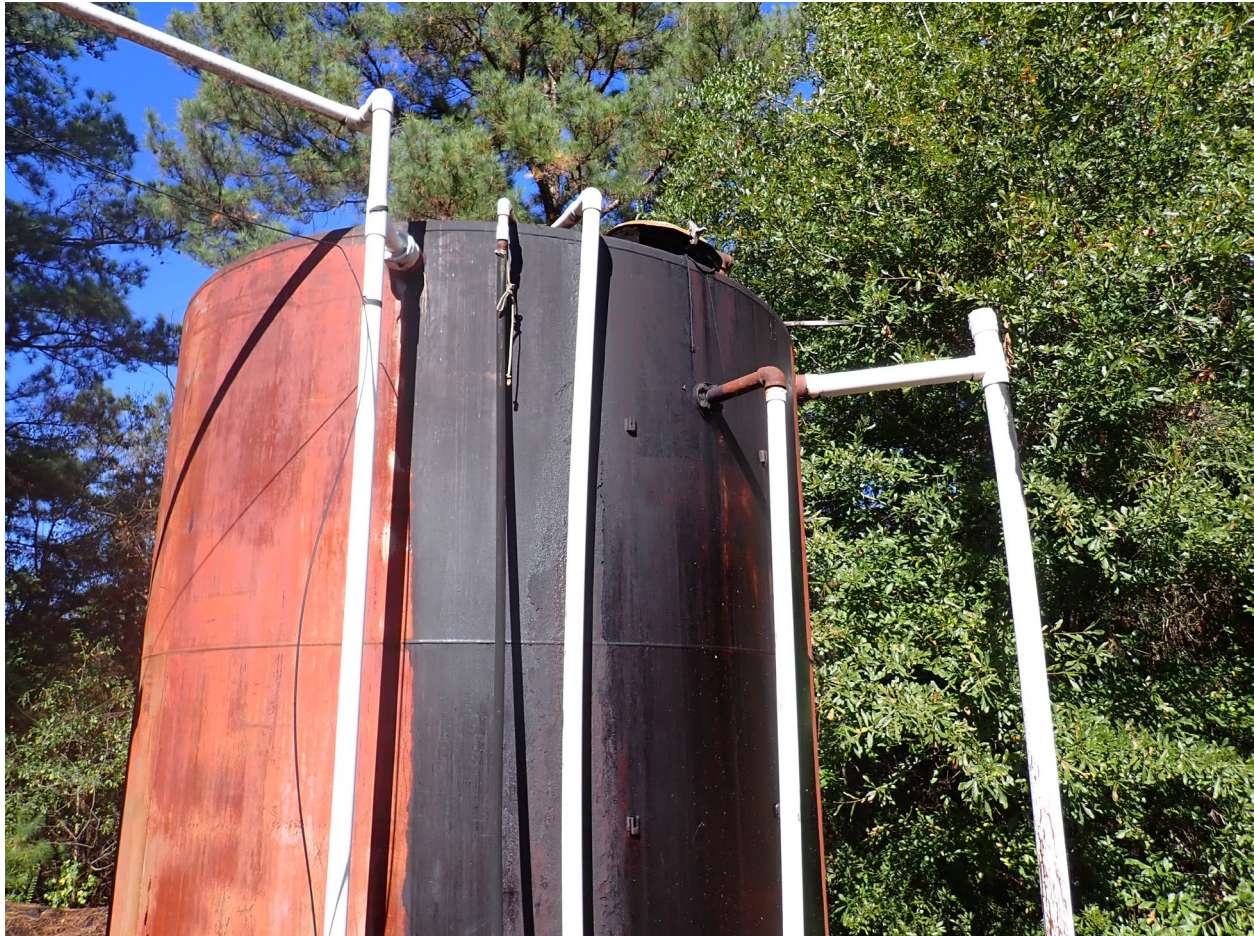
Photo No. 14

I observed the separator with residual oil stains on the outside of the tank, see Photo No. 14.

**Description:** Looking E-NE, this photo shows a previous overflow at one of the tanks (TB #2).

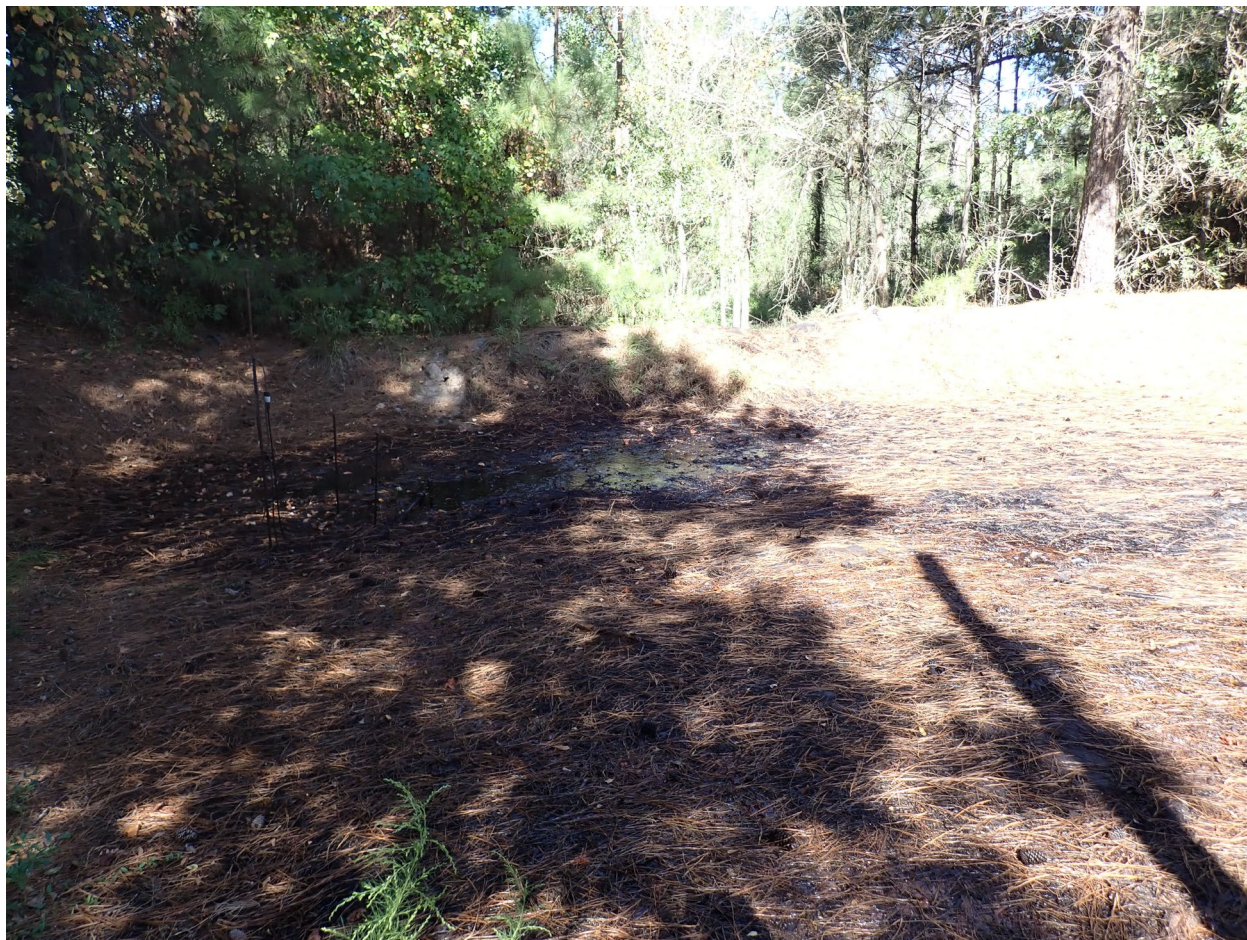
Photo No. 15

**Description:** Looking NE, this photo shows loose oil inside secondary containment (TB #2).

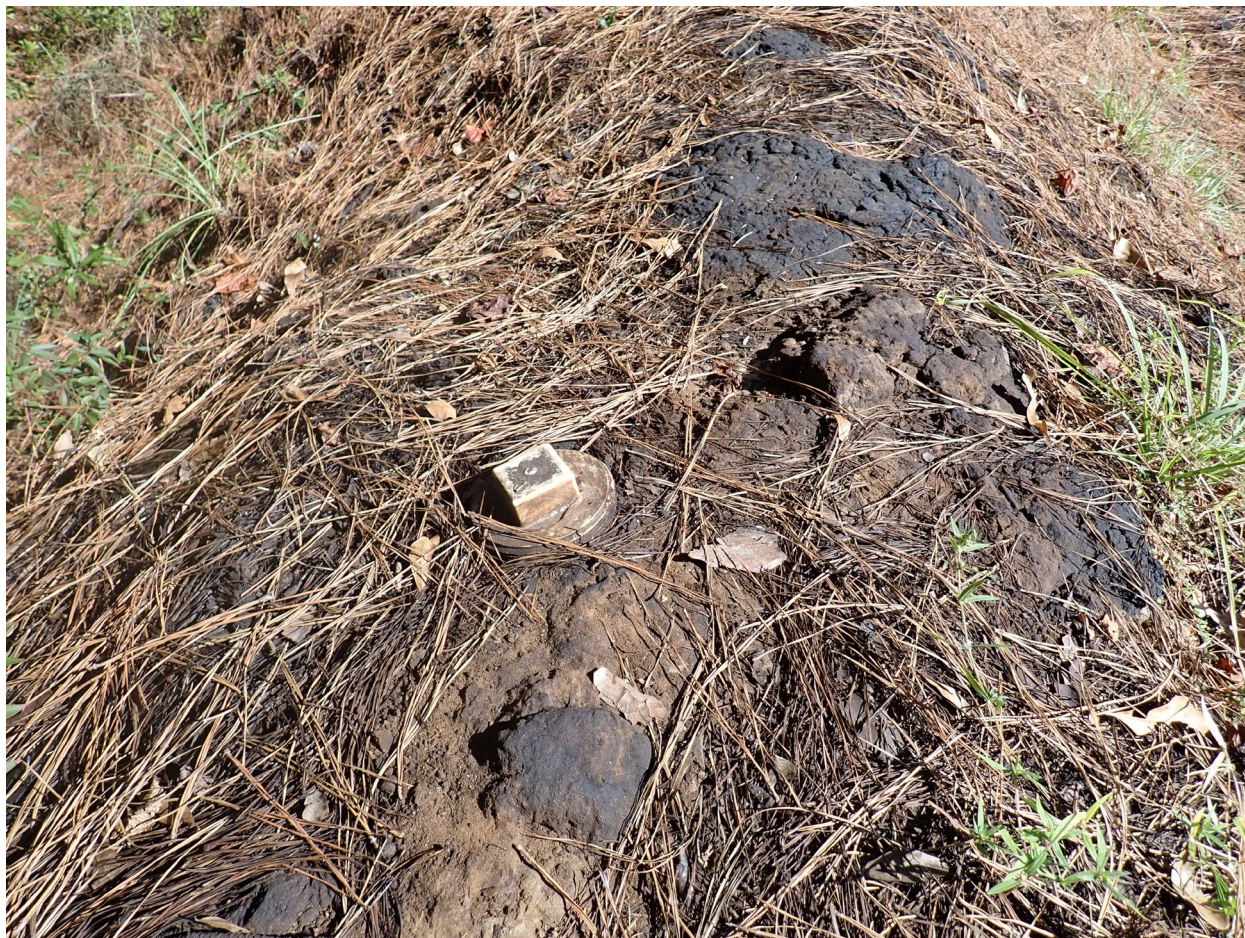
I observed the drainpipe and the cap for TB #2, see Photo No. 16 and No. 17.

**Description:** Looking NW, this photo shows the cap for the drainpipe on top of the secondary containment berm (TB #2).

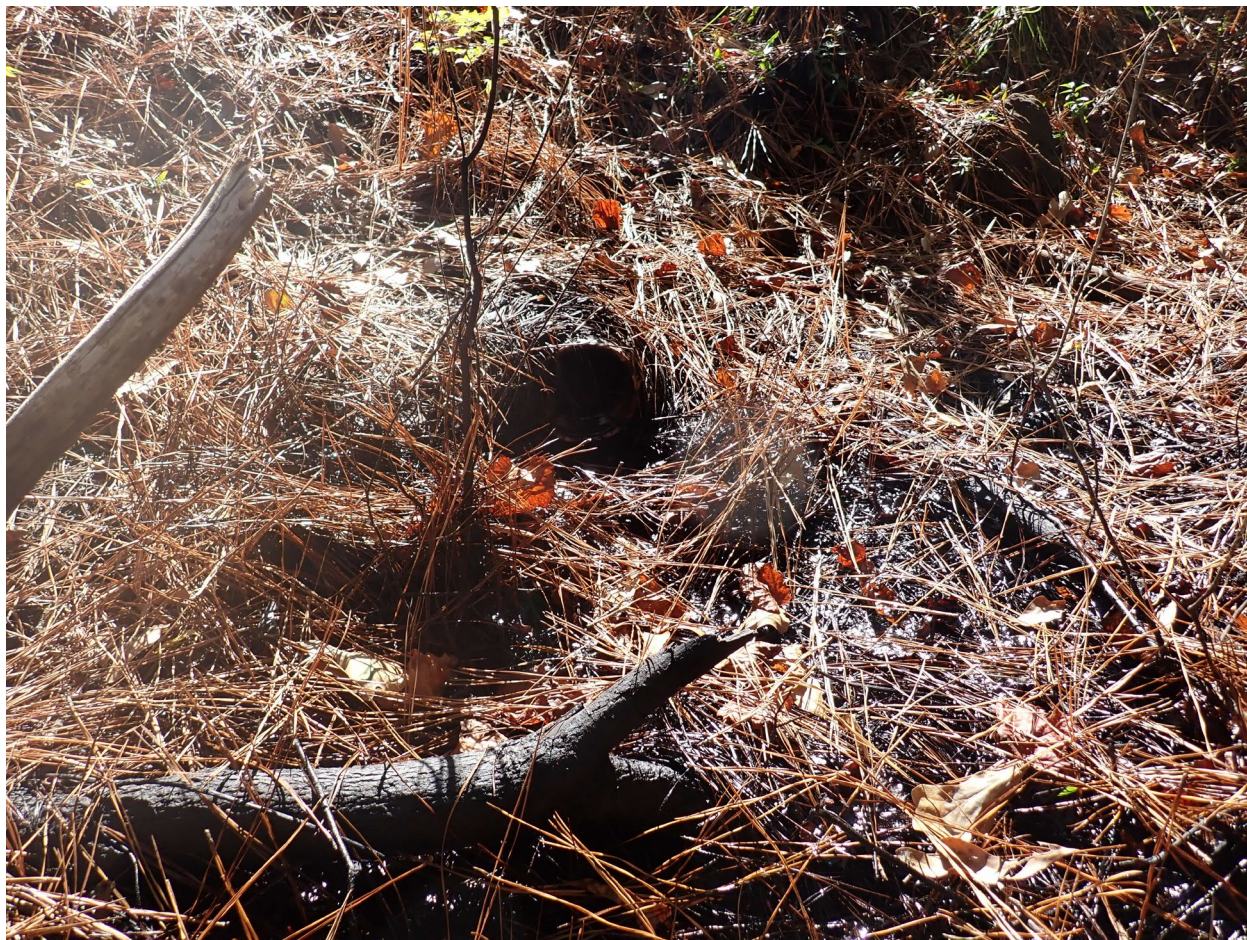
Photo No. 17

**Description:** Looking SW, this photo shows the open drainpipe from Photo No. 16.

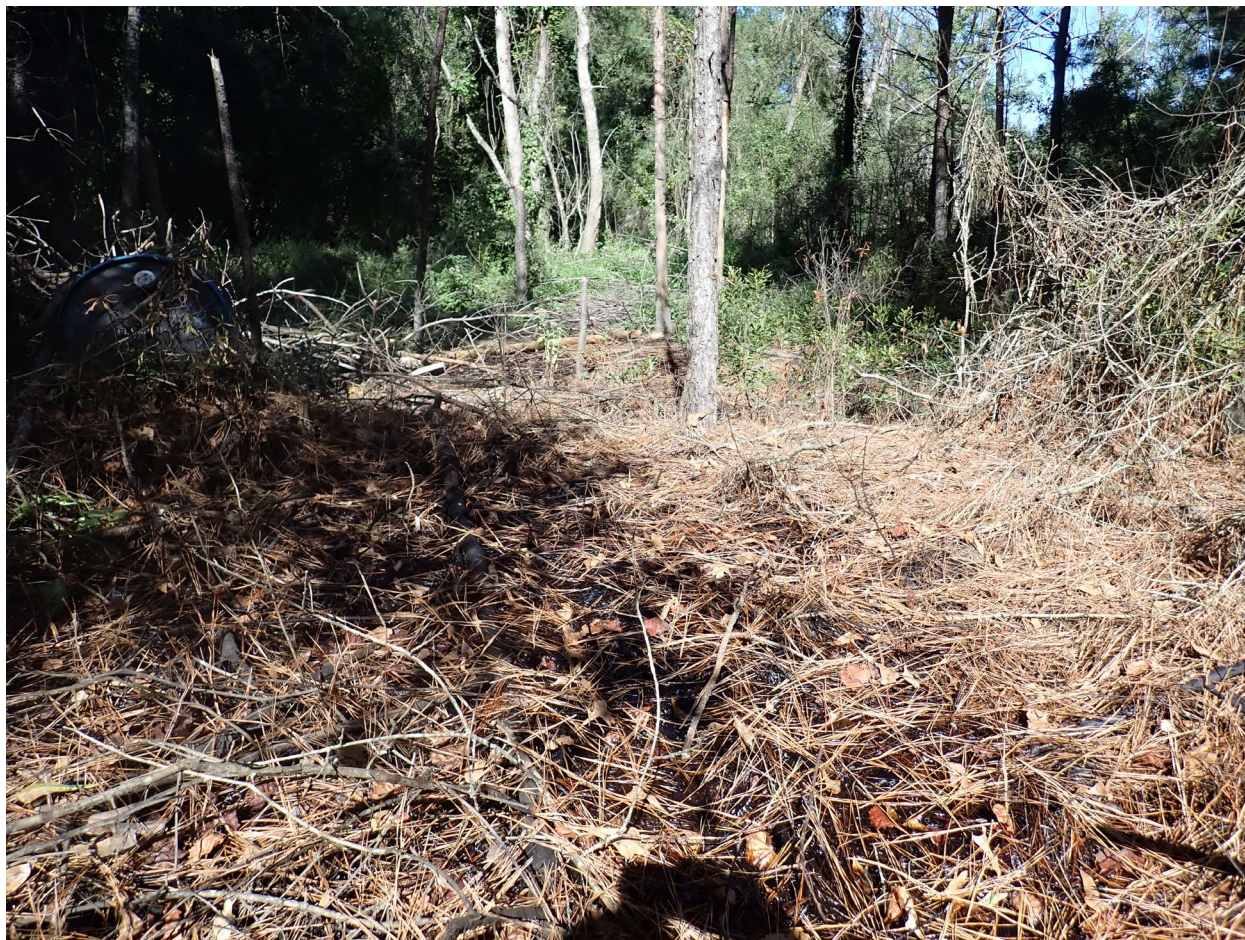
I observed the flowpath of contaminated stormwater originating from TB #2, see Photo No. 18 and No. 19.

**Description:** Looking NE, this photo shows a flowpath from the drainpipe for TB #2 into the surrounding riparian of an unnamed tributary (UT) of Holmes Creek.

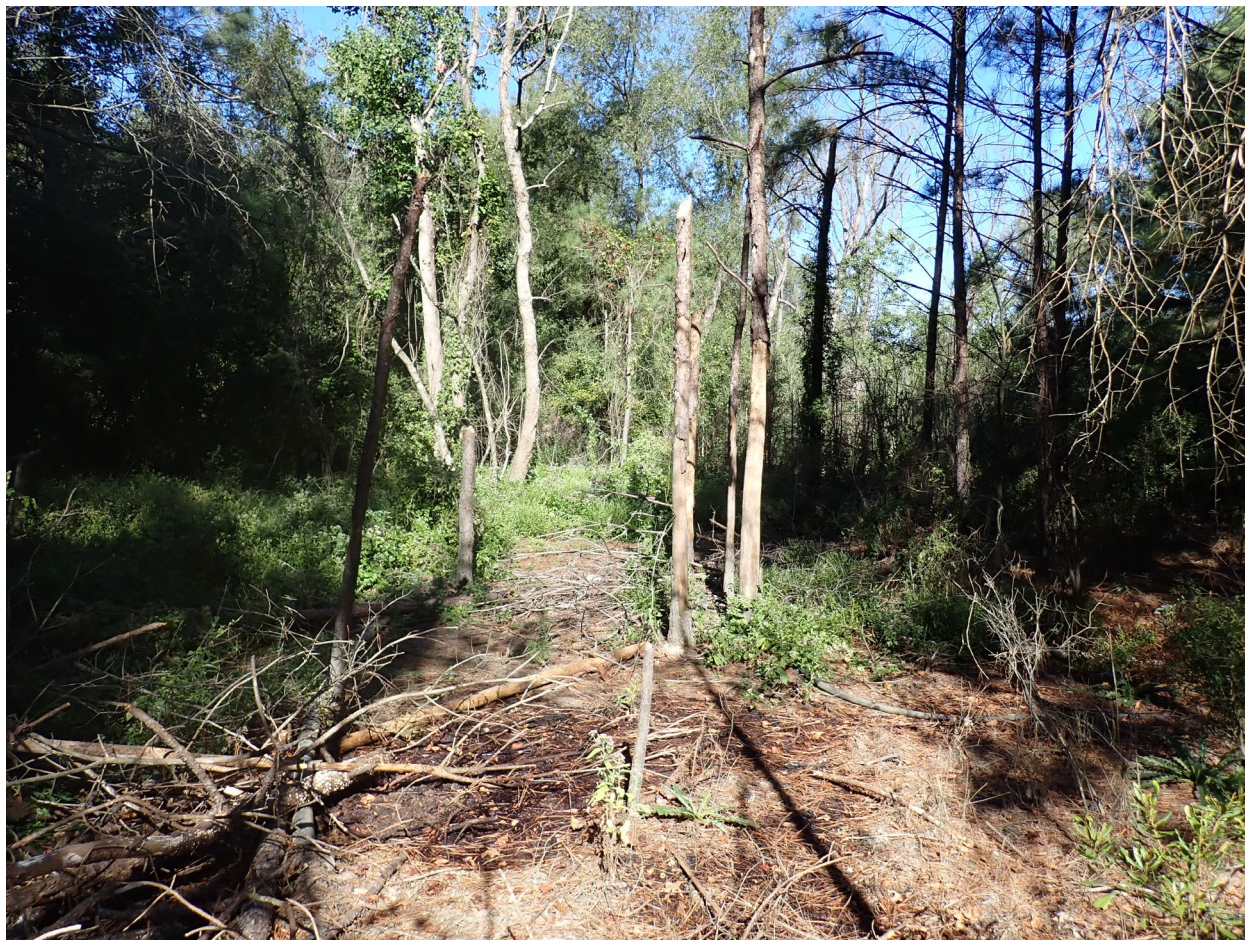
Photo No. 19

**Description:** Looking NE, this photo shows an additional view of the flowpath from Photo No. 18; note loose oil and dead vegetation within flowpath.
