## Region 6 - Enforcement & Compliance Assurance Division

### INSPECTION REPORT

| Inspection Date(s): | 10/08/2024 | |
| Facility Name: | <b>Howard "B" 1 SWD Tank Battery</b> | |

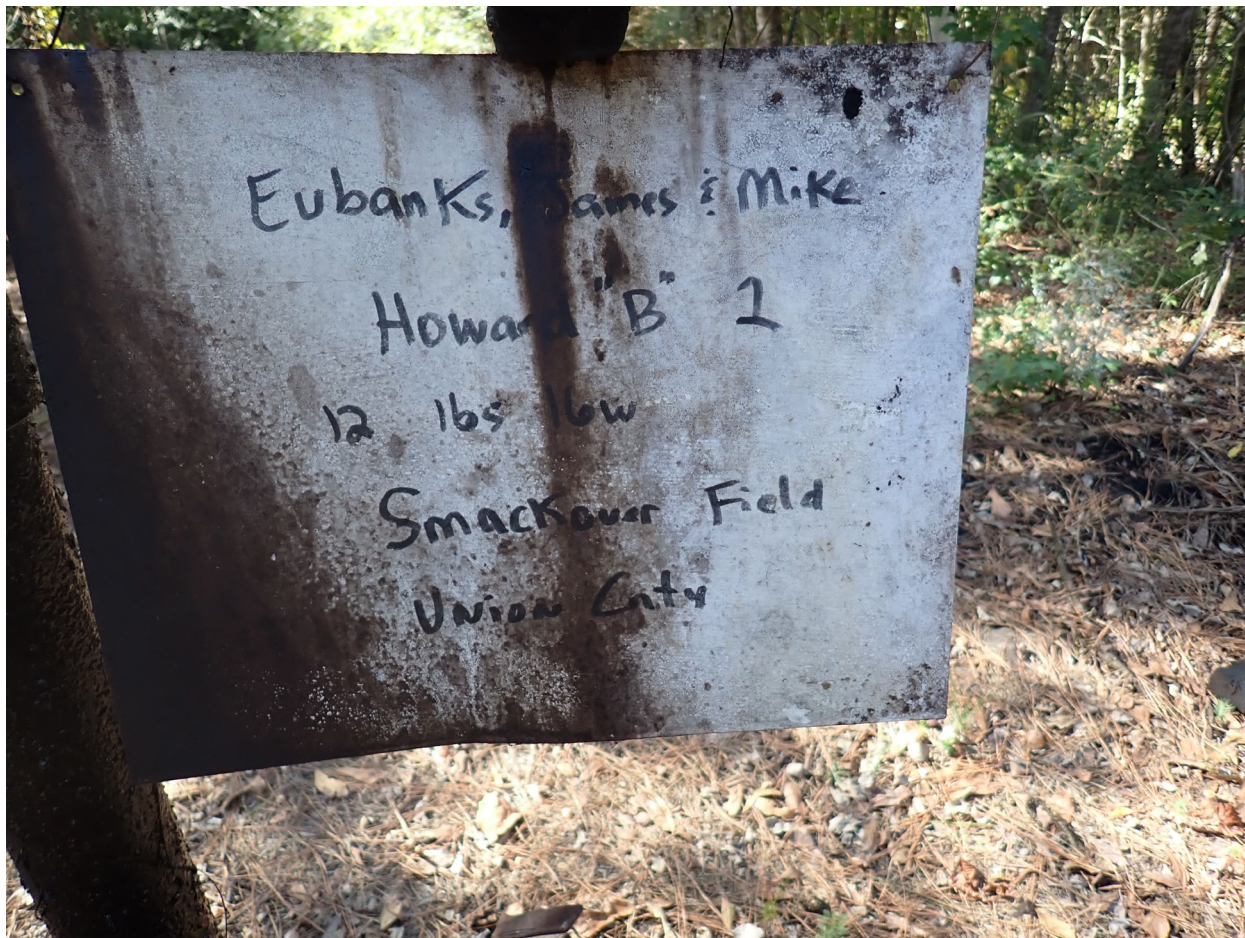
I observed the signage and the SWD well associated with the tank batteries, see Photo No. 20 and No. 21.

**Description:** Looking N-NW, this photo shows the signage at the Howard "B" 1 SWD well.

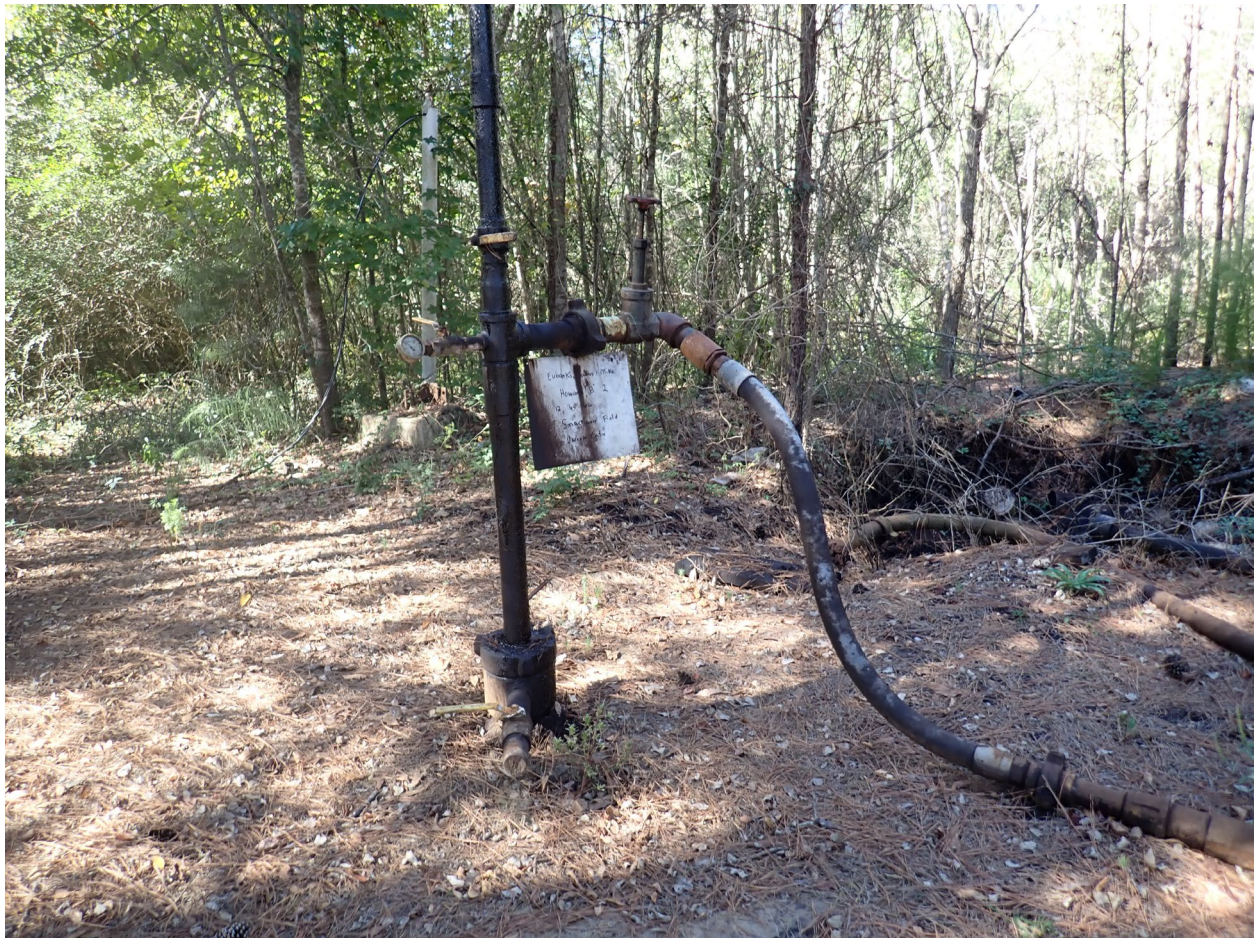
Photo No. 21

**Description:** Looking E-NE, this photo shows an overview of the SWD adjacent to the two tank batteries.

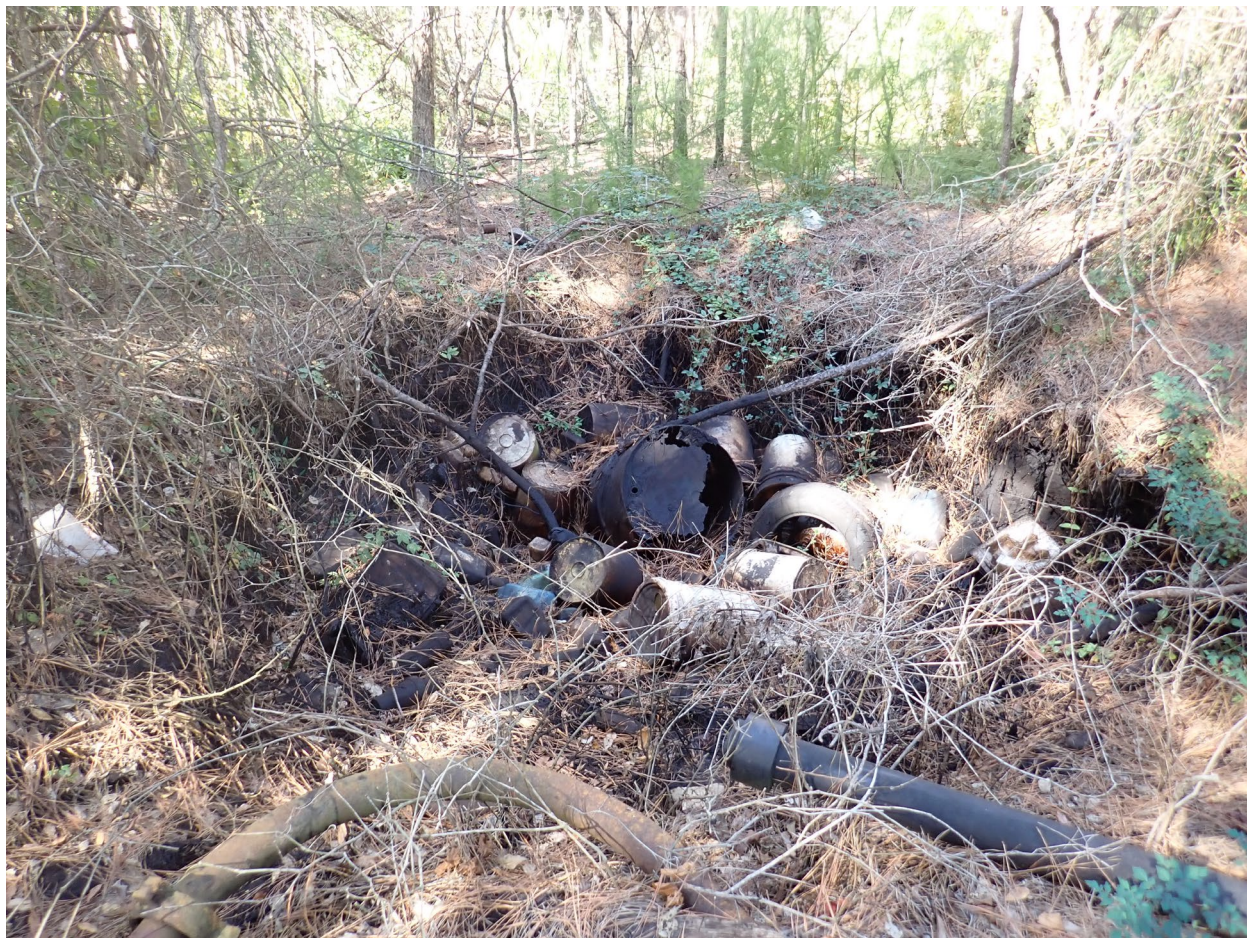
I observed areas of miscellaneous solid waste around the SWD and the tank batteries, see Photo No. 22 and No. 23.

**Description:** Looking SE, this photo shows a waste pit adjacent to the SWD in Photo No. 21.

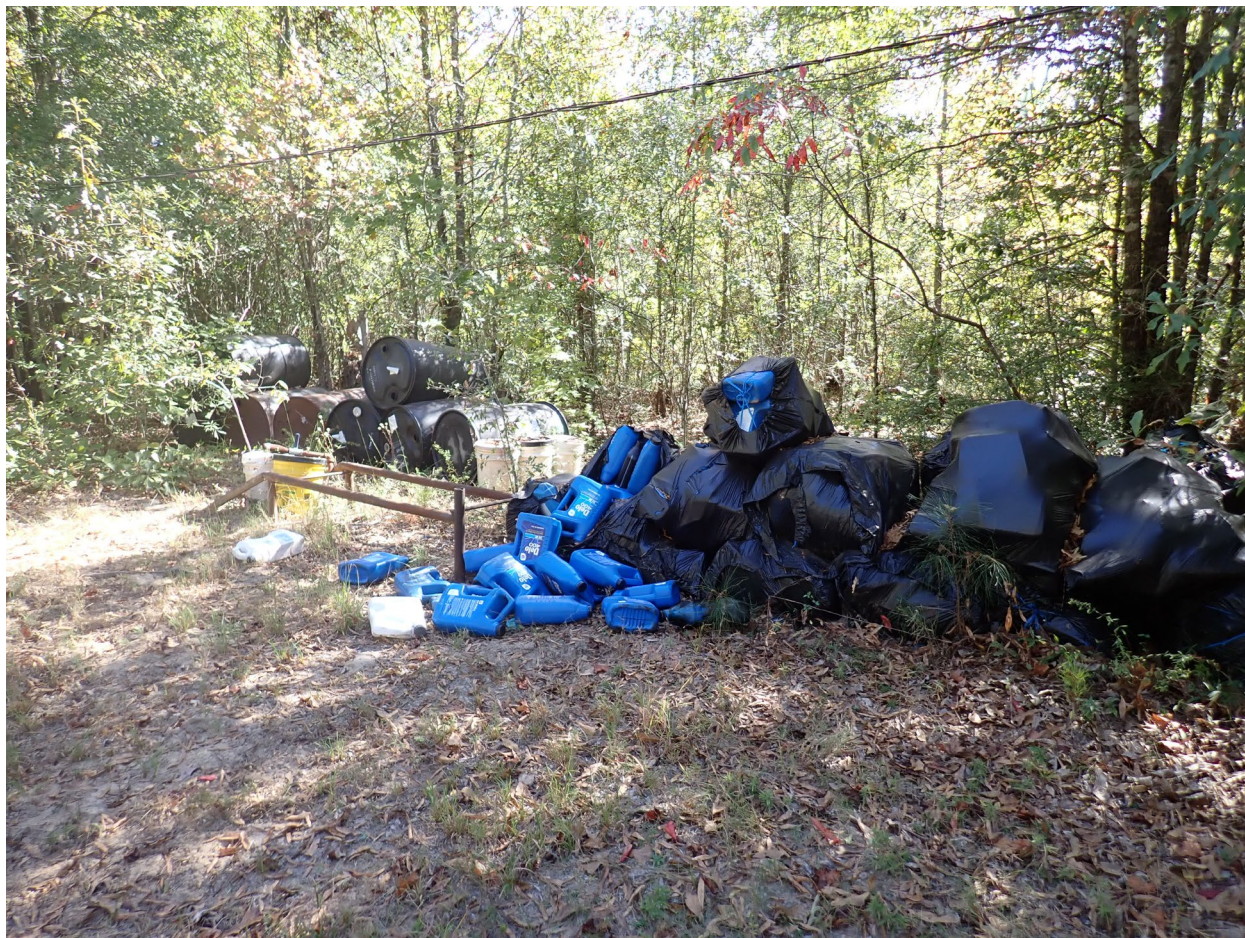
Photo No. 23

**Description:** Looking W, this photo shows miscellaneous petroleum-related containers onsite.
