## Region 6 - Enforcement & Compliance Assurance Division

### INSPECTION REPORT

| Company Name: | CapturePoint, LLC | |
| Facility Name: | North Burbank Unit (NBU) 31 Battery | |

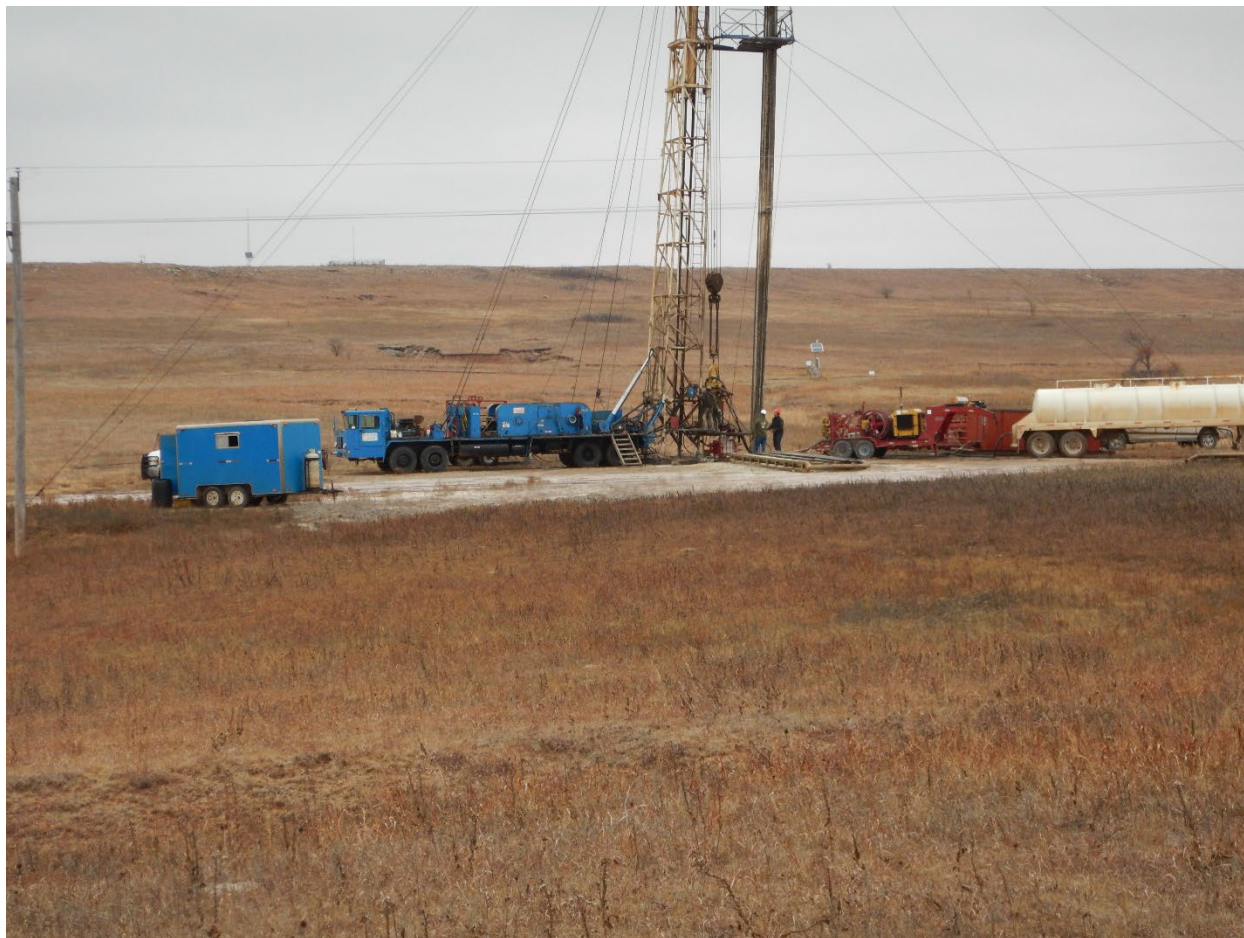
Photo No. 1

From a safe distance, I observed the workover rig performing containment and repair actions on well NBU 23-43 (see photo log, photo No. 1). Well NBU 23-43 was the source from which the blowout occurred, releasing the brine and drilling mud into the unnamed tributary. NBU 23-43 was part of the lease connected to the NBU 31 Battery. I observed the flowpath (see photo No. 2) from the release point (well NBU 23-43) as it traveled west along the lease road toward the Point of Entry (POE).

**Description:** Workover rig on well location where blowout occurred (well NBU 23-43). The rig was actively working, EPA Inspector kept a safe distance away from rig.

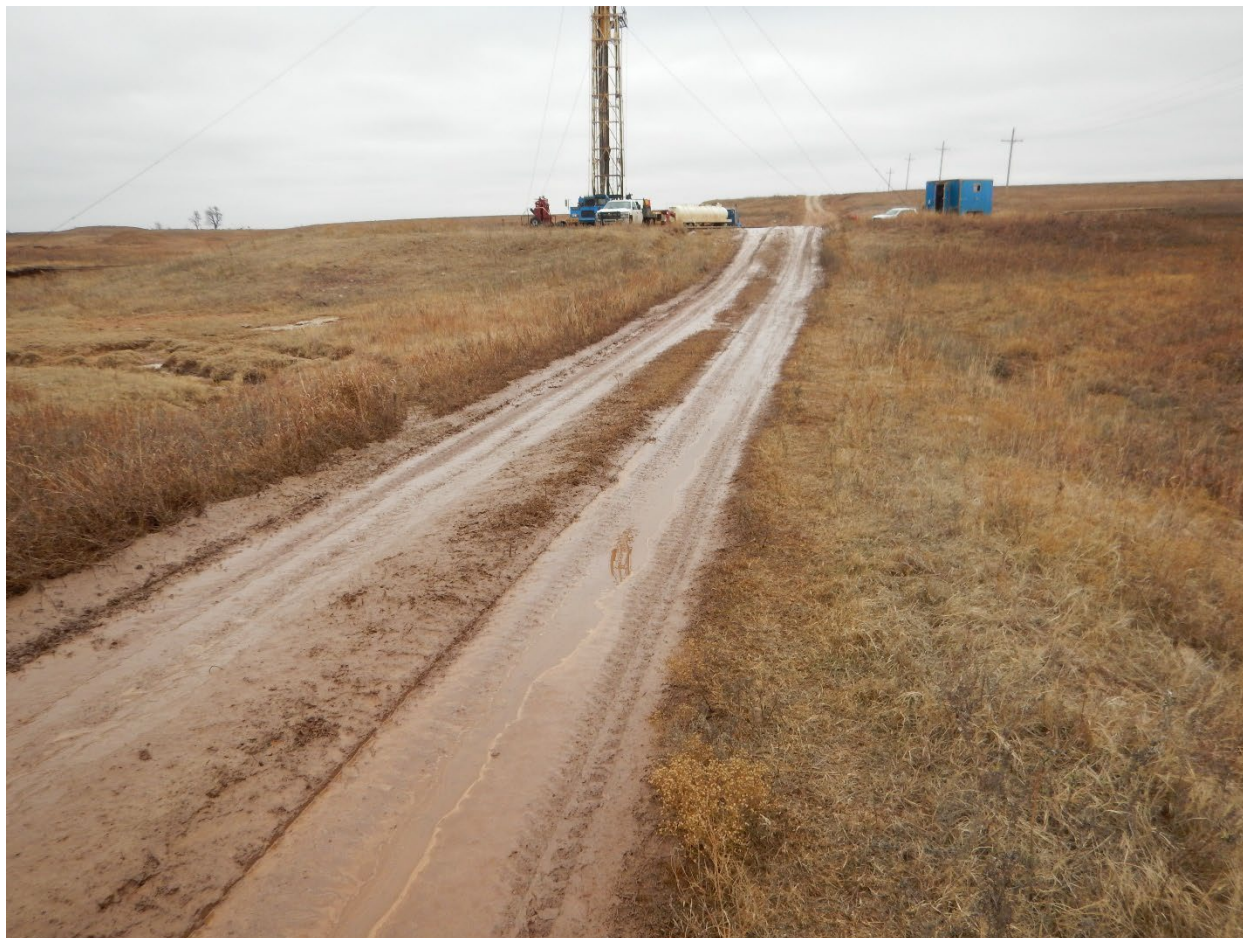
Photo No. 2

**Description:** This was a photo from the Point of Entry (POE) looking along the lease road/flowpath, with a view to the east toward the release point.

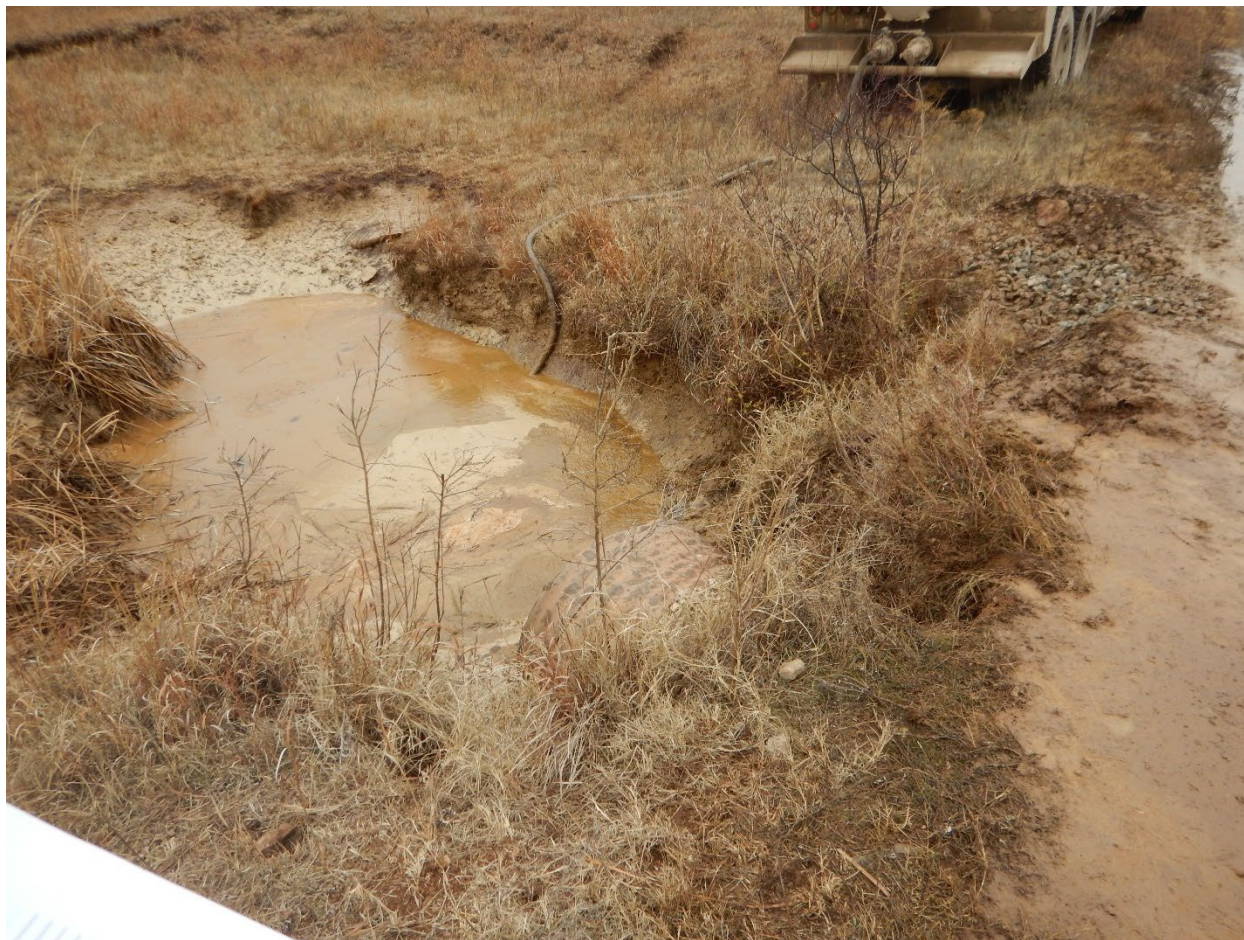
Photo No. 3

I observed the POE (GPS 36.891045, -96.743105) into the main channel of the unnamed tributary (photo No. 3). I observed a TDS field reading of 102,746 mg/L at the POE (photo No. 4). I observed additional TDS field readings of 85,194 mg/L (photo No. 6) and 71,490 mg/L (photo No. 8) along the main channel of the impacted tributary. TDS field readings were taken with a properly calibrated YSI Pro 30 conductivity meter, calibration information was recorded in the inspection field notes logbook.

**Description:** This was the POE into the unnamed tributary. The spilled fluids traveled down the lease road and spilled directly into the impacted tributary.

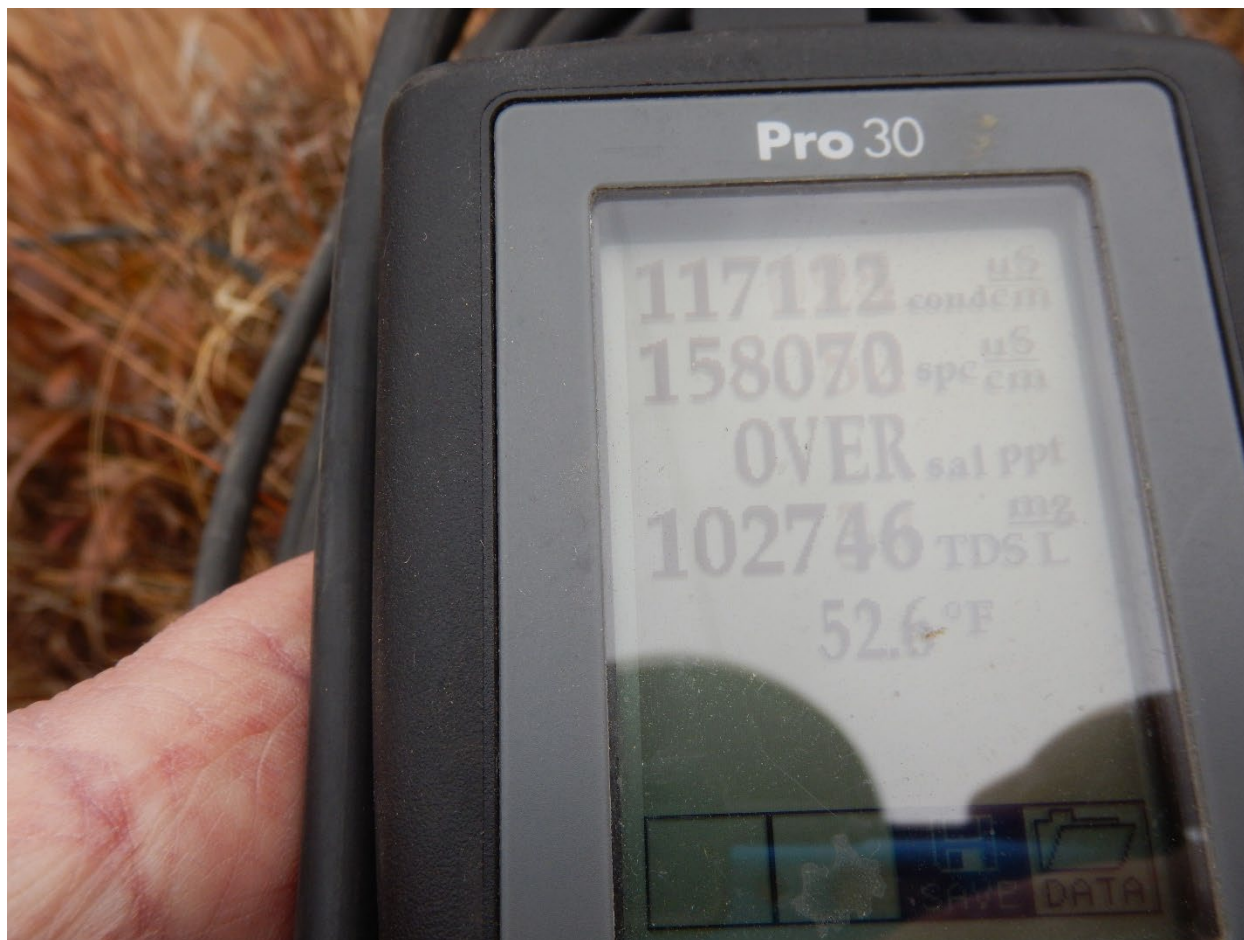
Photo No. 4

**Description:** TDS field reading of 102,746 mg/L, this was taken at the POE.

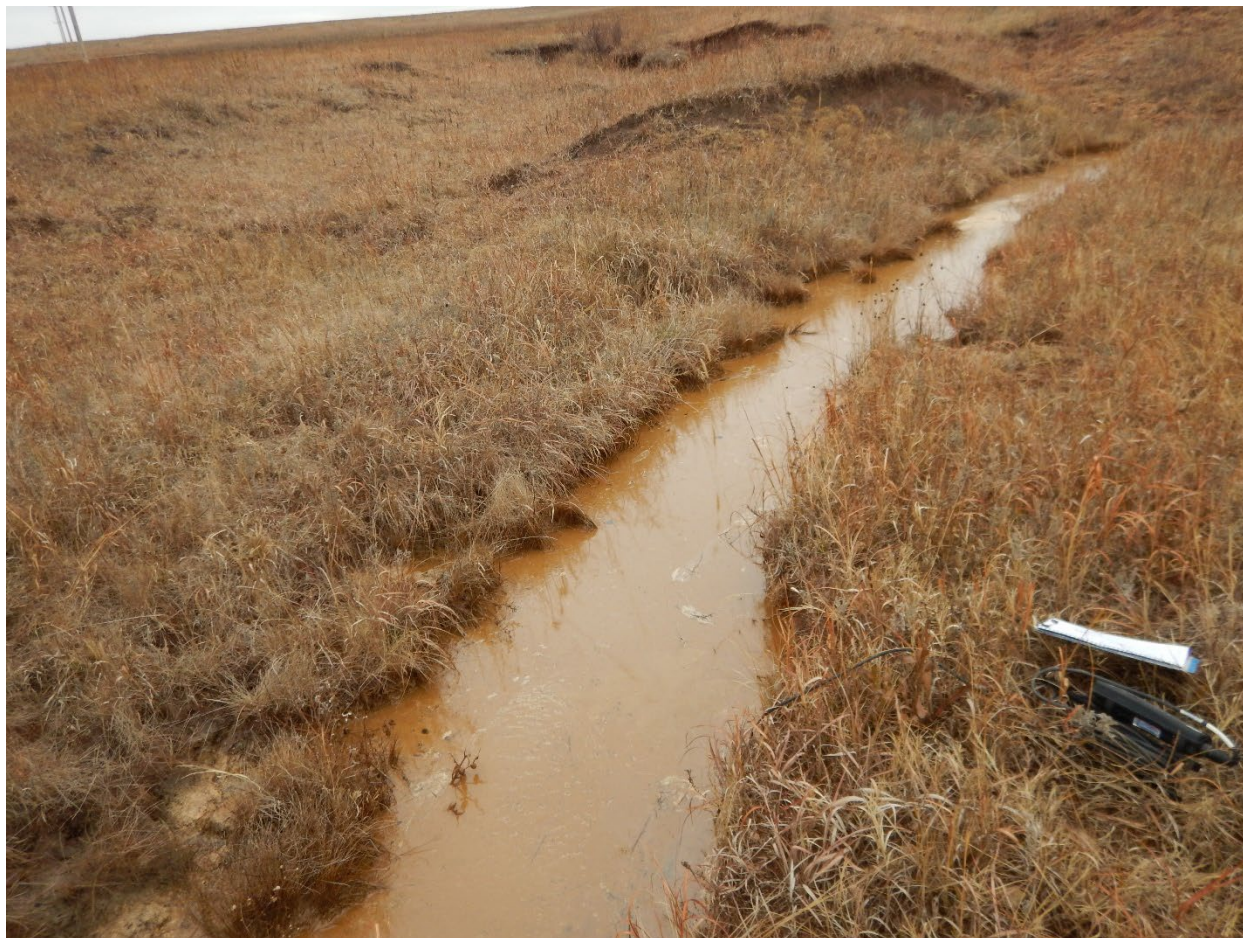
Photo No. 5

**Description:** This was the main channel of the impacted tributary. Upstream and downstream from this location, in areas not impacted by the spill, the main channel of the tributary was dry.

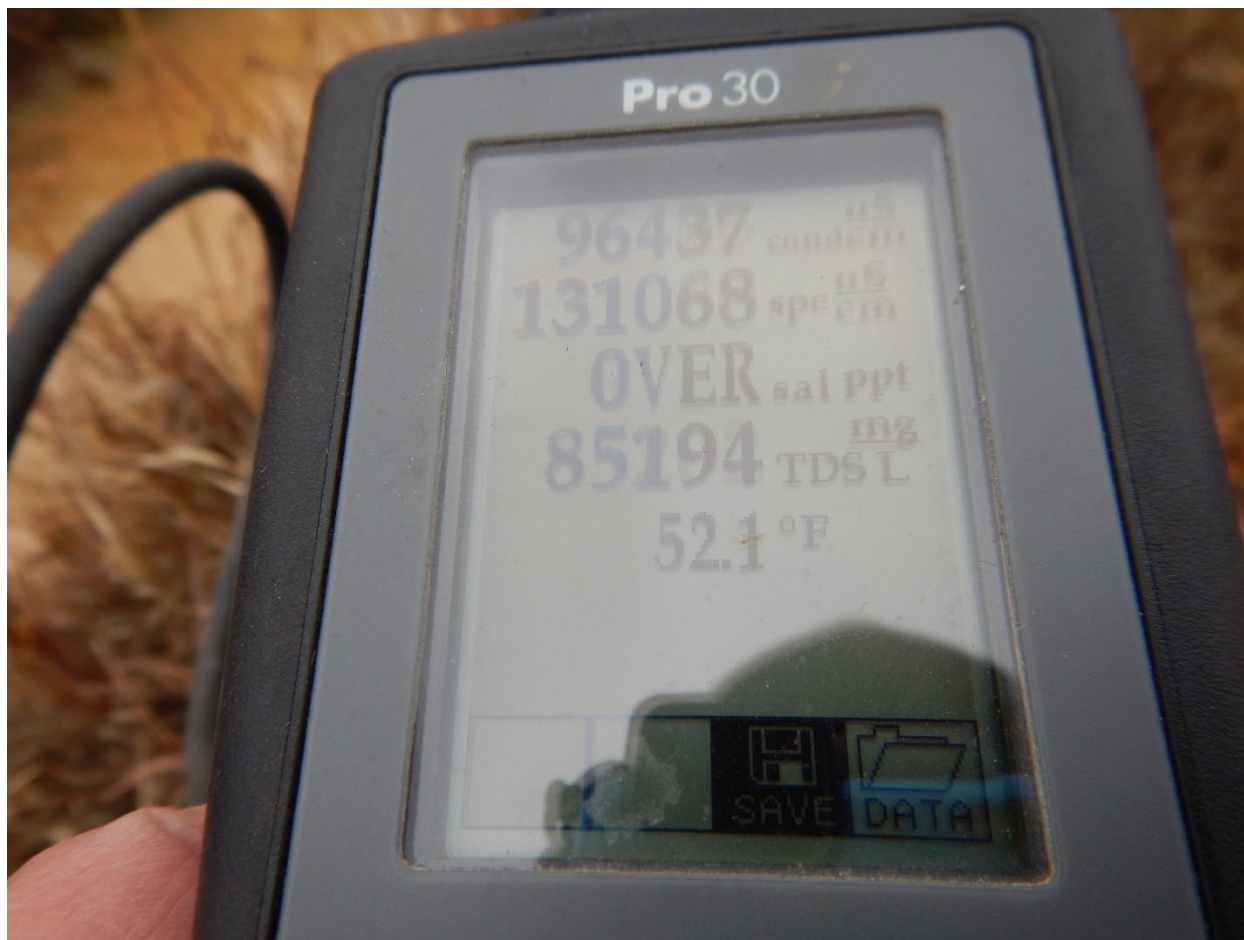
Photo No. 6

**Description:** TDS field reading of 85,194 mg/L taken in the main channel of the impacted tributary.

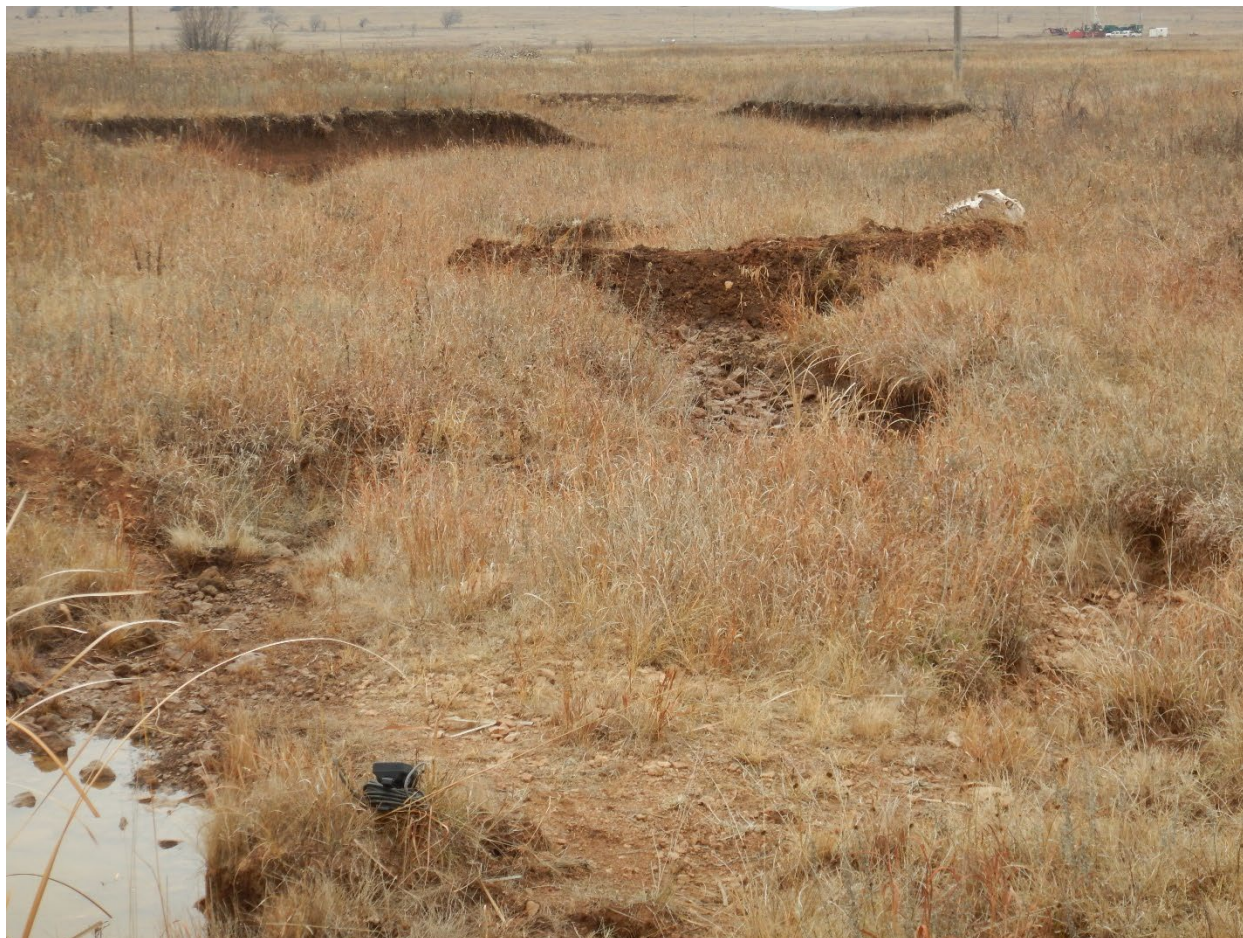
Photo No. 7

I observed three (3) temporary containment dams placed by the operator to prevent further downstream migration of contaminants (see photo No. 7 for the lowermost dam). I observed 2 vacuum trucks removing contaminated water from the impacted tributary. At the time of the inspection, the blowout and spill were both contained, and the spill had traveled approximately .15 miles.

**Description:** Lowermost, temporary containment dam placed by the operator to prevent downstream migration of contaminated water.

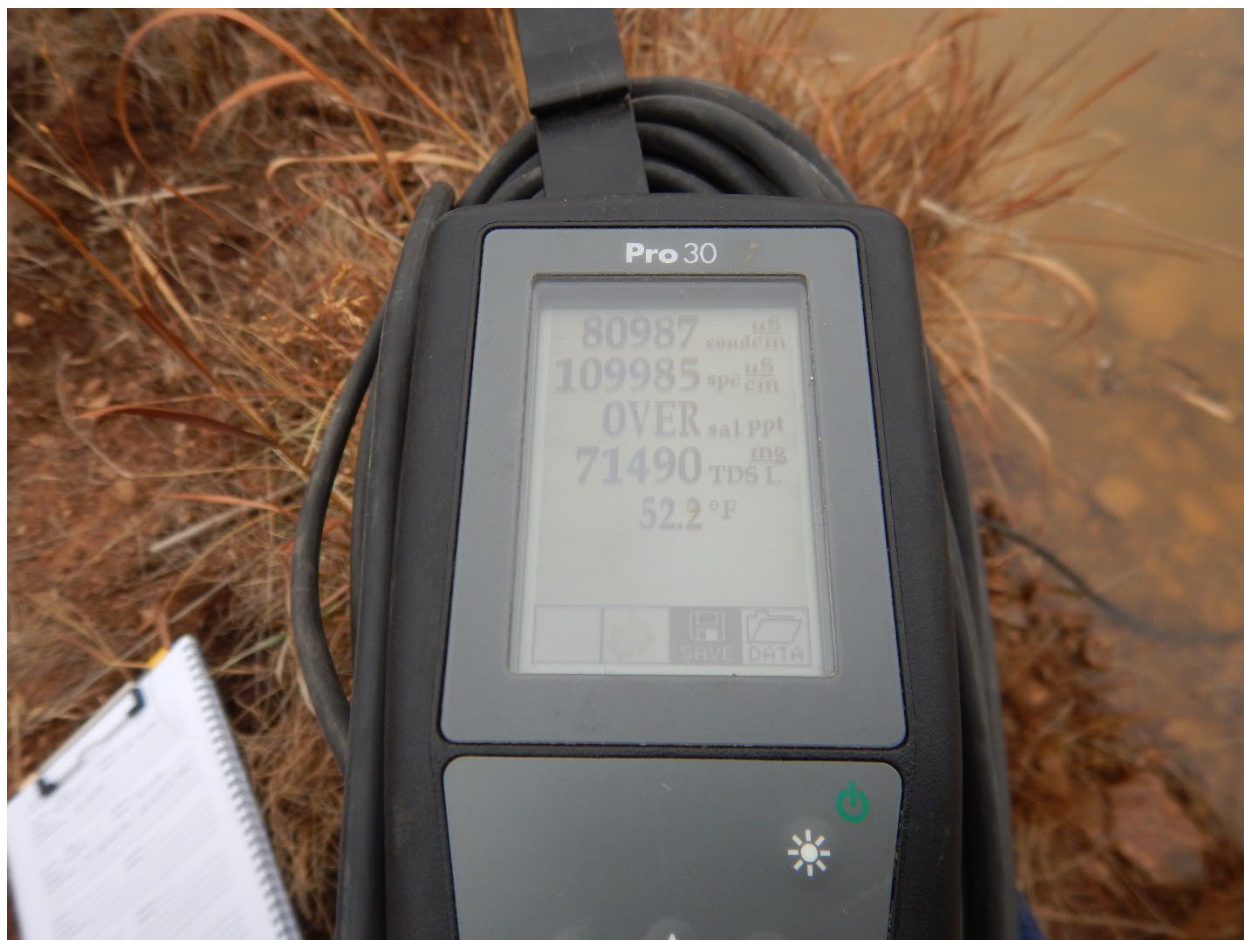
Photo No. 8

**Description:** TDS field reading of 71,490 mg/L taken in the last pool of water, in the main channel of the impacted tributary. The remaining area below this point which was impacted had already been drained by the operator as part of their cleanup operation.
