**Region 6 - Enforcement & Compliance Assurance Division**  
**INSPECTION REPORT**

| Inspection Date(s): | 09/12/2022 to 09/16/2022 | |
| Company Name: | TotalEnergies Petrochemicals & Refining USA, Inc. | |
| Facility Name: | Port Arthur Refinery | |

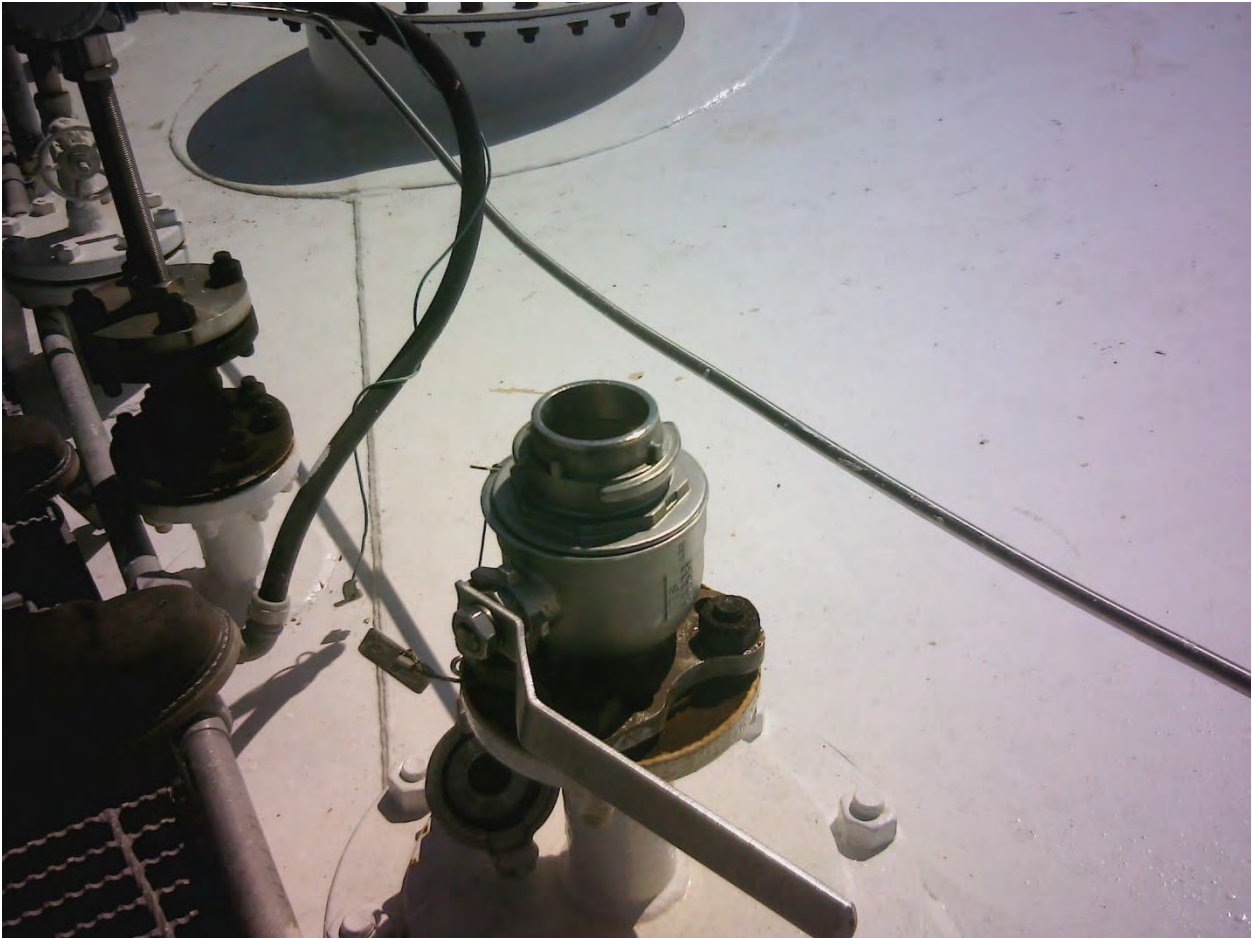
Photo File Name: DC\_0201.jpg

Description: Tank 808 ball valve for the hermetic gauge missing a cap. Open-ended line.

- 3) Inspectors observed open-ended lines, or missing caps, on the ball valves for hermetic gauges on Tanks 807, 808, 809, 810, and 926. 40 CFR 61.242-6(a)(1) requires that all open-ended lines be equipped with a cap, blind flange, plug, or a second valve. 40 CFR 61.242-6(a)(2) requires that the cap, blind flange, plug, or second valve shall seal the open end at all times except during operations requiring process fluid flow through the open-ended valve or line.

October 12, 2022 – EPA and Total had a conference call to discuss the document request status and facility's emissions inventory process. Total shared that all caps of open-ended lines had been replaced and that the gauging company will be instructed to notify facility personnel if caps are missing.

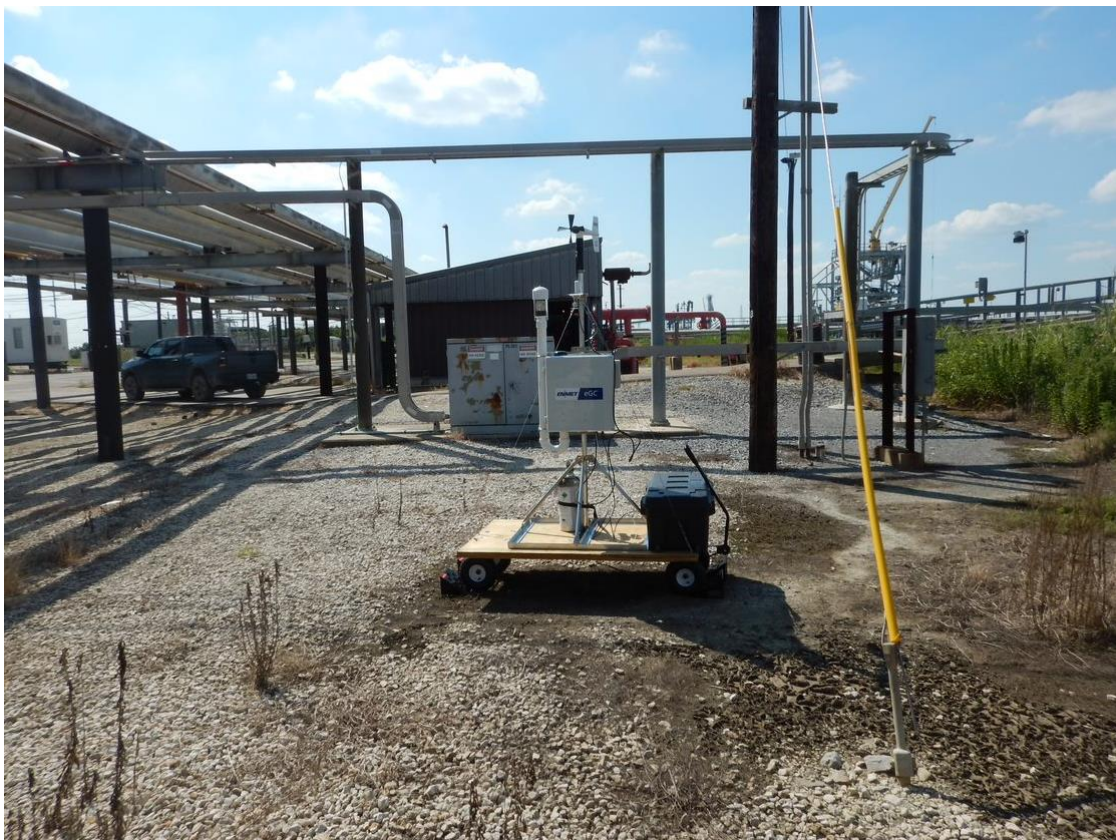
Figure 3. EPA 1B

Site EPA 1B was the second site of EPA 1, this site was located several yards east of site EPA 1A and was still downwind of Dock 3A. EPA 1 was set up at this site at approximately 3:30 pm on September 14, 2022 and stayed there until 9:34 am on September 15, 2022. During this time the wind came from the east-northeast and east, wind speed averaged at around 1.0 – 1.5 mph.

- A single benzene reading of 78.56 ppb was reported at 5:16 pm on September 14, 2022. Wind was from the east at approximately 1.25 mph.
- Significant benzene readings were reported between 8:26 pm – 10:15 pm on September 14, 2022. The highest reading during this time period was 128.1 ppb at 9:06 pm. Winds during this window were coming from the east-northeast at a strength of approximately 1.0 - 1.5 mph.

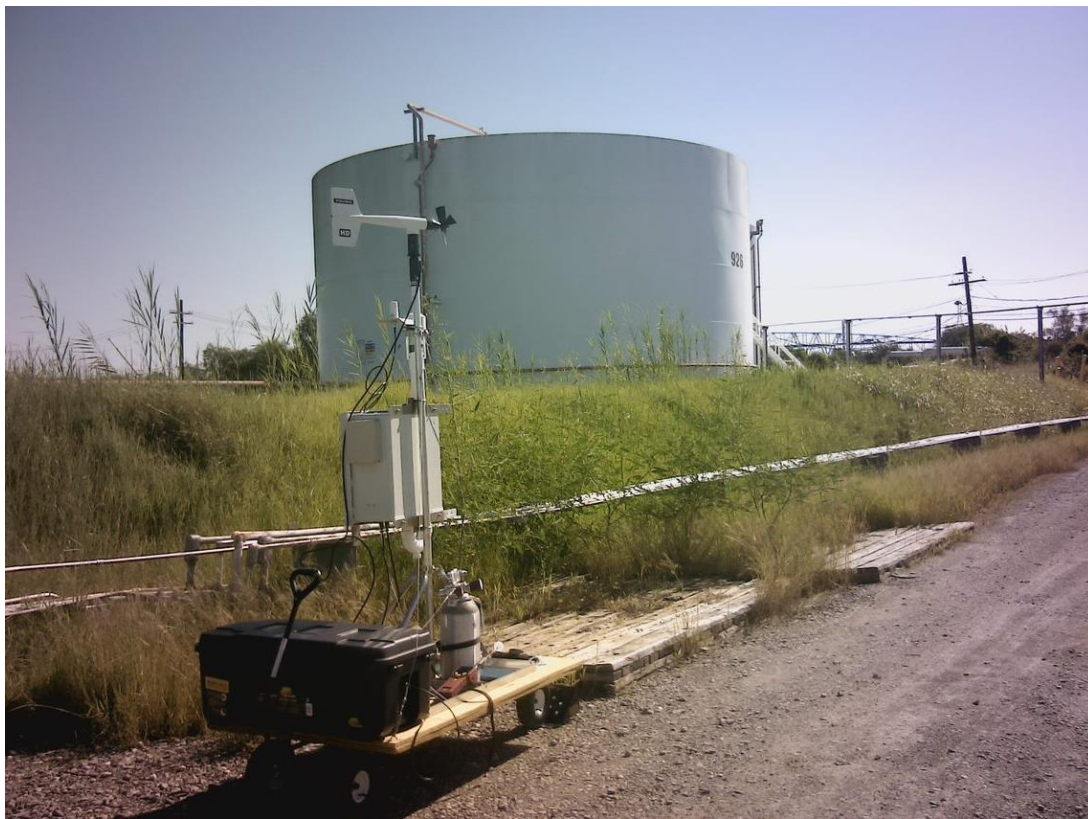
Site EPA 1C was the third site where EPA 1 was positioned, this site was established downwind of T 926. EPA 1 was set up on an access road southeast of T 926 at approximately 10:00 am on September 15, 2022. EPA 1 stayed at this site until 8:46 am on September 16, 2022. This was the last site EPA 1 was set up at during this inspection. Winds came predominantly from the east to southeast with a wind speed of approximately 0.5 – 2.5 mph.

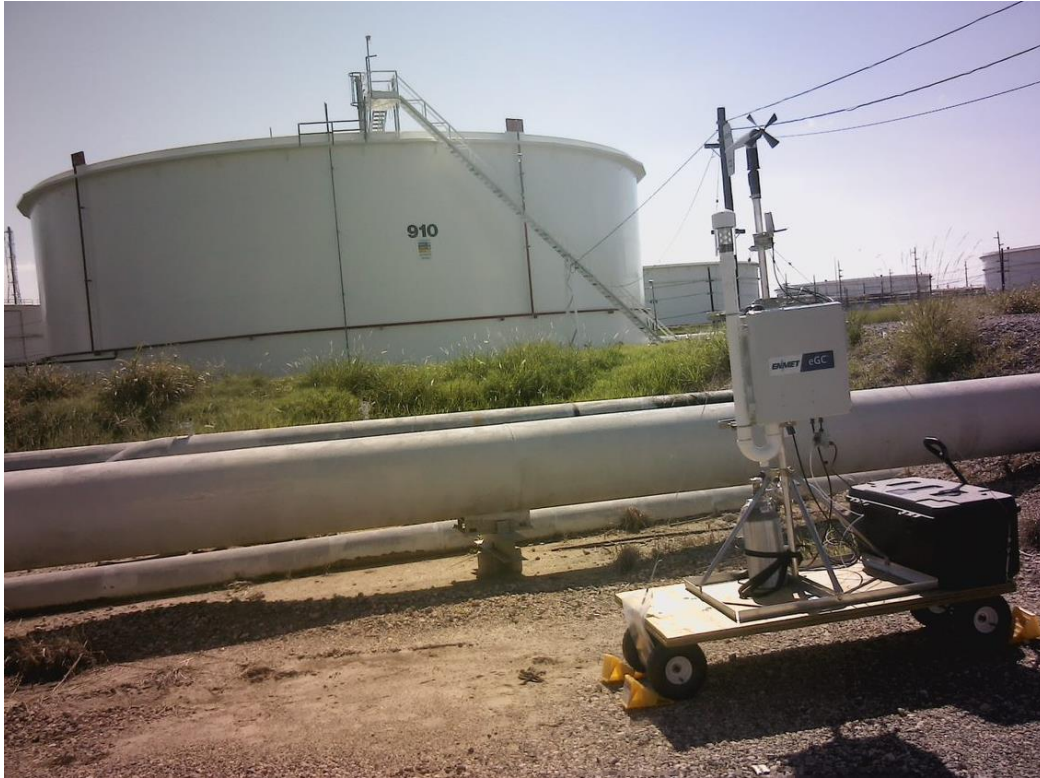
Figure 6. EPA 2D

Site EPA 2D was located downwind of T 541 and T 960 at the corner of a service road. This site was further north than the other EPA 2 sites. EPA 2 was moved to this site at approximately 2:30 pm on September 15, 2022 and stayed there until approximately 7:56 am on September 16, 2022. This was the last site that EPA 2 was stationed at during this inspection. The wind came from the north-northeast and the east during this time and had a strength of 0.5 – 2.0 mph.
