**Region 6 - Enforcement & Compliance Assurance Division**  
**INSPECTION REPORT**

| Inspection Date(s): | 03/28/2022 | |
| Media Program: | Water | |
| Company Name: | <b>Amelia Dairy</b> | |

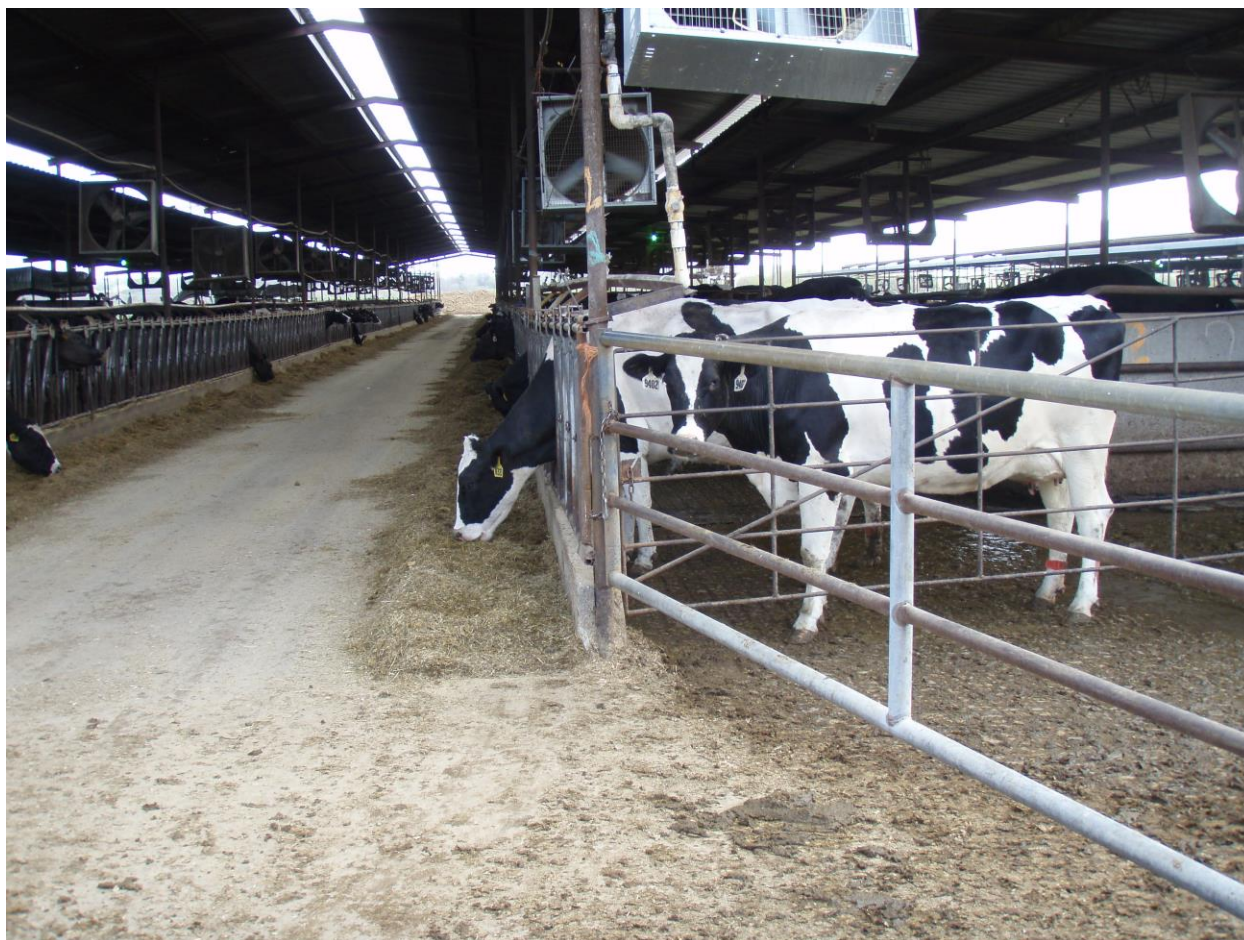
Photo File Name: P3280001.JPG

Description: One of four photographs taken to show a panoramic view of three of the four freestall barns and the old former milking parlor. This is a view of one of the freestall barns. The freestalls discharges flush water into the common concrete basin (located downslope at the far east side of the photograph), thence into the elevated manure screen, followed by RCS 1. The view is toward the east.

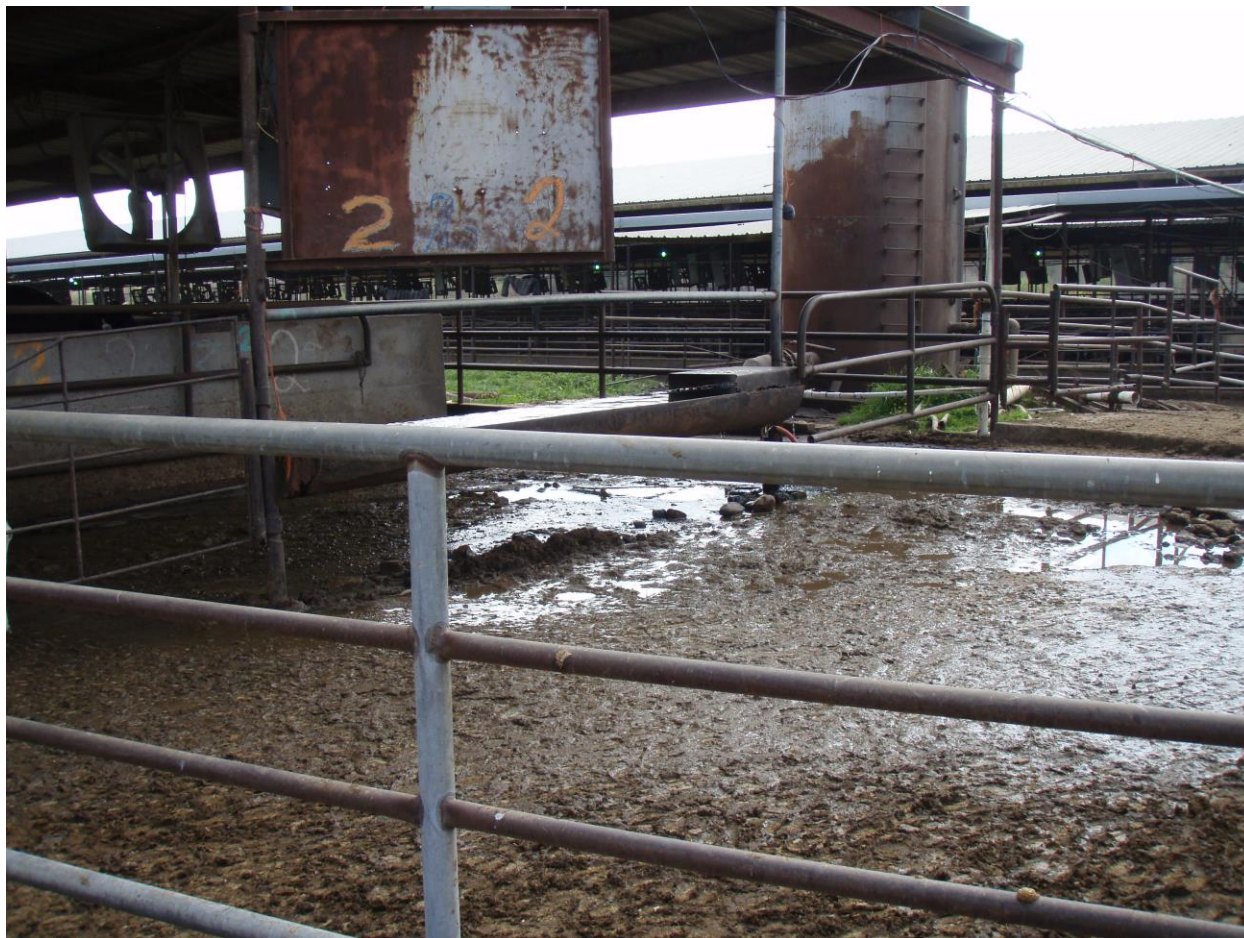
Photo File Name: P3280002.JPG

Description: Continuing with a panoramic view of the freestall area. A water trough was deliberately left leaking so as to provide make-up water to the RCS system for land application due to an ongoing drought in north Texas. The view is toward the southeast.

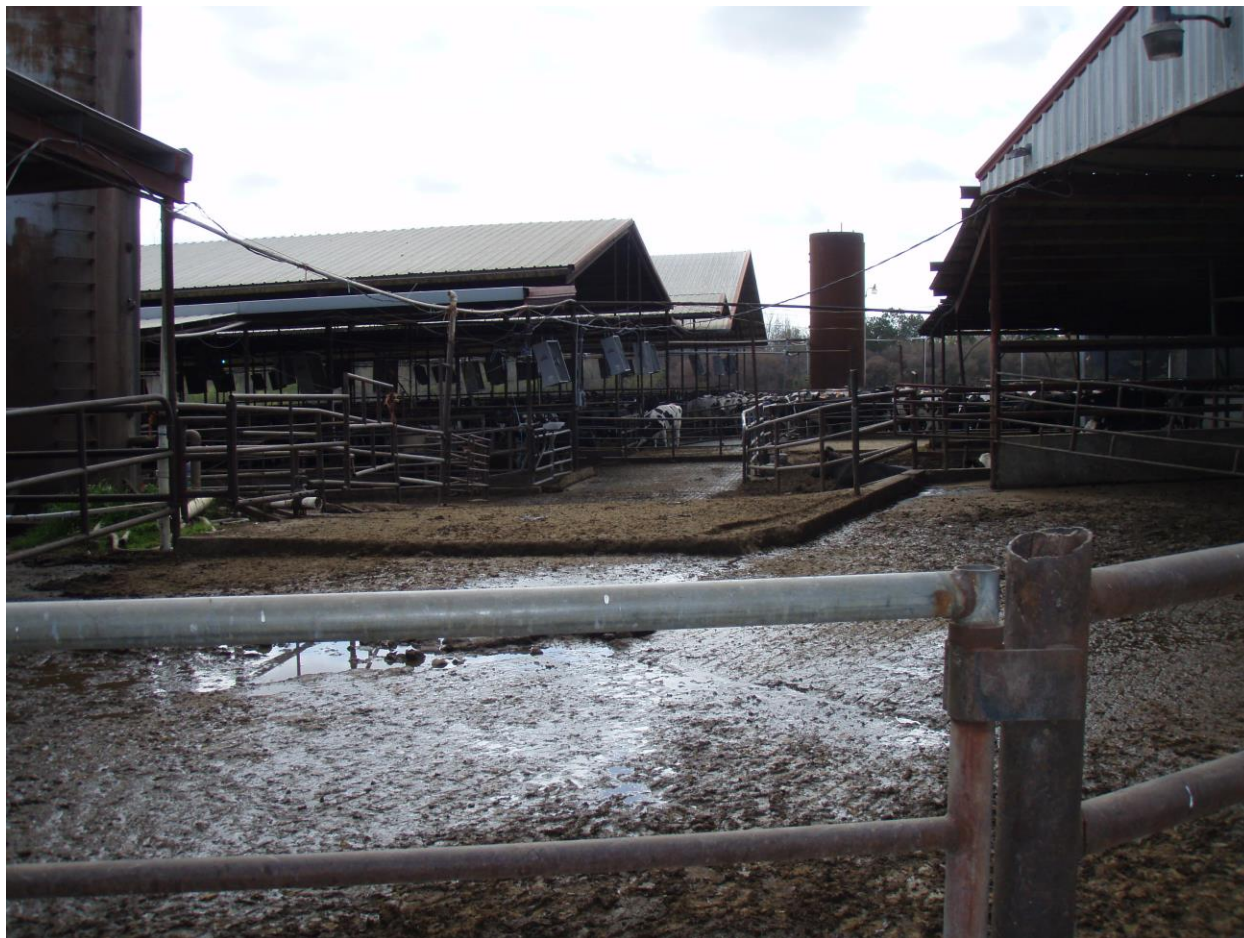
Photo File Name: P3280003.JPG

Description: Continuing with a panoramic view of the freestall area. A view of two additional freestalls in the background and an old former milking parlor (on the right) which is now used for sick cows. The view is toward the south.

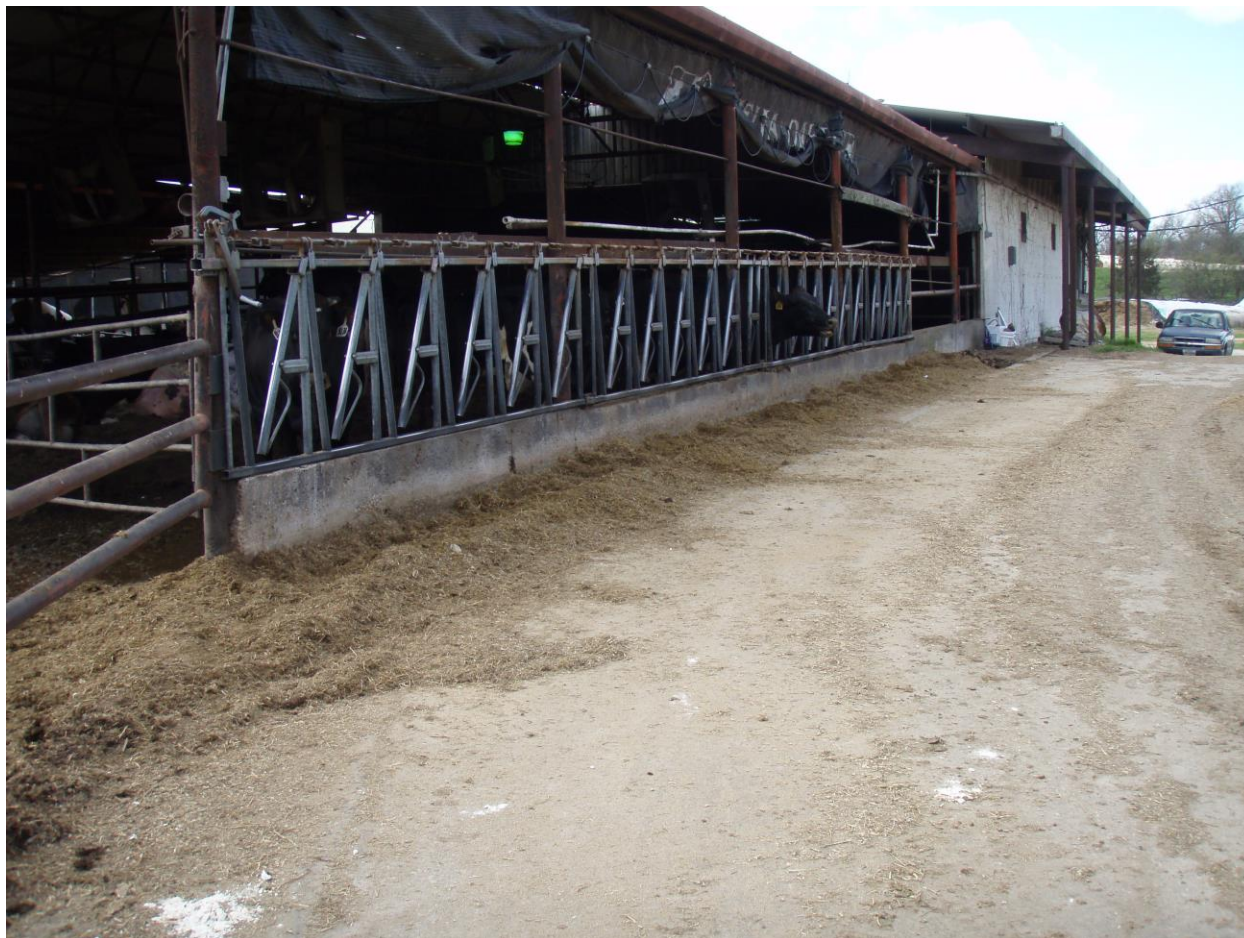
Photo File Name: P3280004.JPG

Description: Continuing with a panoramic view of the freestall and old milking parlor area. The view is of the old former milking parlor which is now used for sick cows. The view is toward the west-southwest.

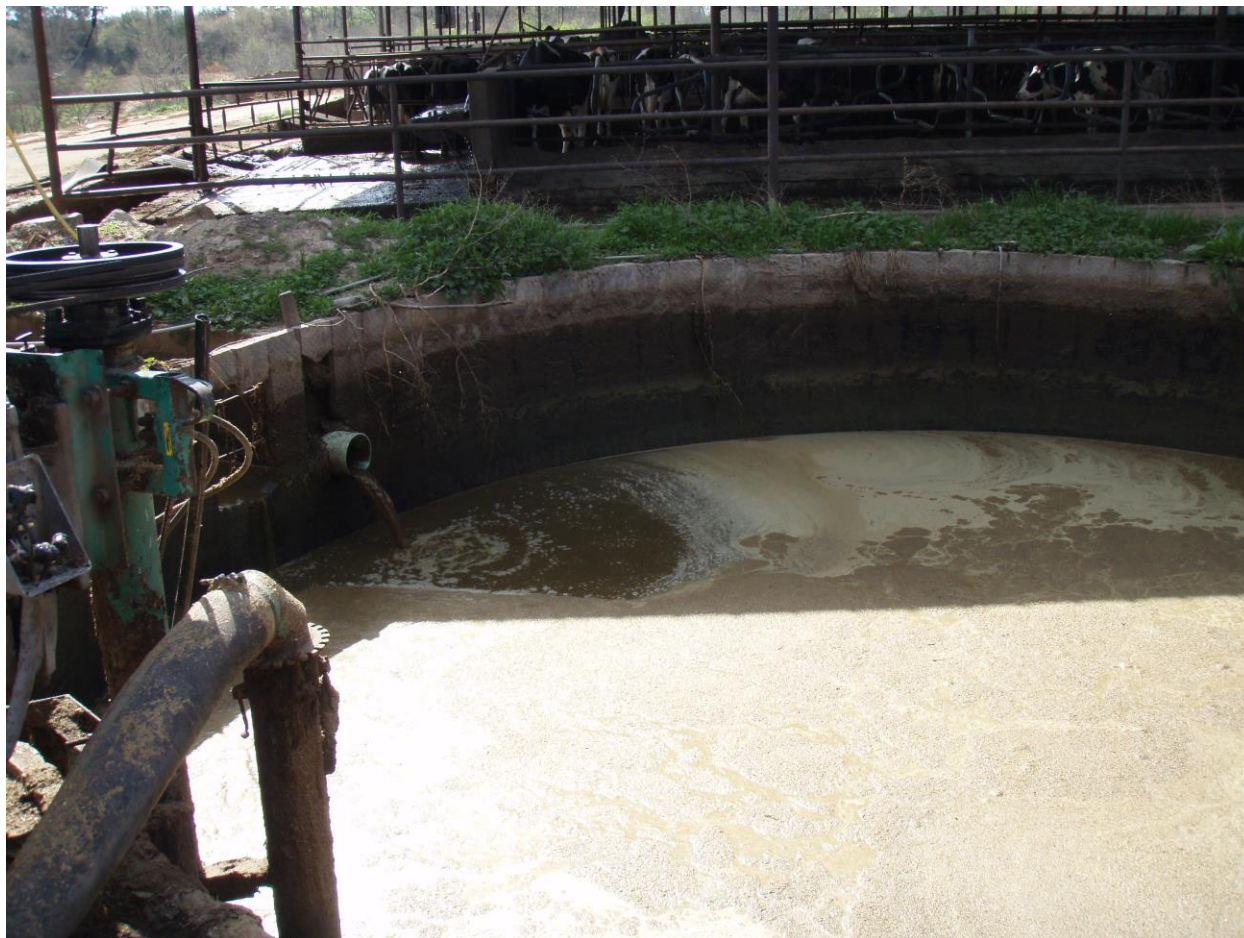
Photo File Name: P3280005.JPG

Description: The centralized concrete pit that collects freestall flush water. It is located on the east side of the three freestalls shown in photos 1-3. The elevated manure screen (not shown) is located on the left side of this collection pit.

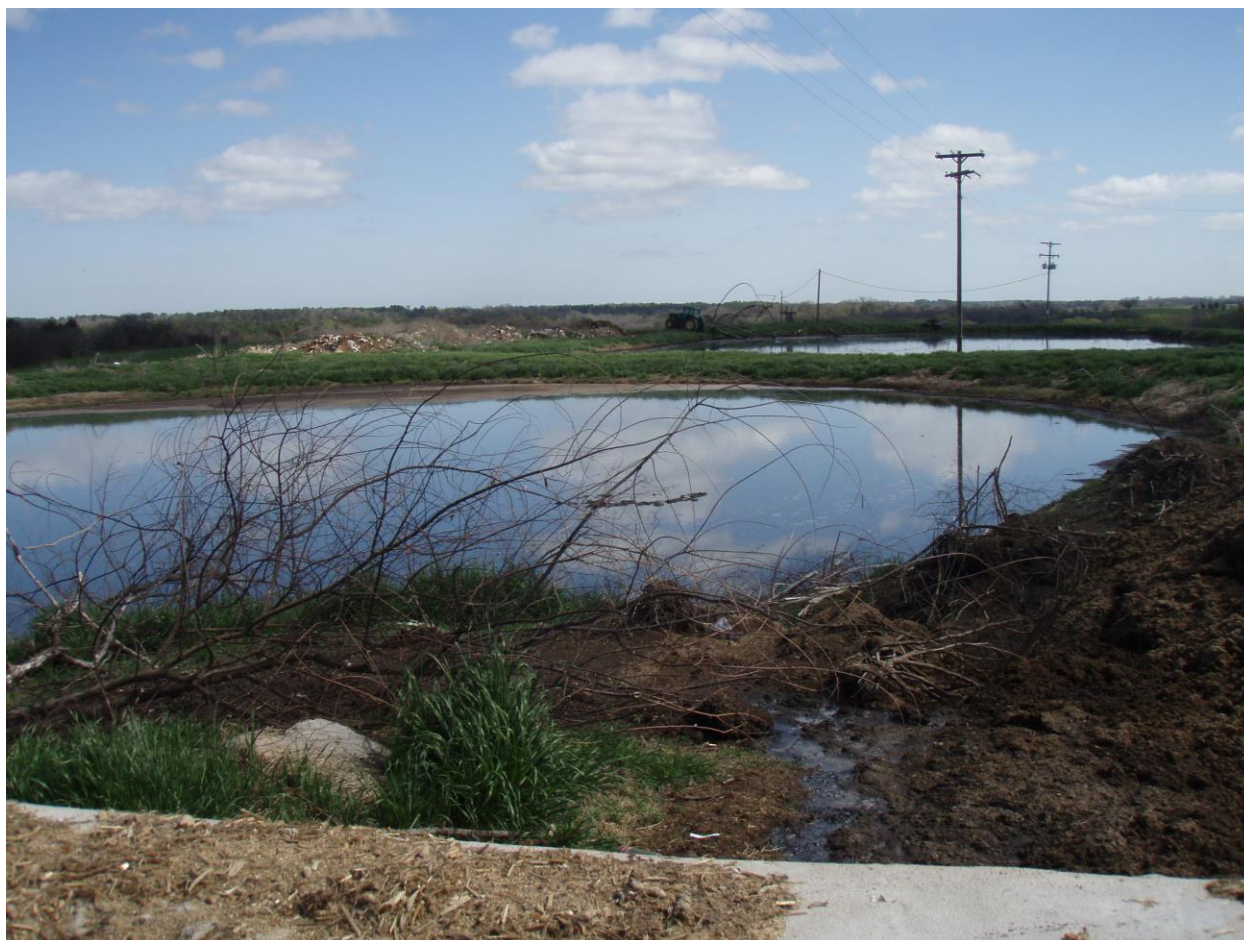
Photo File Name: P3280006.JPG

The second composting area was a formerly used composting location placed on the north embankment of RCS 3. This old compost pile, which has not been used in the past six months, had a significant number of exposed dried cow bones emerging from the long pile (see photo 6). However, any runoff from this composting area would likely enter the RCS. The north side of this composting area was bermed with soil, and a large pasture was located below this area (see photo 8). (AOC 2)

AOC 2: The old composting area located on the north embankment of RCS 3, which has not been used in the past six months, has a significant number of exposed dried cow bones emerging from the long pile. This material appeared ready for final disposition via screening and land application at an agronomic rate, however, the requirements of 30 TAC Chapter 332.(4) were not met due to the apparent scavenging that occurred.

Description: RCS 2 is in the foreground and RCS 3 is in the background. The former mortality composting area is in the background located on top of the RCS 3 embankment (on the left side of the lagoon) which is also shown in Photo 8. Note the numerous exposed dry cow bones in the manure pile. Both lagoons have sufficient freeboard and capacity for the 25-yr/24-hr rain event. The view is toward the east-northeast.

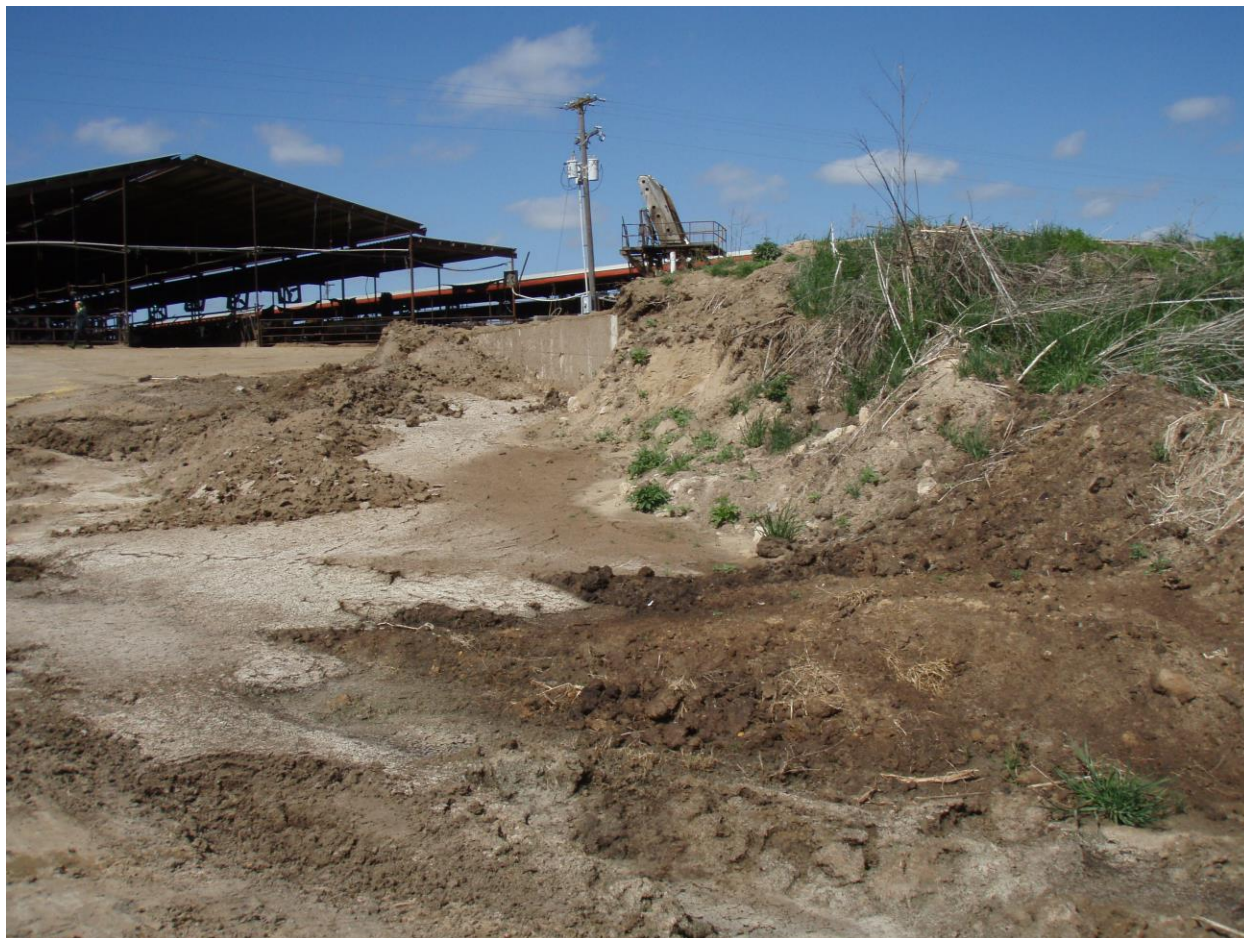
Photo File Name: P3280007.JPG

Manure and sand mix from the clean-out of the centralized collection pit has been emptied onto the ground to dry before being land applied with a manure spreader (see Photo 7). This area is located outside of the RCS drainage area and would discharge storm water runoff into a pasture area located above a tributary of Brushy Creek. All spilled or placed manure must be stored in the watershed of an RCS. (AOC 4)

AOC 4: Manure and sand mix from the clean-out of the centralized collection pit has been emptied onto the ground to dry before being land applied with a manure spreader. This area is located outside of the RCS drainage area and would discharge storm water runoff into a pasture area located above a tributary of Brushy Creek. The area of spilled manure is located just before the wastewater enters RCS 1. All spilled or placed manure must be stored within the watershed of an RCS as required by the CAFO General Permit Part III.A.9.(b). and (c).

Description: Manure and sand mix collected from the centralized collection pit has been emptied onto the ground to dry before being land applied with a manure spreader. This area is located outside of the RCS drainage area and would discharge storm water runoff into a pasture area located above a tributary of Brushy Creek. All spilled or placed manure must be stored in the watershed of an RCS. The location of this manure and sand mix waste is near the influent point of RCS 1, at the southwest corner of the lagoon. The view is toward the northwest.

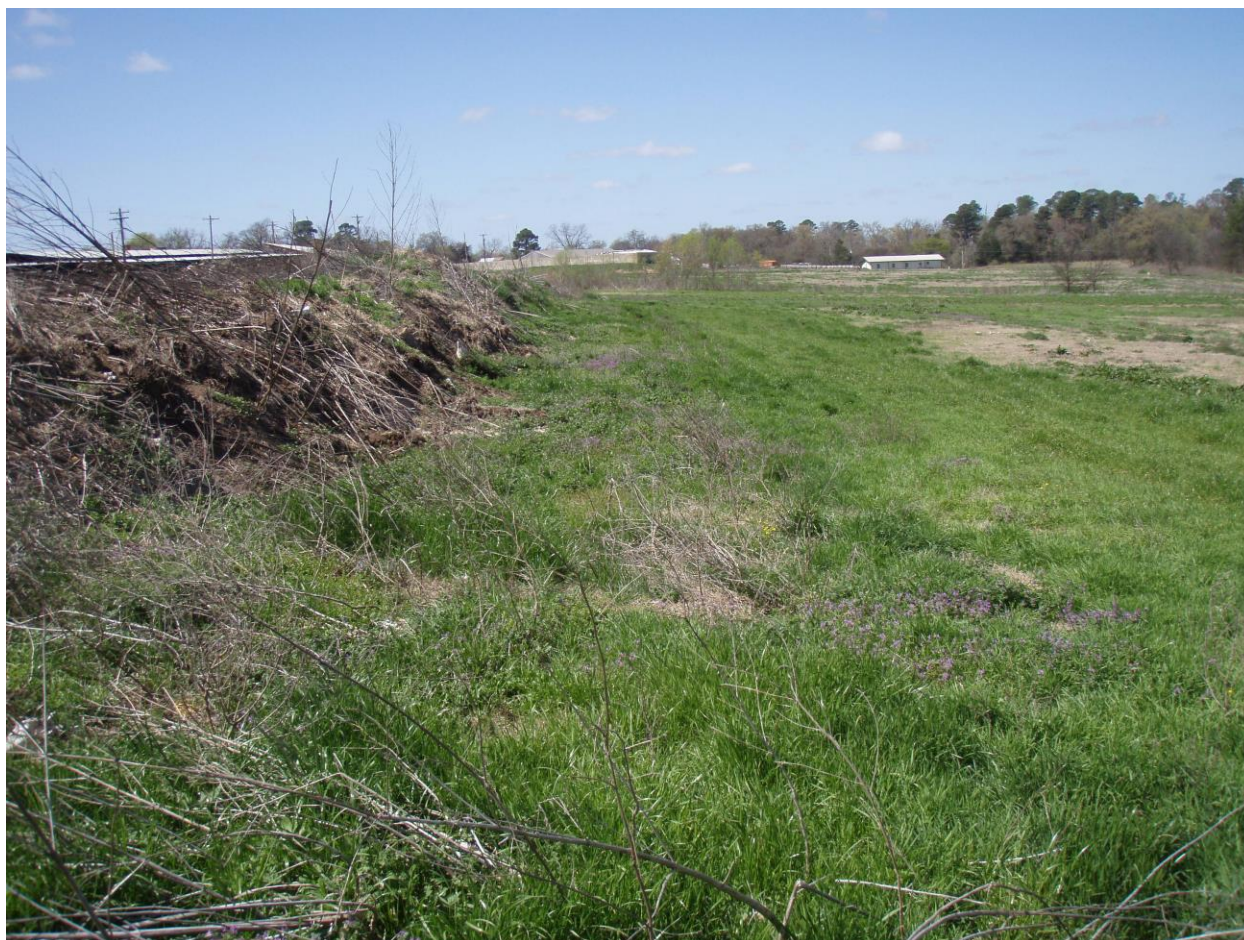
Photo File Name: P3280008.JPG

Description: The north embankment of the old mortality composting area located on the embankment of RCS 3. The pasture located to the right is protected by a soil berm that keeps runoff from the manure pile from discharging into the pasture. This manure pile, which is located on the left side of the berm, was fraught with exposed dry cow bones. The view is toward the west.

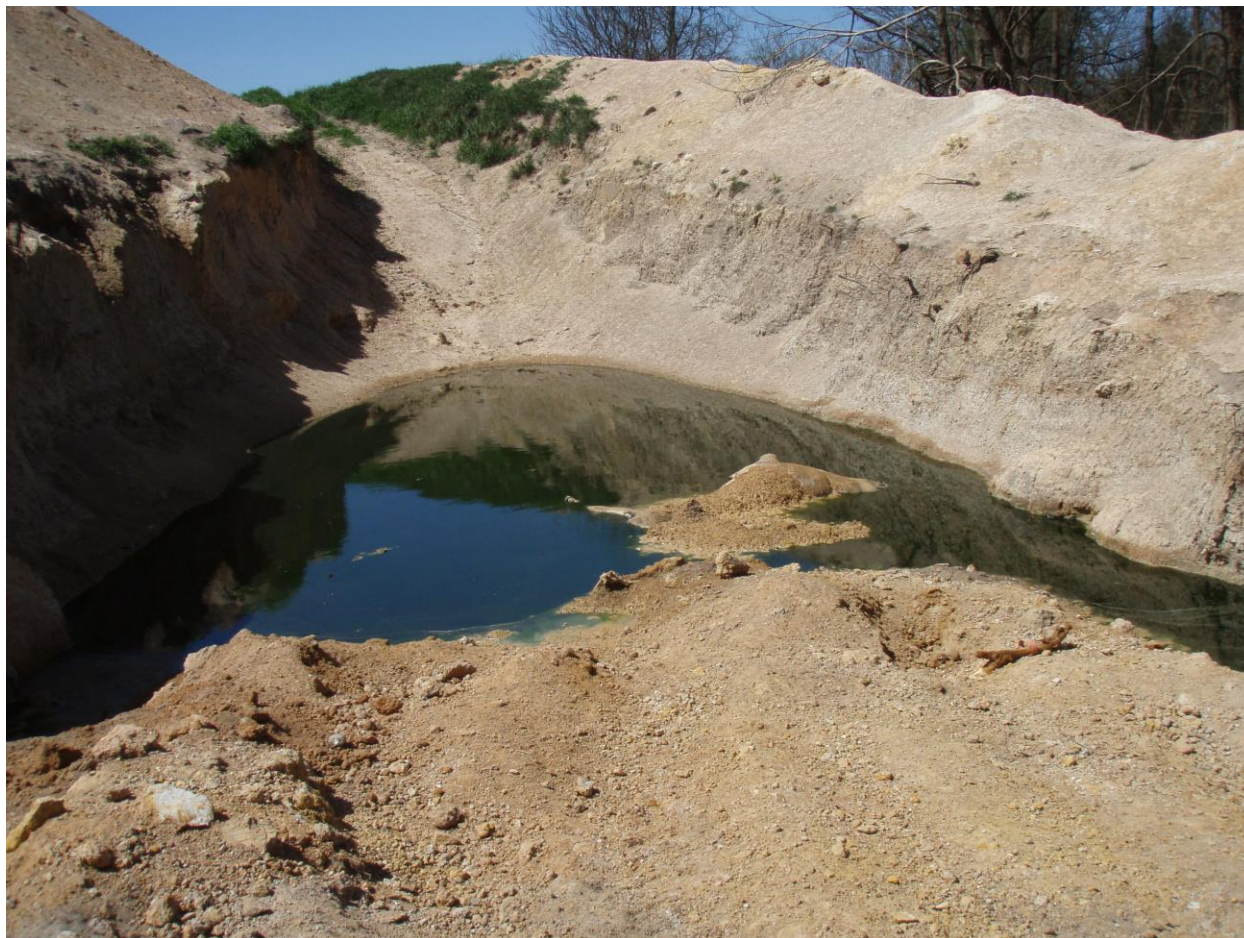
Photo File Name: P3280009.JPG

Mortality management is now being done by burial and are no longer being composted. However, as shown in Photo 9, there was one cow that may have been buried at one time (as evidenced by the small amount of soil that was on the carcass) that was floating on the surface of the burial pit. Numerous vultures were noted flying away as I approached the mortality pit. (AOC 3)

Description: The mortality burial pit has a dead cow floating on the surface. The Texas RG-419, referenced in 4 TAC Sections 31.3, and 58.31(b), requires that dead cattle be buried with three feet of soil. Numerous vultures flew away when I arrived at the site. The view is toward the west.

AOC 3: The mortality management area must be properly managed as required by the TCEQ General CAFO Permit Part III.A.11.(c). This includes (per this facility's mortality disposal practice) burial within 3 days of death using three feet of earthen material as referenced by 4 TAC Sections 31.3, and 58.31(b) which further references RG-419.

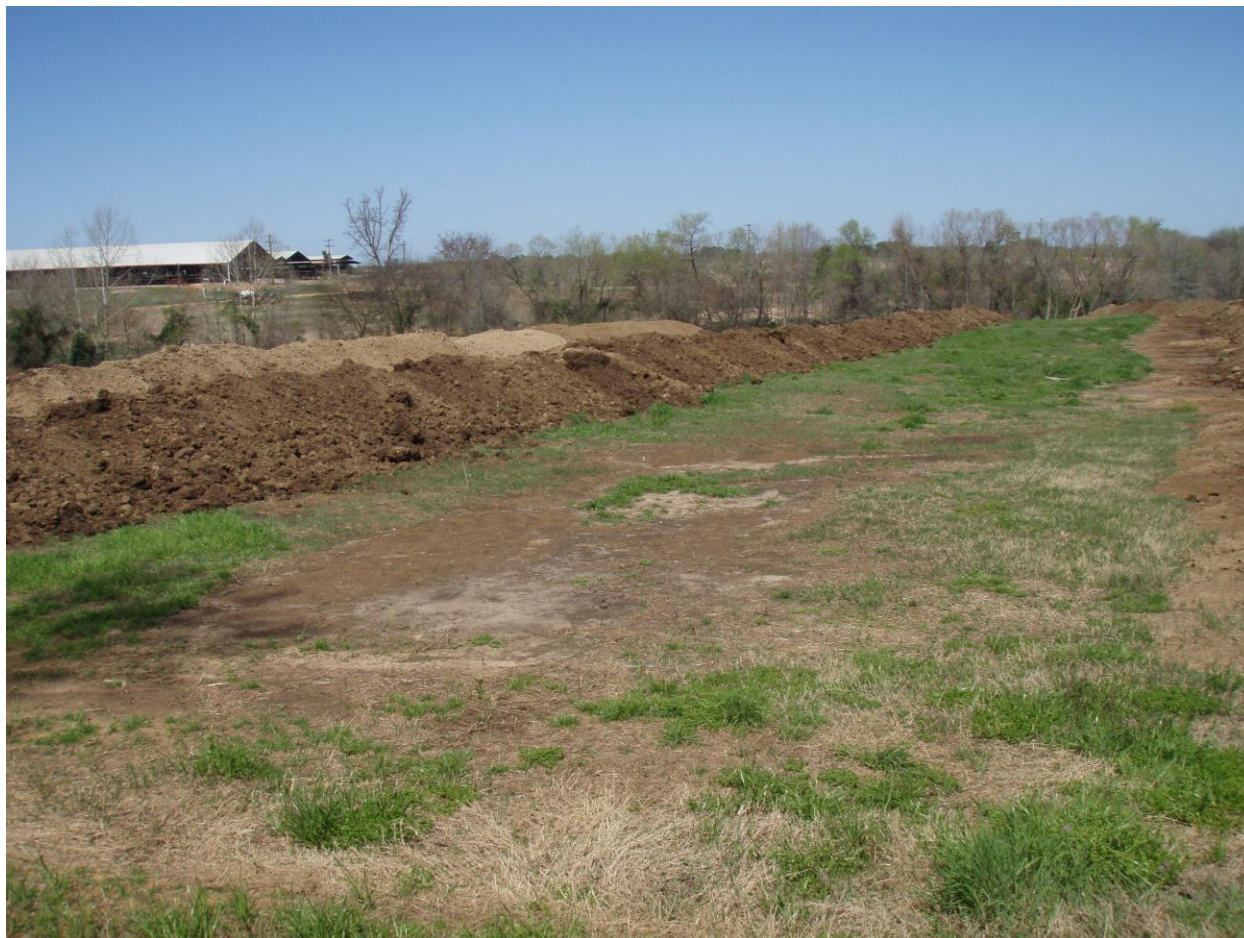
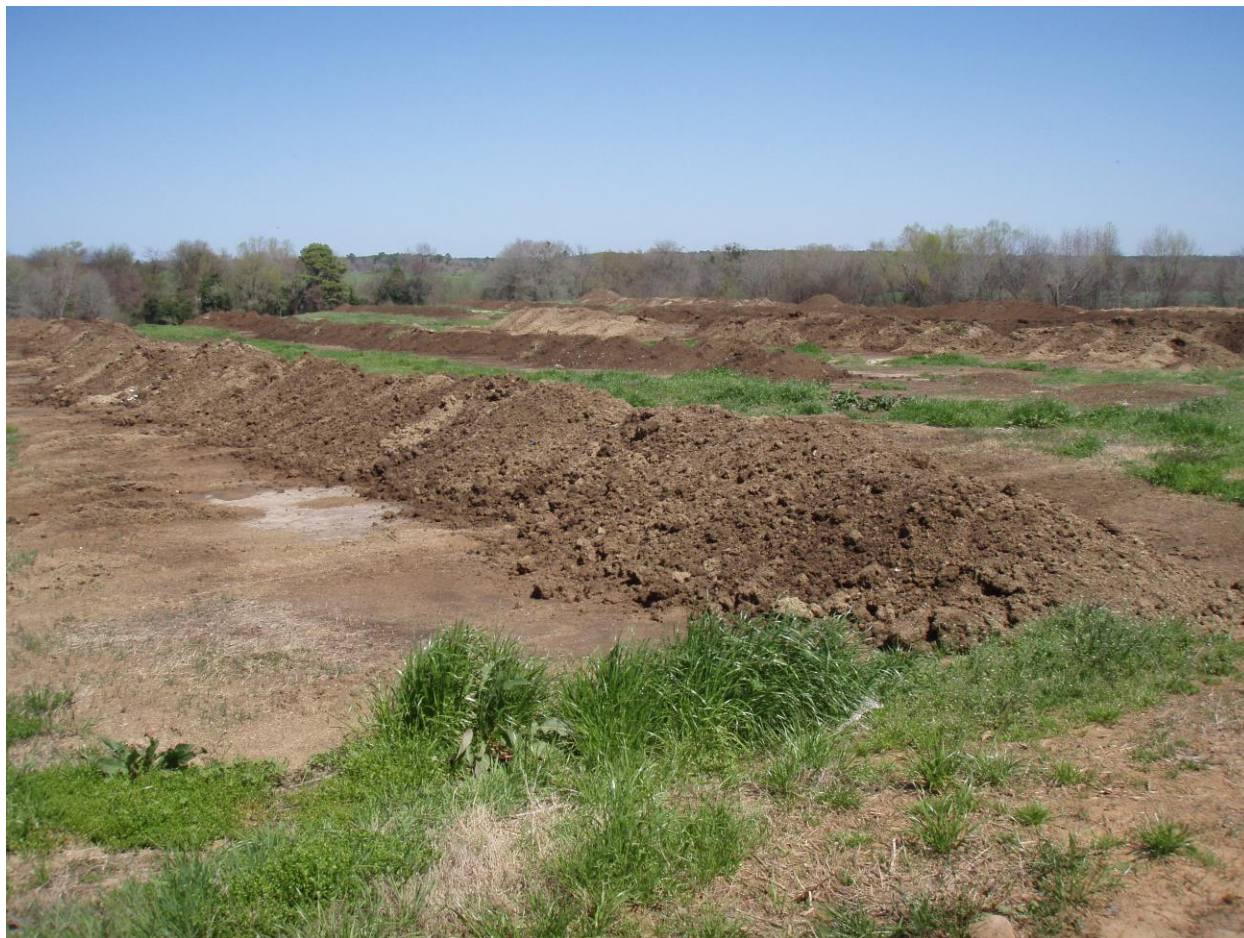
There were two composting areas that were placed out in the open, with one very large composting area placed on the side of a hill immediately upslope of a tributary of Brushy Creek (see photos 10 and 11), and outside of the drainage area of an RCS. This very large composting area had approximately 10-12 long windrows as shown in the March 23, 2021, DigitalGlobe aerial. Runoff from this composting area would discharge into the pasture and creek below. (AOC 1)

AOC 1: A very large composting area was not constructed within the watershed of an RCS. The composting area has approximately 10-12 long windrows, as shown in the attached photolog (Photos 10 and 11), and as seen on the March 23, 2021, DigitalGlobe aerial. Runoff from this composting area would discharge into the pasture and then into a tributary of Brushy Creek located immediately below the composting area. Composting requirements for CAFOs are found in the General Permit Part III.B.4.

Description: A large manure composting area, stored in a pasture above a tributary of Brushy Creek (located at the tree line seen in the background) is not stored in an area that drains into an RCS. Storm water runoff from this area would discharge downslope toward Brushy Creek. The DigitalGlobe aerials show the size of this composting area and its proximity to Brushy Creek. The view is toward the north-northwest.

Description: Another view of the large manure composting area, stored in a pasture above a tributary of Brushy Creek (located at the tree line seen in the background) is not stored in an area that drains into an RCS. Storm water runoff from this area would discharge downslope toward Brushy Creek. The DigitalGlobe aeriels show the size of this composting area and its proximity to Brushy Creek. The view is toward the northeast.

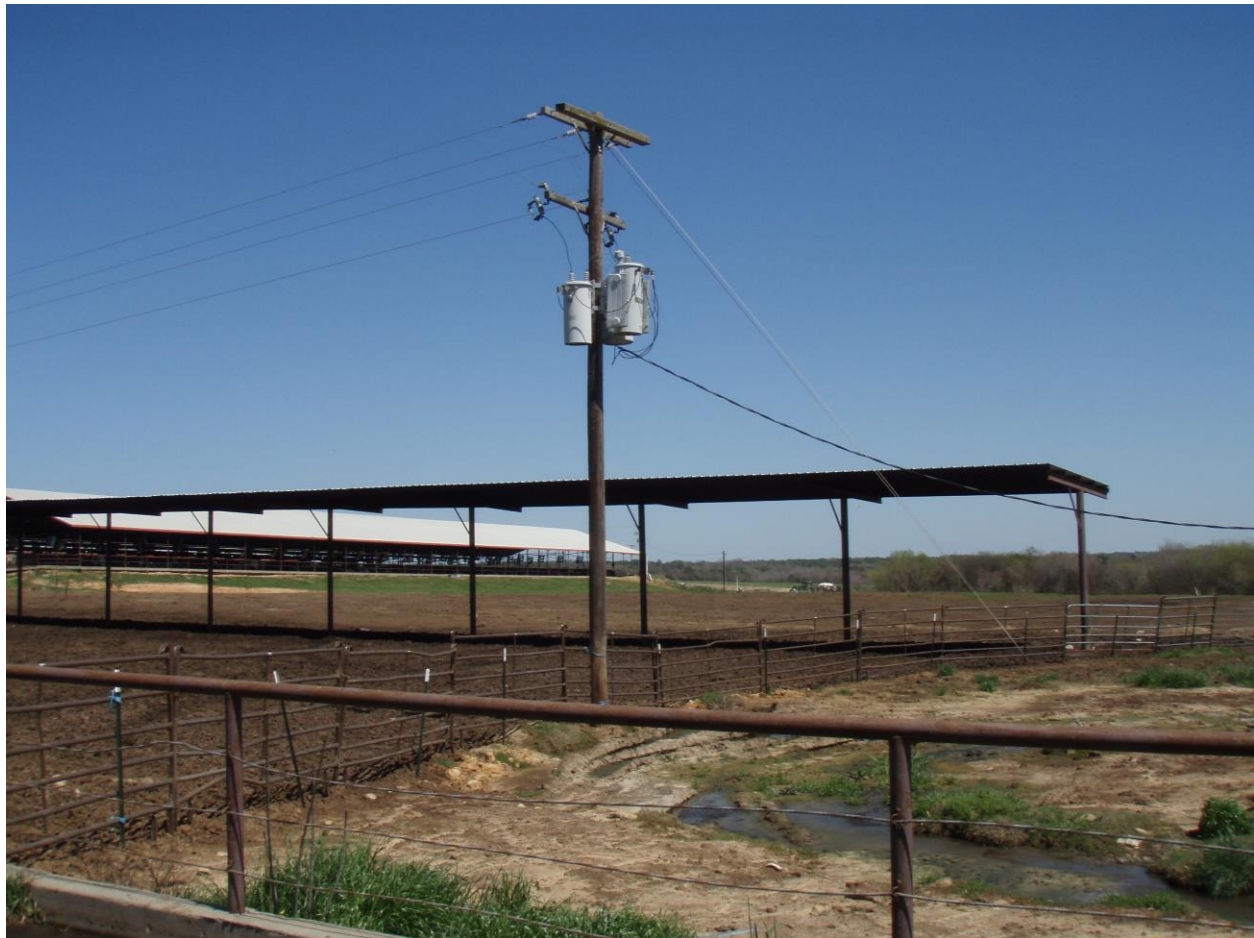
Photo File Name: P3280012.JPG

A portion of the open cattle pen area, located northeast of RCS 4, does not drain storm water runoff into an RCS (see Photo 12). Only one portion of this pen area, located at the shade pole area and westward, would channel runoff into RCS 4. The eastern portion of this pen area is not directed to an RCS. The area that cannot be sloped or bermed to direct storm water runoff to RCS 4 must be fenced-off to cattle confinement. (AOC 5)

Description: The eastern part of the open cattle pen, located northeast of RCS 4, does not drain storm water runoff into an RCS. Only one portion of this pen area, located near the shade pole area and westward, would channel run off into RCS 4. The eastern portion of this pen area is not directed to an RCS.

AOC 5: The open cattle pen area located northeast of RCS 4 does not drain storm water runoff into an RCS. Only one portion of this pen area, located near the shade pole area and westward, would channel run off into RCS 4. The eastern portion of this confinement area that cannot be sloped or bermed to direct storm water runoff to RCS 4 must be fenced-off to cattle confinement as required by the CAFO General Permit Part III.A.6.(c)(2).
