**U.S. Environmental Protection Agency  
Region 5**

**Purpose:** Clean Water Act National Pollutant Discharge Elimination System Inspection

**Facility:** Maynard Steel Castings Company  
2856 South 27<sup>th</sup> Street  
Milwaukee, Wisconsin 53215

**Inspection Date:** November 7, 2023

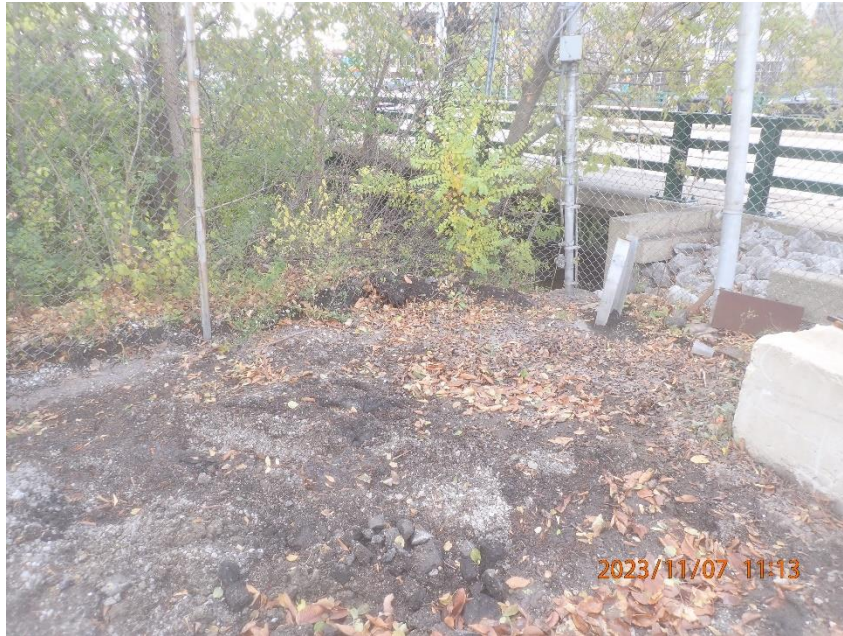
1: PB070001

Description: Southwest corner of parking lot

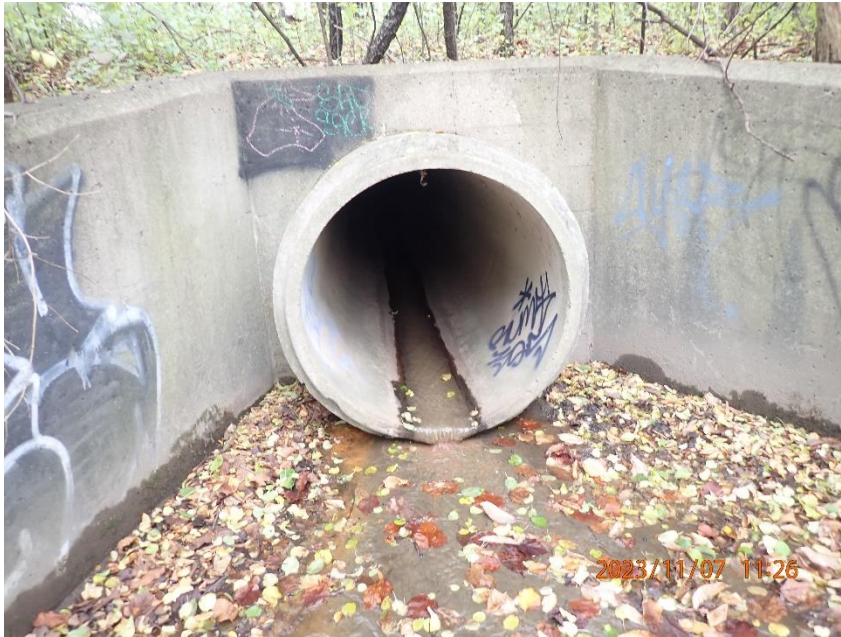
2: PB070002

Description: Outfall 1, actively discharging groundwater from underground drainage tiles and sump pump.

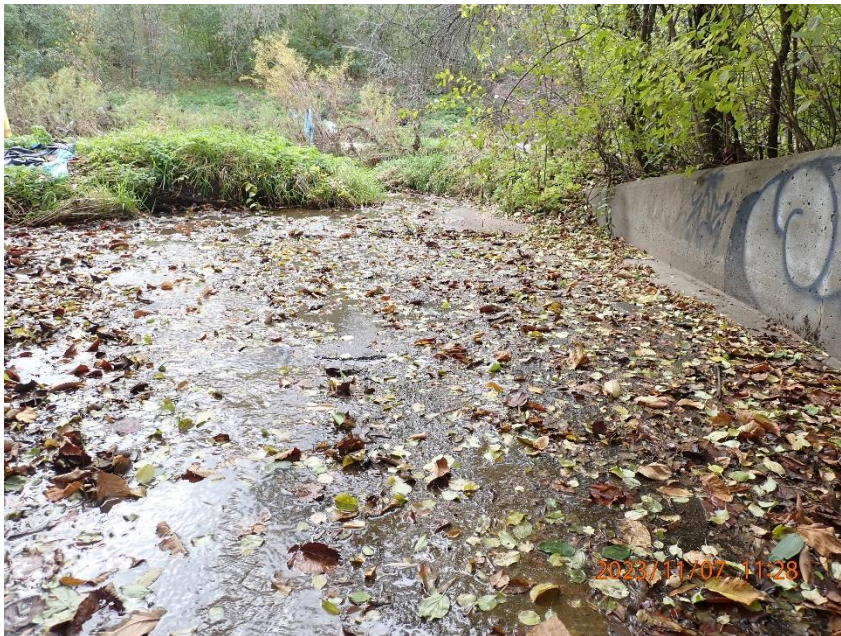
3: PB070003

Description: Discharge from Outfall 1 flowing downhill into the Kinnickinnic River.

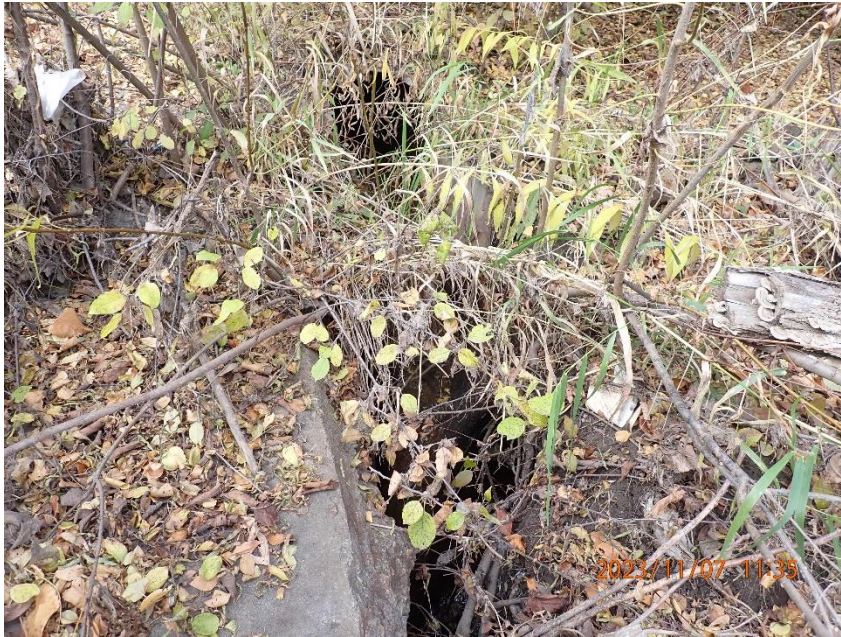
4: PB070004

Description: Outfall 2

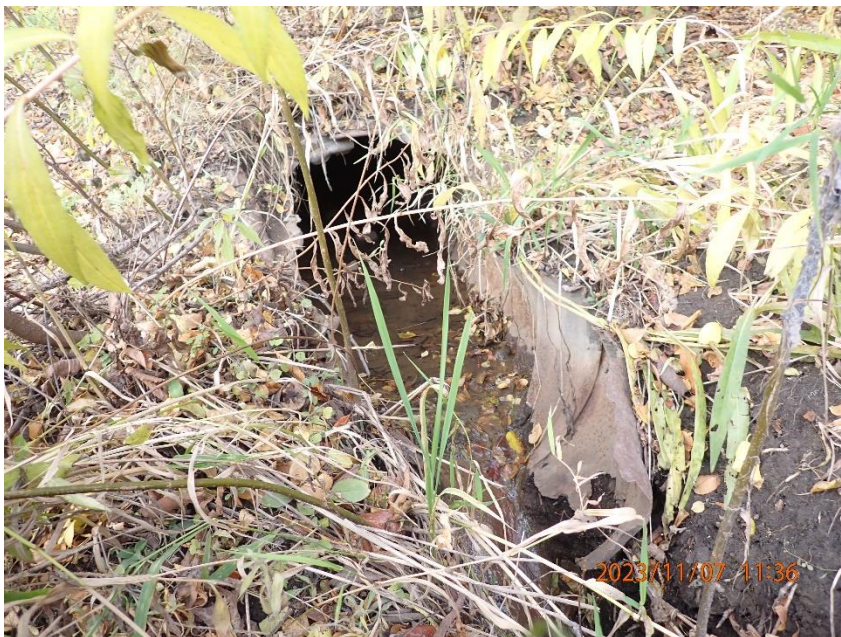
5: PB070005

Description: Outfall 2

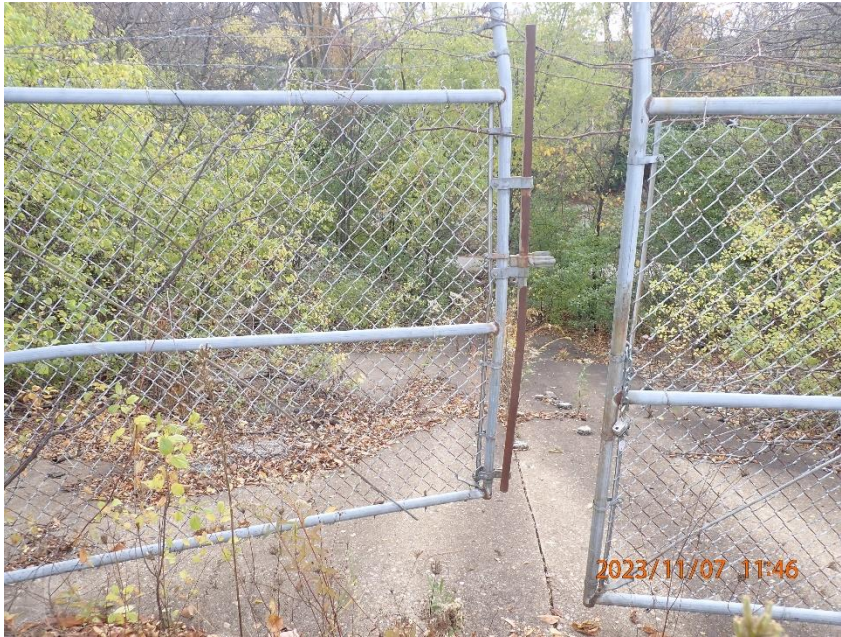
6: PB070006

- Scrap material stored in areas of the parking lot do not have any stormwater control measures in place around them (Photos 7 and 8).
- The paved slope from the south edge of the parking lot leads directly down to the Kinnickinnic River and has no stormwater control measures in place (Photo 6).
- The fenced perimeter of the east yard has several locations where there is either a gap in the stormwater containment berm (Photos 12 and 15) or a failure of the berm and fence, where spent sand flasks have fallen over (Photos 13, 14, and 17).
- The only stormwater control measure for the spent foundry sand pile is a silt fence along a small portion of the pile (Photo 16).

Description: Paved slope from south edge of the parking lot down to the Kinnickinnic River.

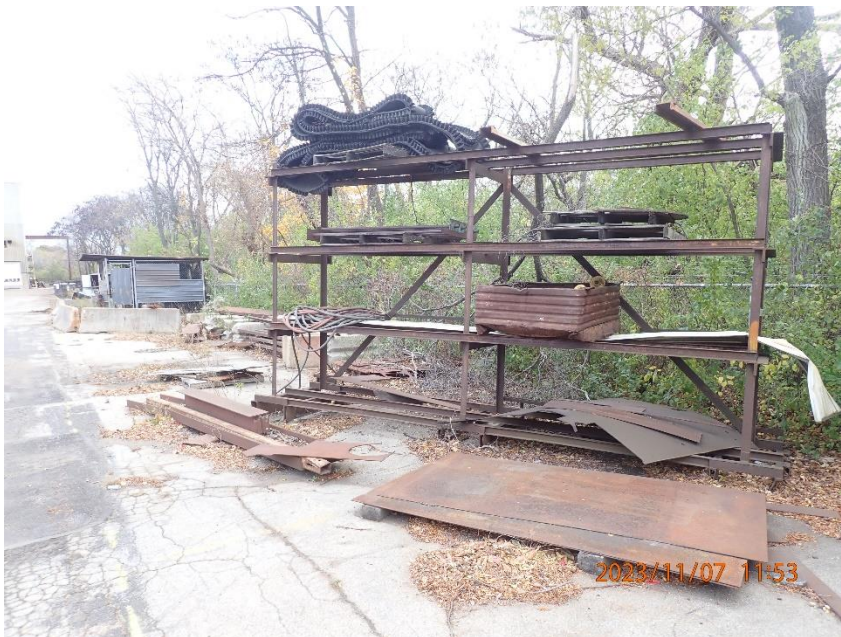
7: PB070007

Description: Spare material area along south edge of parking lot

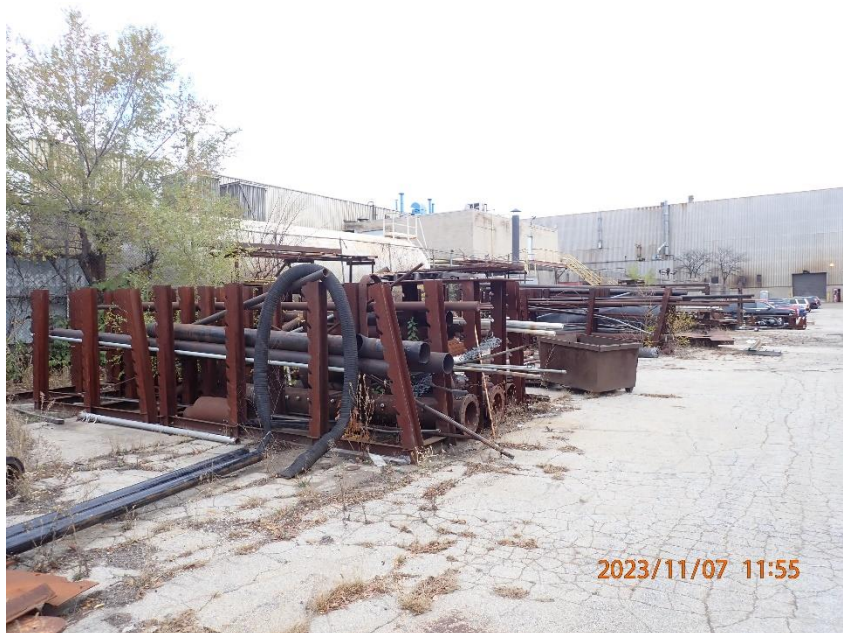
8: PB070008

Description: Spare material area

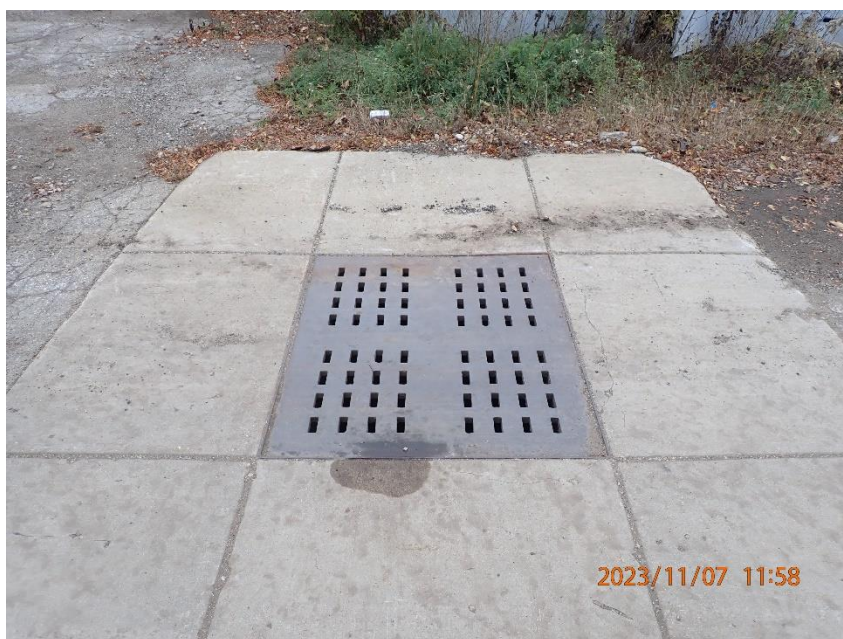
9: PB070009

Description: Stormwater drain in parking lot which discharges to Outfall 1.

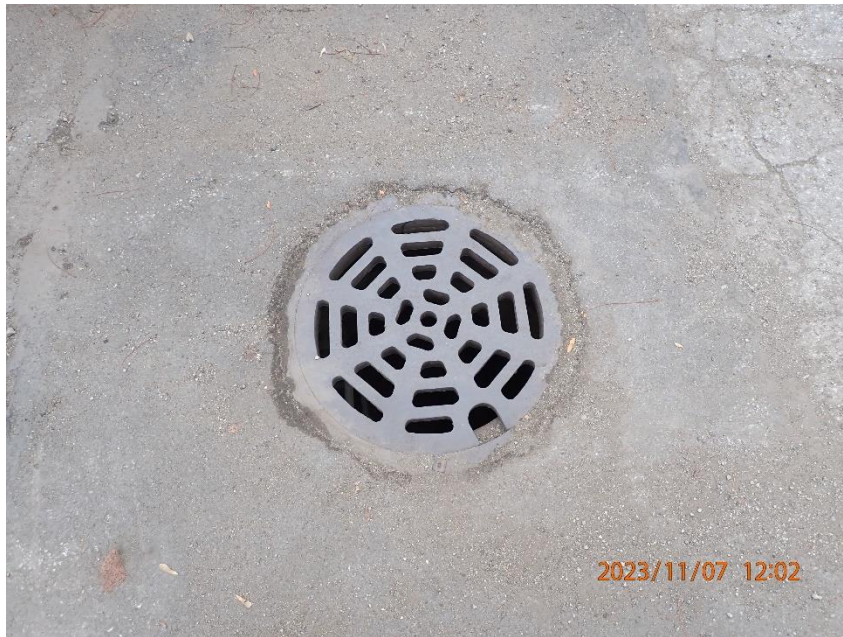
10: PB070010

Description: Stormwater drain in parking lot discharging to Outfall 1; connected to and receives water from the drain shown in Photo 9.

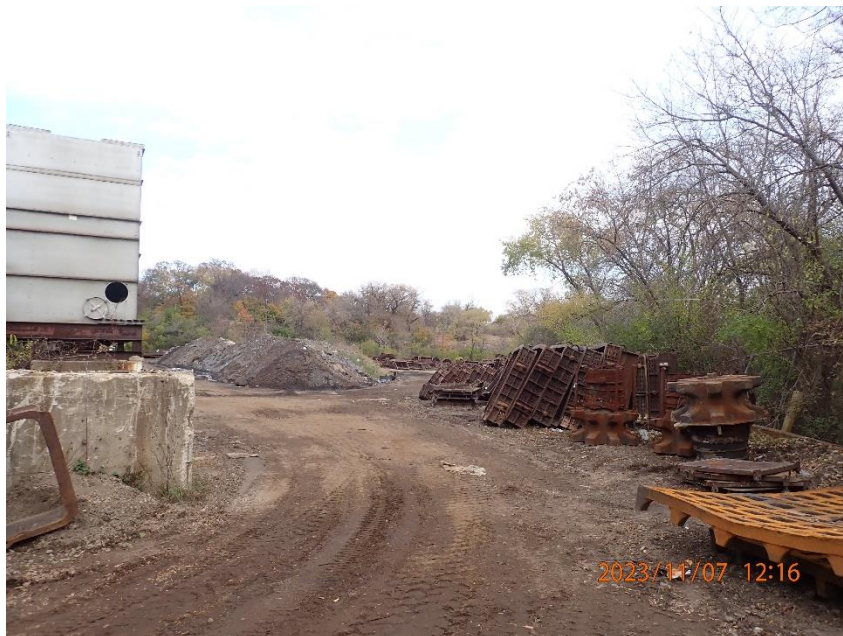
11: PB070011

Description: East yard showing the spent foundry sand pile and spent sand flasks.

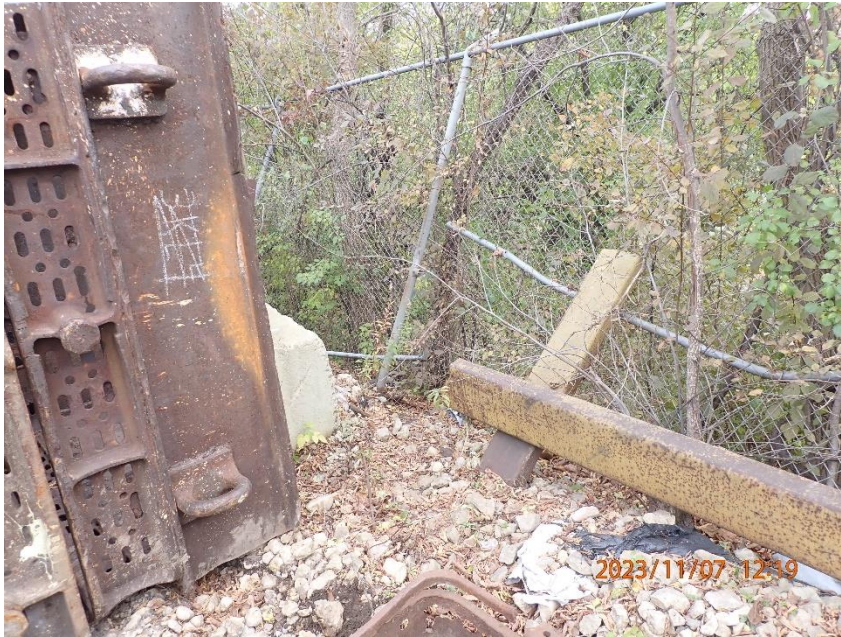
12: PB070012

Description: Gap in stormwater containment berm behind sand flasks

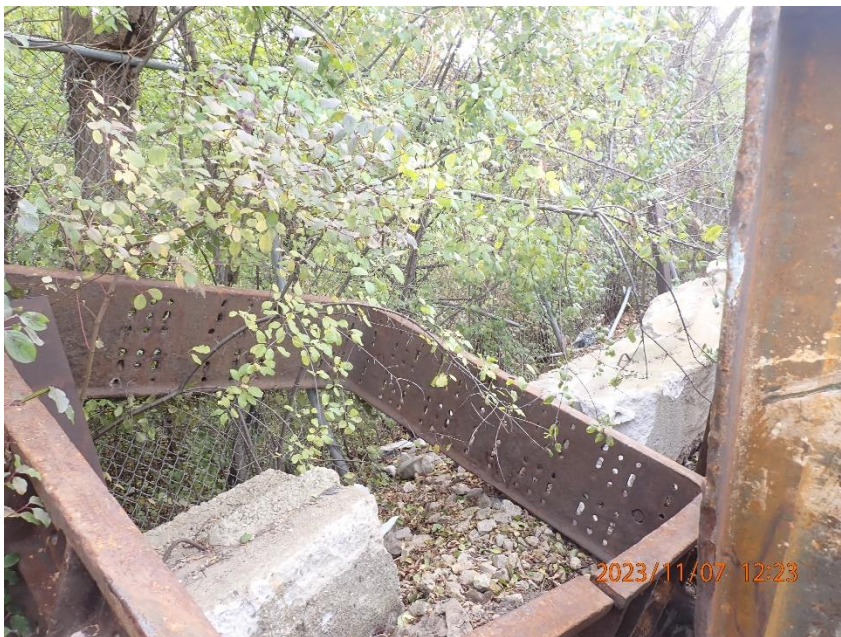
13: PB070013

Description: Sand flasks fallen over onto fence at the top of the slope above the Kinnickinnic River.

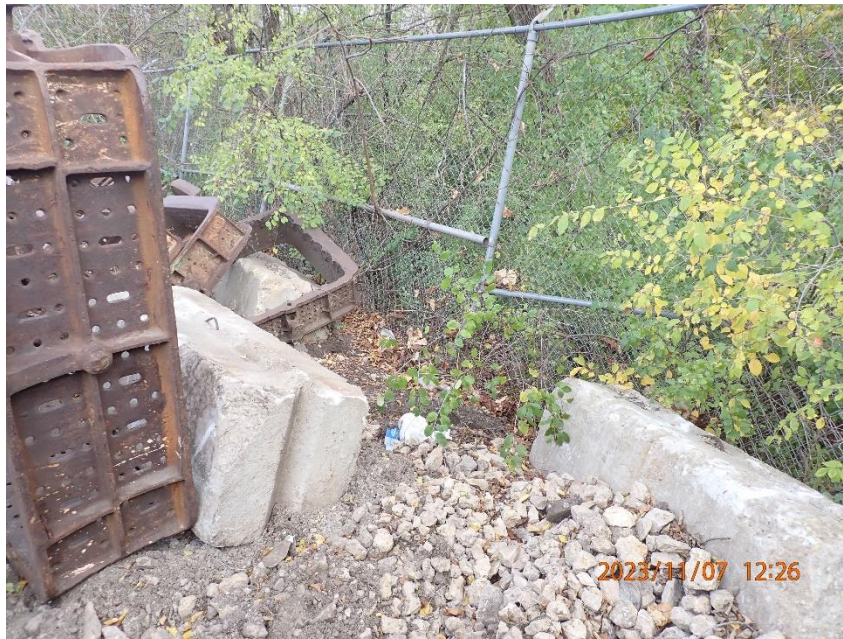
14: PB070014

Description: Failure of stormwater berm and fence

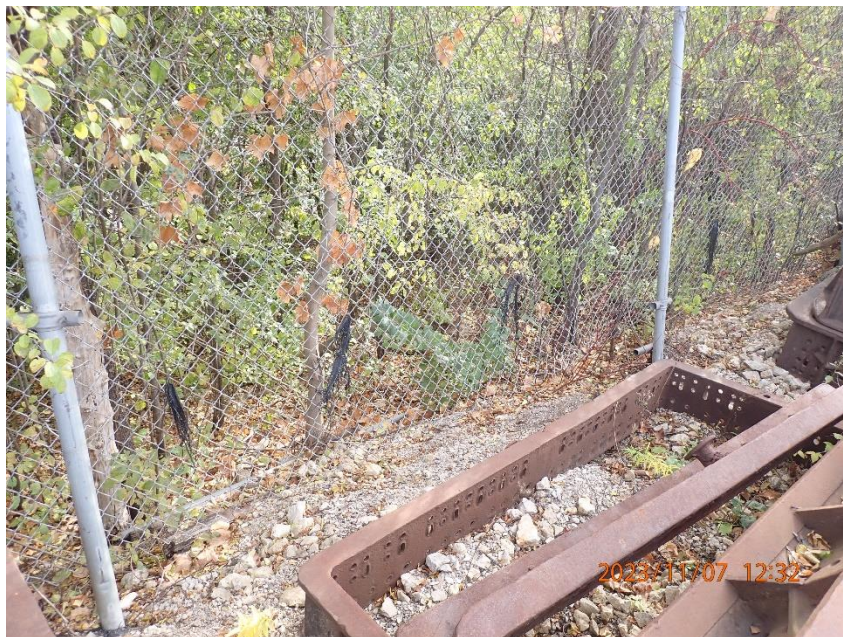
15: PB070015

Description: Gap in the stormwater containment berm behind the sand flasks

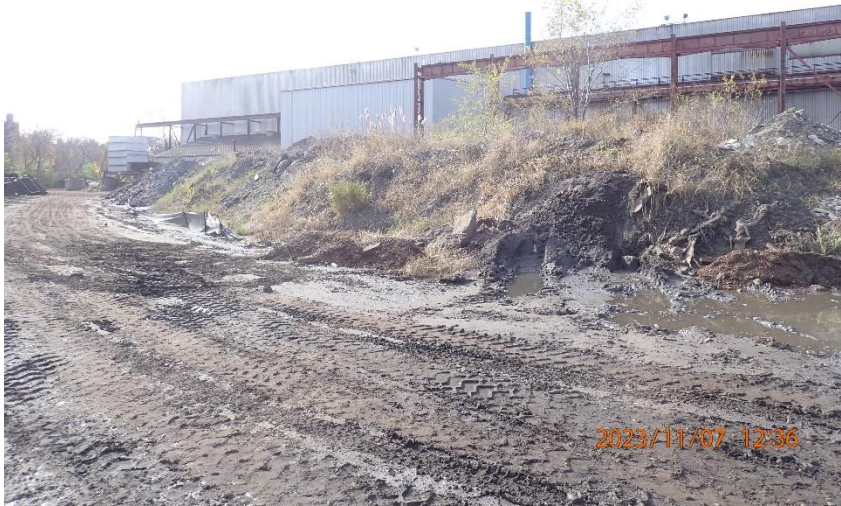
16: PB070016

Description: Spent foundry sand pile

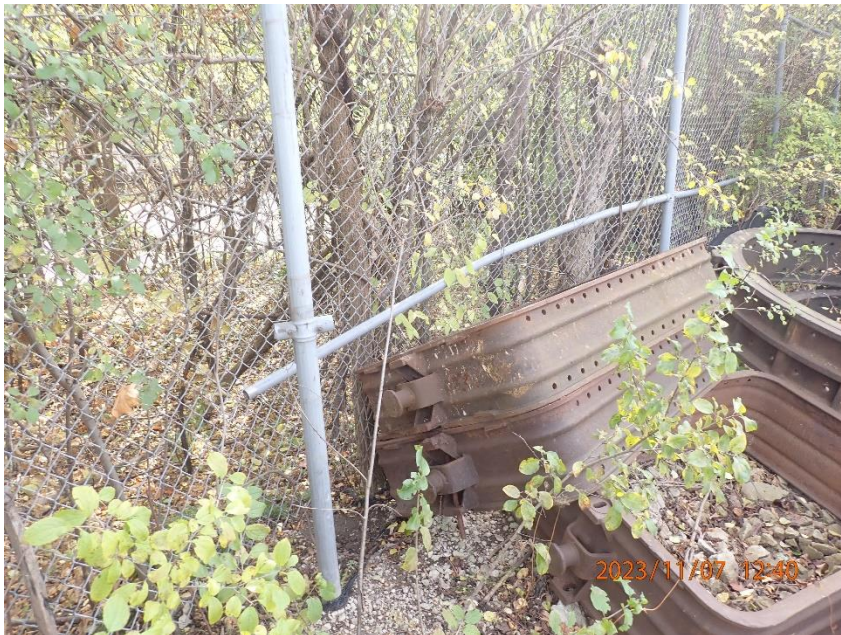
17: PB070017

Description: Sand flasks fallen over onto fence at the top of the slope above the Kinnickinnic River.
