INSPECTION REPORT

| <b>Type of Inspection</b> | Industrial Stormwater Inspection (ISI) | |
| <b>Permittee Name</b> | WOW Logistics | |
| <b>Facility or Site Name</b> | TreeHouse Foods | |

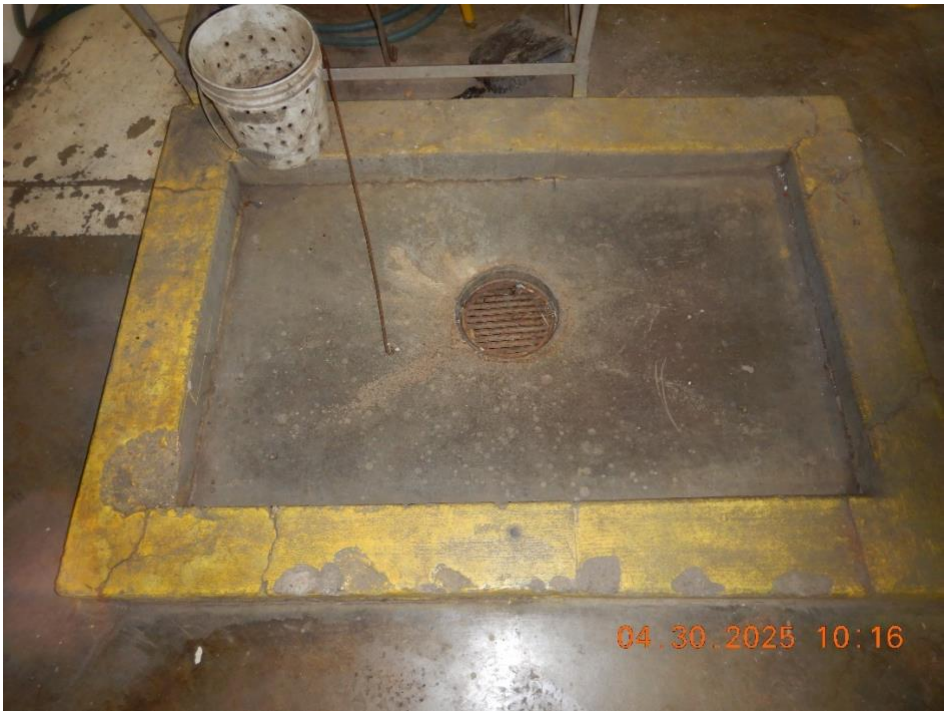
| WOW Logistics – TreeHouse Foods | | | DSCN1100.JPG |

| Indoor drainage near Bright Line repackaging area | | | |

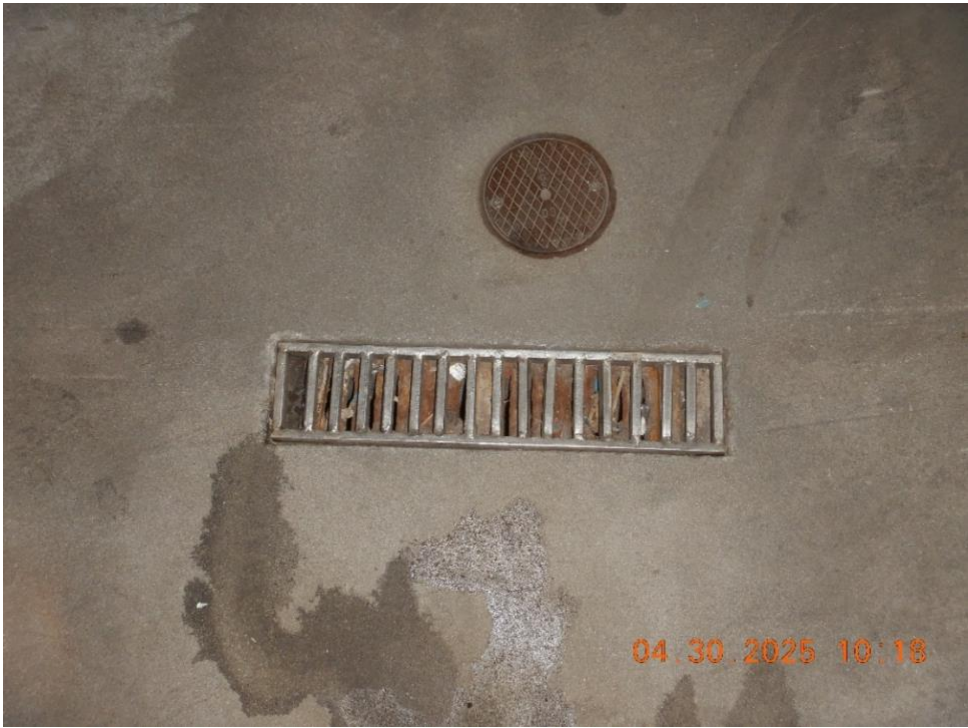
| WOW Logistics – TreeHouse Foods | | | DSCN1101.JPG |

| Indoor drainage near Bright Line repackaging area | | | |

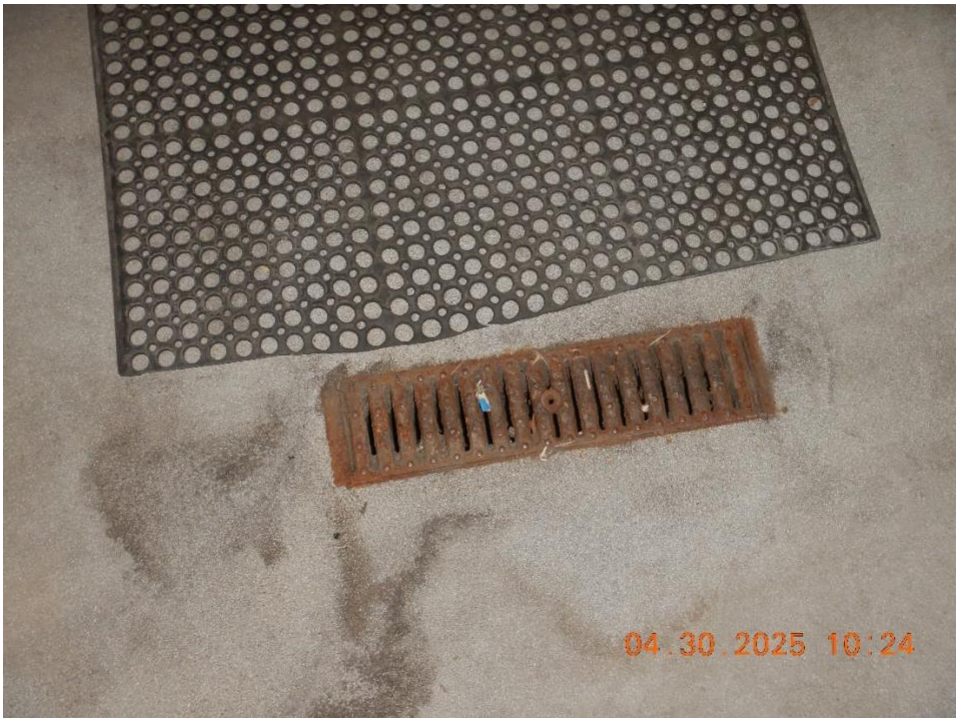
| WOW Logistics – TreeHouse Foods | | | DSCN1102.JPG |

| Indoor drainage near Bright Line repackaging area | | | |

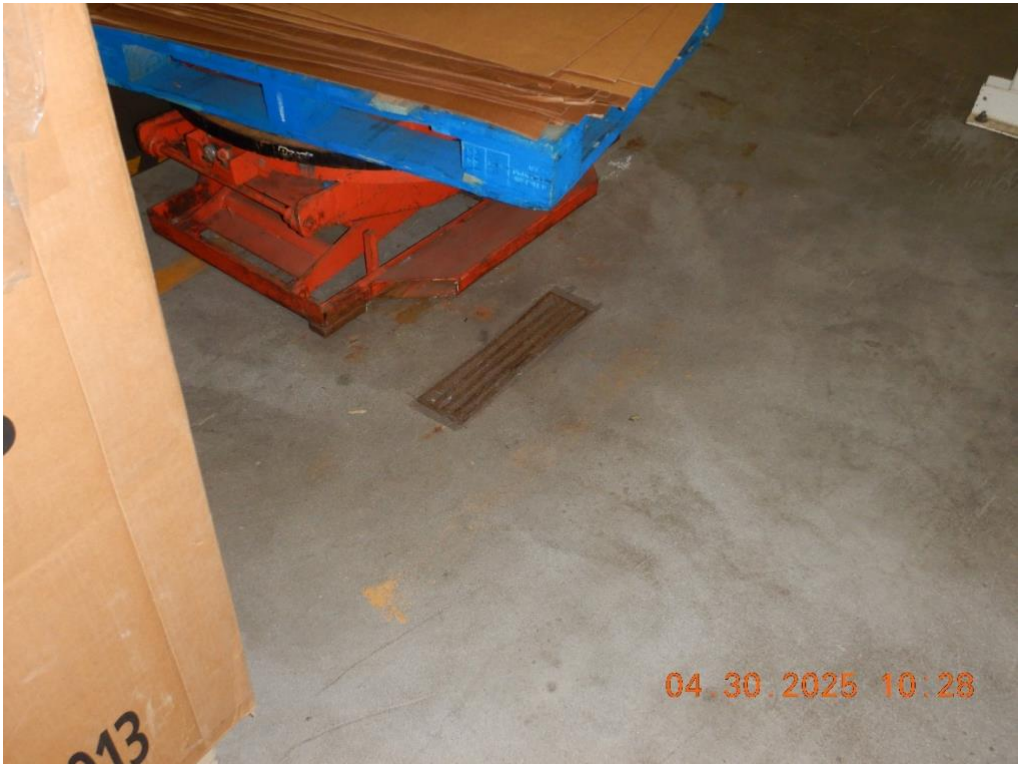
| WOW Logistics – TreeHouse Foods | | | DSCN1103.JPG |

| Indoor drainage near Bright Line repackaging area | | | |

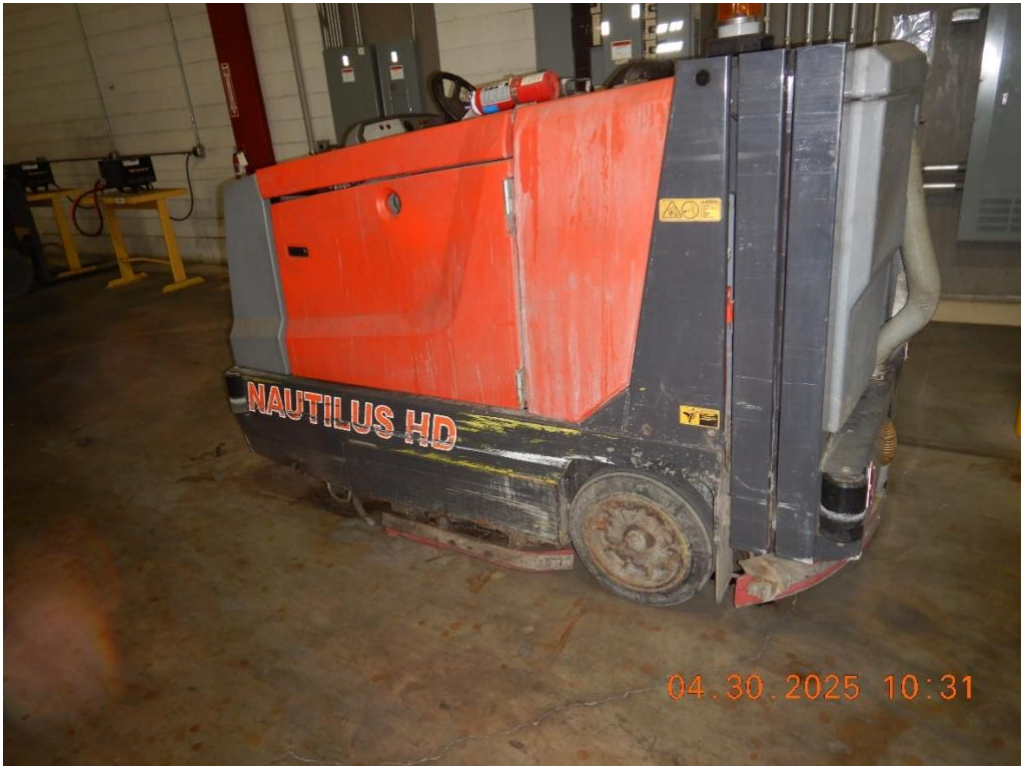
| WOW Logistics – TreeHouse Foods | | | DSCN1104.JPG |

| Indoor Floor Scrubber | | | |

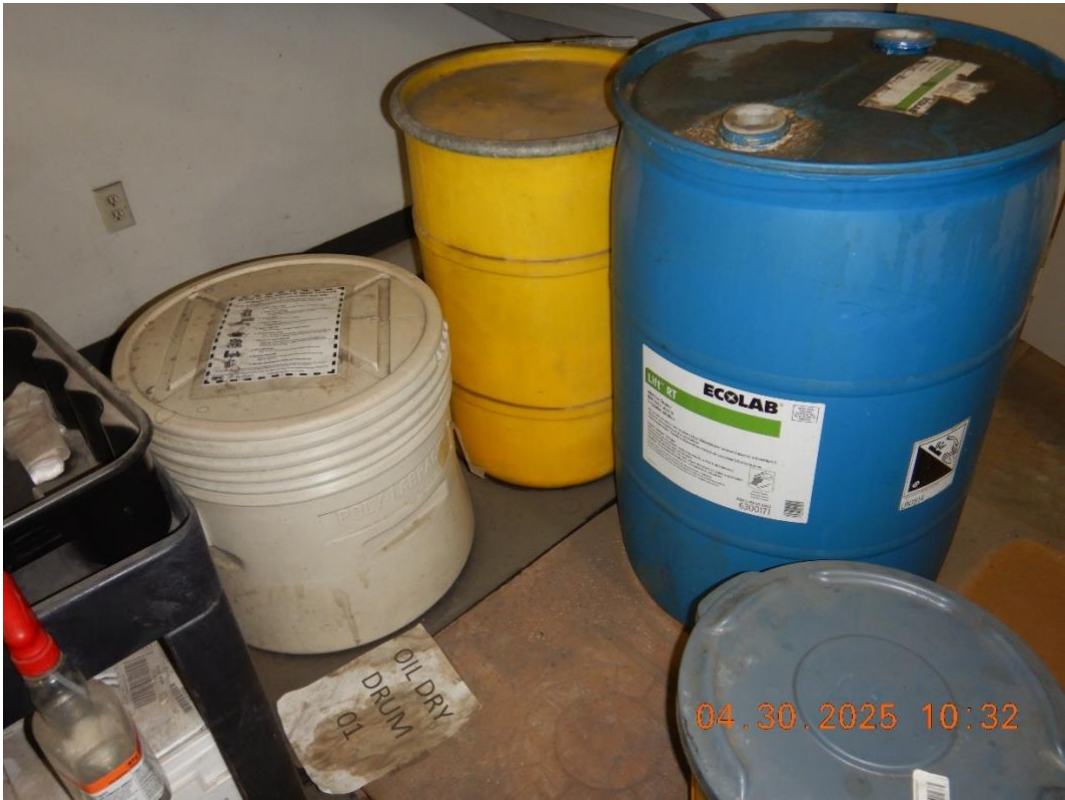
| WOW Logistics – TreeHouse Foods | | | DSCN1105.JPG |

| Indoor Floor Cleaning Chemicals and Soap | | | |

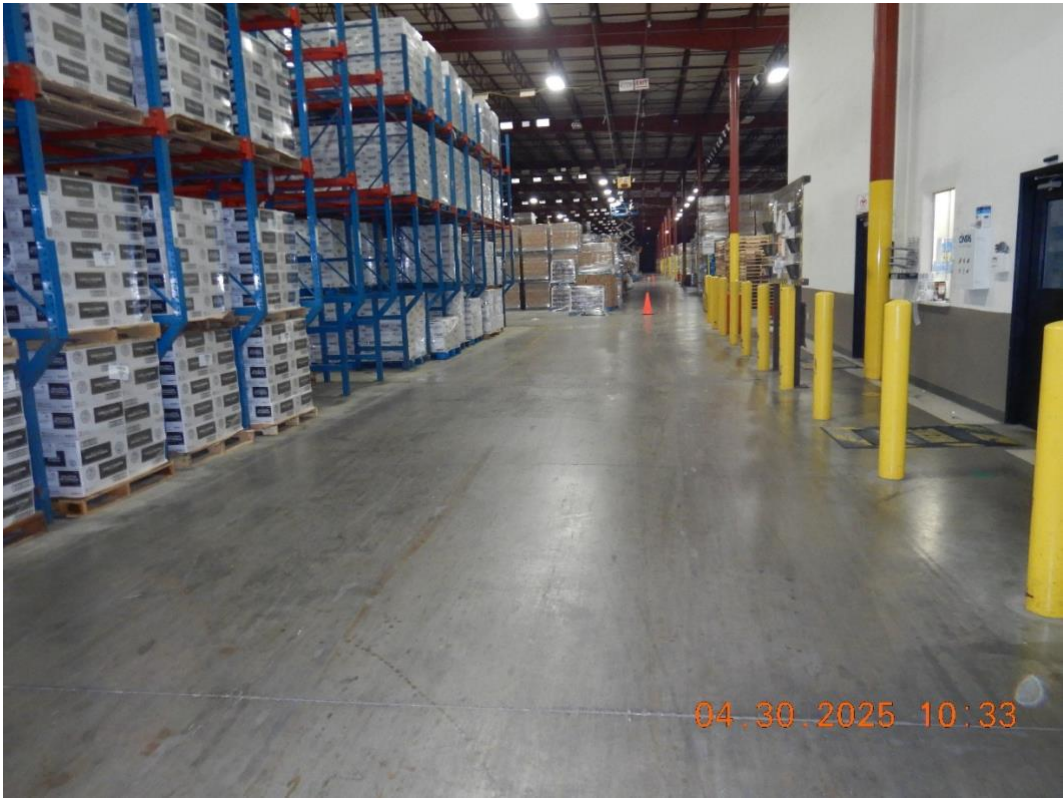
| WOW Logistics – TreeHouse Foods | | | DSCN1106.JPG |

| Indoor Warehouse Area | | | |

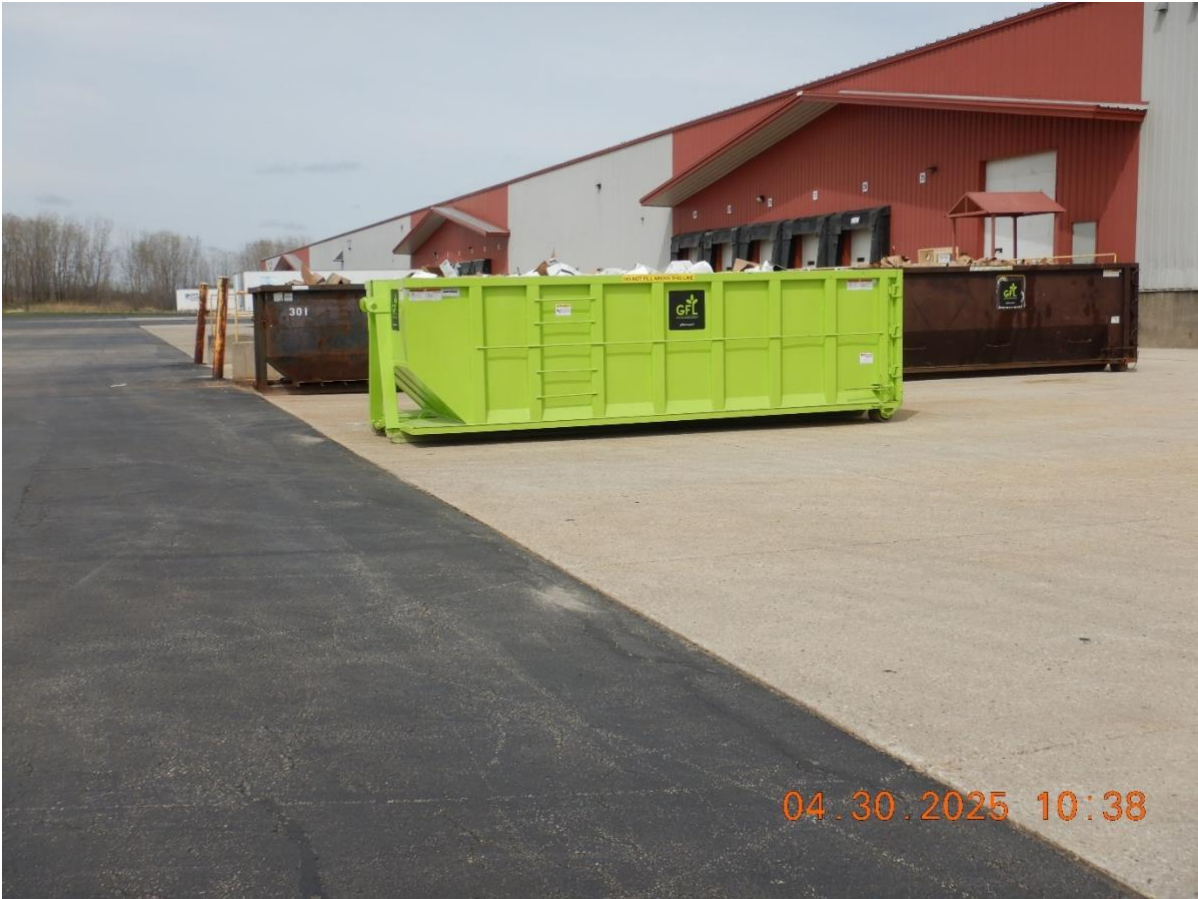
| WOW Logistics – TreeHouse Foods | | | DSCN1107.JPG |

| <p>EPA observed the following during the walkthrough of the outdoor area:</p> <ul style="list-style-type: none"> <li>• Mr. Nguyen observed three open non-covered large roll-offs filled with expired product that could not be sold according to Mr. Hurlbut.</li> <li>• A trash bin with an open lid was observed.</li> </ul> | | |

| AOC Reference #: DN1-OB-001 | Location: Outdoor area |
|---|---|
| Section 2.1.2.2(c) of the EPA Multi-Sector General Permit (MSGP) requires <i>"The permittee must keep clean all exposed areas that are potential sources of pollutants. You must perform good housekeeping measures that includes keeping al dumpster lids closed when not in use to minimize pollutant discharges"</i> . | |
| <b>AOC:</b> <ul style="list-style-type: none"> <li>Three large trash roll-offs and one large bin were observed open and with no cover to minimize exposure to wind and weather.</li> </ul> | |

| Outside open trash roll-offs | | | |

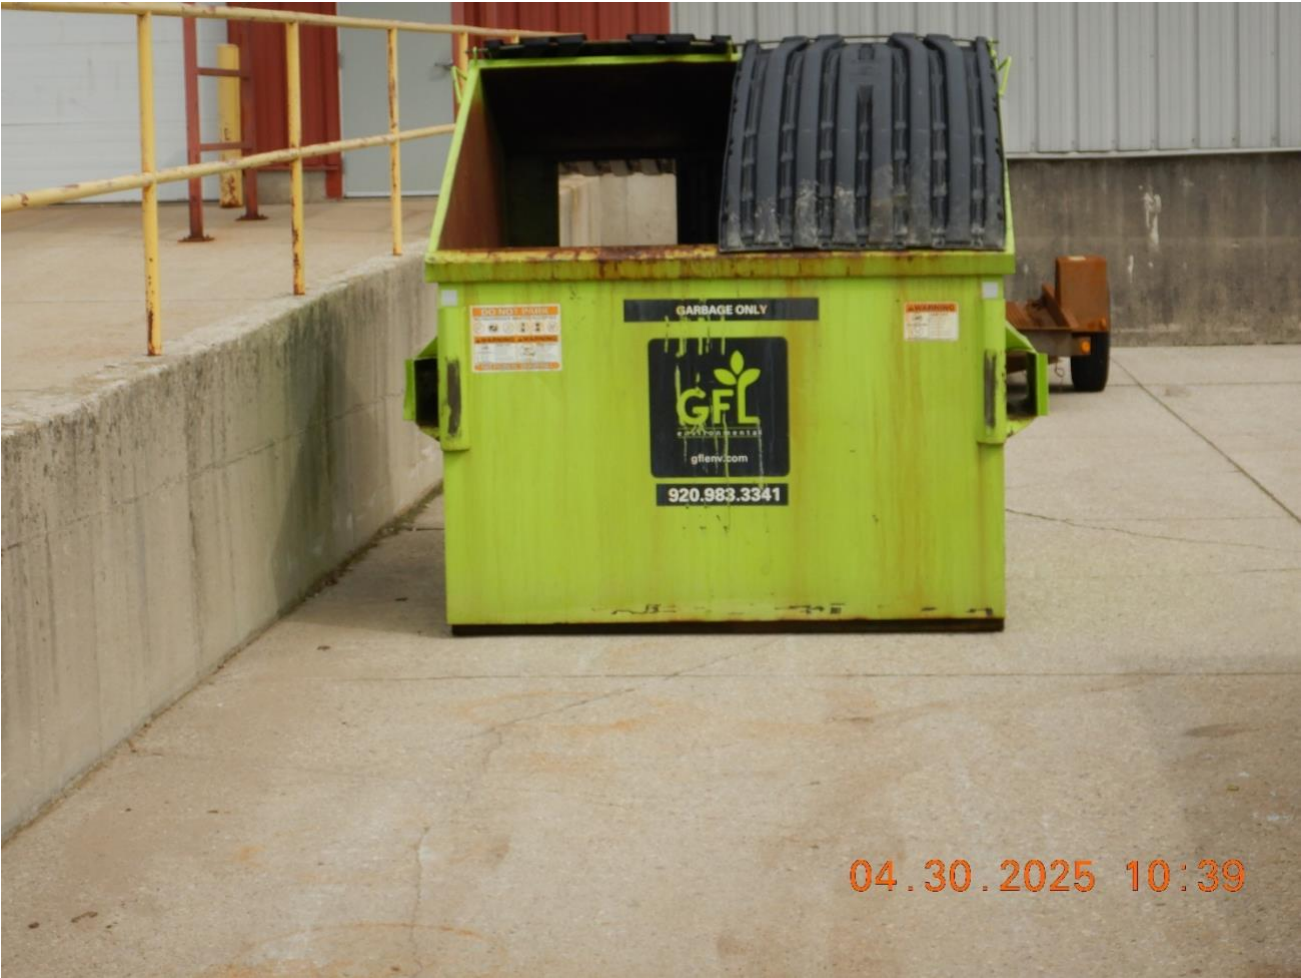
| WOW Logistics – TreeHouse Foods | | | DSCN1108.JPG |

| Outside open trash bin | | | |

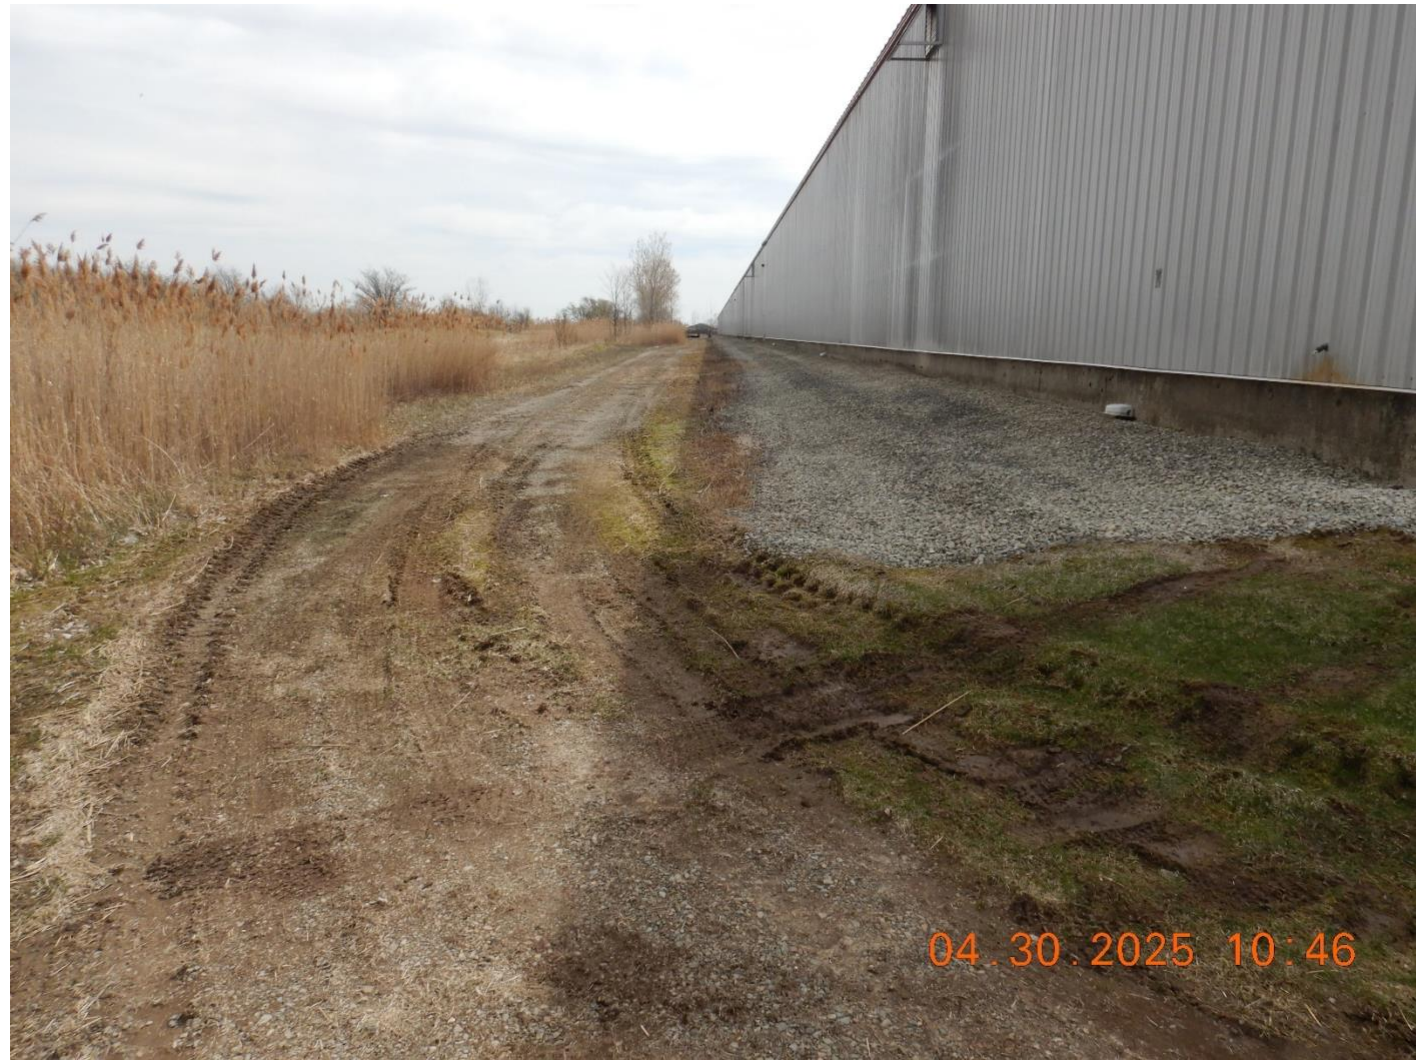
| WOW Logistics – TreeHouse Foods | | | DSCN1109.JPG |

- Mr. Nguyen and walked and observed the north side of the property area behind the building.
- The swale area on the northeast side of the property was observed.

| Outside north side of building | | | |

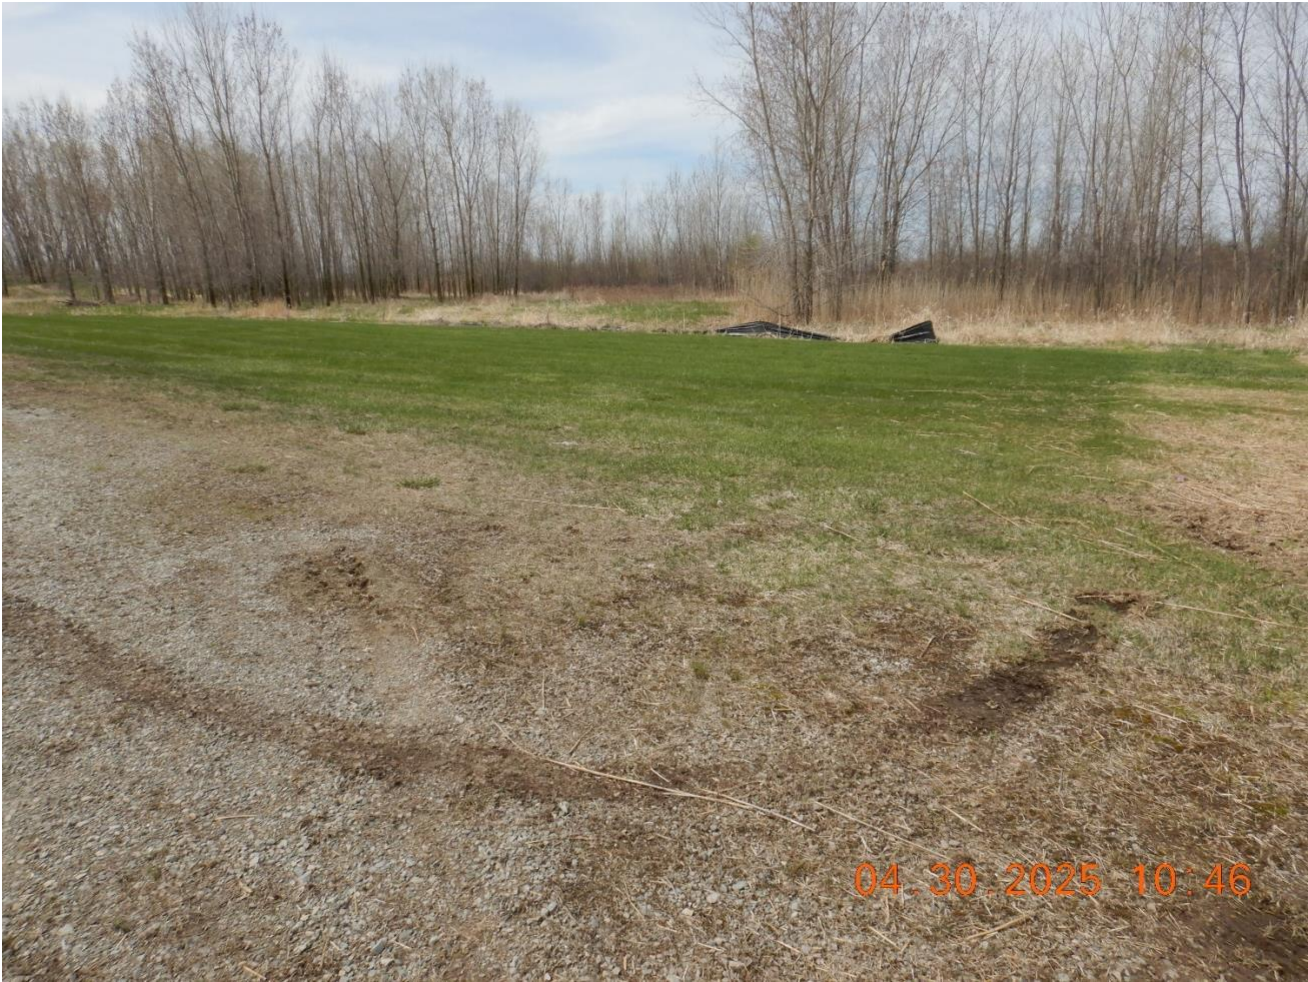
| WOW Logistics – TreeHouse Foods | | | DSCN1110.JPG |

- Mr. Nguyen observed a drainage ditch and silk fence on the west side of the property. Mr. Hurlbut stated the ditch and silk fence are on the adjacent residential property and were installed by the residential property owner.

| Outside west side of building with silk fence from adjacent property | | | |

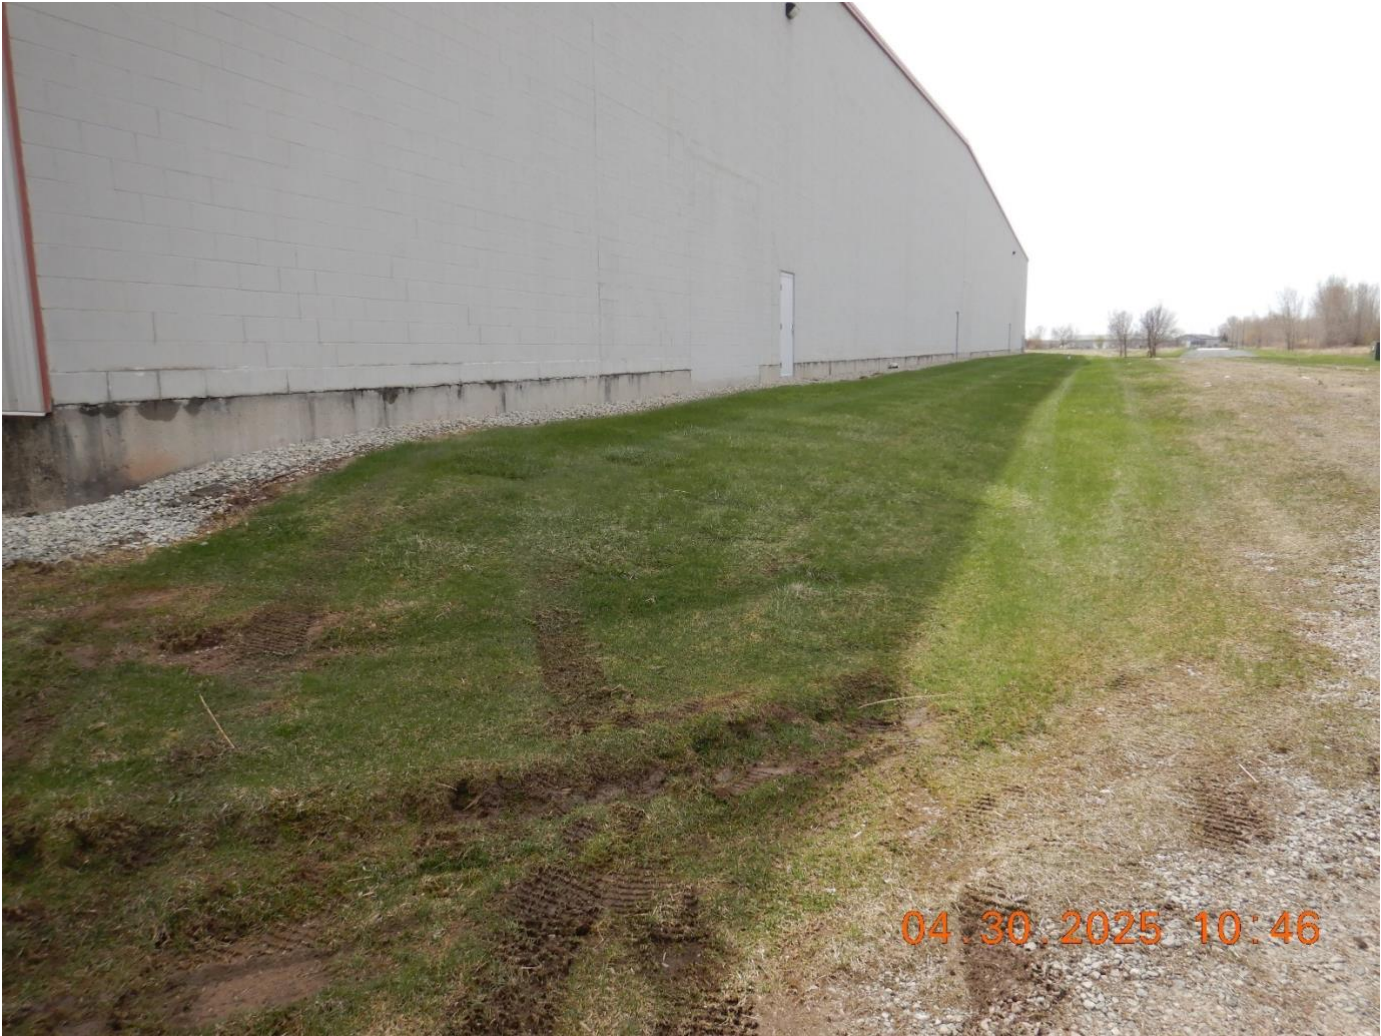
| WOW Logistics – TreeHouse Foods | | | DSCN1111.JPG |

| Outside northeast side of property | | | |

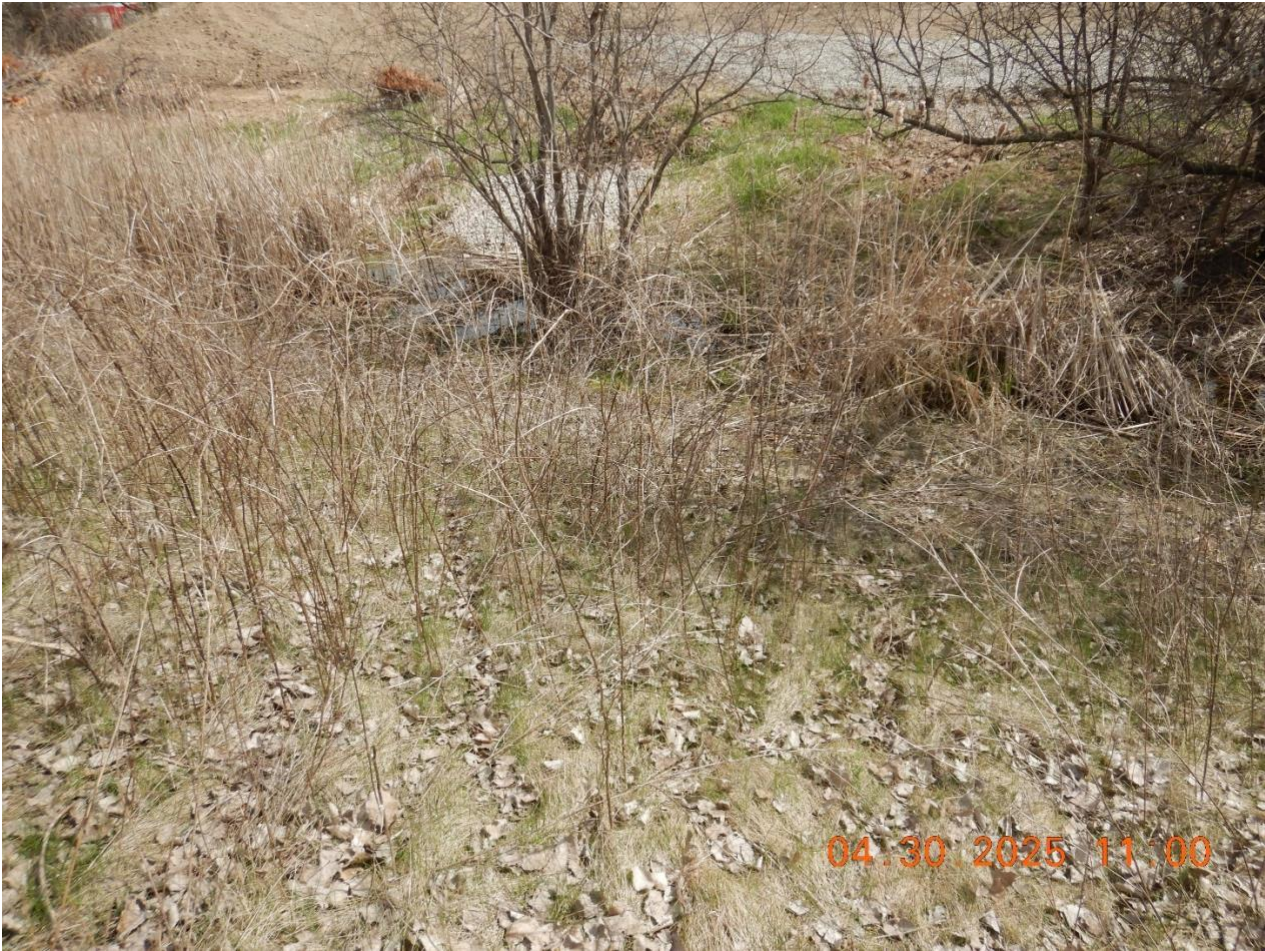
| WOW Logistics – TreeHouse Foods | | | DSCN1112.JPG |

| Outside facing northeast | | | |

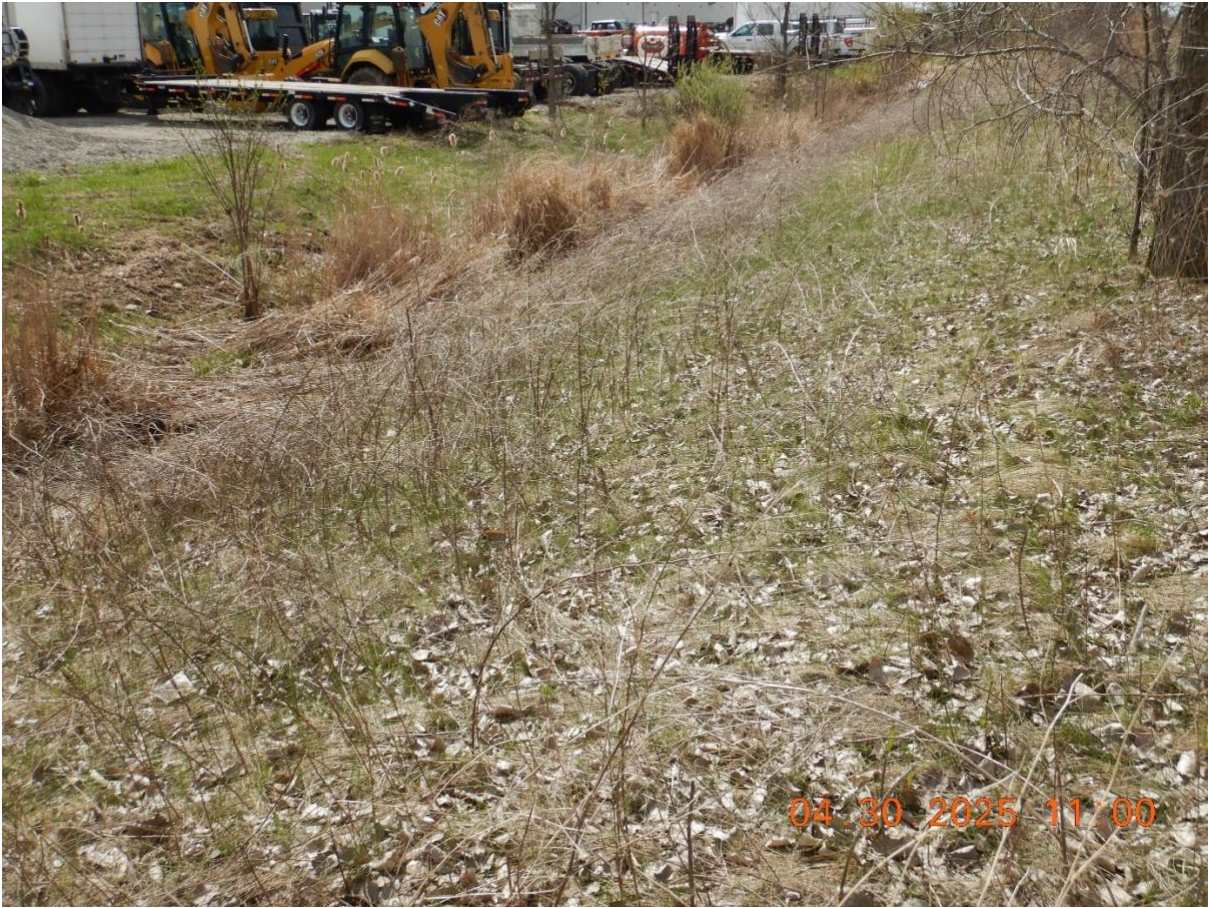
| WOW Logistics – TreeHouse Foods | | | DSCN1113.JPG |

| Outside east side of building with adjacent property | | | |

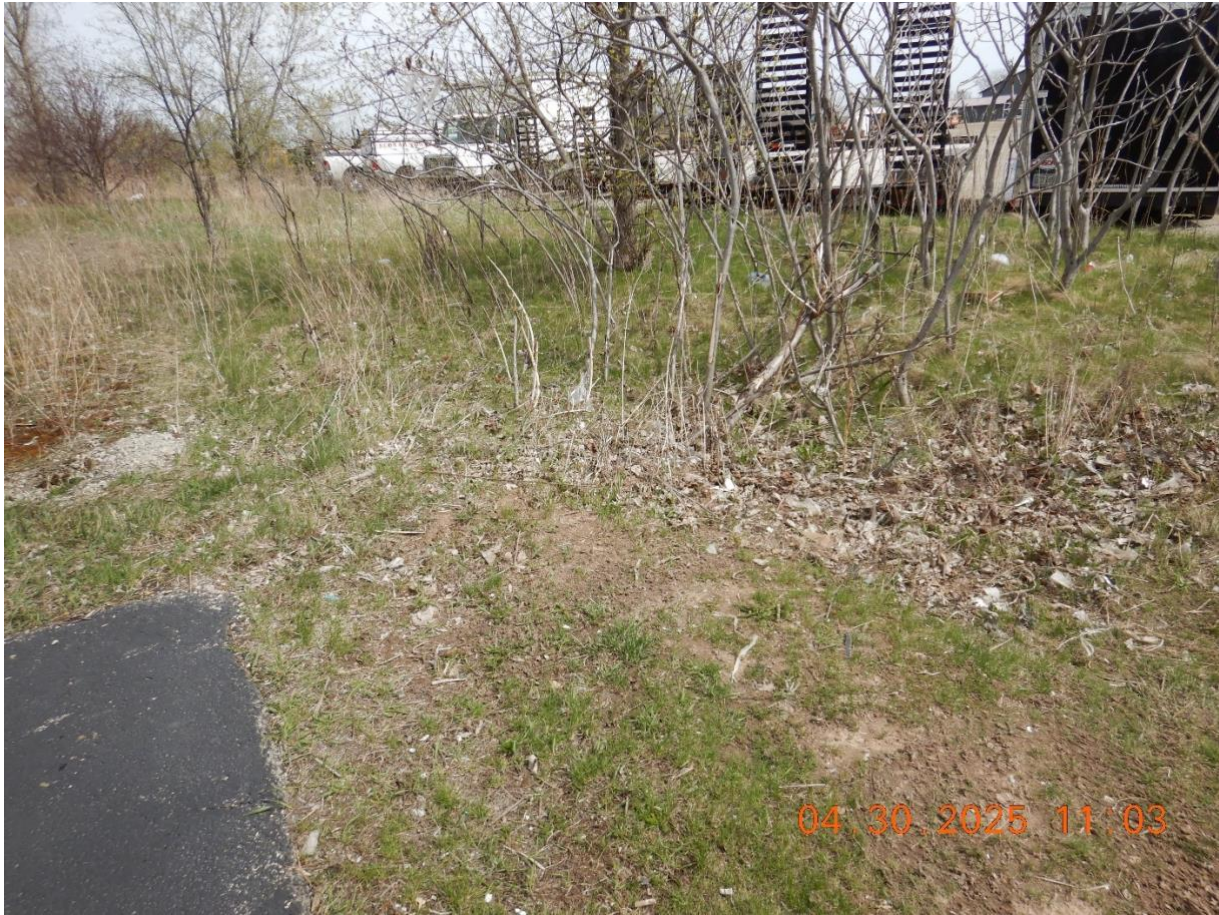
| WOW Logistics – TreeHouse Foods | | | DSCN1114.JPG |

| Outside east side of building with adjacent property | | | |

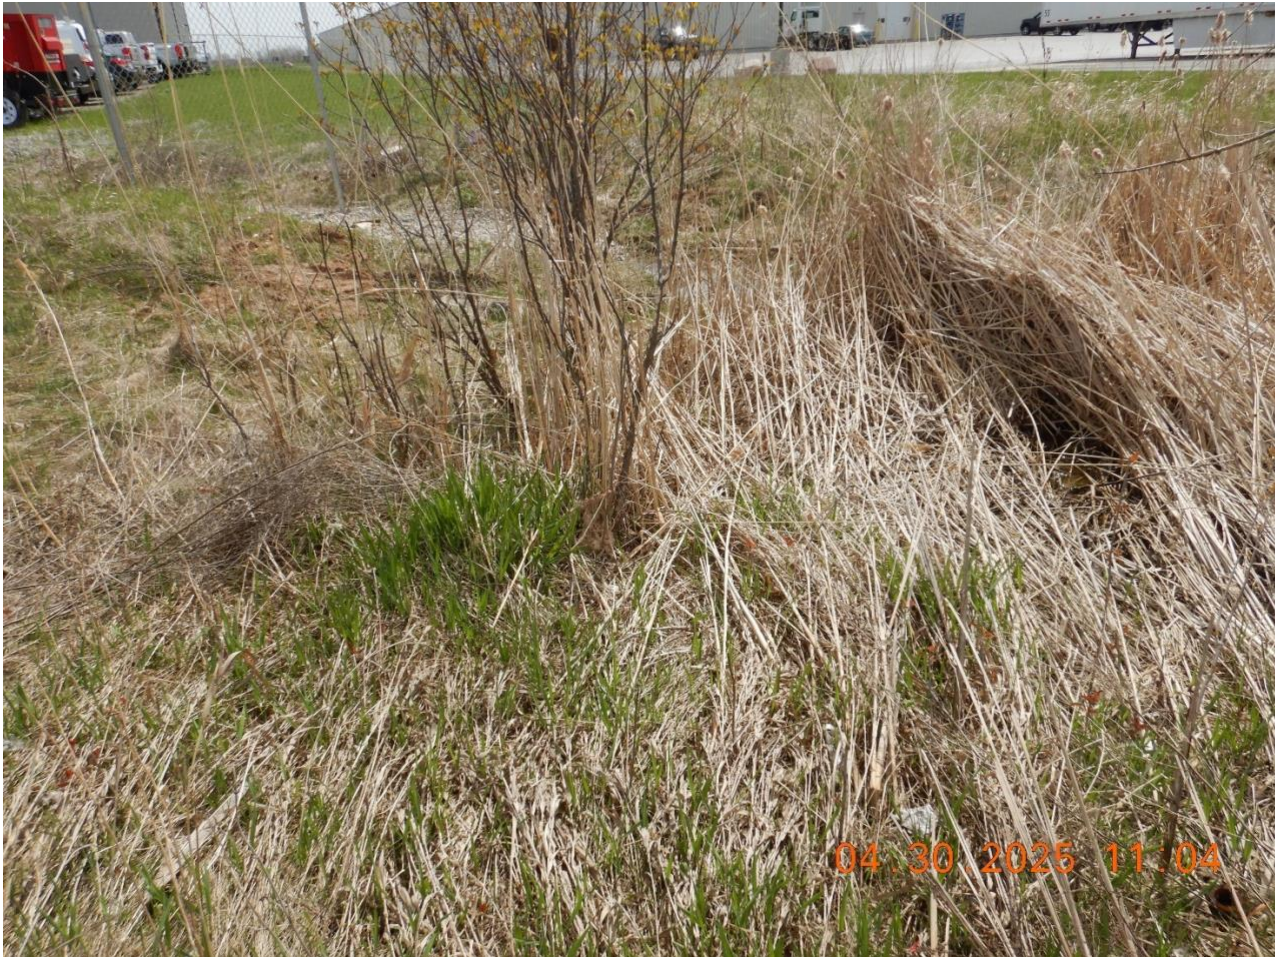
| WOW Logistics – TreeHouse Foods | | | DSCN1115.JPG |

| Outside east side of building with adjacent property | | | |

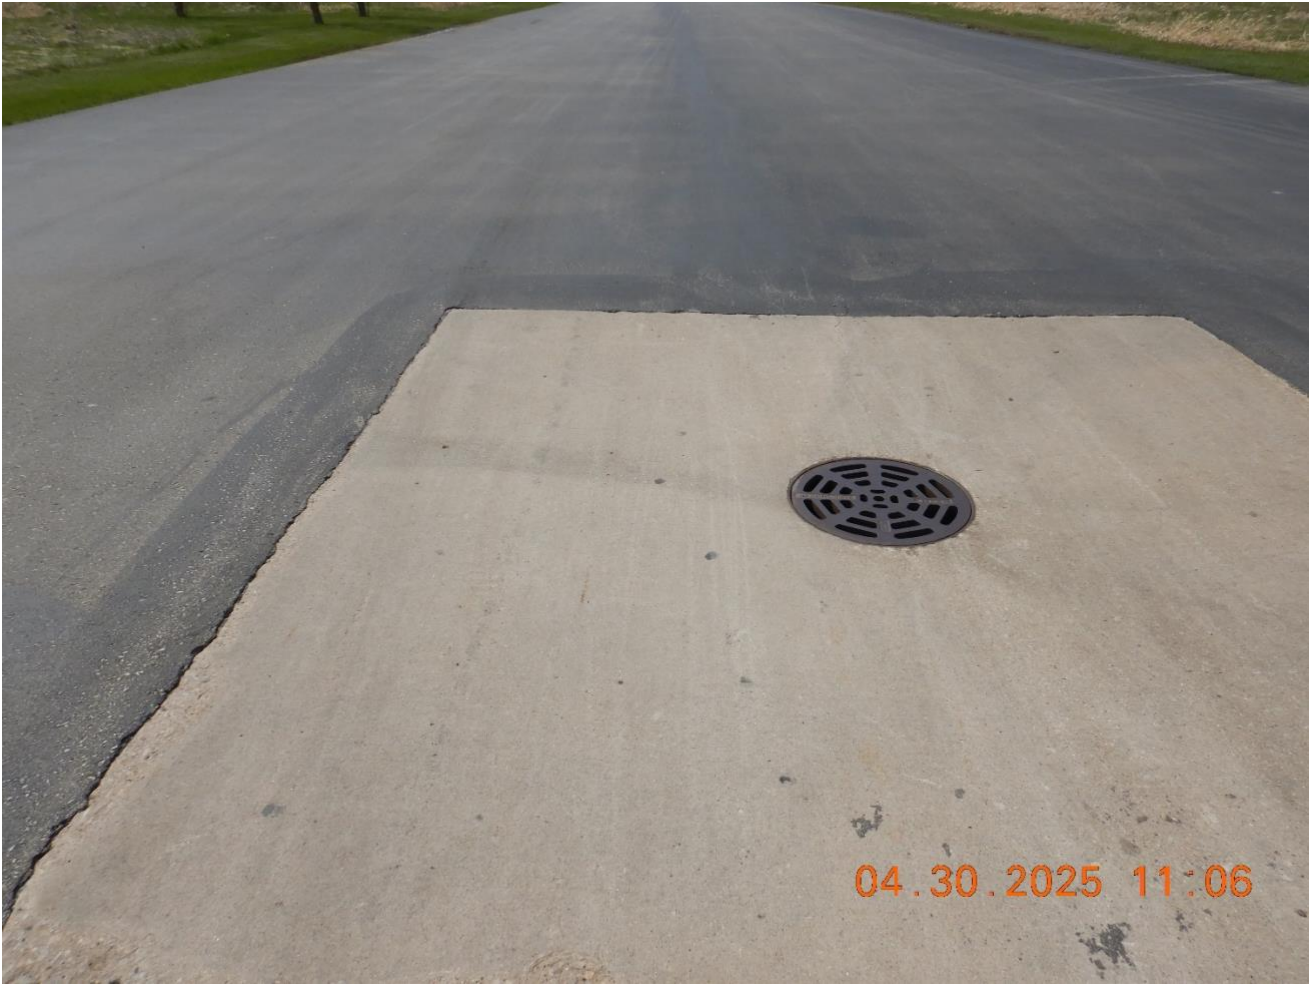
| WOW Logistics – TreeHouse Foods | | | DSCN1116.JPG |

- Mr. Nguyen observed discharge point 002 along the adjacent property on the east side of the facility.
- Three drains (Photos DSCN 1116-DSCN1119) were observed in the asphalt parking lot south of the facility: One drain near the loading and unloading dock on the east side, one drain near the main entrance to the facility, and one drain on the west side near the trash roll-offs and bin. Mr. Hurlbut stated he did know if the drains go to the city sewer system. The drains are not listed as part of the action area and discharge points.

| AOC Reference #: DN1-RR-001 | Record: SWPPP |
|---|---|
| <b>AOC:</b> <ul style="list-style-type: none"> <li>The SWPPP did not include directions of stormwater flow on the site map.</li> <li>The SWPPP did not include loading and unloading areas and locations used for storage and disposal of wastes.</li> <li>The SWPPP did not identify the three drains on the south side of the facility near the waste storage area, the main entrance, and the loading and unloading area.</li> </ul> | |

| Outside drain in front parking lot on east side | | | |

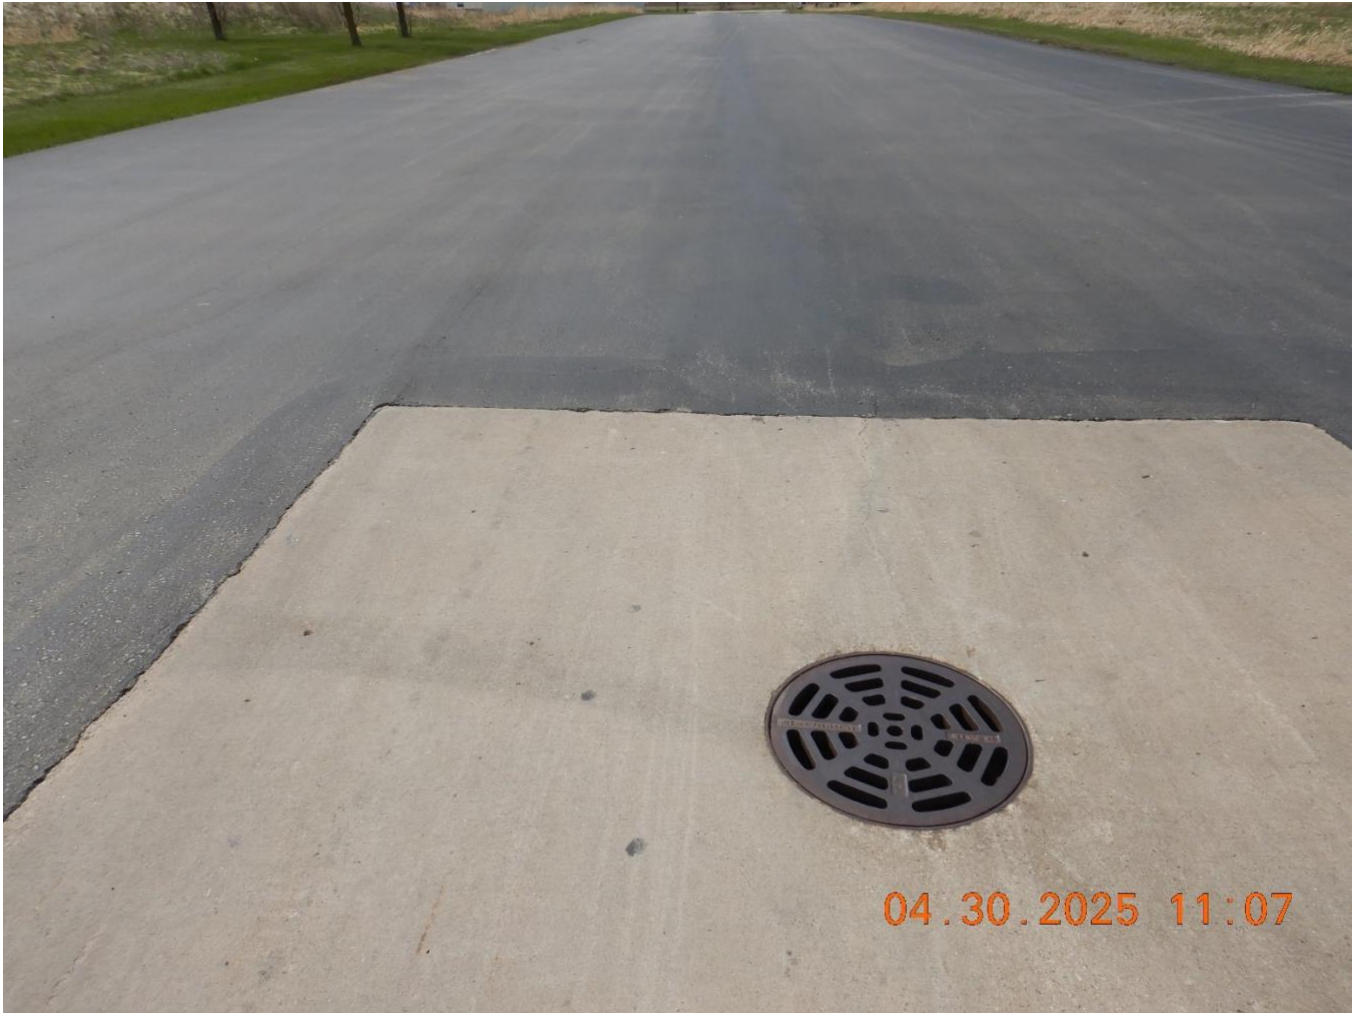
| WOW Logistics – TreeHouse Foods | | | DSCN1117.JPG |

| Outside drain in front parking lot on east side facing employee entrance road on east side | | | |

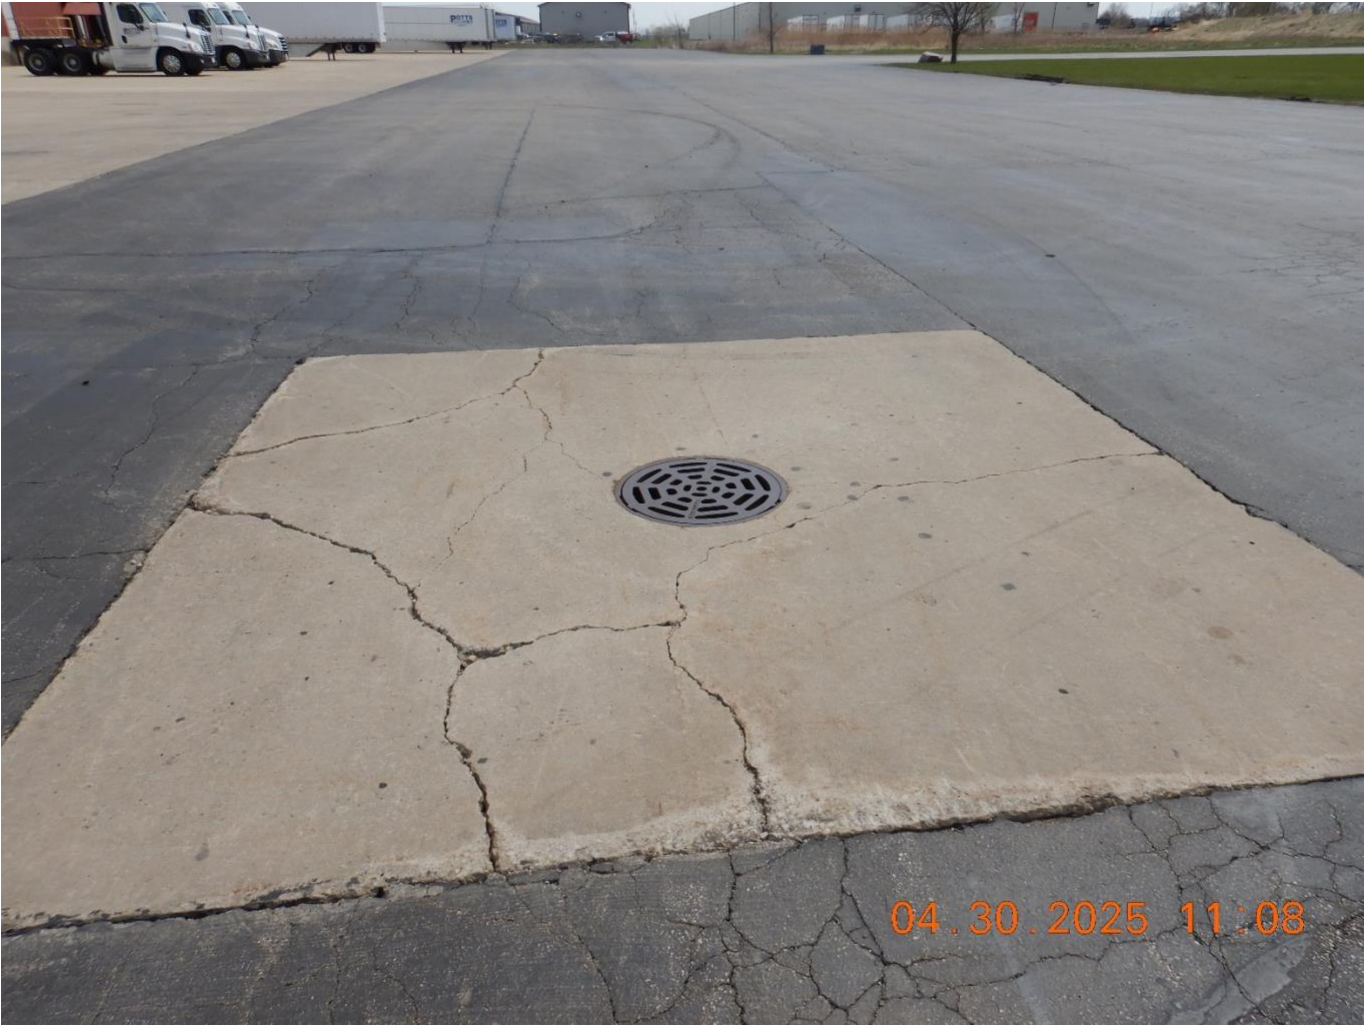
| WOW Logistics – TreeHouse Foods | | | DSCN1118.JPG |

| Outside middle drain in front parking lot near loading/unloading dock | | | |
