INSPECTION REPORT

| <b>Type of Inspection</b> | Industrial Stormwater Inspection (ISI) | |
| <b>Permittee Name</b> | WOW Logistics | |
| <b>Facility or Site Name</b> | TreeHouse Foods | |

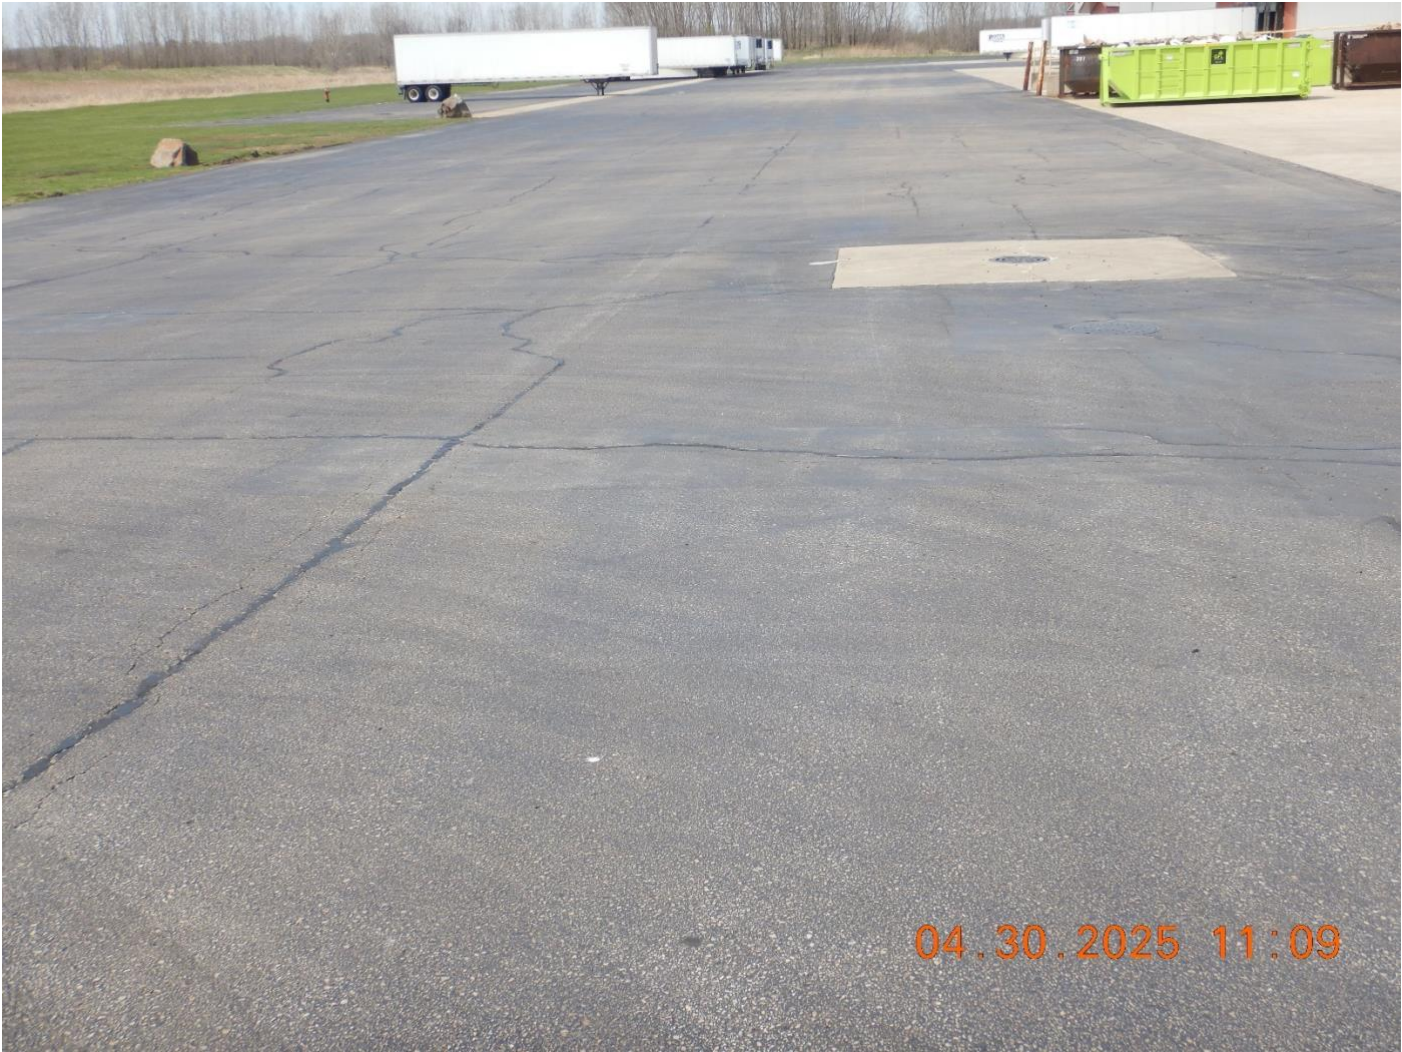
| WOW Logistics – TreeHouse Foods | | | DSCN1119.JPG |

- Mr. Nguyen observed discharge point 002 along the adjacent property on the east side of the facility.
- Three drains (Photos DSCN 1116-DSCN1119) were observed in the asphalt parking lot south of the facility: One drain near the loading and unloading dock on the east side, one drain near the main entrance to the facility, and one drain on the west side near the trash roll-offs and bin. Mr. Hurlbut stated he did know if the drains go to the city sewer system. The drains are not listed as part of the action area and discharge points.

| AOC Reference #: DN1-RR-001 | Record: SWPPP |
|---|---|
| <b>AOC:</b> <ul style="list-style-type: none"> <li>The SWPPP did not include directions of stormwater flow on the site map.</li> <li>The SWPPP did not include loading and unloading areas and locations used for storage and disposal of wastes.</li> <li>The SWPPP did not identify the three drains on the south side of the facility near the waste storage area, the main entrance, and the loading and unloading area.</li> </ul> | |

| Outside drain in front parking lot on the west side | | | |
