**Region 6 - Enforcement & Compliance Assurance Division**  
**INSPECTION REPORT**

| Inspection Date(s): | May 9, 2024 | |
| Facility Name: | Painted Tree Village District South (Phase 1) | |
| Identification/Permit Number: | TXR1582KY | |

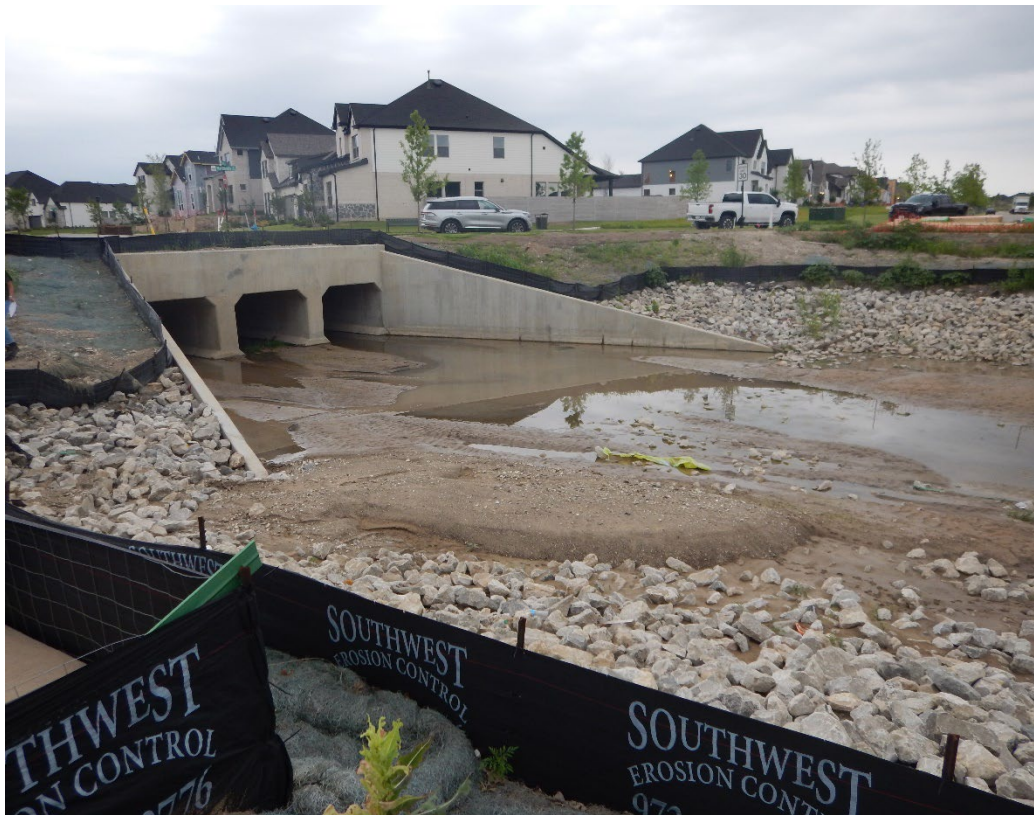
Photo no. 1

- There was evidence of a recent discharge of sediment at the outfall/tributary near the intersection of Outpost Trail and Marilanda Road at the time of inspection. Because the site has many operators developing and building simultaneously, multiple operators are likely responsible for the sediment discharge (**Appendix 1, Photo 1**).

Description: Evidence of a sediment discharge at the outfall immediately east of the site near the intersection of Outpost Trail and Marilanda Road.

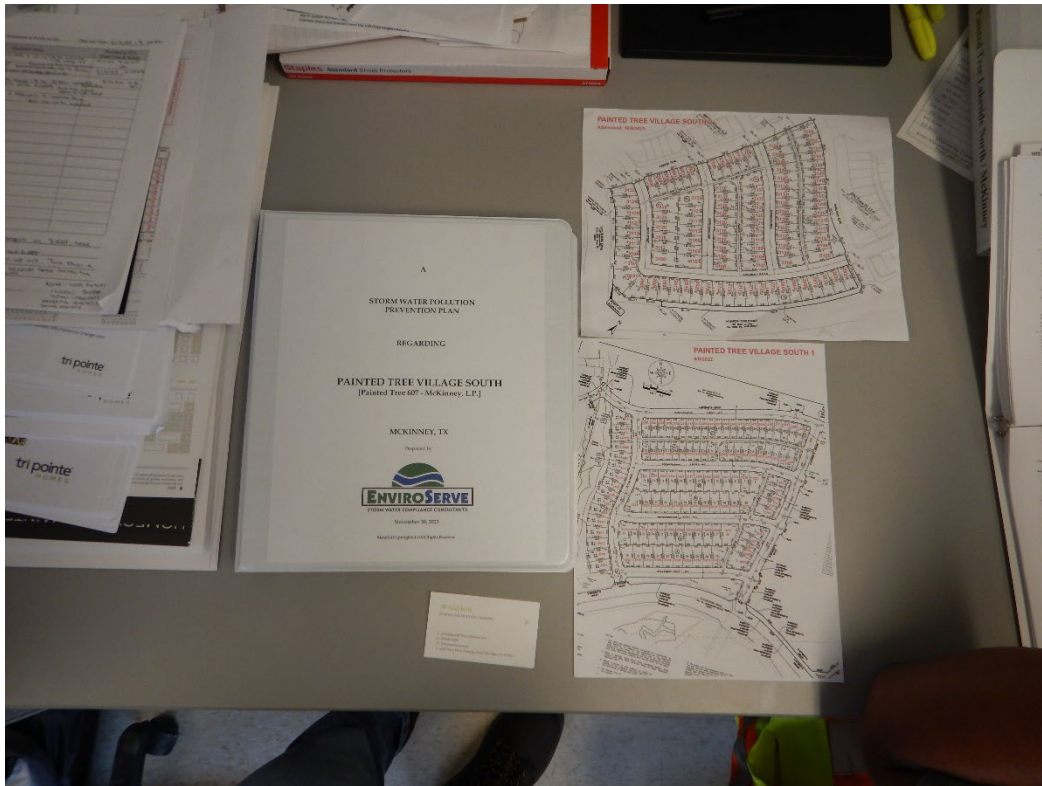
Photo no. 2

- Mr. Giddens was unable to provide a physical copy of the Stormwater Pollution Prevention Plan (SWPPP), an updated site map, or inspection reports for the Village District Phase 1 (TCEQ permit number: TXR1582KY) at the time of inspection. SWPPP booklets for other phases of construction were available in the construction trailer on May 9, 2024 (**Appendix 1, Photo 2**).

Description: Site maps and the Storm Water Pollution Prevention Plan (SWPPP) provided by the construction manager Mr. Giddens for phase 2 of construction. Mr. Giddens was unable to provide the SWPPP, site maps, and inspection reports for Phase 1 at the time of inspection. The phase 1 documentation was obtained digitally from environmental consultant Mr. Boucher on 5/17/2024.

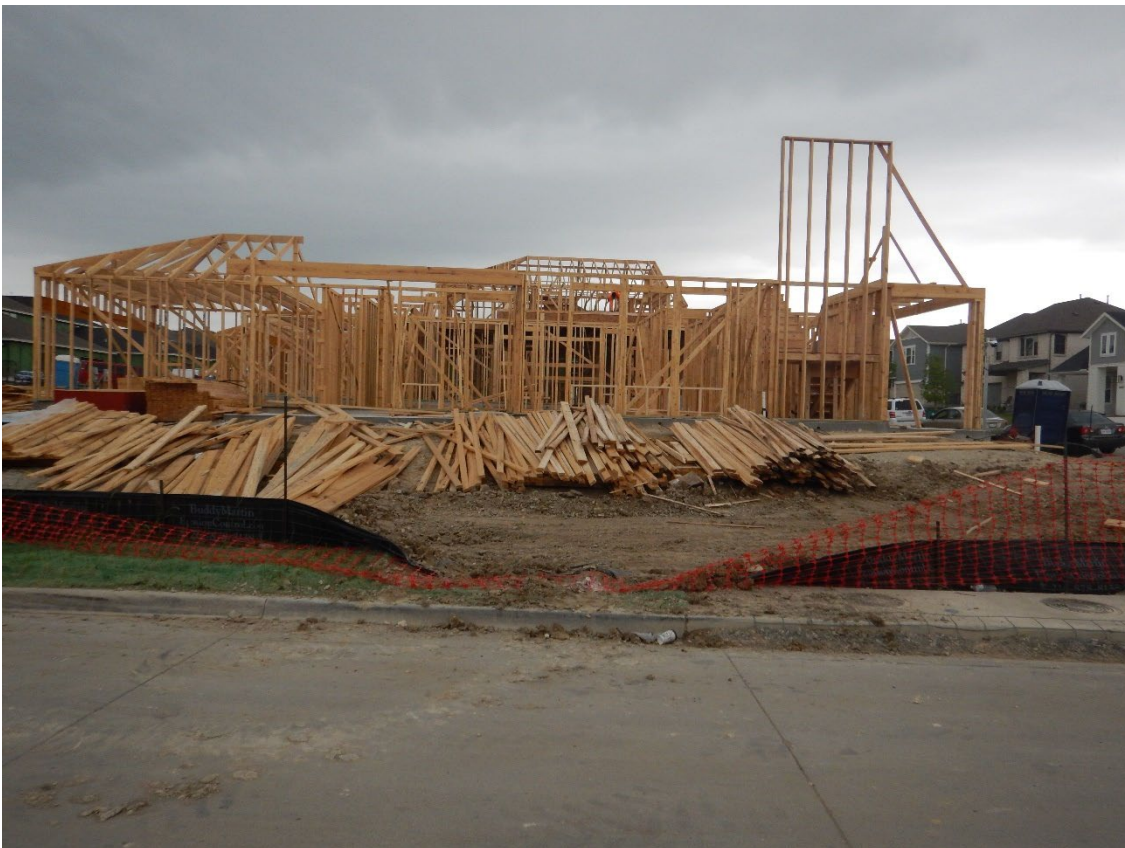
Photo no. 3

- We observed sections of damaged silt fence and worn erosion control blankets along the front of some lots. **(Appendix 1, Photos 3-4)**, allowing sediment to discharge onto the street.

Description: Section of damaged silt fence and worn erosion control blanket along Wyler Drive.

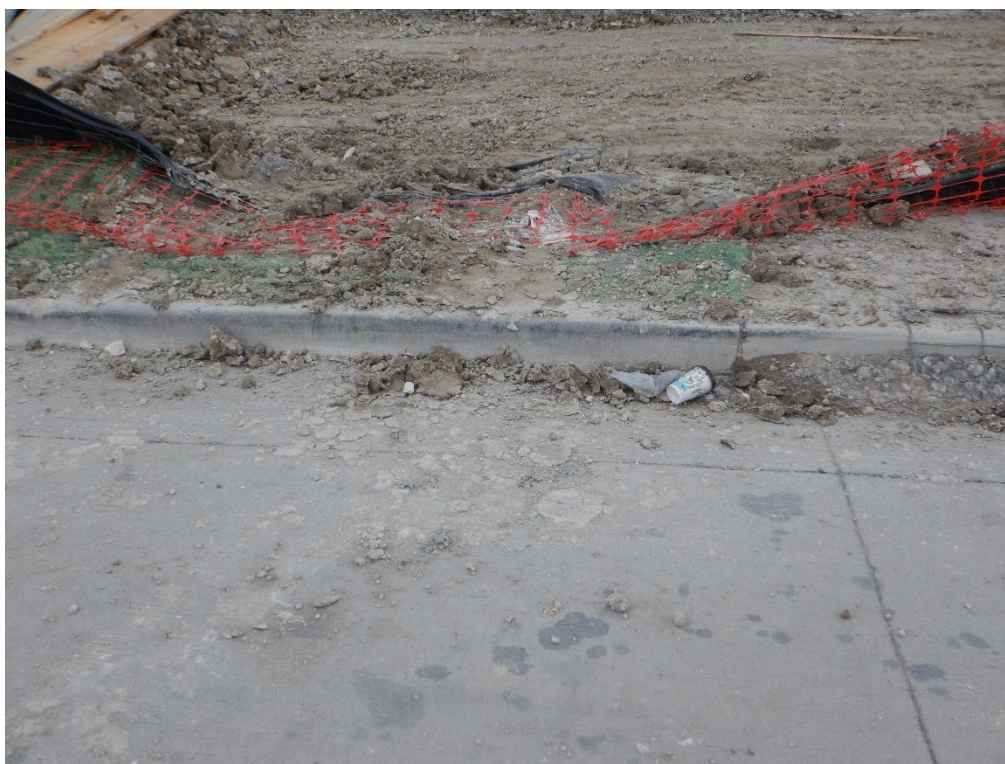
Photo no. 4

Description: Zoomed in photo of the damaged section of silt fence and worn erosion control blanket along Wyler Drive. Also picture is evidence of sediment discharged from the lot onto the street/MS4 near the curb.

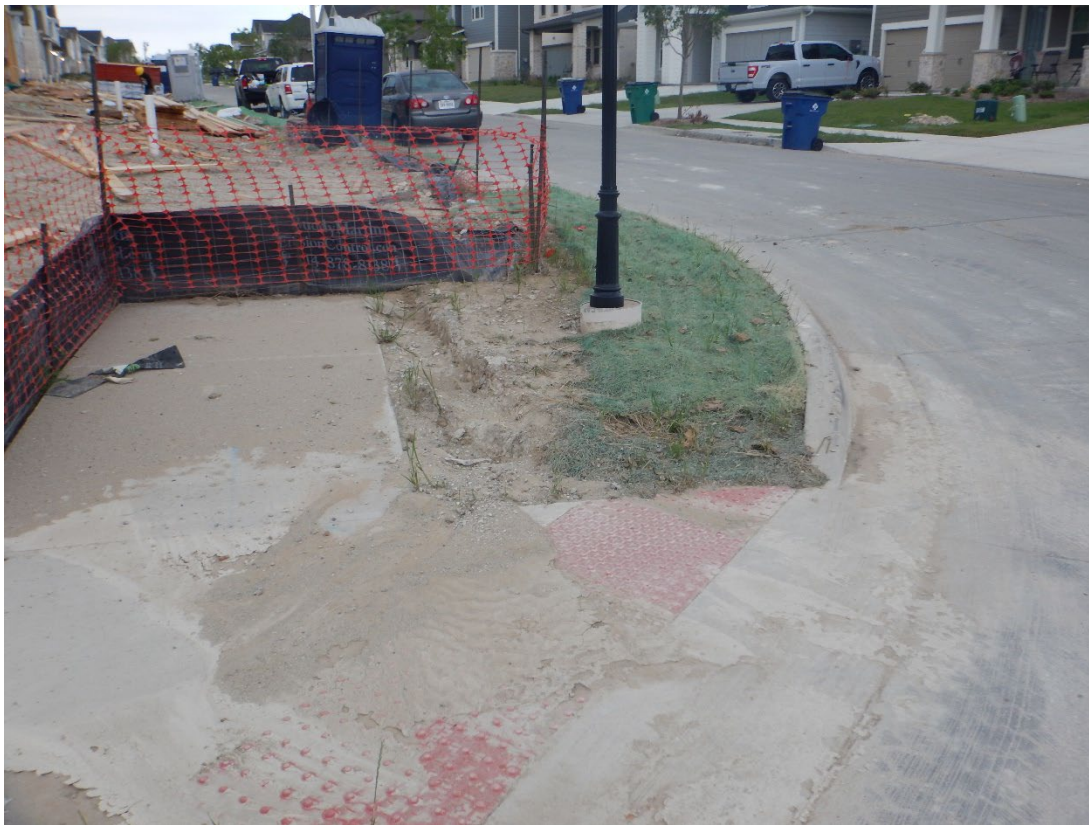
Photo no. 5

- We observed sediment on the sidewalk and street due to ineffective BMPs **(Appendix 1, Photo 5)**.
- We observed improperly installed inlet protection (i.e., the inlet protection had a large gap in the middle, allowing materials such as trash and sediment to enter the inlet) **(Appendix 1, Photos 6-7)**.
- We observed blowable trash and building materials not properly contained **(Appendix 1, Photo 8)**.
- We observed uncontained stockpiles of sediment due to damaged or missing BMPs **(Appendix 1, Photo 9)**.
- We observed sections of missing or damaged erosion control blanket along the lots **(Appendix 1, Photo 10)**.

Description: Ineffective BMPs on Eddington Drive allowing sediment to discharge from the lot onto the sidewalk and street near the intersection of Wyler Drive and Eddington Drive.

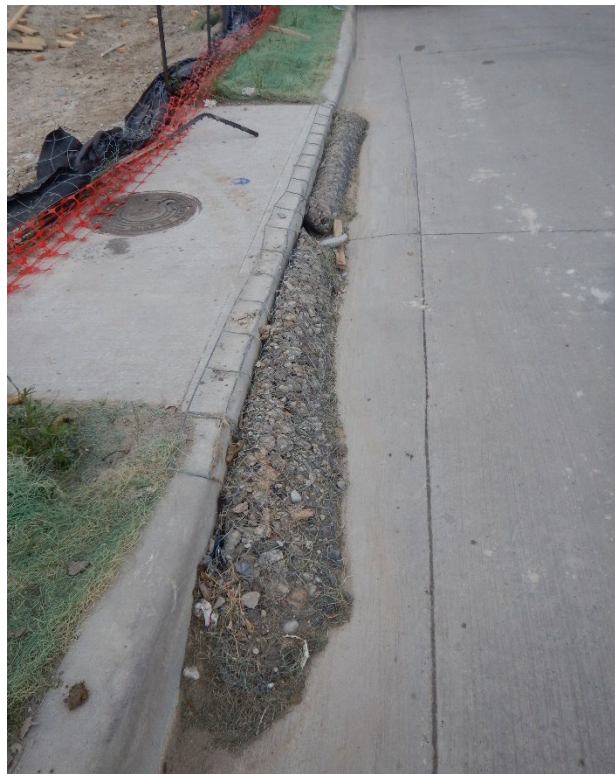
Photo no. 6

Description: Inlet protection on Eddington Drive with a large gap in the middle.

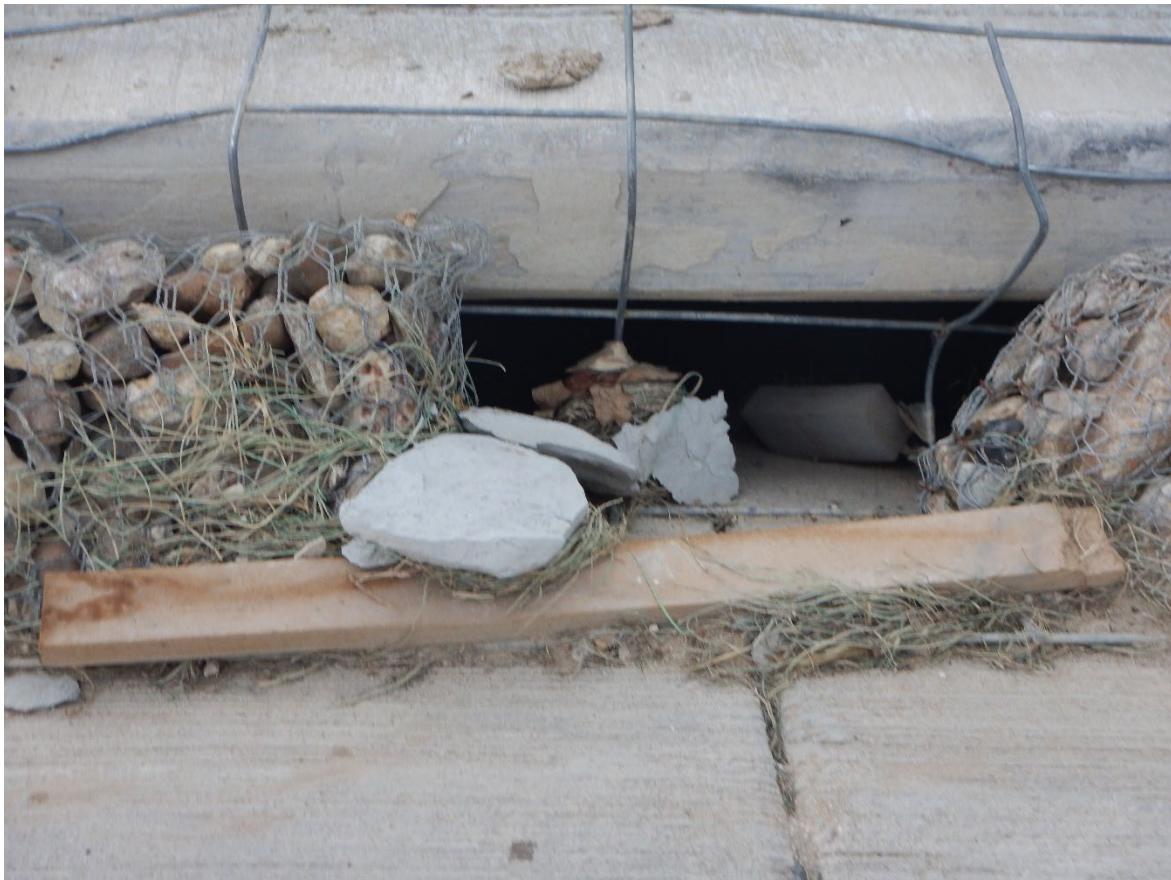
Photo no. 7

Description: Additional photo demonstrating the large gap in the inlet protection on Eddington Drive, allowing for debris and other materials to enter the inlet.

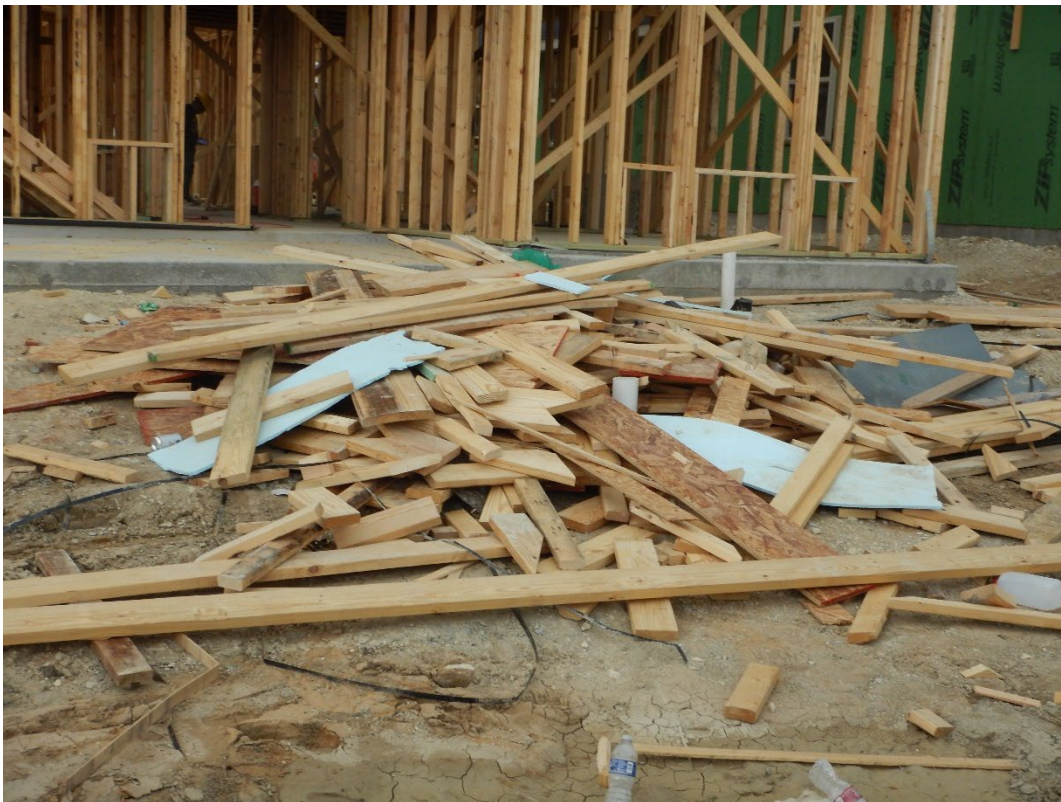
Photo no. 8

Description: Building materials and blowable trash (i.e., plastic water bottles and beer cans) discarded directly on a lot on Eddington Drive. No permanent or temporary trash bins was observed at the time of inspection.

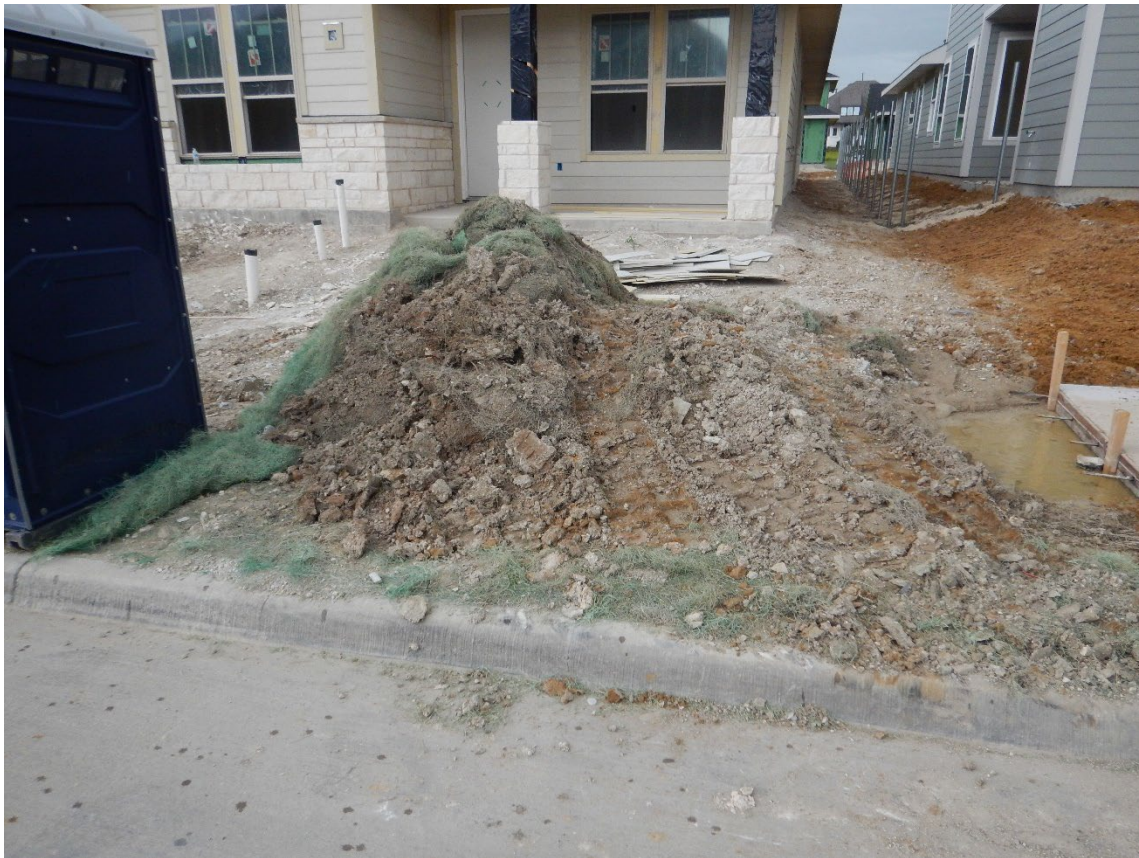
Photo no. 9

Description: Uncontained stockpile of sediment on Eddington Drive. The pictured erosion control blanket is worn and not in effective operating condition.

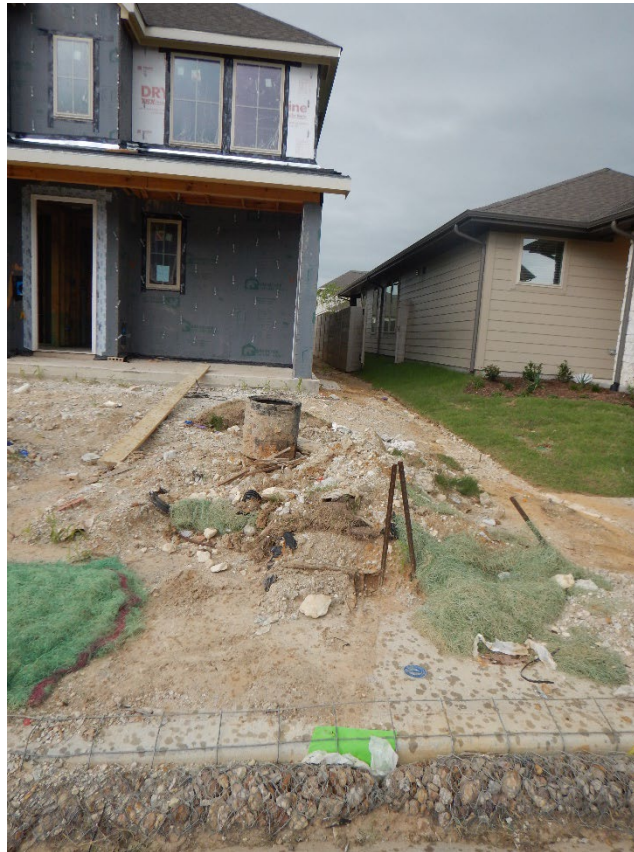
Photo no. 10

Description: Missing section of erosion control blanket along a lot on Eddington Drive, near an inlet. The inlet protection is full of sediment.
