**Region 6 - Enforcement & Compliance Assurance Division**  
**INSPECTION REPORT**

| Inspection Date(s): | 06/05/2023 | |
| Facility Name: | <b>Tri-County Regional Water Distribution District Public Water System</b> | |

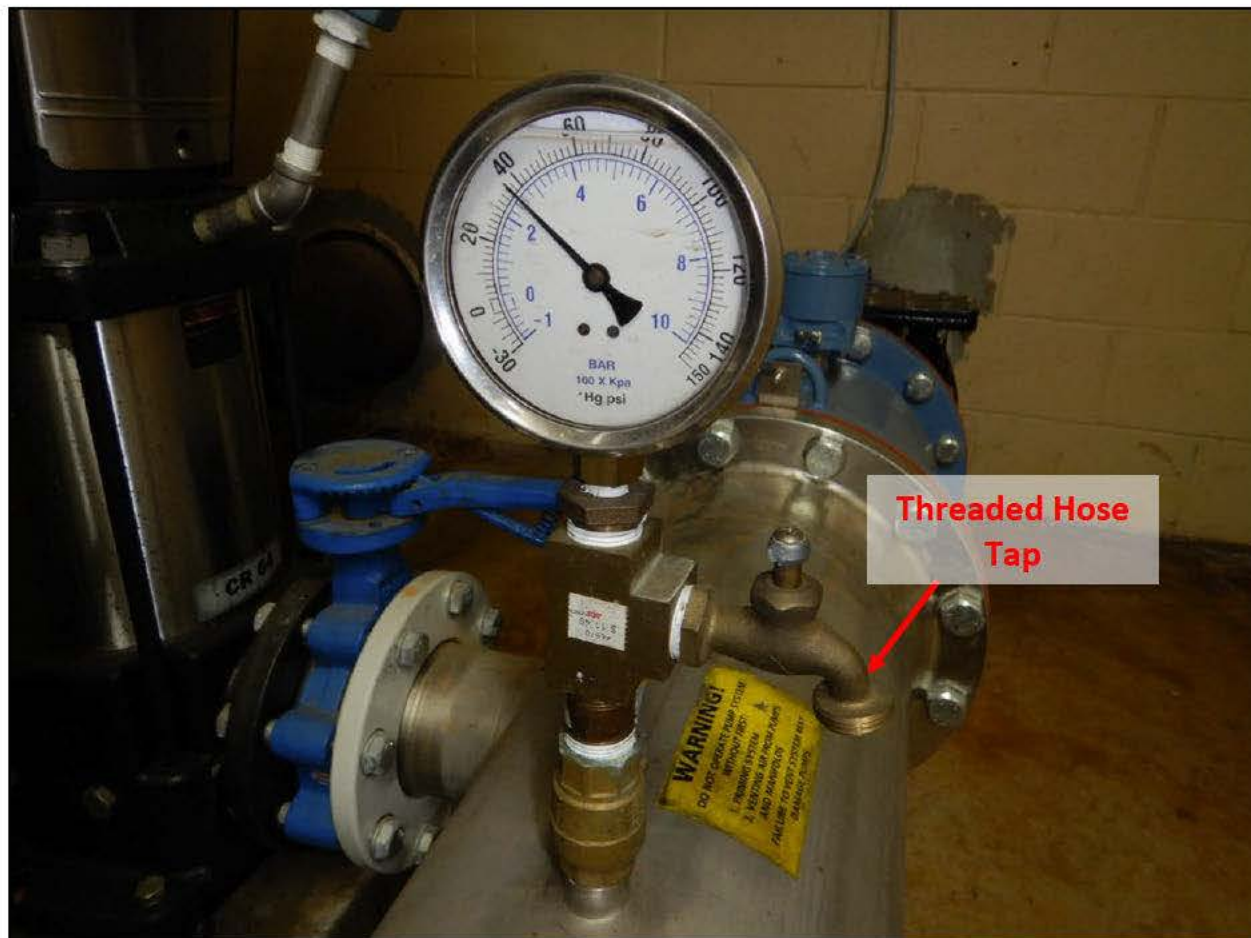
Photo No. 2

**Observation 13.** There were multiple threaded hose taps within the Gum Log (Center Valley) Pump Station without backflow prevention (refer to [Appendix 2, Photograph 2](#)).

**Photograph 2. Threaded Hose Tap, Gum Log (Center Valley) Pump Station** View of a threaded hose tap without backflow prevention extending off of the pump line within the Gum Log (Center Valley) Pump Station.

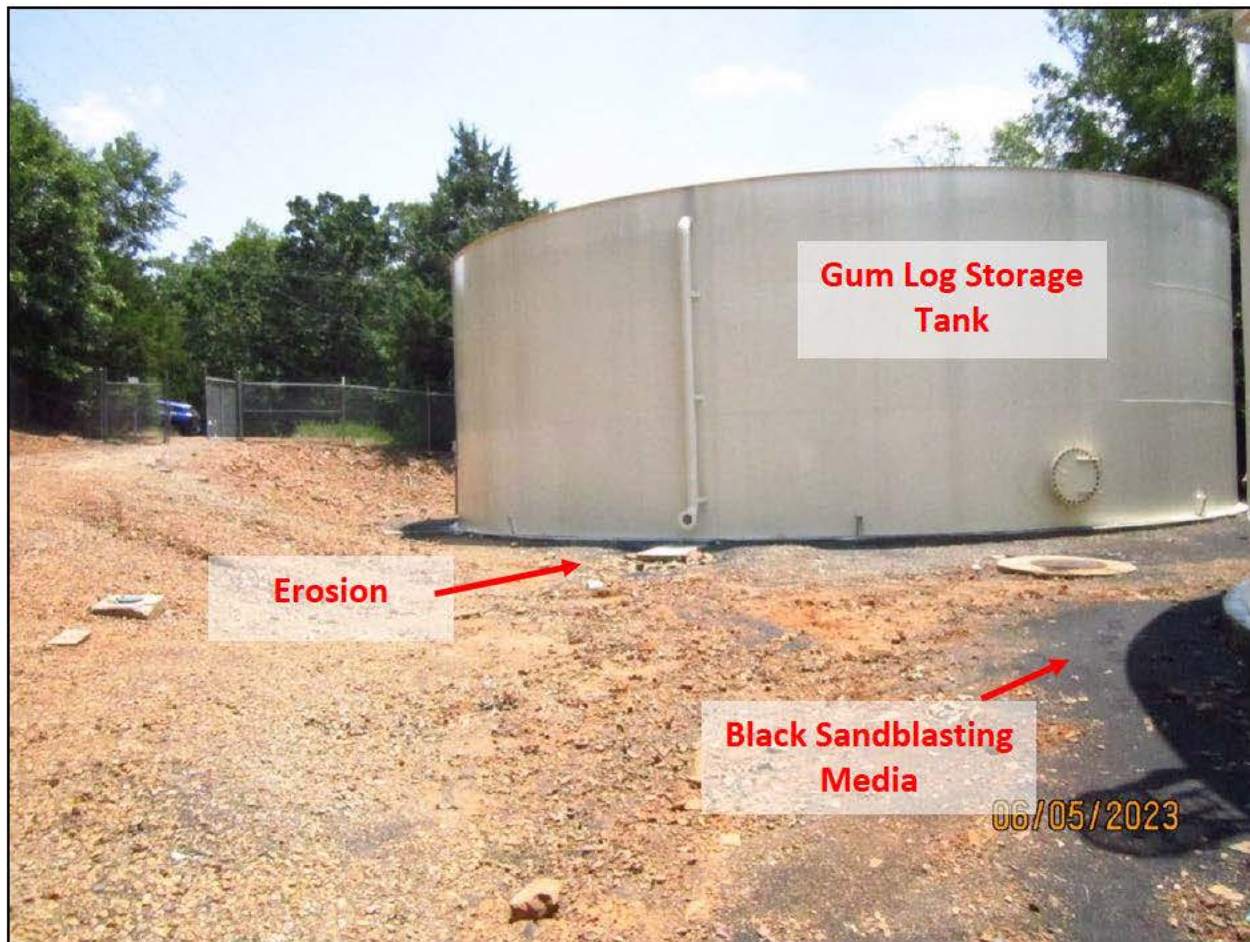
Photo No. 4

**Observation 14.** Erosion was visible around the concrete splash pad beneath the overflow line at one of the Gum Log Storage Tanks (refer to [Appendix 2, Photograph 4](#)). Additionally, sandblasting media from the last time the tanks were resurfaced was visible on the ground surrounding the Gum Log Storage Tanks.

**Photograph 4. Gum Log Storage Tank** View of one of the two, 256,000-gallon Gum Log storage tanks. In this image, erosion can be seen beneath the overflow line, and black sandblasting media from the resurfacing of the tank can also be observed.

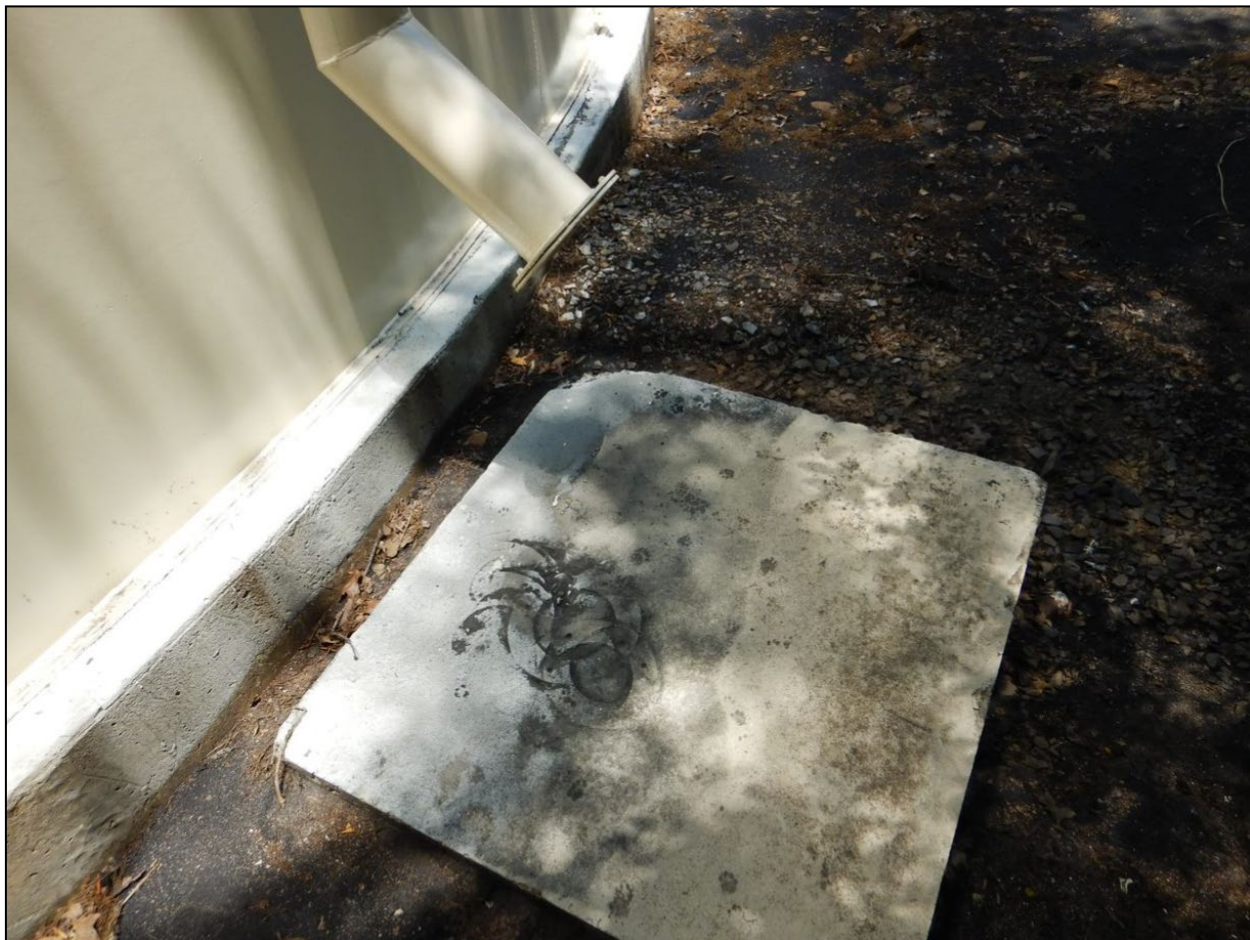
Photo No. 6

**Photograph 6. Splash Pad, Gum Log Storage Tank** View of the splash pad beneath the overflow line at one of the Gum Log Storage Tanks. The second tank contained a splash pad that was similar to this one.

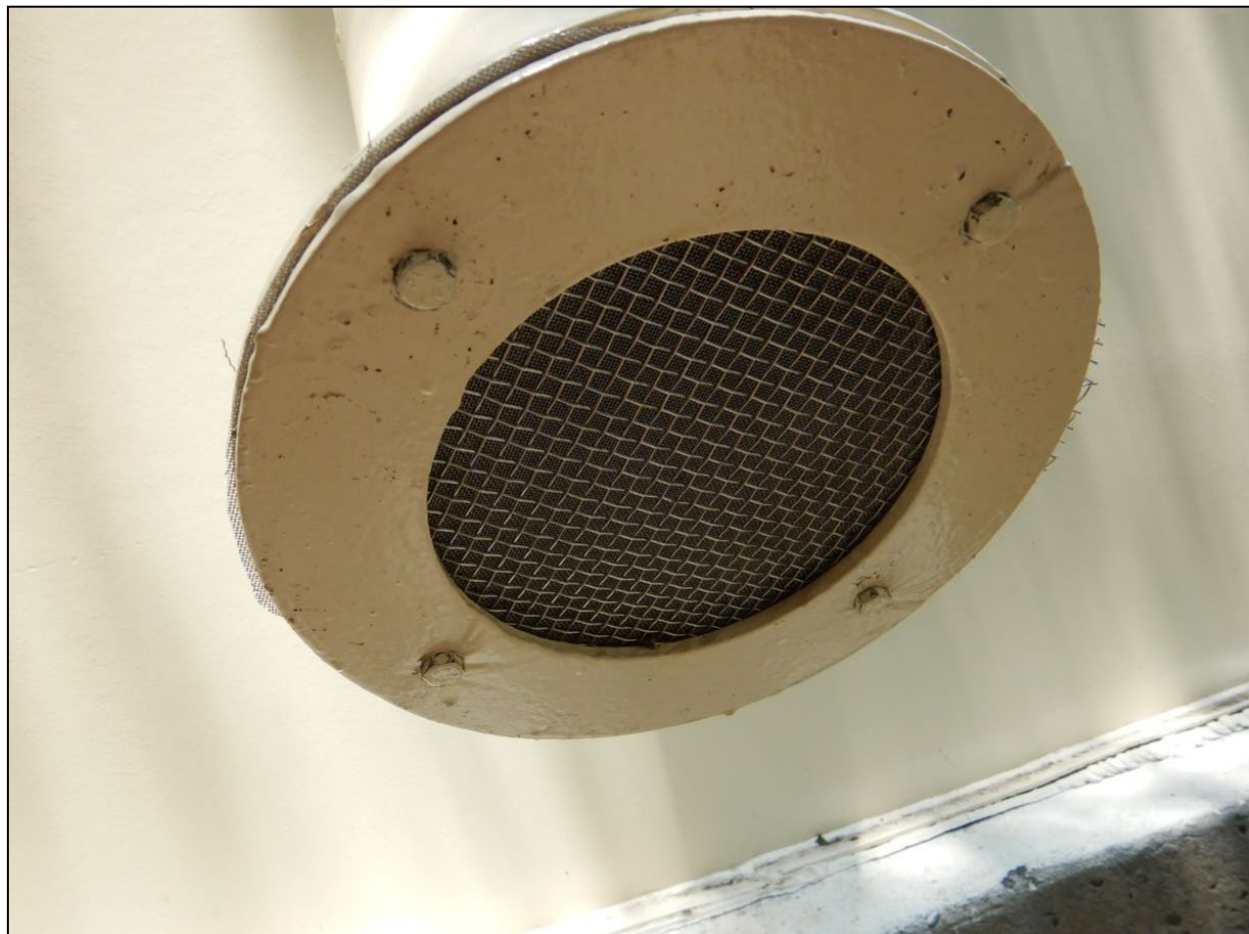
Photo No. 7

**Photograph 7. Overflow Line, Gum Log Storage Tank** View the end of the overflow line at one of the Gum Log Storage Tanks. The opening was covered by a 24-inch mesh screen, as well as an additional coarse screen. The second tank contained an overflow line and a screen that was similar to this one.

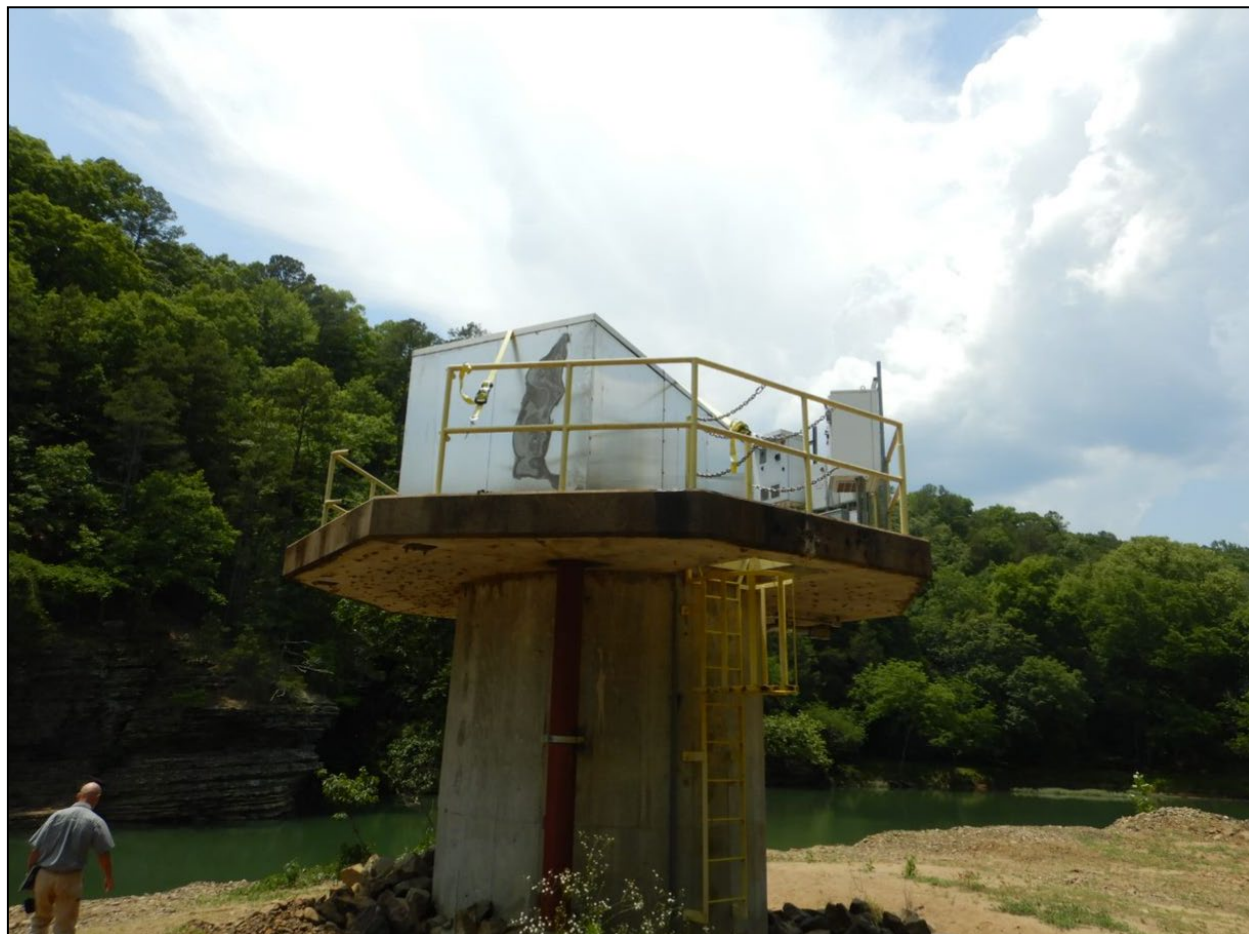
Photo No. 10

**Photograph 10. Pump Structure, Hector WTP Intake** View of the pump structure at the intake for the Hector WTP. The intake is located in the Illinois Bayou. Tri-County owns the land surrounding the intake, which is a protection barrier for the surface water quality and an extra layer of security for the water plant intake structure.

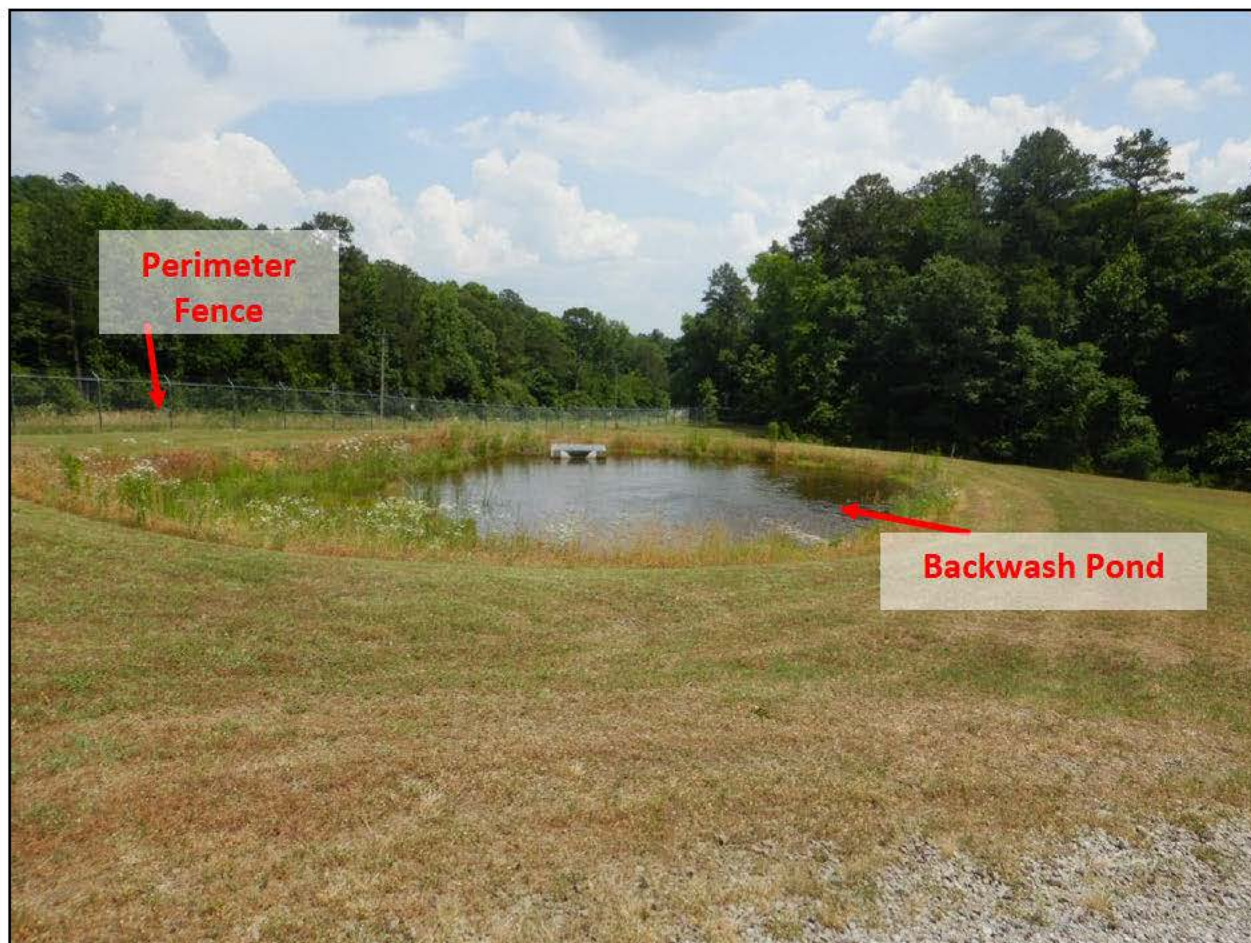
Photo No. 11

**Photograph 11. Perimeter Fence, Hector WTP** View of the locked perimeter fence with barbed wire that surrounds the Hector WTP property. Also pictured is the pond that filter backwash product is sent to.

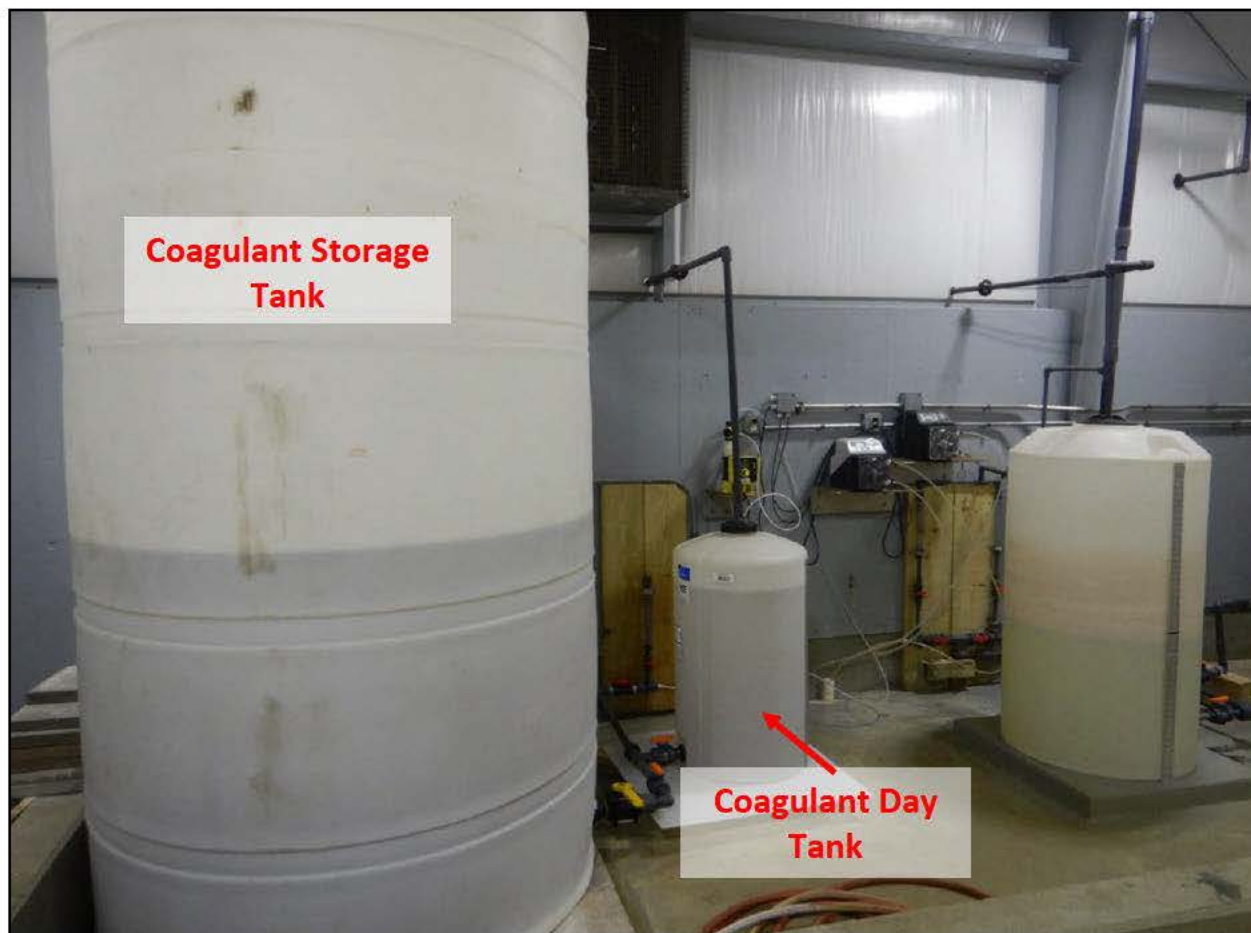
Photo No. 13

**Observation 16.** When the EPA Inspection Team arrived at the Hector WTP, there was no label on the coagulant tank (refer to [Appendix 2, Photograph 13](#)). WTP representatives stated that the tank was new, and the label had not been added yet. When WTP representatives became aware of this, a label was added. Additionally, the caustic soda tank was on cinderblocks, and therefore was elevated above the secondary containment wall that it was surrounded by (refer to [Appendix 2, Photograph 14](#)).

Photograph 13. Coagulant Tank, [REDACTED] View of the Coagulant storage and day tanks [REDACTED]  
[REDACTED] The coagulant tank did not have a label when the EPA Inspection Team arrived onsite, but a label was placed on the tank once operators became aware of this.

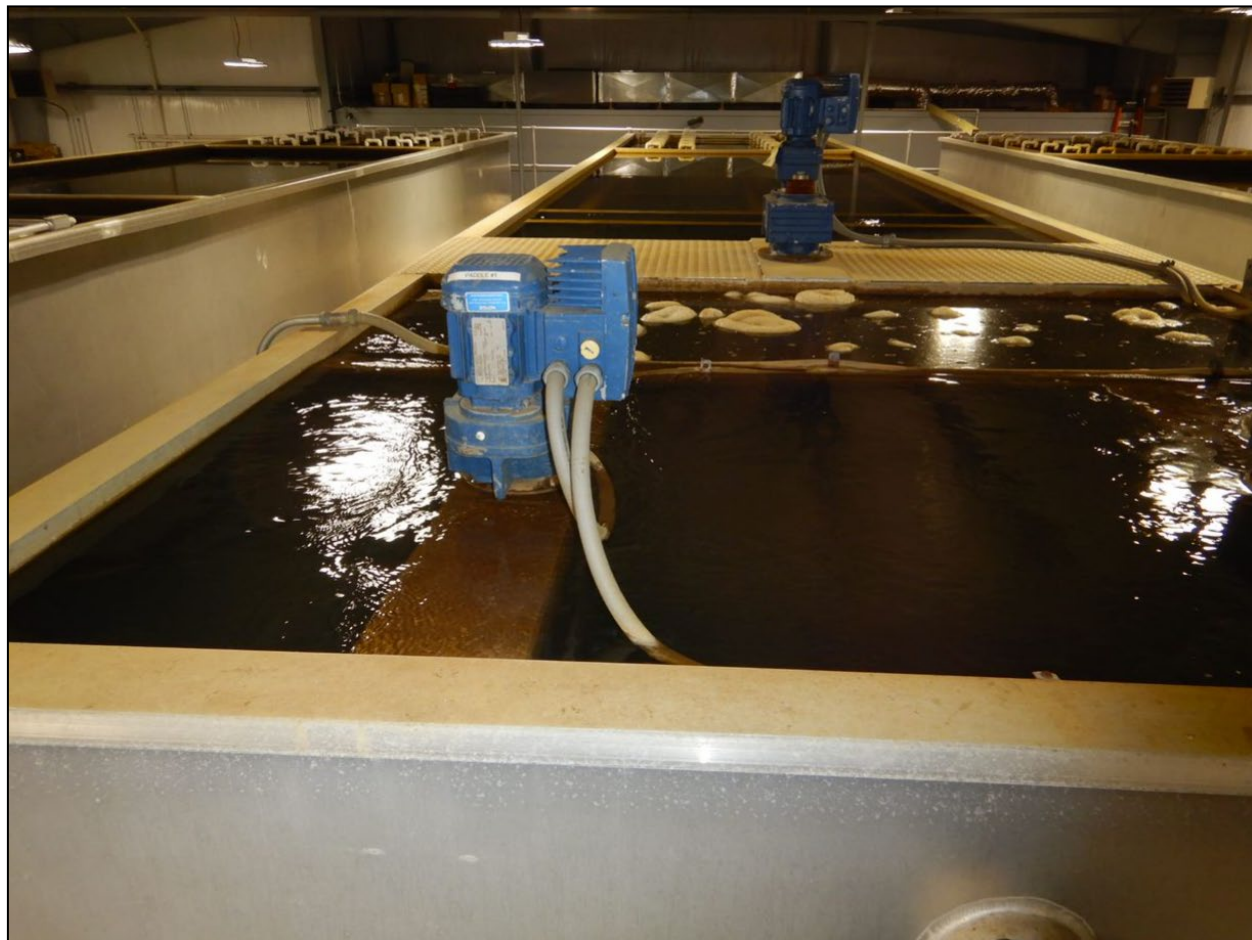
Photo No. 15

**Observation 17.** The water level in the tank containing Train #2 at the Hector WTP was approximately two inches below the top of the tank when the EPA Inspection Team arrived (refer to [Appendix 2, Photograph 15](#)). WTP representatives attributed this to a malfunction with the tank's level indicator. Due to the high-water level, water was overflowing into the backwash basin, which is ordinarily used to transport filter backwash product to an onsite backwash pond (refer to [Appendix 2, Photographs 11 and 16](#)). While the EPA Inspection Team was onsite, an operator was able to reset the level indicator, and the water level in the tank returned to normal.

**Photograph 15. Treatment Train #2 Tank, Hector WTP** View of the Train #2 treatment tank at the Hector WTP. When the EPA Inspection Team arrived, the water level was approximately two inches below the edge of the tank. Once operators reset the level sensor, the water level lowered.

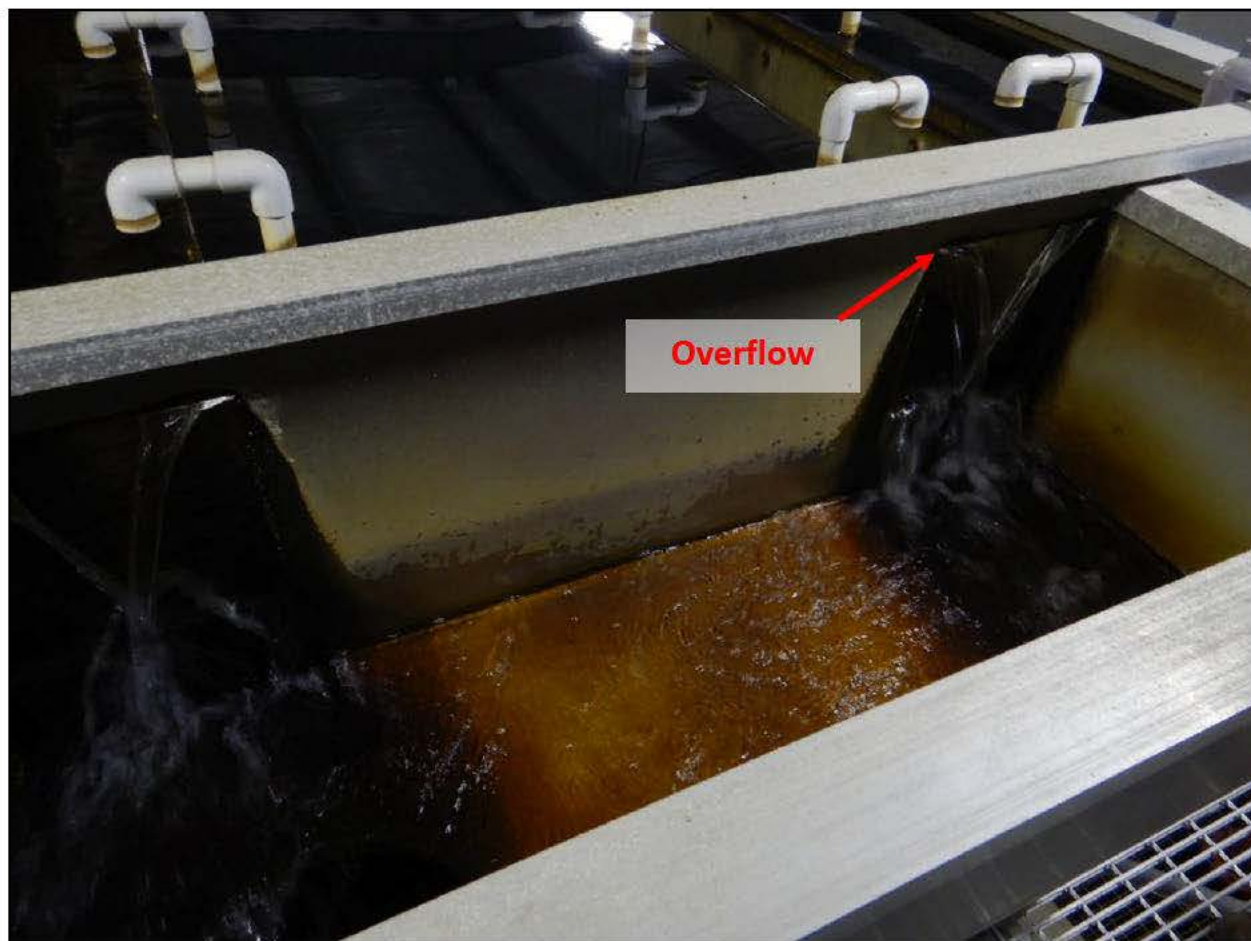
Photo No. 16

**Photograph 16. Treatment Train #2 Tank, Hector WTP** View of the water overflowing into the backwash basin due to a high water level in the tank.

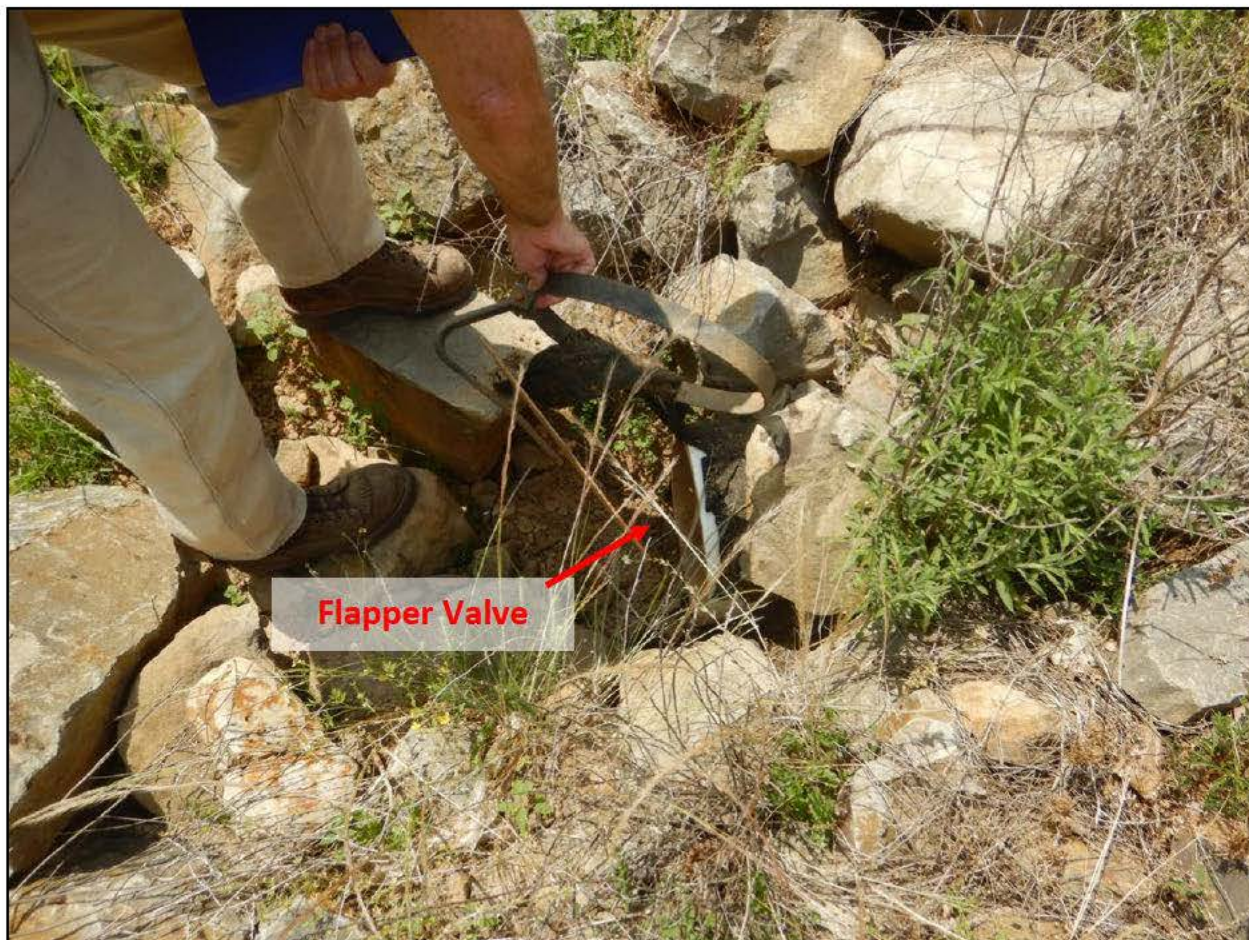
**Observation 18.** The flapper at the end of the overflow pipe of the Clearwell #1 storage tank had fallen off and was laying on the ground (refer to [Appendix 2, Photograph 19](#)). In addition, there was no mesh protecting the overflow line from insect intrusion.

**Photograph 19. Clearwell #1 Storage Tank Flapper Valve** View of the Clearwell #1 storage tank flapper valve at the end of the overflow line. The flapper valve was on the ground and in a state of disrepair. No screen was observed on the overflow line.
