**Region 6 - Enforcement & Compliance Assurance Division**  
**INSPECTION REPORT**

| Inspection Date(s): | 11/09/2021 (updated 12/27/2021 and 2/07/ 2022) | |
| Company Name: | <b>El Paso Water Utilities</b> | |
| Facility Name: | <b>John T. Hickerson WWTF - Frontera Lift Station</b> | |

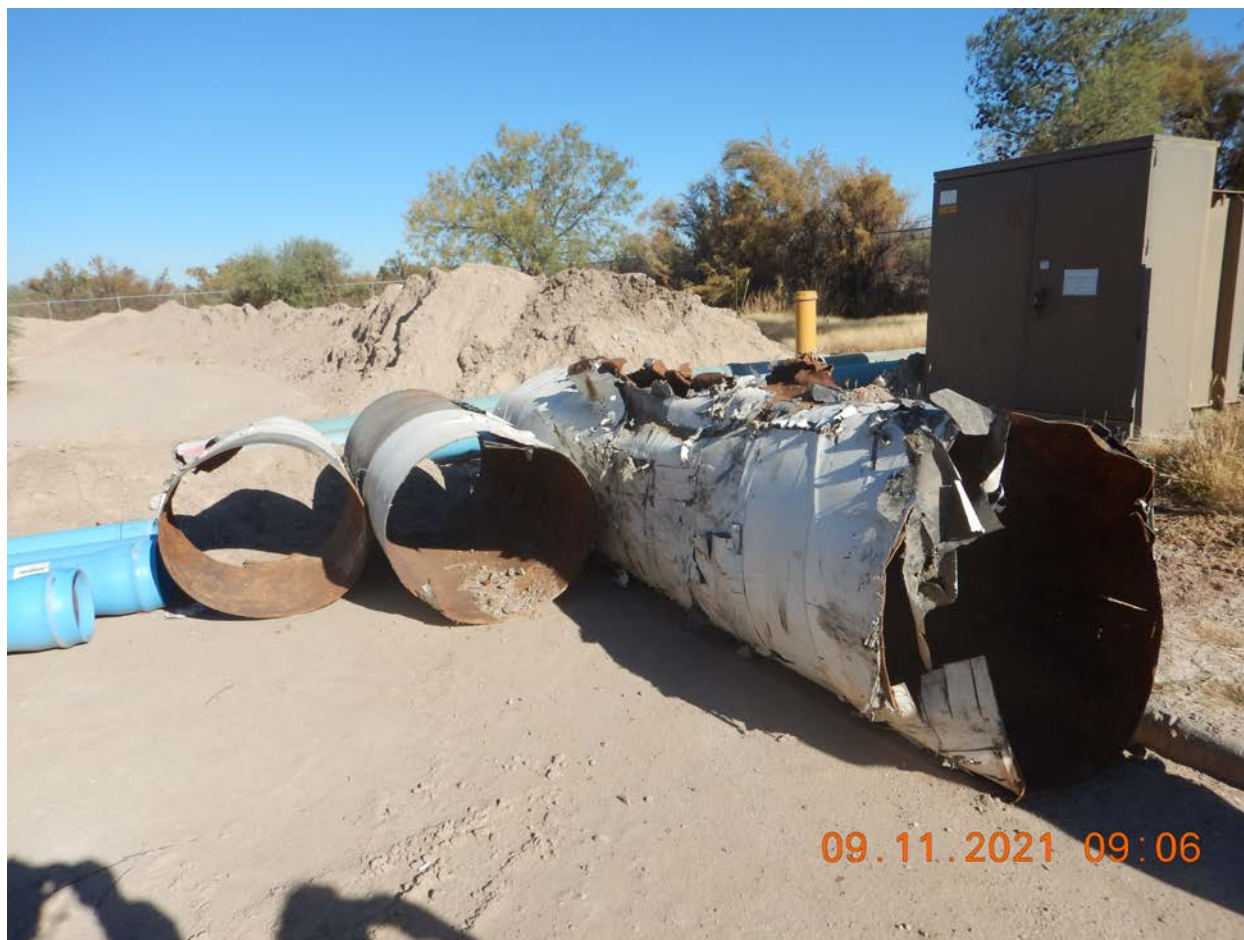
Photo No. 1

- Frontera Lift Station- experienced collection line failure on August 13, 2021. It was stated EPW was proceeding with a forensic analysis to determine the cause of the failure (Appendix 1 Photograph #1). Repairs also required dewatering for construction as the static water level (SWL) was stated to be at 15-feet below land surface (BLS) (Appendix 1 Photograph #2). Note: The size and transition of the various collection lines are represented in Appendix 2 Frontera Force Mains.

Previously existing collection lines staged in proximity of Frontera Lift Station awaiting forensic analysis. (DSCN2003) Photographed by D. Esparza

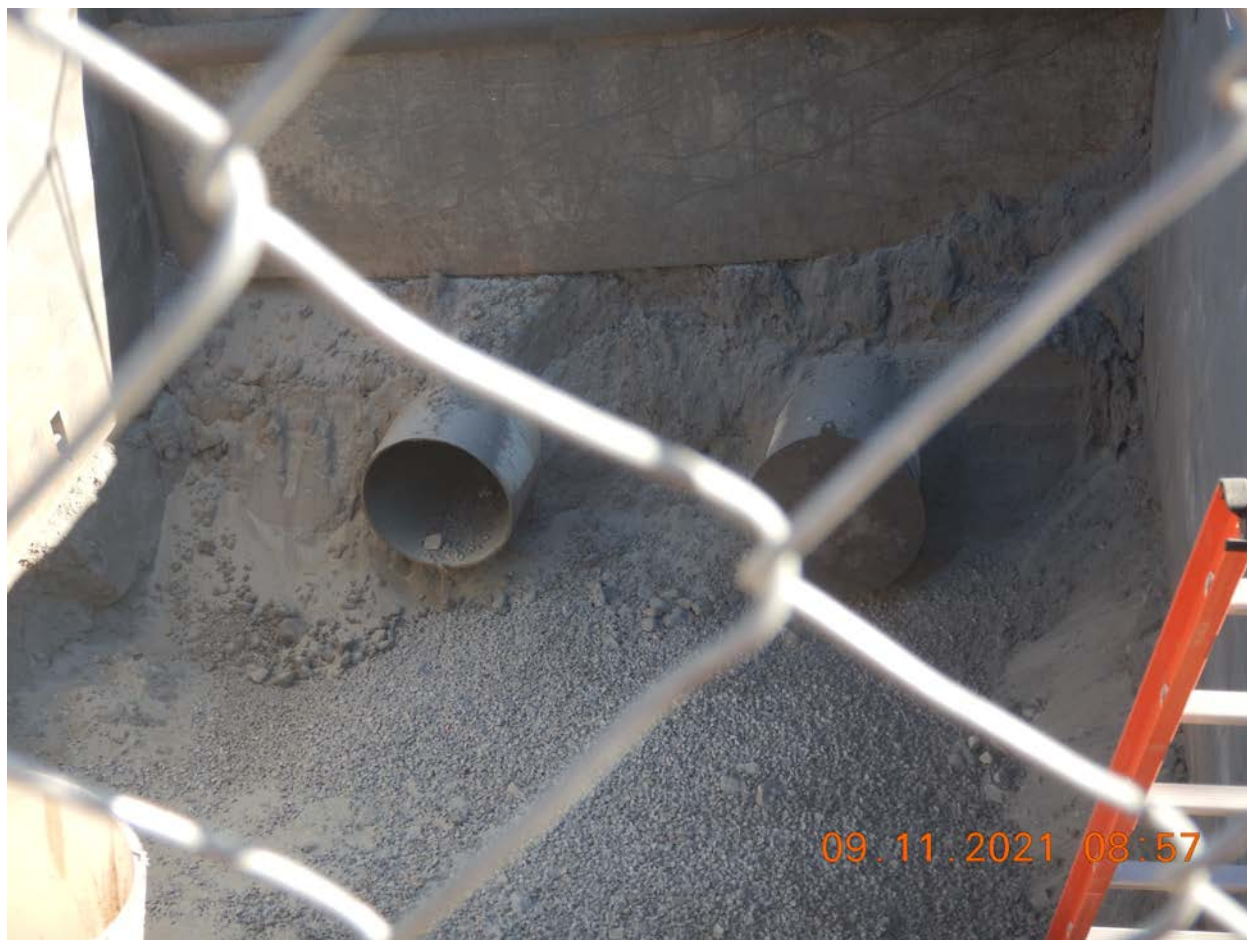
Photo No. 2

View of dewatered excavation with new collection line stub outs in-place. Note: these new dual collection lines are approximately 30-inch diameter. (DSCN2001) Photographed by D. Esparza

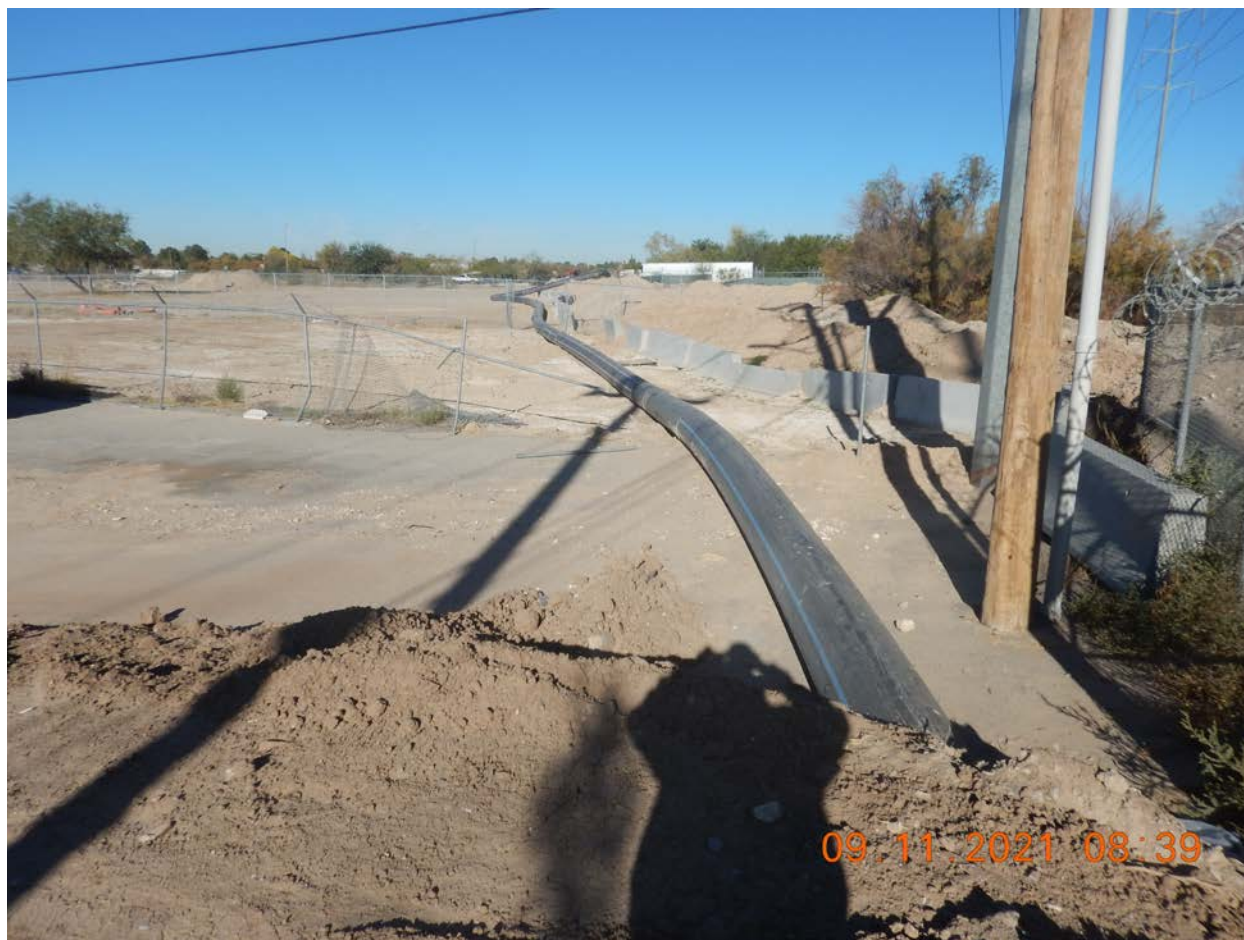
Photo No. 3

- The SSO event required temporary tie-in and routing of above ground piping to discharge into a stormwater drop inlet (Appendix 1 Photograph #3, Photograph #4, and Photograph #5). Prior to this in-place by-pass piping, earthen berms were constructed to contain the wastewater that flowed overland into the same inlet (Appendix 1 Photograph #6, Photograph #7).

View of temporary above ground piping. (DSCN1998). Photographed by D. Esparza

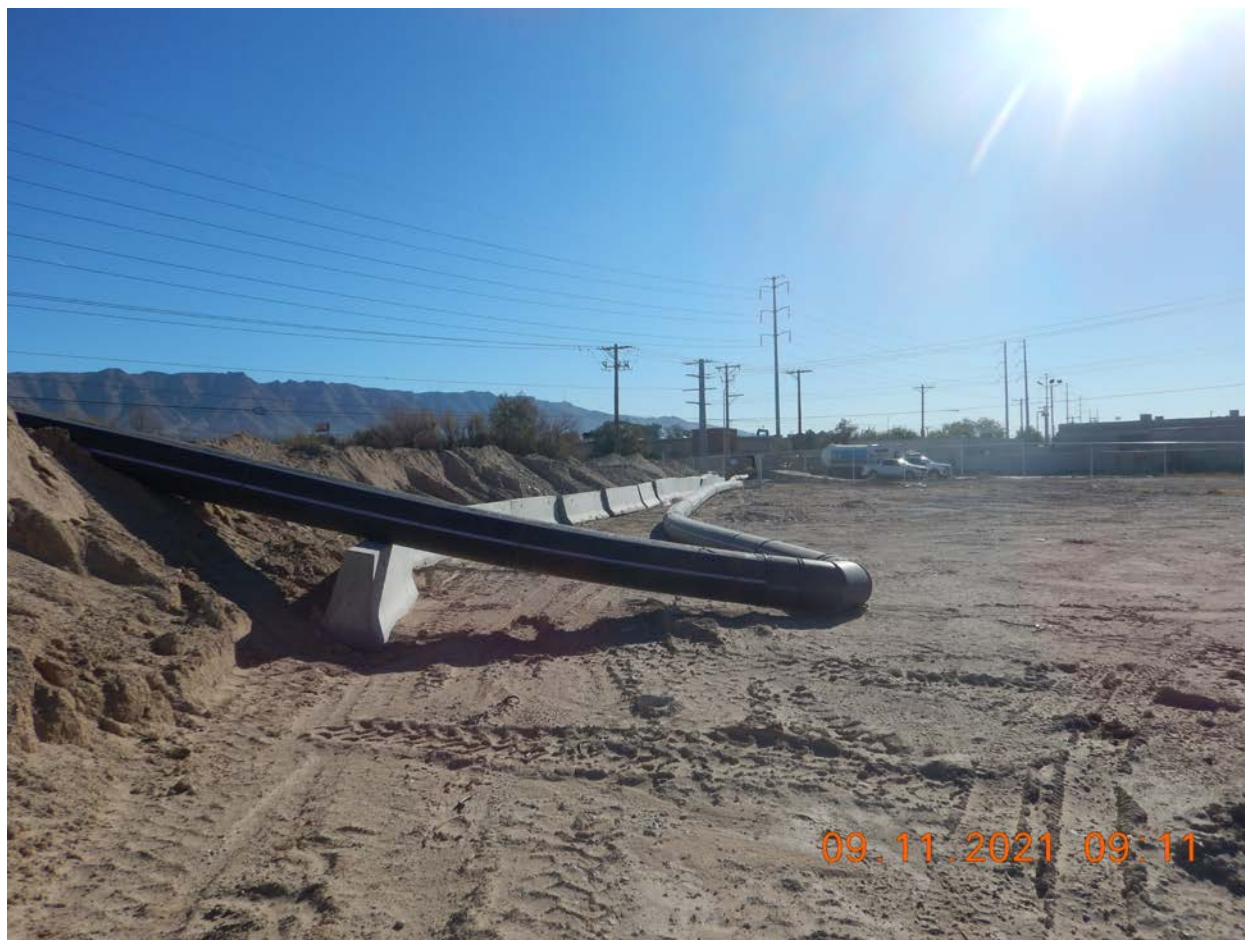
Photo No. 4

Additional view of above ground temporary piping. Note: the lift station, is in the approximate center left of the photograph. (DSCN2006) Photographed by D. Esparza

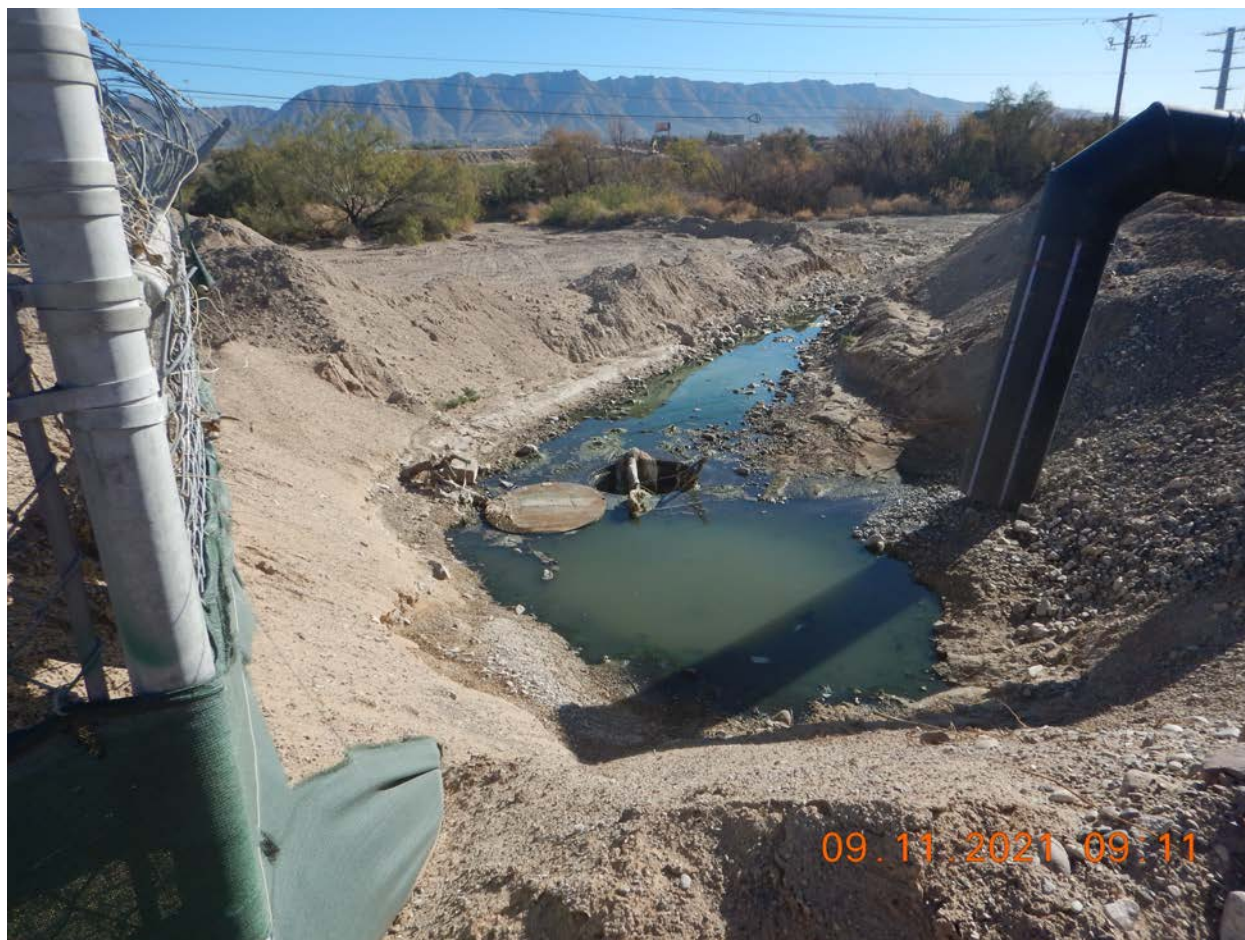
Photo No. 5

View of the temporary above ground piping (left side of photograph) and stormwater drop inlet. (DSCN2007). Photographed by D. Esparza

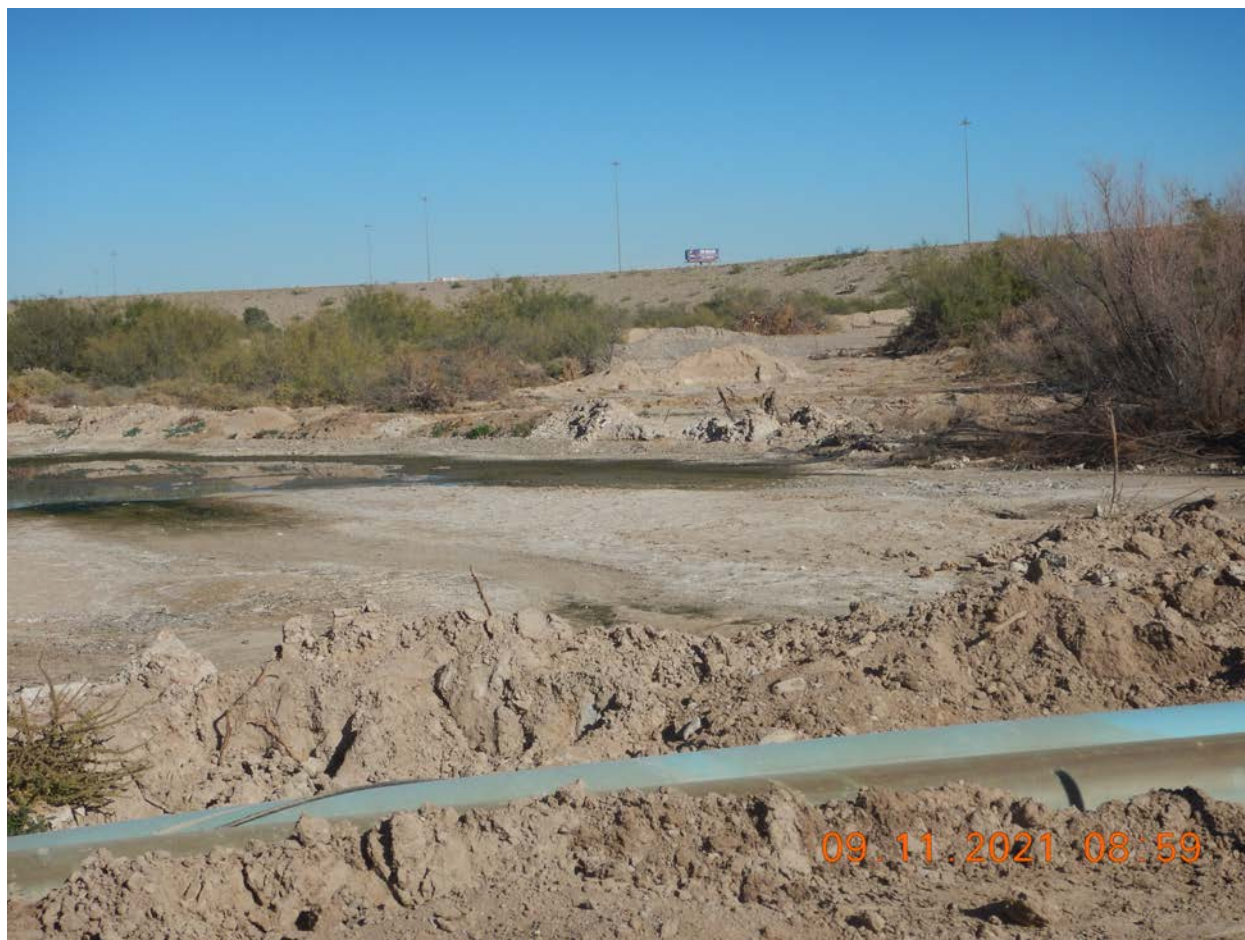
Photo No. 6

View of earthen berms constructed to contain wastewater flows, prior to placement of temporary above ground piping. Note: the lift station is in the approximate lower right of the photograph. (DSCN2002). Photographed by D. Esparza

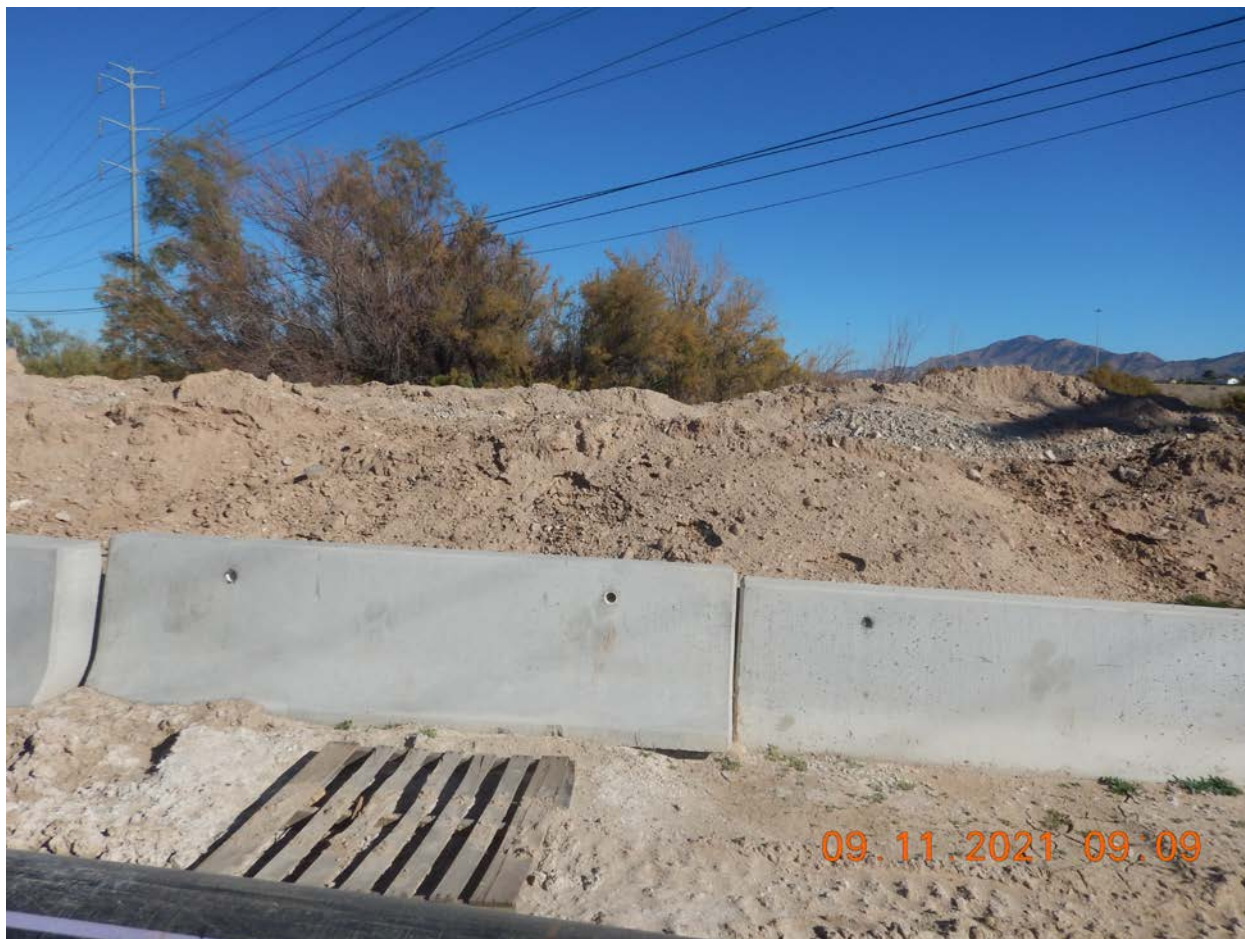
Photo No. 7

View of the constructed earthen berm and above ground temporary by-pass piping in foreground. Note: concrete barriers typically placed to prevent wash-out. (DSCN2005). Photographed by D. Esparza

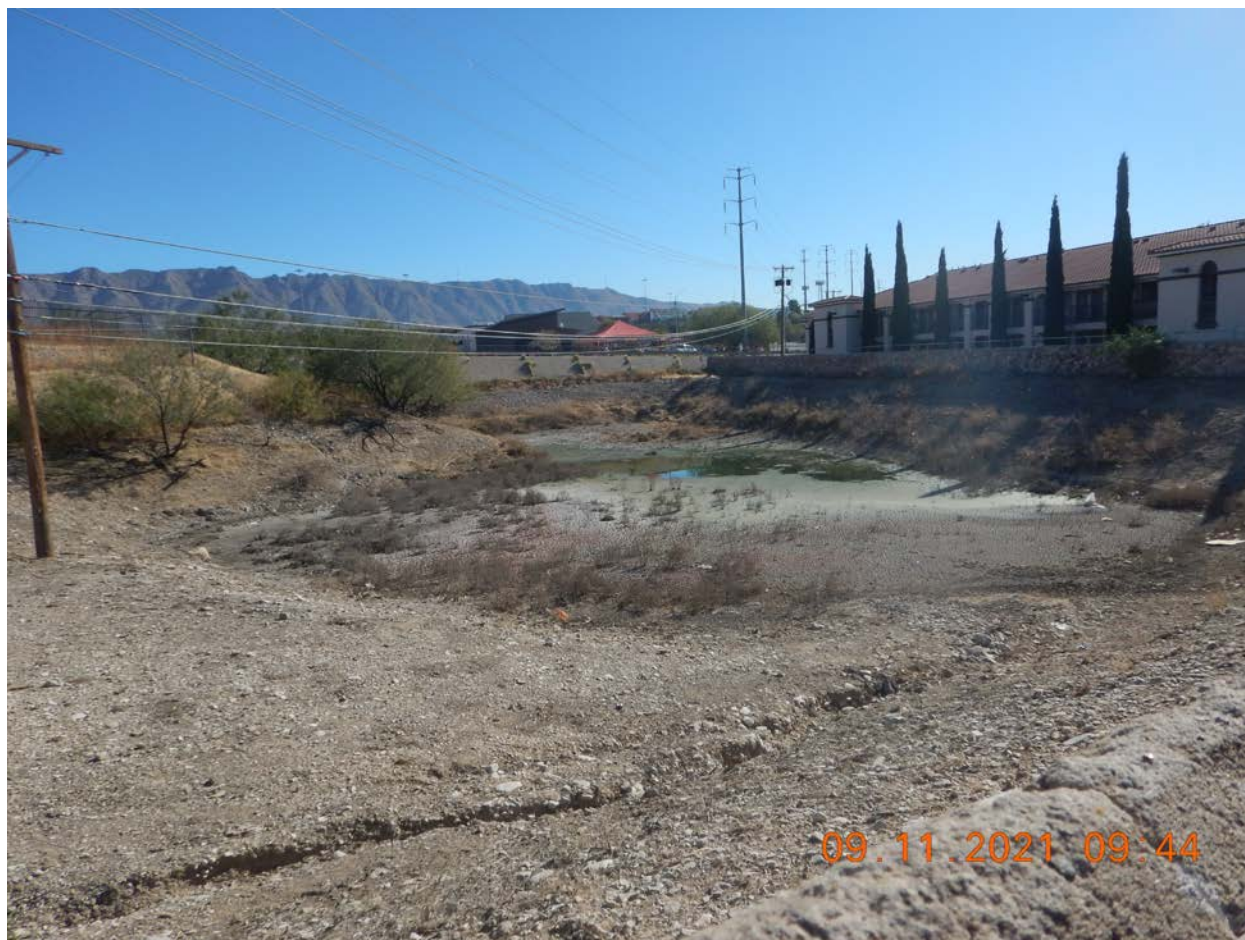
Photo No. 8

- Doniphan Park Circle failure (August 13- August 21)- SSO flowing to Southwest inlet; thence into an adjacent retention pond. (Appendix 1 Photograph #8, and Photograph #9). Note: the retention pond in Photograph #8 equates to approximately 26K-ft<sup>2</sup> in surface area. It appeared restoration efforts had been attempted, though SSO debris, and visible staining, remained (Appendix 1 Photograph #10, Photograph #11).

View of retention pond located along the approximate southeast side of Doniphan Park Circle. (DSCN2010). Photographed by D. Esparza

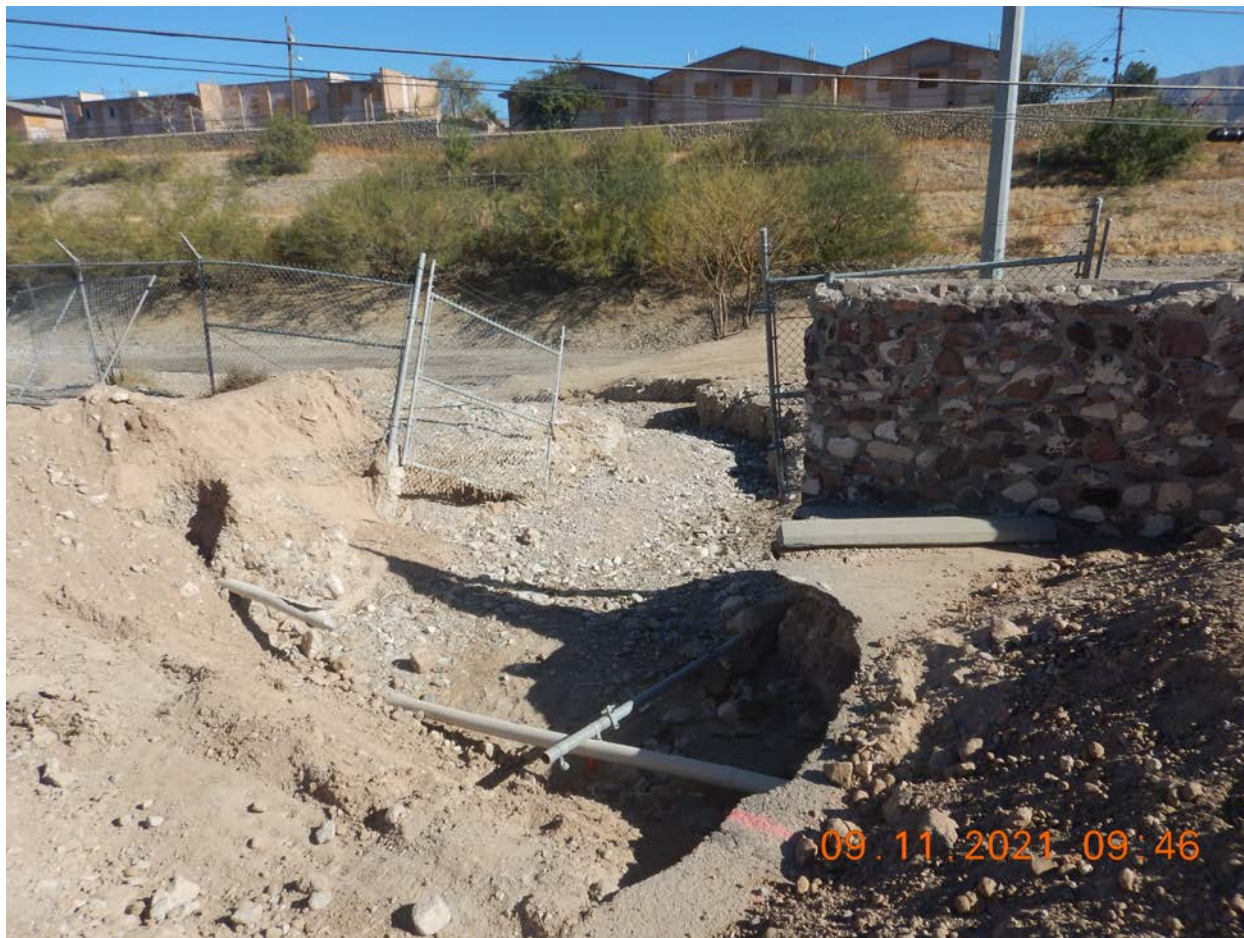
Photo No. 9

- Doniphan Park Circle failure (August 13- August 21) -No signage or public notice was posted near Doniphan Park Circle or at the low-lying impoundments that exhibited significant SSO debris and staining. Additionally, the adjacent wire fabric perimeter fencing was undermined or washed out.

View of the wash-out and undermining of wire fabric fencing. Note: retention pond in previous photograph is located at the right side of this photograph (DSCN2013). Photographed by D Esparza

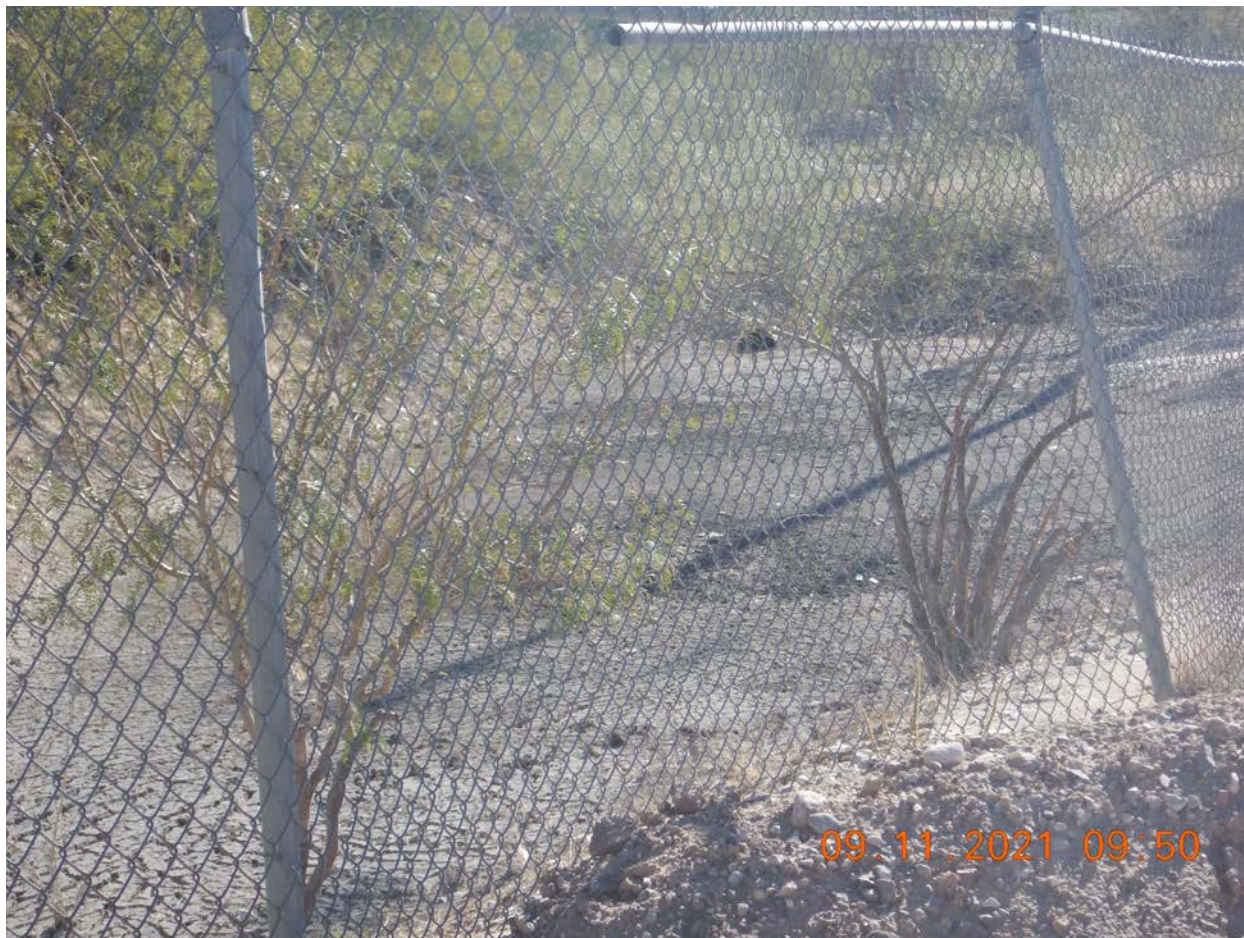
Photo No. 10

View of stressed vegetation located along east side of wire fabric fencing and north of retention pond described in previous photograph. (DSCN2016) Photographed by D. Esparza

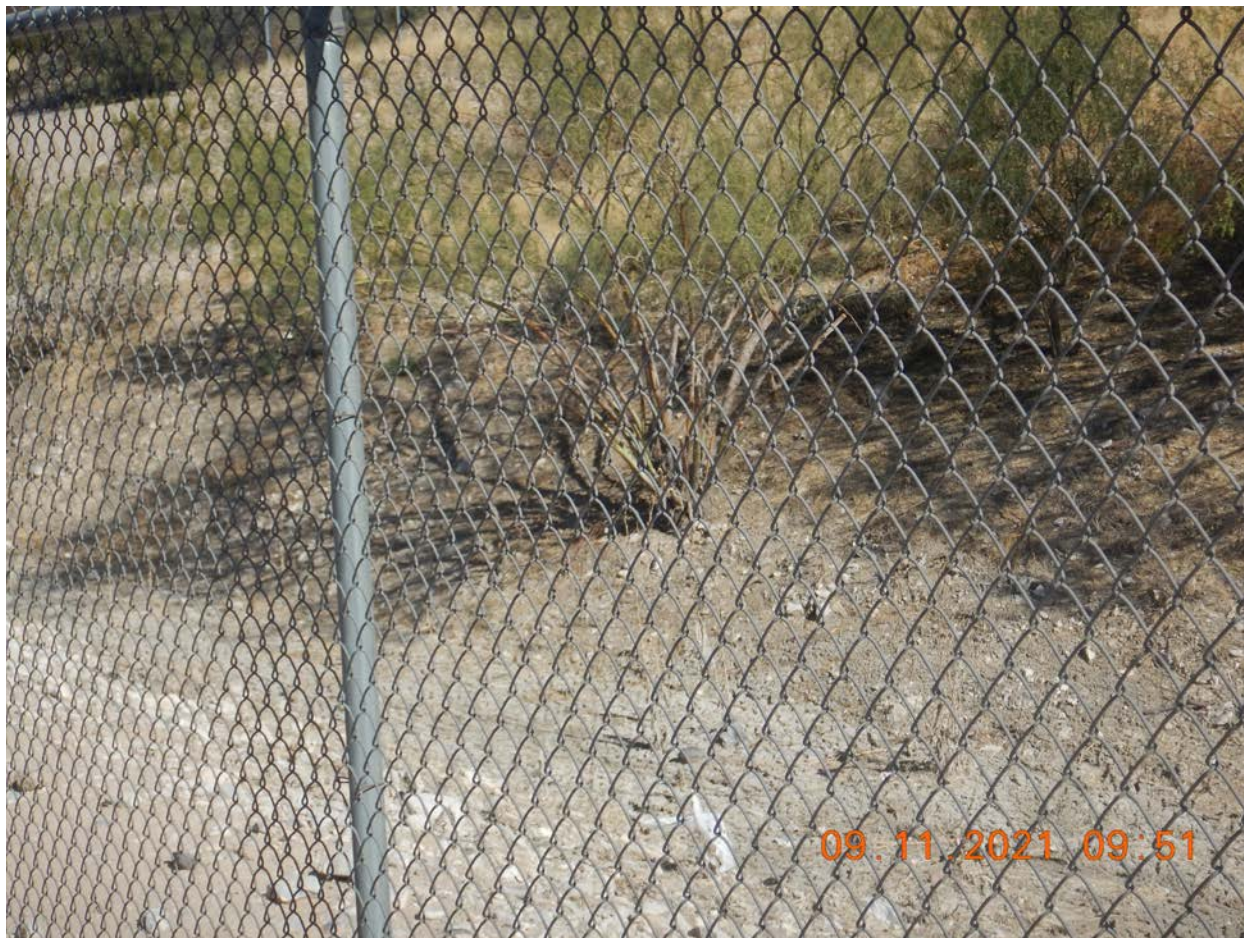
Photo No. 11

Additional view of earthen ditch along east side of wire fabric fencing. Note: stressed vegetation, staining and SSO debris. (DSCN2018) Photographed by D. Esparza

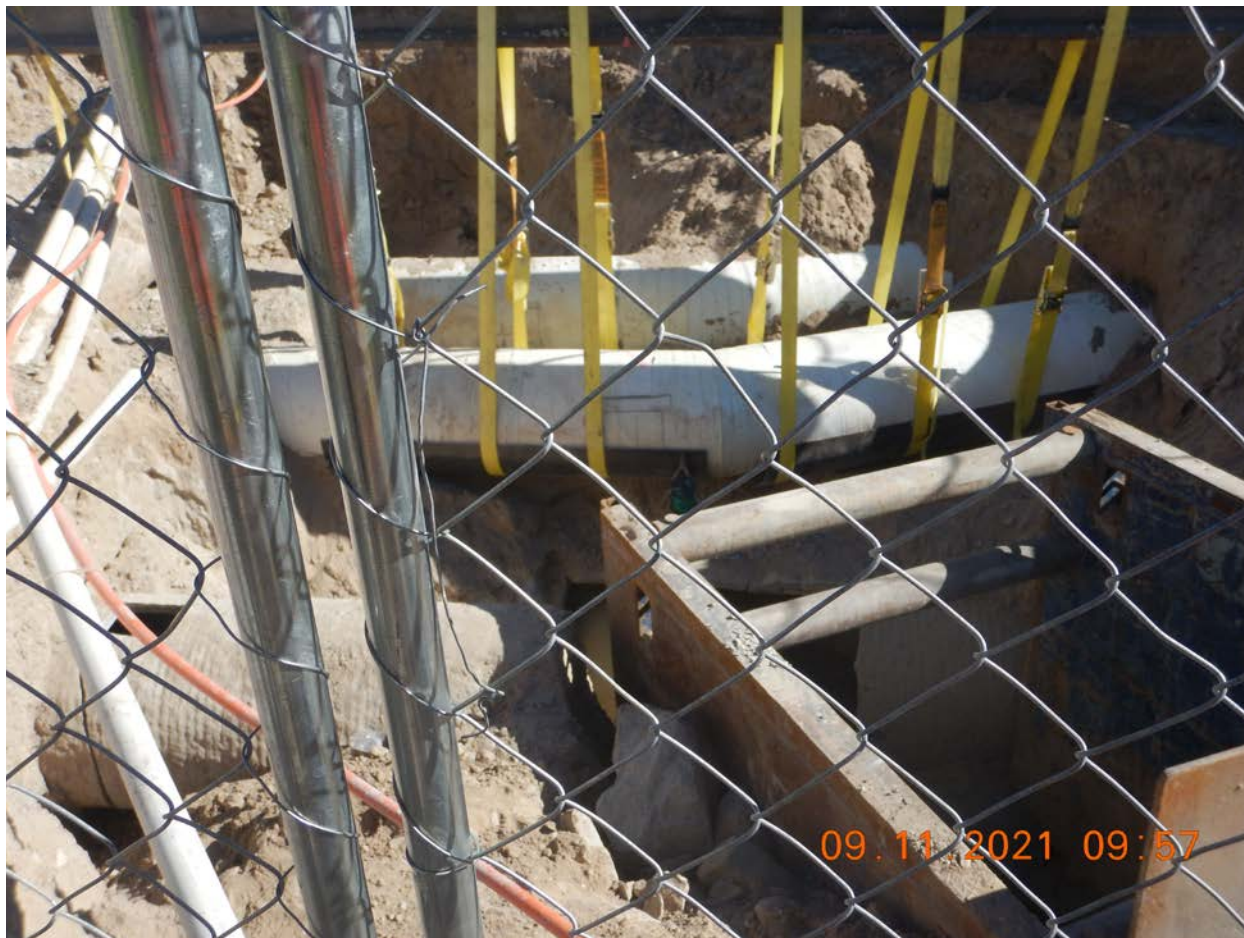
Photo No. 12

- An open excavation exhibited the existing dual 30-inch conduits (Appendix 1 Photograph #12). It was stated the existing lines were to be abandoned. These conduits were intended to act independently from one another and utilize an isolation valve. However, the isolation valve also failed. The new alignment (Appendix 1 Photograph #13) was to utilize an existing abandoned 54-inch water line as a sleeve to hasten replacement (using a slip line method).

View of existing dual 30-inch collection lines. Note: it was stated these dual lines are to be abandoned. (DSCN2020). Photographed by D. Esparza

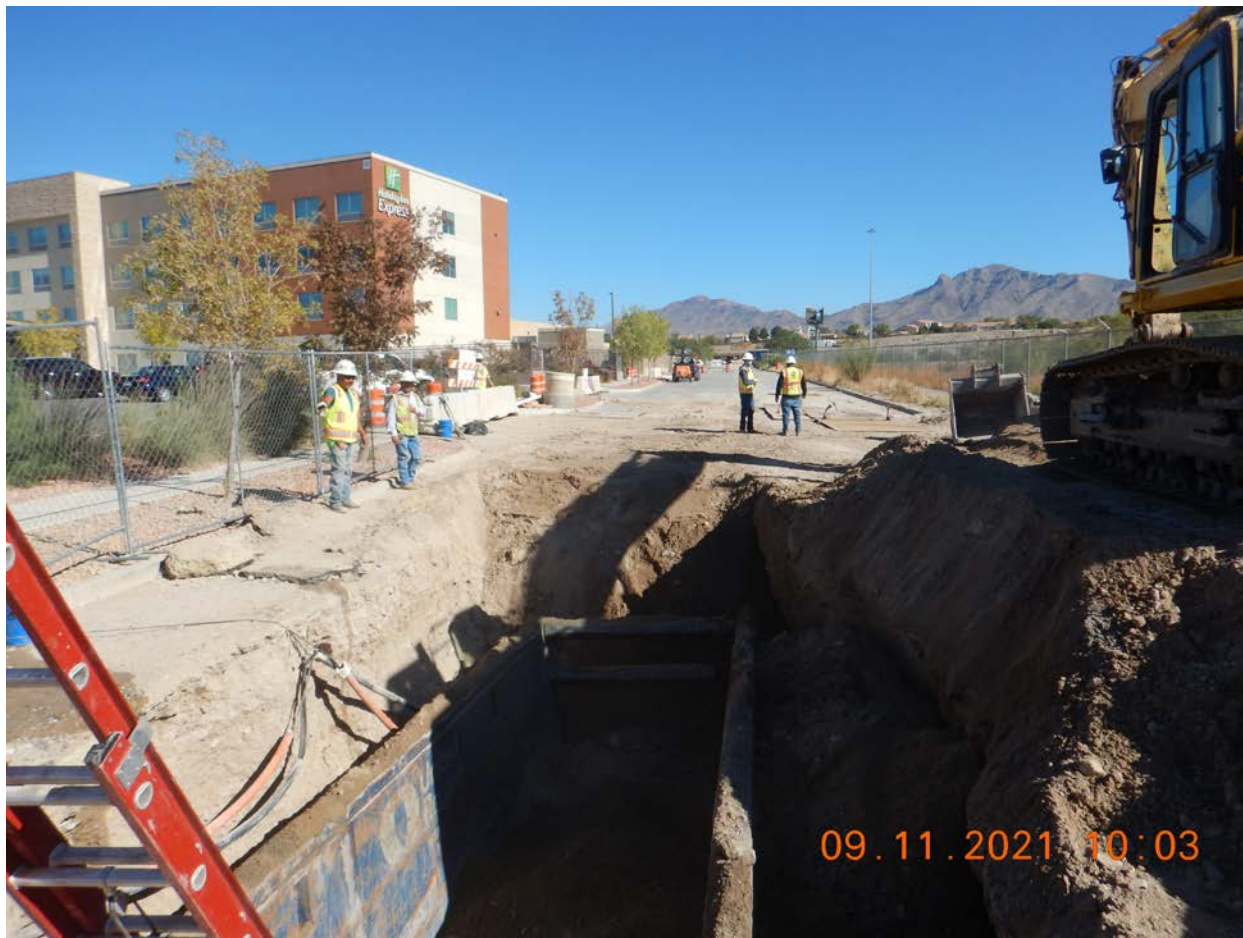
Photo No. 13

View of open excavation in the vicinity of the new alignment utilizing an existing abandoned 54-inch water line and a "slip line method" of placement to hasten replacement. (DSCN2024). Photographed by D. Esparza

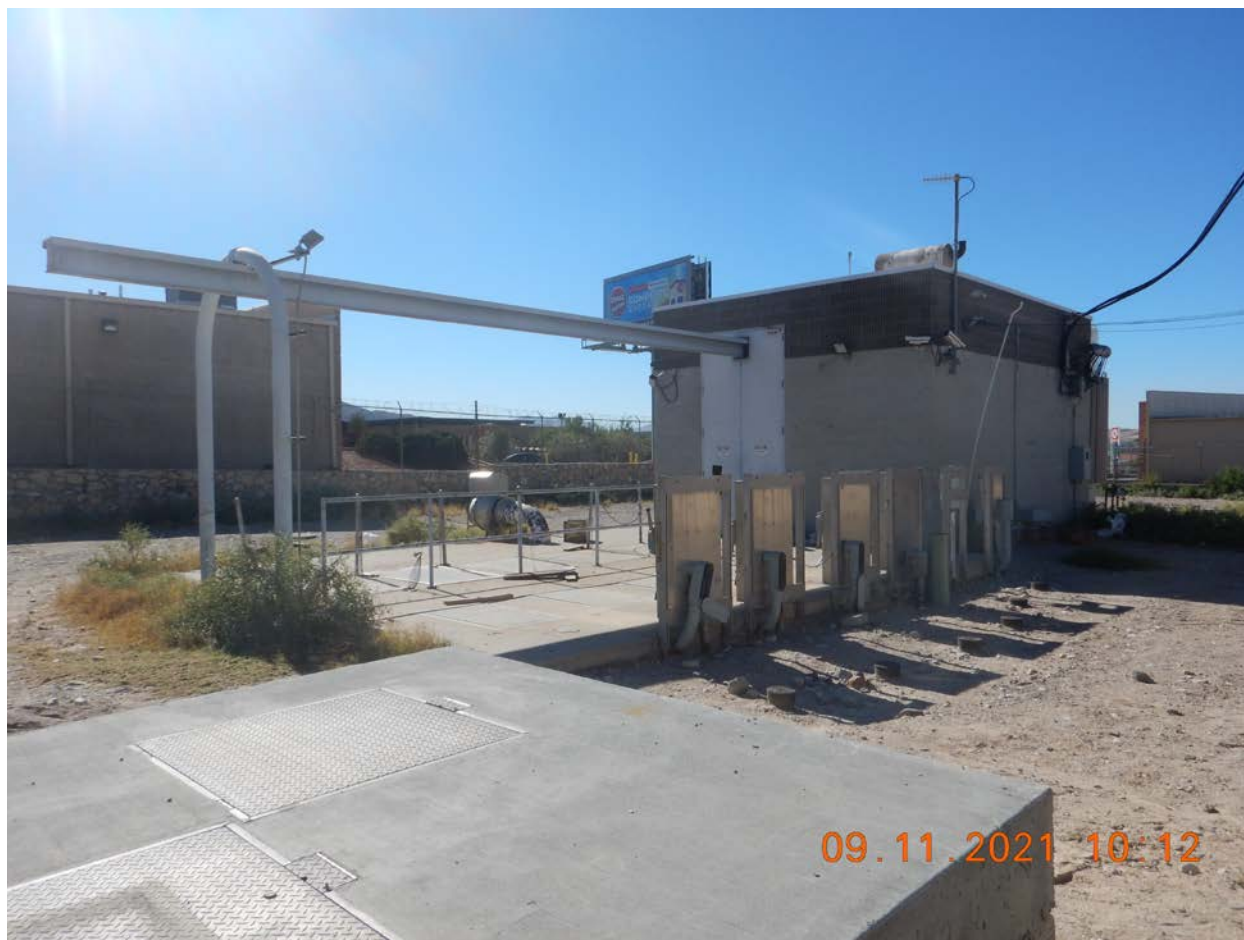
Photo No. 14

View of the Sunland Park Lift Station located west of the Doniphan Park Circle dual 30-inch force main failure. (DSCN2025). Photographed by D. Esparza

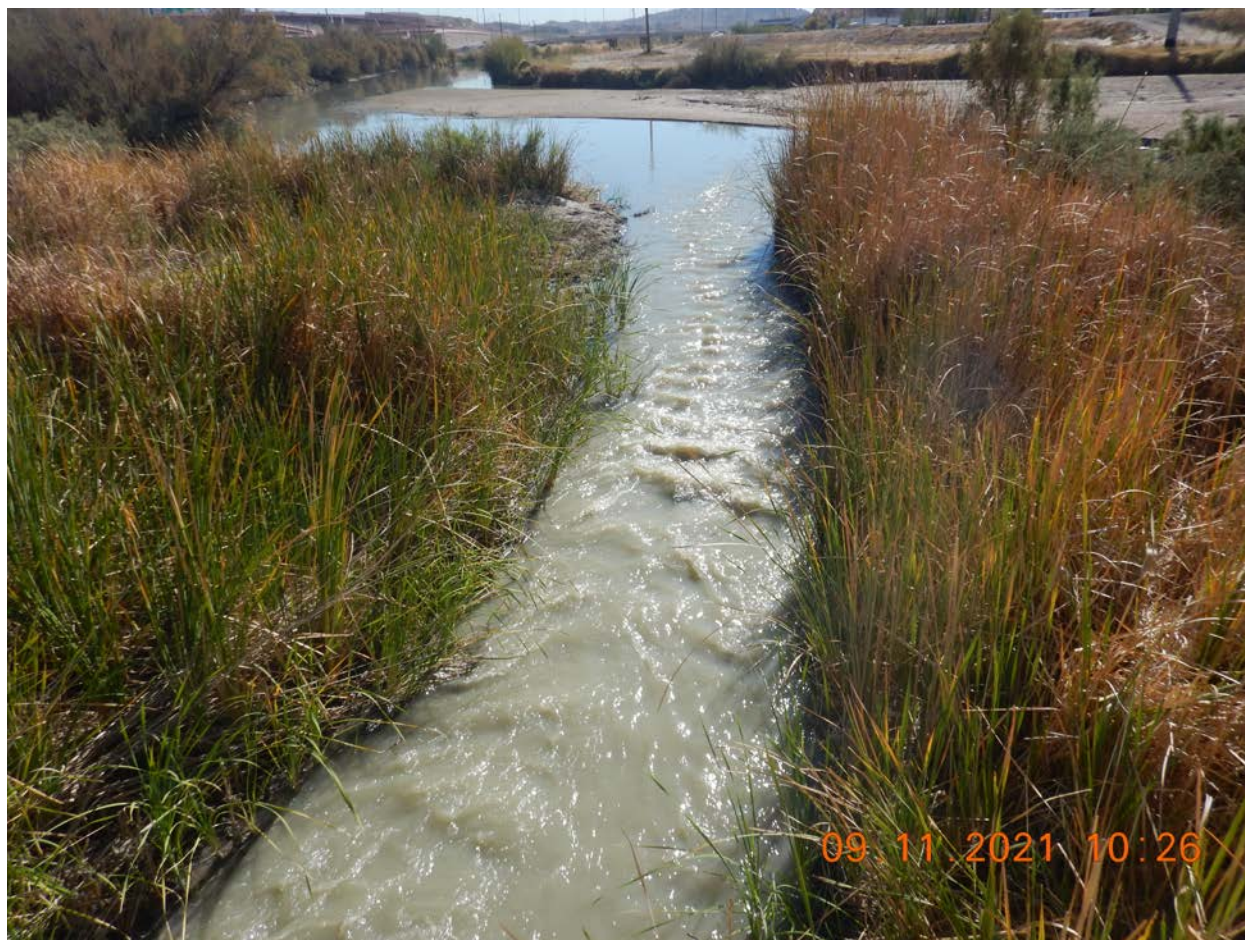
Photo No. 15

- Observation of SSO flow into the Rio Grande near the Rio Grande Power Station (3501 Doniphan Drive) (Appendix 1 Photograph #15, and Photograph #16). Note: this structure is in Sunland Park, New Mexico, though the outfall to the Rio Grande is in Texas. The SSO flows traverse into the Rio Grande and downstream past the Courchesne Bridge (approximately 800-feet) (Appendix 1 Photograph #17, Photograph #18, and Photograph #19).

- Observation of SSO flow into Rio Grande near the vicinity of the Rio Grande Power Station (3501 Doniphan Drive). (Appendix 1 Photograph #15 and Photograph #16). Note: this power station structure is in Sunland Park, New Mexico, though the outfall is in Texas. The SSO flows traverse into the Rio Grande and downstream past the Courcesne Bridge (approximately 800-feet) (Appendix 1 Photograph #17, Photograph #18, and Photograph #19); thus, potentially impacting the State of Texas, New Mexico, and Republic of Mexico.

View of SSO flow into Rio Grande in the vicinity of the Rio Grande Power Station (3501 Doniphan Drive). (DSCN2030). Photographed by D. Esparza

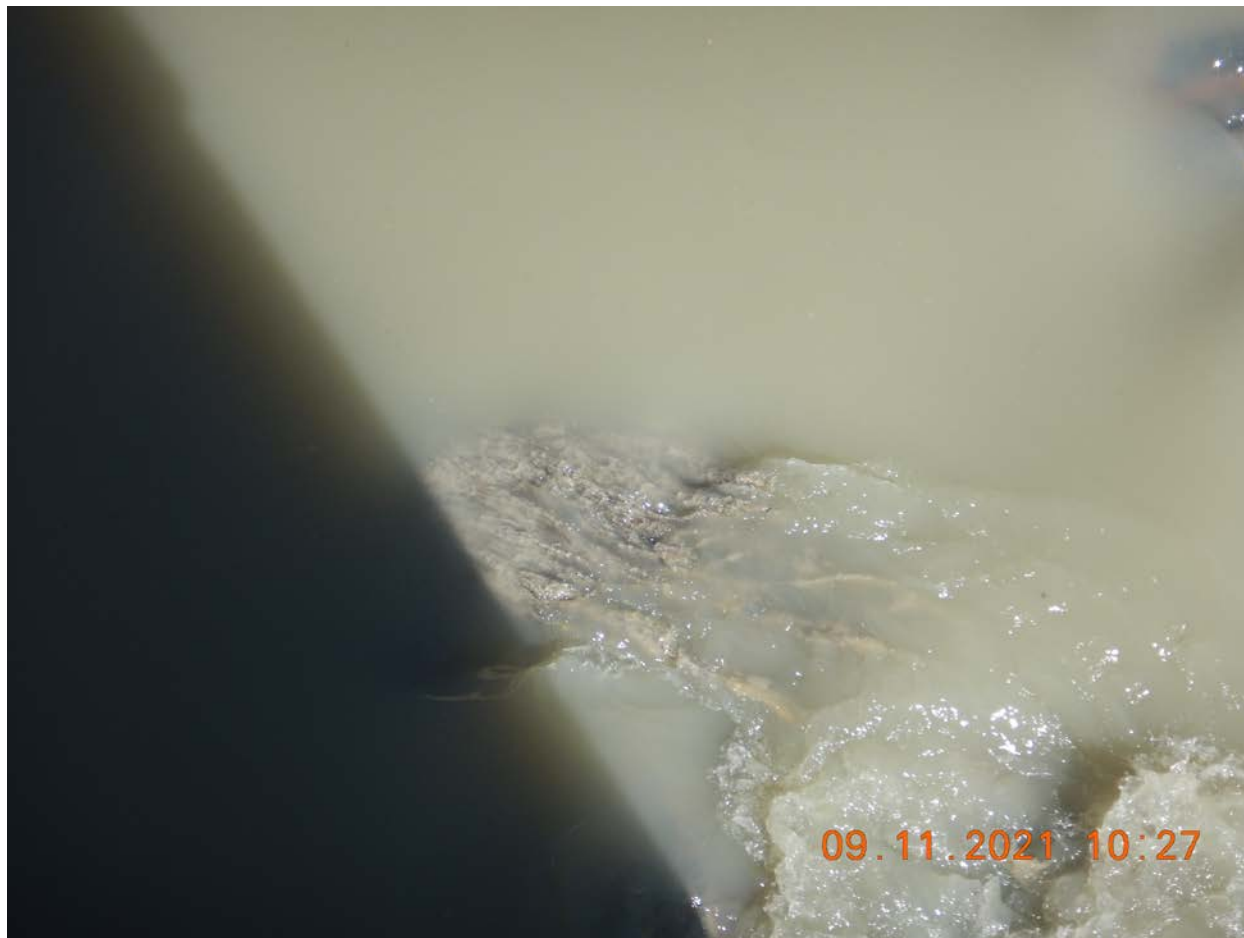
Photo No. 16

View of SSO flow into Rio Grande at outfall. Note: SSO debris in approximate center of photograph. (DSCN2032) Photographed by D. Esparza

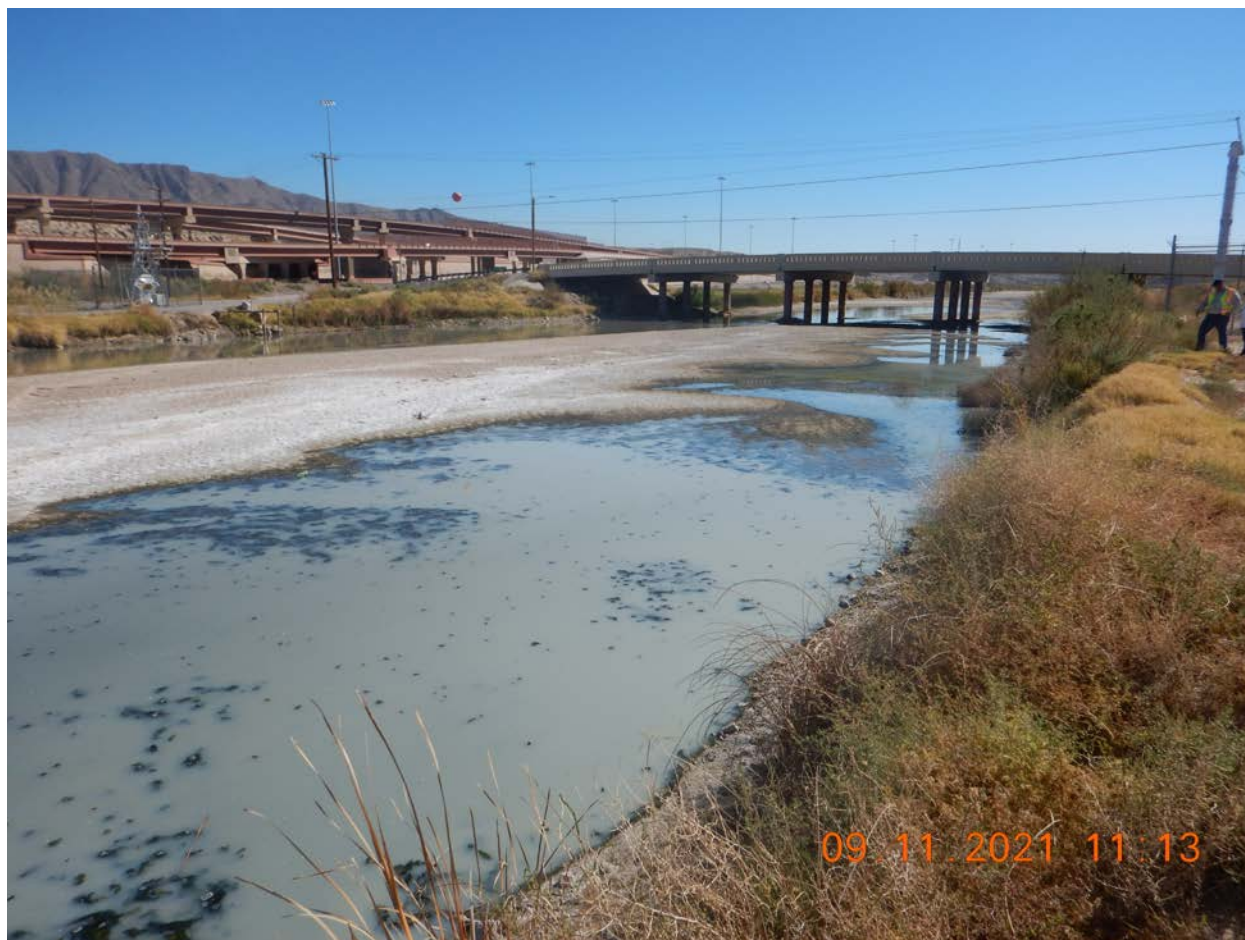
Photo No. 17

View of SSO flows within the Rio Grande standing along the west side. Note: visible growth of algal blooms and pungent aromatics. The Courchesne Bridge is located approximately 800-feet south of the outfall. (DSCN2046) Photographed by D. Esparza

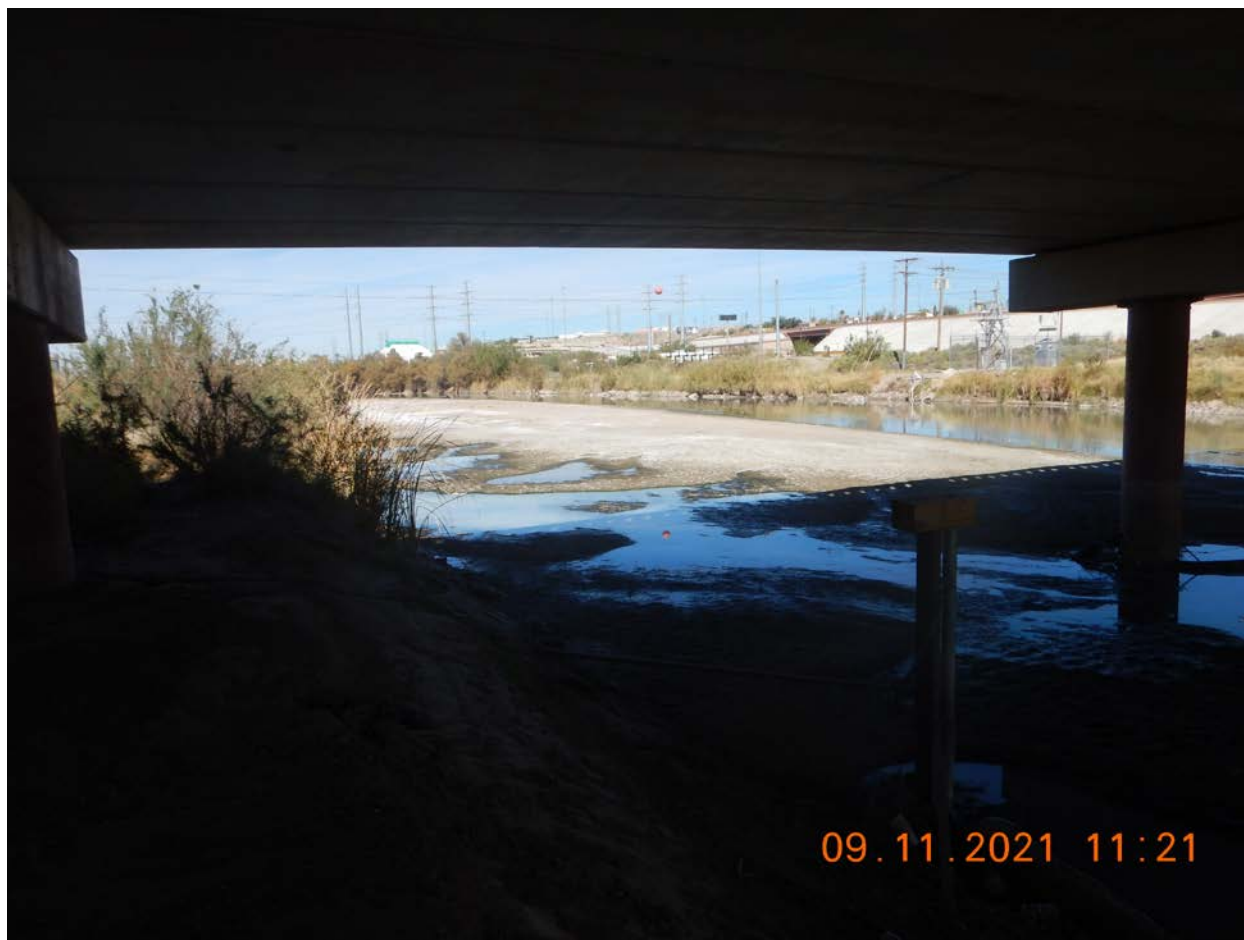
Photo No. 18

View beneath the Courchesne Bridge looking towards the approximate north. (DSCN2048)  
Photographed by D. Esparza
