**Region 6 - Enforcement & Compliance Assurance Division**  
**INSPECTION REPORT**

| Inspection Date(s): | 11/09/2021 (updated 12/27/2021 and 2/07/ 2022) | |
| Company Name: | <b>El Paso Water Utilities</b> | |
| Facility Name: | <b>John T. Hickerson WWTF - Frontera Lift Station</b> | |

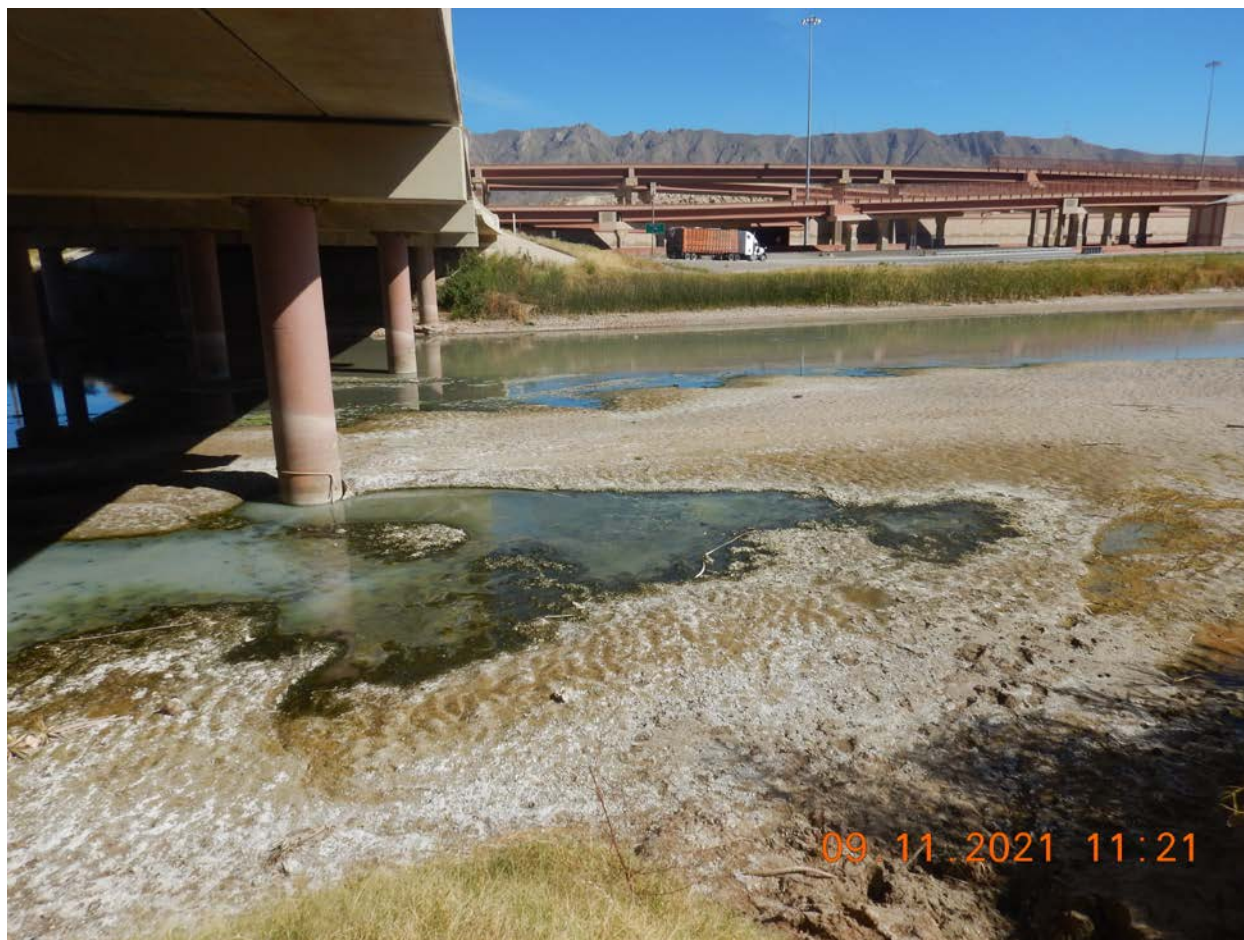
Photo No. 19

View of Rio Grande from the approximate southside of the Courchesne Bridge. Note: the visible ponding, staining, and stressed vegetation. (DSCN2049) Photographed by D. Esparza

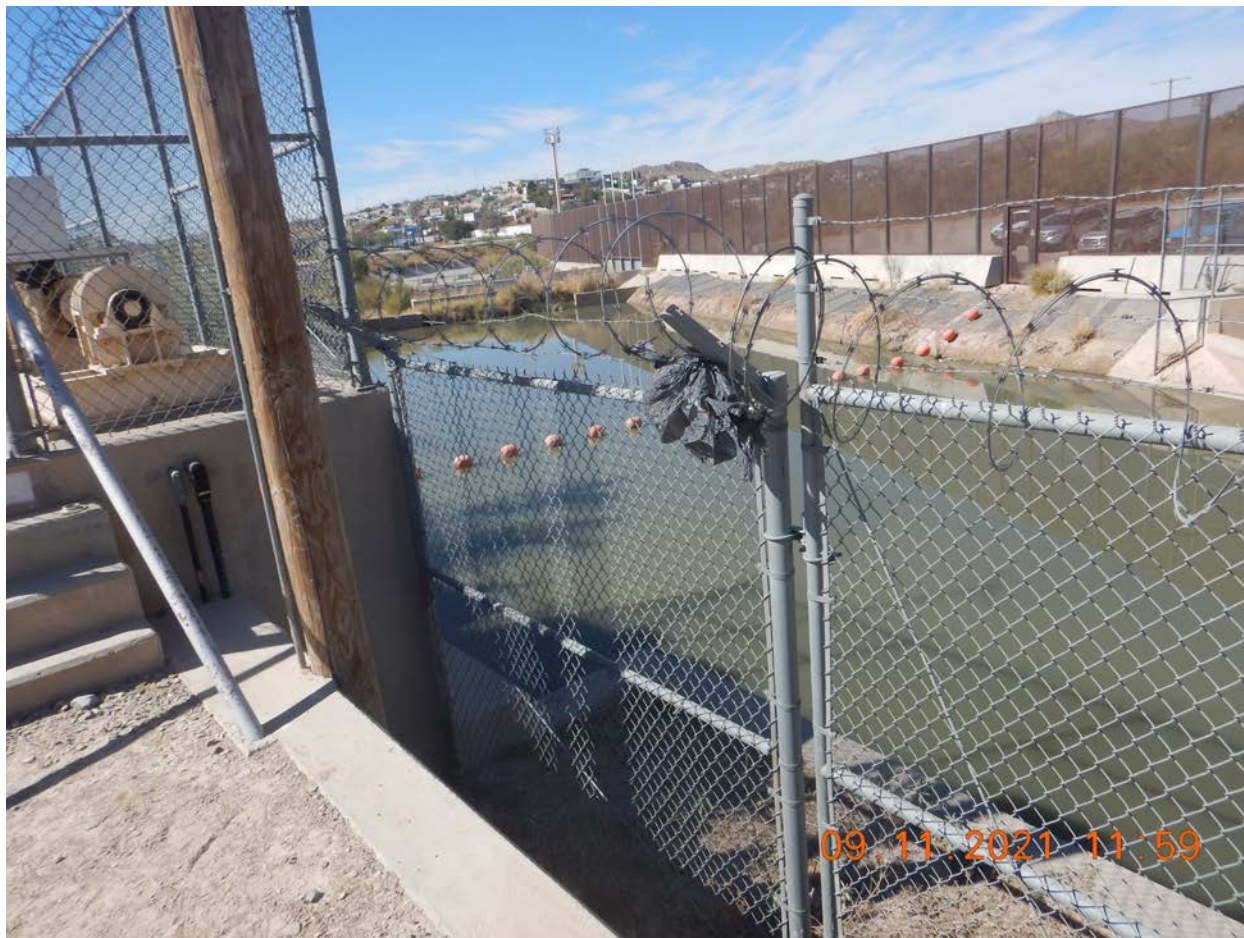
Photo No. 20

- A portion of the SSO flow is diverted from the Rio Grande into the concrete lined American Canal at the American Dam (approximately 1.5-miles downstream from the Rio Grande entry point (Appendix 1 Photograph #20) for treatment at the Hickerson WWTP.

View of SSO flow within the American Canal at the American Dam. Note: this location is approximately 1.5-miles downstream of the SSO flow entry point into the Rio Grande. (DSCN2056) Photographed by D. Esparza

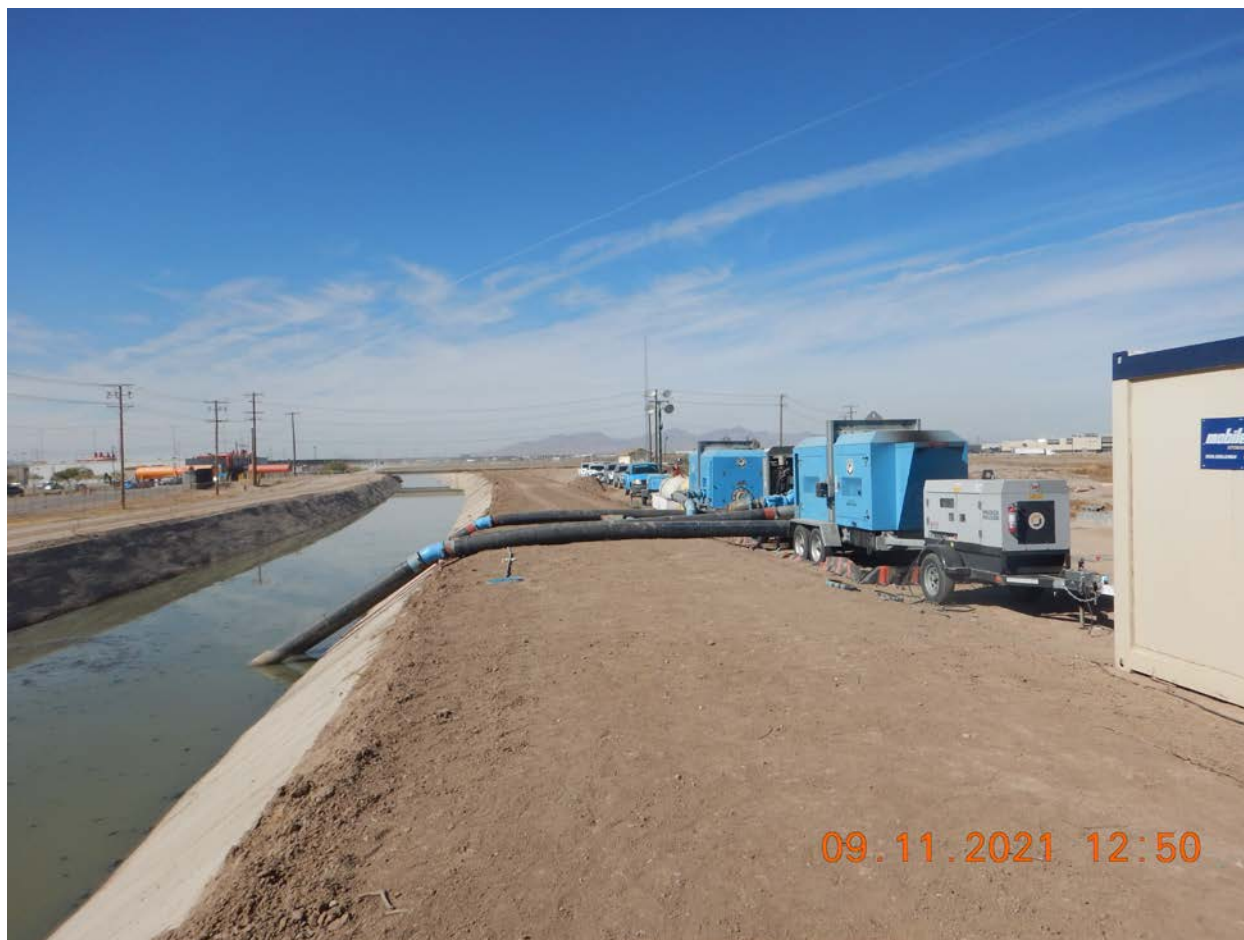
Photo No. 21

- The SSO flow was being diverted from the Riverside Canal via pumps at approximately 7MGD into two (2) closed conduits; thence into 2 manholes that flow into the Bustamante WWTP for treatment (approximately 20-miles downstream) (Appendix 1 Photograph #21, Photograph #22) and discharge at the outfall (Appendix 1 Photograph #23). El Paso constructed an earthen berm within the Riverside Canal to expedite the effectiveness of the pumping equipment (Appendix 1 Photograph #24).

View of temporary pumps within the Riverside Canal extracting SSO flow for treatment at the Roberto Bustamante WWTP. Note: these two (2) mobile pumps are operating at approximately 7MGD and are located some 20-miles downstream. (DSCN2062) Photographed by D. Esparza

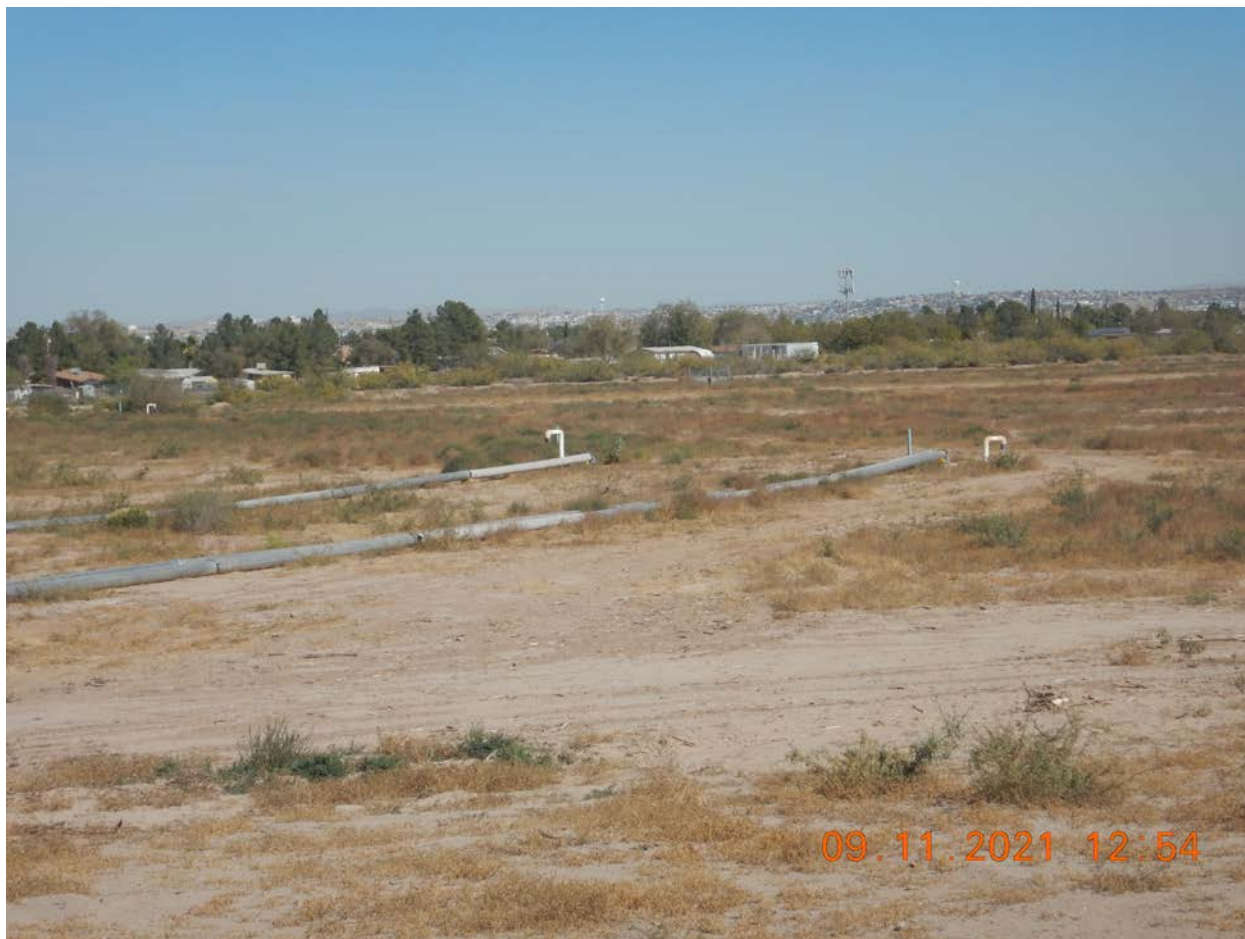
Photo No. 22

View of temporary above ground by-pass piping used in conjunction with mobile pumps in previous Photograph #21. This piping discharges into two (2) manholes that flow into the Roberto Bustamante WWTP for treatment. (DSCN2064). Photographed by D. Esparza

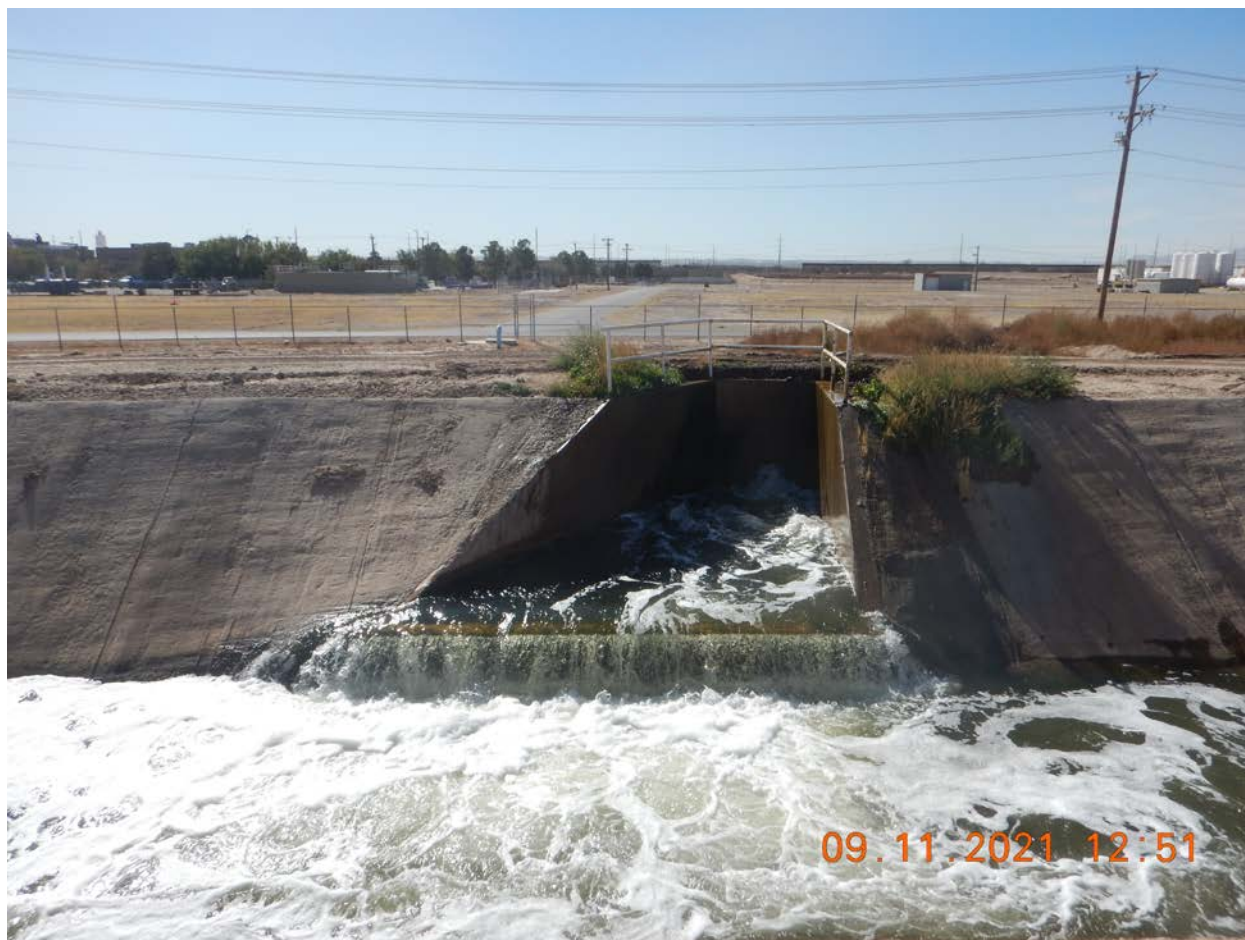
Photo No. 23

View of outfall from the Roberto Bustamante WWTP. (DSCN2063) Photographed by D. Esparza

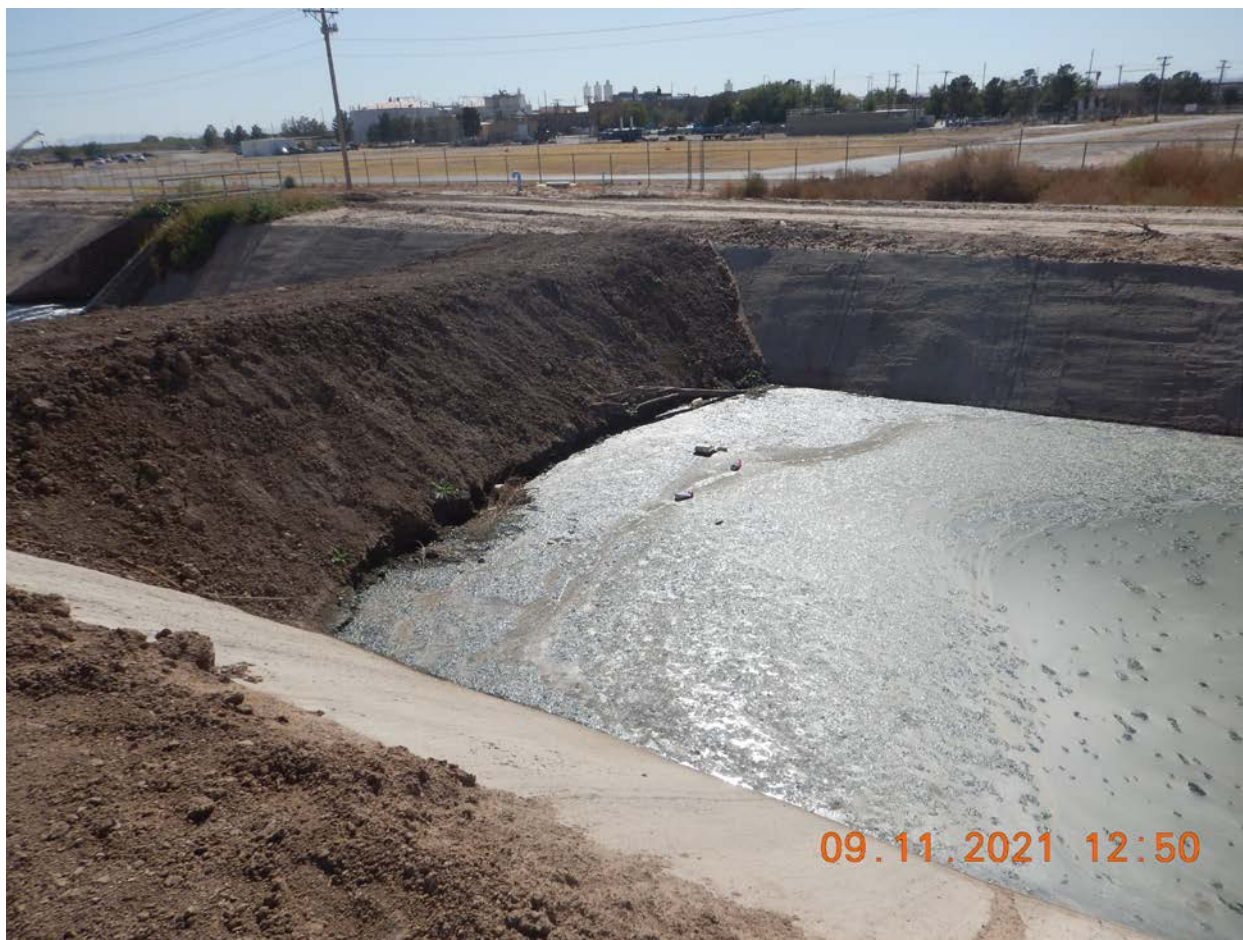
Photo No. 24

View of earthen berm constructed by El Paso Water within the Riverside Canal to expediate the effectiveness of the pumping equipment. The Roberto Bustamante WWTP outfall is in the approximate center left of the photograph. (DSCN2060). Photographed by D. Esparza

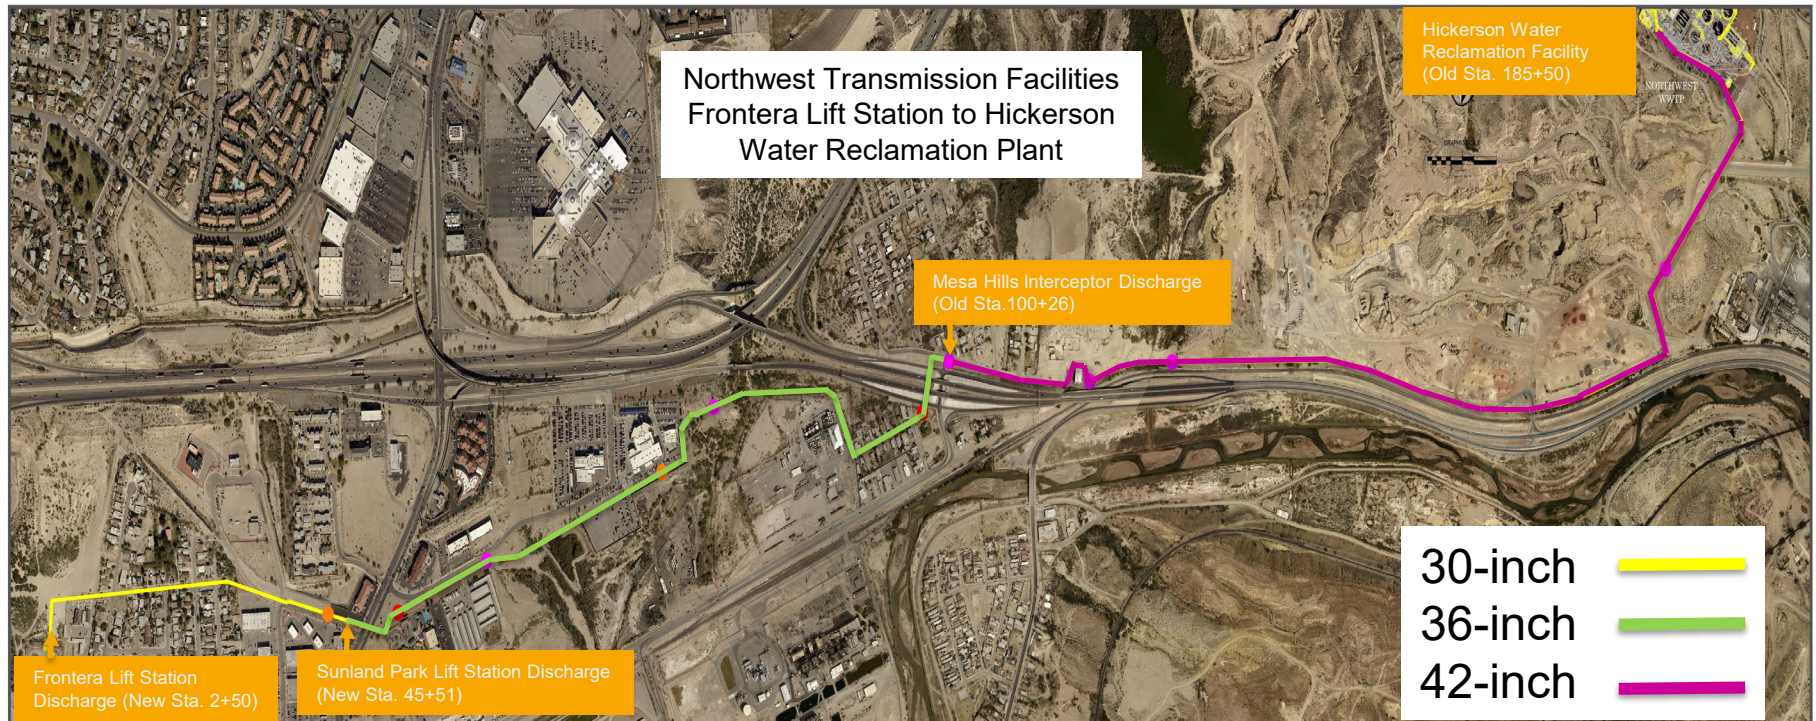
# Frontera Force Mains and Sunland Park Lift Station

- **1. Frontera Force Main (FFM) Collection System Schematic Info (pdf)- a “line” type drawing with identifying colors delineating the transition from the stated 30-inch to 36-inch to 42-inch from the beginning of project (BOP) (Sta 0+00) to end of project (EOP), with Station point noted**
