**Region 6 - Enforcement & Compliance Assurance Division**  
**INSPECTION REPORT**

| Inspection Date(s): | 06/08/2023 | |
| Company Name: | Oshara Mutual Domestic Wastewater Association | |
| Facility Name: | Oshara Village Water Reclamation Facility | |

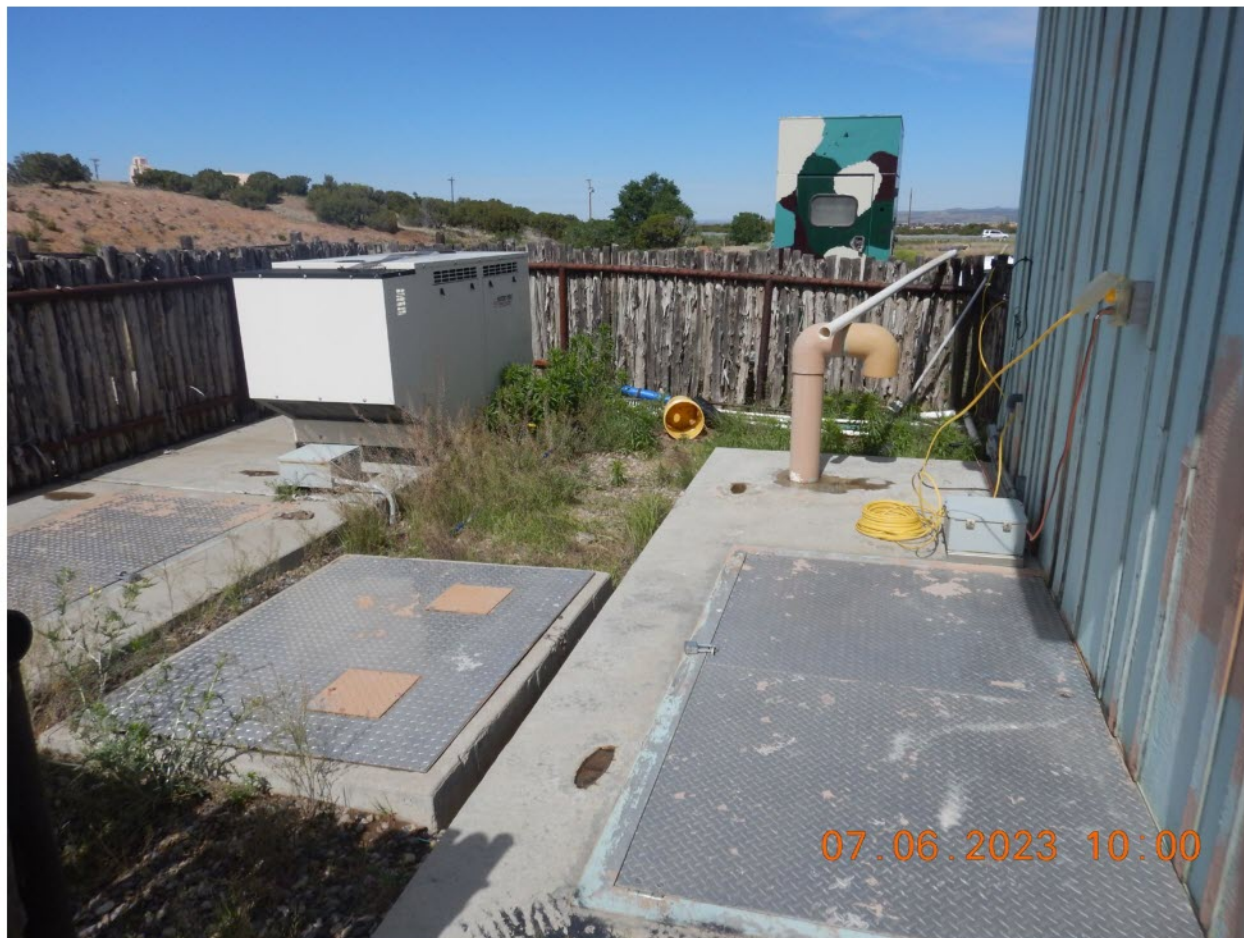
Photo No. 1

- Extensive vegetative overgrowth throughout the facility area was visible, which could potentially attract rodents and/or vermin; thus, causing undermining of the facility structures.
- There are two (2) back-up generator onsite, but their operational status is unknown.
- No facility personnel were onsite and locked doors prevented ready access.

View of the Water Reclamation Facility treatment process equipment located in below ground locked hatchways along the approximate south side of the locked building. Note: the back-up generator, the extensive vegetative overgrowth and inside view of perimeter fencing. (DSCN2540) Photographed by D. Esparza

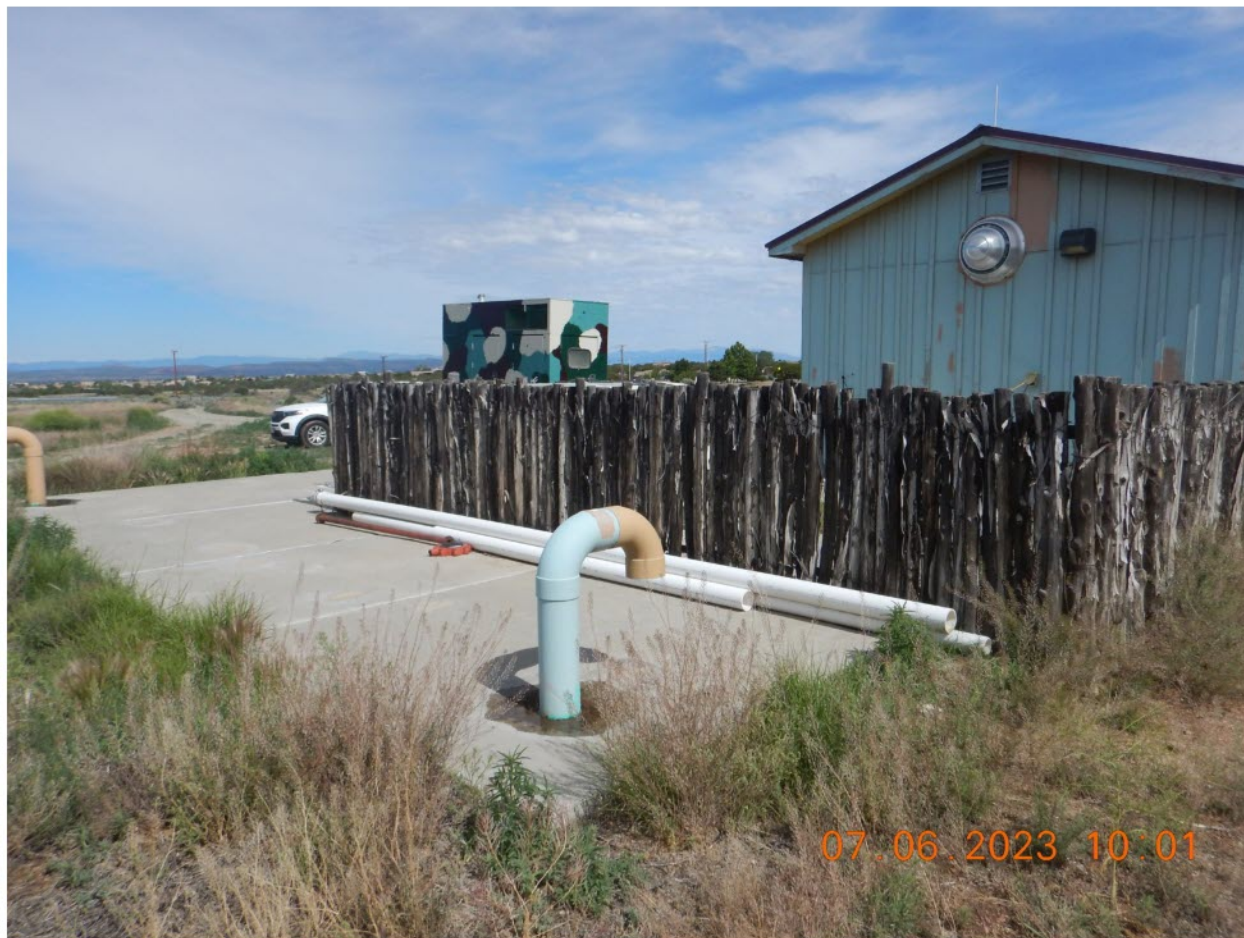
Photo No. 2

Note the additional back-up generator, the extensive vegetative overgrowth and outside view of perimeter fencing looking approximately Northeast. (DSCN2542) Photographed by D. Esparza

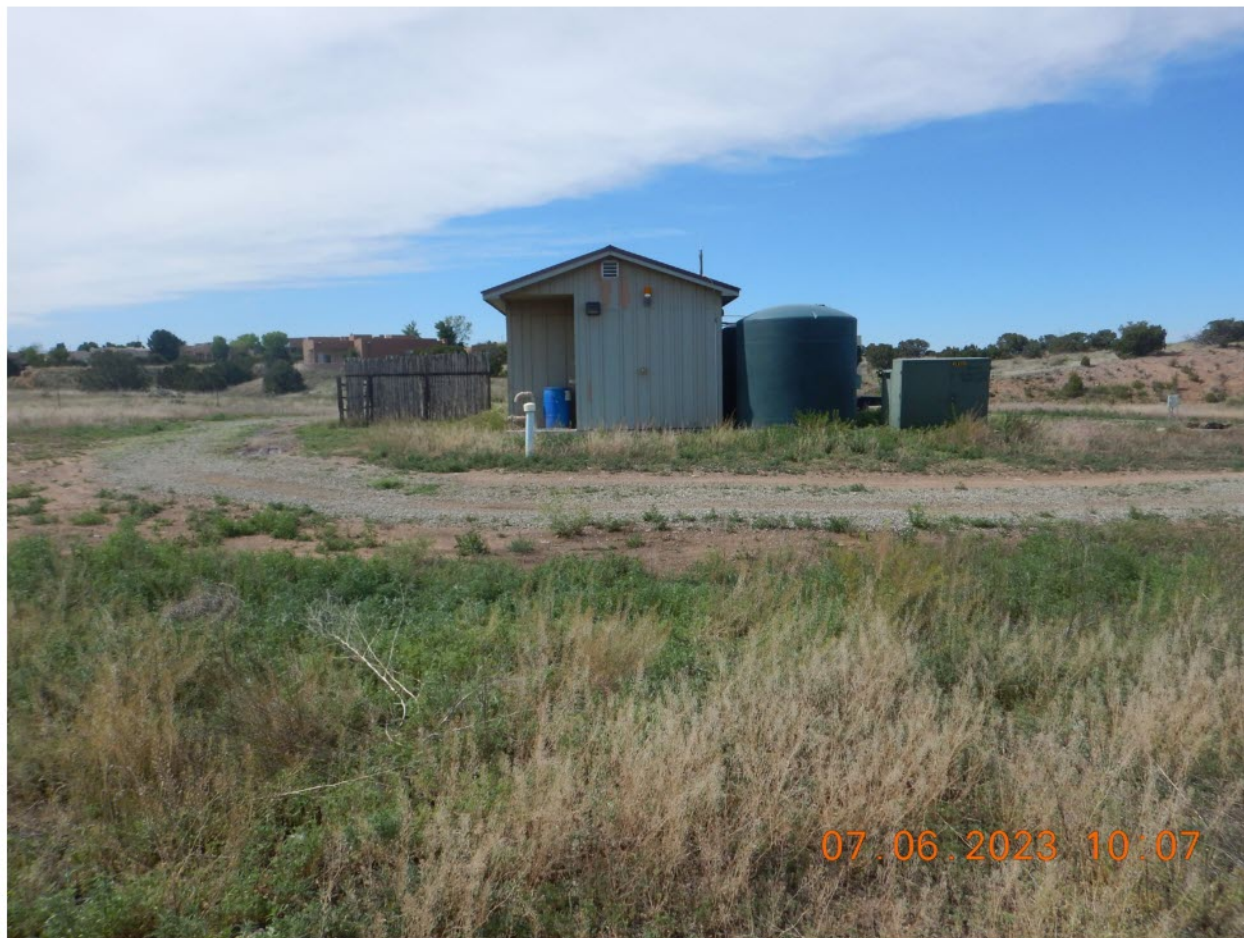
Photo No. 3

View of the Operators Building and electrical transformer looking approximately South and indicated on Frachetti Site Plan (**Appendix 3 Oshara Village Site Plan**). What is not defined or described is the poly-tank. (DSCN2546) Photographed by D. Esparza

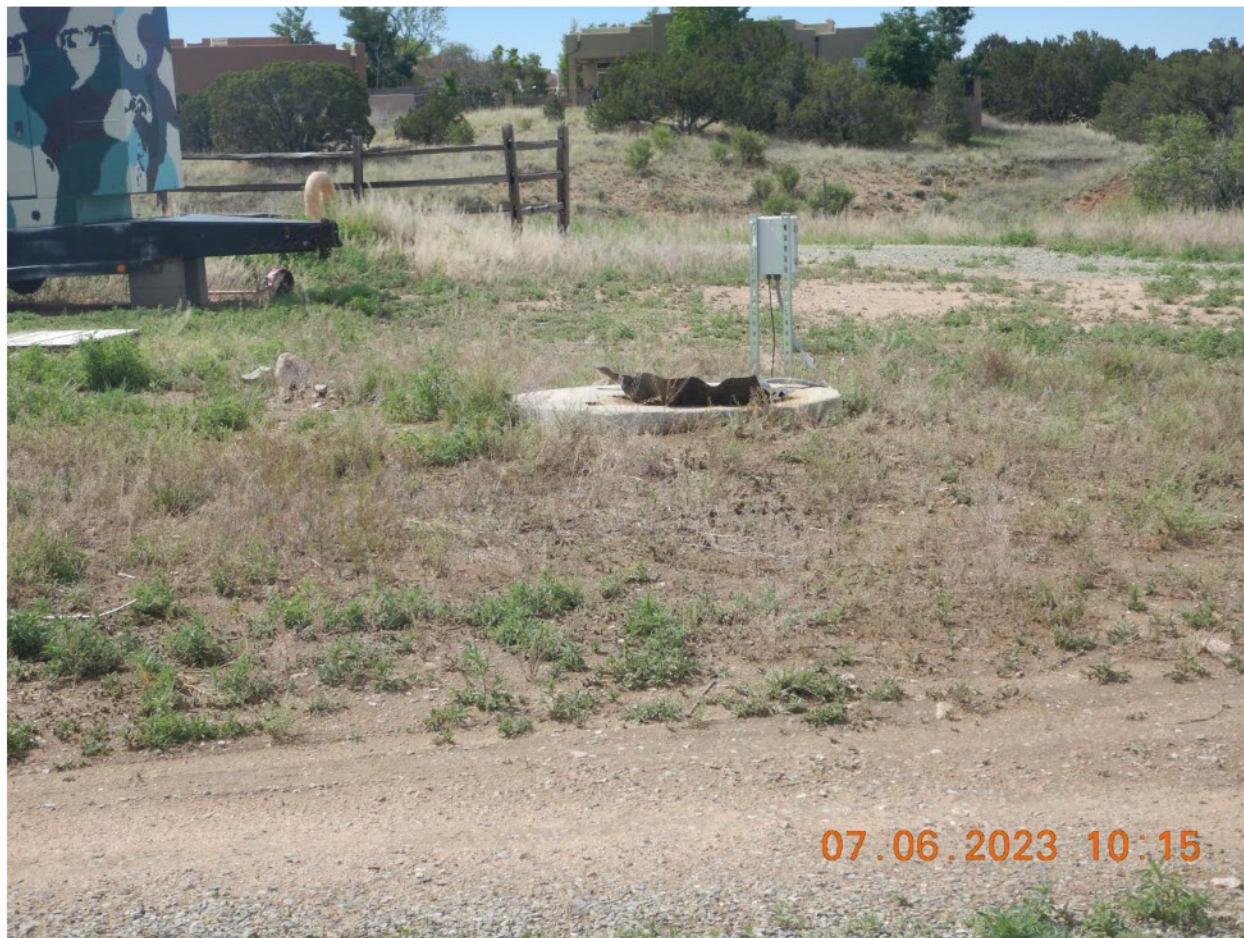
Photo No. 4

View of the adjacent wet well located at the approximate Northwest corner of the Operators Building. Note: the lack of perimeter fencing and vegetative overgrowth. (DSCN2551) Photographed by D. Esparza

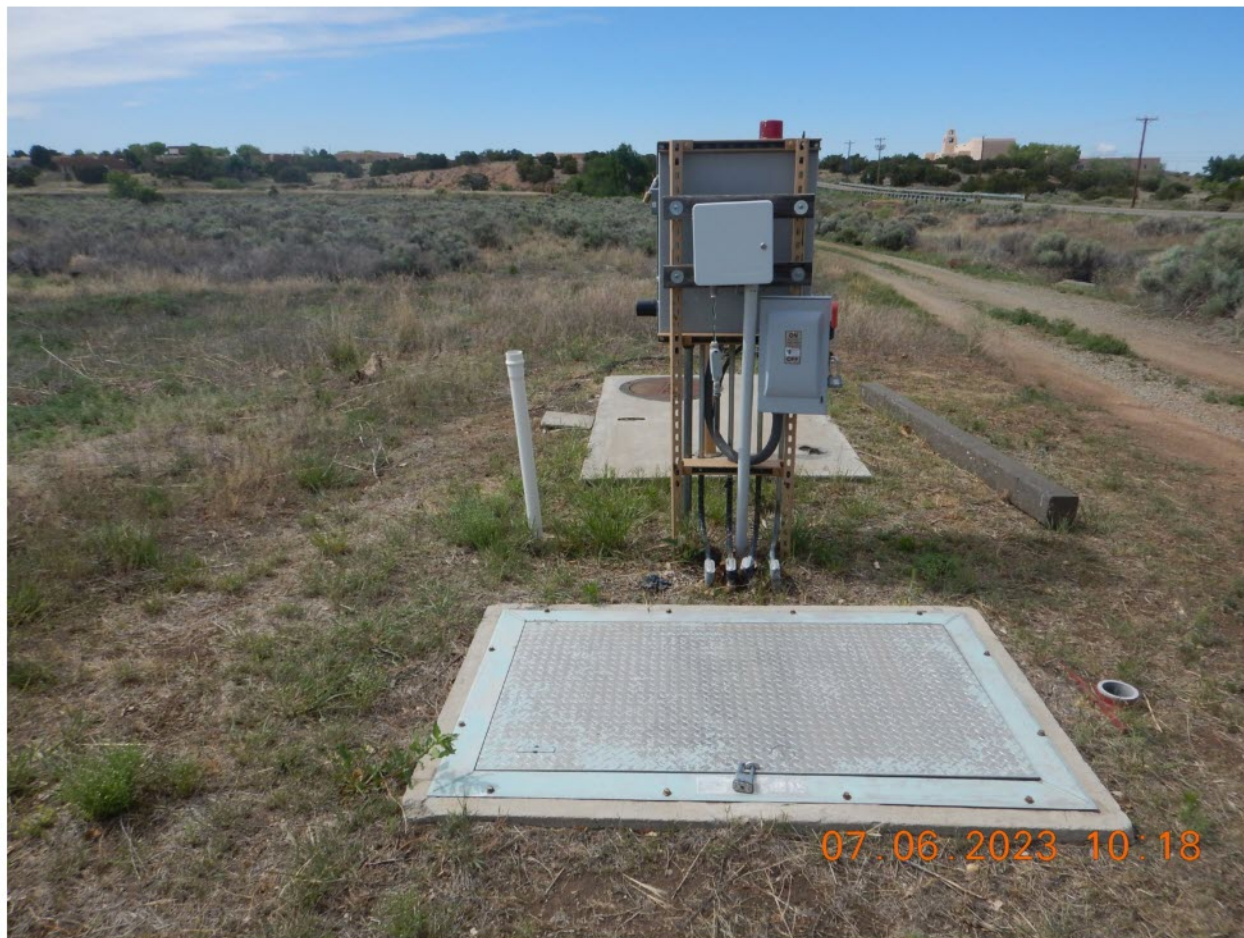
Photo No. 5

View of the Oshara Village WRF individual lift station located approximately 600-feet Northwest the WRF Facility. Note: the lack of perimeter fencing and the locked hatchway. (DSCN2552) Photographed by D. Esparza

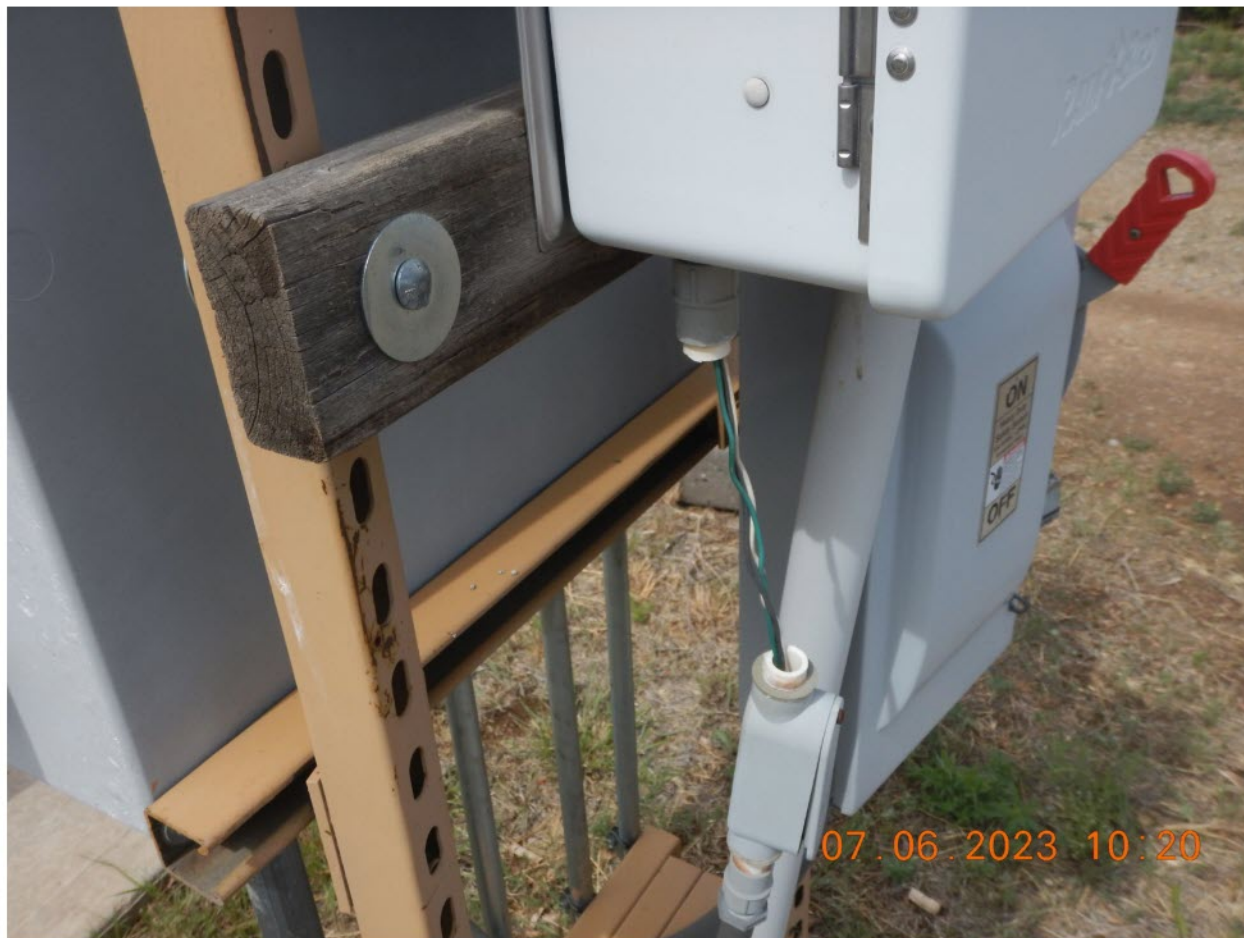
Photo No. 6

View of the Oshara Village WRF individual lift station electrical box. Note: the exposed wiring (no conduit). (DSCN2556) Photographed by D. Esparza
