INSPECTION REPORT

| Type of Inspection | Compliance Evaluation Inspection (CEI) | | |
| Company Name | Phillips 66 Company | | |
| Facility or Site Name | Phillips 66 Co Ferndale | | |

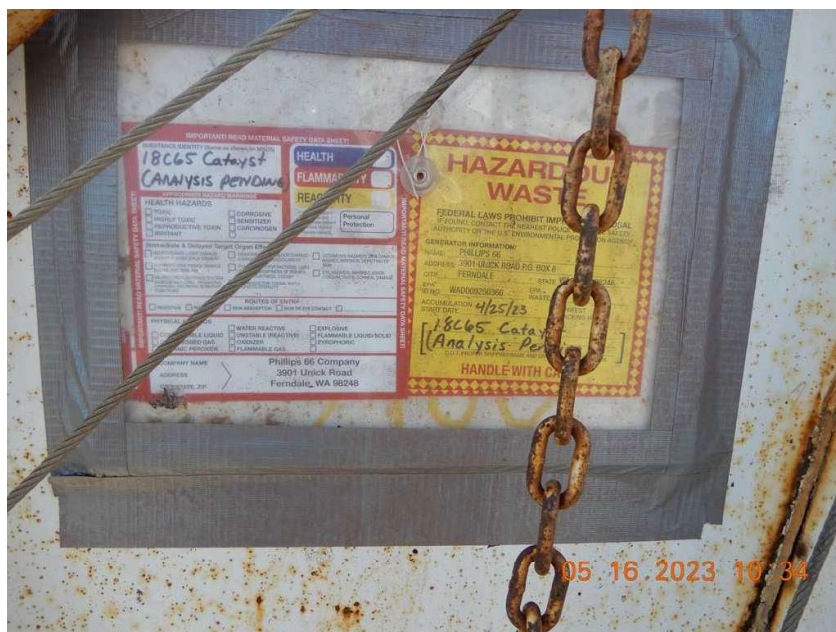
| [Title] | | | DSCN0673.JPG |

We also saw a 20 cubic yard roll-off container that was labeled "Pending Analysis" and dated 4/25/23. At the time of the inspection, the roll-off container was marked with a hazardous waste label and National Fire Protection Association (NFPA) hazard/risk label but was not closed. There were clear gaps between the lid and the top of the roll-off. There was foam sealant between the lid and the roll-off that had been applied, in an attempt to seal the lid; however, some of the foam sealant was no longer in place and caused gaps between the lid and the roll-off. During the inspection, we asked for a copy of the analytical results.

| Close-up view of the gap between the lid and the top of the 20 cubic yard roll-off, showing that the roll-off container is not closed. | | | |

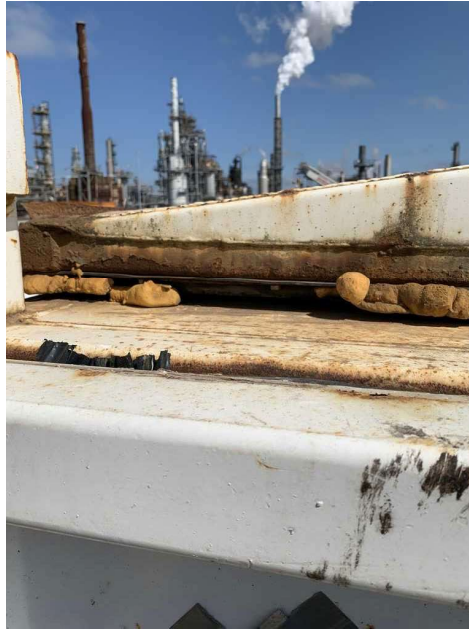
| [Title] | | | IMG_1019.jpg |

| View of hazardous waste label on roll-off pending analysis of 18665 catalyst in permitted storage area. | | | |

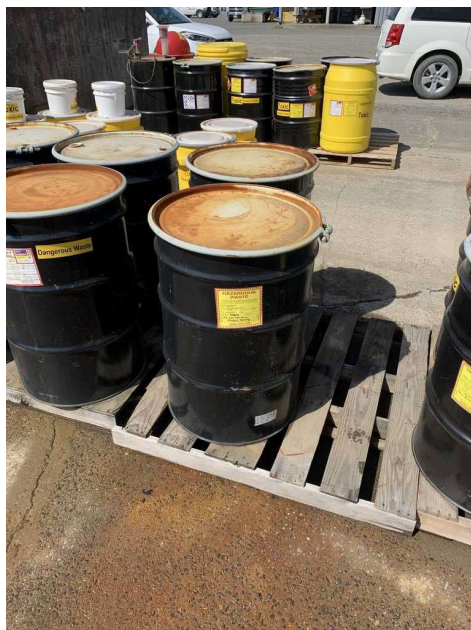
| [Title] | | | IMG_1021.jpg |

We also saw two 55-gallon containers that were labeled as hazardous waste but were not marked with hazard/risk indicators. One of the containers was marked as being "4D 200 Material" dated 9/28/22 and the other was marked as "Orifice chamber catalyst - pending analysis" dated 9/29/22. I explained that wastes designated as "Pending Analysis" were required to be labeled or marked with a hazard/risk indicator and the words "Hazardous Waste." I went on to say that if they did not know what the hazard/risk was associated with the waste, they should apply a hazard/risk marking associated with what they are having the waste tested for, such as "Toxic" if they're running Toxicity Characteristic Leaching Procedure (TCLP) or "Ignitable" if they are running flashpoint.

| View of 55-gallon waste storage container that is not marked with a hazard/risk indicator. | | | |

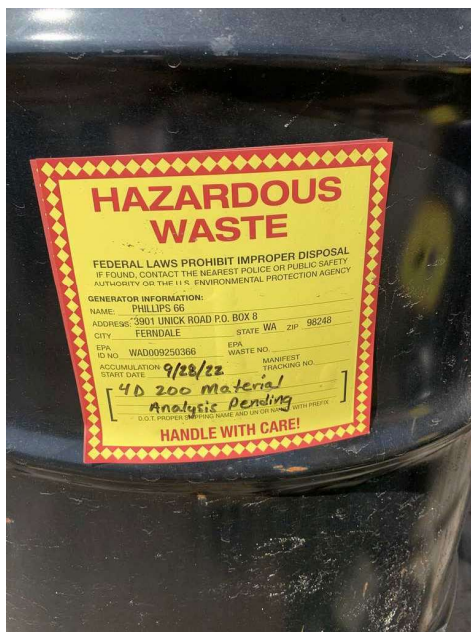
| [Title] | | | IMG_1022.jpg |

| View of 55-gallon waste storage container that is not marked with a hazard/risk indicator. | | | |

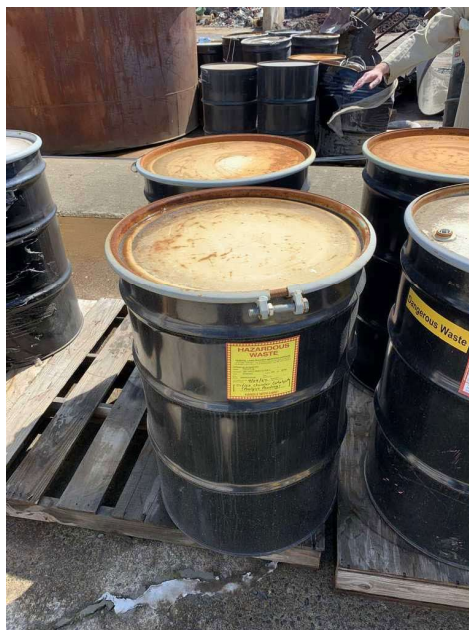
| [Title] | | | IMG_1023.jpg |

| Close-up view of the label on the 55-gallon waste storage container that is not marked with a hazard/risk indicator. | | | |

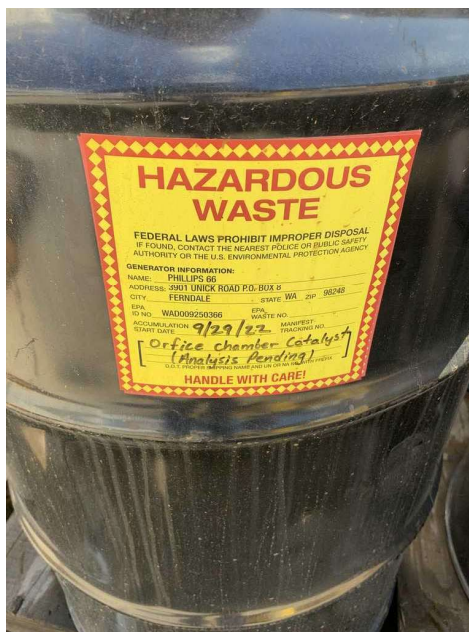
| [Title] | | | IMG_1024.jpg |

| View of 55-gallon waste storage container that is not marked with a hazard/risk indicator. | | | |

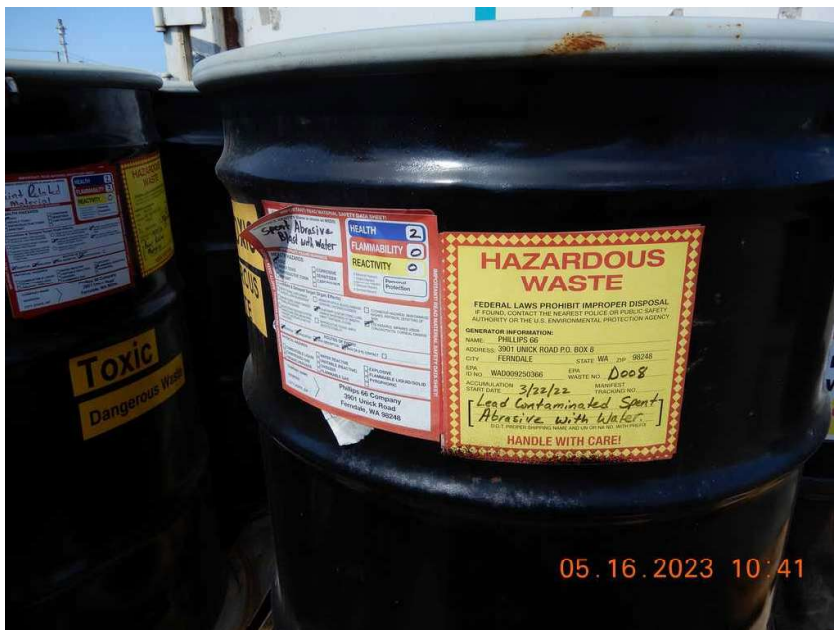
| [Title] | | | DSCN0674.JPG |

| Close-up view of the label on the 55-gallon waste storage container that is not marked with a hazard/risk indicator. | | | |

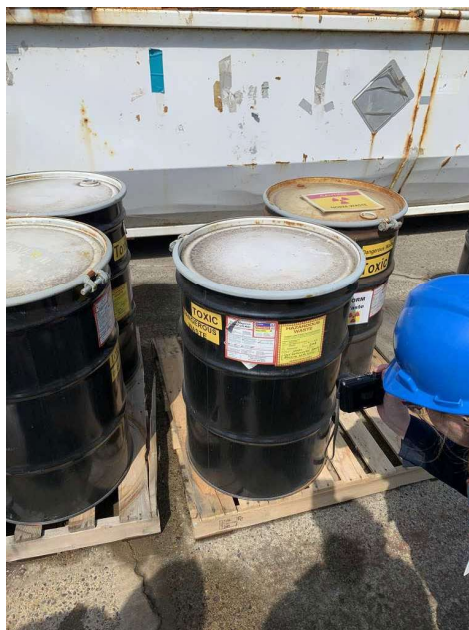
| [Title] | | | IMG_1025.jpg |

| View of hazardous waste label on 55-gallon container in permitted storage area of D008 waste with date of 3/22/22. | | | |

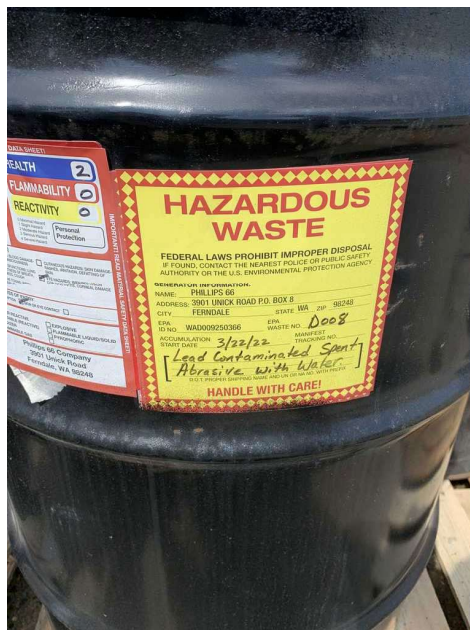
| [Title] | | | IMG_1026.jpg |

We also saw a 55-gallon waste storage container that was labeled as "Lead contaminated spent abrasive with water." The container was marked with a hazardous waste label and a hazard/risk indicator; however, the container was marked with an accumulation start date (ASD) of 3/22/22. The container of hazardous waste had been in storage at the site's permitted long-term storage area (TSD) for greater than a year. At the time of the inspection, the container had been in storage at the site for 420 days.

| View of a hazardous waste container that has been in storage at the facility's permitted storage area for greater than one year. | | | |

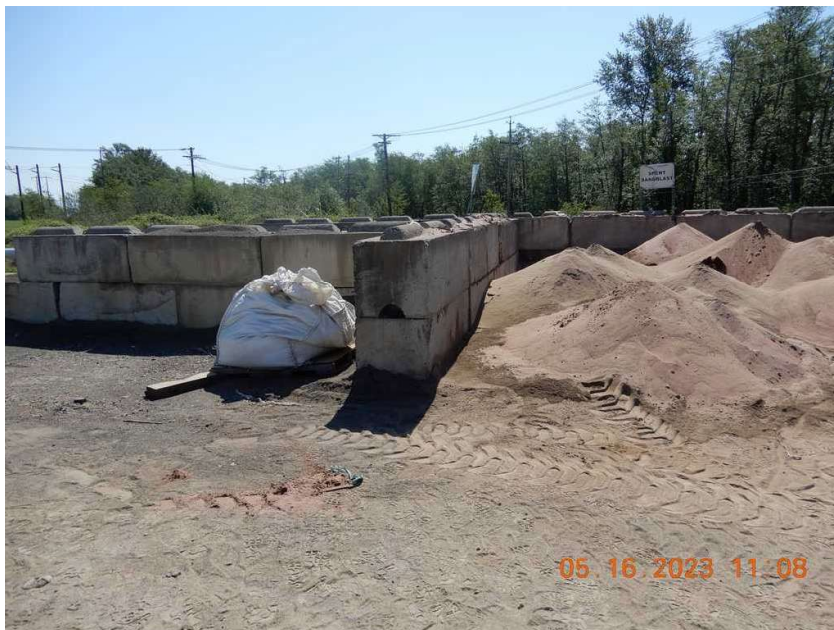
| [Title] | | | DSCN0676.JPG |

We observed piles of spent sandblast media on a pad and some on the ground. Spent sandblast media is placed into supersacks and then brought to the pad and then dumped into the pad area. The facility accumulates the sandblast media until there is enough to fill a roll-off container and then a composite sample is taken for analysis.

| View of spent sandblast sand accumulated on pad next to permitted storage area. | | | |

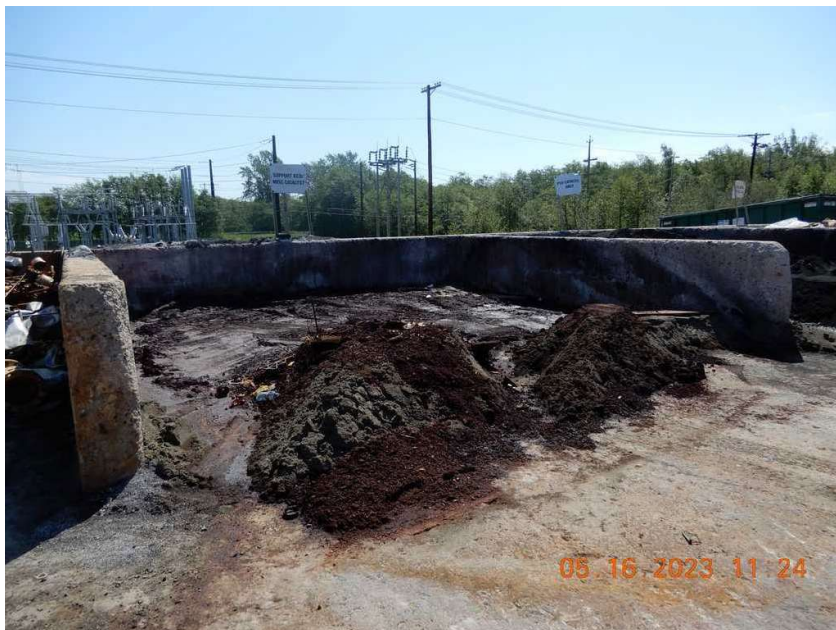
| [Title] | | | DSCN0678.JPG |

After leaving the spent sandblast area, we went to the Catalyst Bunkers, adjacent to the permitted storage area. While in this area, we observed what Mr. Sumera told us were piles of Purge Treatment Unit (PTU) catalyst generated during blowdown of the scrubbers. Mr. Sumera described the catalysts as support bed and miscellaneous catalysts, and that they are non-hazardous. He does not keep a log but would have notes about the spent catalysts.

| View of PTU catalyst bunker with spent catalyst being accumulated. | | | |

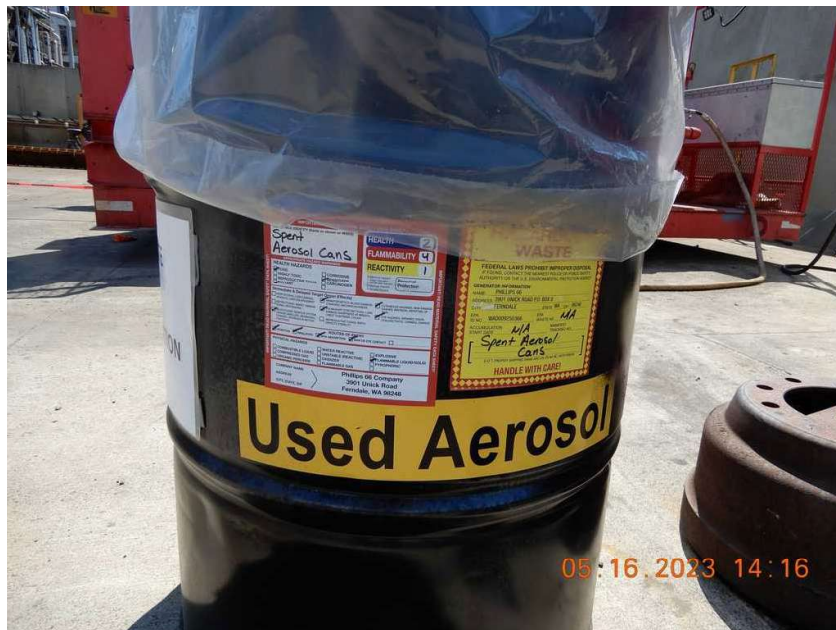
| [Title] | | | DSCN0680.JPG |

While on the Main Slab, we observed a 55-gallon waste aerosol SAA container. At the time of the inspection, the container was empty; however, the container was not closed. The container had an attached lid with a swinging door that wasn't designed to be used with a container holding hazardous waste, as it doesn't make a complete seal when closed. The failure for the container to close is due to a design flaw. The swinging door does not make a complete seal when in the closed position. A noticeable gap can be seen around the entire swinging door and the lid, even when the swinging door appears to be in the closed position.

| View of waste aerosol can collection drum at the main bundle cleaning pad; drum not closed but was empty. | | | |

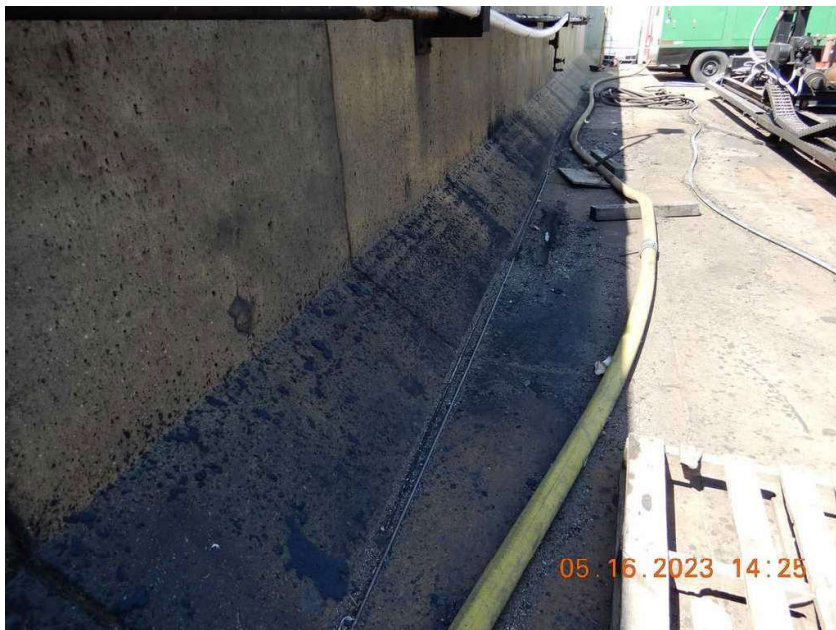
| [Title] | | | DSCN0682.JPG |

We also observed waste and debris on the pad that looked like dried waste solids (K050) from the bundle cleaning process. According to facility personnel, contractor personnel perform the bundle cleaning. During the inspection of the bundle cleaning area, I asked site personnel for a copy of their bundle cleaning

| View of solid residues on the bundle cleaning pad. | | | |

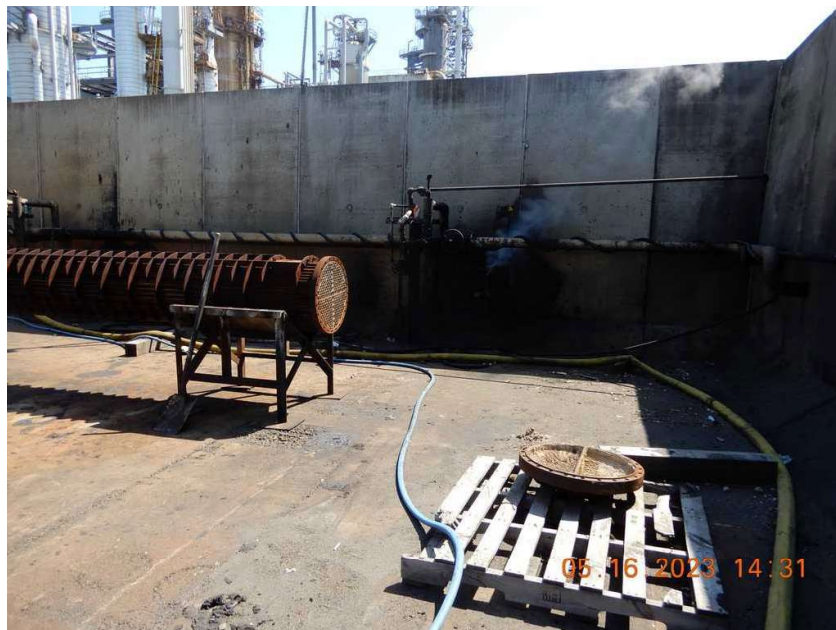
| [Title] | | | DSCN0684.JPG |

| Another view of solid residues on the bundle cleaning pad. | | | |

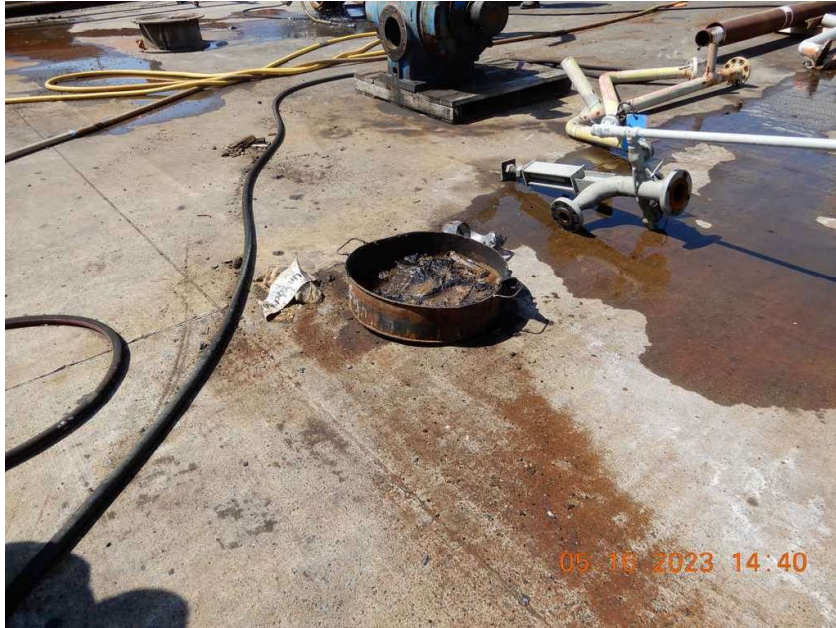
| [Title] | | | DSCN0687.JPG |

| Another view of solid residues on the bundle cleaning pad. | | | |

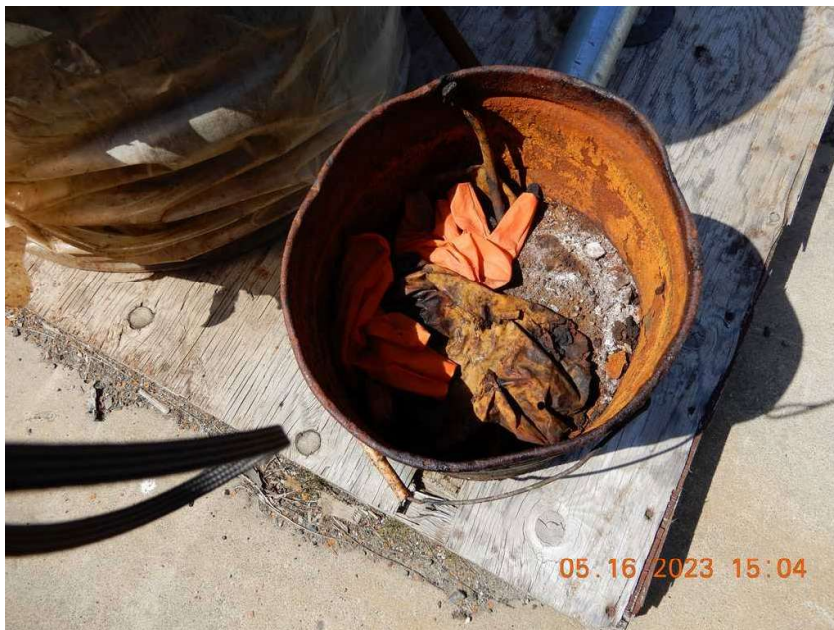
| [Title] | | | DSCN0694.JPG |

| View of five-gallon bucket containing an unknown waste, next to 900 pad. | | | |

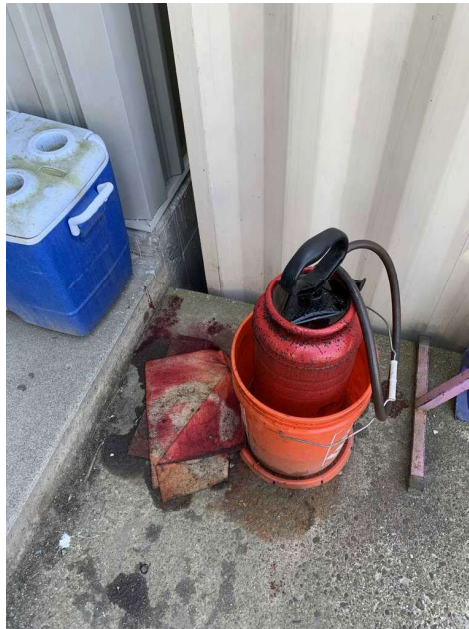
| [Title] | | | IMG_1054.jpg |

We also saw a leaking container of what was determined by facility personnel to be, "Rail Deicer." At the time

| Close-up view of the leaking container of deicer. | | | |

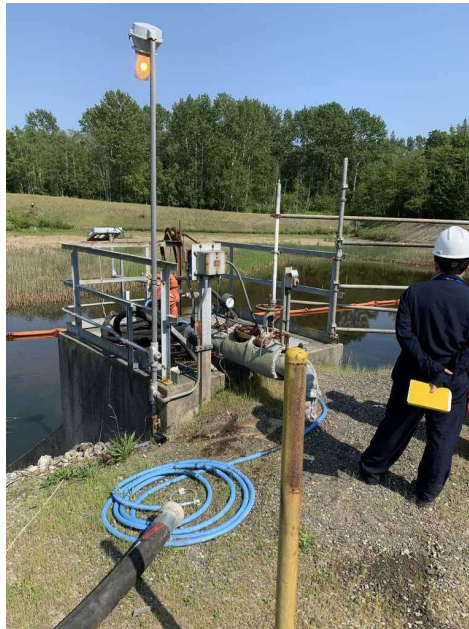
| [Title] | | | IMG_1114.jpg |

| View of staining seen here inside the Spill Basin. | | | |

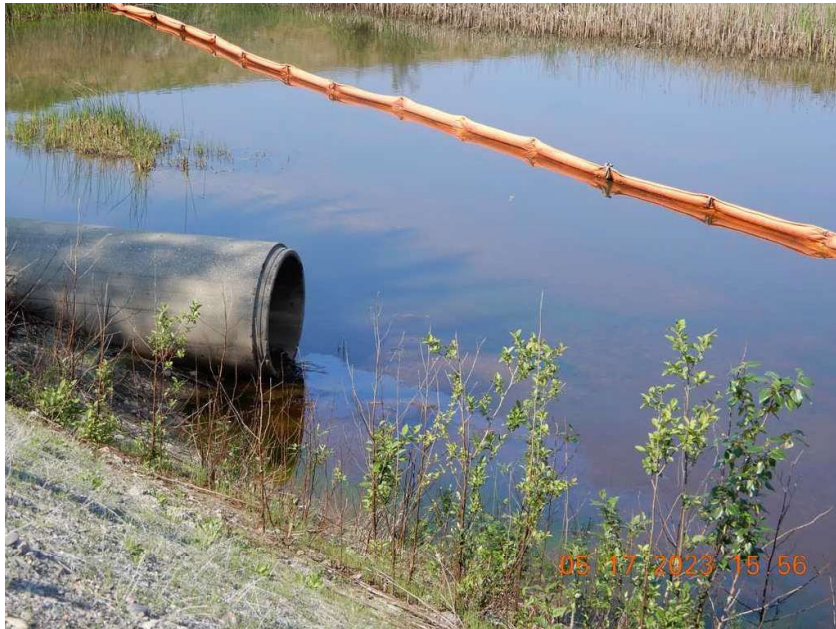
| [Title] | | | DSCN0707.JPG |

| Another view of the staining inside the Spill Basin. | | | |

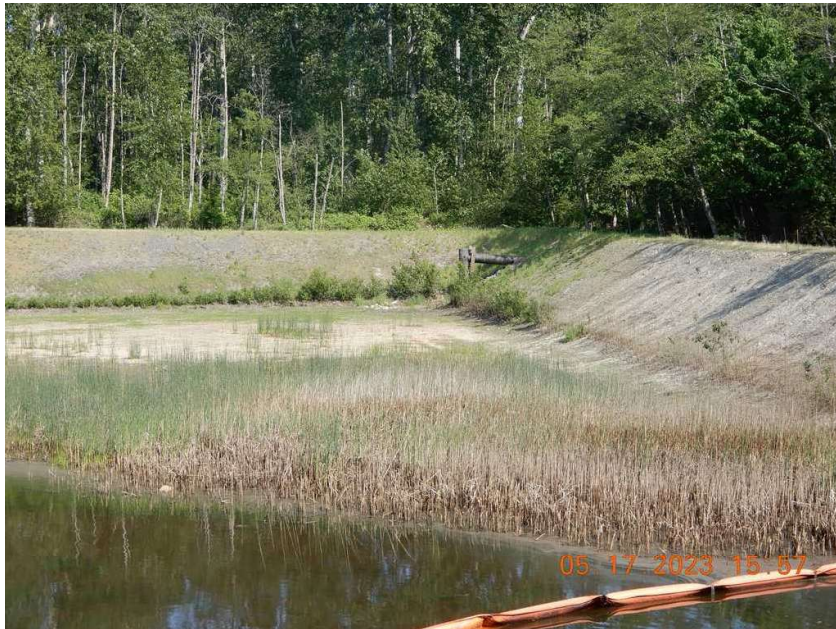
| [Title] | | | DSCN0709.JPG |

| View of oily sheen from lift station pipe discharge flowing down Spill Basin. | | | |

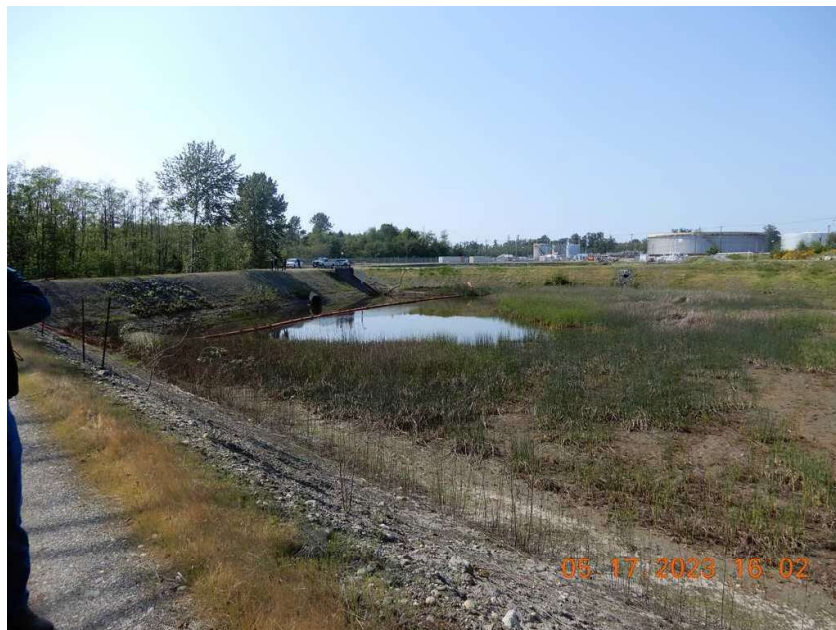
| [Title] | | | DSCN0710.JPG |

| Another view of the sheen in the spill basin. | | | |

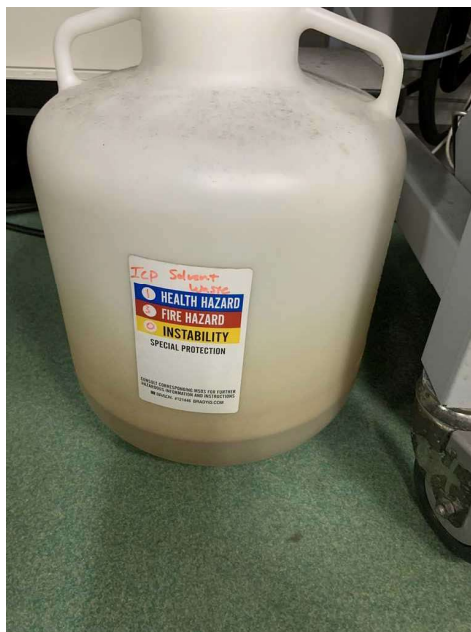
| [Title] | | | IMG_1181.jpg |

| View of a 2-gallon, poly, hazardous waste container of waste ICP Solvent (Xylene) that is not labeled with the words "Hazardous Waste." | | | |

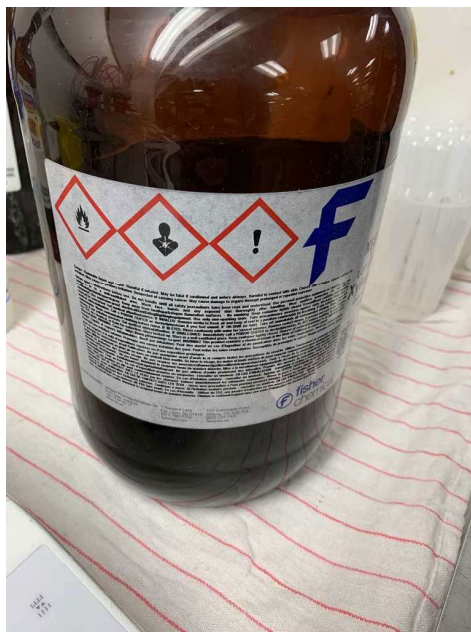
| [Title] | | | IMG_1182.jpg |

| Close-up view of a 2-gallon, poly, hazardous waste container of waste ICP Solvent (Xylene) that is not labeled with the words "Hazardous Waste." | | | |

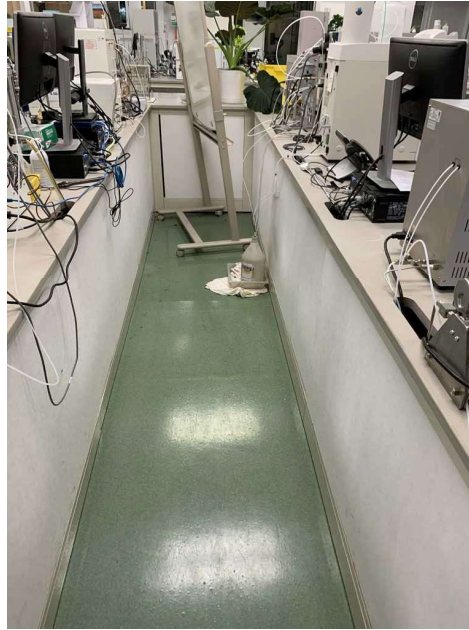
| [Title] | | | IMG_1189.jpg |

| View of containers that hold sample waste and acid wastes that are seen here not labeled with the words "Hazardous Waste." | | | |

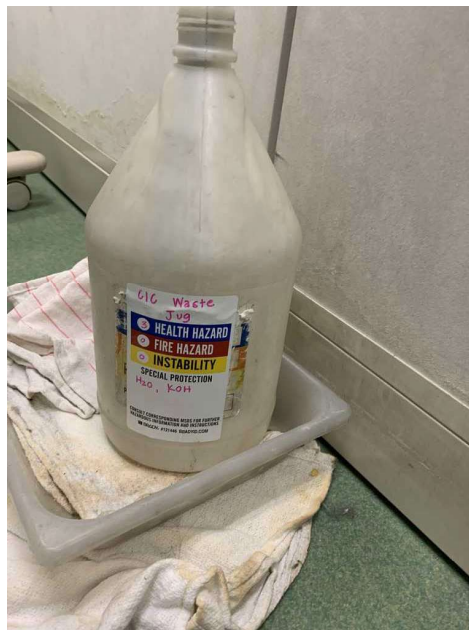
| [Title] | | | IMG_1190.jpg |

| View of a 1-gallon container of chromatograph waste that is not labeled with the words "Hazardous Waste." | | | |

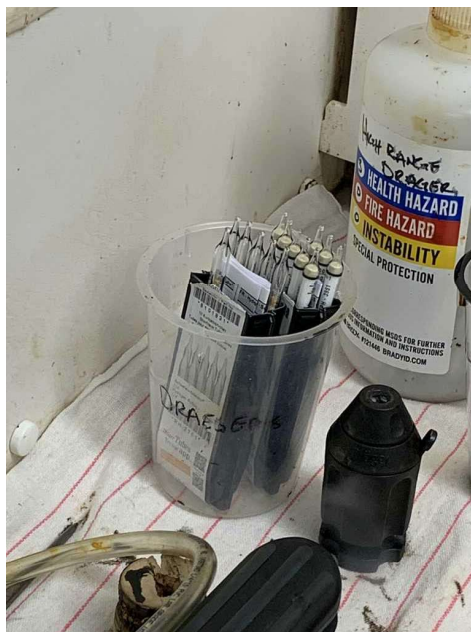
| [Title] | | | IMG_1193.jpg |

| View of a beaker inside the fume hood that is holding some spent/used Draeger tubes, seen here not closed, not labeled "Hazardous Waste," and not marked with a hazard indicator. | | | |

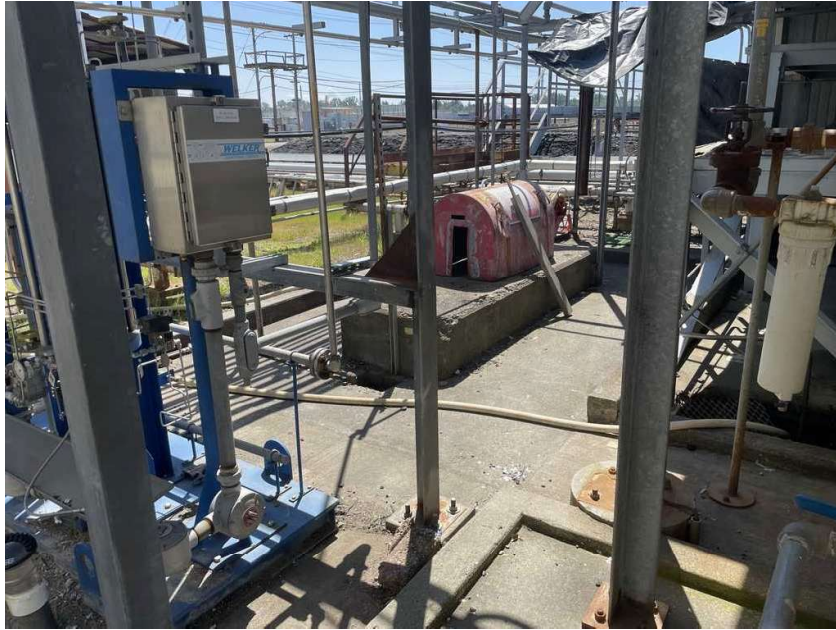
| [Title] | | | Old Engine Lab (4).jpg |

| Photo submitted to show that the waste gas and floor dry was cleaned up; however, waste can still be seen on the floor of the lab. | | | |
