A & E Metal Recycling And Packaging, Inc.  
EPA Clean Water Act Inspection  
Photo Album  
11-18-21

Inspectors Alex Rosenberg and  
Rachel Olugbemi

EPA – MSGP Inspection  
11/18/21

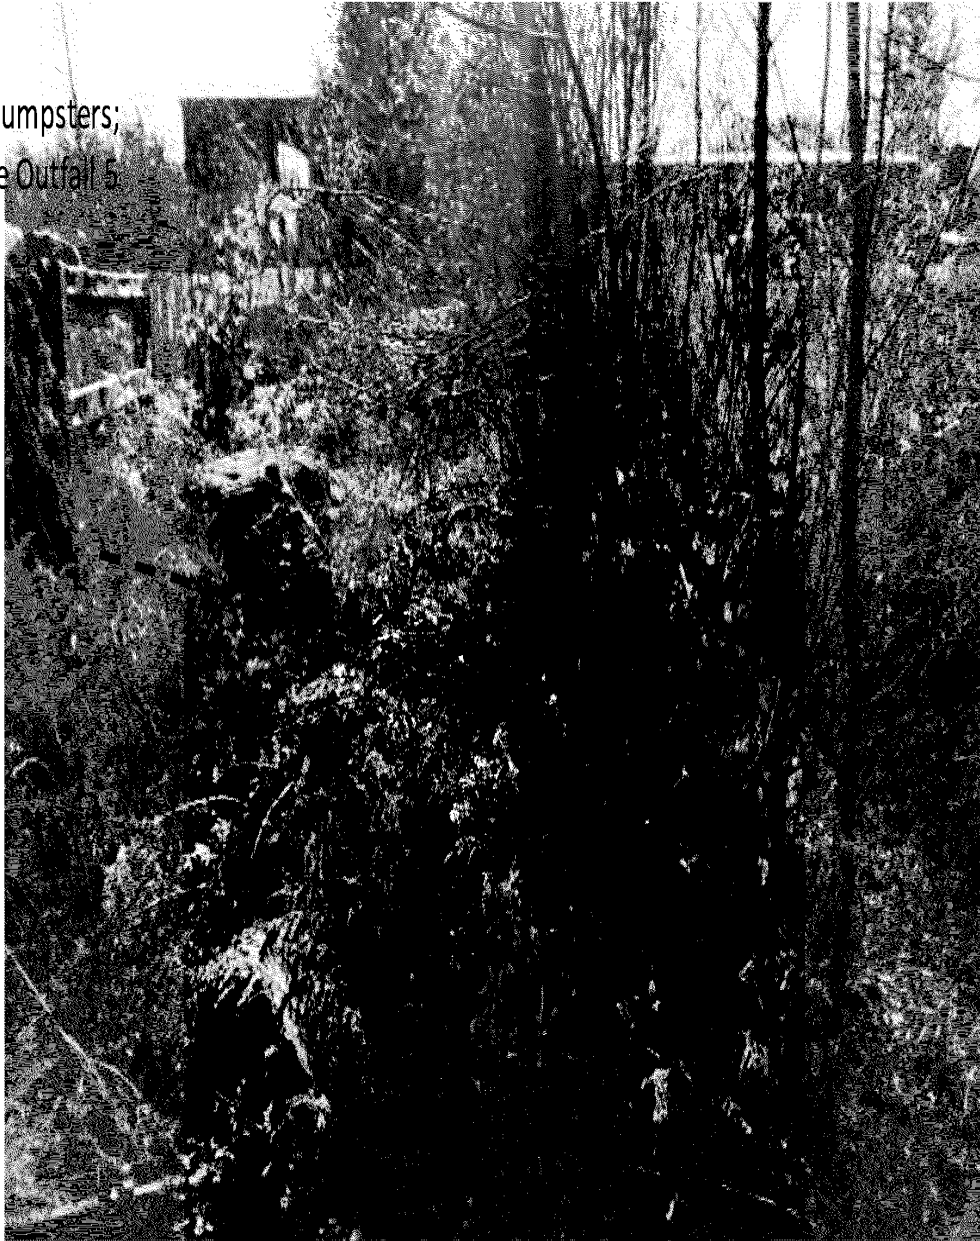
# AREA 3

Open Dumpsters;  
Possible Outfall 5

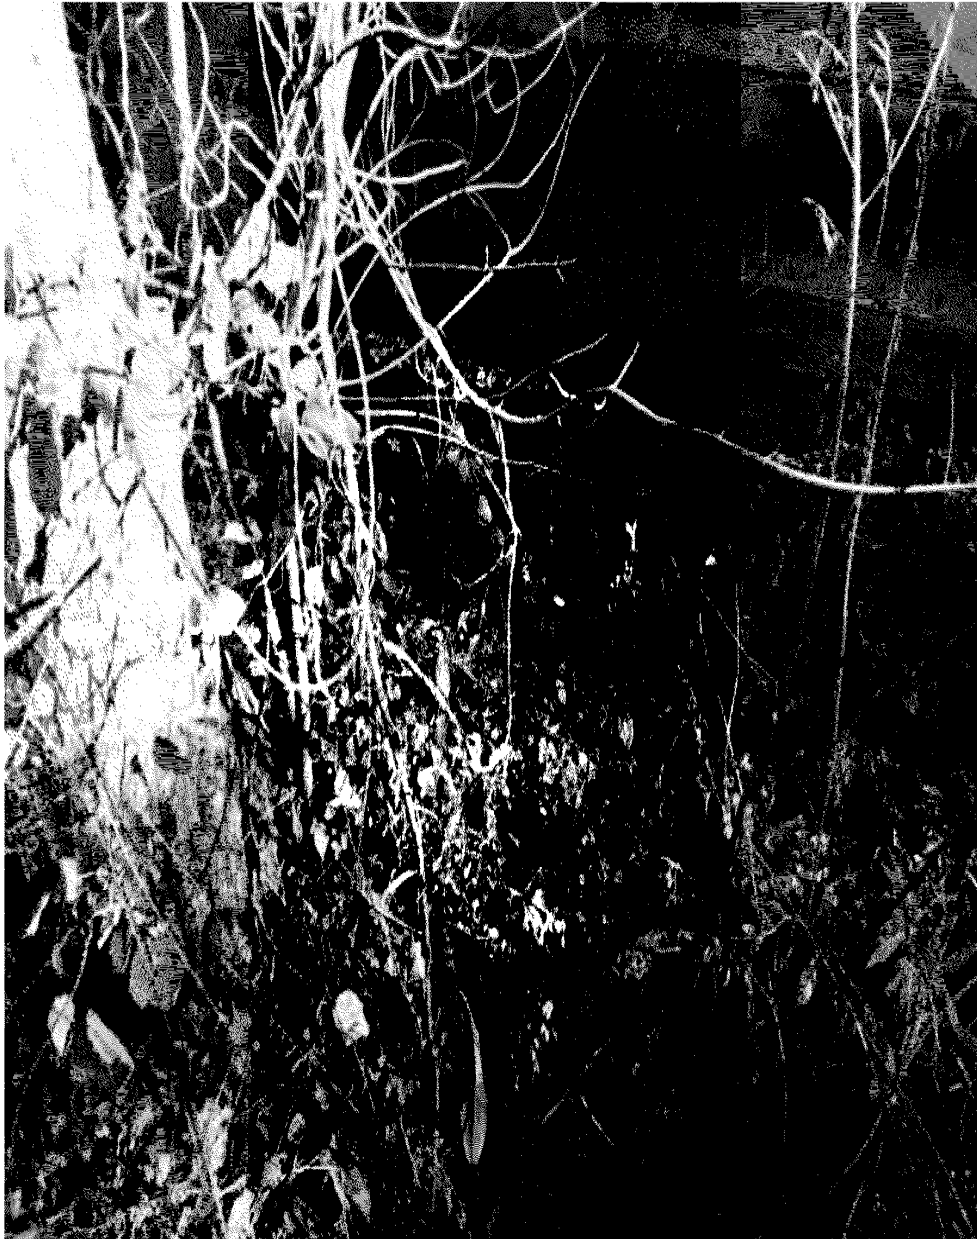
AREA 1 –  
CATCHMENT  
TO POSSIBLE  
OUTFALL 2

Possible Outfall 2

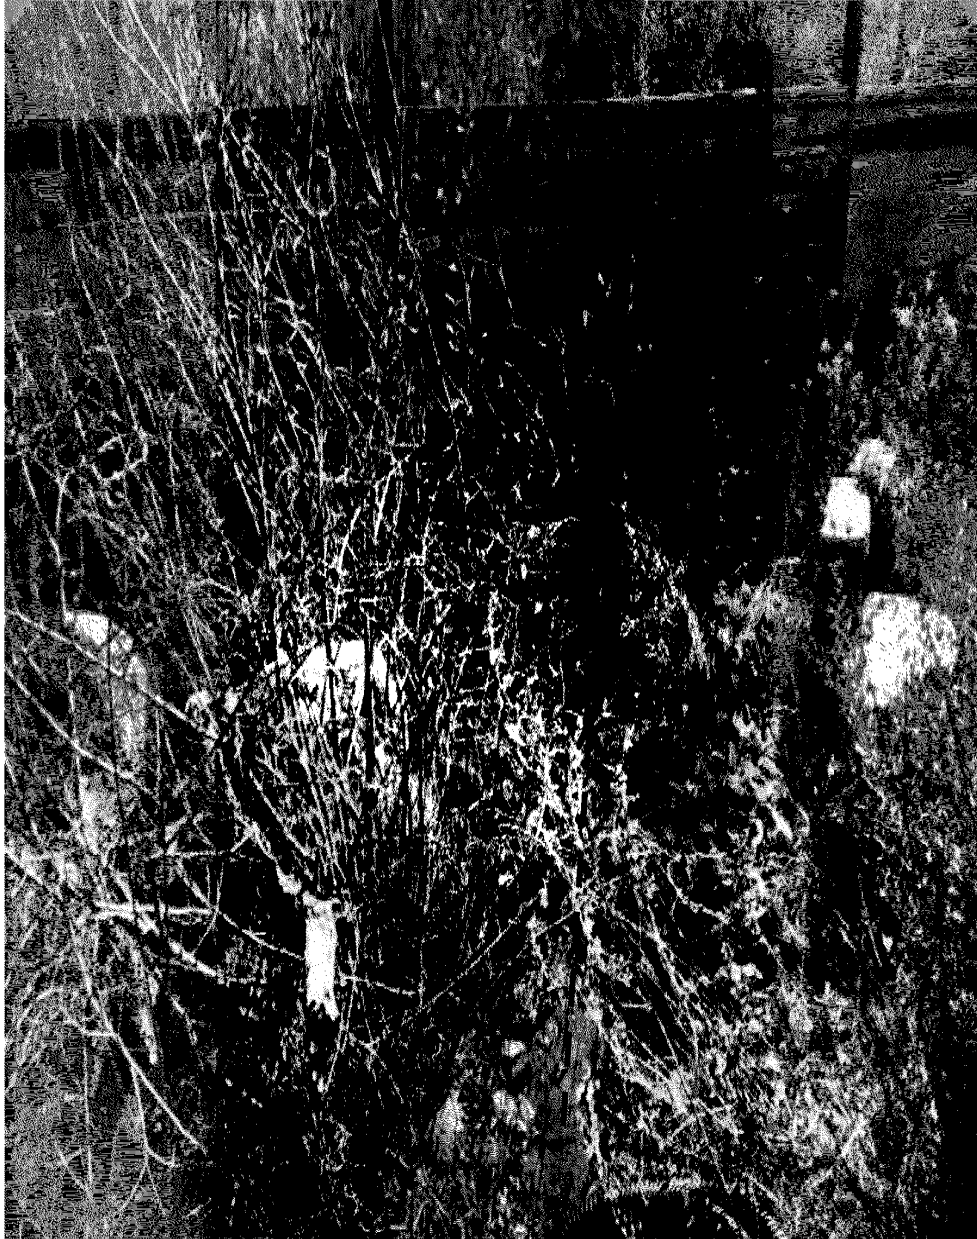
AREA 1 –  
CATCHMENT  
TO POSSIBLE  
OUTFALL 3

Possible Outfall 3 –  
from overflow  
culvert of wetland  
pond

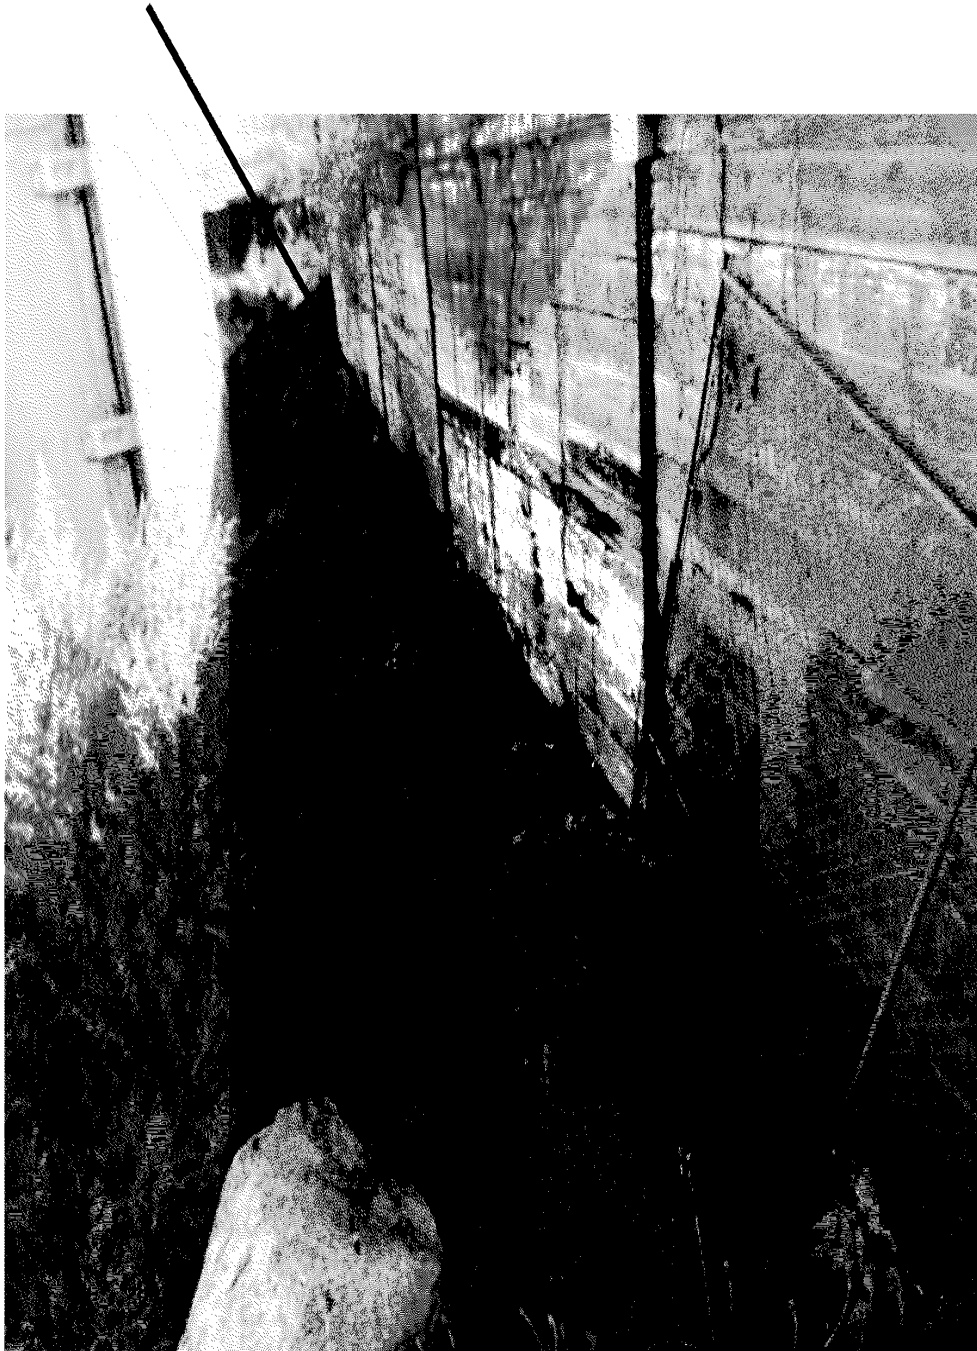
AREA 2

Possible Outfall 4 –  
from Area 2
