**Well Inspection**  
**Osage DNR / Environmental Protection Agency**  
**1201 Elm Street, Suite 500**  
**Dallas, Texas 75270**

| | Suite 150 | <b>Lease Name</b> North Burbank Unit | | | |
| | Allen, TX 75013 | <b>Well ID</b> 82-W6 | | | |
| <b>Inspection Reason</b> | Plugging Witnessed | <b>Responsible Company at Time of Inspection</b> | | CapturePoint, LLC | |

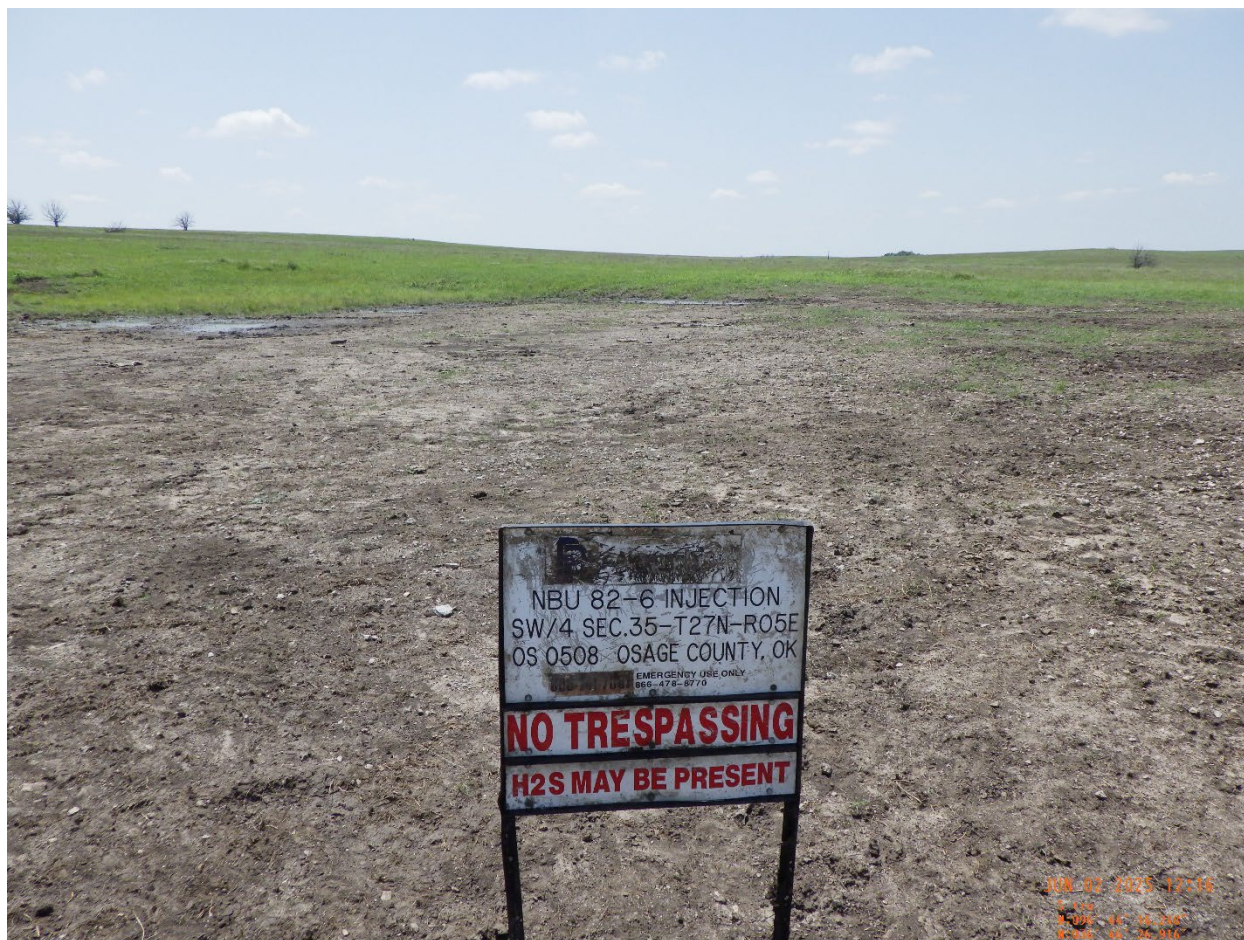
Photo No. 1

**Description:** This was the location of well OS0508000 after surface restoration was completed.
