**Well Inspection**  
**Osage DNR / Environmental Protection Agency**  
**1201 Elm Street, Suite 500**  
**Dallas, Texas 75270**

| | | <b>Lease Name</b> | NAVAL RESERVE UNIT | | |
| | | <b>Well ID</b> | 30W3 | | |
| <b>Inspection Reason</b> | Plugging Witnessed | <b>Responsible Company at Time of Inspection</b> | Contango Resources, LLC | | |

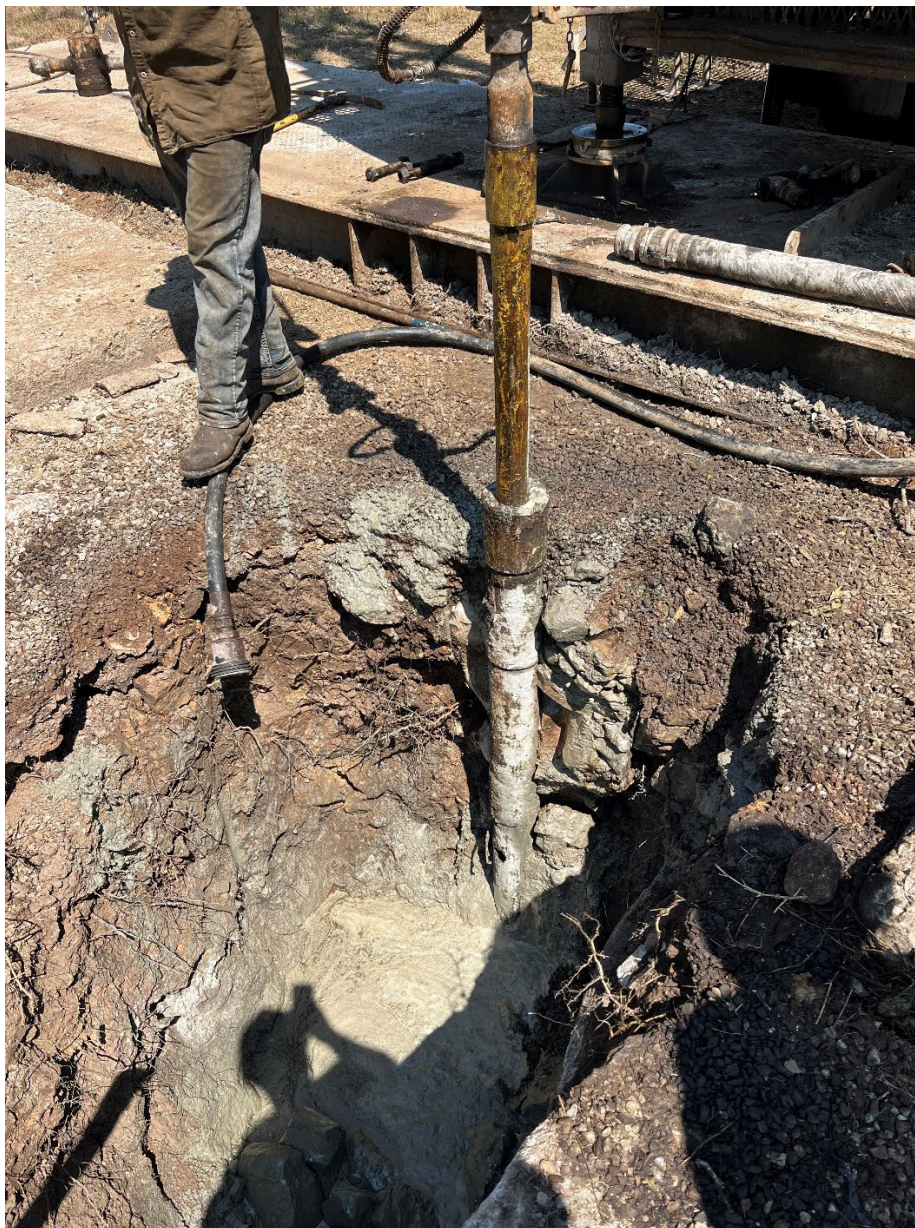
Photo No. 1

**Description:** This was well OS2898000 at the time of the inspection with cement circulated to the surface.
