## Clean Water Act Section 404: Site Visit/Case Development

| Site Name | Care365 Realty, LLC Property | | | | |
| Site Address* | 272 NY State Route 59 (Tax ID: 55.12-1-5) | | | | |

| Inspection Purpose | Initial site visit | | |

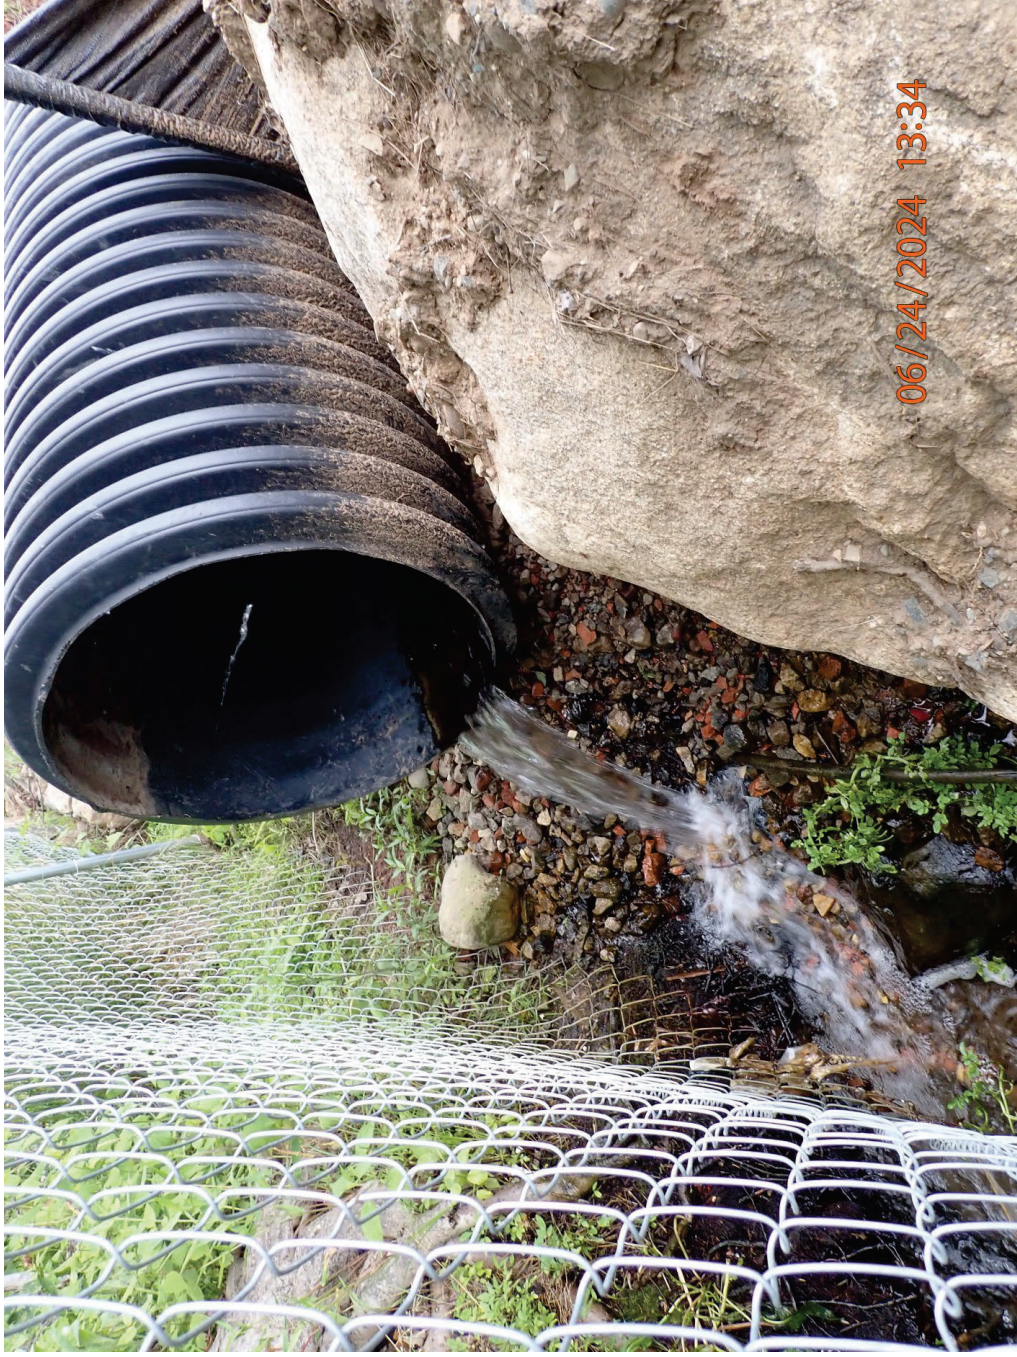
**Date:** 6/24/2024  
**Time:** 1:34 PM  
**Photographer:** S. Andreescu  
**Photo ID:** 9 – P6240568  
**Description:**  
36" plastic corrugated culvert

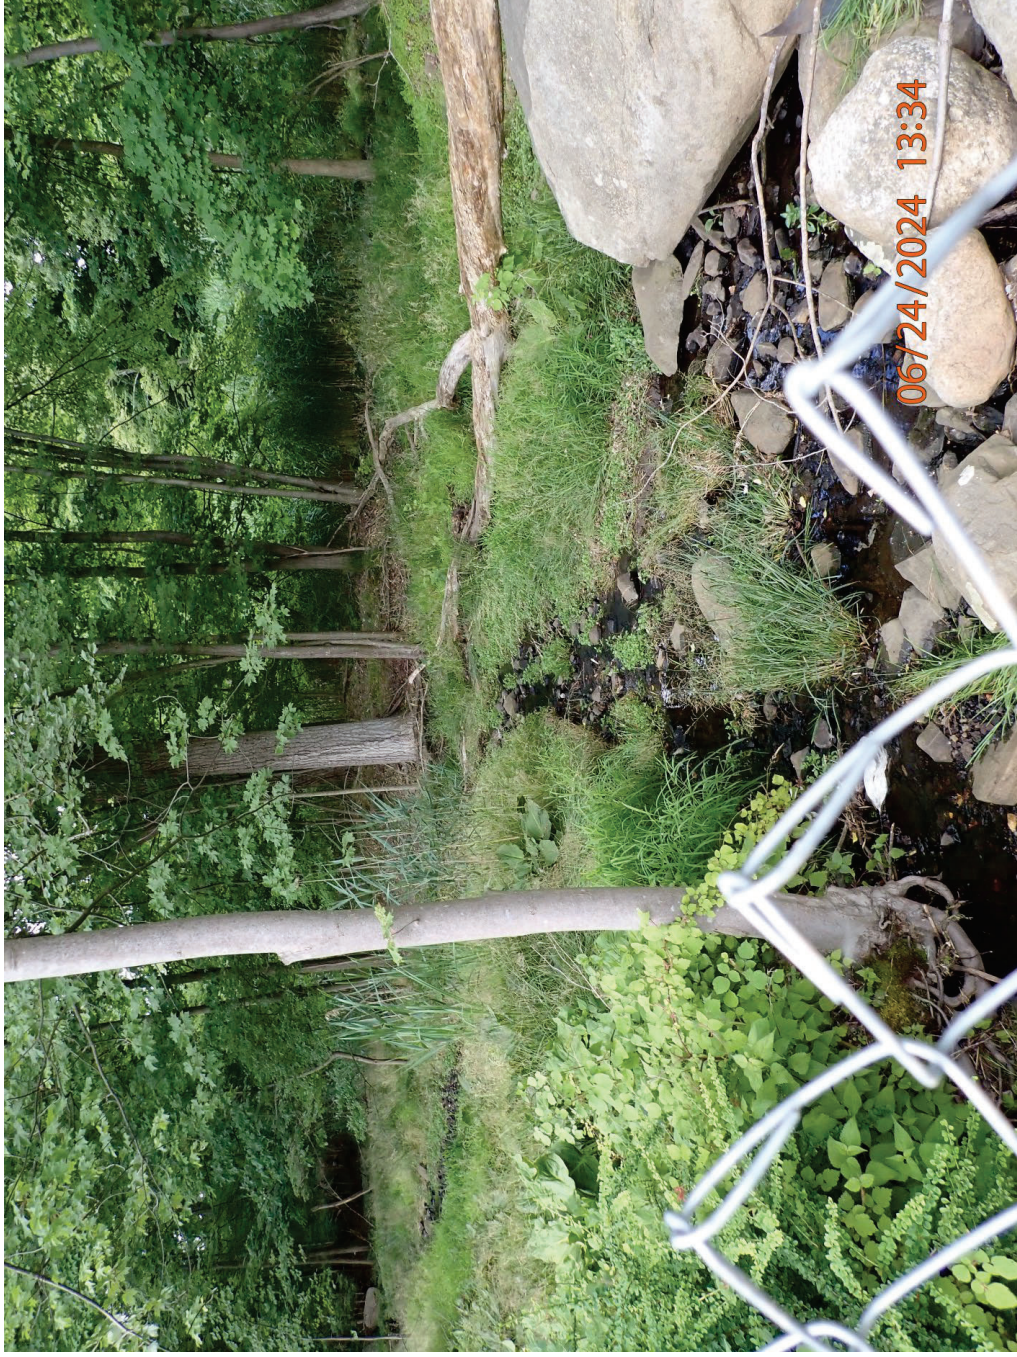
**Date:** 6/24/2024  
**Time:** 1:34 PM  
**Photographer:** S. Andreescu  
**Photo ID:** 10 – P6240569

Downstream view

Stream on neighboring property

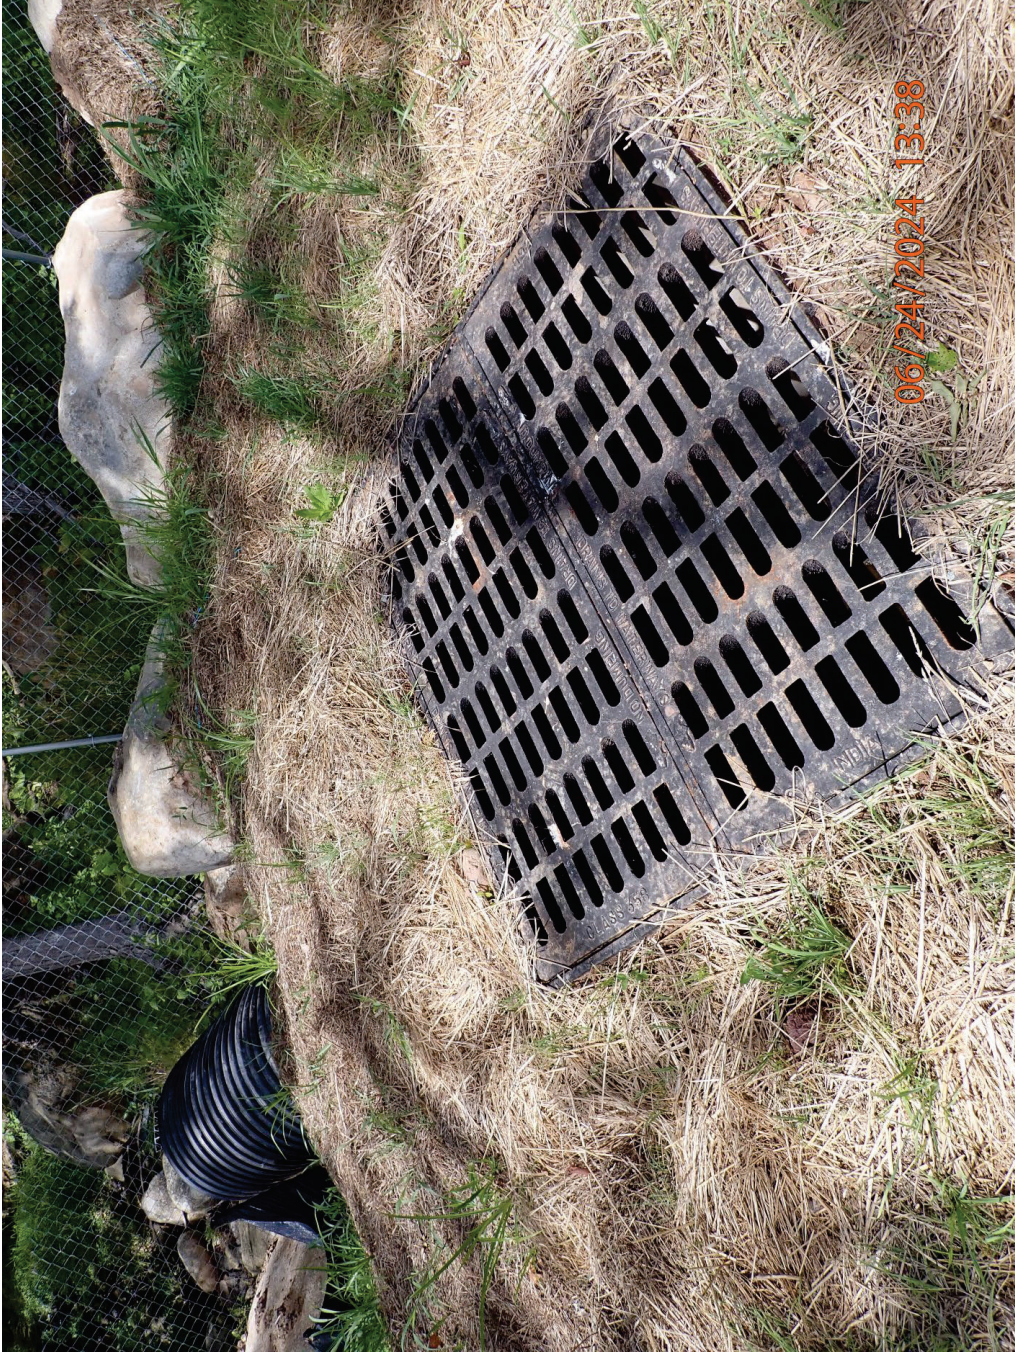
**Date:** 6/24/2024  
**Time:** 1:38 PM  
**Photographer:** S. Andreescu  
**Photo ID:** 11 – P6240570

| Potential issues of concern include the piping of a stream and the discharge of earthen fill material into wetlands without prior | | | |

**Description:**  
Grate over piped stream

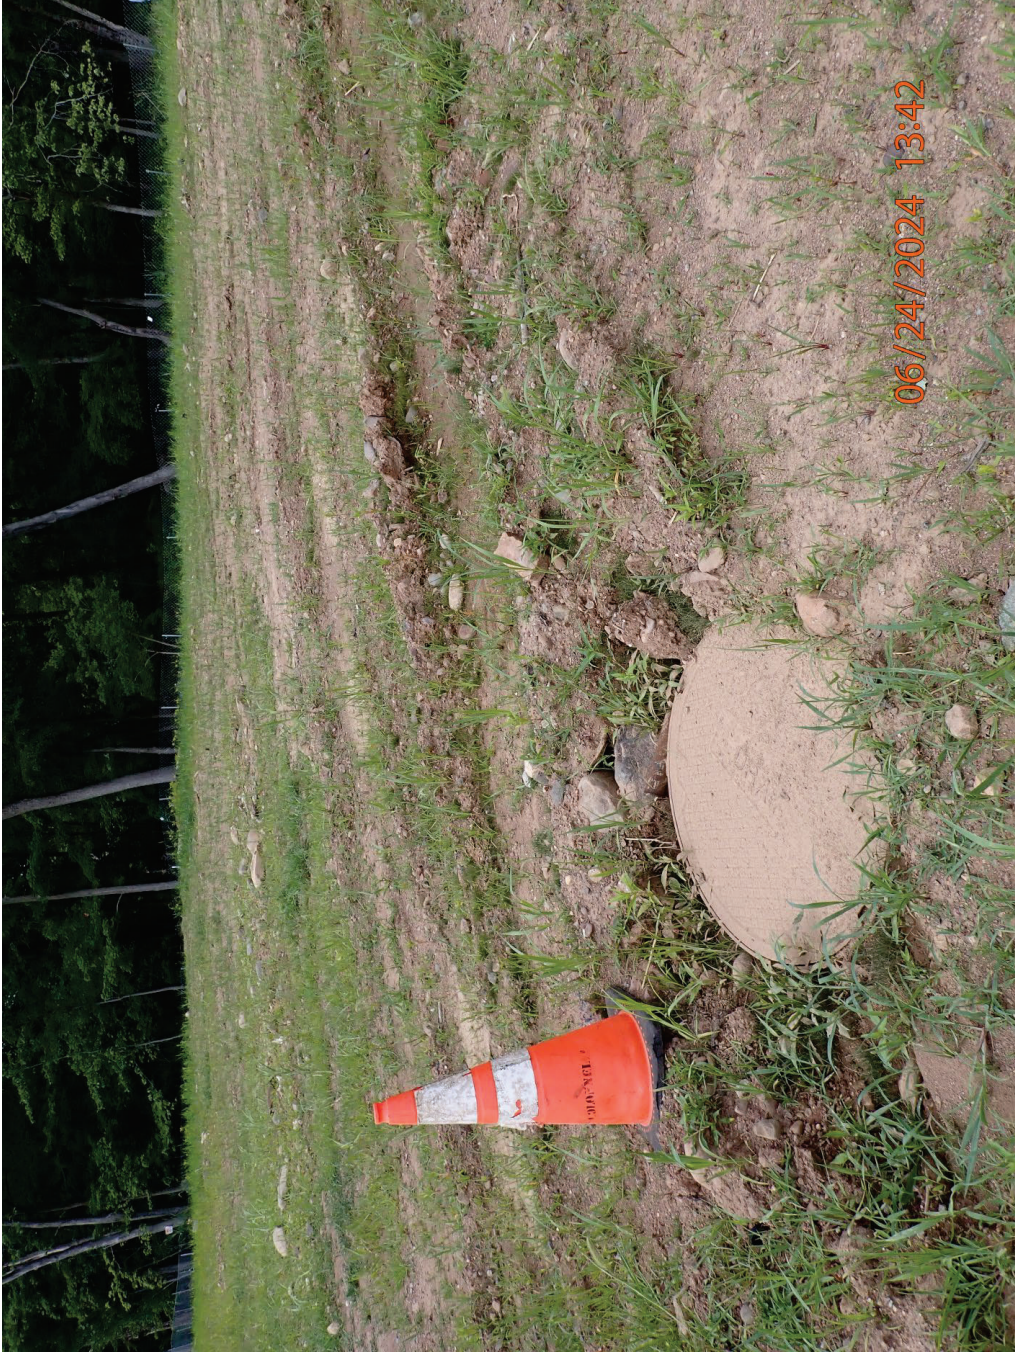
**Date:** 6/24/2024  
**Time:** 1:42 PM  
**Photographer:** S. Andreescu  
**Photo ID:** 12 – P6240571

**Description:**  
Manhole over piped stream

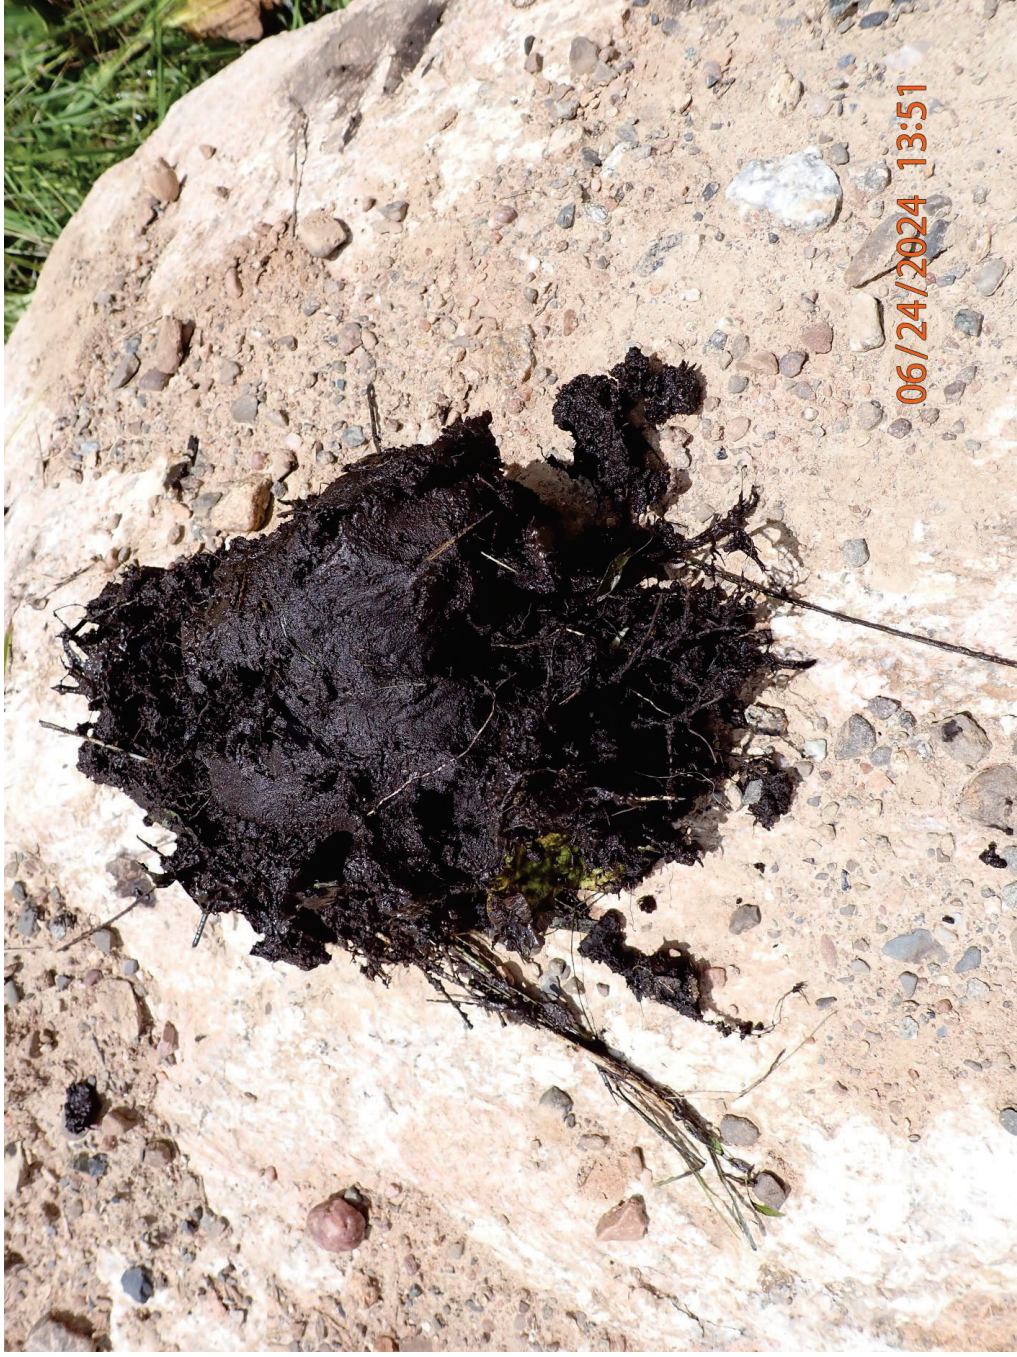
**Date:** 6/24/2024  
**Time:** 1:51 PM  
**Photographer:** S. Andreescu  
**Photo ID:** 13 – P6240572

**Description:**  
Mucky soil sample

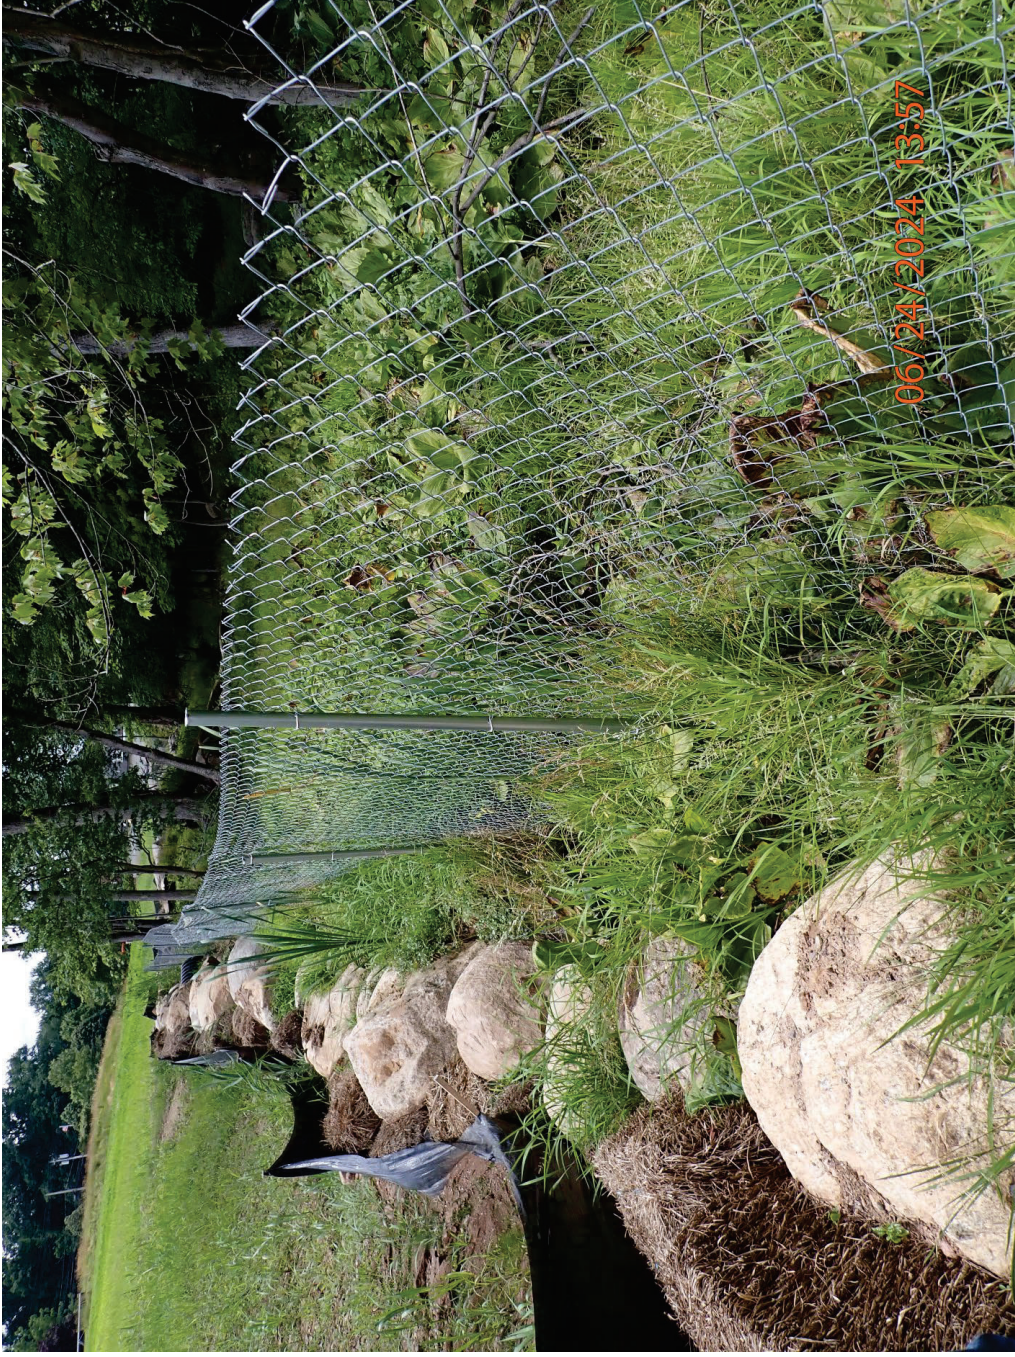
**Date:** 6/24/2024  
**Time:** 1:57 PM  
**Photographer:** S. Andreescu  
**Photo ID:** 16 – P6240575  
**Description:**  
Limit of disturbance and  
property line

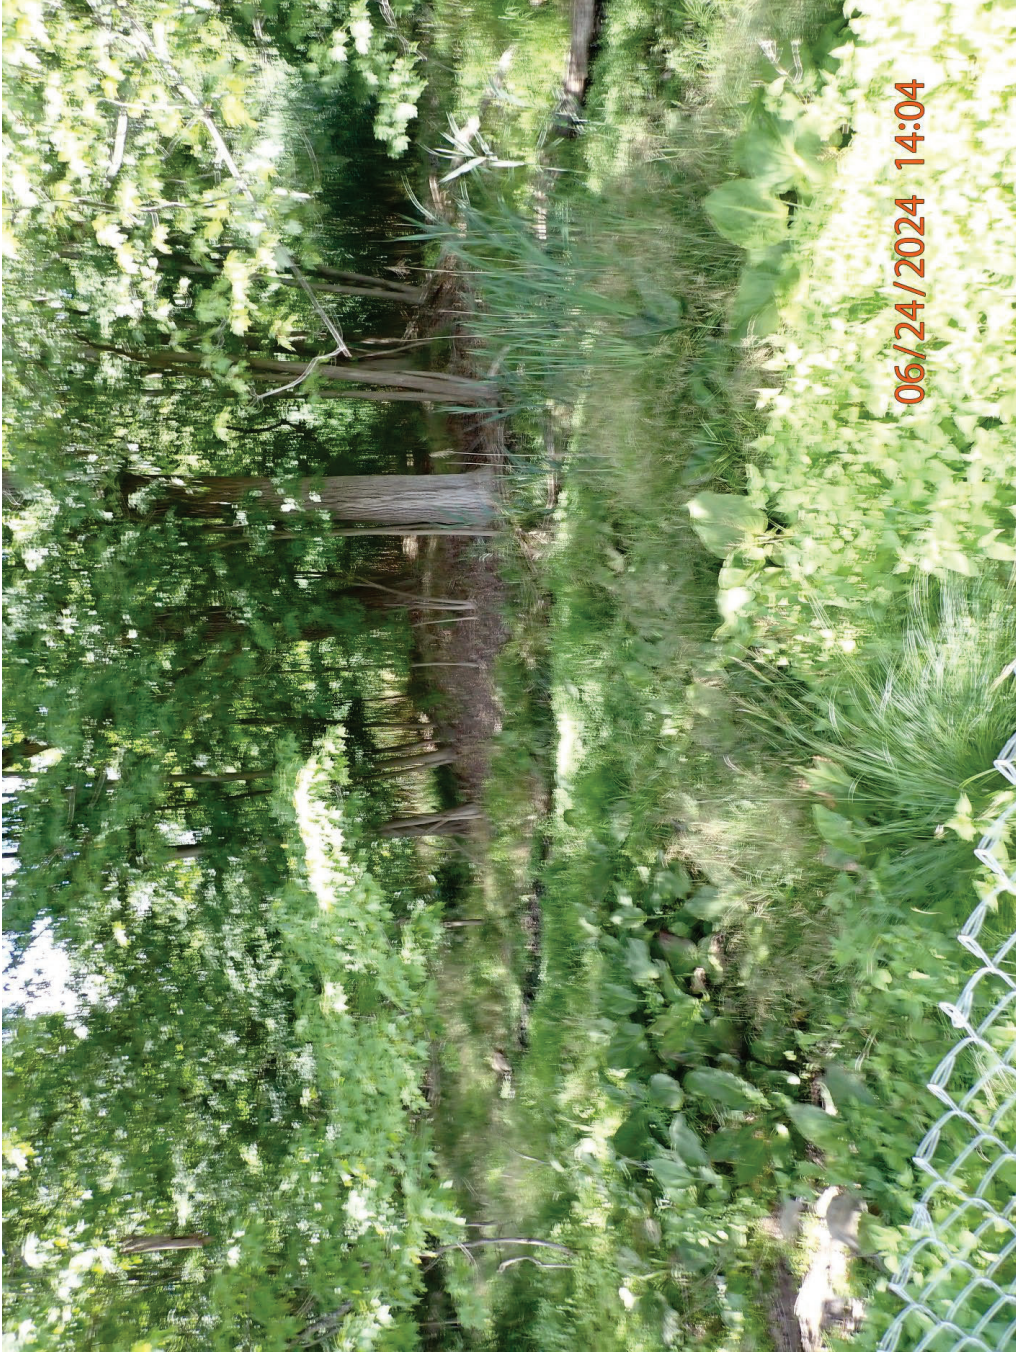
**Date:** 6/24/2024  
**Time:** 2:04 PM  
**Photographer:** S. Andreescu  
**Photo ID:** 17 – P6240576

**Description:**  
Likely wetland on neighboring property

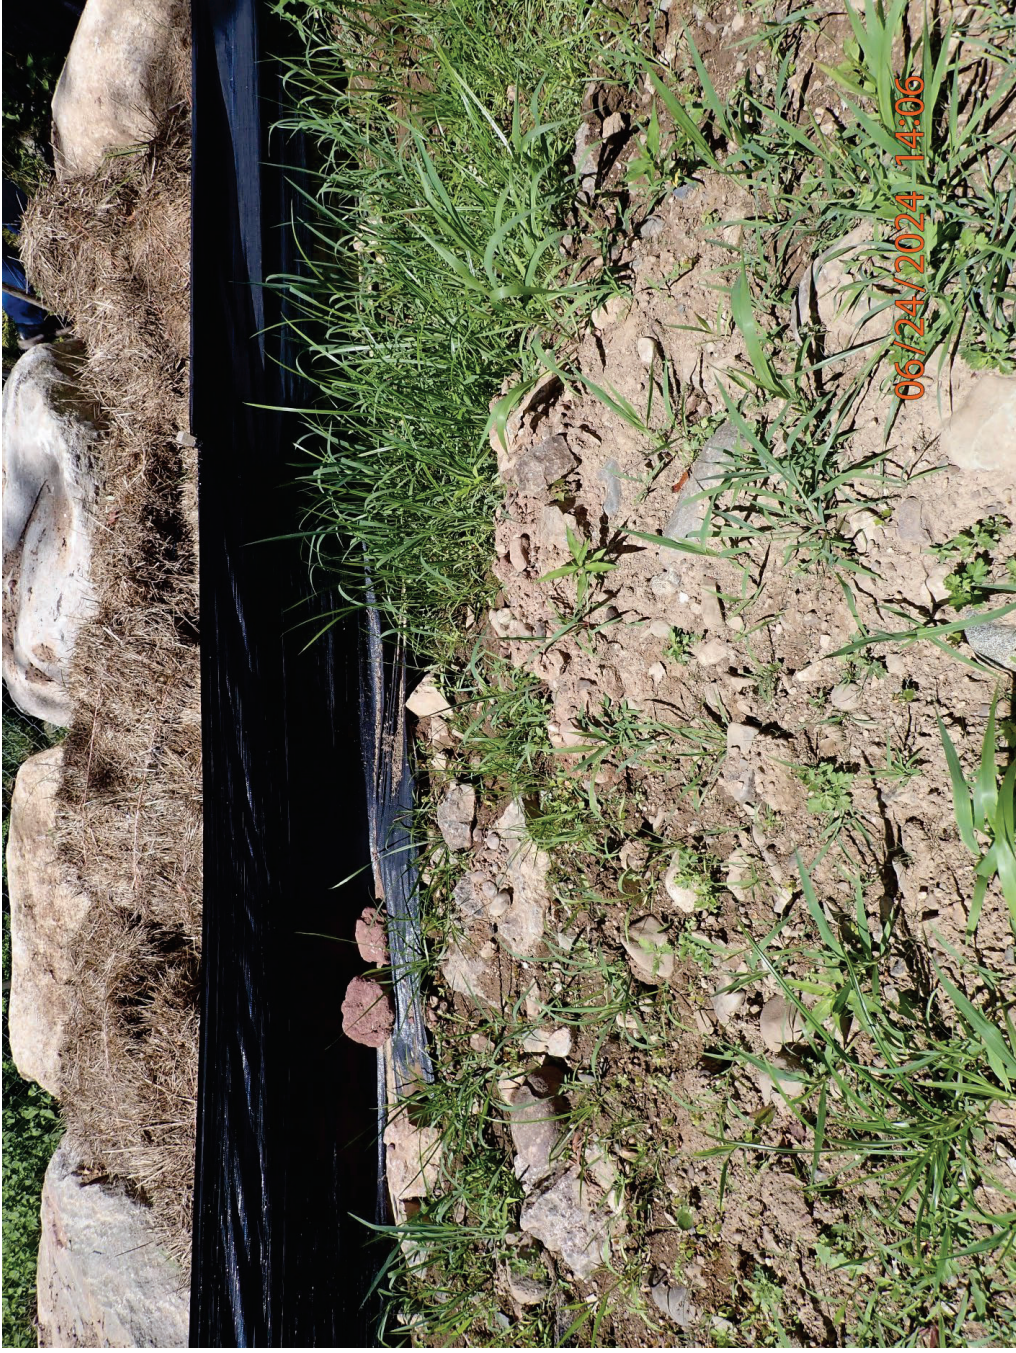
**Date:** 6/24/2024  
**Time:** 2:06 PM  
**Photographer:** S. Andreescu  
**Photo ID:** 18 – P6240577

Fill material consisting of  
boulder, cobble, gravel, dirt
