## INSPECTION REPORT

| Type of Inspection | Compliance Evaluation Inspection (CEI) | | |
| Company Name | Northern Star (POGO), LLC | | |

The facility was inspected to ensure compliance with standards for hazardous waste generators and universal waste management (40 C.F.R. Parts 262 through 273) and used oil management (40 C.F.R. Part 279). The inspection was conducted as part of a Core Program requirement for FY 2024.

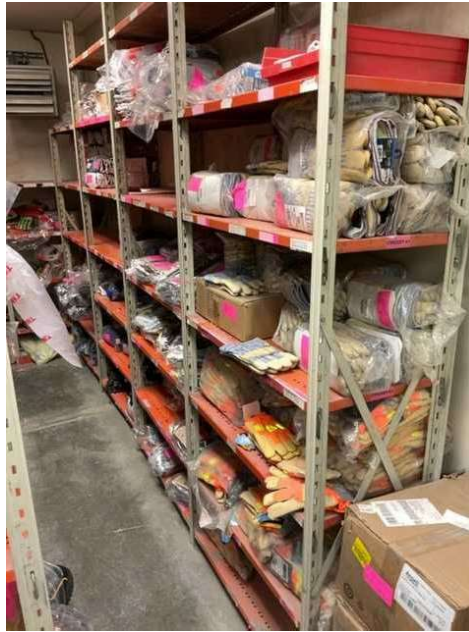
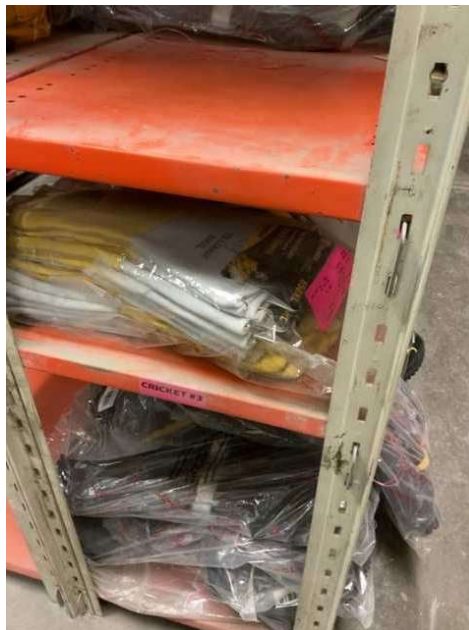
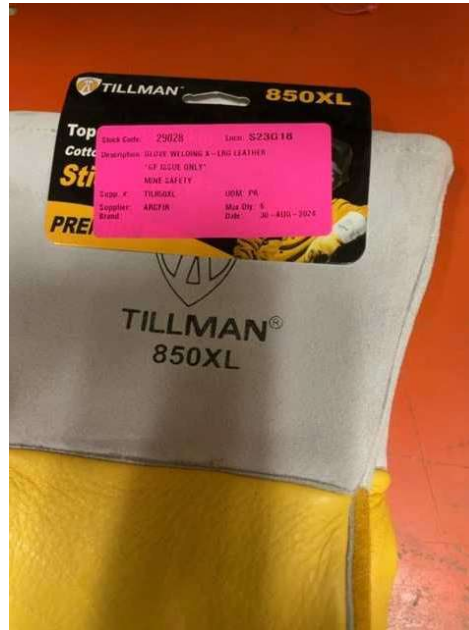
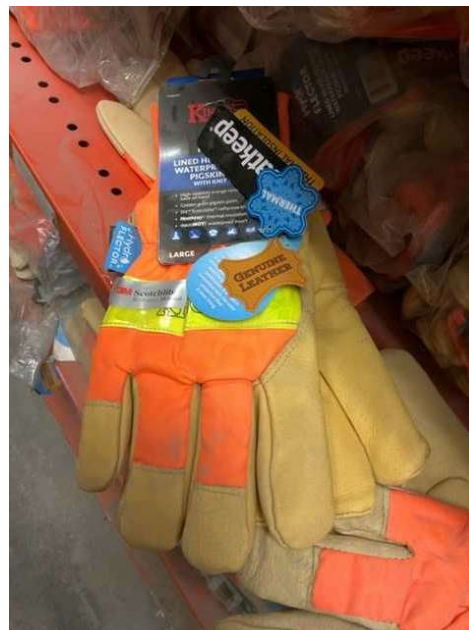
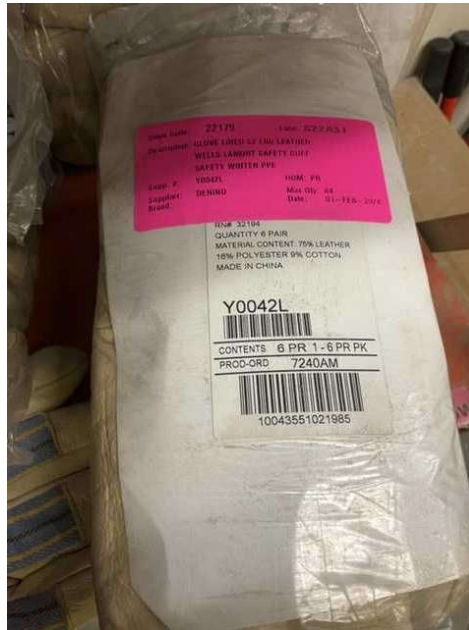
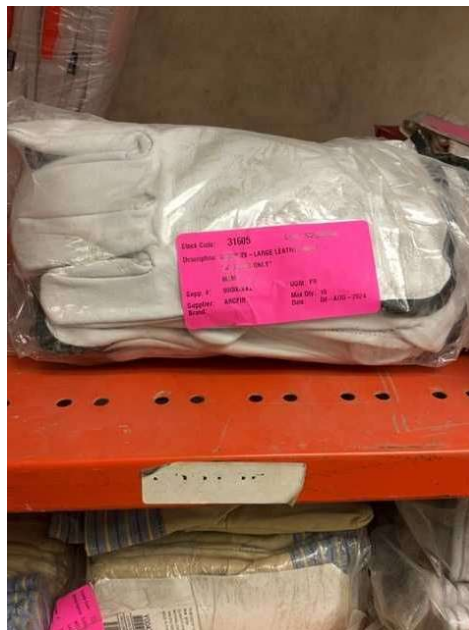
| <b>Building:</b> Warehouse | <b>Area:</b> | <b>Sub-area:</b> |
|---|---|---|
| Failure to make a hazardous waste determination at the point of generation for waste leather gloves. | <b>Regulation:</b> | <b>Sections:</b> |

| View of leather gloves in stock for issue at the facility. | | | |

| View of leather gloves in stock for issue at the facility. | | | |

| Close-up view of leather gloves in stock for issue at the facility. | | | |

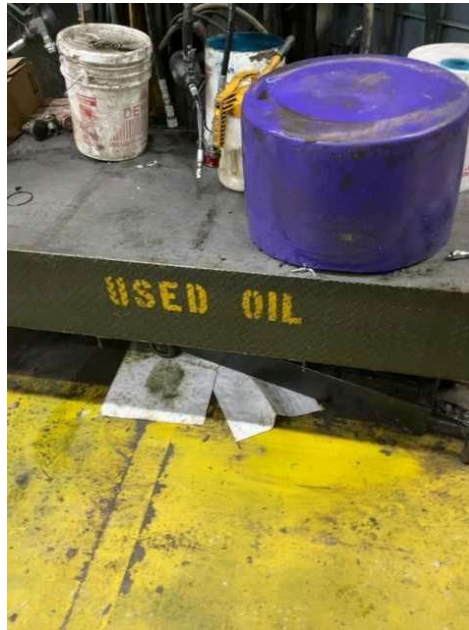
There were two used oil receivers (rolling drain pans) that were not labeled with the words "Used Oil." One was not labeled at all, and the other one's labeling had deteriorated to the point that it required relabeling.

| View of another used oil receiver, seen here beneath a raised platform, that is not labeled with the words "Used Oil." | | | |

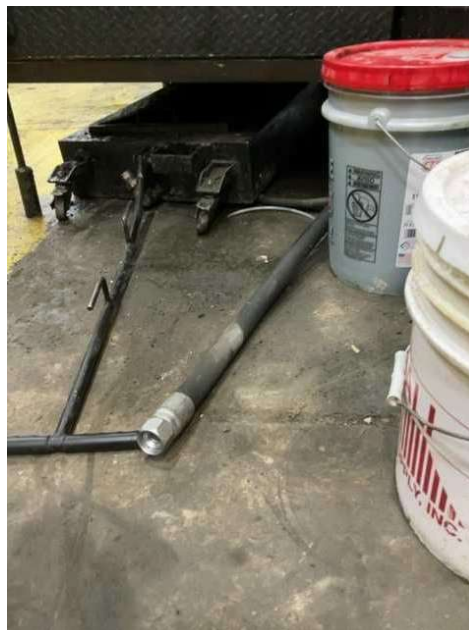
| Another view of the same used oil receiver, seen here beneath the platform, that is not labeled with the words "Used Oil." | | | |

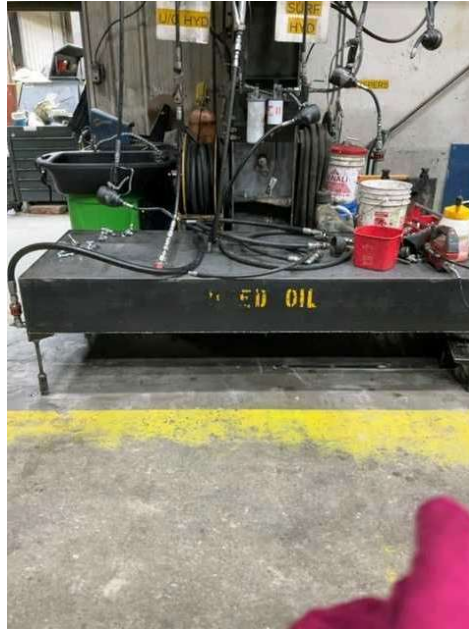
| Another view of the same used oil receiver, seen here beneath the platform, that is not labeled with the words "Used Oil." | | | |

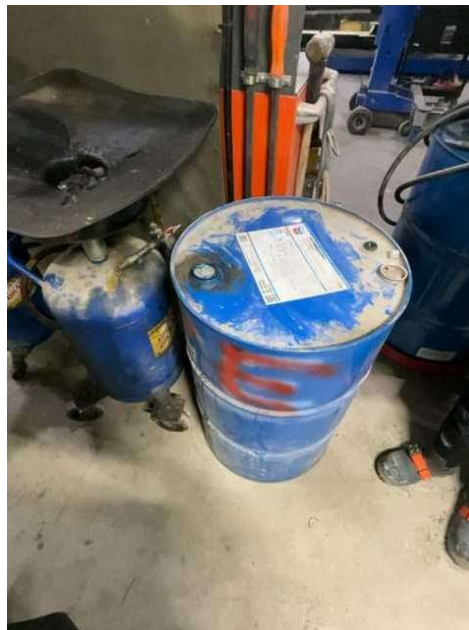
In Bay 1 there was a stationary used oil collector that was also not labeled with the words used oil. The previous labeling had deteriorated to the point that it required relabeling.

| View of used oil collector with deteriorated labeling that requires relabeling with the words used oil. | | | |

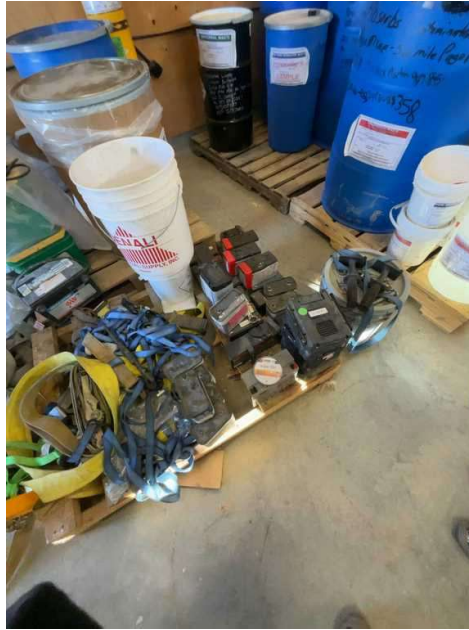
During the inspection, I observed 18 to 20 waste batteries on a pallet that were not labeled or clearly marked as "Universal Waste – Battery," "Waste Battery," or "Used Battery." I asked about management of those batteries; Ms. Clancy did not know how the batteries were managed. The facility's October 16, 2024 response letter stated that all batteries are managed as Universal waste while on site and then shipped to Total Reclaim - Anchorage for recycling.

| Waste batteries that are managed as universal waste, but seen here unlabeled. | | | |

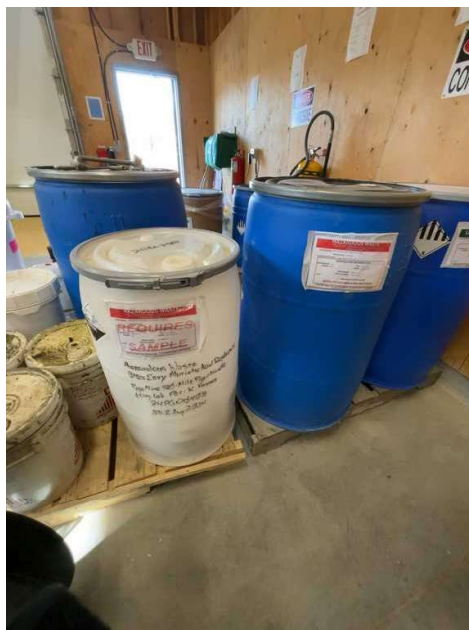
| View of waste containers in the CAA. Seen here are a few containers that are not labeled and appear to need a waste determination. | | | |

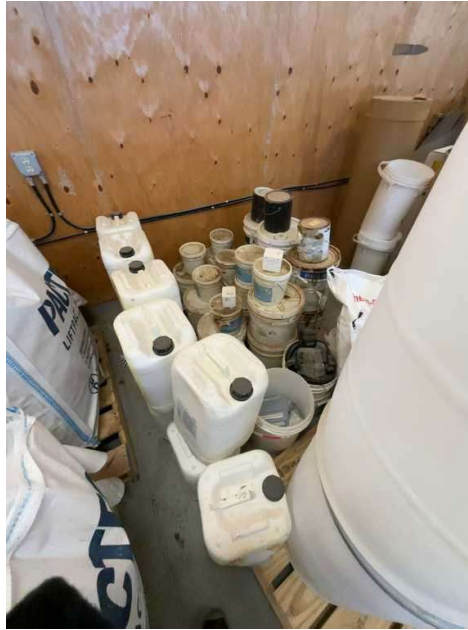
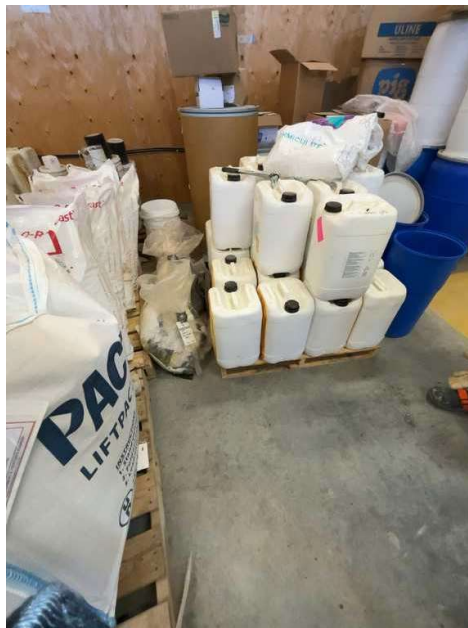
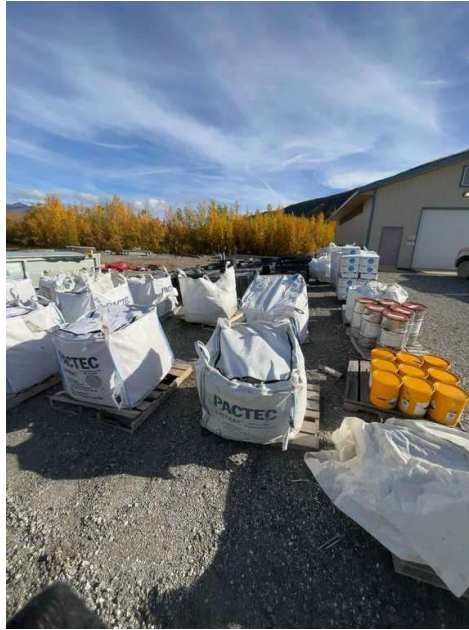
| Failure to make a hazardous waste determination at the point of generation. | <b>Regulation:</b> | <b>Sections:</b> |

| View of suspect wastes that the facility may have failed to make a hazardous waste determination at the point of generation. | | | |

| Another view of the same suspect wastes that the facility may have failed to make a hazardous waste determination at the point of generation. | | | |

| View of additional suspect wastes that the facility may have failed to make a hazardous waste determination at the point of generation. | | | |

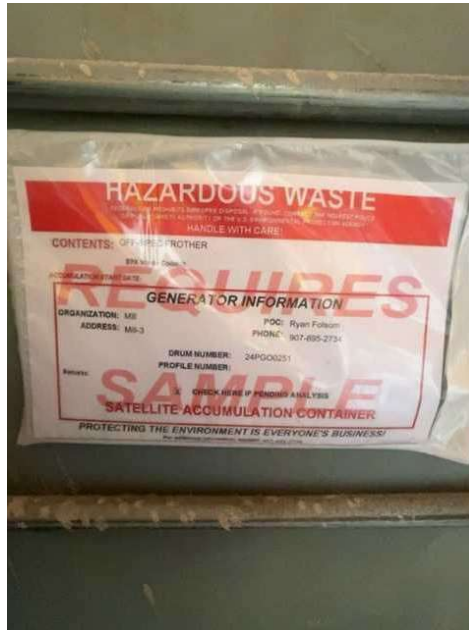
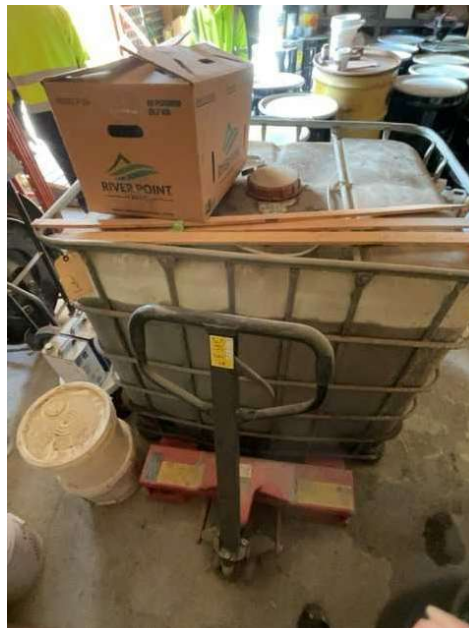
- A 375-gallon tote labeled "Hazardous Waste-Frother-Pending Analysis," with no accumulation start date (ASD), and no hazard indicator.
- A five-gallon container of waste hydraulic fluid not labeled with the words "Used Oil."
- Multiple containers in various sizes that appeared to be inherently waste-like. There was no indication as to how long the suspected wastes had been onsite.

| View of 375-gallon tote labeled as Hazardous Waste pending analysis, with no ASD, or hazard indicator. | | | |

| Close-up view of the label on the 375-gallon tote labeled as Hazardous Waste pending analysis, with no ASD, or hazard indicator. | | | |

*The SDS was used to perform a waste determination and profile the Frother for offsite management. The material is non-hazardous. After completing the waste determination and profiling, the correct labels were generated and are now affixed. A photograph of a correct label is included as Attachment 4.*

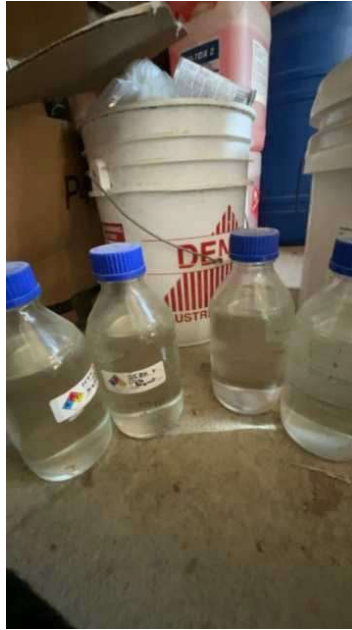
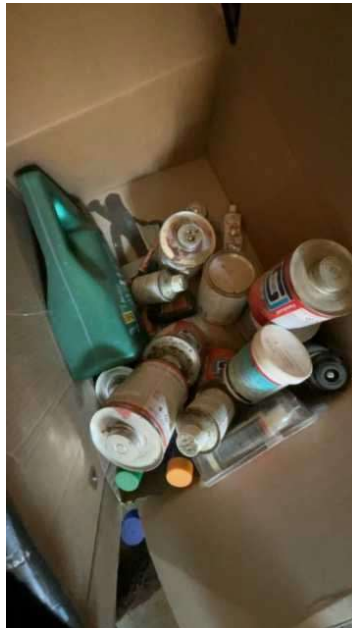
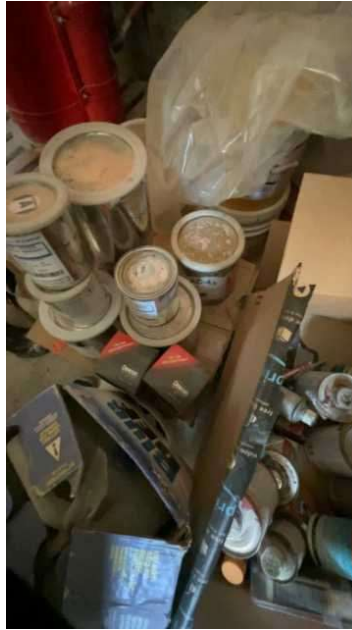
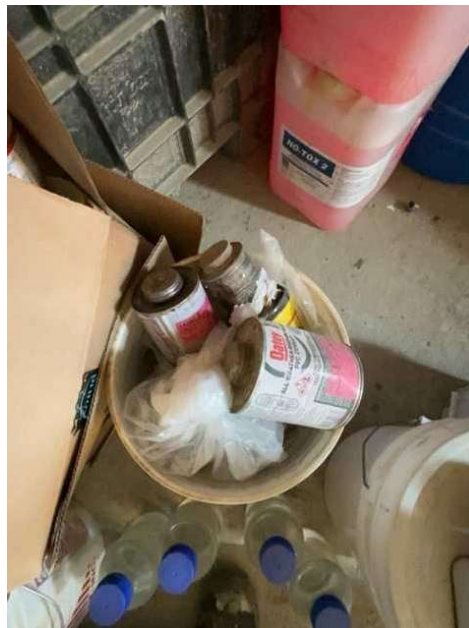
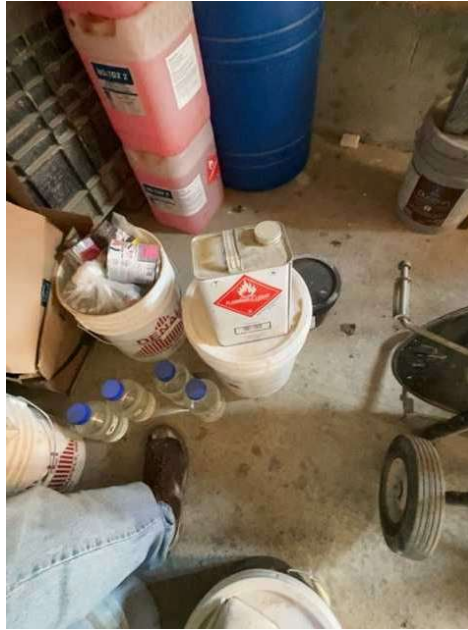
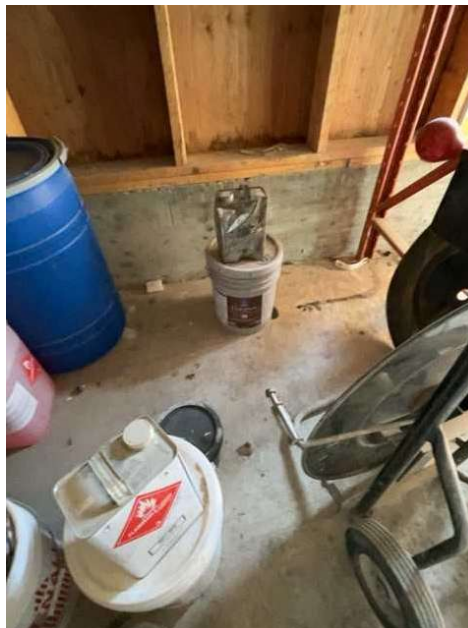
| <p>A five-gallon container of waste hydraulic fluid not labeled with the words "Used Oil."</p> <p>Failure to make a hazardous waste determination at the point of generation for multiple containers in various sizes that appeared to be inherently waste-like. There was no indication as to how long the suspected wastes had been onsite.</p> | <b>Regulation:</b> | <b>Sections:</b> |

| View of various containers all over the floor of the CAA that look like they require a hazardous waste determination. | | | |

| Another view of various containers all over the floor of the CAA that look like they require a hazardous waste determination. | | | |

| Another view of various containers all over the floor of the CAA that look like they require a hazardous waste determination. | | | |

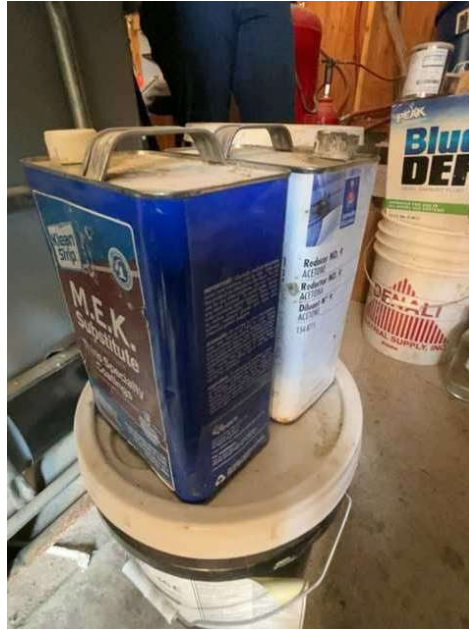
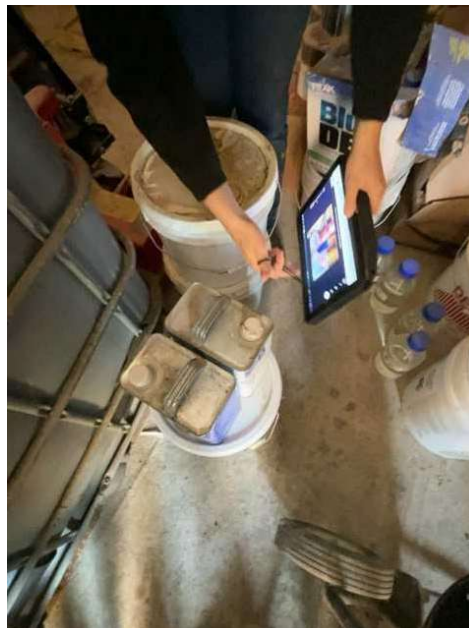
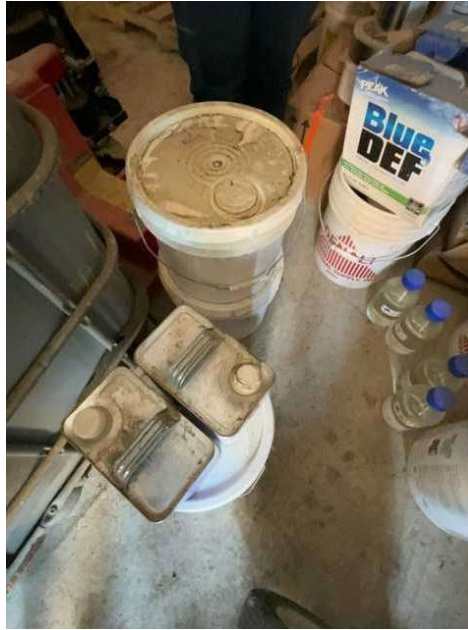
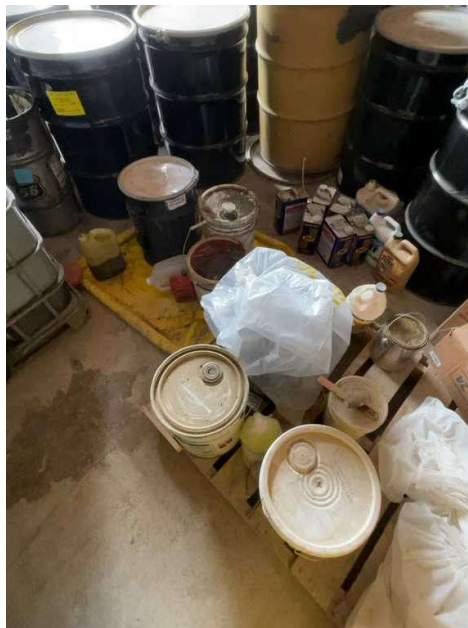
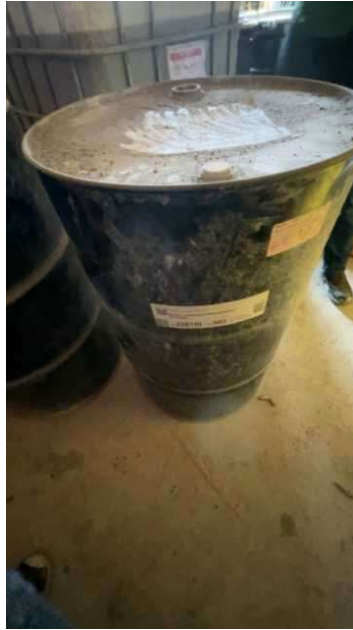
| Another view of various containers all over the floor of the CAA that look like they require a hazardous waste determination. | | | |

| Another view of various containers all over the floor of the CAA that look like they require a hazardous waste determination. | | | |

| Another view of various containers all over the floor of the CAA that look like they require a hazardous waste determination. | | | |

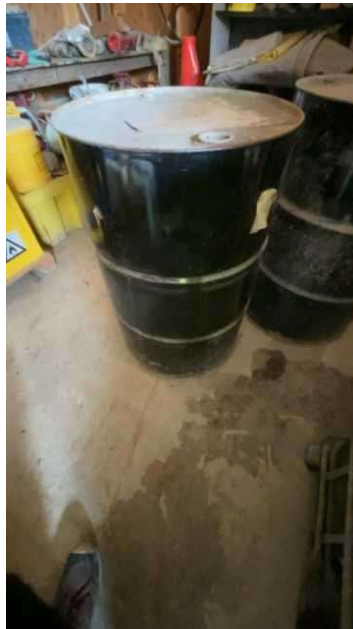
| A view of a 55-gallon container in the CAA that requires a hazardous waste determination. | | | |

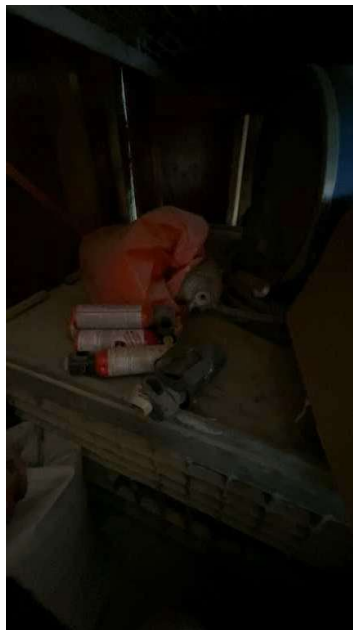
| Another 55-gallon container in the CAA that requires a hazardous waste determination. | | | |

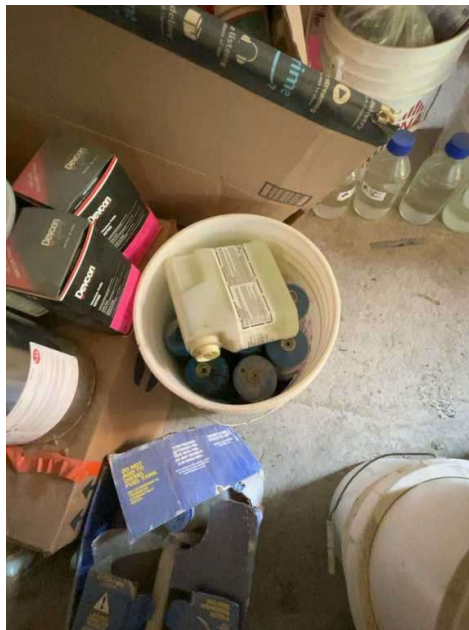
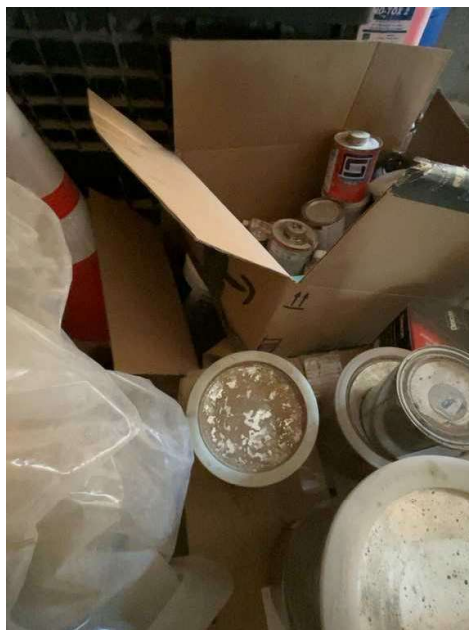
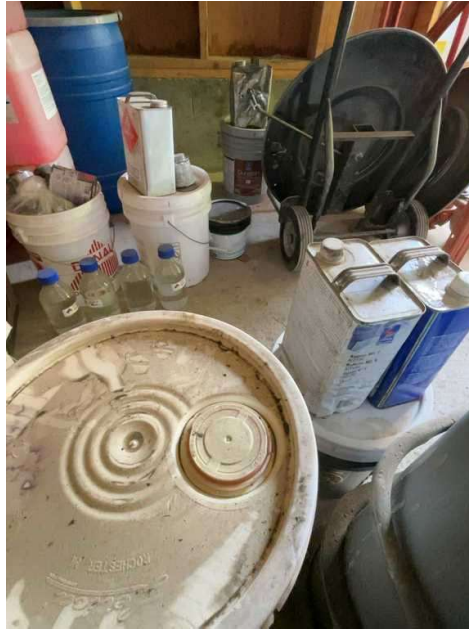
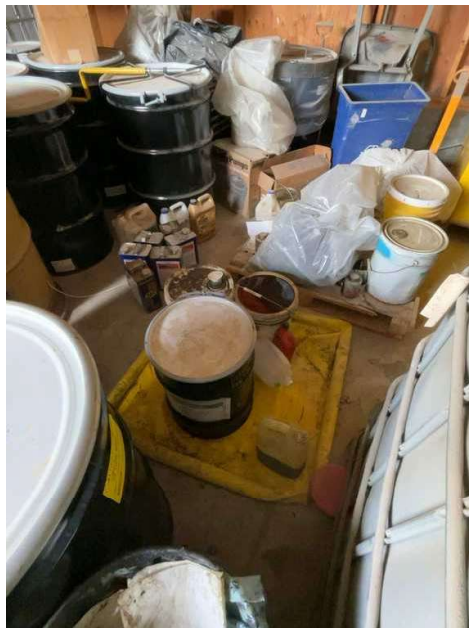
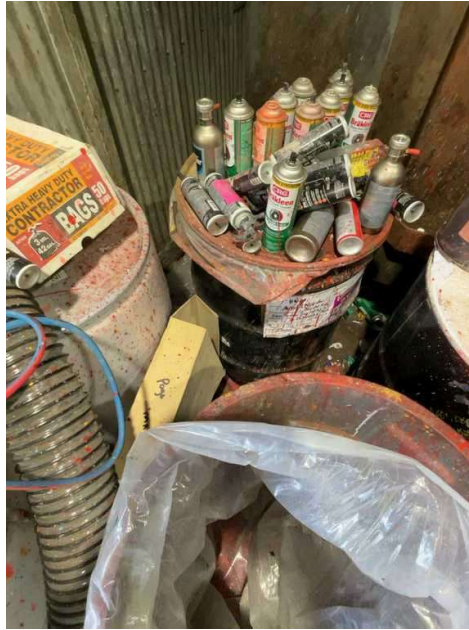
| Another view of various containers all over the floor of the CAA that look like they require a hazardous waste determination. | | | |

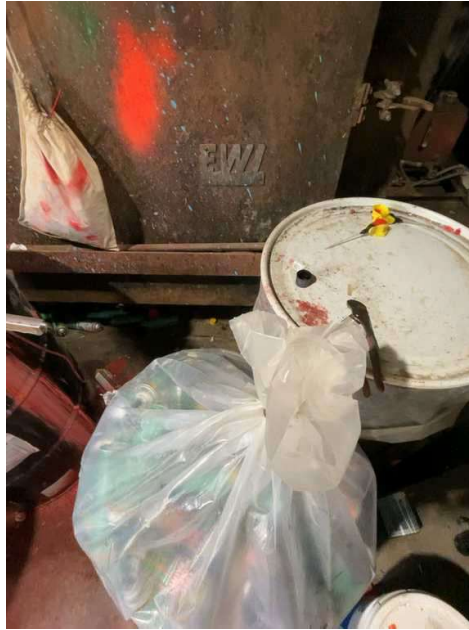
| <p>At the time of the inspection there were four bags of waste aerosol cans and another 22 loose waste aerosols on top of a container that were not labeled or clearly marked with any of the following phrases: "Universal Waste – Aerosol," "Used Aerosol," or "Waste Aerosol."</p> <p>Failure to maintain and operate with regard to a SAA container being used to accumulate waste aerosol can residue. There was a significant amount of aerosol can residue that had been released in and around the area where the aerosol can were punctured.</p> | <b>Regulation:</b> | <b>Sections:</b> |

| View of a bag of waste aerosol cans that is not labeled. | | | |

All aerosol bags noted during the inspection have been punctured. Incoming Aerosols Connex is completely empty as of September 25, 2024 – see Attachment 5.

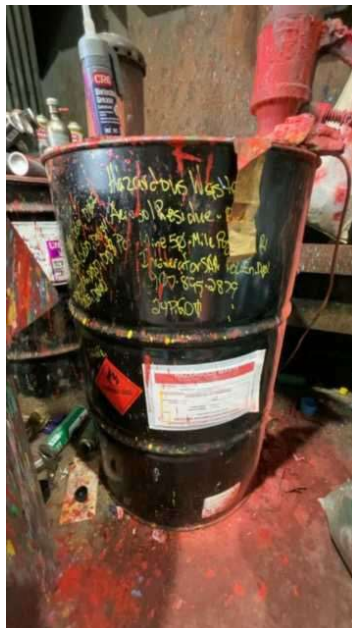
| View of hazardous waste SAA container of aerosol can residue from can puncturing, seen here with splattering and overspray of aerosol can contents all over the SAA. | | | |

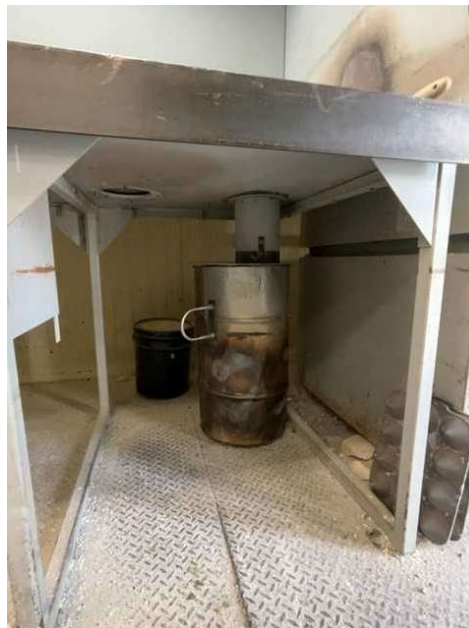
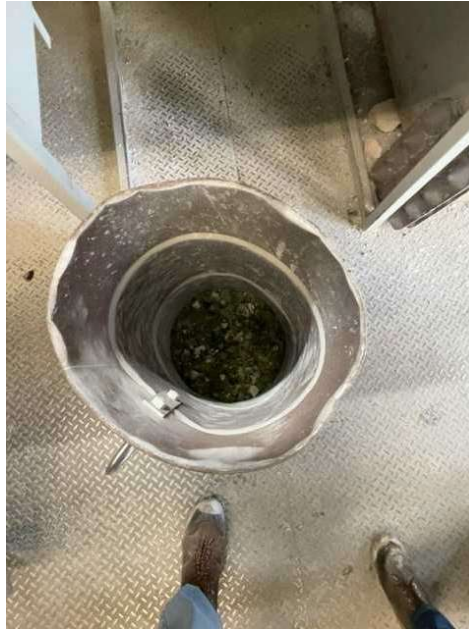
While inspecting the Assay Lab, I saw a container that was approximately 15-gallons in size. The container was beneath an opening in a table where the hot waste crucibles/cupels/and slag was being directed. The contents of this container are transferred to the hazardous waste crucibles/cupels/and slag tote in the Assay Lab CAA. I had Assay Lab personnel pull the container from beneath the table and we saw that it contained some waste crucibles/cupels/and slag. At the time of the inspection, the container was being utilized as a SAA container and was not closed, labeled with the words "Hazardous Waste," or marked with the hazard indicator. This was a repeat issue that was identified during the last RCRA compliance inspection in 2019.

| <p>A 15-gallon SAA container of Assay lab wastes and was not closed, labeled with the words "Hazardous Waste," or marked with the hazard indicator.</p> <p>This was a repeat issue identified during the last RCRA compliance inspection in 2019.</p> | <b>Regulation:</b> | <b>Sections:</b> |

| View of a SAA container, beneath pouring hood, collecting waste crucibles that is seen here not labeled "Hazardous Waste," not marked with a hazard indicator, and not closed. | | | |

| Another view of the same SAA container, beneath pouring hood, collecting waste crucibles that is not labeled "Hazardous Waste," not marked with a hazard indicator, and not closed. | | | |

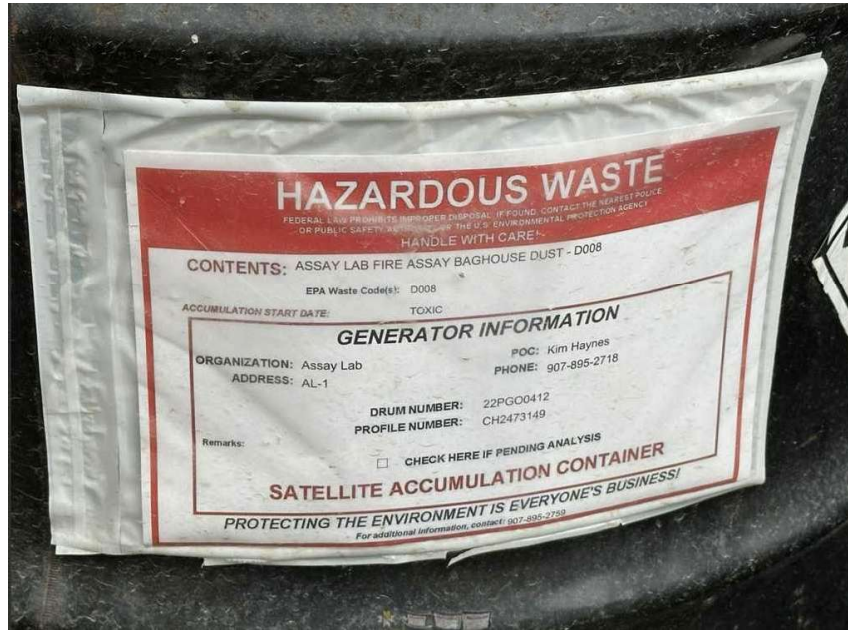
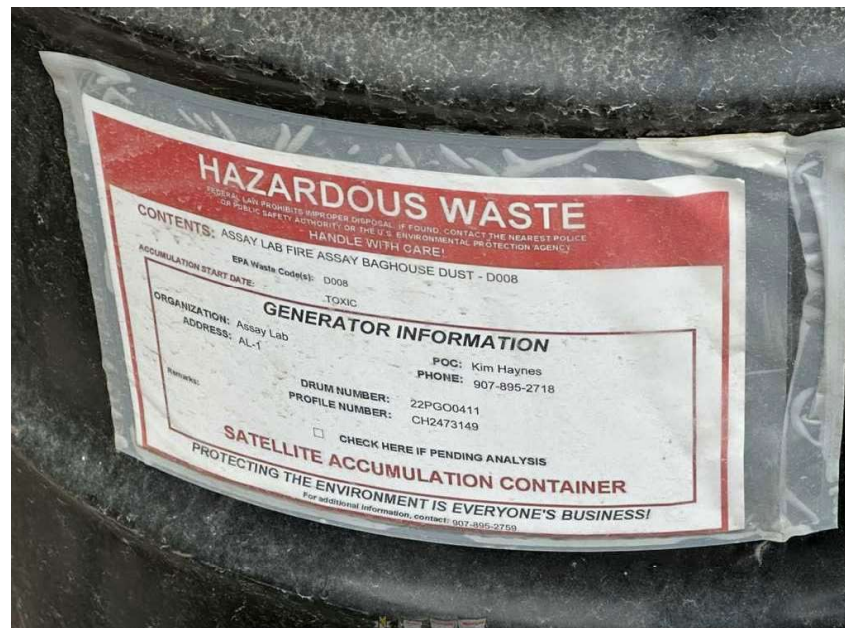
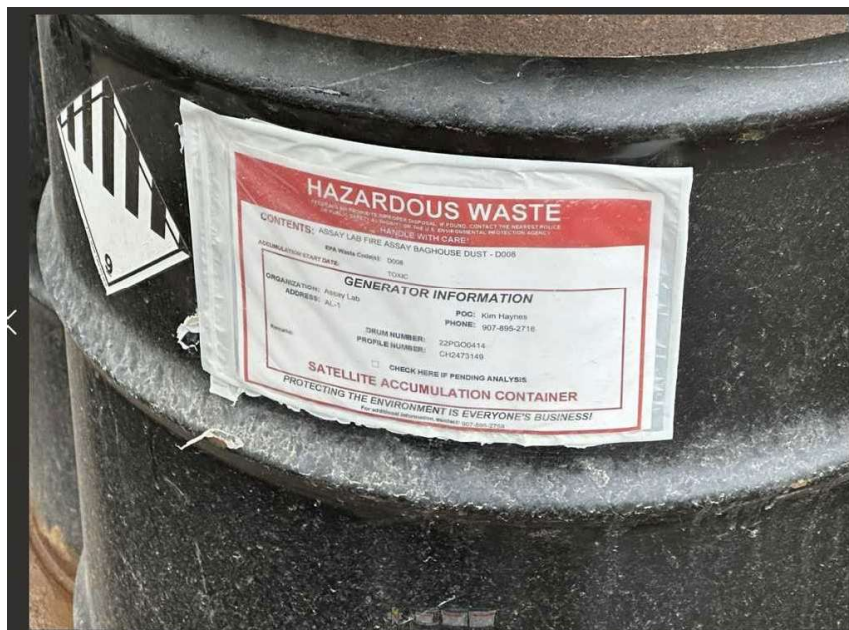
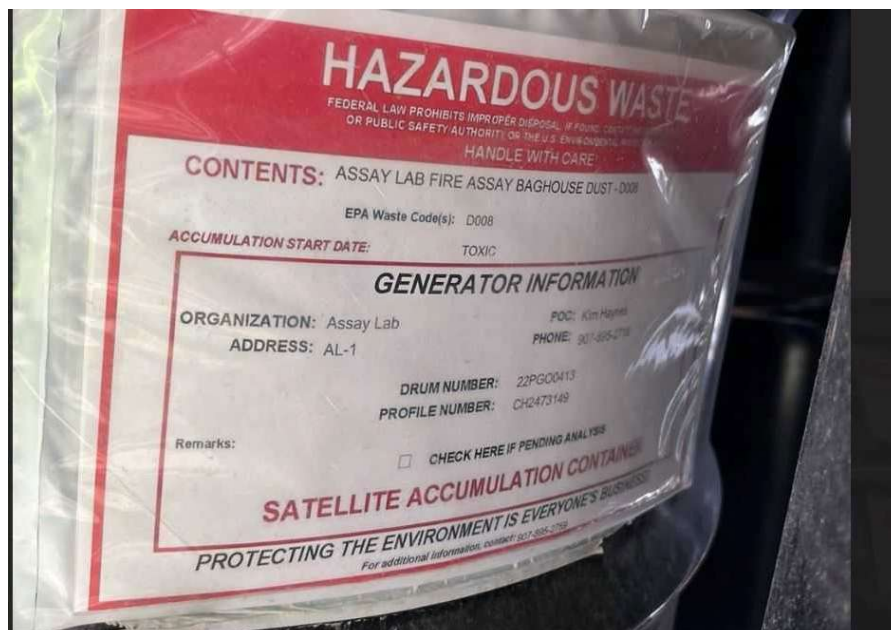
Mr. John Salzman, Environmental Coordinator sent me an email, dated 10/01/24, that included attached photos of the hazardous waste labels on each of the four 55-gallon containers of the baghouse dust waste. The photos provided in the email depicted the containers as they were labeled on the day of the inspection, SAA containers with no ASDs.

| <p>There were four, 55-gallon containers of hazardous waste baghouse dust connected to the base of the baghouse, all were labeled "Hazardous Waste" and simultaneously collecting dust. These four containers were not marked with ASDs and labeled as SAA containers.</p> | <b>Regulation:</b> | <b>Sections:</b> |

| Photo of the container label sent in by the facility showing no changes. The label still indicates the container is an SAA container vs an accumulation container and there is no ASD. | | | |
