# NPDES Compliance Inspection Report

**Rick Franklin Corporation  
Lebanon, Oregon**

**Permit #: ORR607180**

**Inspection Date: December 17, 2021**

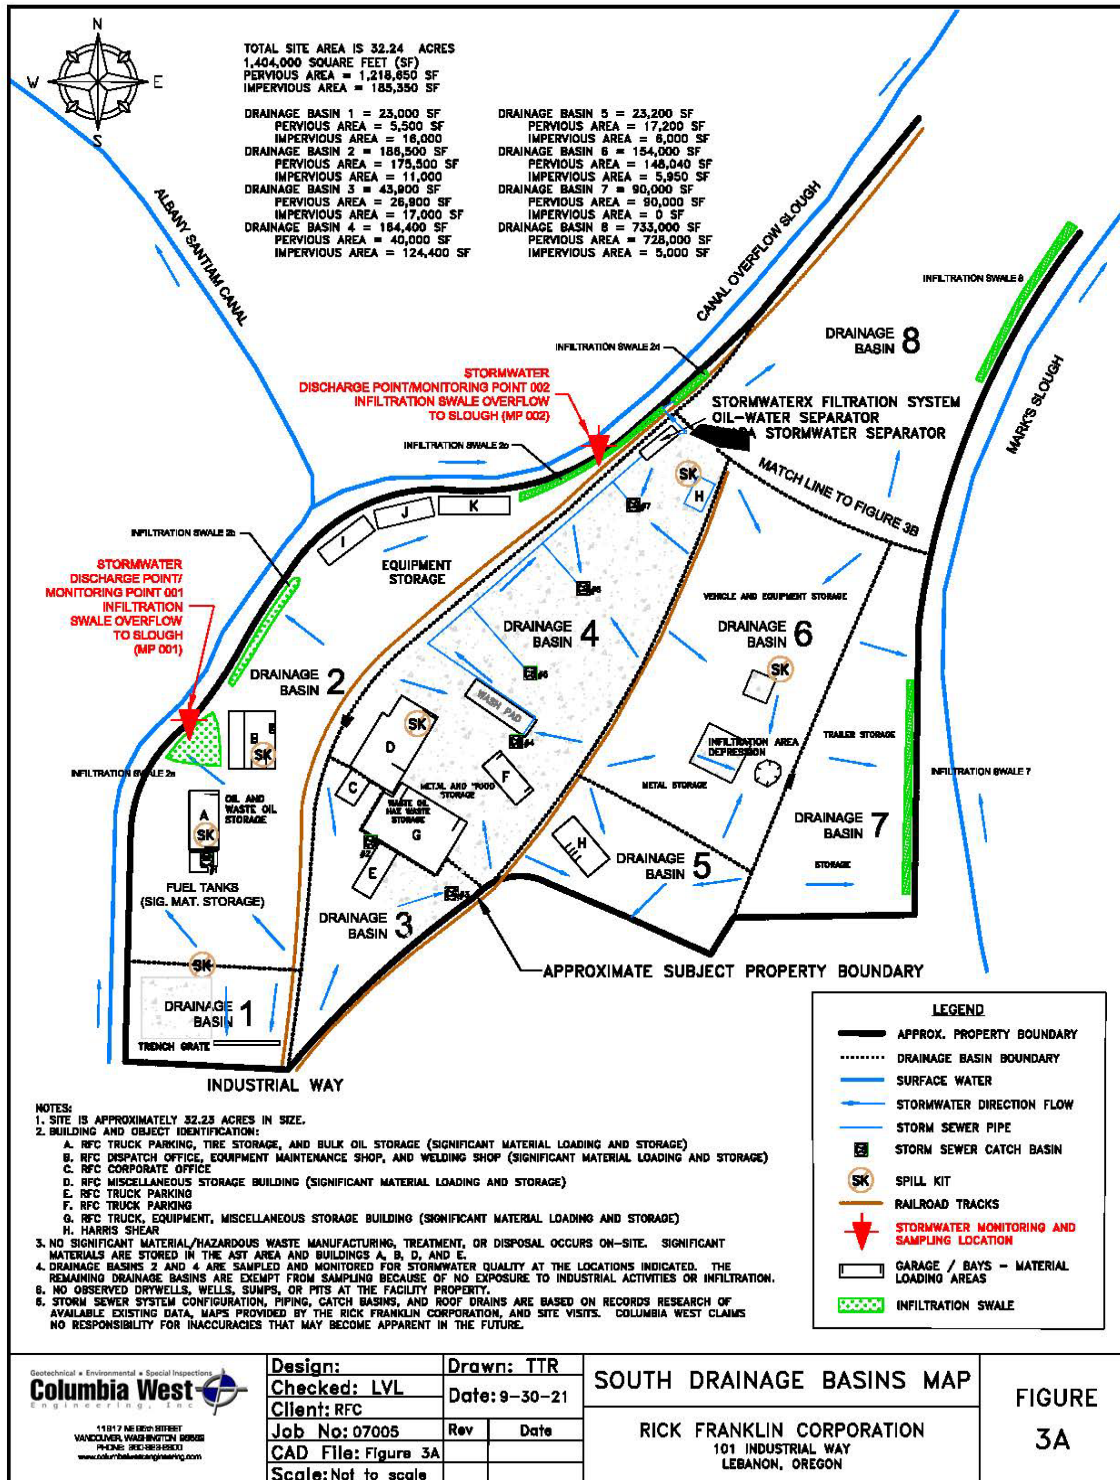
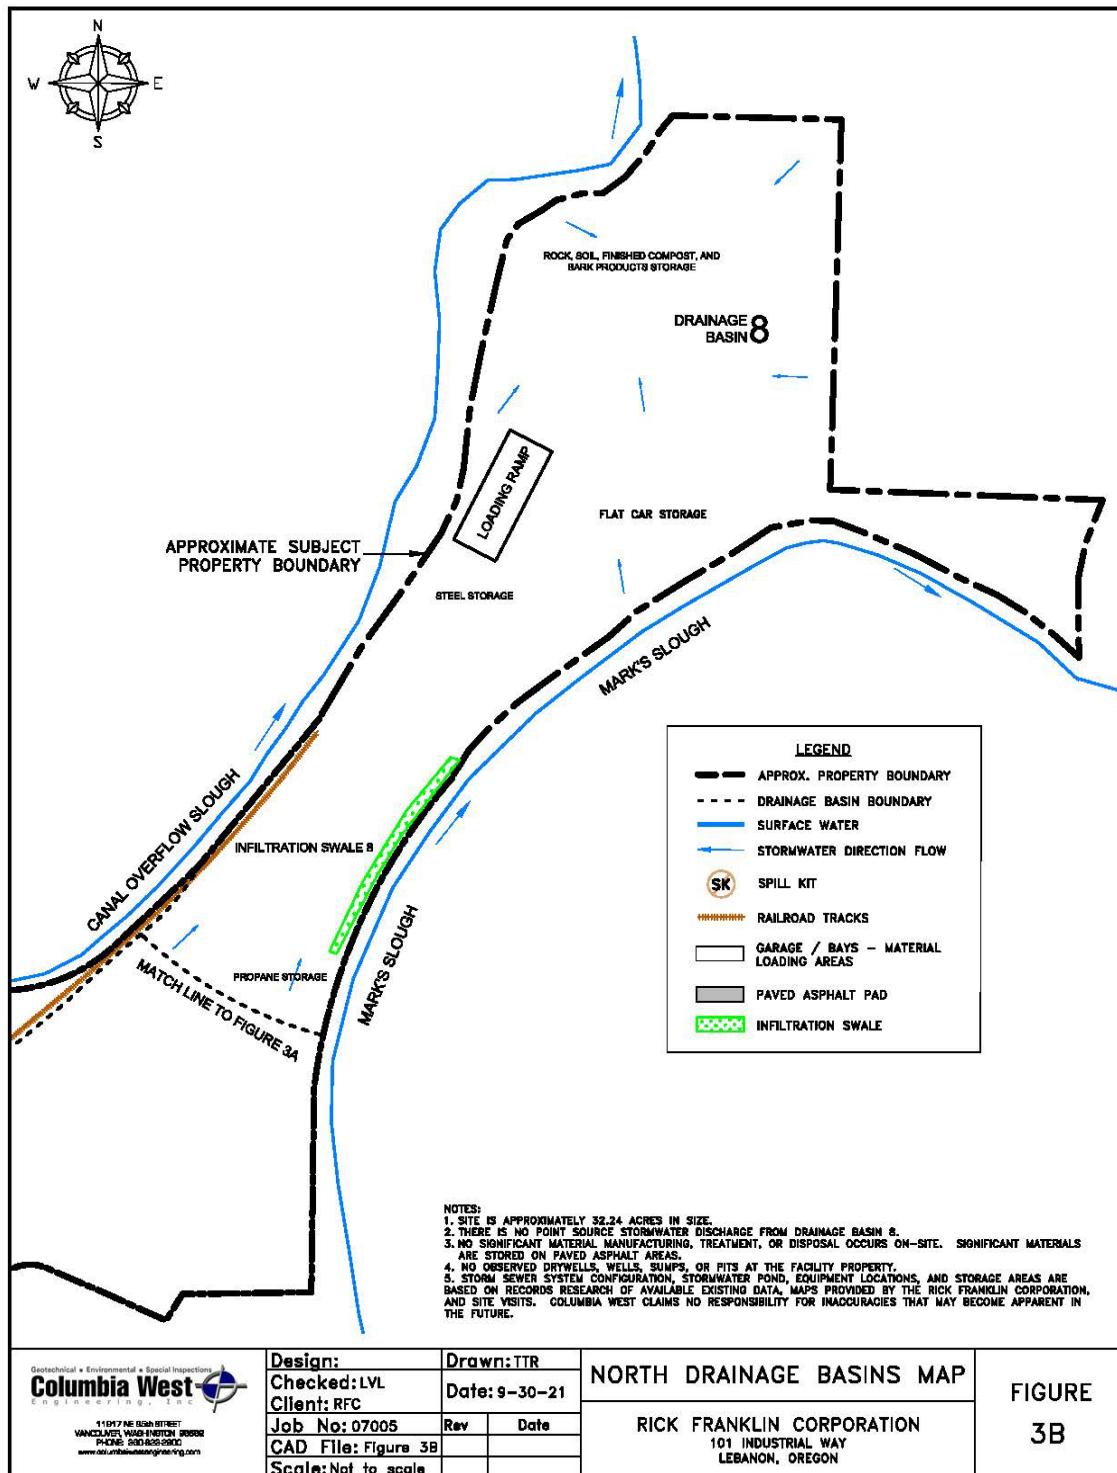
Schedule A.10.b.i.6 of the Permit states must include and clearly label "paved areas and buildings within each drainage area..."

The site map shows three buildings, labeled I, J, and K, positioned end-to-end. The labels were not identified at the bottom of the map in number two of "Notes" as other structures had been identified.

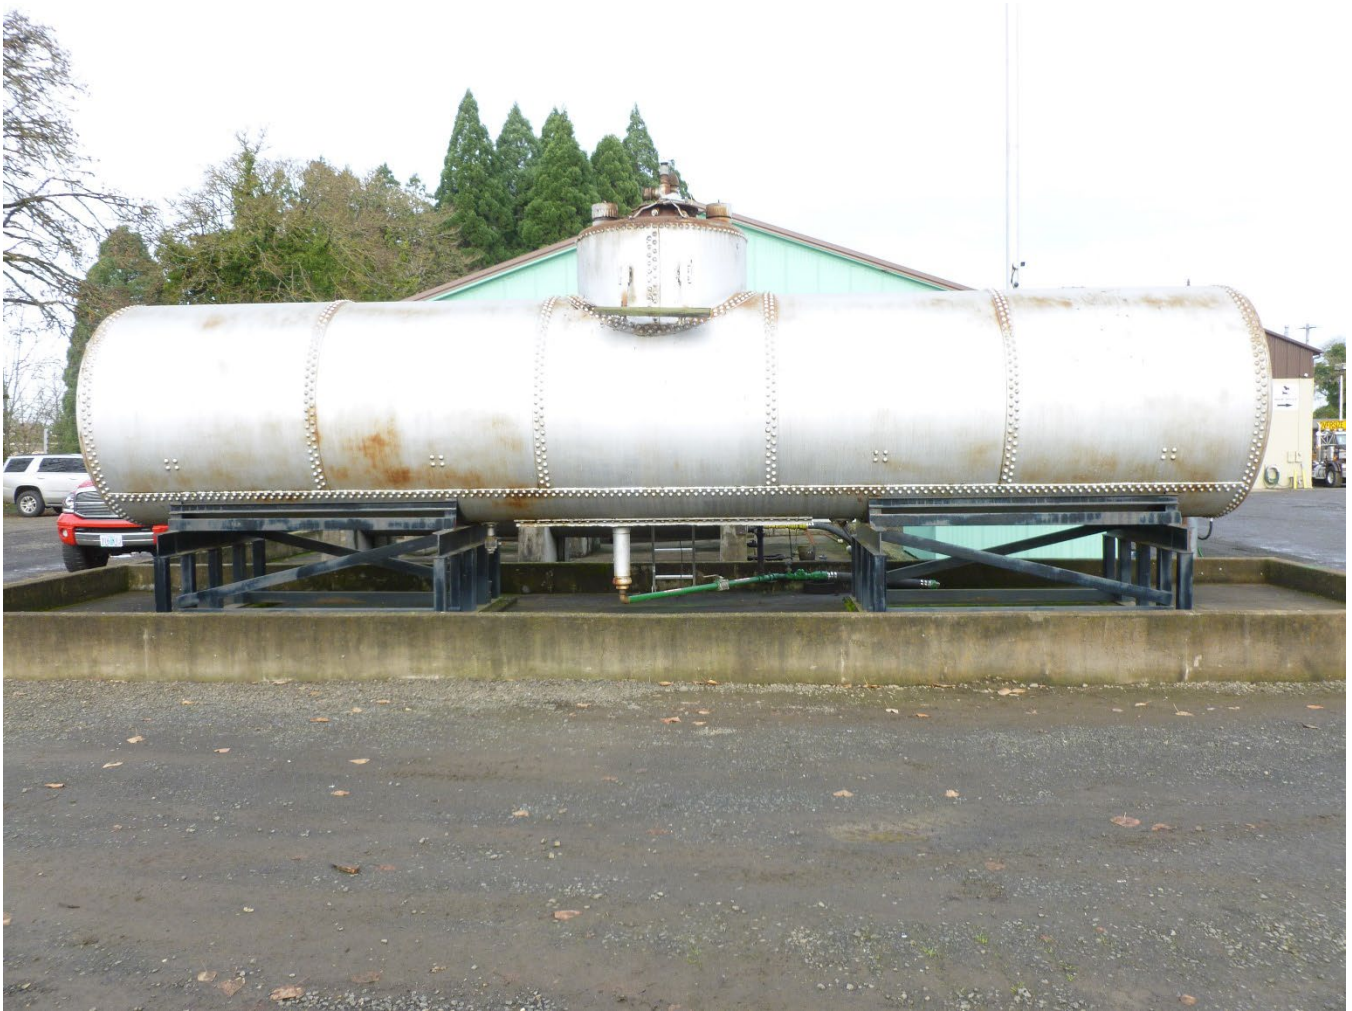
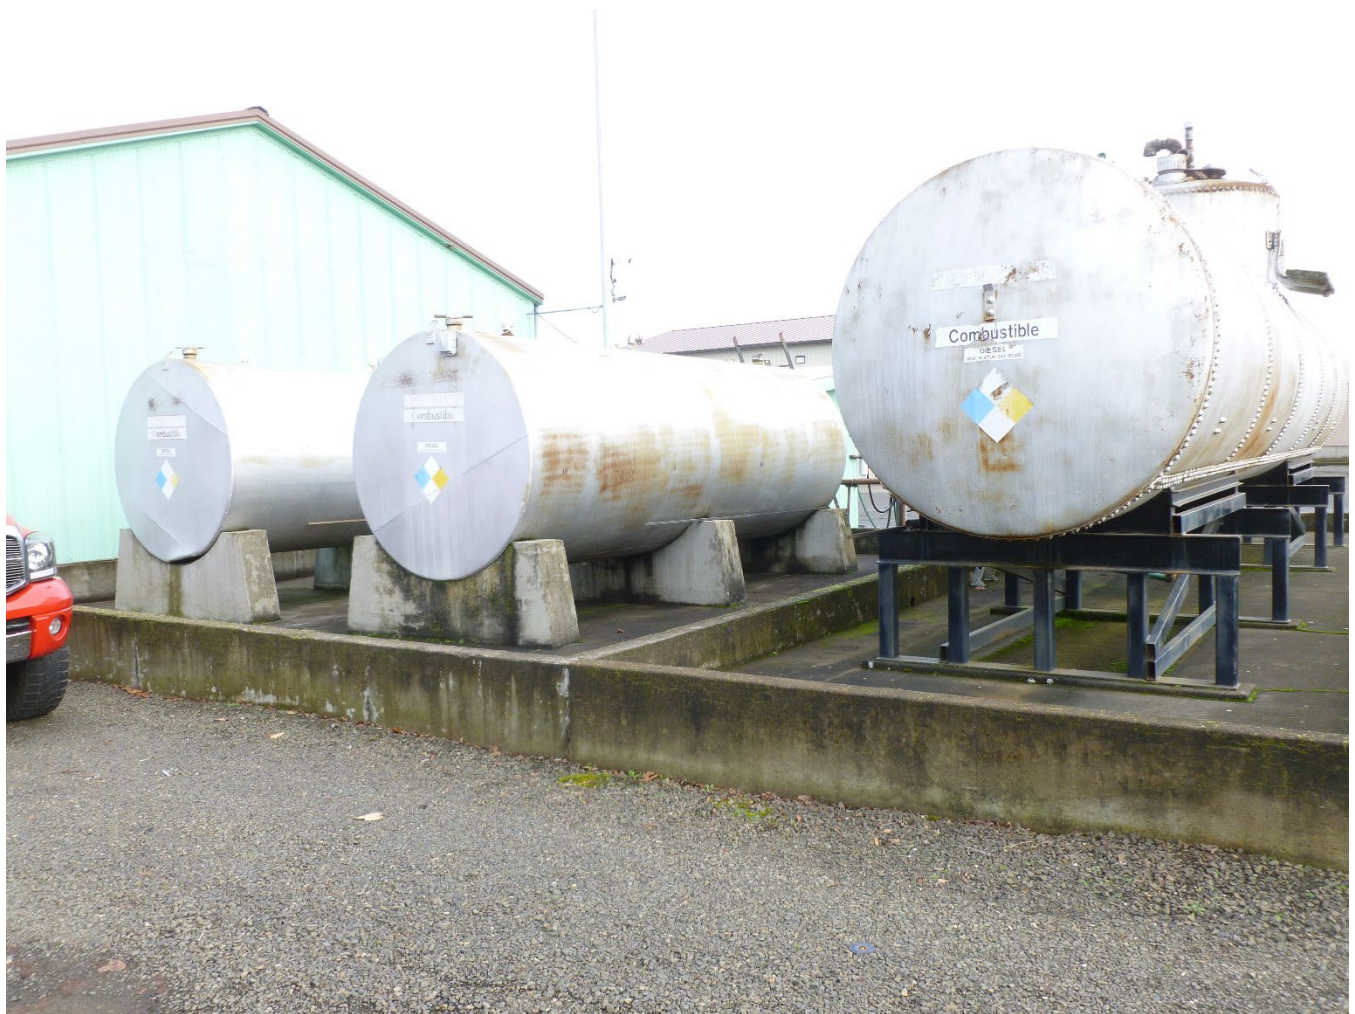
I told Mr. Robinson I wanted to see the diesel storage tanks that were mentioned in the opening conference. From the office, we walked west to the tanks. The facility has three diesel storage tanks, two 3,200 gallon tanks and one 8,000 gallon tank (**Photos 1 & 2**). All three tanks are double-walled and held in secondary containment.

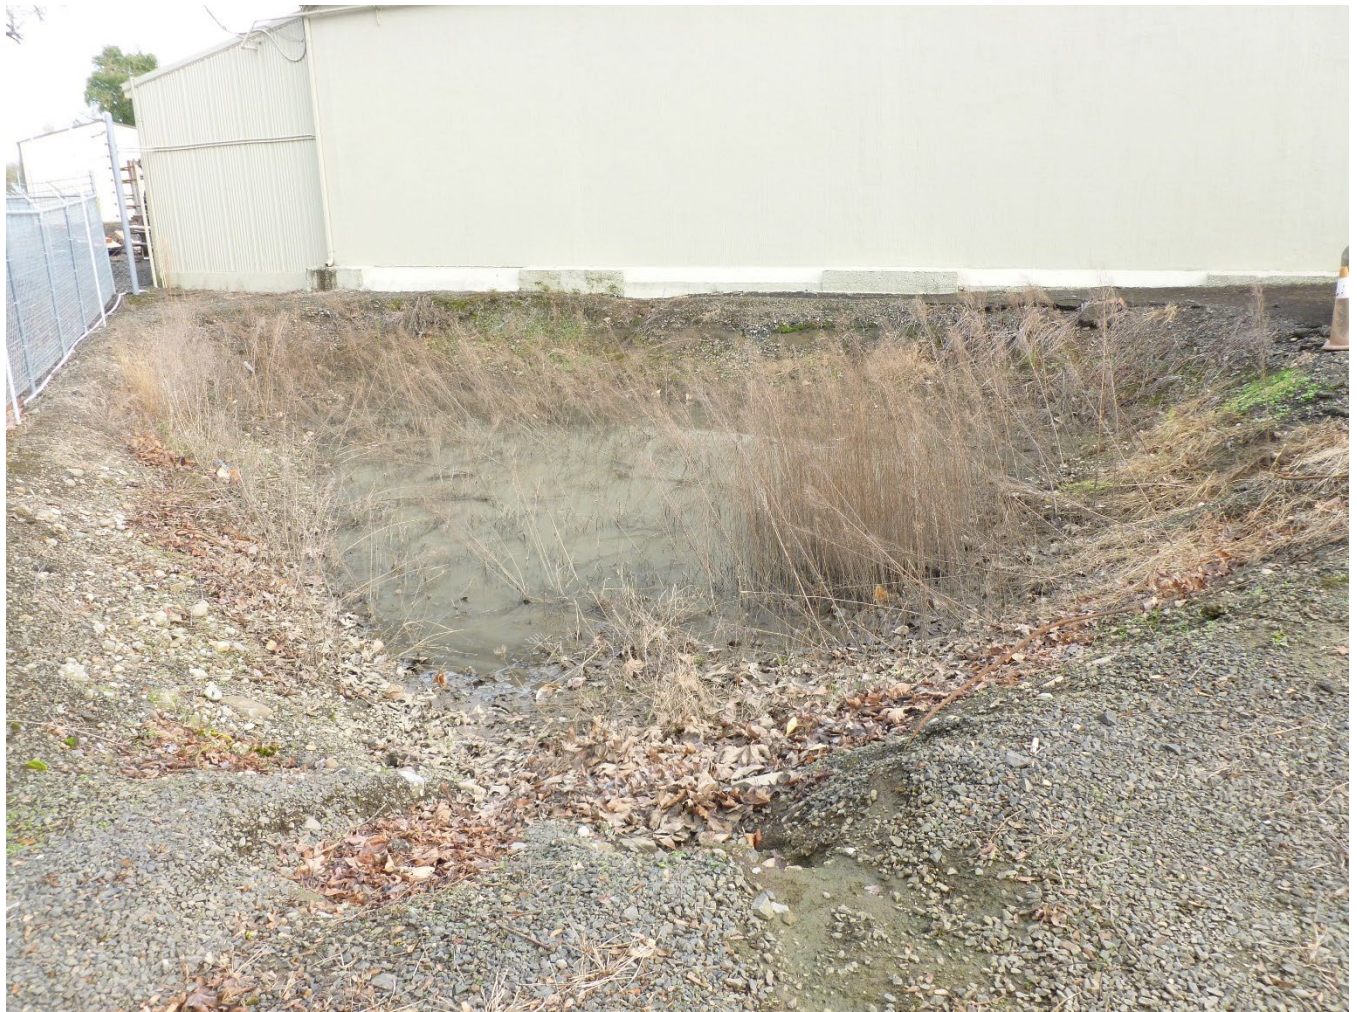
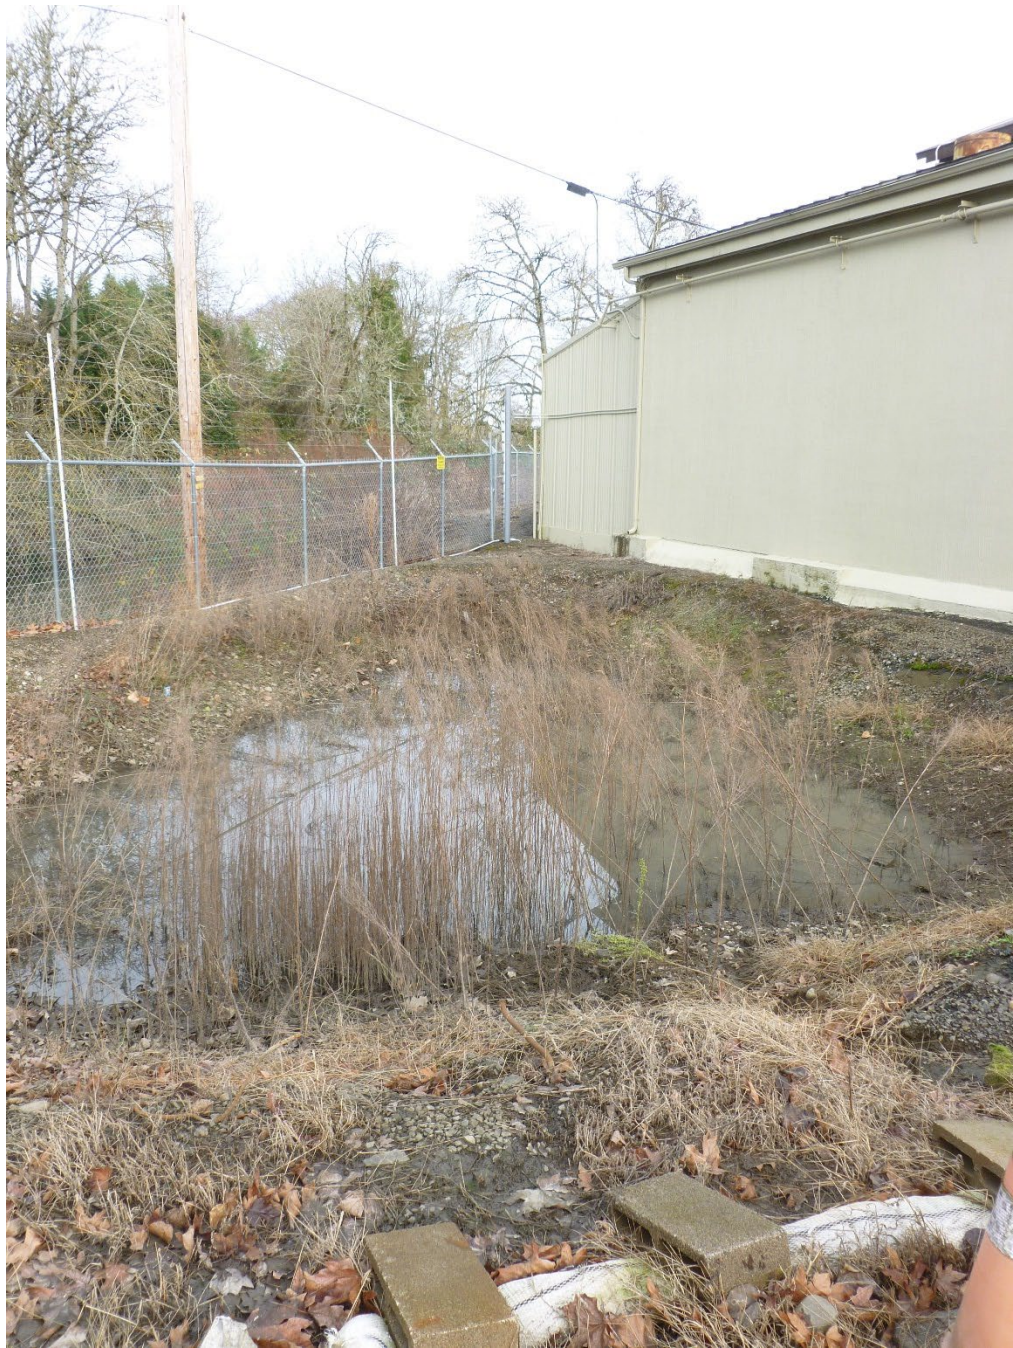
From the storage tanks, we turned slightly north and came to bioswale 1, MP001 (**Photos 3 & 4**). We continued north and came to bioswale 2, MP002 (**Photo 5**). Bioswales 1 and 2 are adjacent to the Albany-Santiam Canal.

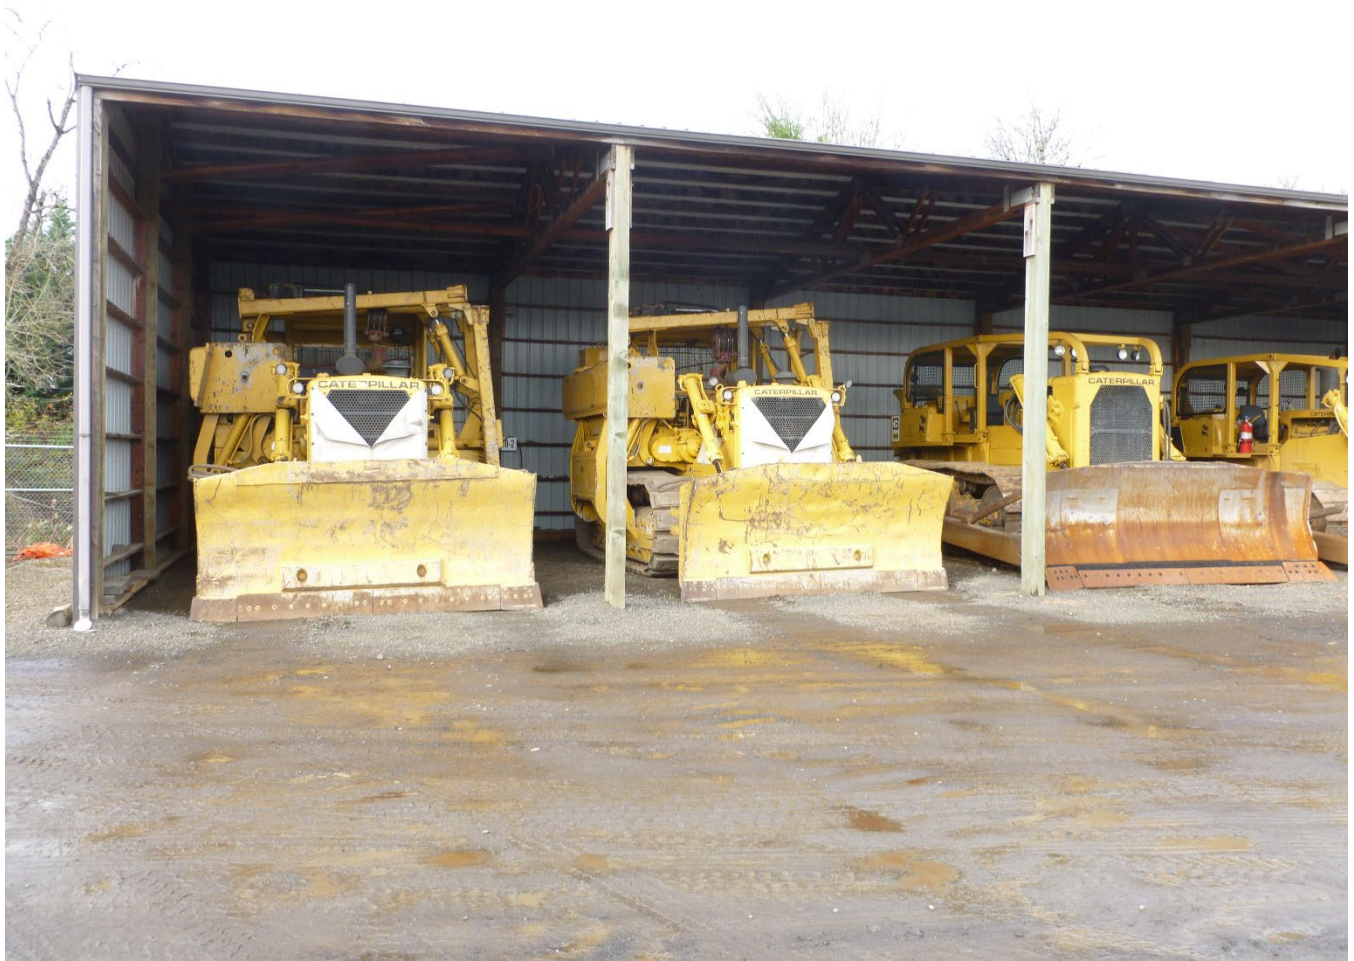
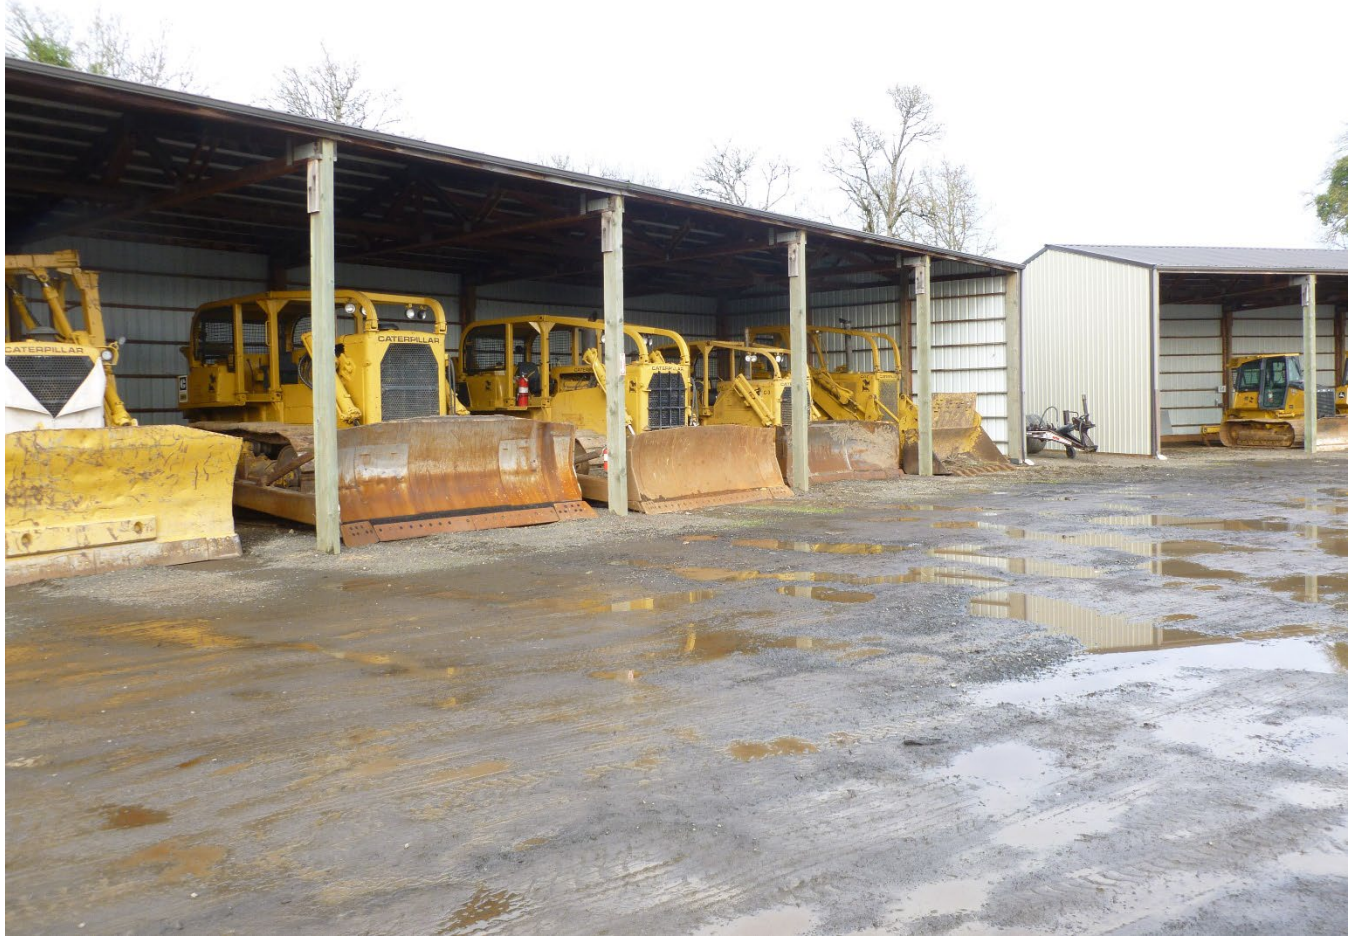
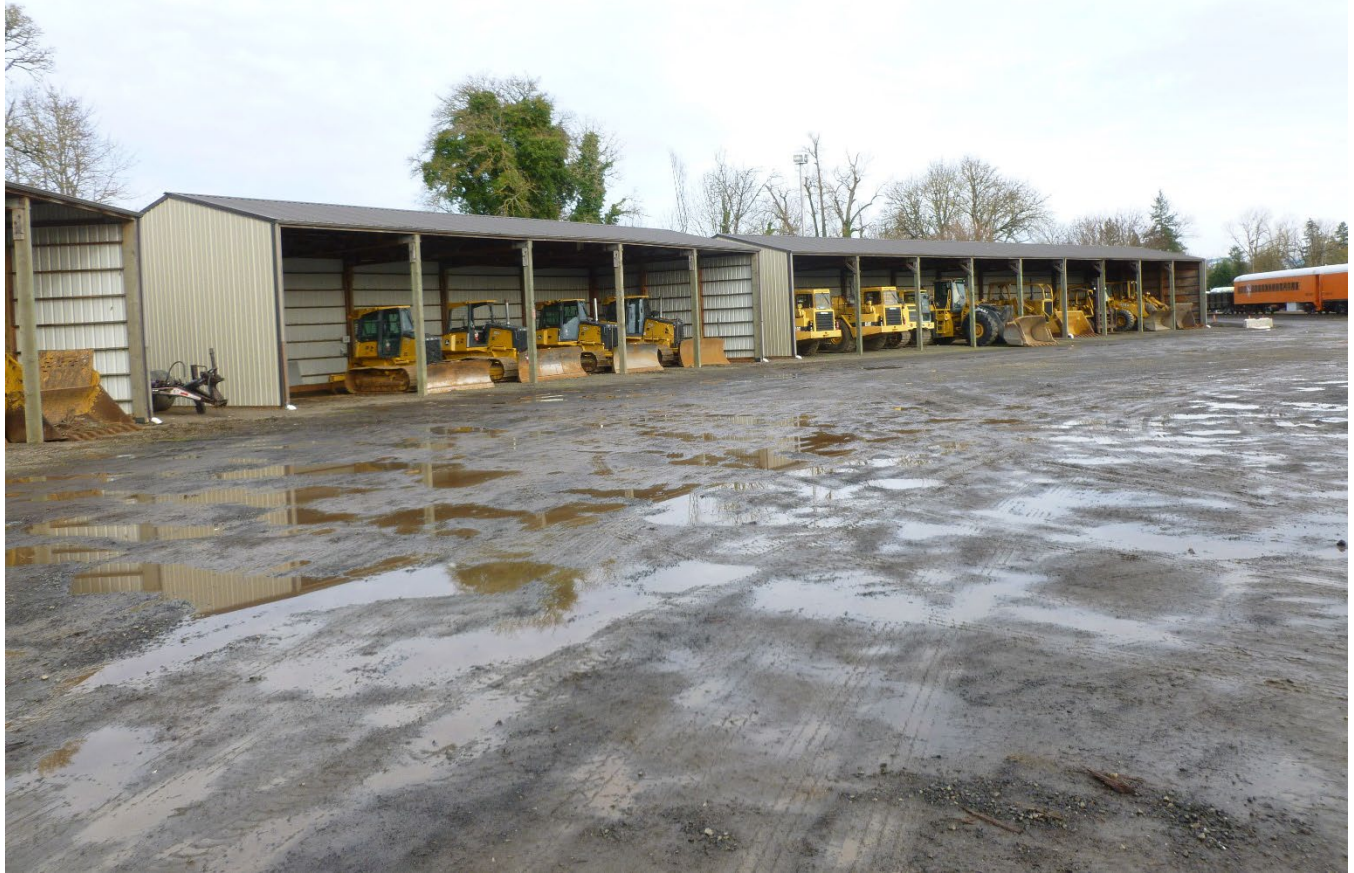
I observed heavy equipment stored under cover (**Photos 6 – 8**). The yard, as can also be seen in photos 6 – 8, has puddles of water from a recent rainfall event but no water flowing at the time of the inspection.

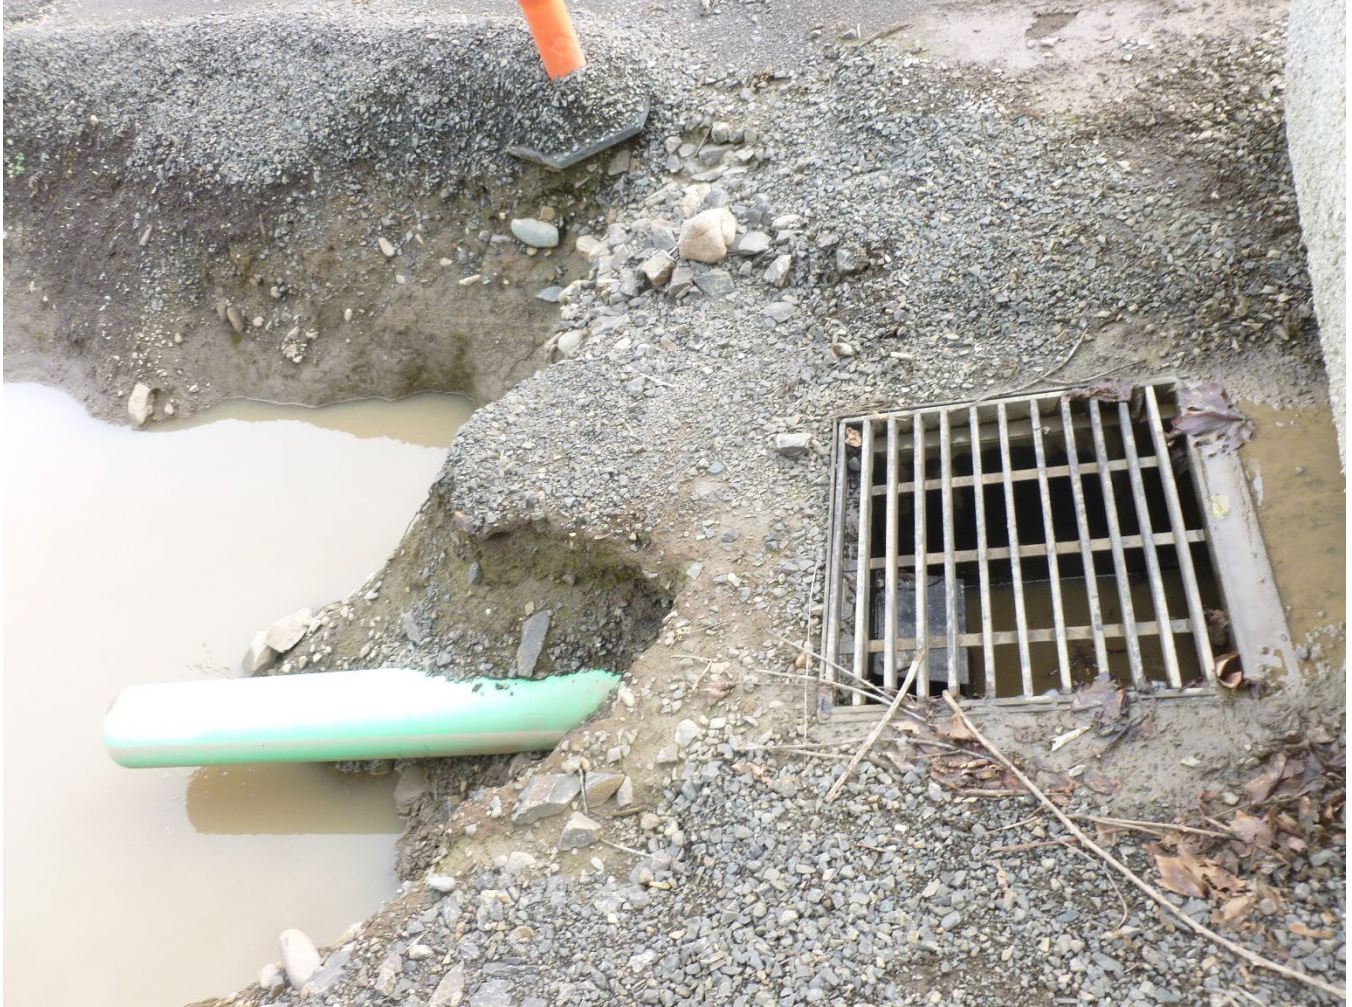
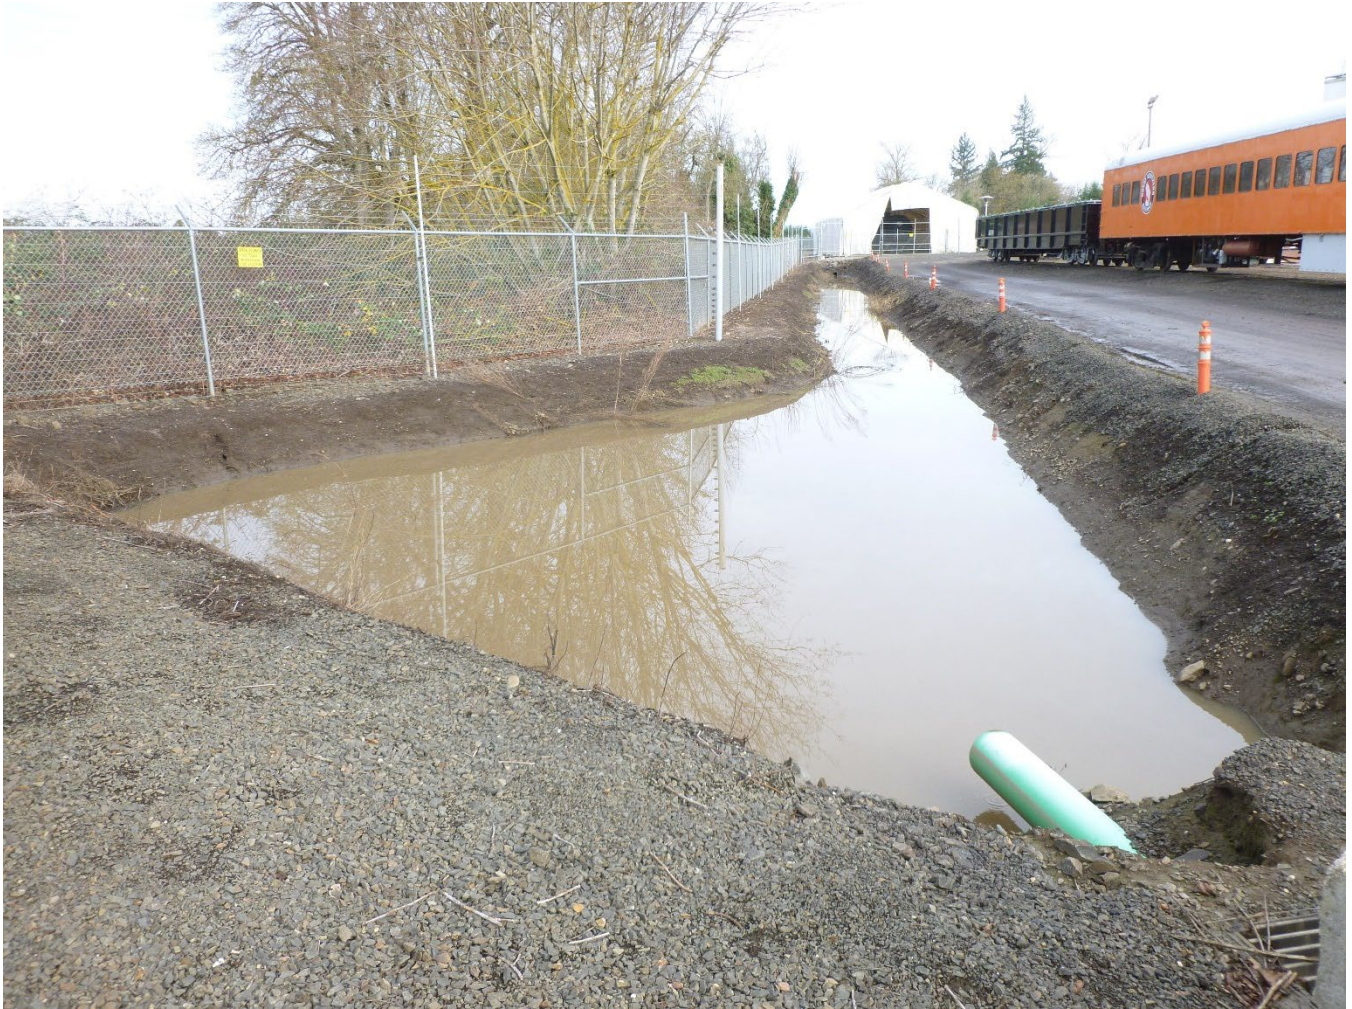
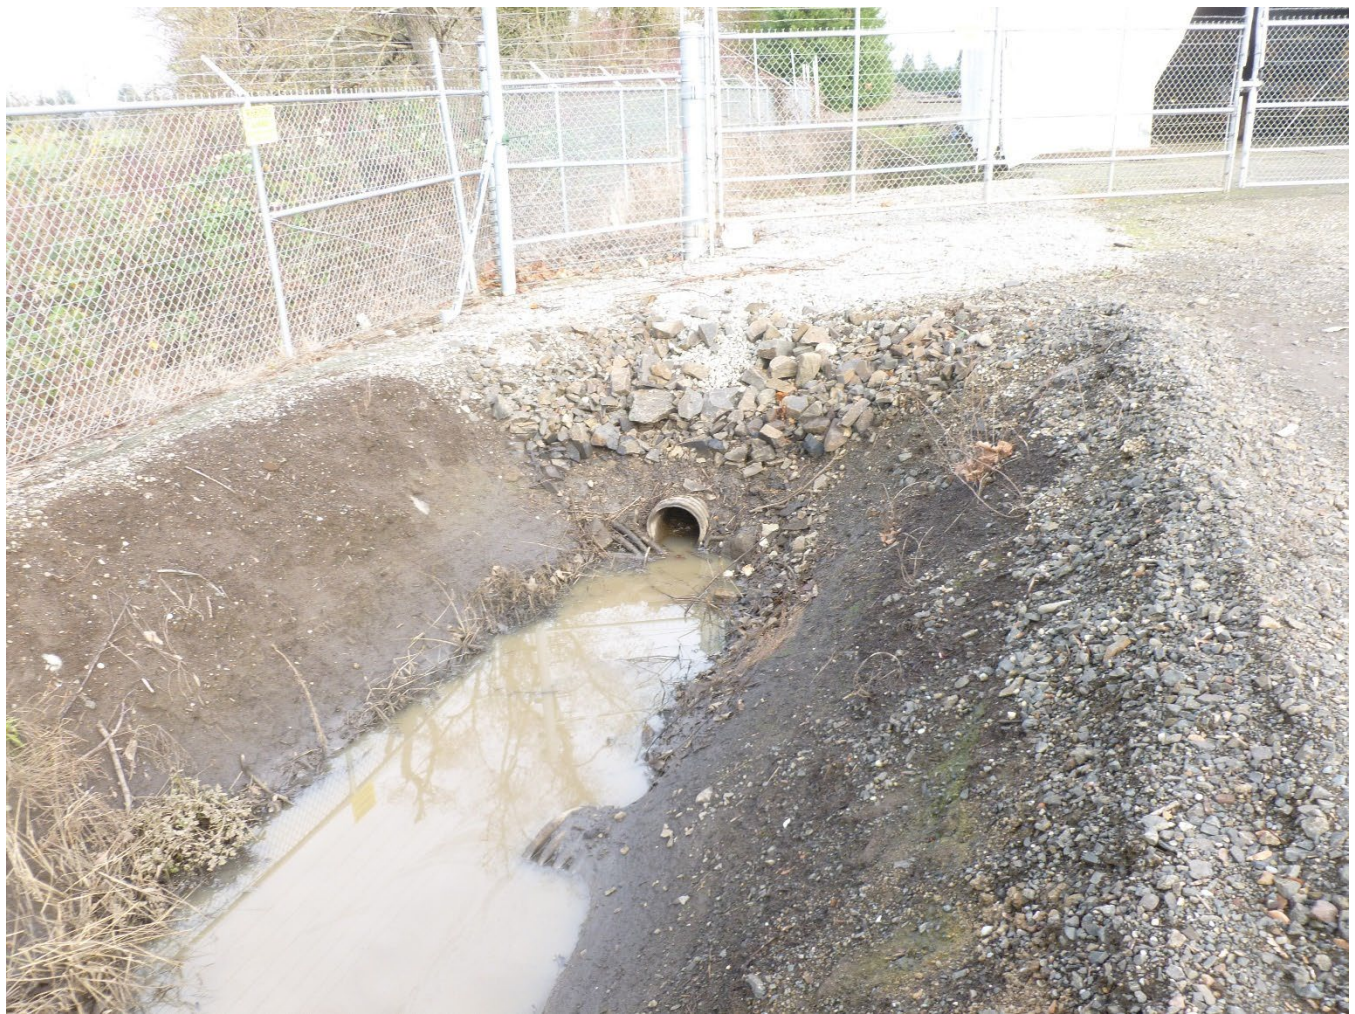
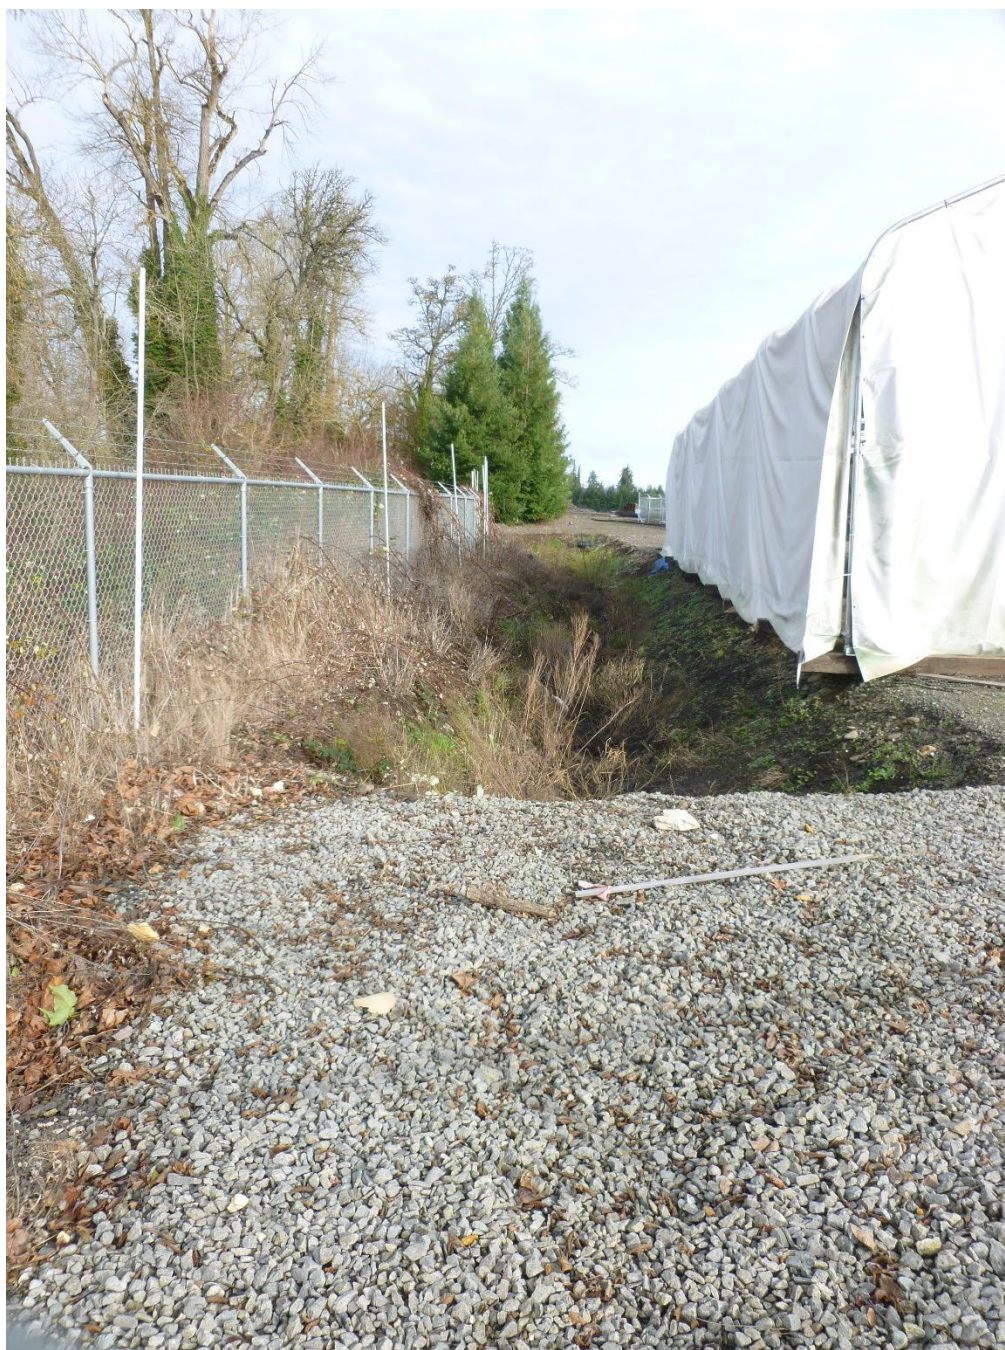
We continued walking north to bioswale 3 (**Photos 9 – 12**). Photo 9 shows a white PVC pipe that drains stormwater into the bioswale. Also in the photo is a catch basin to the right of the pipe. There are six catch basins around the site to collect stormwater. The culvert seen in Photo 11 goes underground and drains the stormwater to a perforated pipe to facilitate disbursement and infiltration. Bioswale 3 is long and adjacent to both the Albany-Santiam Canal and the Canal Overflow Slough.

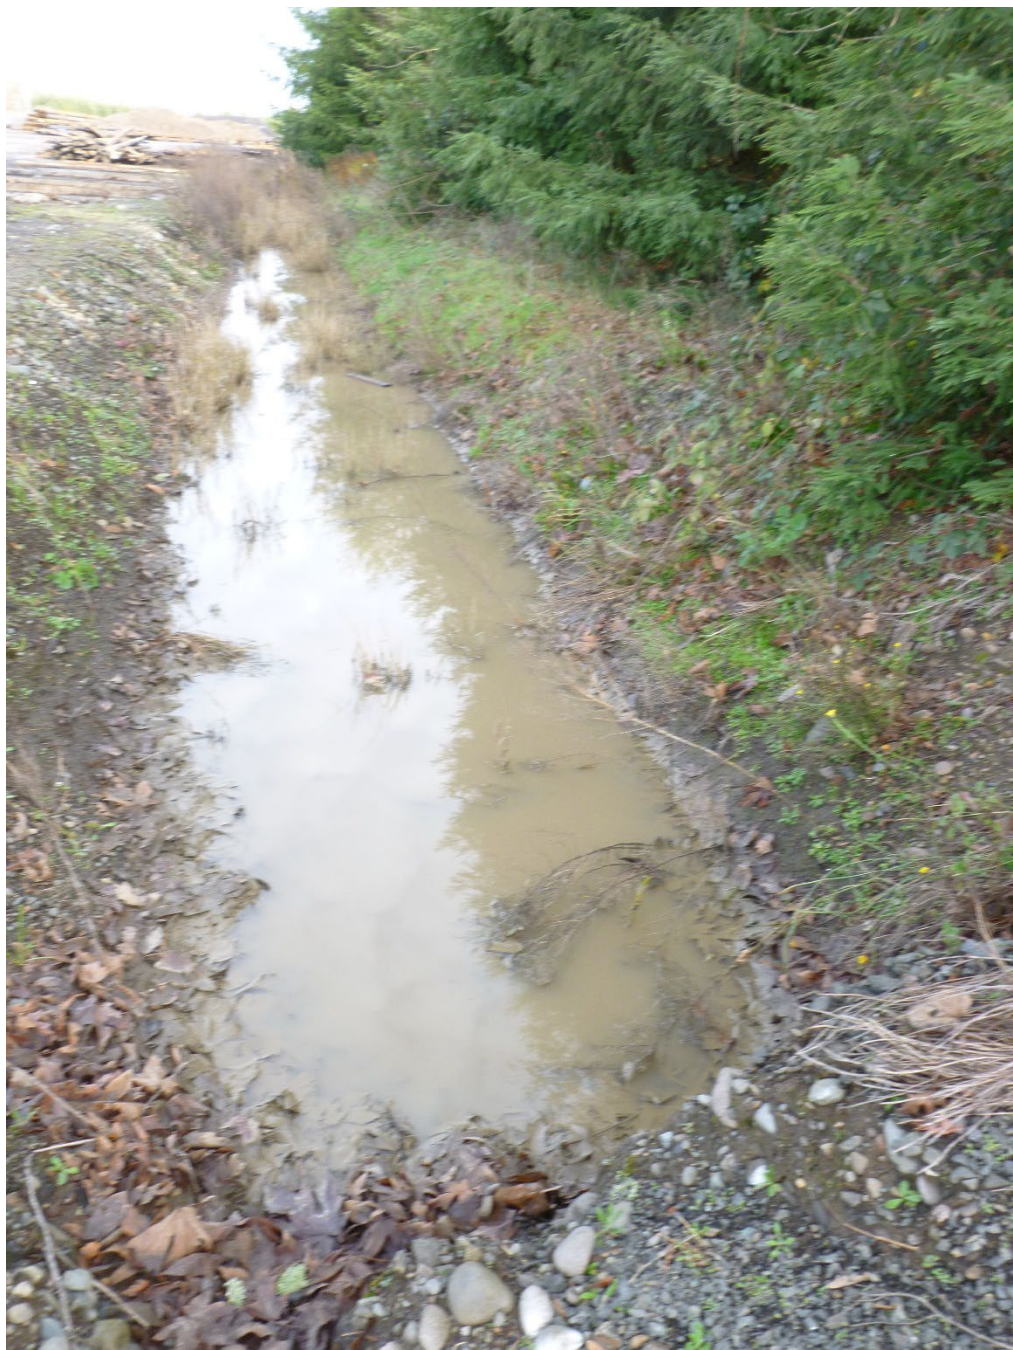
We walked north past the chain-link fence to the storage yard that stores rail cars, scrap steel, and rock, soil, finished compost and bark products. We turned east. Once we got to the edge of the property, we turned south. Walking south, I observed bioswales 5 (**Photo 13**), bioswale 4 (**Photo 14**), and bioswale 6 (**Photo 15**).

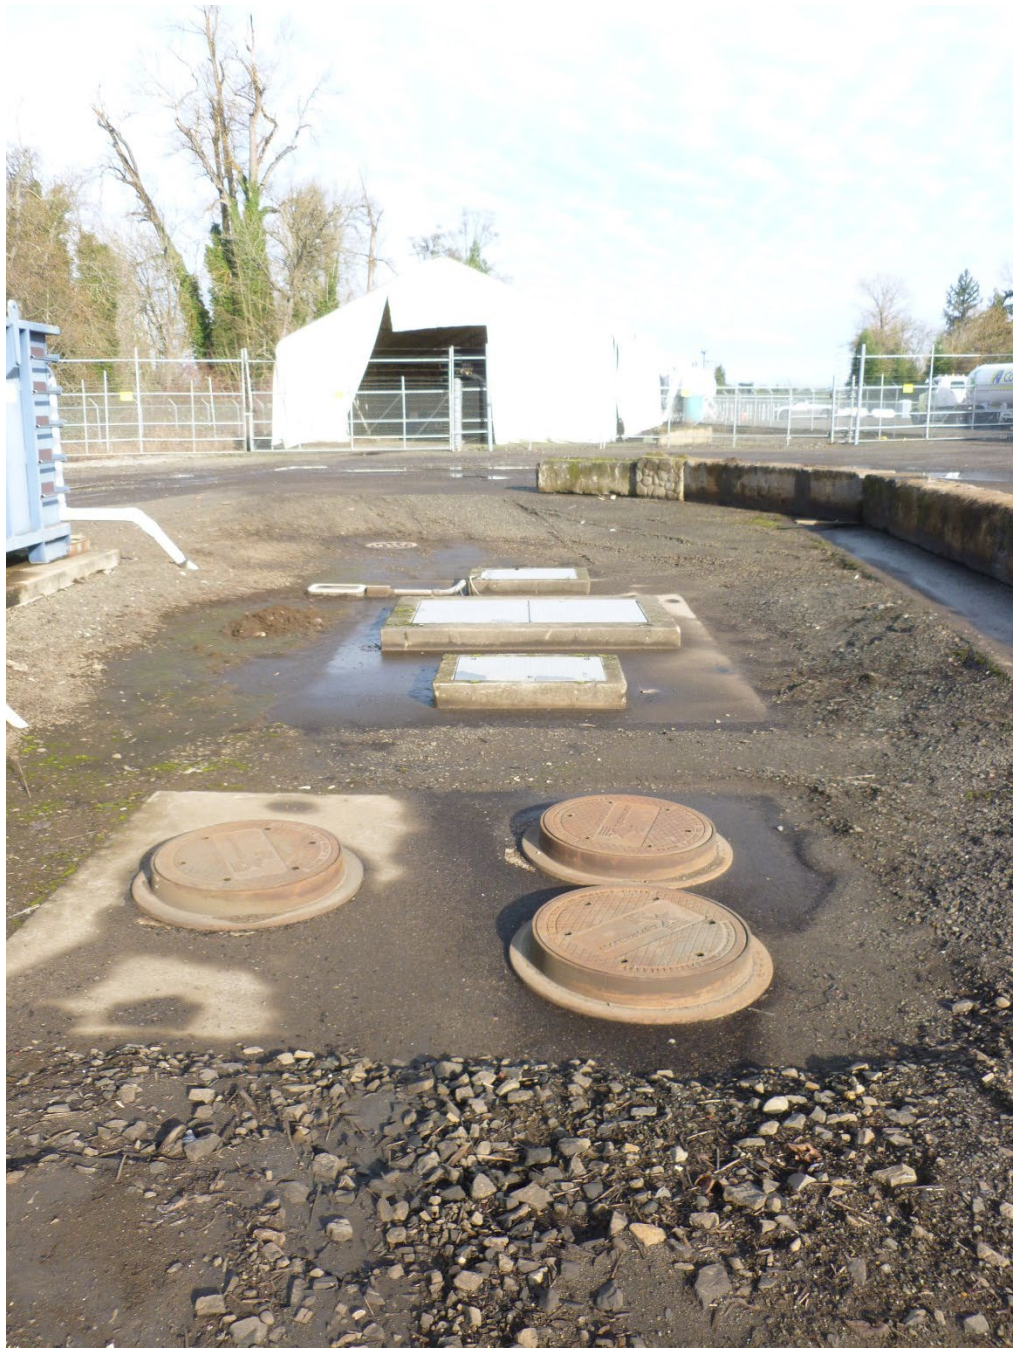
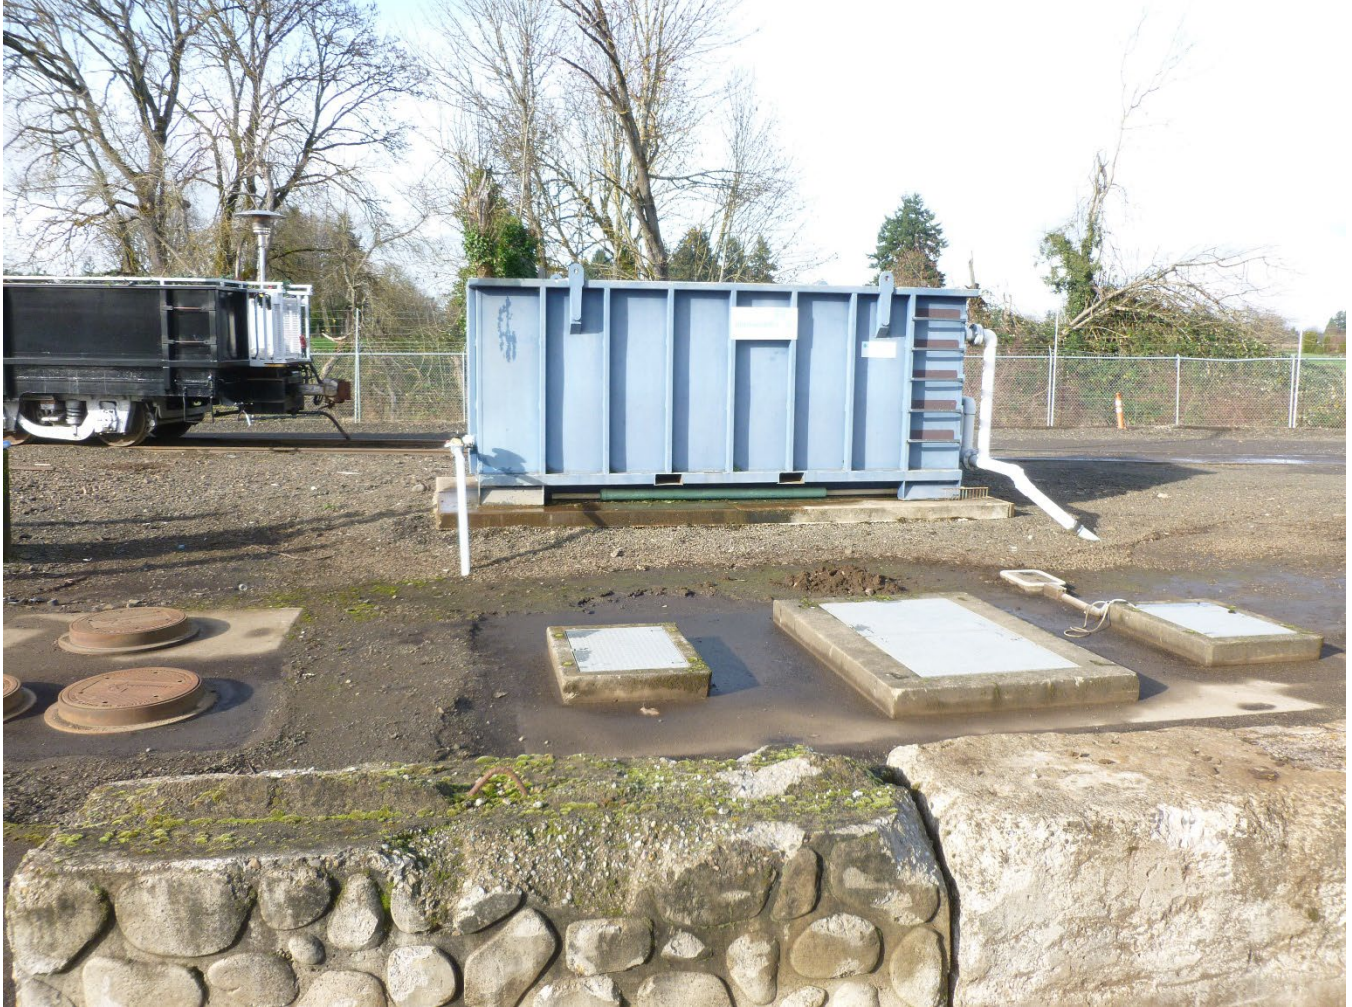
After we finished observing the bioswales, we walked back west so I could look at the oil/water separator and filtration system (**Photos 16 – 18**). The round manhole covers for the oil/water separator can be seen near frame in photo 16 and on the right in photo 17. Mr. Robinson explained that all stormwater collected by the site's catch basins is directed to the oil/water separator.
