# NPDES Compliance Inspection Report

**Rick Franklin Corporation  
Lebanon, Oregon**

**Permit #: ORR607180**

**Inspection Date: December 17, 2021**

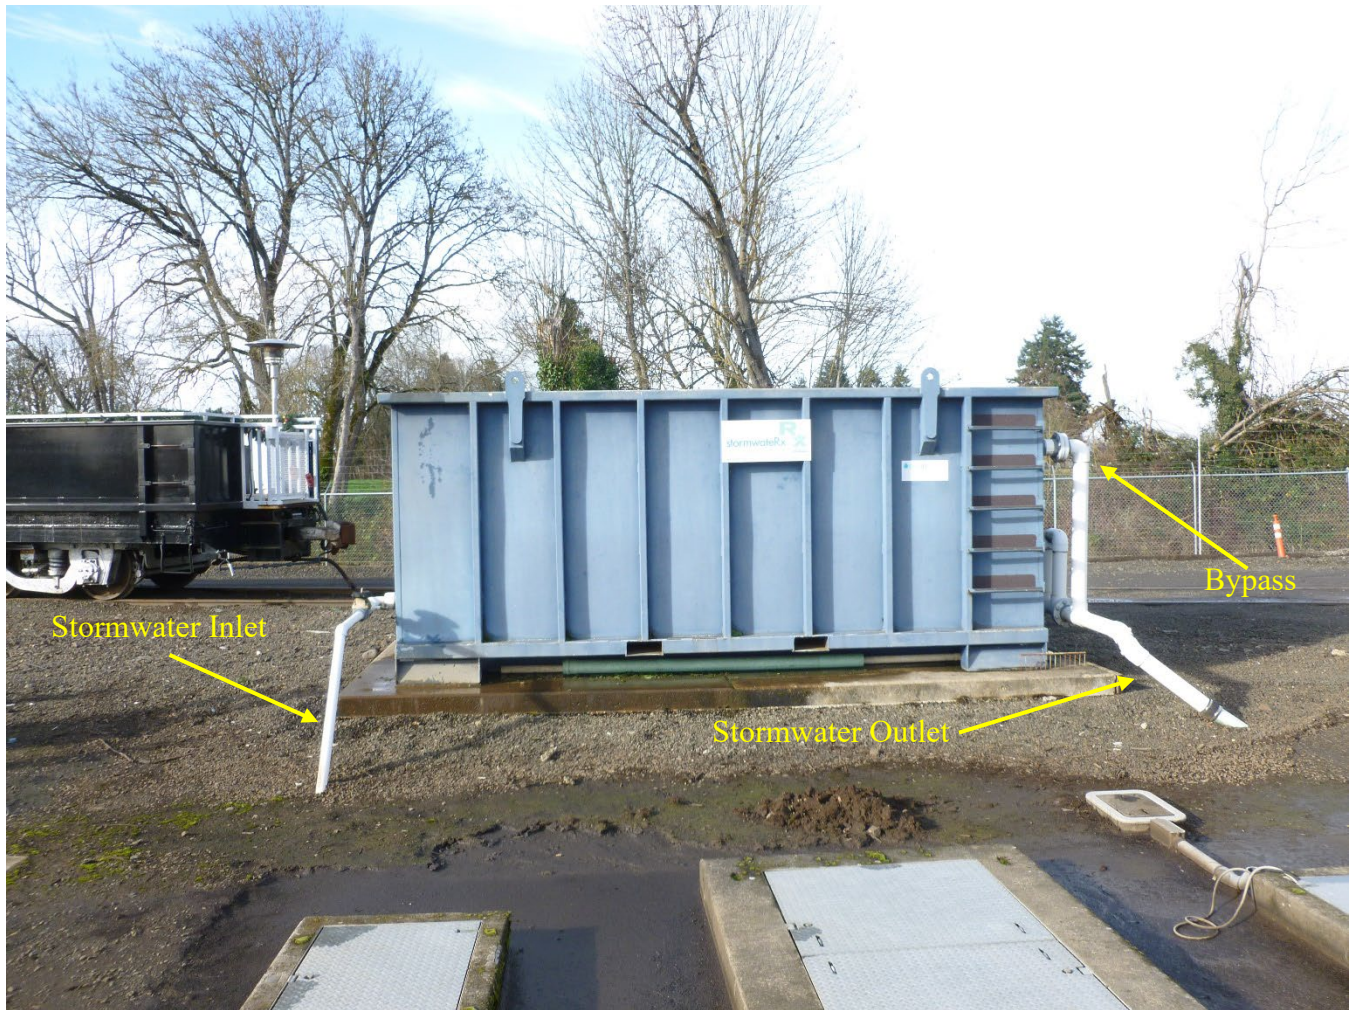
**Photo 18 / P1010144** – stormwaterRx™ Filtration Unit

After the stormwater completes its cycle through the oil/water separator, it is pumped to the blue stormwaterRx™ unit by the lift station shown directly in front of the filtration unit in photo 18 and 19. The stormwater enters the filtration unit through the pipe on the left side of the image. The stormwater percolates up through the media bed. The water then flows through a perforated PVC pipe, situated above the filtration media which distributes water across the length of the filtration unit. The stormwater infiltrates the sand filtration media. As the filtration unit starts to fill, the water level rises and, under normal conditions, the water exits the filtration unit when the water level reaches the lower pipe on the right side of the unit. The filtration unit is also equipped with an overflow bypass in case of excessive rainfall. The bypass is the upper pipe on the right side of the unit. Once the water exits the filtration unit, it flows underground to one of the bioswales where it can evaporate or continue to infiltrate.
