## Region 6 - Enforcement & Compliance Assurance Division

### INSPECTION REPORT

| Media: | RCRA Compliance Evaluation Inspection | |
| Company Name: | Qarbon Aerospace Foundation | |

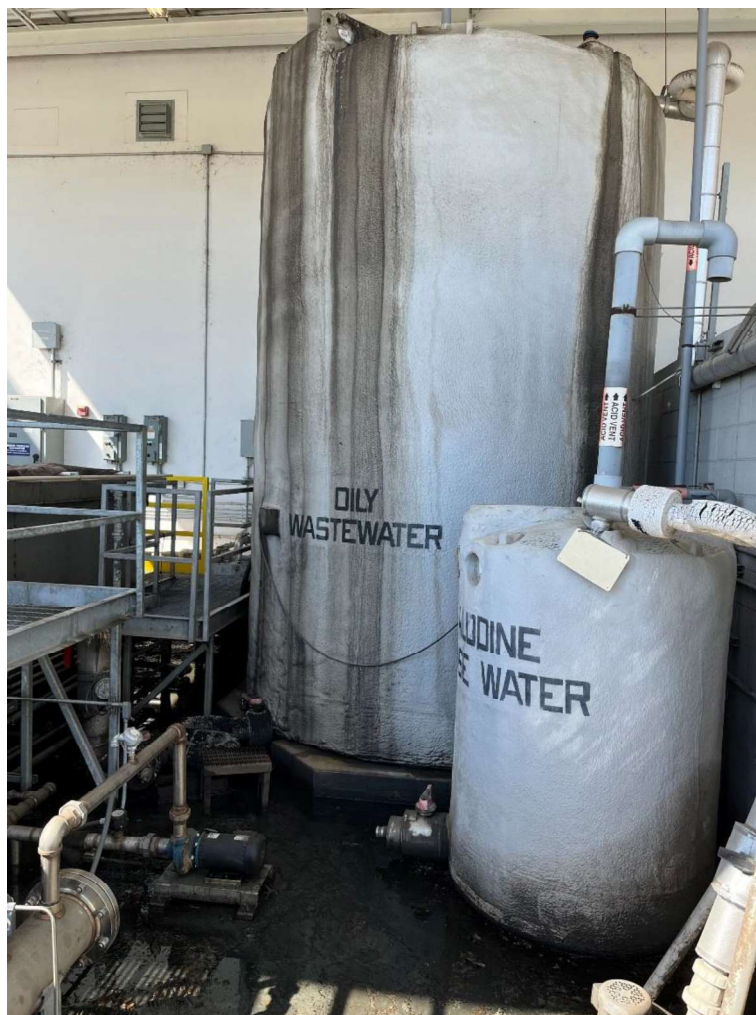
Photo No. 1

On the east side of the main building, adjacent to the maintenance shop, I observed a Tank Farm with two above-ground storage tanks in secondary containment (Appendix 1, Photo 1). It contained an 8,500-gallon tank of non-hazardous oily wastewater and an inactive Alodine rinse water tank. The oily wastewater tank is listed as unit 002 with a non-hazardous regulated status in the Notice of Registration (NOR). However, the tank's capacity is recorded as 10,000 gallons instead of the observed 8,500 gallons during the inspection. I noticed a spill of oily wastewater in the secondary containment as a result of overfill. The oily wastewater is generated from washing equipment and an X-ray process. In the same area, I observed an unknown riser within the secondary containment area (Appendix 1, Photo 2).

| Description: | Overview of tank battery with oily wastewater tank. | | |

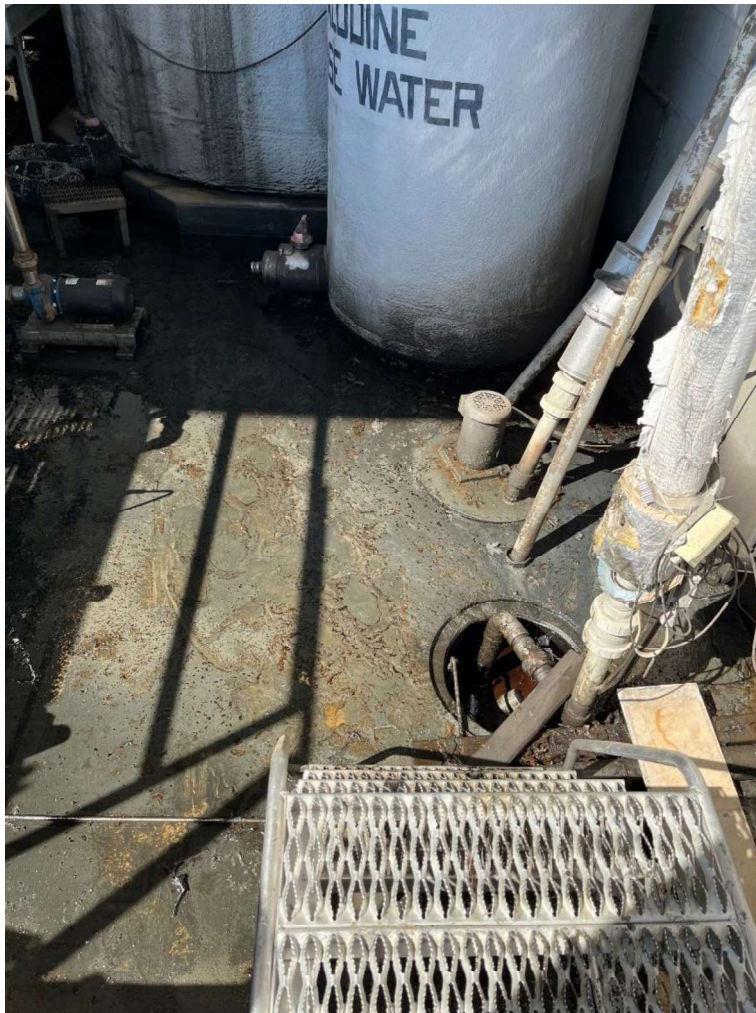
Photo No. 2

| Description: | Close view of unknown riser in secondary containment area. |

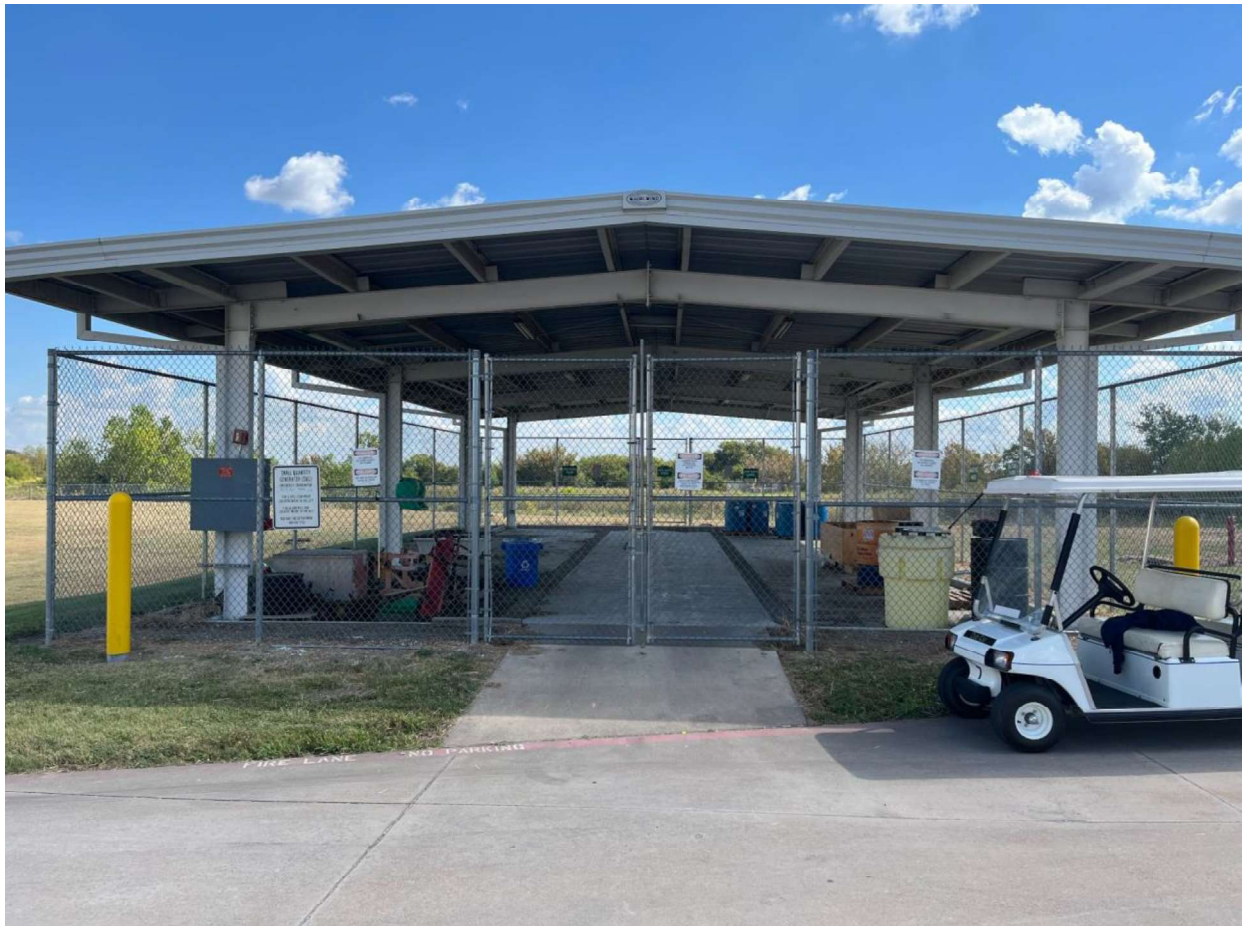
Photo No. 3

On the northeast side of the main building, I observed a covered CAA with both hazardous waste and universal waste (Appendix 1, Photo 3). There were 4 boxes and two bundles of universal waste lamps that were not labeled or marked clearly as required in the standards for universal waste handlers (See Section III – Preliminary Findings for additional regulatory citations).

| Description: | Overview of CAA. |

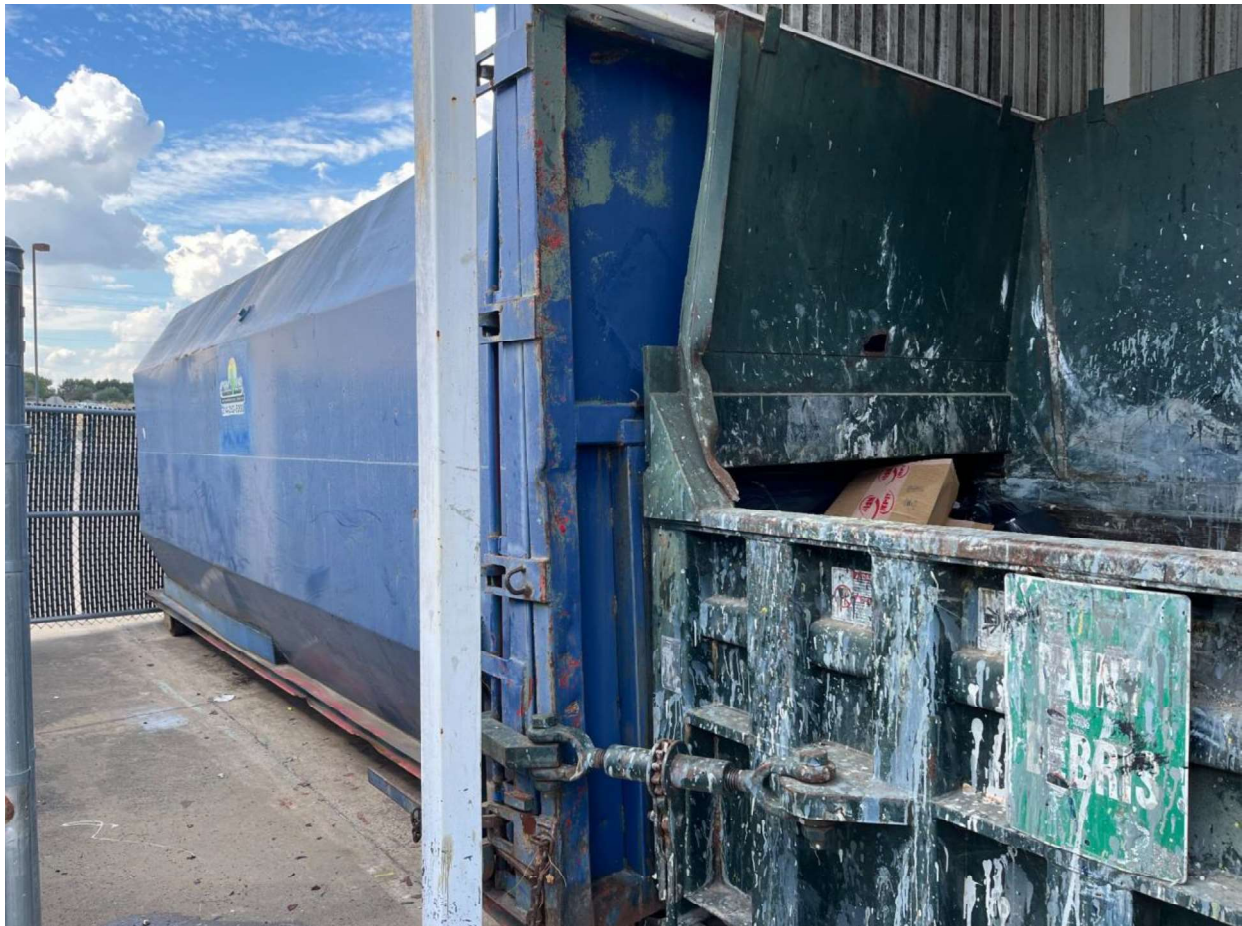
Photo No. 4

There are two Satellite Accumulation Areas allocated for the painting operations. During my inspection, I observed a paint compactor on the northwest side of the main building. The paint waste from the painting operations was consolidated and processed at the paint compactor. Additionally, I saw a rolloff box connected to the paint compactor that contained paint waste but was missing universal waste labeling (Appendix 1, Photo 4).

| Description: | Roll-off box without universal waste label attached to paint compactor. |

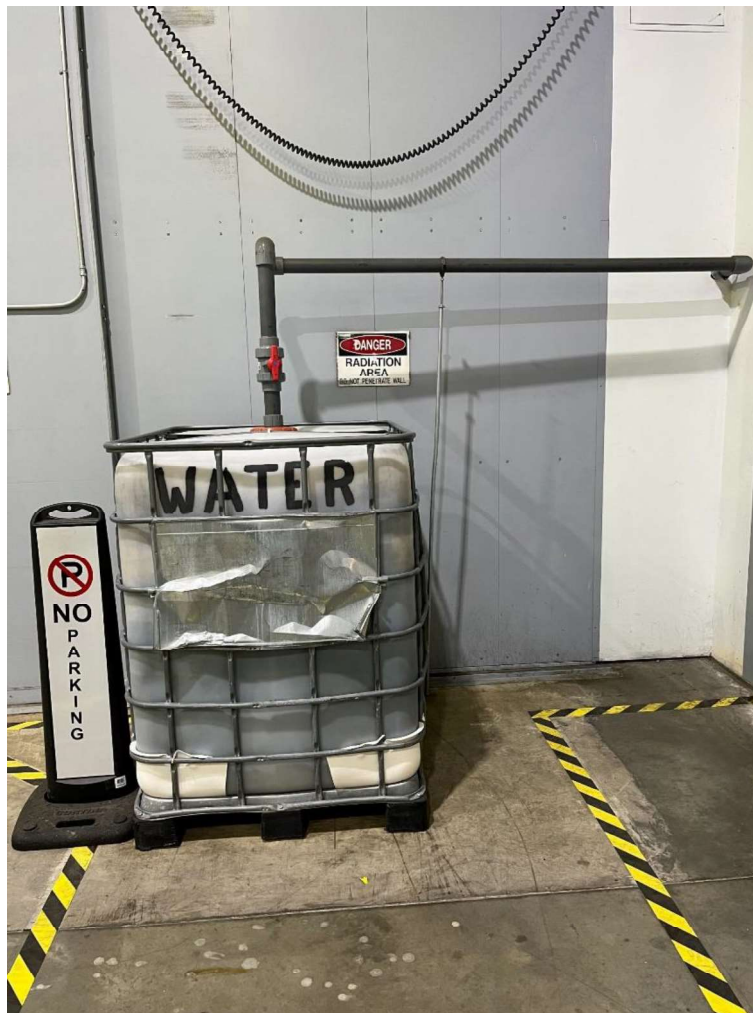
Photo No. 5

I then walked back inside the facility building to inspect the X-ray operation. I noticed that the wastewater from the used developer solution was drained to the sump and collected in a 275-gallon tote (Appendix 1, Photo 5). Upon my request, Qarbon submitted a wastewater determination result with silver at a Total Recoverable concentration of 0.0671 mg/L (Appendix 3). However, the analytical report states that the sample was received at the laboratory with insufficient preservation at a pH of >2, which does not meet the requirement of <2 under EPA Method 200.8. EPA has requested for a new test.

Description: Close view of tote used to collect wastewater from X-ray process.
