**Report Title:** Clean Water Act, Section 404 Inspection Report for the Johnson Farms Site  
**Inspection Date(s):** 02/01/2023  
**Start Time:** 9:00am **End Time:** 11:40am

**Regulatory Program(s):** Inspections authorized pursuant to Clean Water Act, Sections 308 and 404 (33 U.S.C. §§ 1318 and 1344)  
**Site Name:** Johnson Farms

**Site Location:** South of Slalom Drive (Virginia Beach Parcel ID: 14949977880000)  
Virginia Beach, Virginia 23453  
**Latitude:** 36.77212448° N **Longitude:** -76.051011° W

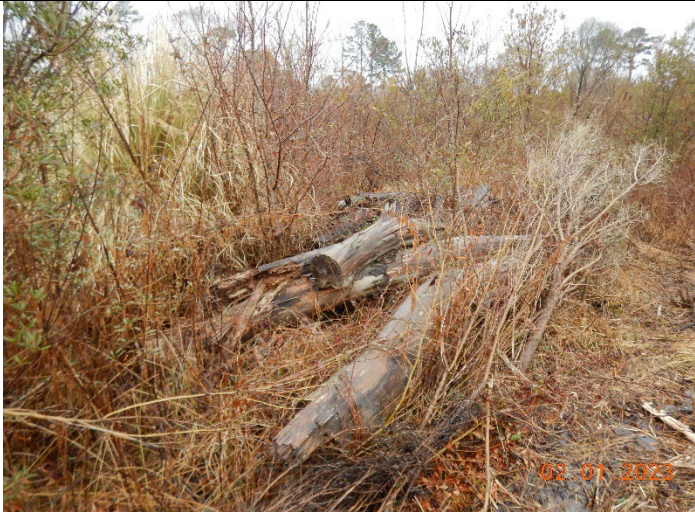
| <p>02.01.2023</p> | <p>Johnson Farms<br/>Date: February 1, 2023<br/>Photo ID: DSCN4336<br/>Photo taken by: Robert George</p> <p>Notes: Woody debris located along the path that had been recently mowed through the early successional habitat onsite.</p> |

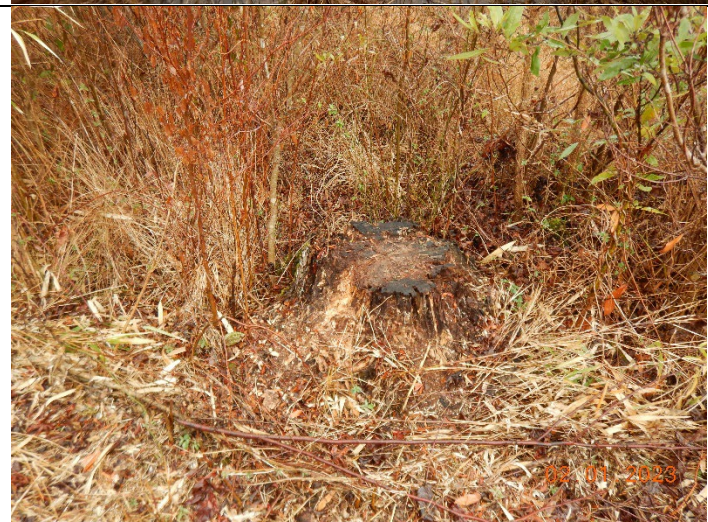
| | <p>Johnson Farms<br/>Date: February 1, 2023<br/>Photo ID: DSCN4339<br/>Photo taken by: Robert George</p> <p>Notes: View of a stump that was left in place following the logging that occurred onsite in 2018.</p> |

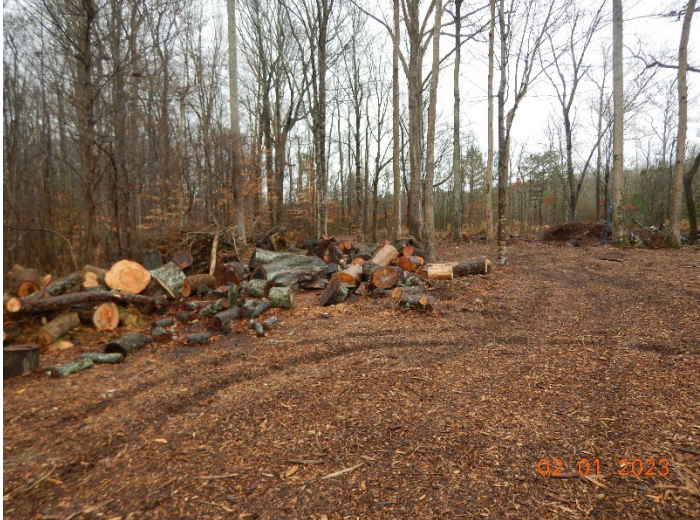
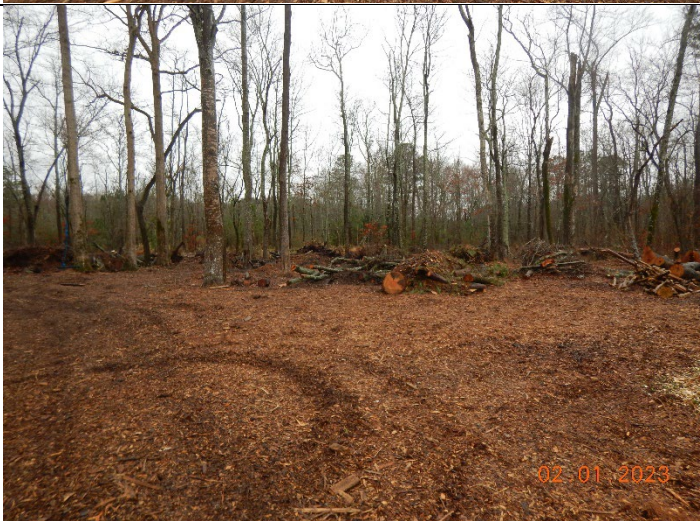
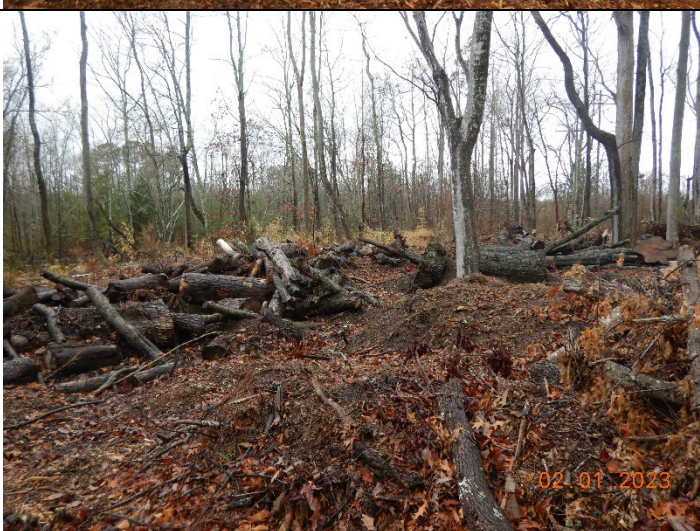
The inspection team then returned to the transmission-tower easement and walked west to the central portion of the Site (DSCN4351-DSCN4354). Surface water was observed draining from the northern portion of the Site to the southern portion of the Site across the transmission-tower easement (DSCN4353). Immediately to the south of the transmission-tower easement, the inspection team observed an area where woody debris and wood chips were discharged (DSCN4355-DSCN4357, DSCN4360, DSCN4361). Henceforth, this area will be referred to as Area of Concern (“AOC”) 1.

| A photograph showing a wooded area with a large pile of cut logs and wood chips on the ground. The ground is covered in brown leaves and wood chips. The background shows bare trees and a cloudy sky. A date stamp "02.01.2023" is visible in the bottom right corner of the photo. | <p>Johnson Farms<br/>Date: February 1, 2023<br/>Photo ID: DSCN4355<br/>Photo taken by: Robert George</p> <p>Notes: View of Area of Concern ("AOC") 1, where woody debris and wood chips were discharged.</p> |
| A photograph showing a wooded area with a large pile of cut logs and wood chips on the ground. The ground is covered in brown leaves and wood chips. The background shows bare trees and a cloudy sky. A date stamp "02.01.2023" is visible in the bottom right corner of the photo. | <p>Johnson Farms<br/>Date: February 1, 2023<br/>Photo ID: DSCN4356<br/>Photo taken by: Robert George</p> <p>Notes: View of AOC-1, where woody debris and wood chips were discharged.</p> |
| A photograph showing a wooded area with a large pile of cut logs and wood chips on the ground. The ground is covered in brown leaves and wood chips. The background shows bare trees and a cloudy sky. A date stamp "02.01.2023" is visible in the bottom right corner of the photo. | <p>Johnson Farms<br/>Date: February 1, 2023<br/>Photo ID: DSCN4357<br/>Photo taken by: Robert George</p> <p>Notes: View of AOC-1, where woody debris and wood chips were discharged.</p> |

Reclamation of AOC-2 and AOC-3 by returning the areas to natural, pre-disturbance grade was discussed and agreed to onsite. Pulling back the wood chips/mulch from the wetland areas at AOC-1 was also discussed. Mr. Deans said that he could implement those restoration activities, however, the current conditions were too wet, but he thought that he could do the work in April.

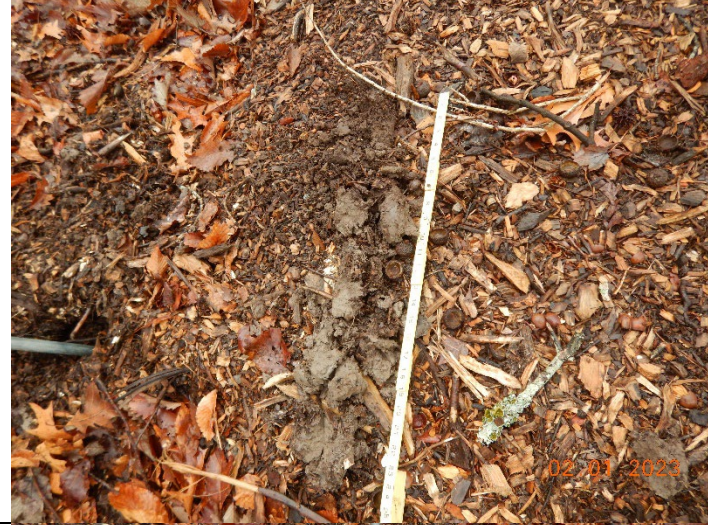
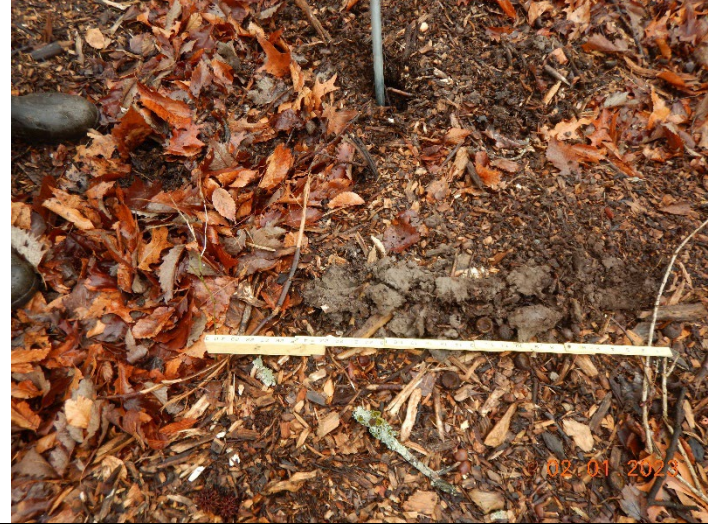
Soil boring Bor-1 was documented at AOC-1 at 36.769635°, -76.054112° (See Site Figure [Attachment 2] and photos DSCN4358 and DSCN4359): [fill layer 8 inches deep] wood chips, [native soil surface 0-6 inches] 10YR 2/1 sandy loam; [6-16 inches] 10YR 2/1 sandy loam; [16-20 inches] 10YR 4/1 clay loam; and [20-24+ inches] 95% 10 YR 4/1 clay loam with and 5% 5YR 4/6 redoximorphic features. The observed soil profile met the technical definition of a hydric soil. The vegetation and hydrology were significantly impacted by the discharge of wood chips. Photos DSCN4365 through DSCN4368 illustrate the perimeter of the fill and contrast the filled area to the naturally occurring conditions on this portion of the Site.

| A photograph showing a soil sample extraction site. A vertical ruler is placed in the soil, which is covered with brown leaves and mulch. The ruler is marked in inches. The date '02.01.2023' is visible in the bottom right corner of the photo. | <p>Johnson Farms<br/>Date: February 1, 2023<br/>Photo ID: DSCN4358<br/>Photo taken by: Robert George</p> <p>Notes: Soil sample extracted from soil Bor-1, exhibiting a reduced matrix.</p> |
| A photograph showing a soil sample extraction site. A horizontal ruler is placed on the ground, which is covered with brown leaves and mulch. The ruler is marked in inches. The date '02.01.2023' is visible in the bottom right corner of the photo. | <p>Johnson Farms<br/>Date: February 1, 2023<br/>Photo ID: DSCN4359<br/>Photo taken by: Robert George</p> <p>Notes: Soil sample extracted from soil Bor-1, exhibiting a reduced matrix.</p> |

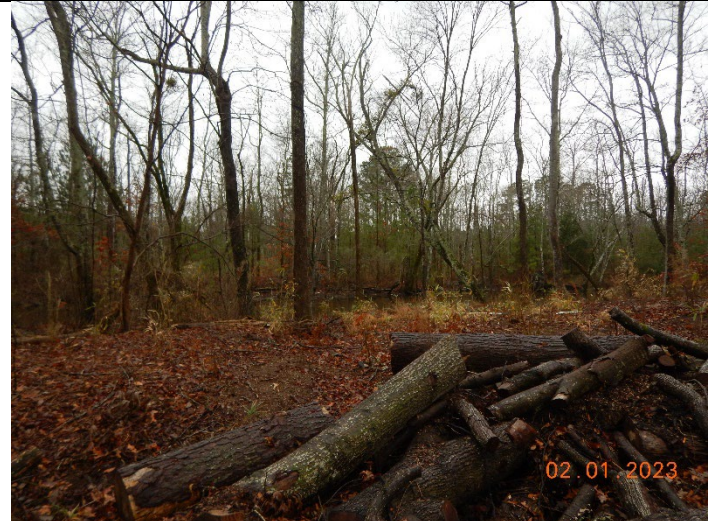
| A photograph showing a view of logs discharged on the ground. The logs are stacked in a pile, and the background shows a forest with bare trees. The date '02.01.2023' is visible in the bottom right corner of the photo. | <p>Johnson Farms<br/>Date: February 1, 2023<br/>Photo ID: DSCN4360<br/>Photo taken by: Robert George</p> <p>Notes: View of logs discharged on at AOC-1.</p> |

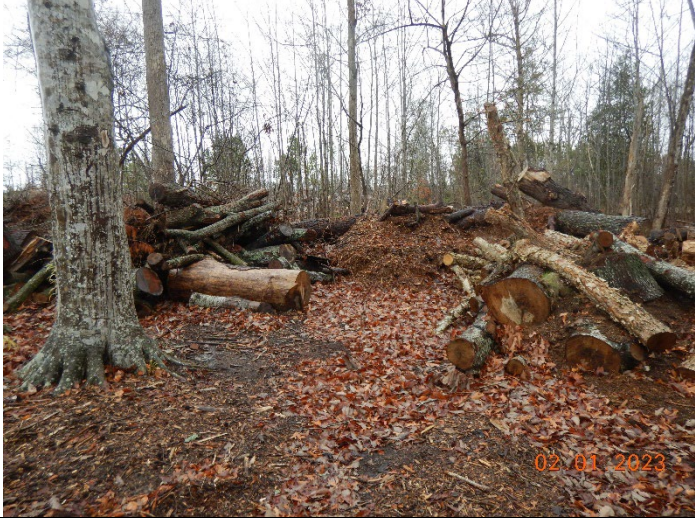
| | <p>Johnson Farms<br/>Date: February 1, 2023<br/>Photo ID: DSCN4361<br/>Photo taken by: Robert George</p> <p>Notes: View of logs discharged at AOC-1.</p> |

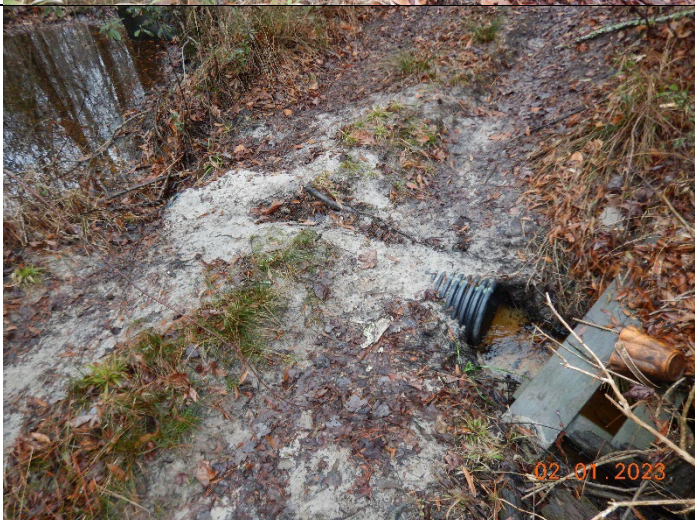
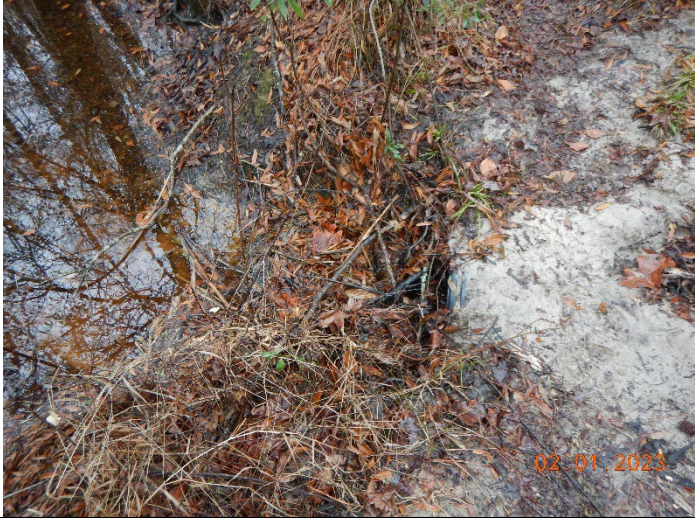
The inspection team walked southward on a path that bordered the western branch of West Neck Creek and documented the conditions (DSCN4362). A culvert was observed draining the Site and discharging water into the stream (DSCN4363 and DSCN4364). The inspection team then walked northward and encountered Mr. Deans at the transmission-tower easement at approximately 10:40 am. Mr. Deans stated that he purchased the property in the fall of 2022 and the Site was left in a state of disrepair by the former lessee, Mr. Mason. Mr. Deans stated that he cleaned up the Site and that the pile of wood chips at AOC-1 preceded his ownership, however, he stated that he recently added two loads and spread them out.

| | <p>Johnson Farms<br/>Date: February 1, 2023<br/>Photo ID: DSCN4363<br/>Photo taken by: Robert George</p> <p>Notes: Culvert that drained the southern portion of the site and discharged water into the West Neck Creek.</p> |

| | <p>Johnson Farms<br/>Date: February 1, 2023<br/>Photo ID: DSCN4364<br/>Photo taken by: Robert George</p> <p>Notes: Culvert that drained the southern portion of the site and discharged water into the West Neck Creek.</p> |

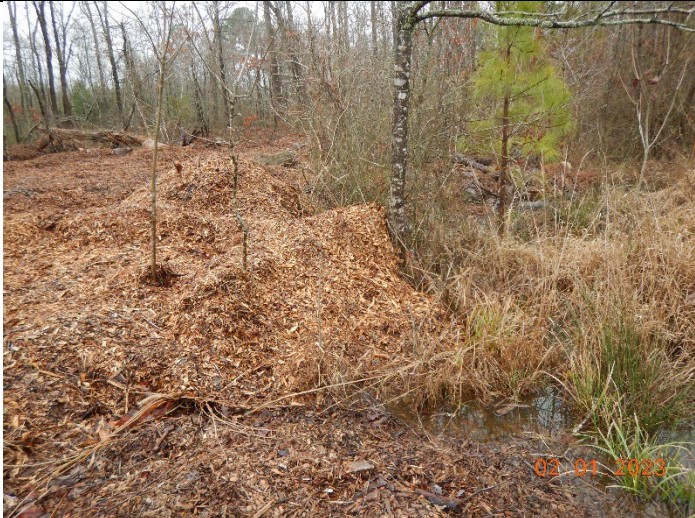
| | <p>Johnson Farms<br/>Date: February 1, 2023<br/>Photo ID: DSCN4365<br/>Photo taken by: Robert George</p> <p>Notes: Wood chips discharged into freshwater wetlands located at AOC-1.</p> |

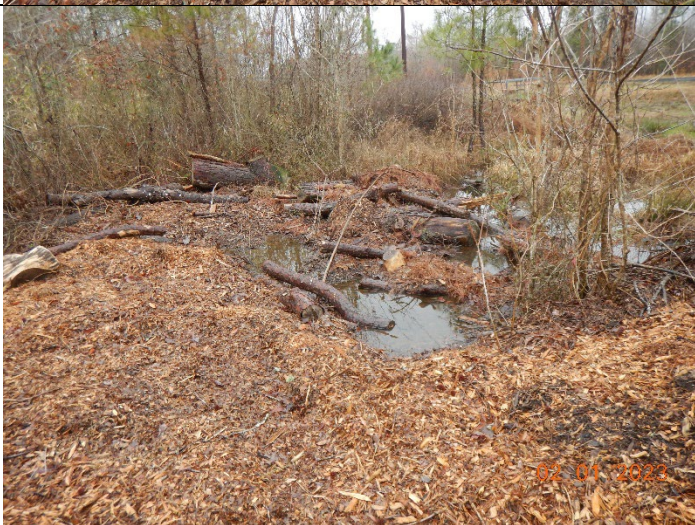
| | <p>Johnson Farms<br/>Date: February 1, 2023<br/>Photo ID: DSCN4366<br/>Photo taken by: Robert George</p> <p>Notes: Mulch and logs discharged into freshwater wetlands located at AOC-1.</p> |

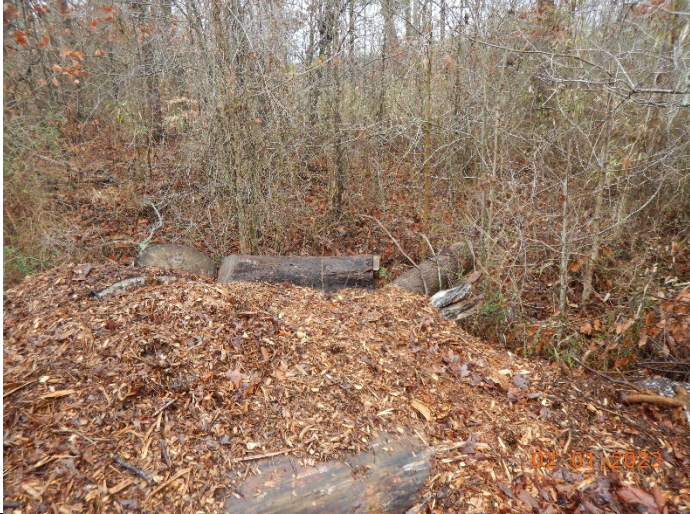
| | <p>Johnson Farms<br/>Date: February 1, 2023<br/>Photo ID: DSCN4367<br/>Photo taken by: Robert George</p> <p>Notes: Wood chips discharged into freshwater wetlands located at AOC-1. Note the difference in elevation in the foreground relative to the background.</p> |

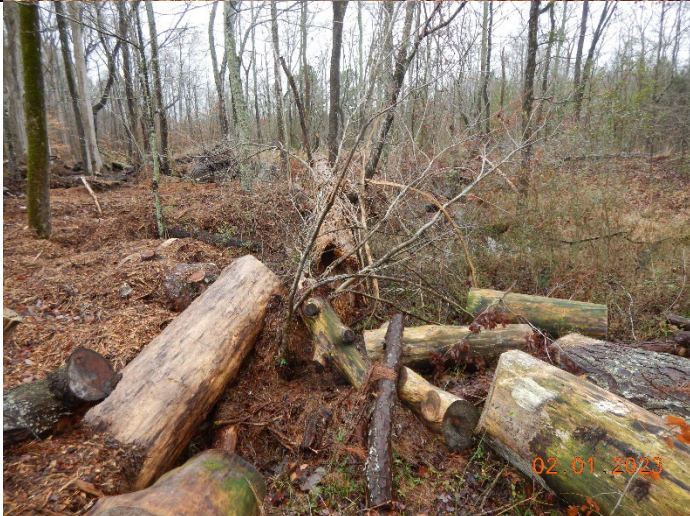
| | <p>Johnson Farms<br/>Date: February 1, 2023<br/>Photo ID: DSCN4368<br/>Photo taken by: Robert George</p> <p>Notes: View of an area where logs were discharged at AOC-1.</p> |

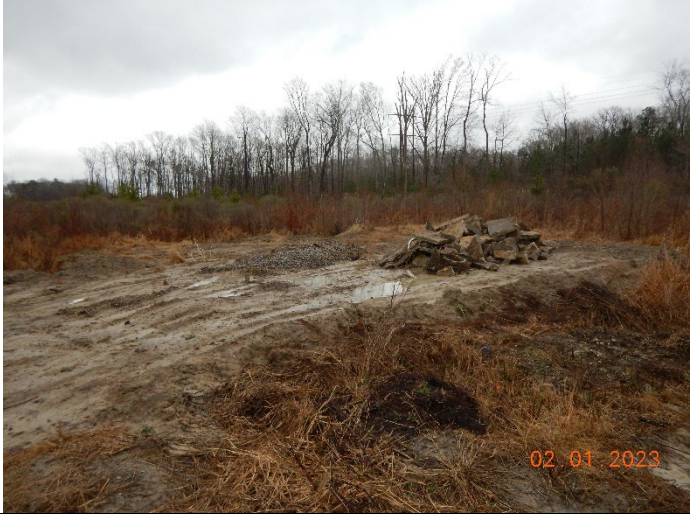
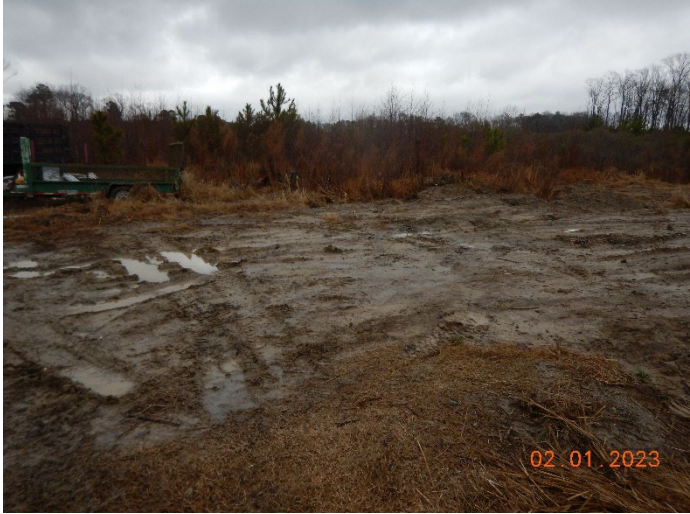
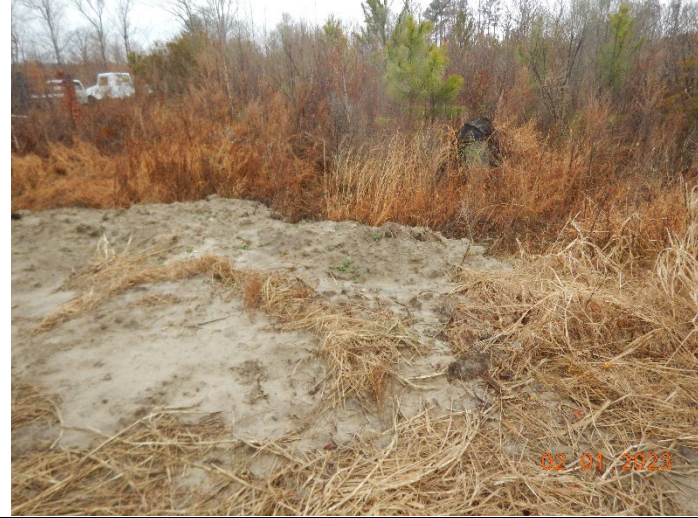
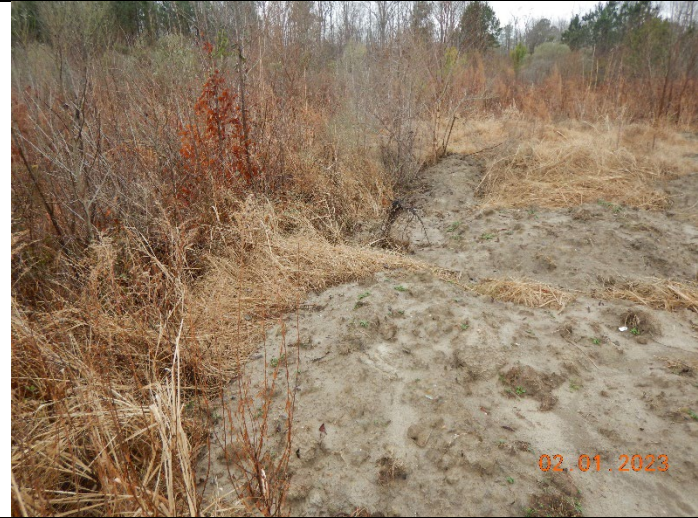
The EPA walked northward on a gravel road that was located on the central portion of the Site. A goat enclosure was observed to the west of the road (DSCN4369). To the east of the road, a dirt pile with concrete pieces was observed to be placed in wetlands along the road (DSCN4371-DSCN4374). Henceforth, this area will be referred to as AOC-2 (Attachment 2).

| | <p>Johnson Farms<br/>Date: February 1, 2023<br/>Photo ID: DSCN4371<br/>Photo taken by: Robert George</p> <p>Notes: Eastward view of AOC-2 where fill had been discharged.</p> |
| | <p>Johnson Farms<br/>Date: February 1, 2023<br/>Photo ID: DSCN4372<br/>Photo taken by: Robert George</p> <p>Notes: Eastward view of AOC-2 where fill had been discharged.</p> |

| | <p>Johnson Farms<br/>Date: February 1, 2023<br/>Photo ID: DSCN4373<br/>Photo taken by: Robert George</p> <p>Notes: Eastward view of AOC-2 where fill had been discharged.</p> |
| | <p>Johnson Farms<br/>Date: February 1, 2023<br/>Photo ID: DSCN4374<br/>Photo taken by: Robert George</p> <p>Notes: Eastward view of AOC-2 where fill had been discharged.</p> |

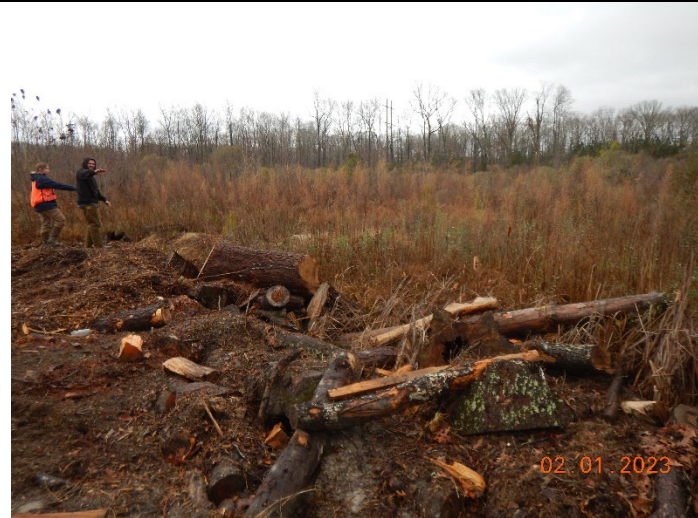
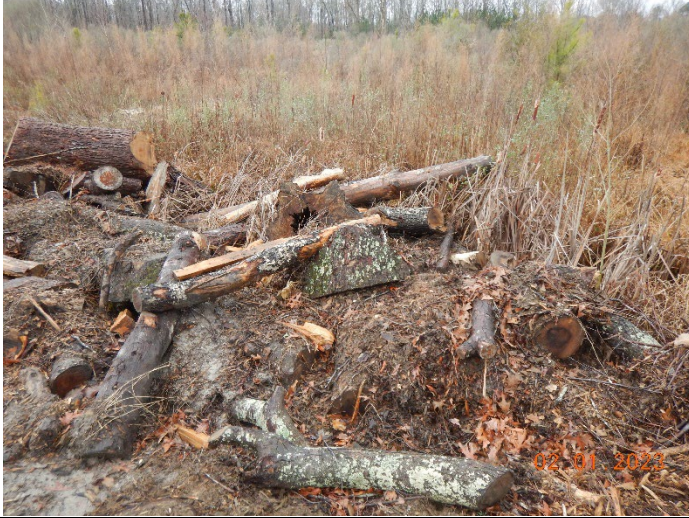
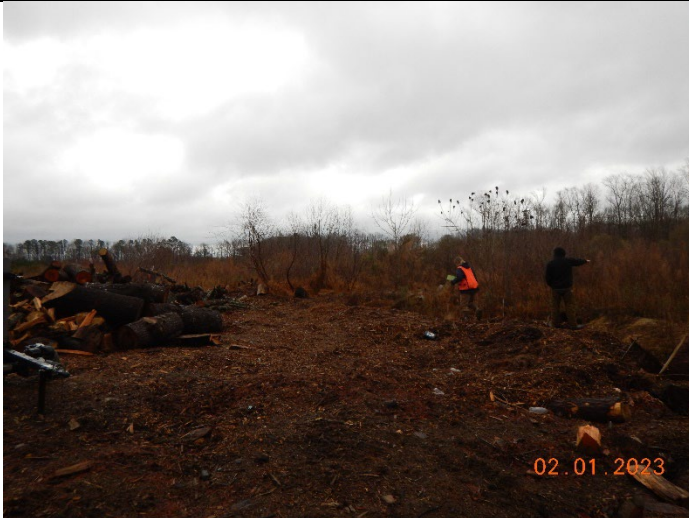
The inspection attendees met at the parking area and an excavated hole that had been filled with woody debris was observed to the south of the parking area (DSCN4375- DSCN4377). Henceforth, this area will be referred to as AOC-3 (Attachment 2). The Closing Conference was then conducted.

| | <p>Johnson Farms<br/>Date: February 1, 2023<br/>Photo ID: DSCN4375<br/>Photo taken by: Robert George</p> <p>Notes: Area to the south of the parking area that appeared to be excavated and filled with woody refuse. AOC-3</p> |

| A close-up photograph showing a pile of cut logs and woody debris on a grassy slope. The logs are of various sizes and are scattered across the ground. The background shows a line of trees and a clear sky. A date stamp ".02.01.2023" is visible in the bottom right corner of the photo. | <p>Johnson Farms<br/>Date: February 1, 2023<br/>Photo ID: DSCN4376<br/>Photo taken by: Robert George</p> <p>Notes: Area to the south of the parking area that appeared to be excavated and filled with woody refuse. AOC-3</p> |
| A wide-angle photograph of a cleared area, likely a parking area, with two people standing in the distance. The ground is covered in dirt and debris. The background shows a line of trees and a cloudy sky. A date stamp ".02.01.2023" is visible in the bottom right corner of the photo. | <p>Johnson Farms<br/>Date: February 1, 2023<br/>Photo ID: DSCN4377<br/>Photo taken by: Robert George</p> <p>Notes: Area to the south of the parking area that appeared to be filled with woody refuse. AOC-3</p> |
