| <b>Inspection Date(s):</b> | 02/11/2025 | |
| <b>Media Program:</b> | Drinking Water | |
| <b>Regulatory Program(s)</b> | Safe Drinking Water Act (SDWA) | |
| <b>System Name:</b> | City of Deer Park PWS | |

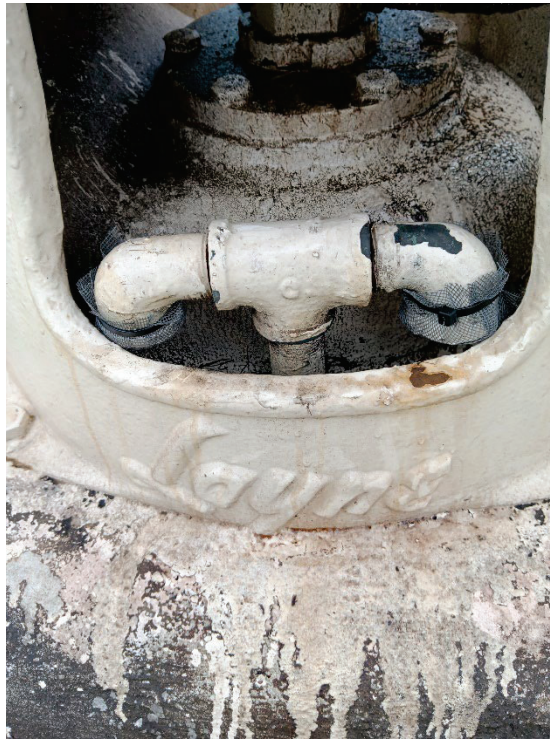
**Observation 4.** The EPA inspection team observed that a well vent screen felt corroded to the touch at Well #2.

Vent screens replaced on Well #2. This photograph addresses Observation 4.

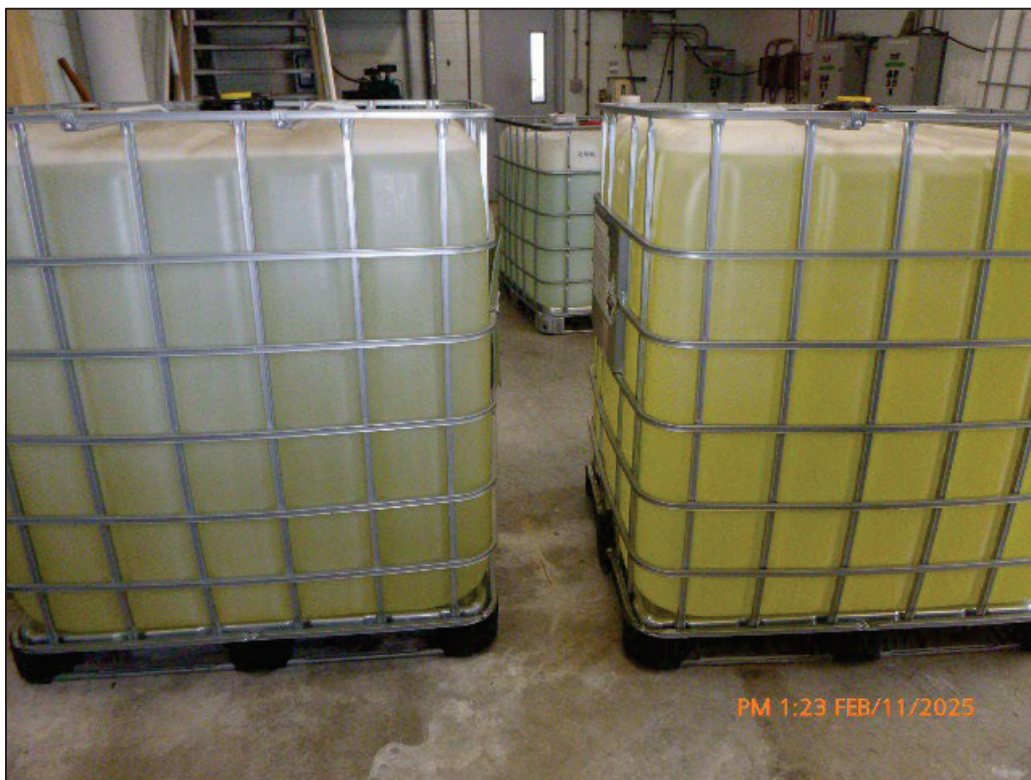
Photograph 1. 02/11/2025 1:23 PM P1010157.JPG

The System has a laboratory certified for coliform analysis. The laboratory is also used to analyze total organic carbon, alkalinity, pH, and chlorine residual for process control purposes. Chemical storage is located at the SWTP, with all chemicals except polymer and phosphate delivered in bulk and stored onsite. The EPA inspection team observed that there was no secondary containment for spare chemical vats of sodium hypochlorite and LAS ([Appendix 3, Photograph 1](#)).

**Observation 9.** The EPA inspection team observed no secondary containment for spare totes of sodium hypochlorite and LAS at the SWTP ([Appendix 3, Photograph 1](#)).

Description: SWTP. Spare chemical totes of sodium hypochlorite and LAS without secondary containment.

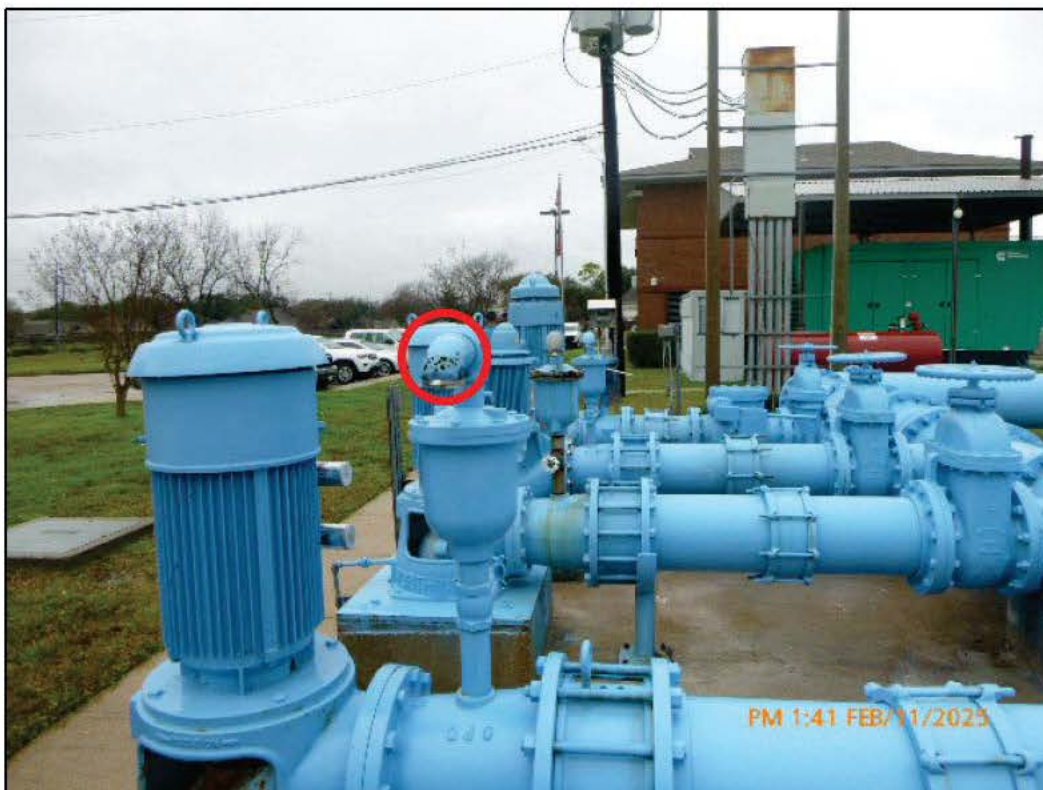
Photograph 2. 02/11/2025 1:23 PM P1010167.JPG

All treated water flows to a clearwell and is transferred by pumps to two 1-MG storage tanks. The EPA inspection team observed that the air release valve discharge pipe on one of the transfer pumps was corroded ([Appendix 3, Photograph 2](#)).

**Observation 5.** The air release valve discharge pipe on one of the clearwell transfer pumps was corroded at the SWTP ([Appendix 3, Photograph 2](#)).

Description: SWTP. Corrosion on high service pump air release valve.

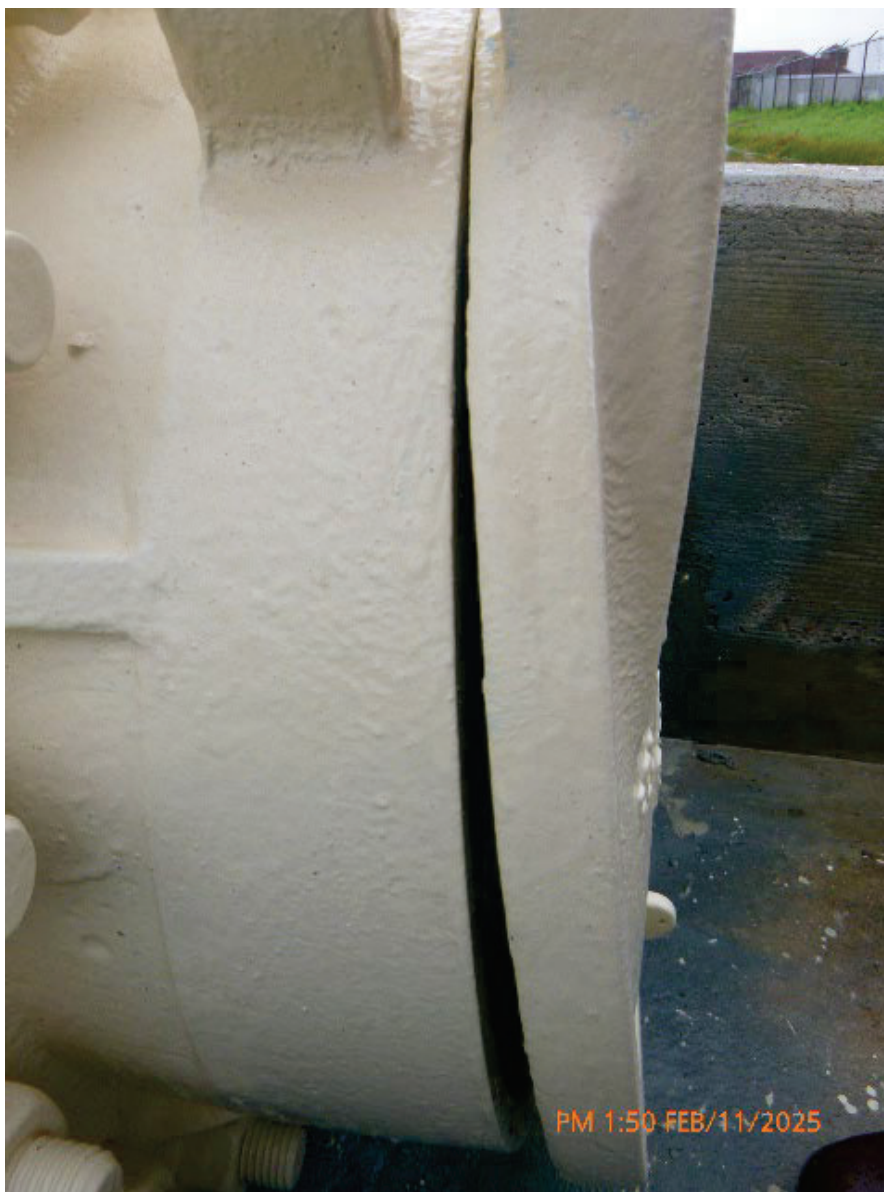
Photograph 3. 02/11/2025 1:50 P1010173.JPG

The EPA inspection team observed a gap on the flapper valve on the southern 1-MG ground storage tank ([Appendix 3, Photograph 3](#)). During the inspection, the operator readjusted the hinge on the flapper valve, resolving the gap. Both 1-MG storage tanks lacked locked ladder cages ([Appendix 3, Photograph 4](#) and [Photograph 5](#)). Four high service pumps transfer water from the 1-MG storage tanks

**Observation 10.** The EPA Inspection team observed a gap on the 1-MG finished water storage tank overflow flapper valve at the SWTP ([Appendix 3, Photograph 3](#)).

Description: SWTP. Gap on the overflow flapper valve at southern 1-MG storage tank.

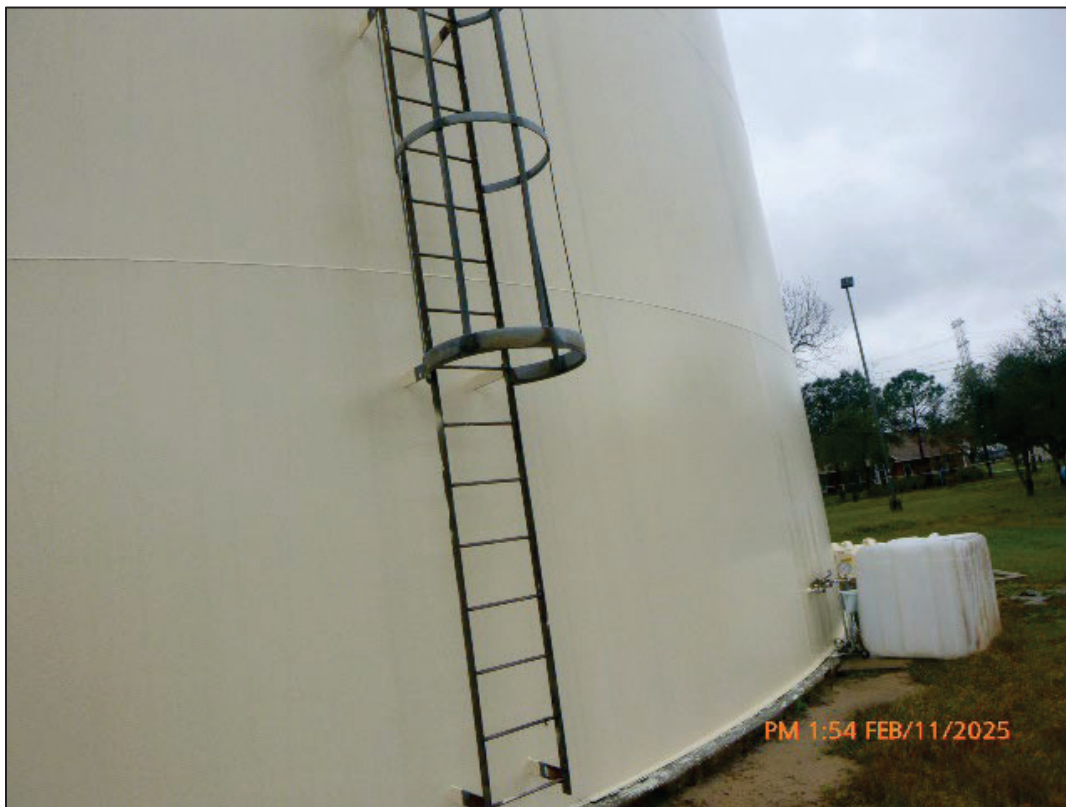
Photograph 4. 02/11/2025 1:54 PM P101178.JPG

Description: SWTP. Missing lock on southern 1.0 MG storage tank access ladder.

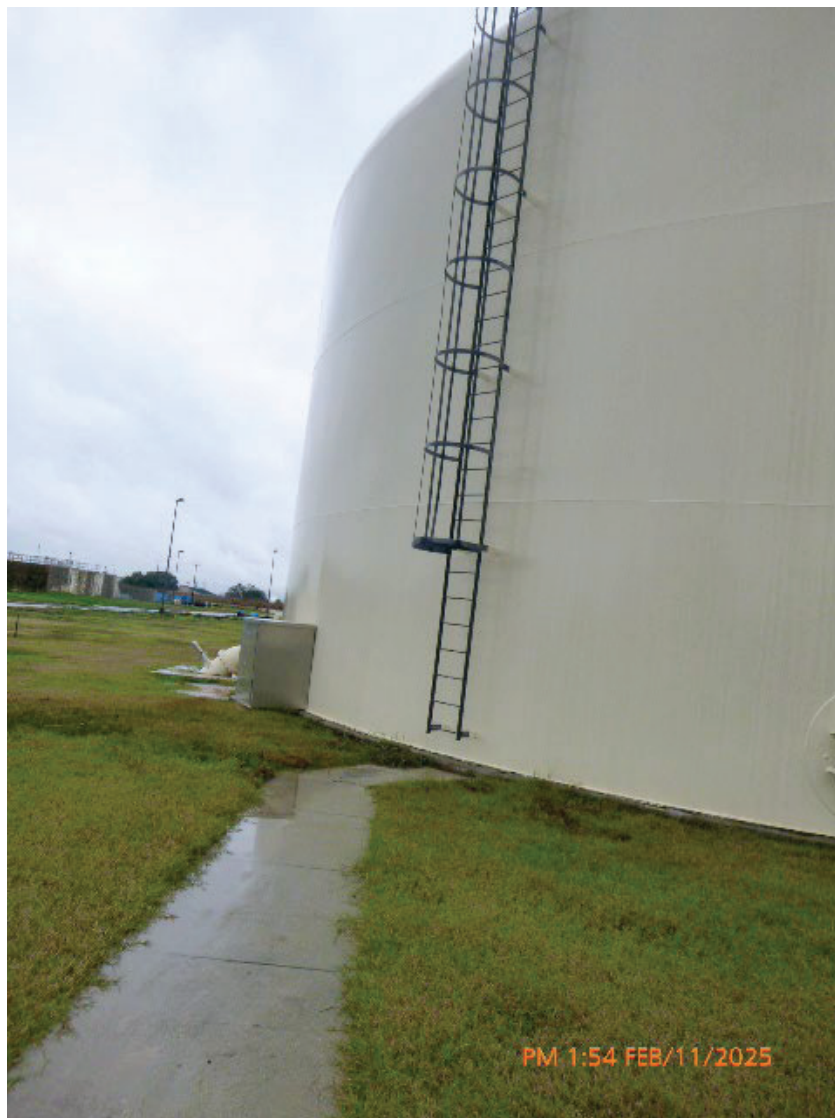
Photograph 5. 02/11/2025 1:54 PM P101179.JPG

Description: SWTP. Missing lock on northern 1.0 MG storage tank access ladder.

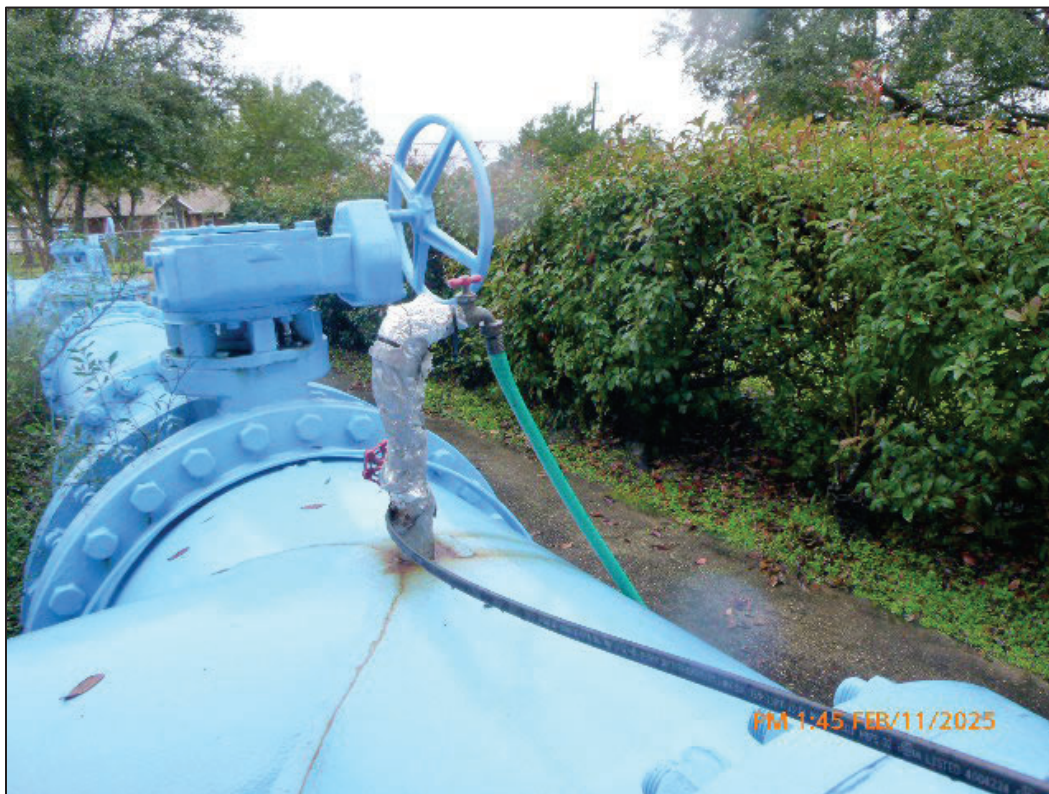
Photograph 6. 02/11/2025 1:45 PM P1010172.JPG

to the distribution system. The EPA inspection team observed a threaded sample tap with a hose on the high service pump discharge lines ([Appendix 3, Photograph 6](#)). The hose was attached to allow water to run and prevent freezing during the recent cold weather event.

**Observation 8.** The EPA inspection team observed a hose connected to the high service pump discharge line at the SWTP to prevent freezing of the line (see [Appendix 3, Photograph 6](#)).

Description: SWTP. Threaded sample tap with hose connected on the high service pump discharge line.

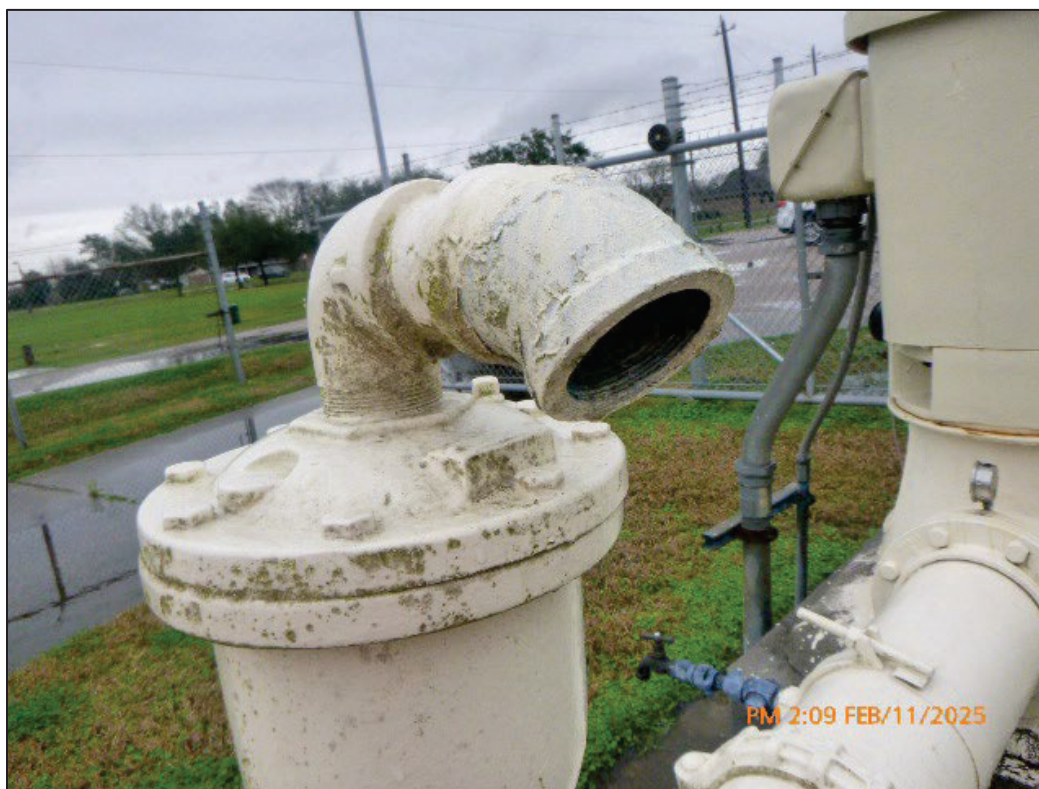
Photograph 7. 02/11/2025 2:09 PM P1010185.JPG

**Observation 6.** The EPA Inspection team observed that the screen on the air release valve at Well #2 was missing ([Appendix 3, Photograph 7](#)).

Description: Plant 2. Well #2. Missing screen on the air release valve.

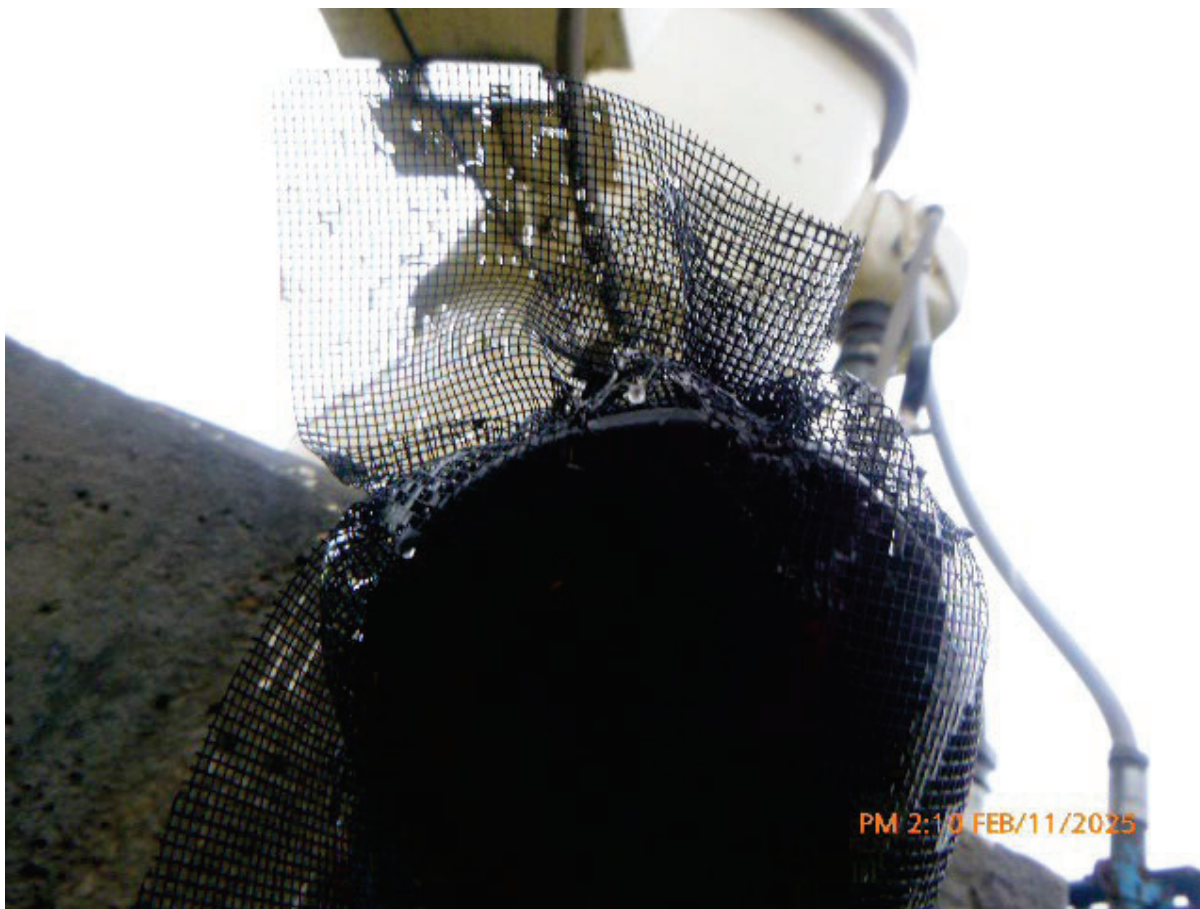
**Observation 3.** The EPA inspection team observed a partially-torn screen on the sounding tube at Well #2 ([Appendix 3, Photograph 8](#)).

Photograph 8. 02/11/2025 2:10 PM P1010187.JPG  
Description: Plant 2. Torn screen on Well #2 sounding tube.

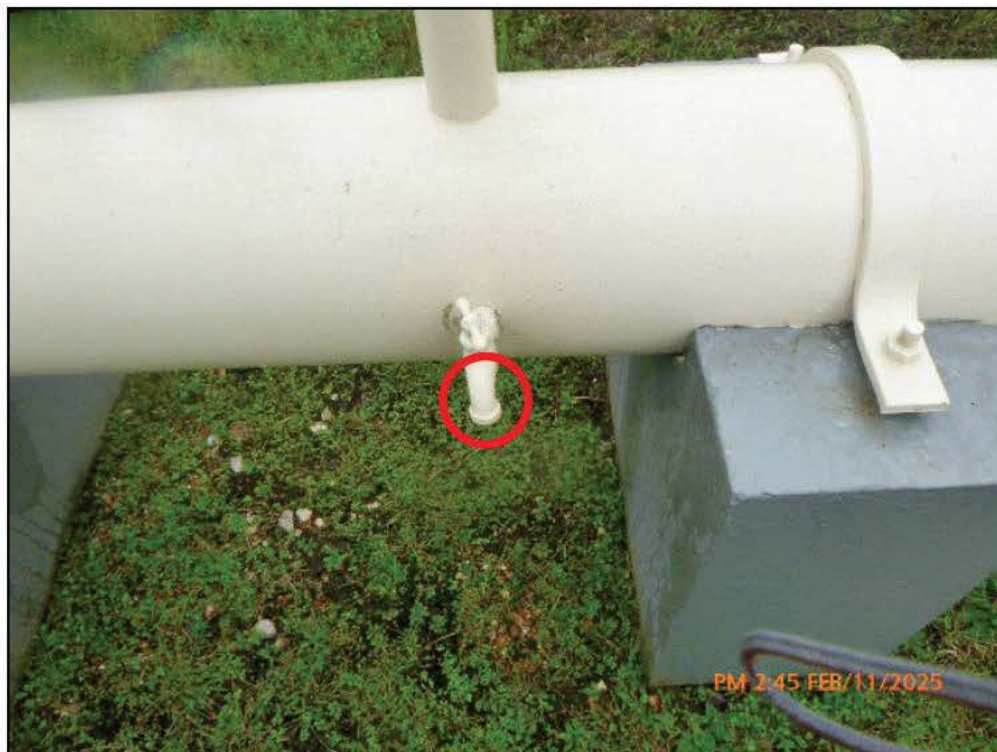
Photograph 9. 02/11/2025 2:45 PM P1010201.JPG

Description: Plant 4. Threaded sample tap on Well #4 discharge line.

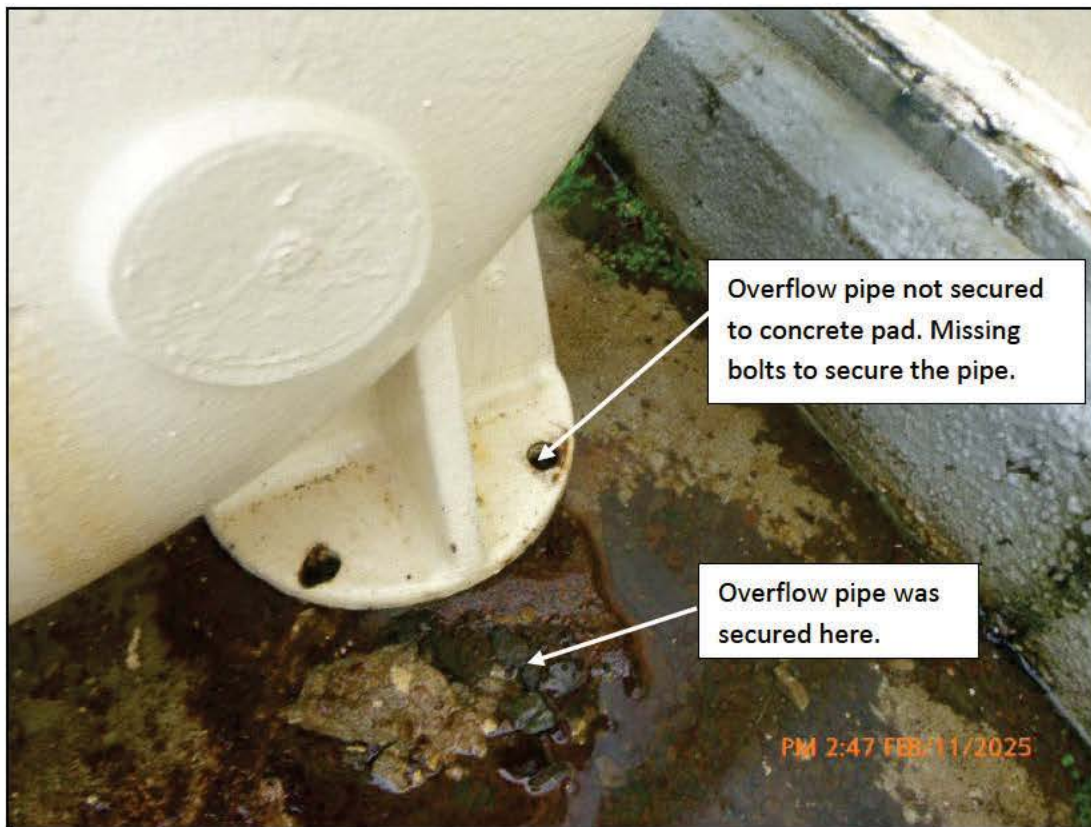
Photograph 10. 02/11/2025 2:47 PM P1010206.JPG

**Observation 11.** The EPA inspection team observed that the overflow piping on the 1-MG storage tank at Plant 4 was loose and not secured to the concrete slab ([Appendix 3, Photograph 10](#)).

Description: Plant 4. Overflow piping for the 1.0-MG ground storage tank not secured to concrete pad

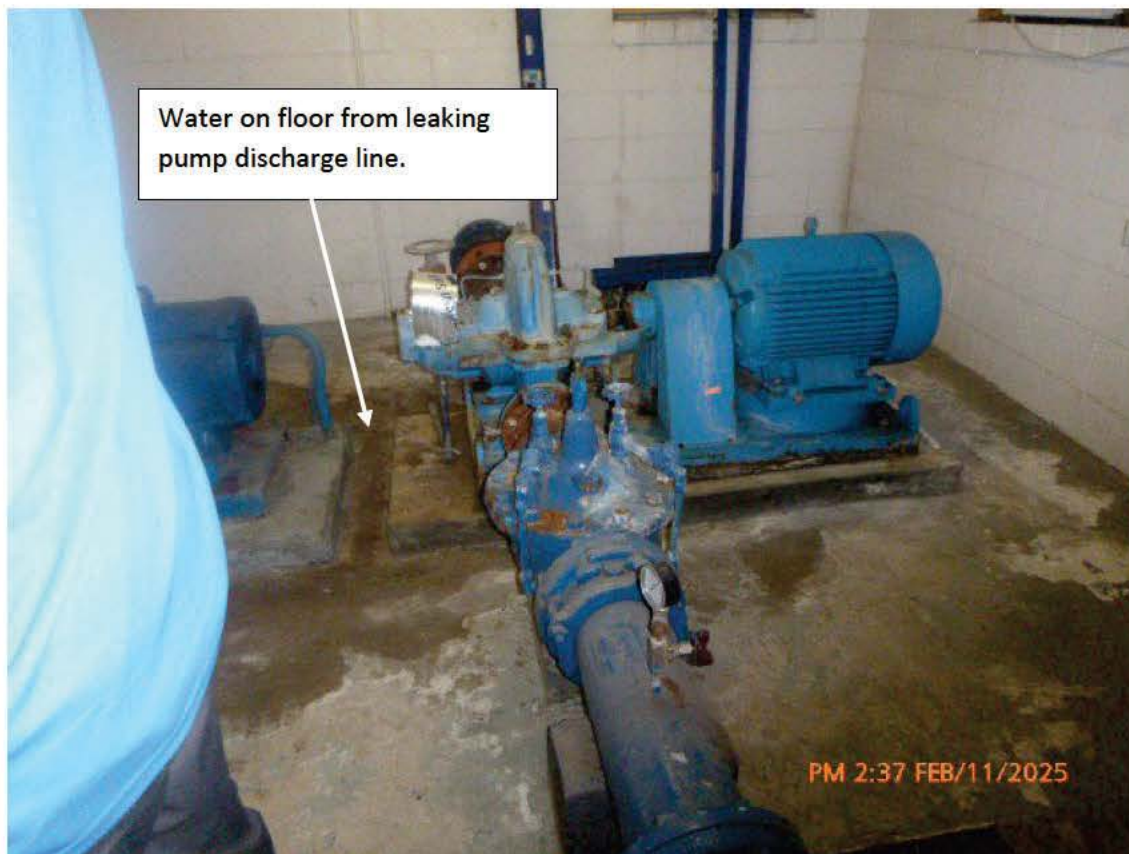
Photograph 11. 02/11/2025 2:37 PM P1010191.JPG

Description: Plant 4. Standing water on booster pump building floor; a booster pump discharge line was leaking at the time of the inspection.

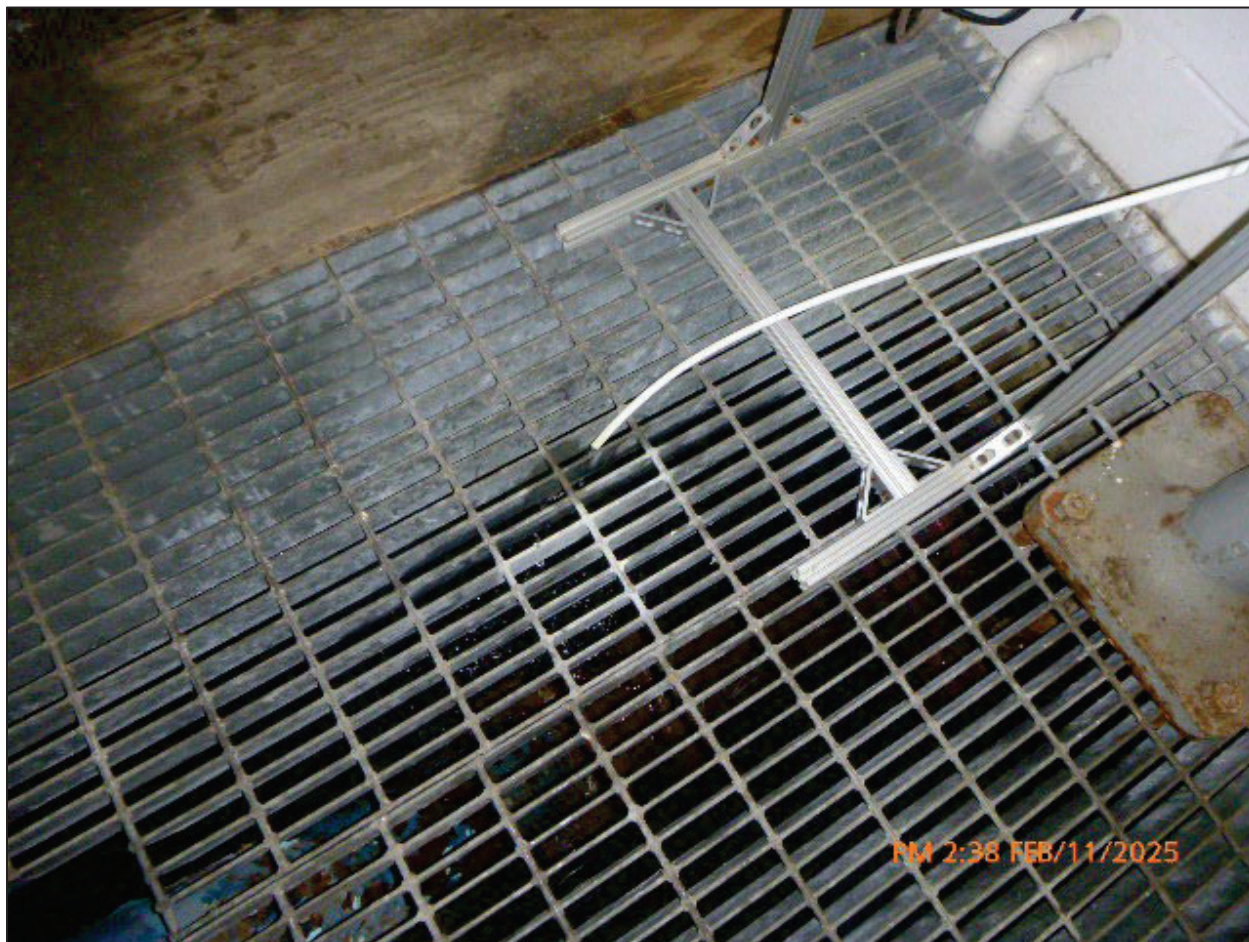
Photograph 12. 02/11/2025 2:38 PM P1010194.JPG

Description: Plant 4. Standing water in the sump under the booster pump floor; water is from the online chloramine analyzer discharge and from leaking booster pump discharge line.

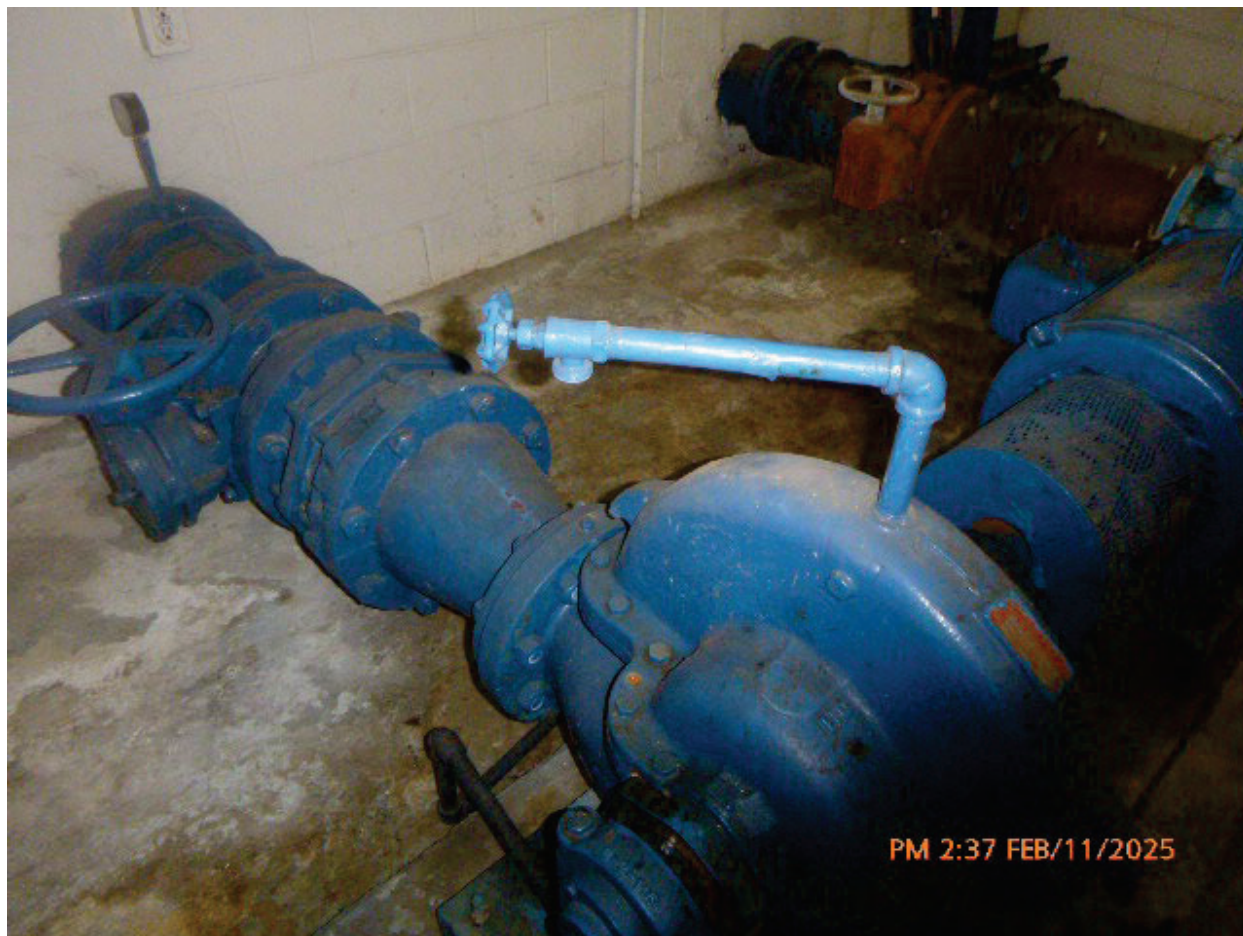
Photograph 13. 02/11/2025 2:37 PM P1010193.JPG

Description: Plant 4. Threaded sample tap on booster pump discharge line.
