### INSPECTION REPORT

| Inspection Date(s): | 06/07/2022 | | |
| Regulatory Program(s) | NPDES | | |
| Company Name: | <b>Gonzalez Dairy, Inc.</b> | | |

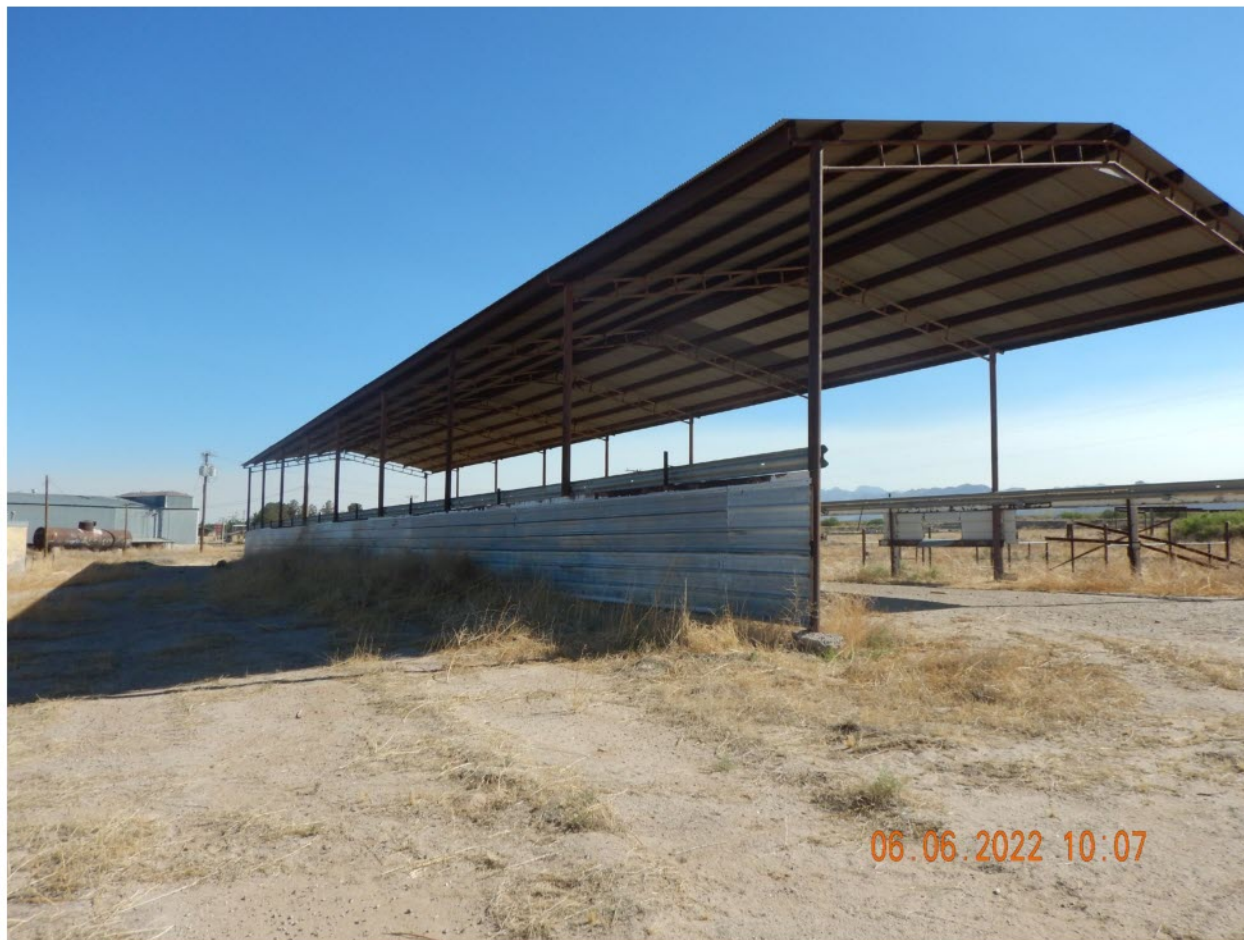
Photo No. 1

Photograph File Name: DSCN0791.JPG  
Date of Photograph: 06/06/2022  
Latitude and Longitude: 32.142528, -106.651367  
Orientation: NW  
Map Datum: WGS-84  
Time of Photo: 10:07 AM  
Photographer: Jack Arias  
Description: This image shows a hay covered area that is part of the dairy facility.

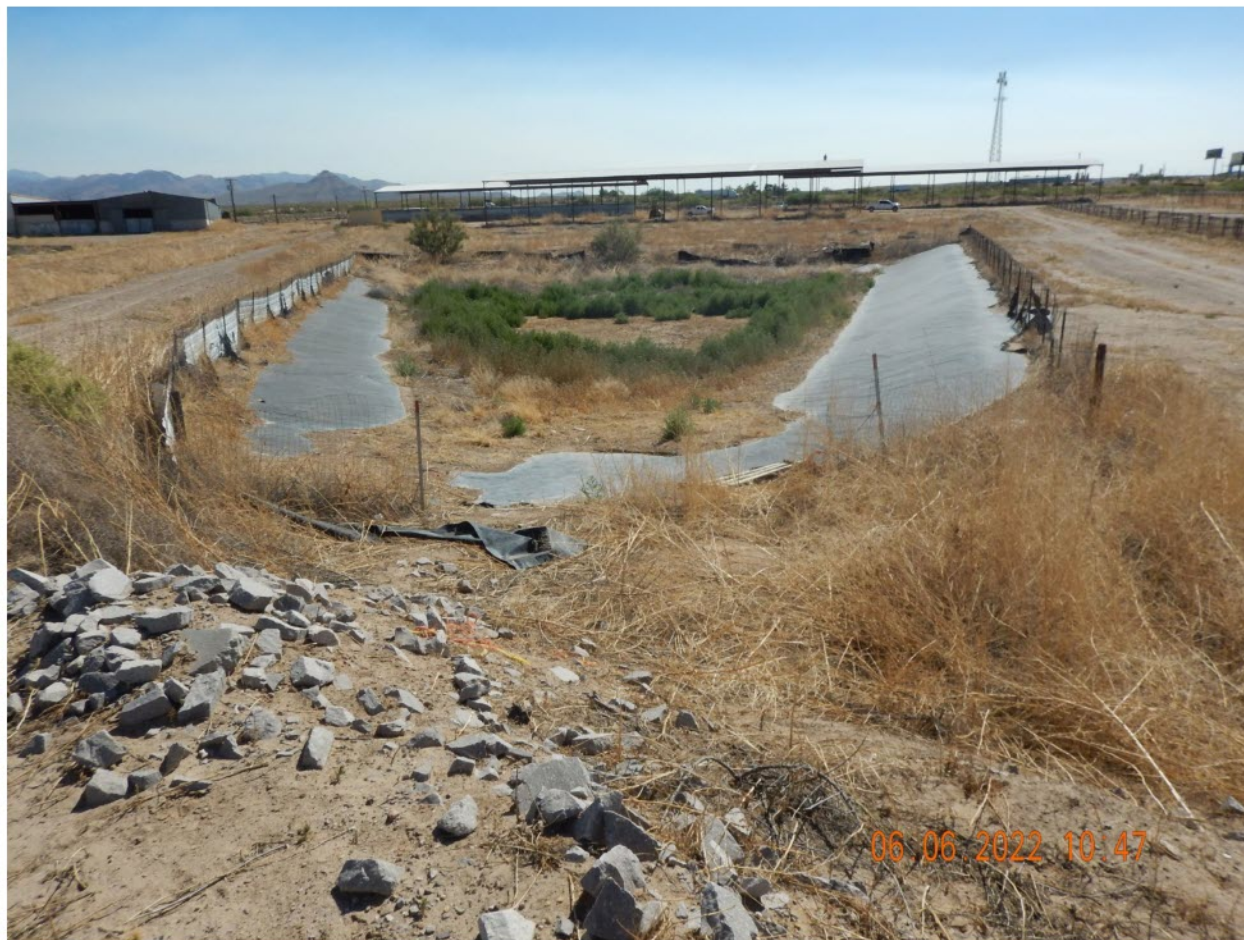
Photo No. 2

Gonzalez Dairy consist of two synthetically lined process wastewater lagoons or impoundments (#1 and #2) that form part of the watershed retention control structures (RCS). Impoundments #1 and #2 show manure solids inside their perimeters (See Photo Nos. 2 - 3 in Appendix 1).

This image shows a wastewater lagoon or impoundment #1 that formed part of the watershed retention control structures (RCS). There is a buildup of manure solids in the structure.

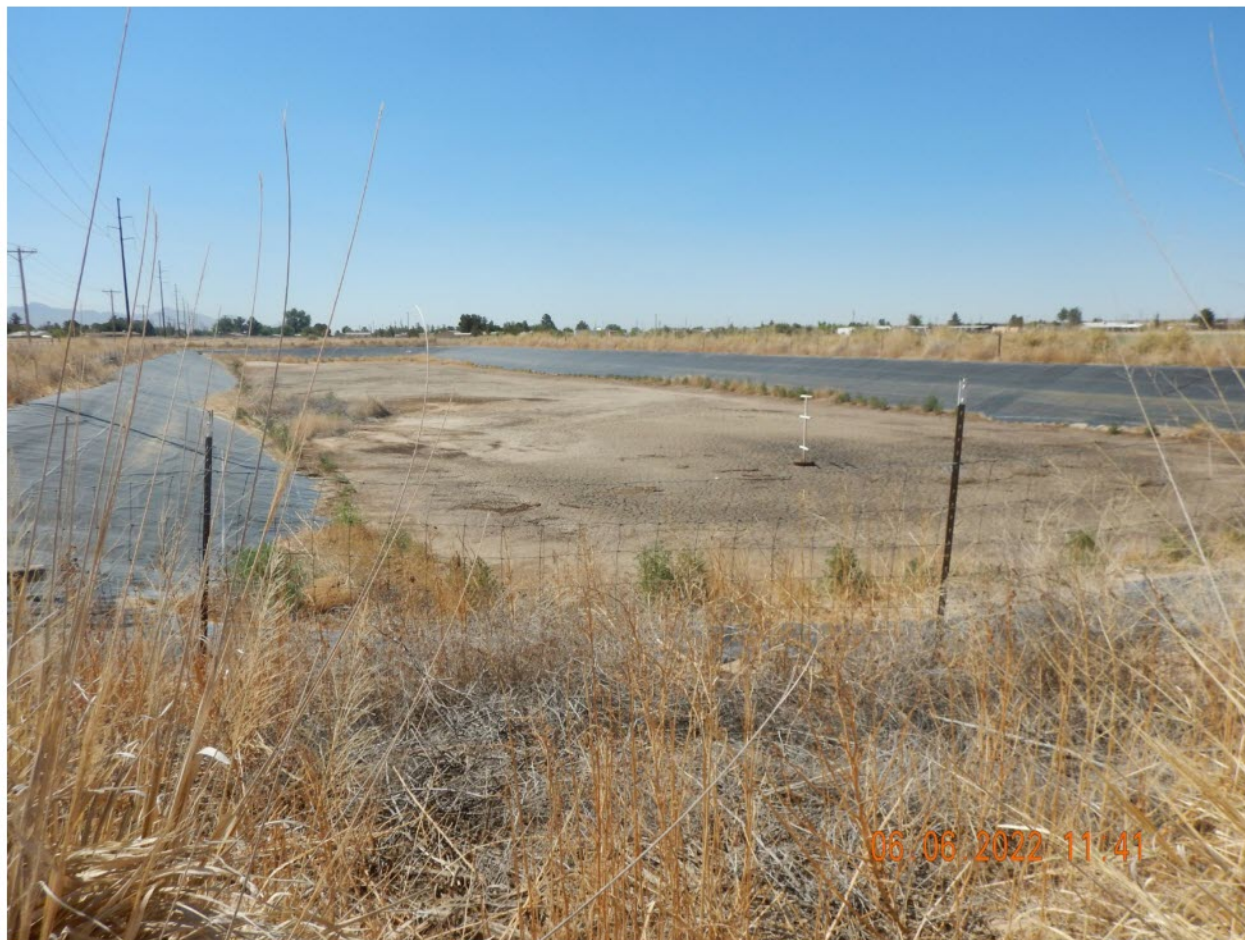
Photo No. 3

This image shows a wastewater lagoon or impoundment #2 that formed part of the watershed retention control structures (RCS). There is a buildup of manure solids in the structure.

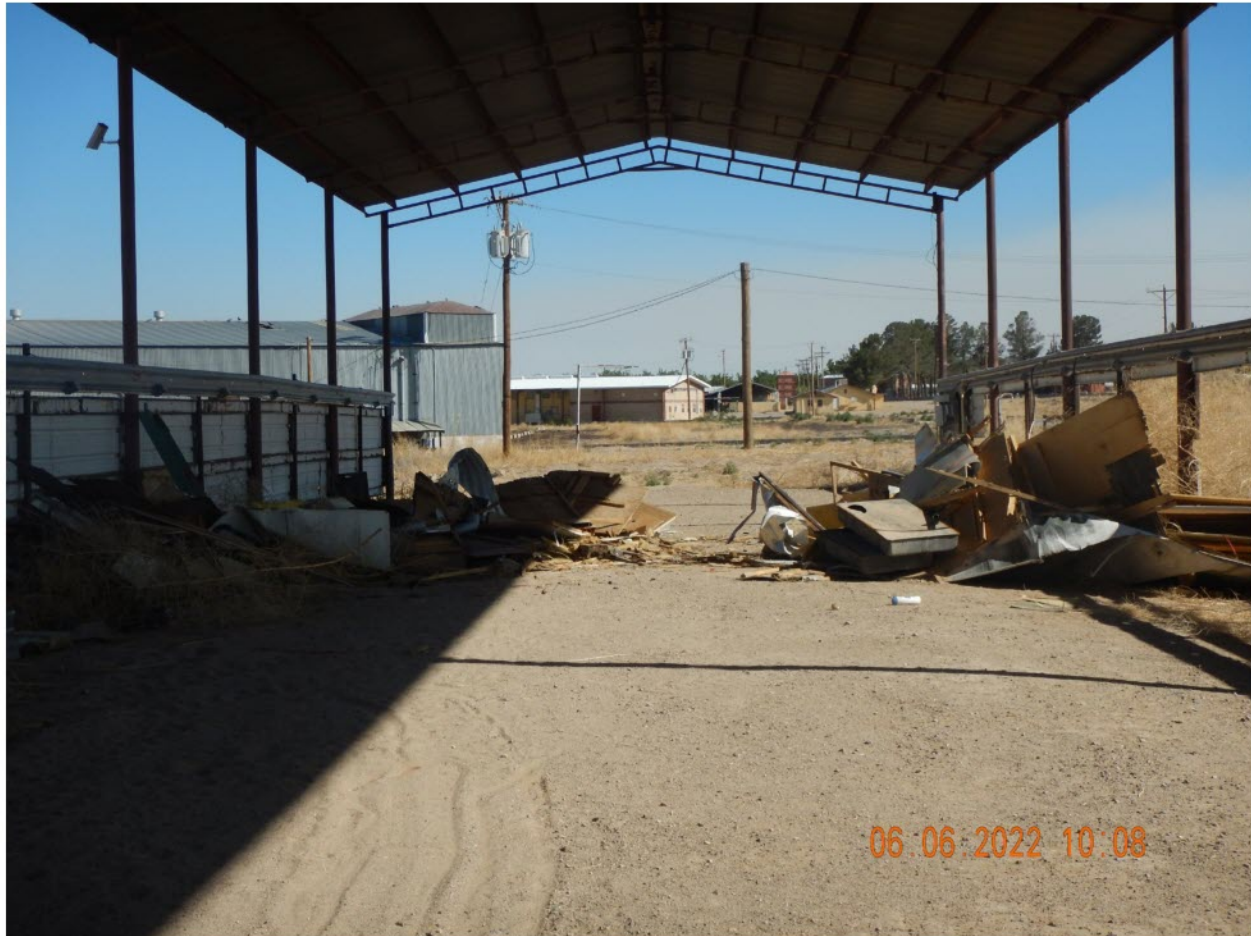
We observe that trash was stored at this location (See Photo No. 4 in Appendix 1).

Photograph File Name: DSCN0793.JPG  
Date of Photograph: 06/06/2022  
Latitude and Longitude: 32.142528, -106.651367  
Orientation: NW  
Map Datum: WGS-84  
Time of Photo: 10:08 AM  
Photographer: Jack Arias  
Description: This image shows trash stored at this location.

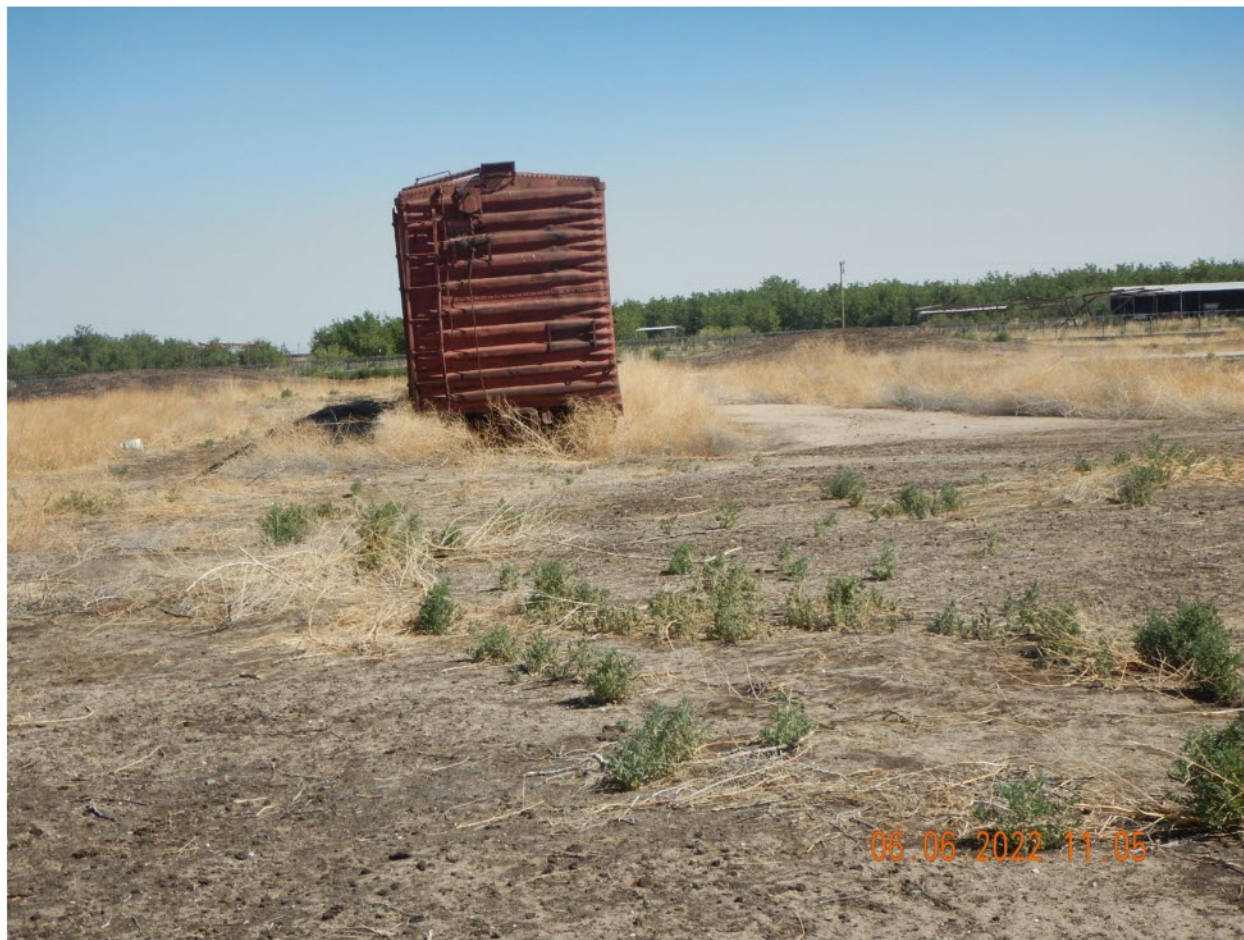
Photo No. 5

We observe large buildup of manure solids inside pens. Manure solids should be removed, and area regraded and leveled to allow proper runoff (See Photo Nos. 5 - 8 in Appendix 1).

Photograph File Name: DSCN0825.JPG  
Date of Photograph: 06/06/2022  
Latitude and Longitude: 32.144721, -106.656433  
Orientation: N  
Map Datum: WGS-84  
Time of Photo: 11:05 AM  
Photographer: Jack Arias  
Description: This image shows an accumulation of manure solids next to pens.

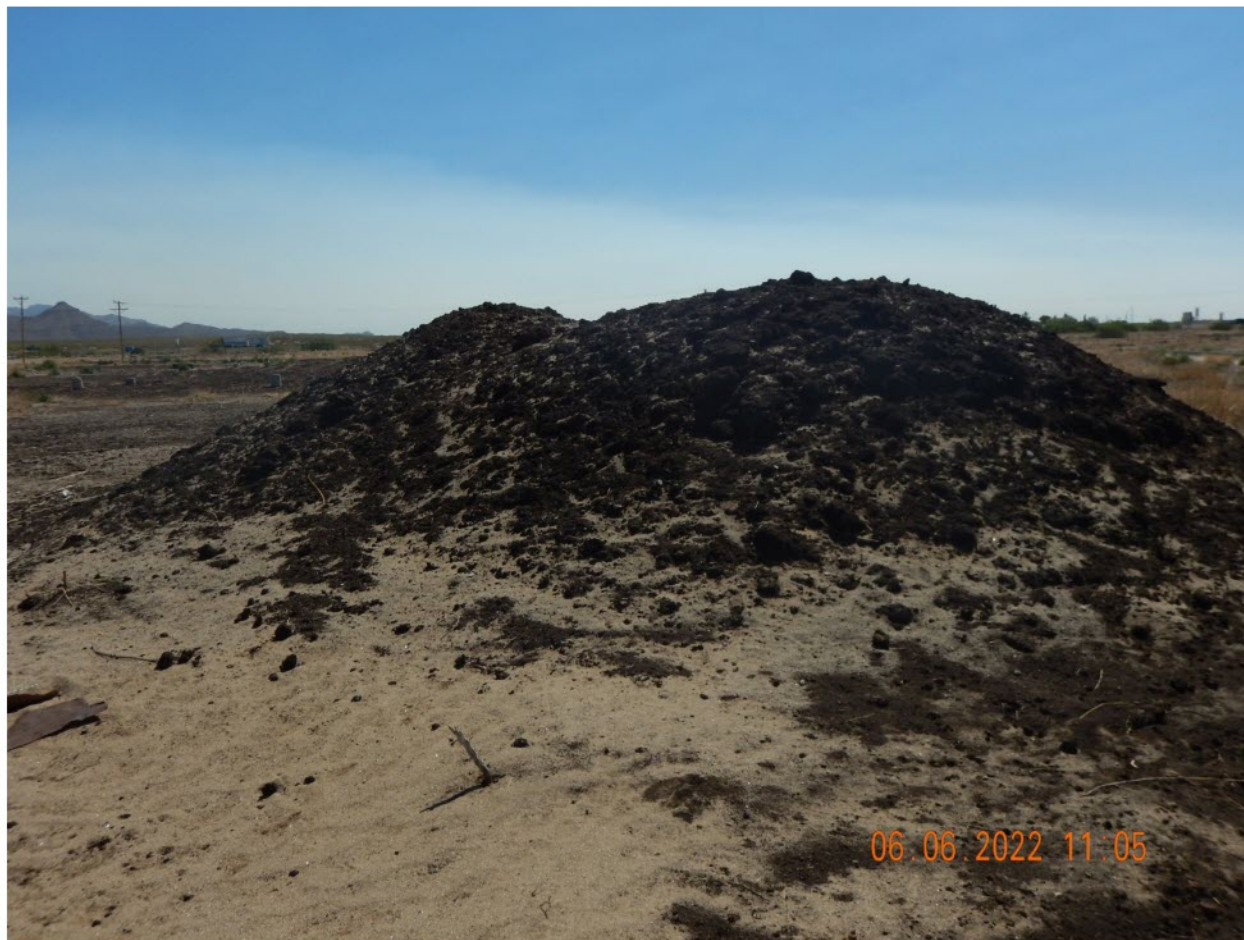
Photo No. 6

Photograph File Name: DSCN0826.JPG  
Date of Photograph: 06/06/2022  
Latitude and Longitude: 32.157803, -106.668447  
Orientation: N  
Map Datum: WGS-84  
Time of Photo: 11:05 AM  
Photographer: Jack Arias  
Description: This image shows manure solids next to pens.

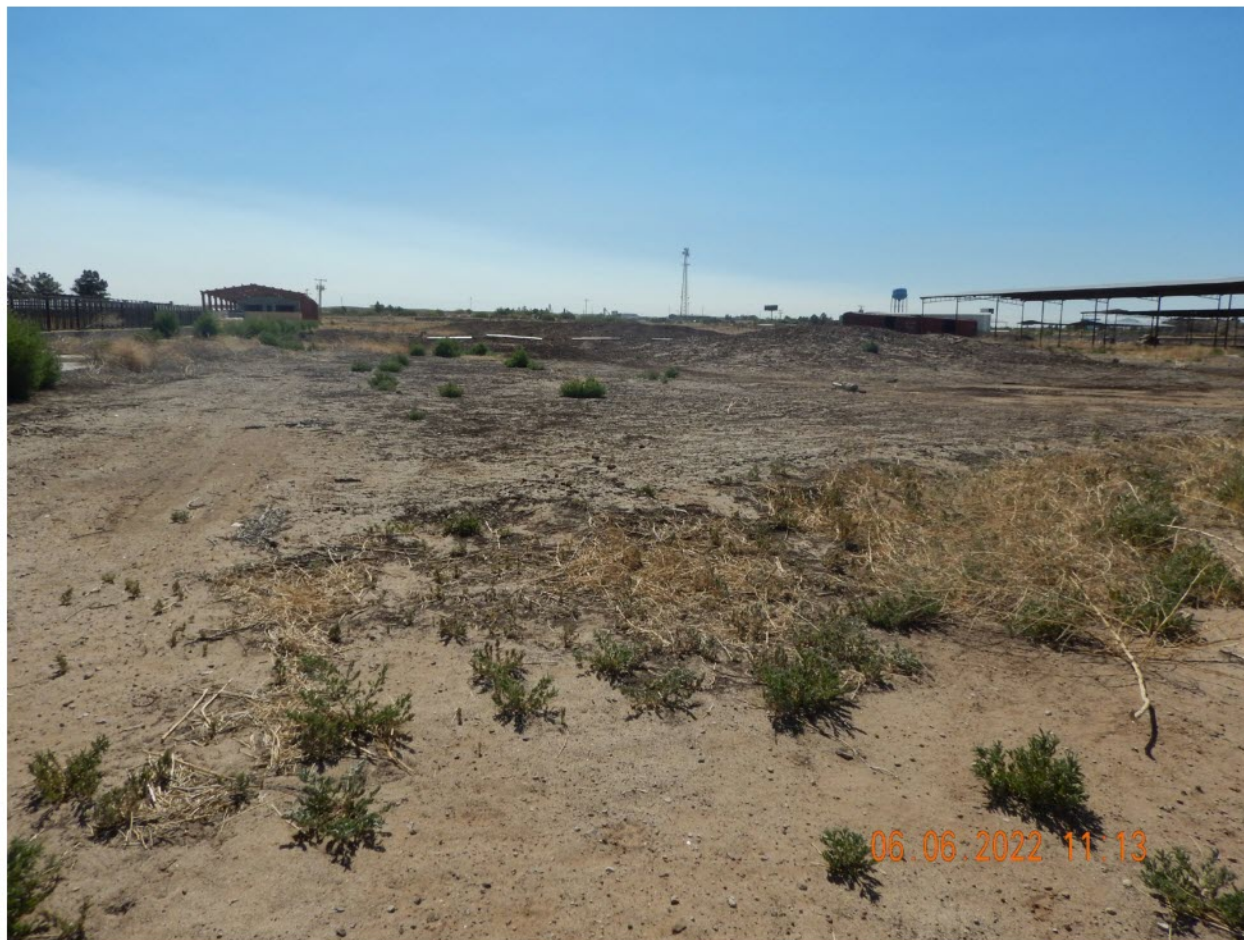
Photo No. 7

Photograph File Name: DSCN0827.JPG  
Date of Photograph: 06/06/2022  
Latitude and Longitude: 32.144721, -106.656433  
Orientation: N  
Map Datum: WGS-84  
Time of Photo: 11:13 AM  
Photographer: Jack Arias  
Description: This image shows manure solids inside old pens.

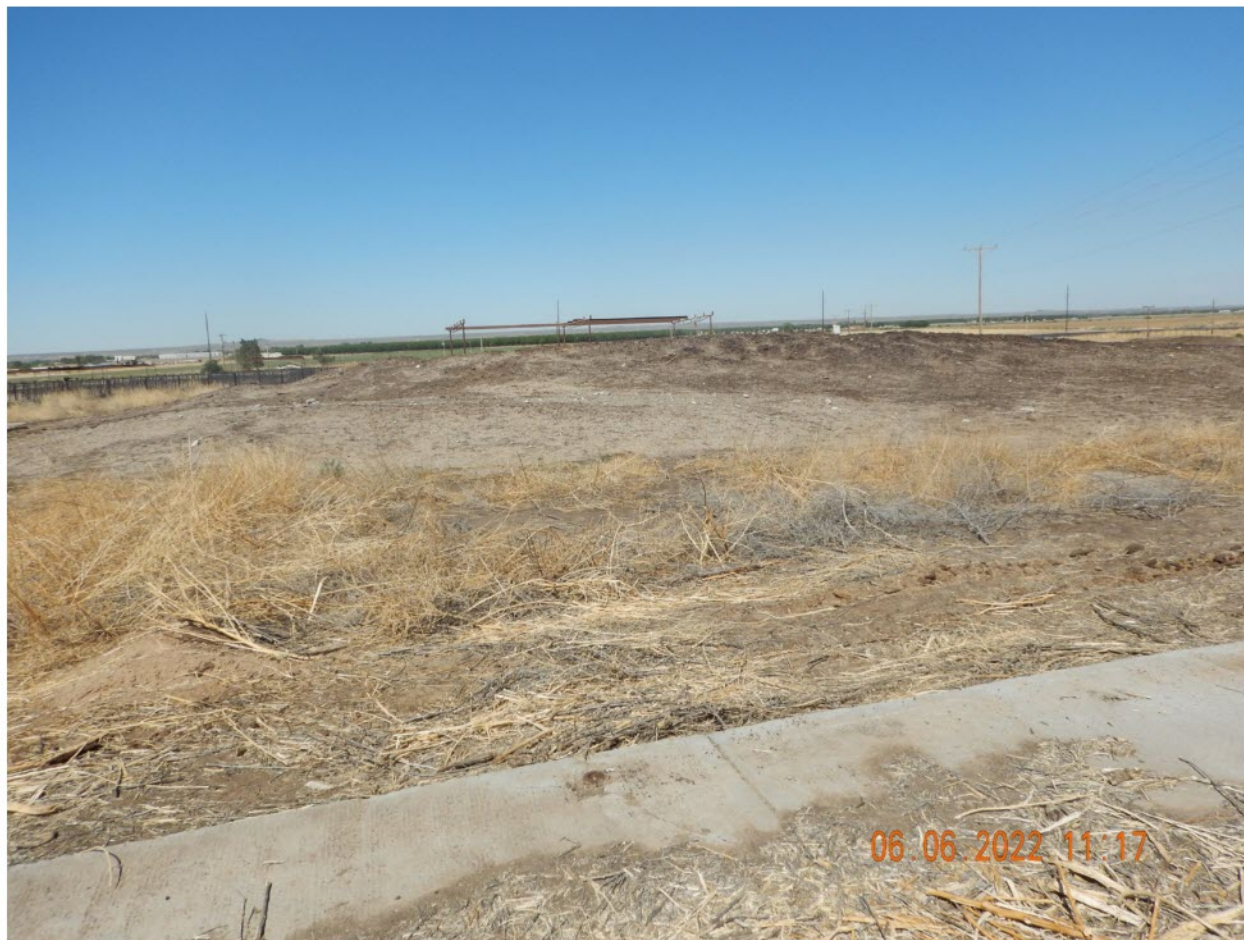
Photo No. 8

Photograph File Name: DSCN0835.JPG  
Date of Photograph: 06/06/2022  
Latitude and Longitude: 32.144167, -106.656982  
Orientation: W  
Map Datum: WGS-84  
Time of Photo: 11:17 AM  
Photographer: Jack Arias  
Description: This image shows manure solids inside old pens.

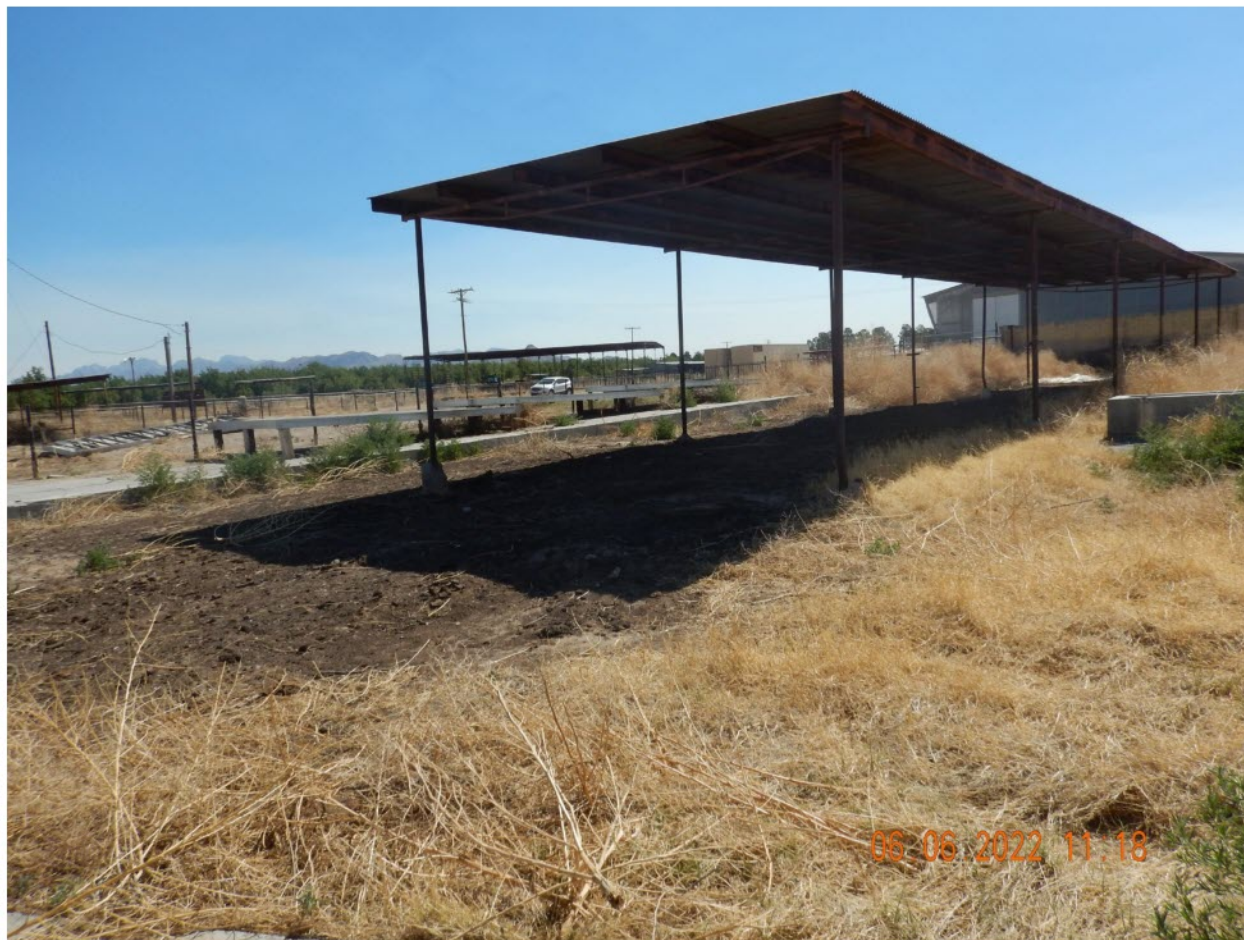
Photo No. 9

We observe undefined ditches, an open wastewater door, and other areas with manure solids inside and around their perimeters (See Photo Nos.9 - 13 in Appendix 1).

Photograph File Name: DSCN0836.JPG  
Date of Photograph: 06/06/2022  
Latitude and Longitude: 32.142051, -106.651099  
Orientation: E  
Map Datum: WGS-84  
Time of Photo: 11:18 PM  
Photographer: Jack Arias  
Description: This image shows manure solids inside and around pens.

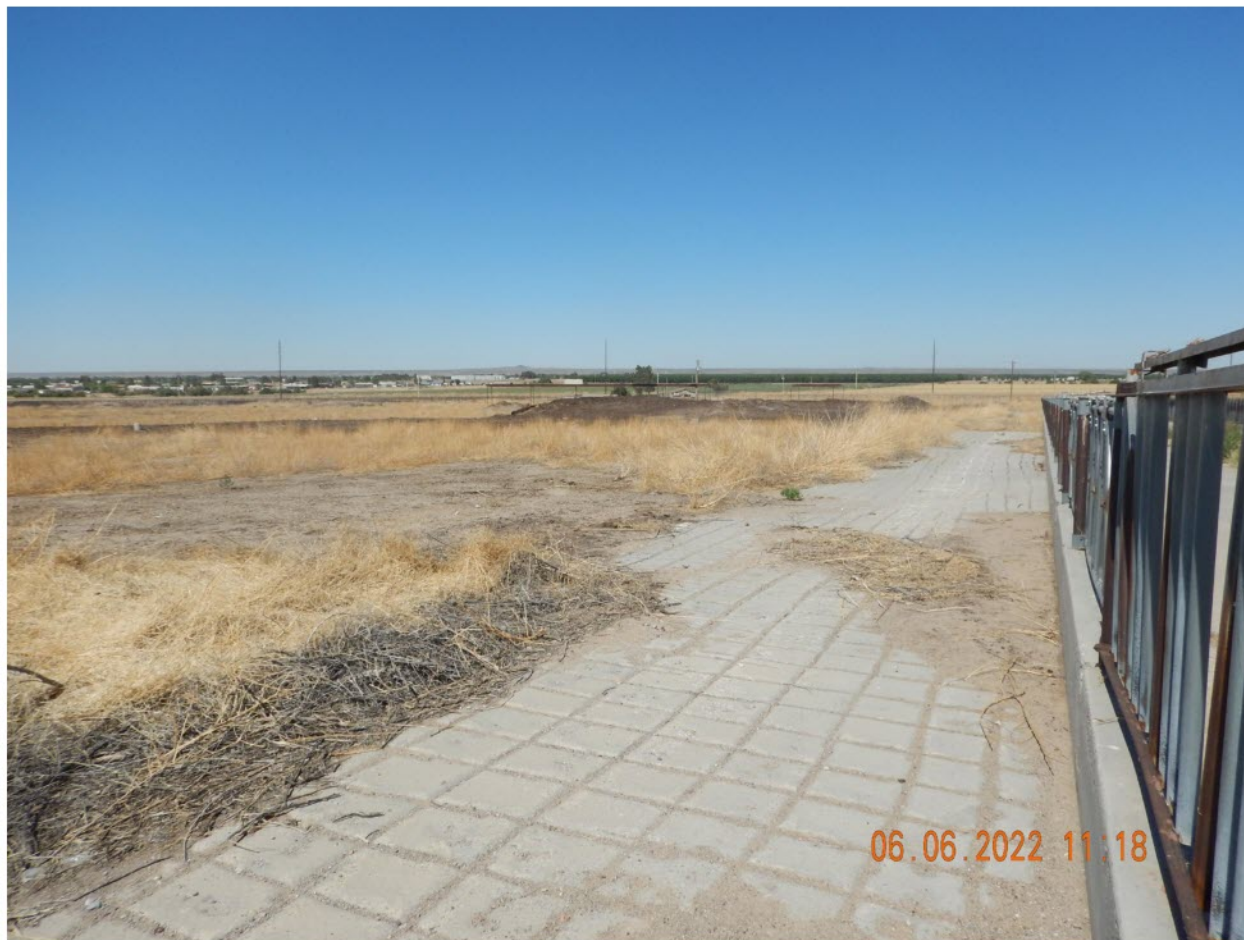
Photo No. 10

Photograph File Name: DSCN0838.JPG  
Date of Photograph: 06/06/2022  
Latitude and Longitude: 32.144167, -106.656982  
Orientation: SE  
Map Datum: WGS-84  
Time of Photo: 11:18 PM  
Photographer: Jack Arias  
Description: This image shows manure solids next to feed lanes.

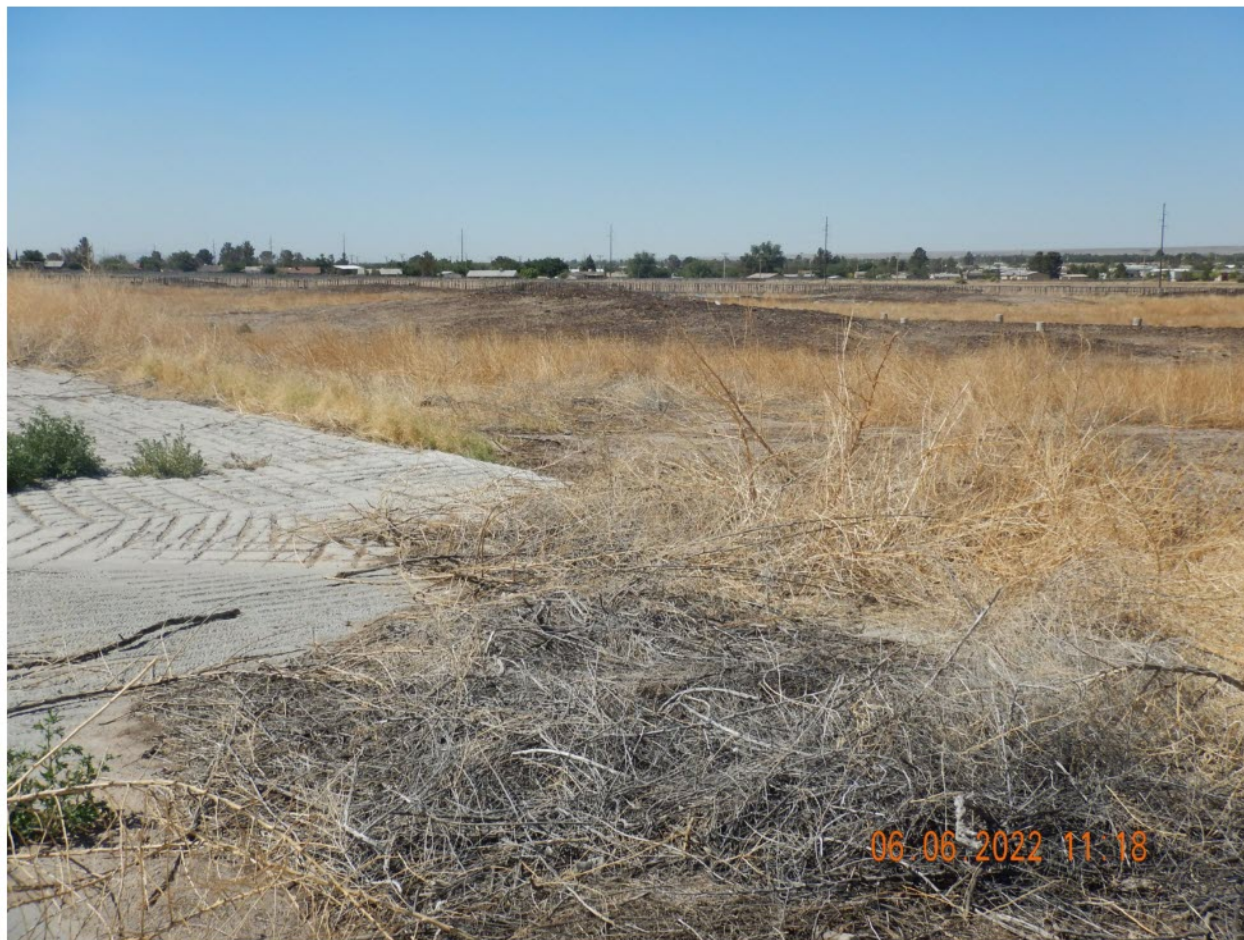
Photo No. 11

Photograph File Name: DSCN0840.JPG  
Date of Photograph: 06/06/2022  
Latitude and Longitude: 32.144167, -106.656982  
Orientation: SE  
Map Datum: WGS-84  
Time of Photo: 11:18 AM  
Photographer: Jack Arias  
Description: This image shows manure solids next to feed lanes.

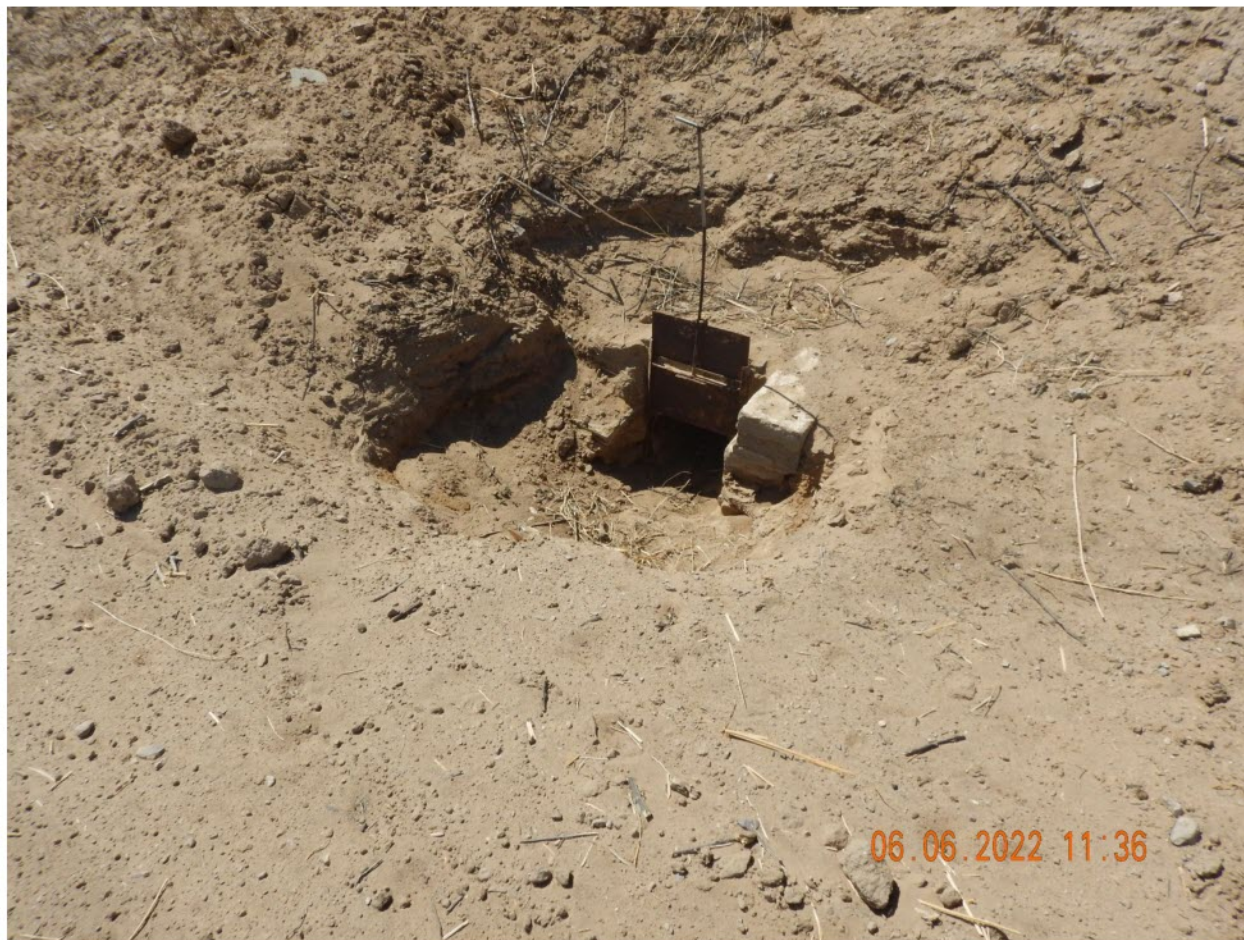
Photo No. 12

Photograph File Name: DSCN0856.JPG  
Date of Photograph: 06/06/2022  
Latitude and Longitude: 32.144339, -106.657185  
Orientation: S  
Map Datum: WGS-84  
Time of Photo: 11:36 AM  
Photographer: Jack Arias  
Description: This image shows an open wastewater door next to impoundment #2.

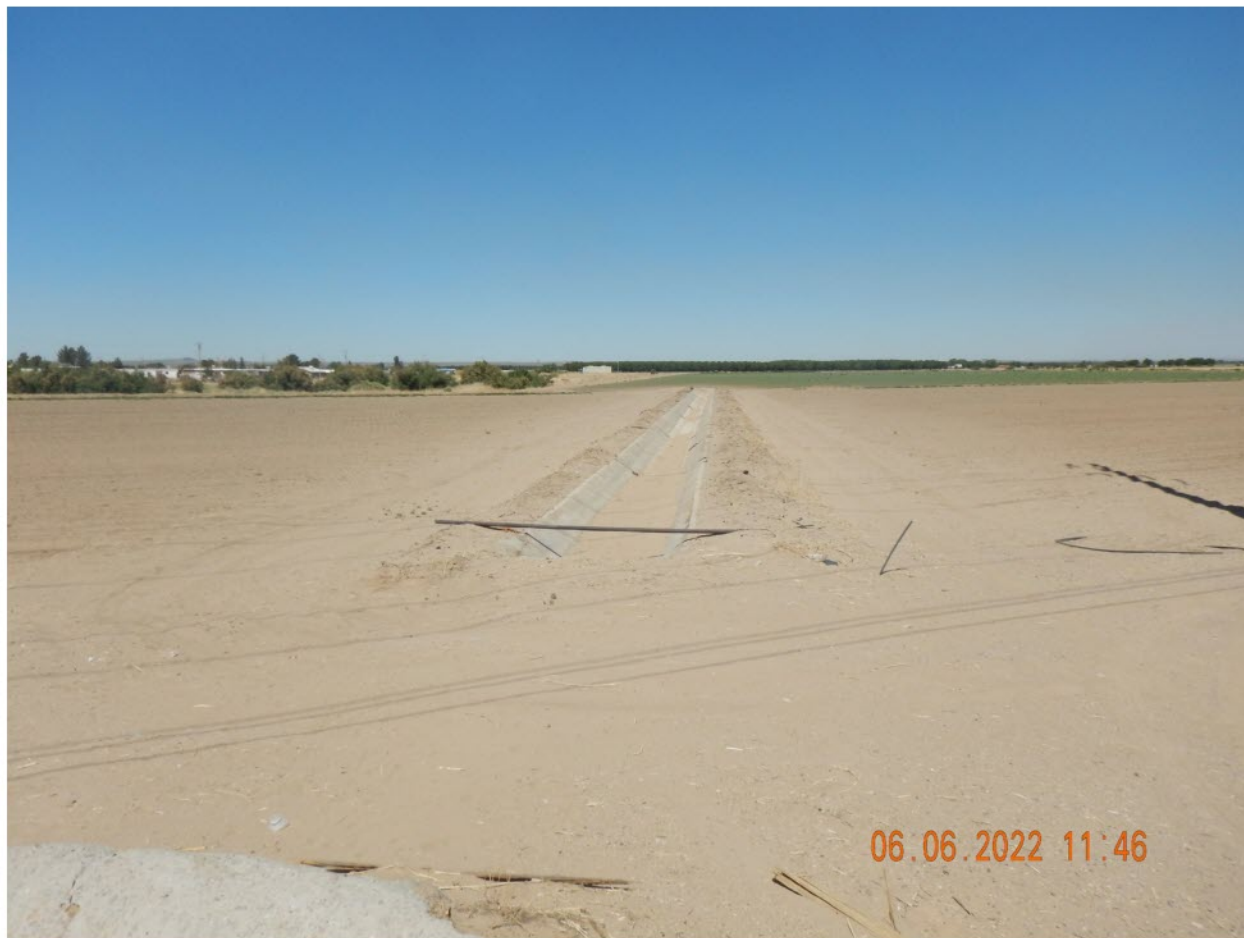
Photo No. 13

Photograph File Name: DSCN0865.JPG  
Date of Photograph: 06/06/2022  
Latitude and Longitude: 32.144339, -106.657185  
Orientation: S  
Map Datum: WGS-84  
Time of Photo: 11:46 AM  
Photographer: Jack Arias  
Description: This image shows an undefined ditch next to impoundment #2.
