## REGION 10 Enforcement Division

### INSPECTION REPORT

| <b>Company Name:</b> | State of Alaska Department of Transportation and Public Facilities (Alaska DOT & PF), Alaska Marine Highway System (AMHS) | | |

Type of inspection: CEI - Compliance Evaluation Inspection

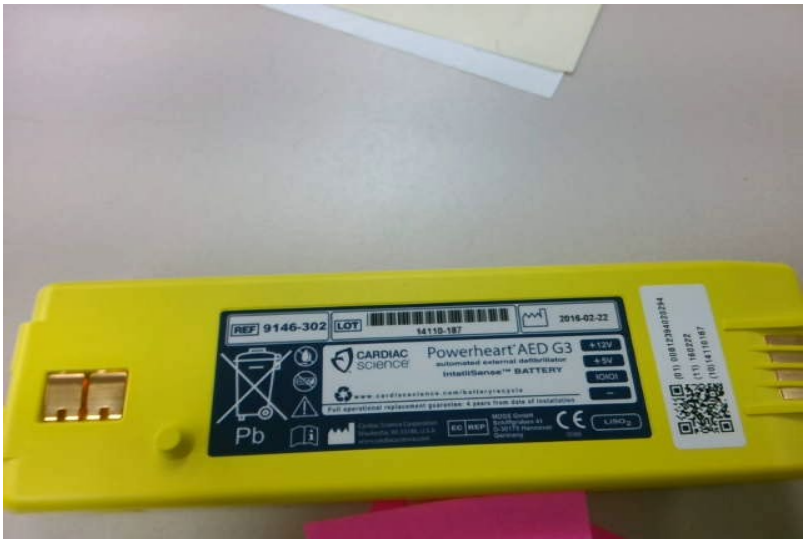
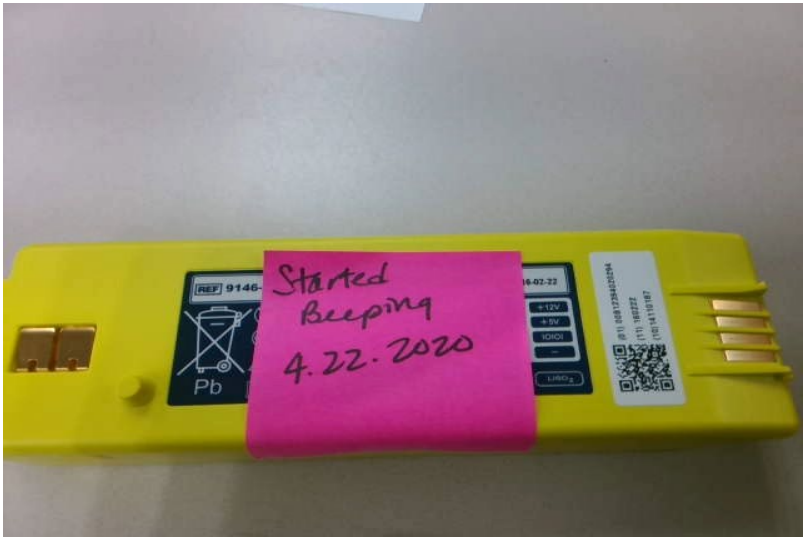
| While I was in the Terminal Office, I saw two batteries that, according to facility representatives, were waste batteries. One was a lead-acid battery that came out of a defibrillator and was dated 4/22/2020. The second battery was a Ni-Cad battery that came out of a hand-held radio and was dated 12/28/2020. | |

| <b>Building:</b> AMHS Terminal | <b>Area:</b> Terminal Office | <b>Sub-area:</b> |
|---|---|---|
| The facility failed to meet the universal waste labeling requirements with regard to the waste batteries. | <b>Citations:</b> | <b>Sections:</b> |

| <p>[Title]</p> <p>08/05/2021 12:15 PM (AKT)</p> <p>Jon Jones</p> <p>Terminal Office</p> <p>No CBI</p> <p>No PII</p> <p>View of waste lead-acid battery from defibrillator.</p> | |
| <p>[Title]</p> <p>08/05/2021 12:17 PM (AKT)</p> <p>Jon Jones</p> <p>Terminal Office</p> <p>No CBI</p> <p>No PII</p> <p>View of the date the waste lead-acid battery became a waste.</p> | |

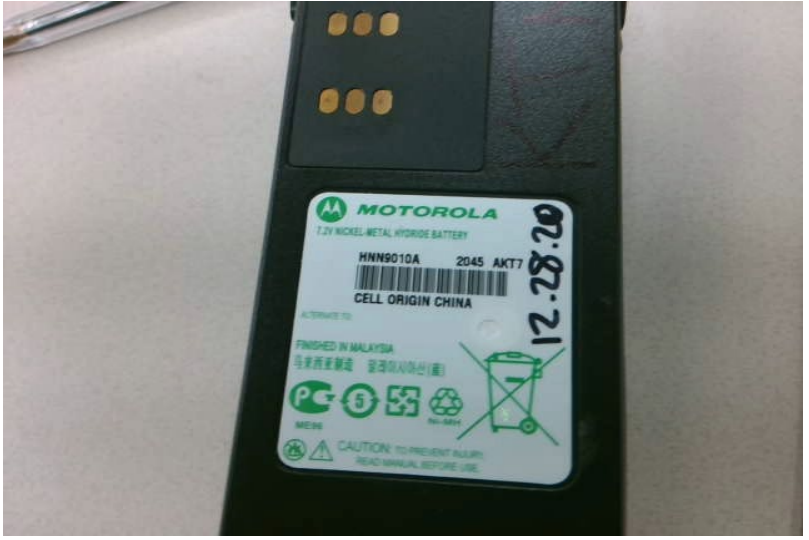
| <p>[Title]</p> <p>08/05/2021 12:33 PM (AKT)</p> <p>Jon Jones</p> <p>Terminal Office</p> <p>No CBI</p> <p>No PII</p> <p>View of waste NiCad battery from handheld radio.</p> | |

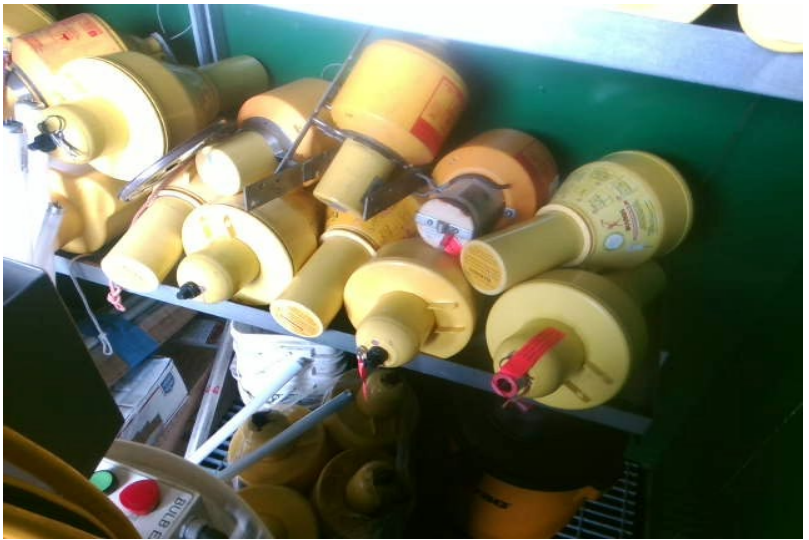
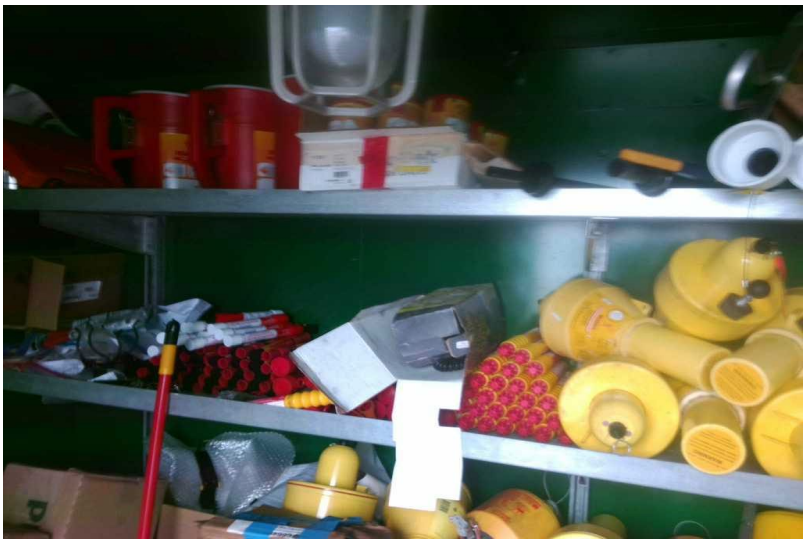
While inspecting the hazardous waste Connex, I saw that the facility had, according to Mr. Clayton, a large number of expired flares and rockets used for maritime emergencies. Mr. Clayton told me the facility used to give the expired flares and rockets away to a local maritime organization that used them for training purposes. He said that organization has since gone to another type of training and no longer accepts these expired flares. He told me they were in the process of trying to figure out what to do with them.

| The facility has failed to make a waste determination for the expired flares and rockets. | <b>Citations:</b> | <b>Sections:</b> |

| <p>[Title]</p> <p>08/05/2021 01:54 PM (AKT)</p> <p>Jon Jones</p> <p>Hazardous waste Connex/Lamp crushing side</p> <p>No CBI</p> <p>No PII</p> <p>View of waste flares and rockets in the hazardous waste Connex.</p> | |
| <p>[Title]</p> <p>08/05/2021 01:55 PM (AKT)</p> <p>Jon Jones</p> <p>Hazardous waste Connex/Lamp crushing side</p> <p>No CBI</p> <p>No PII</p> <p>Another view of waste flares and rockets in the hazardous waste Connex.</p> | |

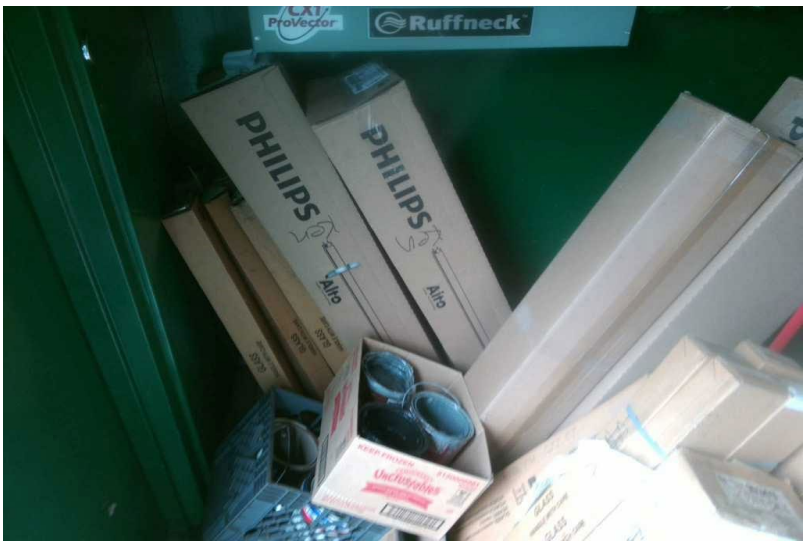
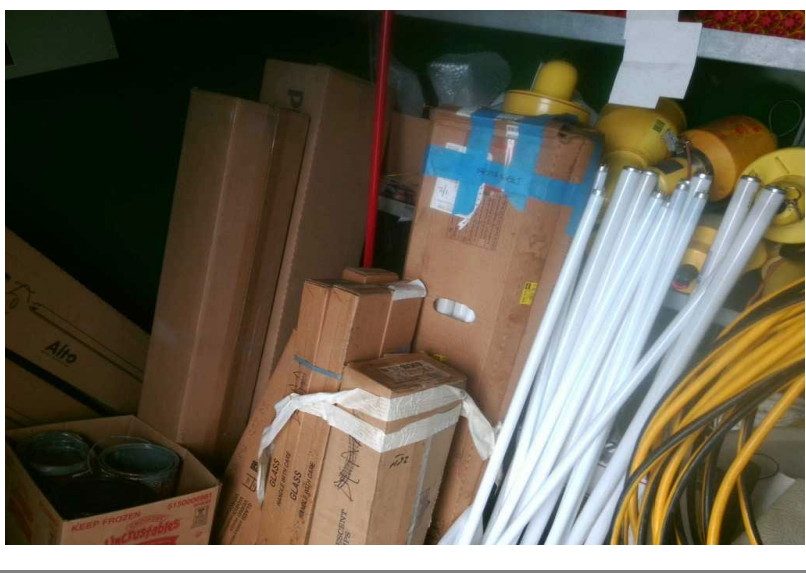
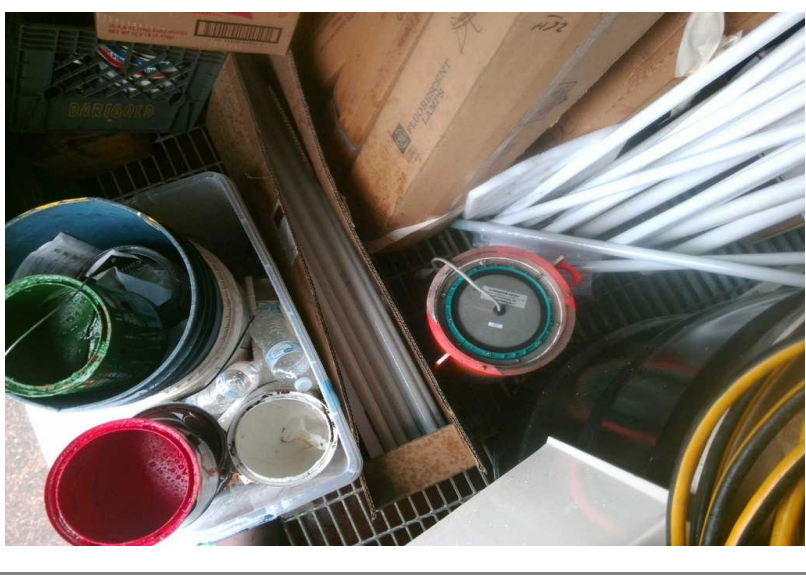
At the time of the inspection, while inside the hazardous waste Connex, I saw multiple cardboard containers that held four-foot fluorescent lamps, and I saw some loose four-foot fluorescent lamps. I also saw a drum-top lamp crusher connected to a 55-gallon container. Some cardboard containers that held four-foot fluorescent lamps were labeled with the words, "Dead Bulbs", "Burnout Bulbs", or "Bad". Most of the lamps also had darkened ends which are indicative of waste fluorescent lamps. I asked Mr. Clayton, after he arrived onsite, about the fluorescent lamps and he stated that they were waste lamps. According to Mr. Clayton the fluorescent lamps are generated on vessels and in the Terminal. He stated that the lamps are placed inside the hazardous waste Connex and then they are crushed with the drum-top crusher. While in the hazardous waste Connex I saw the following waste lamps:

- 16 unpackaged, four-foot waste lamps
- 19 boxes of four-foot waste lamps - 6 of the boxes were not closed and all 19 boxes were improperly labeled.

| <b>Building:</b> AMHS Terminal | <b>Area:</b> Terminal Office | <b>Sub-area:</b> |
|---|---|---|
| At the time of the inspection, I saw: <ul style="list-style-type: none"> <li>• 16 loose and unpackaged waste fluorescent lamps.</li> <li>• 19 boxes of waste fluorescent lamps - 6 of the boxes were not closed, and all 19 boxes were improperly labeled.</li> </ul> | <b>Citations:</b> | <b>Sections:</b> |
| The facility failed to meet the universal waste labeling requirements with regard to the waste lamps prior to crushing. | <b>Citations:</b> | <b>Sections:</b> |

| <p>[Title]</p> <p>08/05/2021 01:28 PM (AKT)</p> <p>Jon Jones</p> <p>Hazardous waste Connex/Lamp crushing side</p> <p>No CBI</p> <p>No PII</p> <p>View of boxes containing waste fluorescent lamps.</p> | |

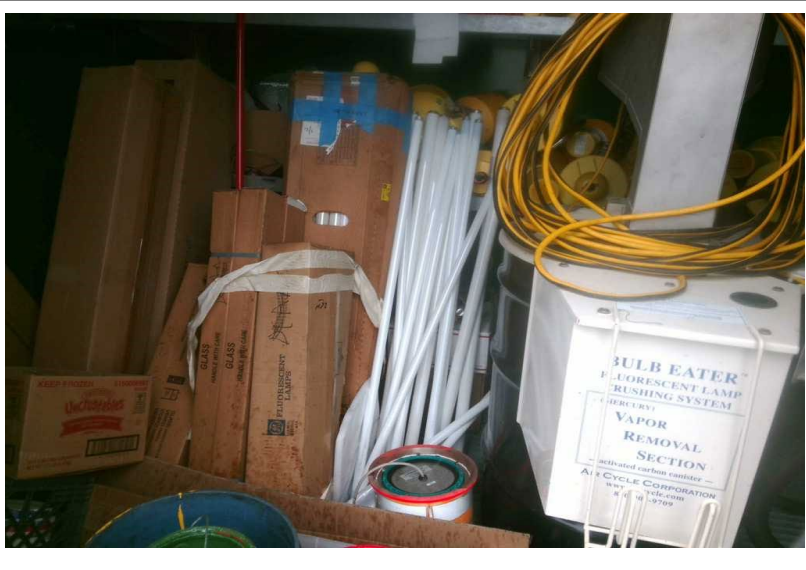
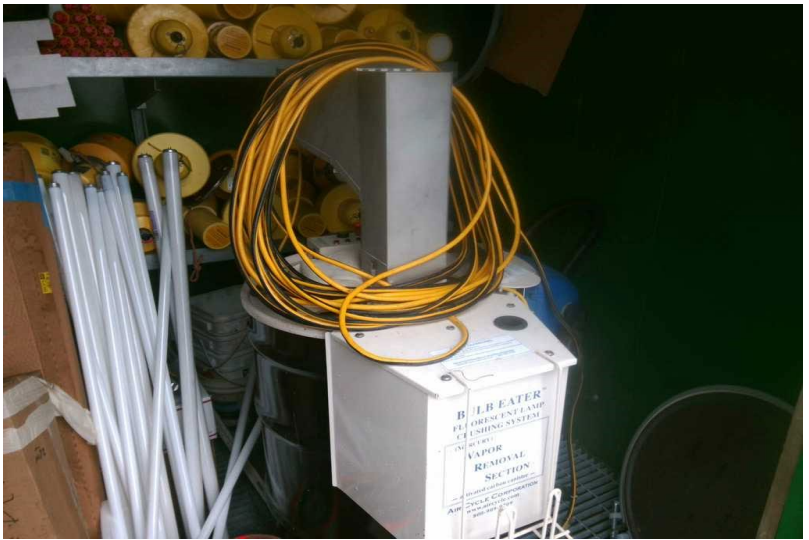
While inspecting the hazardous waste Connex I saw that the facility had a drum-top bulb eater (Lamp crusher). After Mr. Clayton arrived, he told me that ADOT&PF crushes the waste fluorescent lamps and disposes of the crushed lamps. According to the copies of hazardous waste manifests that were provided by Mr. Clayton to me following the inspection, the crushed waste fluorescent lamps were being managed as hazardous waste to which ADOT&PF assigns the waste code for mercury. Mr. Clayton did not provide any information to indicate that the facility was operating in accordance with the small or large quantity generator conditions in order to treat hazardous waste in its own containers.

| <p>[Title]</p> <p>08/05/2021 01:30 PM (AKT)</p> <p>Jon Jones</p> <p>Hazardous waste Connex/Lamp crushing side</p> <p>No CBI</p> <p>No PII</p> <p>Another view of boxes containing waste fluorescent lamps and loose waste fluorescent lamps adjacent to the "Bulb Eater."</p> | |

| <p>[Title]</p> <p>08/05/2021 01:30 PM (AKT)</p> <p>Jon Jones</p> <p>Hazardous waste Connex/Lamp crushing side</p> <p>No CBI</p> <p>No PII</p> <p>Another view of boxes containing waste fluorescent lamps and loose waste fluorescent lamps adjacent to the "Bulb Eater."</p> | |

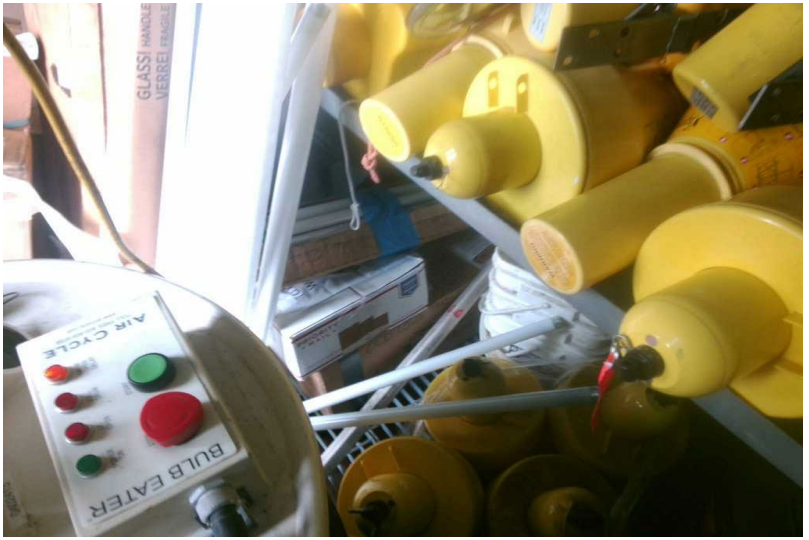
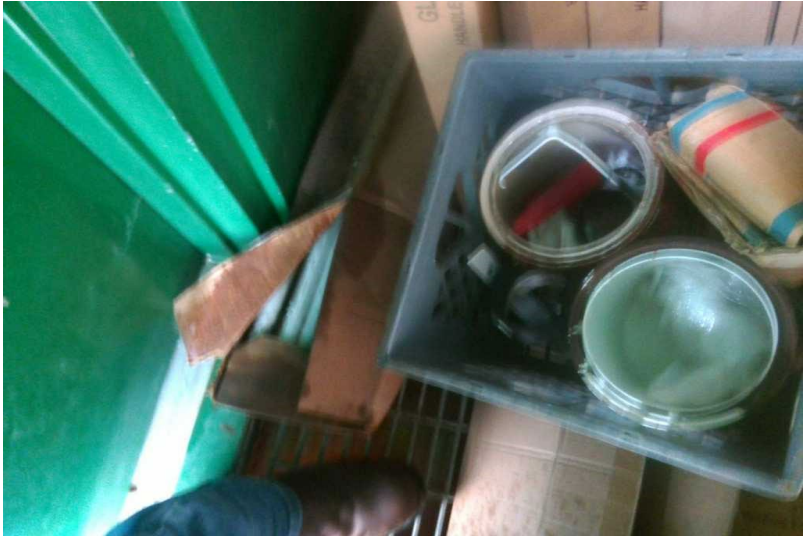
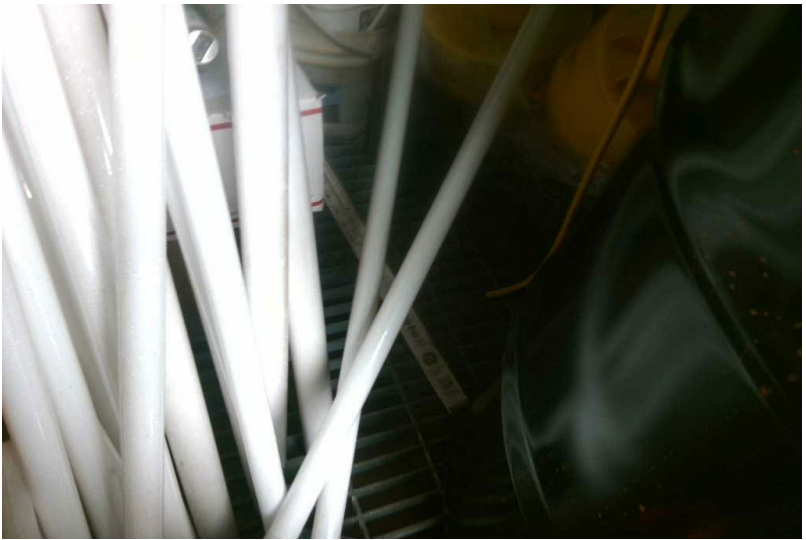
| <p>[Title]</p> <p>08/05/2021 01:31 PM (AKT)</p> <p>Jon Jones</p> <p>Hazardous waste Connex/Lamp crushing side</p> <p>No CBI</p> <p>No PII</p> <p>View of loose waste fluorescent lamps.</p> | |

| <p>[Title]</p> <p>08/05/2021 01:44 PM (AKT)</p> <p>Jon Jones</p> <p>Hazardous waste Connex/Lamp crushing side</p> <p>No CBI</p> <p>No PII</p> <p>Another view of waste fluorescent lamps.</p> | |

| <p>[Title]</p> <p>08/05/2021 01:44 PM (AKT)</p> <p>Jon Jones</p> <p>Hazardous waste Connex/Lamp crushing side</p> <p>No CBI</p> <p>No PII</p> <p>Another view of loose waste fluorescent lamps.</p> | |

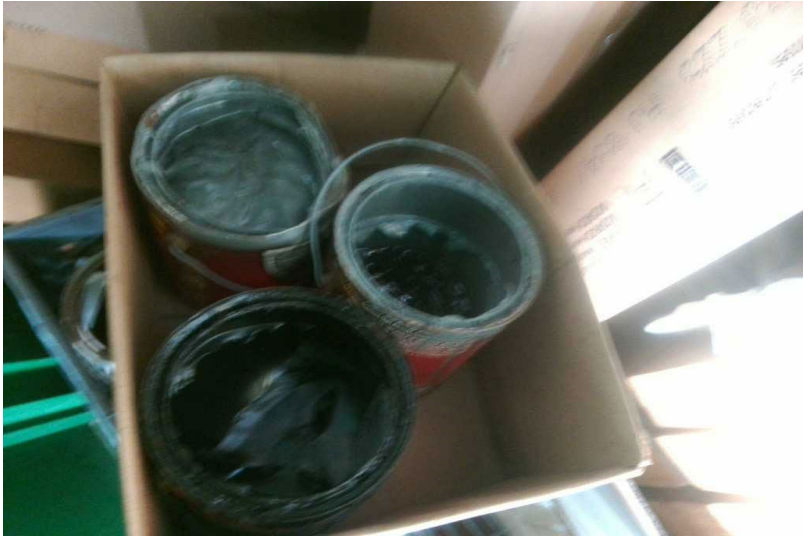
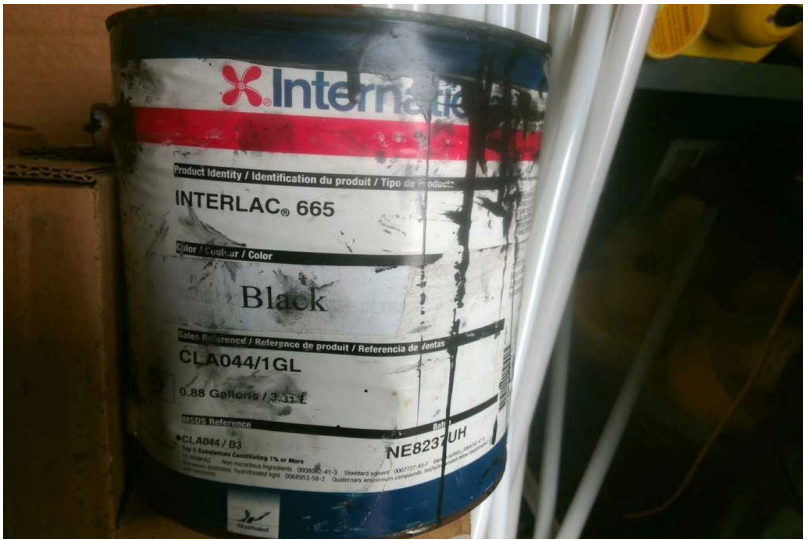
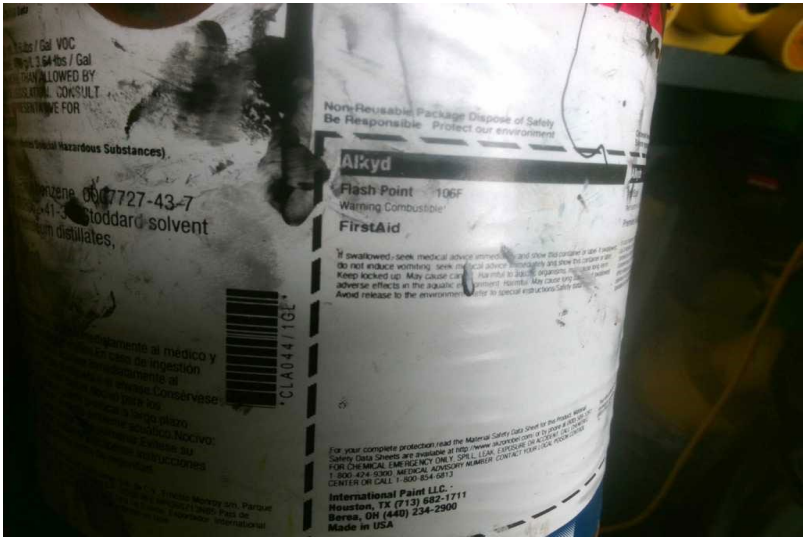
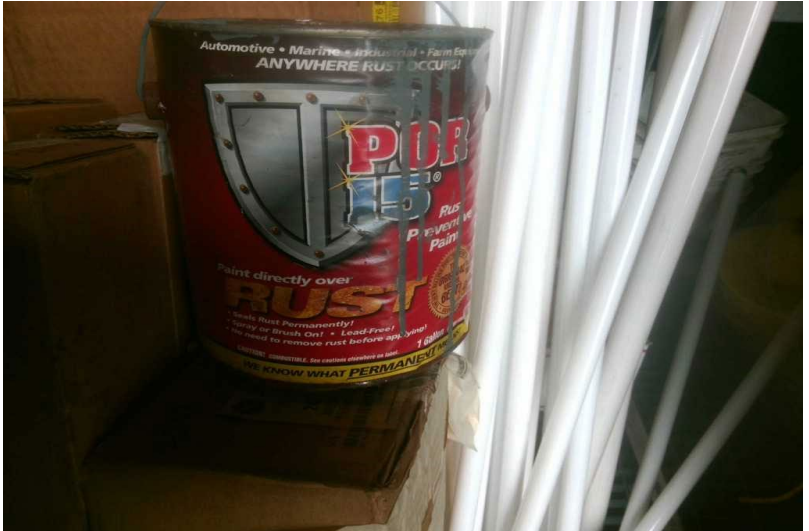
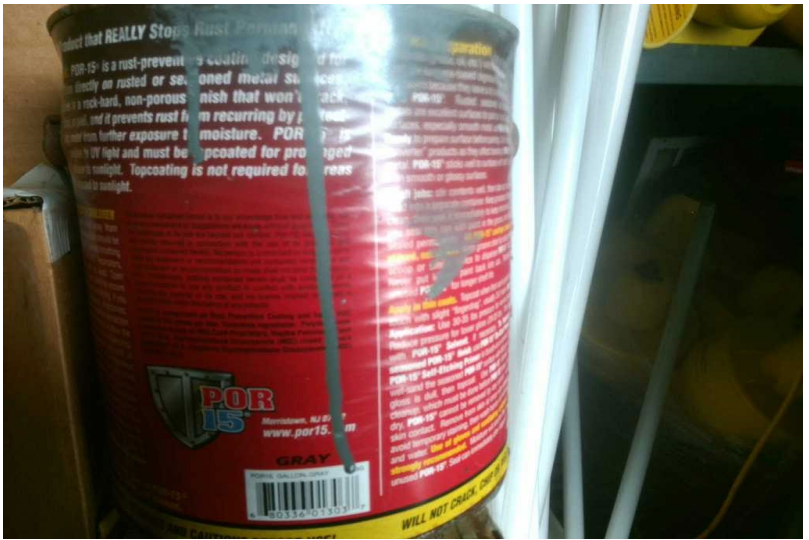
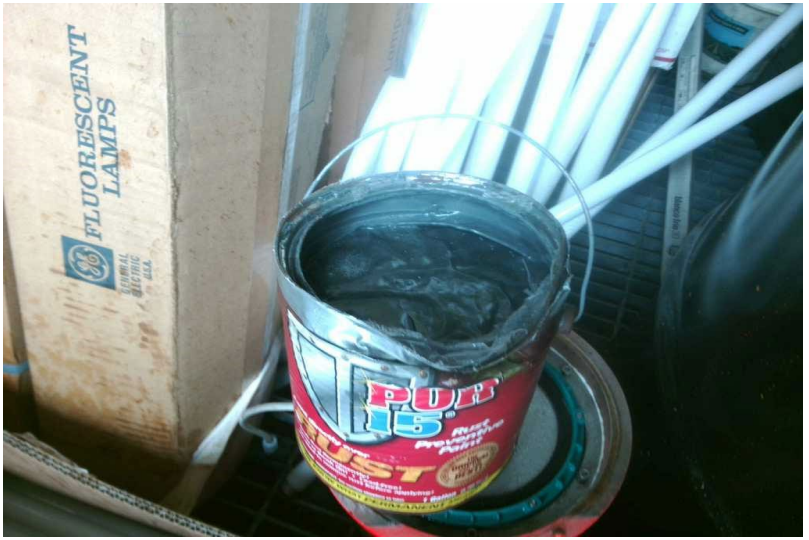
While in the hazardous waste Connex I saw various one-gallon containers of waste paint. Six of the one-gallon containers of waste paint were not closed, and the contents had been allowed to dry out. At least some of the labels on the containers indicated their contents were combustible and others identified the contents as stoddard solvent and hazardous substances. At the time of the inspection, it did not appear that the six containers would have been "RCRA-empty" prior to drying out.

| <p>[Title]</p> <p>08/05/2021 01:37 PM (AKT)</p> <p>Jon Jones</p> <p>Hazardous waste Connex/Lamp crushing side</p> <p>No CBI</p> <p>No PII</p> <p>View of various one-gallon containers of waste paint that has been allowed to dry out.</p> | |

| <p>[Title]</p> <p>08/05/2021 01:37 PM (AKT)</p> <p>Jon Jones</p> <p>Hazardous waste Connex/Lamp crushing side</p> <p>No CBI</p> <p>No PII</p> <p>View of the label on the container.</p> | |

| <p>[Title]</p> <p>08/05/2021 01:42 PM (AKT)</p> <p>Jon Jones</p> <p>Hazardous waste Connex/Lamp crushing side</p> <p>No CBI</p> <p>No PII</p> <p>Another view of a one-gallon container of waste paint that has been allowed to dry out.</p> | |

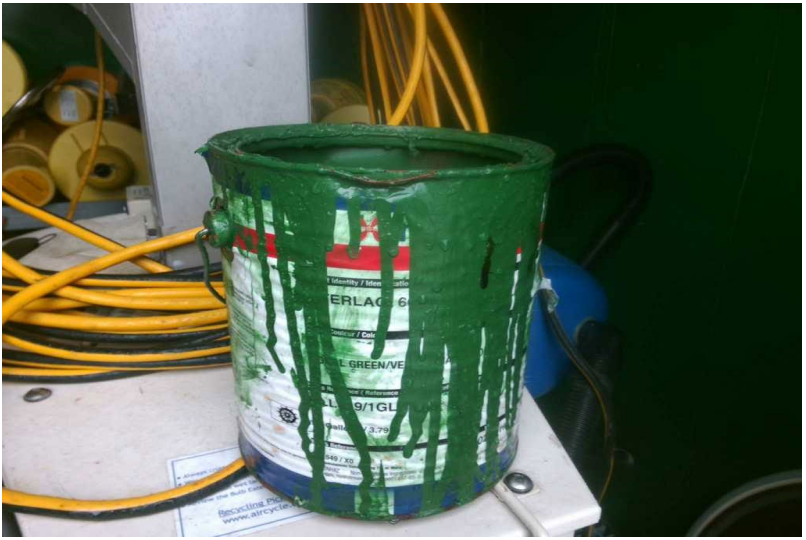
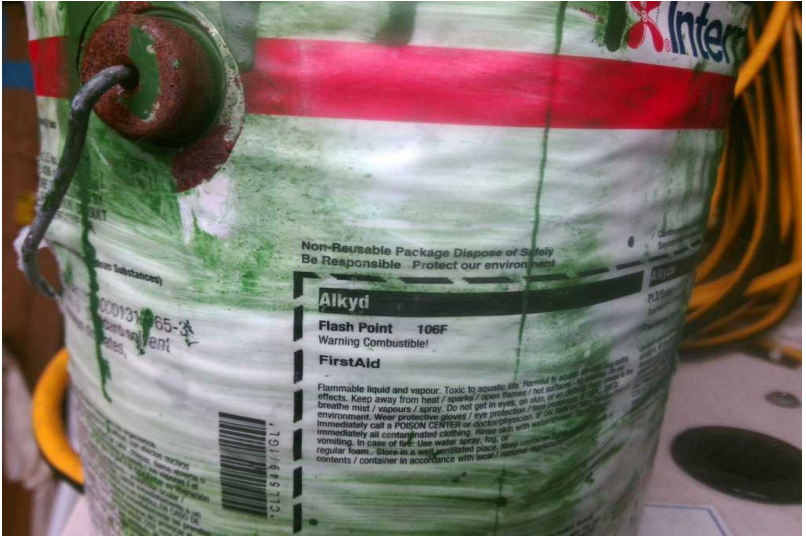
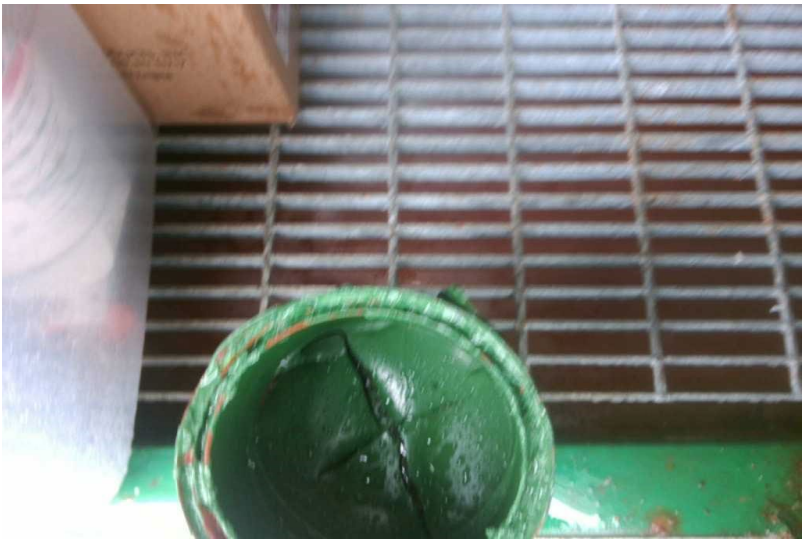
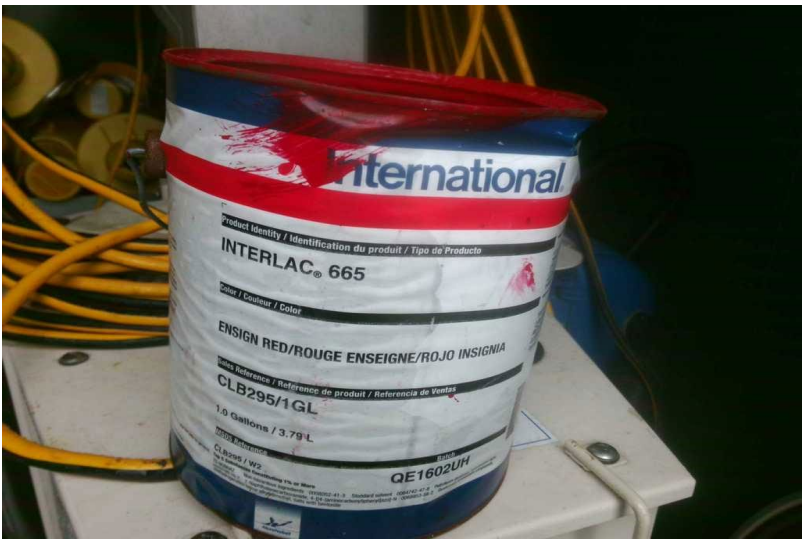
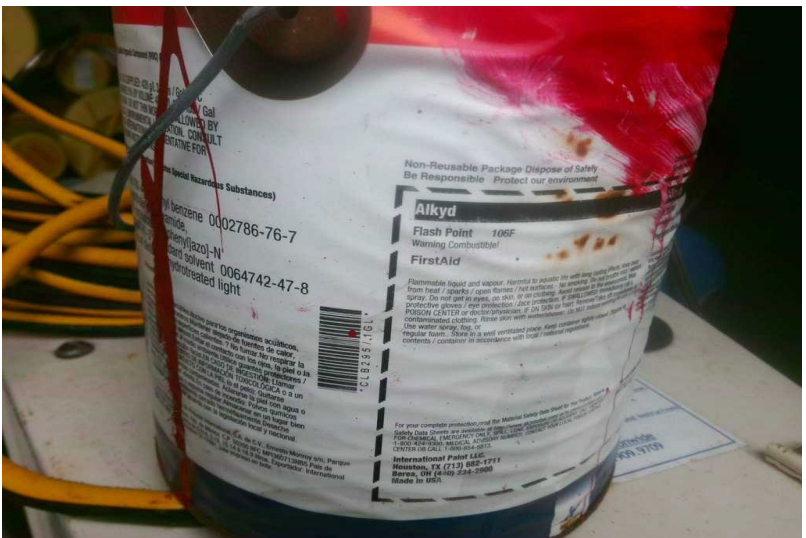
| <p>[Title]</p> <p>08/05/2021 01:46 PM (AKT)</p> <p>Jon Jones</p> <p>Hazardous waste Connex/Lamp crushing side</p> <p>No CBI</p> <p>No PII</p> <p>Another view of a one-gallon container of waste paint that has been allowed to dry out.</p> | |
| <p>[Title]</p> <p>08/05/2021 01:47 PM (AKT)</p> <p>Jon Jones</p> <p>Hazardous waste Connex/Lamp crushing side</p> <p>No CBI</p> <p>No PII</p> <p>A view of the label on the paint can, seen in the previous photo.</p> | |

| <p>[Title]</p> <p>08/05/2021 01:47 PM (AKT)</p> <p>Jon Jones</p> <p>Hazardous waste Connex/Lamp crushing side</p> <p>No CBI</p> <p>No PII</p> <p>A view of the contents of the container seen in the previous two photos.</p> | |
| <p>[Title]</p> <p>08/05/2021 01:48 PM (AKT)</p> <p>Jon Jones</p> <p>Hazardous waste Connex/Lamp crushing side</p> <p>No CBI</p> <p>No PII</p> <p>Another view of the labeling on the containers of dried paint.</p> | |
| <p>[Title]</p> <p>08/05/2021 01:49 PM (AKT)</p> <p>Jon Jones</p> <p>Hazardous waste Connex/Lamp crushing side</p> <p>No CBI</p> <p>No PII</p> <p>Another view of the labeling on the containers of dried paint.</p> | |

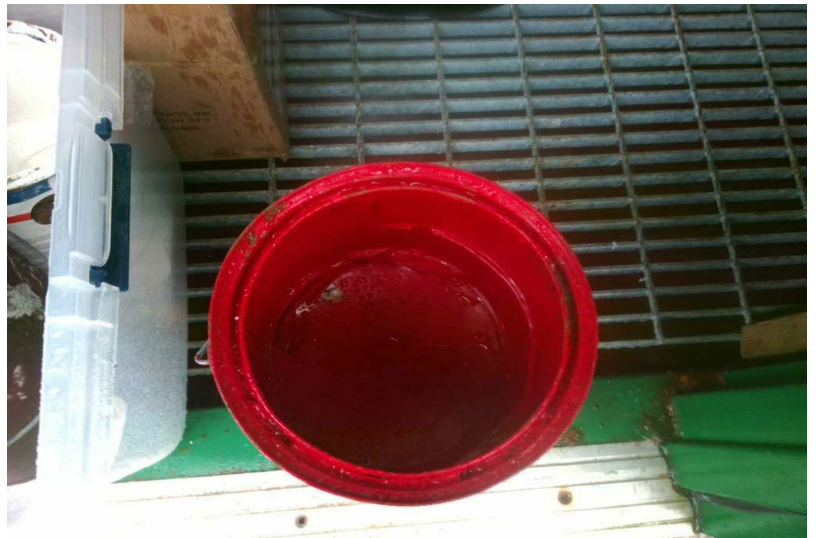
| A view of the contents of the container seen in the previous two photos. |

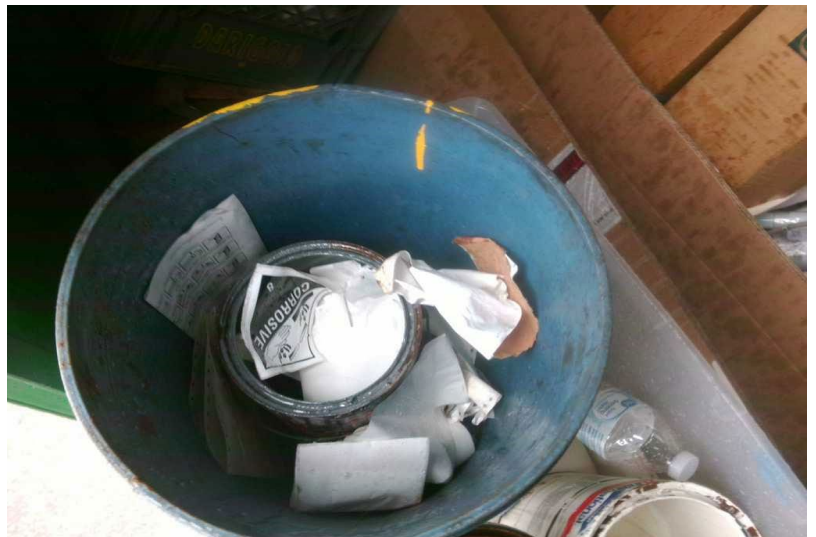
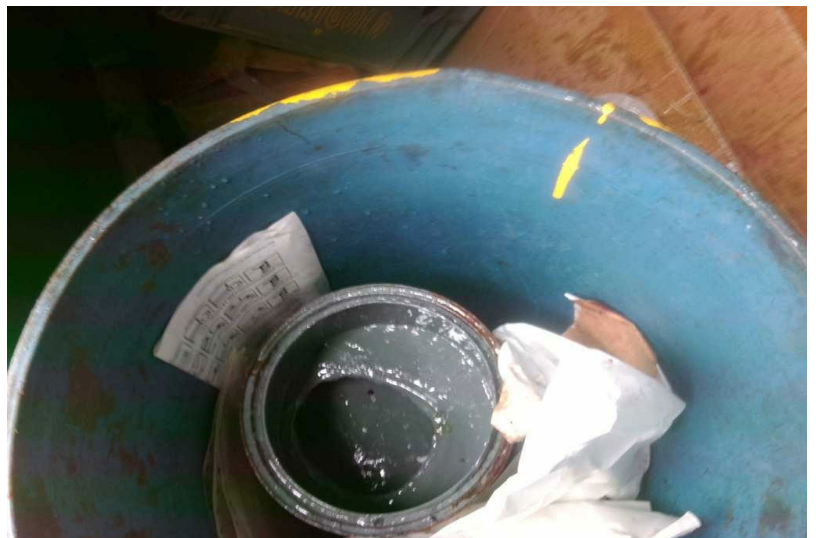
| Another view of a one-gallon container of waste paint that has been allowed to dry out. |

| A view of the contents inside the container seen in the previous photo. |

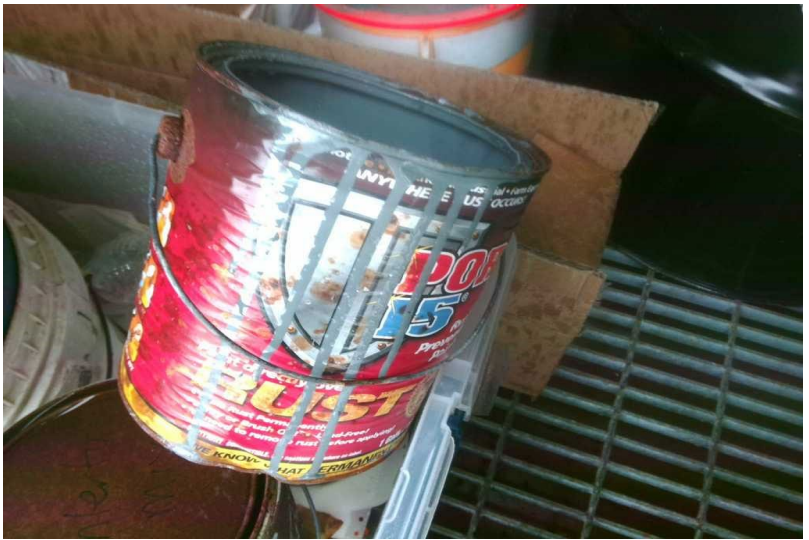
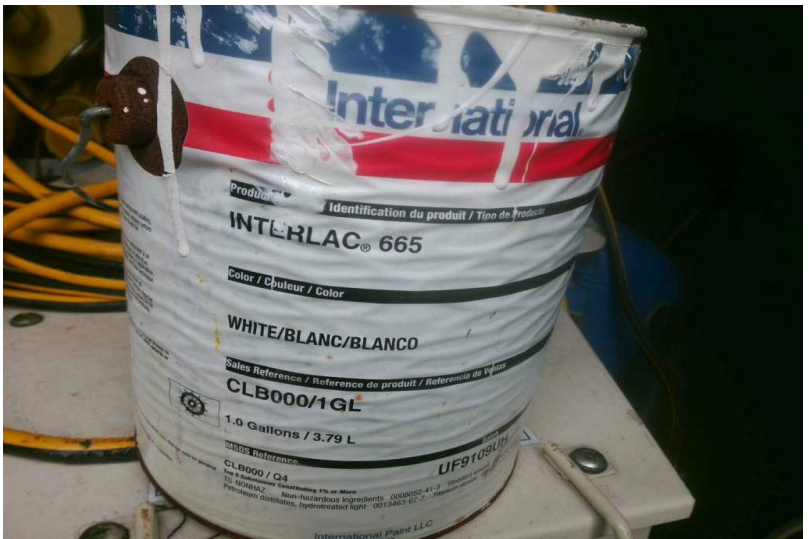
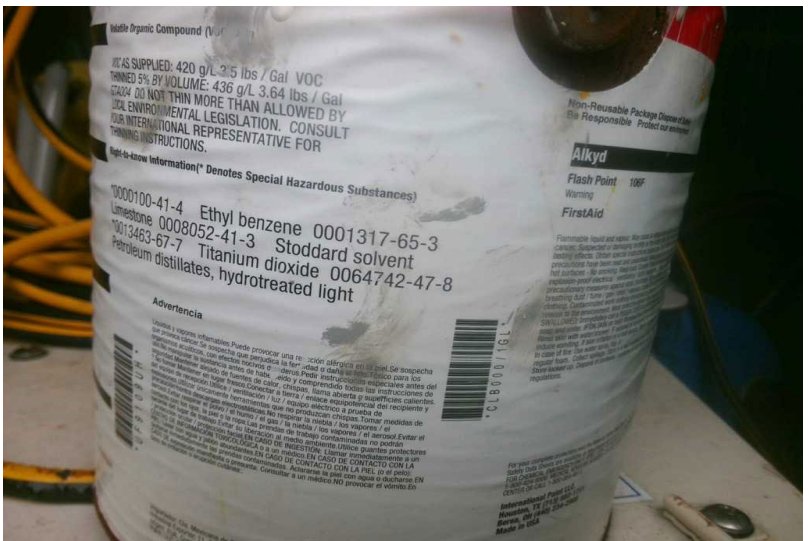
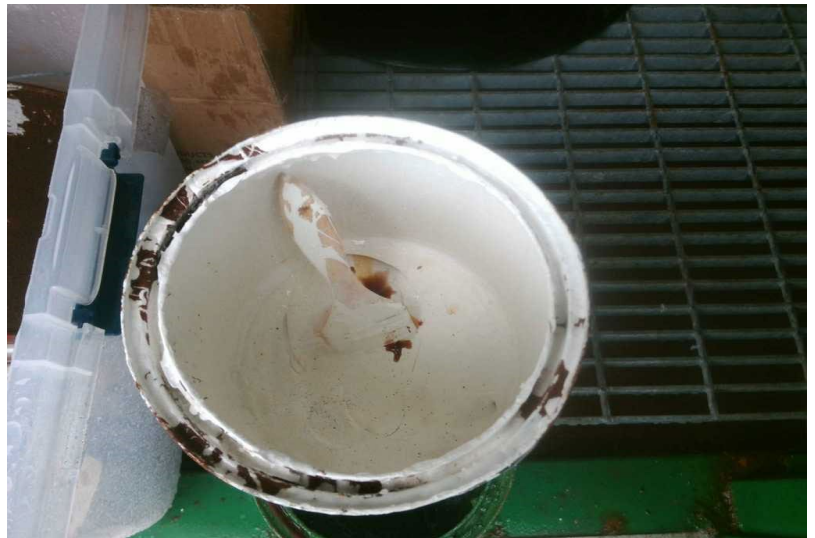
| <p>[Title]</p> <p>08/05/2021 01:51 PM (AKT)</p> <p>Jon Jones</p> <p>Hazardous waste Connex/Lamp crushing side</p> <p>No CBI</p> <p>No PII</p> <p>A view of the label on the can seen in the previous photo.</p> | |
| <p>[Title]</p> <p>08/05/2021 01:52 PM (AKT)</p> <p>Jon Jones</p> <p>Hazardous waste Connex/Lamp crushing side</p> <p>No CBI</p> <p>No PII</p> <p>A view of the label on another can of dried out paint.</p> | |
| <p>[Title]</p> <p>08/05/2021 01:53 PM (AKT)</p> <p>Jon Jones</p> <p>Hazardous waste Connex/Lamp crushing side</p> <p>No CBI</p> <p>No PII</p> <p>A close-up view of the labeling on the container seen in the previous photo.</p> | |

| A view of the contents inside of the container seen in the previous two photos. |

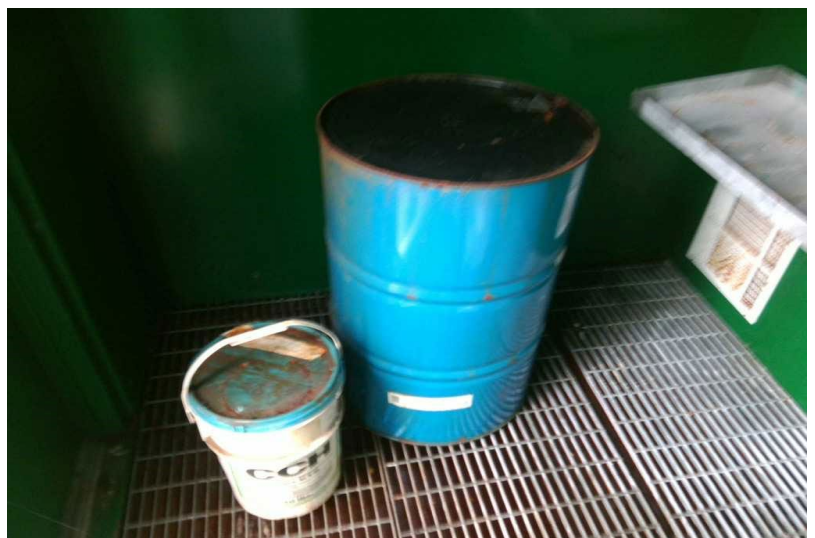
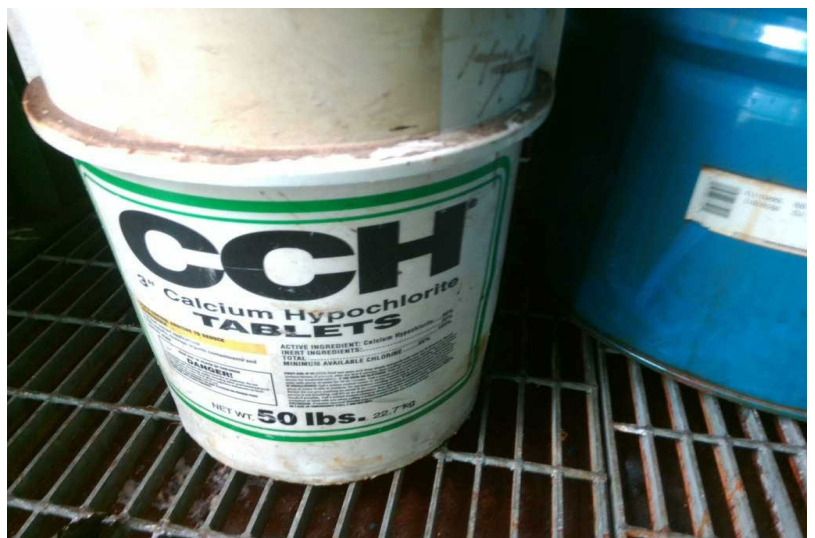
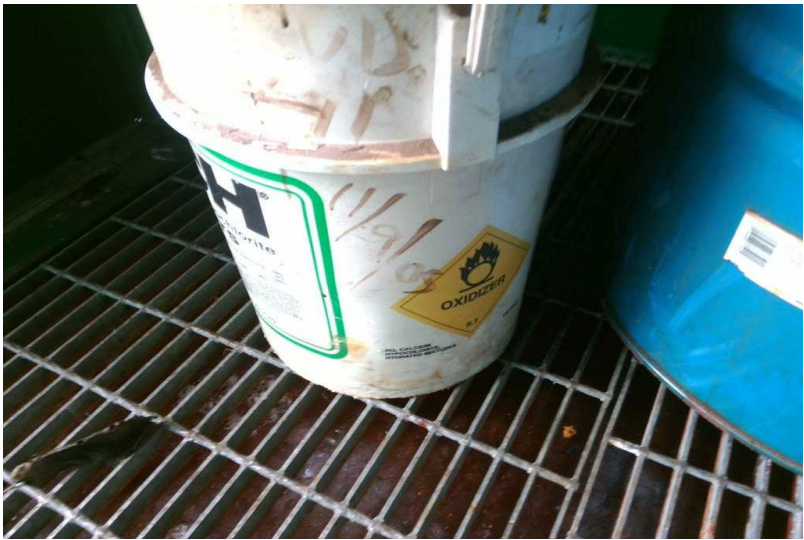
At the time of the inspection, I saw a 5-gallon container and a 55-gallon container located in the paint and chemical side of the hazardous waste Connex. Mr. Larson told me that he had no idea what the 5-gallon container held. The 5-gallon container was labeled as calcium hypochlorite capsules. The 55-gallon container was empty. After Mr. Clayton arrived, he verified that the 5-gallon container held calcium hypochlorite capsules and that the 55-gallon container was empty.

| The facility has failed to make a waste determination for the five-gallon container of calcium hypochlorite capsules. | <b>Citations:</b> | <b>Sections:</b> |

| View of the Calcium Hypochlorite tablet container. |

| A close-up view of the Calcium Hypochlorite tablet container. |

| <div>[Title]</div> <div>08/05/2021 01:13 PM (AKT)</div> <div>Jon Jones</div> <div>Hazardous waste Connex/Paint and chemical side</div> <div>No CBI</div> <div>No PII</div> <div>Another close-up view of the Calcium Hypochlorite tablet container.</div> | |

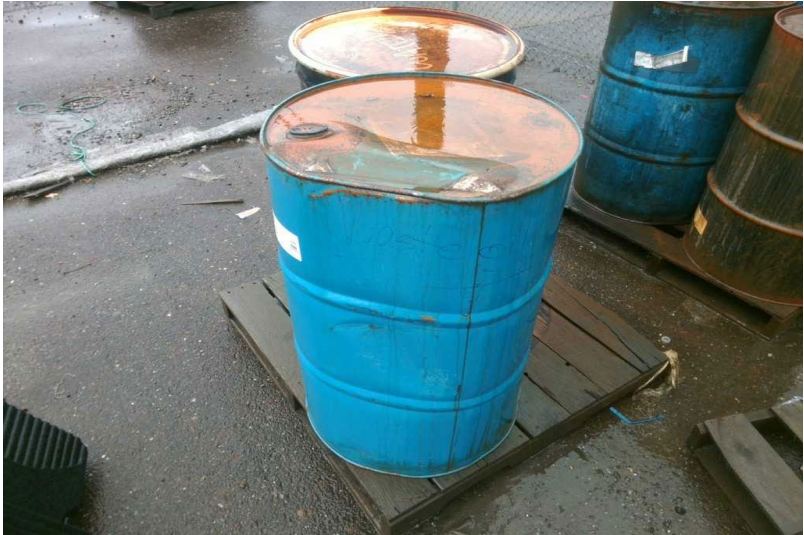
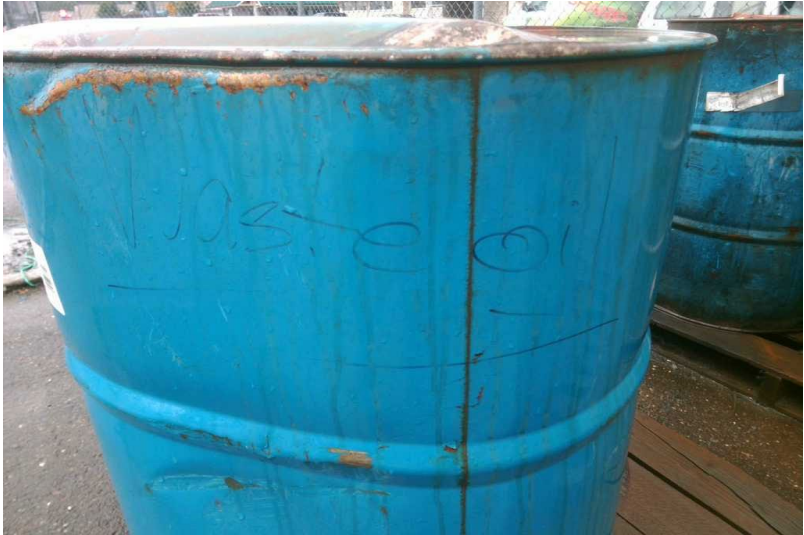
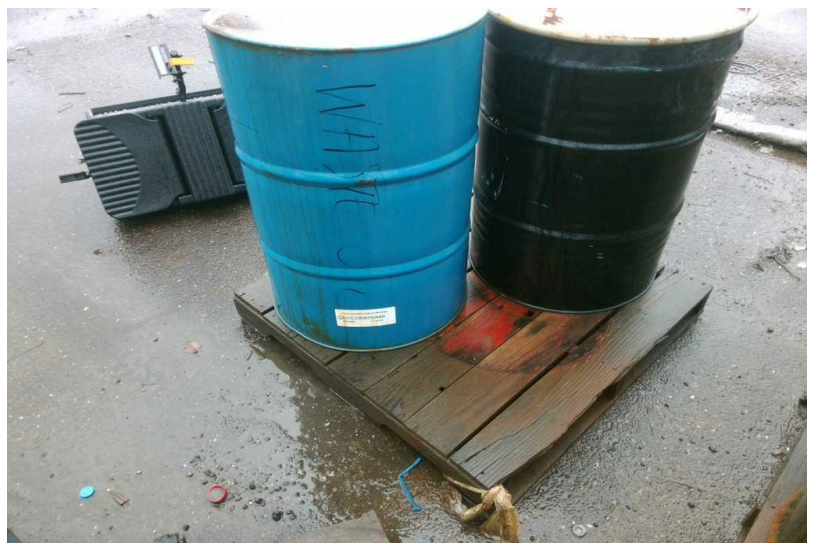
| While inspecting the area just outside the warehouse I saw a 55-gallon container that was labeled with the words, "Waste Oil." I pushed on the container and it felt full. Mr. Clayton verified that the container held used oil. | |

| <div>[Title]</div> <div>08/05/2021 02:18 PM (AKT)</div> <div>Jon Jones</div> <div>Little gray warehouse/Just outside along fence</div> <div>No CBI</div> <div>No PII</div> <div>View of 55-gallon container labeled as waste oil.</div> | |
| <div>[Title]</div> <div>08/05/2021 02:18 PM (AKT)</div> <div>Jon Jones</div> <div>Little gray warehouse/Just outside along fence</div> <div>No CBI</div> <div>No PII</div> <div>Close-up view of the container showing the words, "Waste Oil."</div> | |

| Another view of the same container with the words "Waste Oil." |

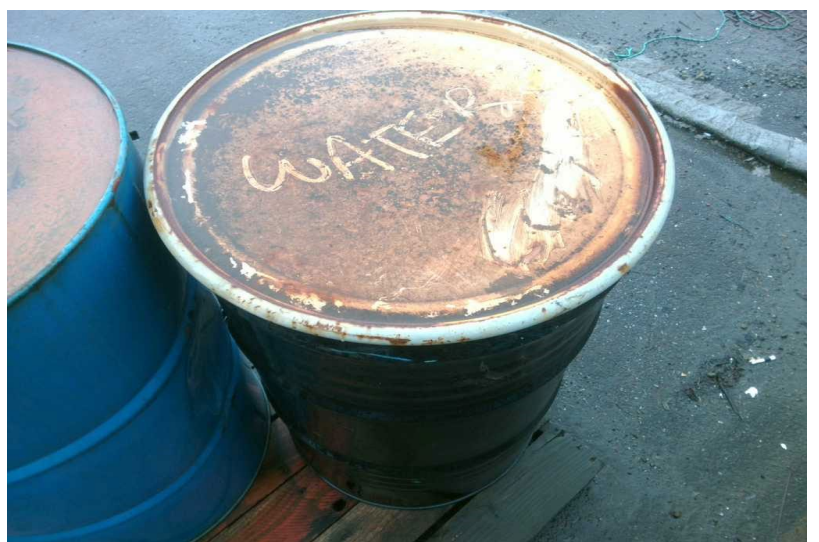
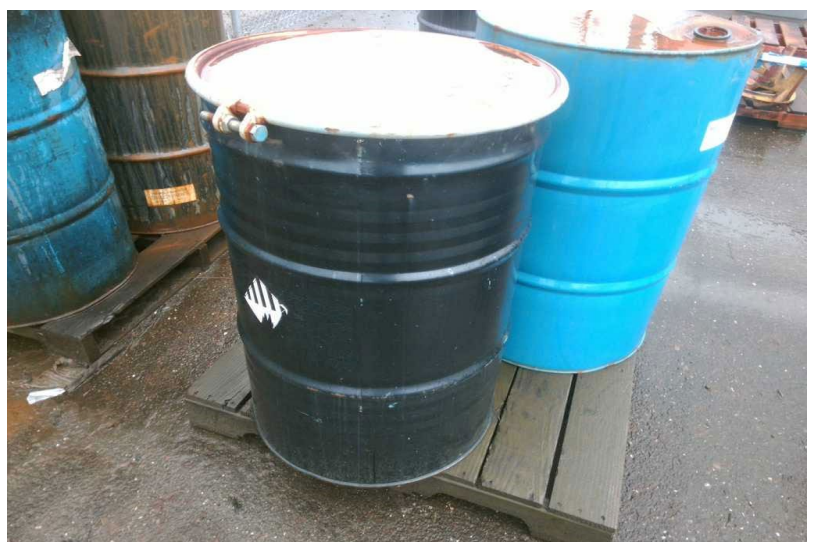
| The facility has failed to make a waste determination for the 55-gallon container labeled "Water?" | <b>Citations:</b> | <b>Sections:</b> |

| View of the 55-gallon container labeled "Water?" |

| Another view of the 55-gallon container labeled "Water." |

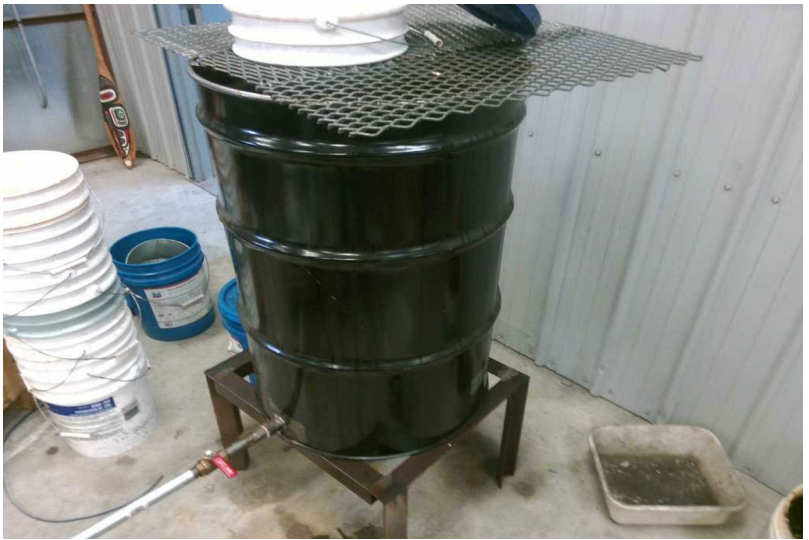
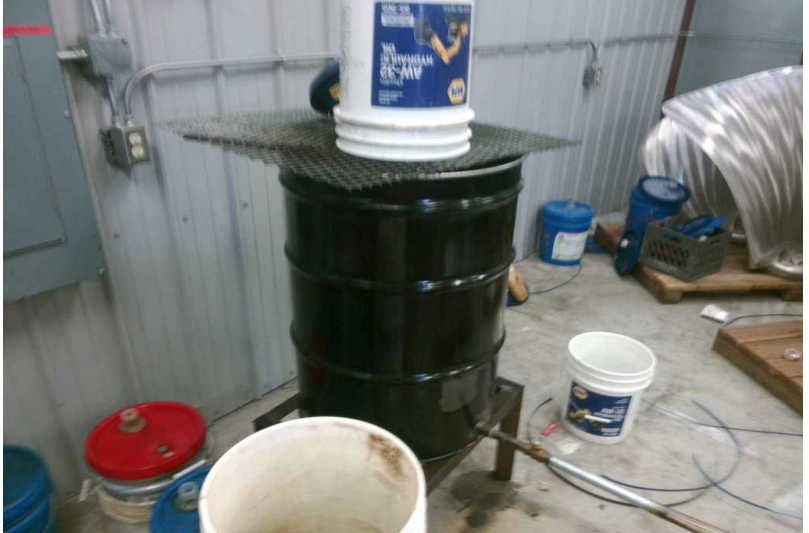
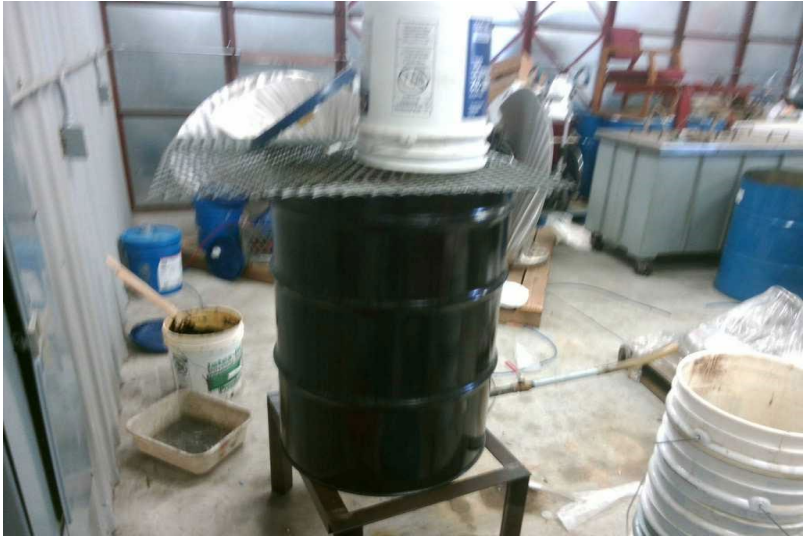
| <p>[Title]</p> <p>08/05/2021 02:36 PM (AKT)</p> <p>Jon Jones</p> <p>Little gray warehouse/Southside interior</p> <p>No CBI</p> <p>No PII</p> <p>View of a 55-gallon container that is half-full of used oil and not labeled.</p> | |
| <p>[Title]</p> <p>08/05/2021 02:36 PM (AKT)</p> <p>Jon Jones</p> <p>Little gray warehouse/Southside interior</p> <p>No CBI</p> <p>No PII</p> <p>Another view of the same 55-gallon container, seen in the previous photo, that is half-full of used oil and not labeled.</p> | |
| <p>[Title]</p> <p>08/05/2021 02:36 PM (AKT)</p> <p>Jon Jones</p> <p>Little gray warehouse/Southside interior</p> <p>No CBI</p> <p>No PII</p> <p>Another view of the same 55-gallon container, seen in the previous photo, that is half-full of used oil and not labeled.</p> | |
