**Region 6 - Enforcement & Compliance Assurance Division**  
**INSPECTION REPORT**

| Inspection Date(s): | 09/09/2025 | |
| Company Name: | <b>Spur Energy Partners, LLC (Spur)</b> | |
| Facility Name: | <b>Multiple Facilities in Eddy County, NM</b> | |

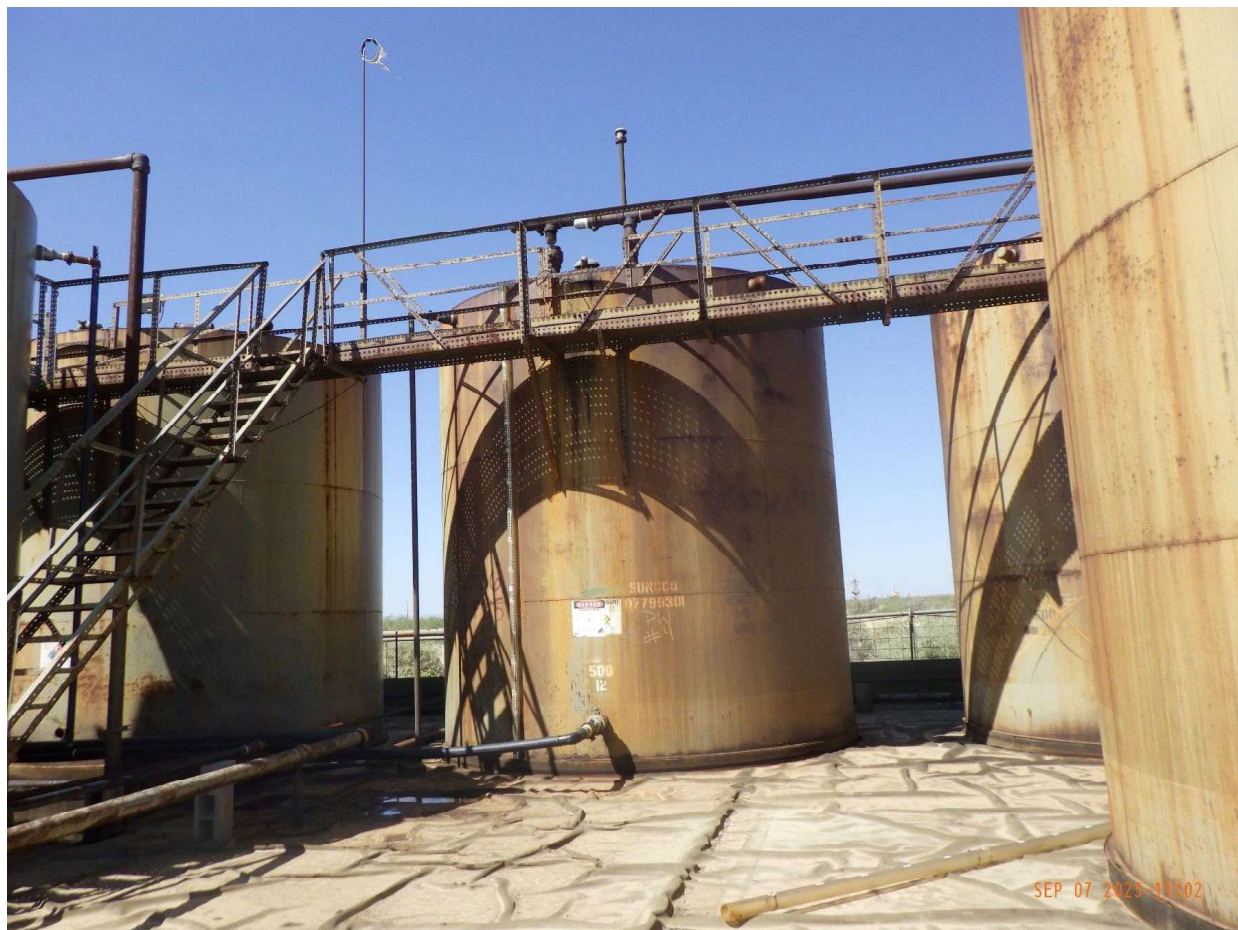
1. Hydrocarbon emissions from PRV on produced water storage tank 72238 at Arkansas 23 Fee 3.
2. Un-combusted hydrocarbon emissions from the dual pressure flare at Alto Amms 21 Tank.

| Description: | Produced Water Storage Tank 72238 – The date/time stamp on the photo is incorrect. | | |

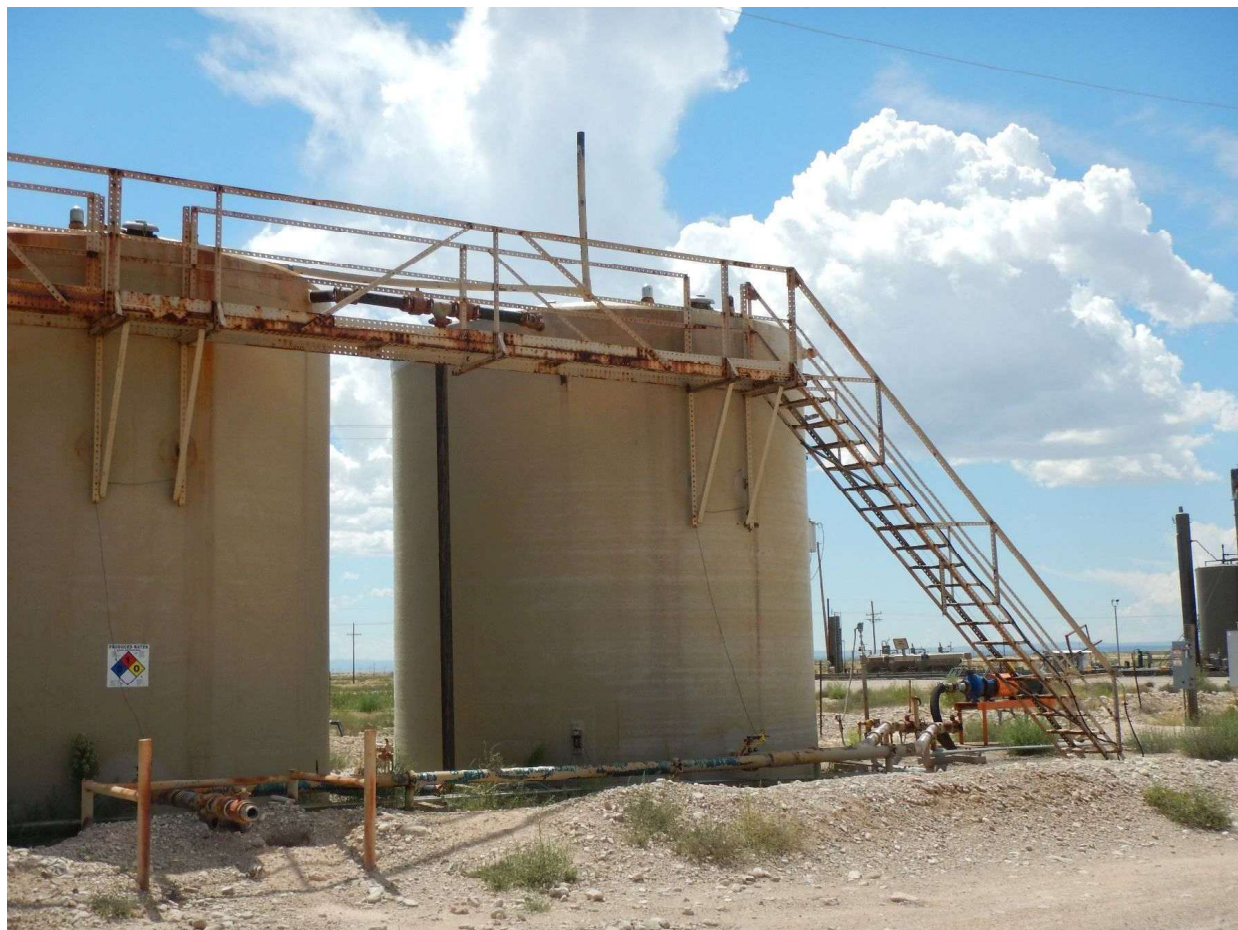
3. Hydrocarbon emissions from the manifold PRV above oil storage tank 74538 at Alto Amms 21 Tank.
4. Hydrocarbon emissions from the PRV on produced water storage tank at B&B/Ross Ranch Yeso Battery.

| Description: | Produced Water Storage Tank with hydrocarbon emissions from PRV | | |

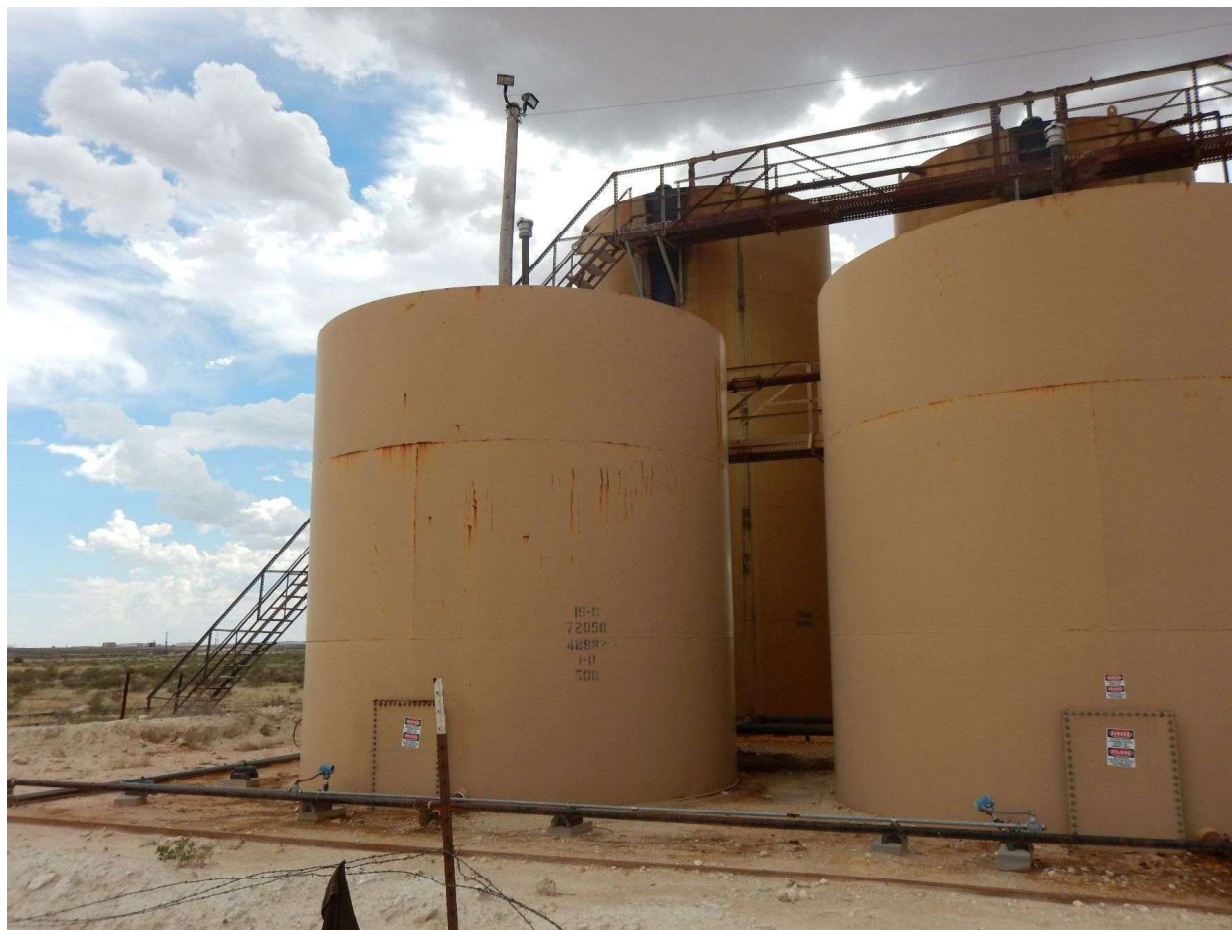
5. Hydrocarbon emissions from the thief hatch on oil storage tank 71962 at Goodman 22 Battery.
6. Hydrocarbon emissions from the PRV on the produced water storage tank next to oil storage tank 71963 at Goodman 22 Battery.

| Description: | Oil Storage Tank 71962 | | |

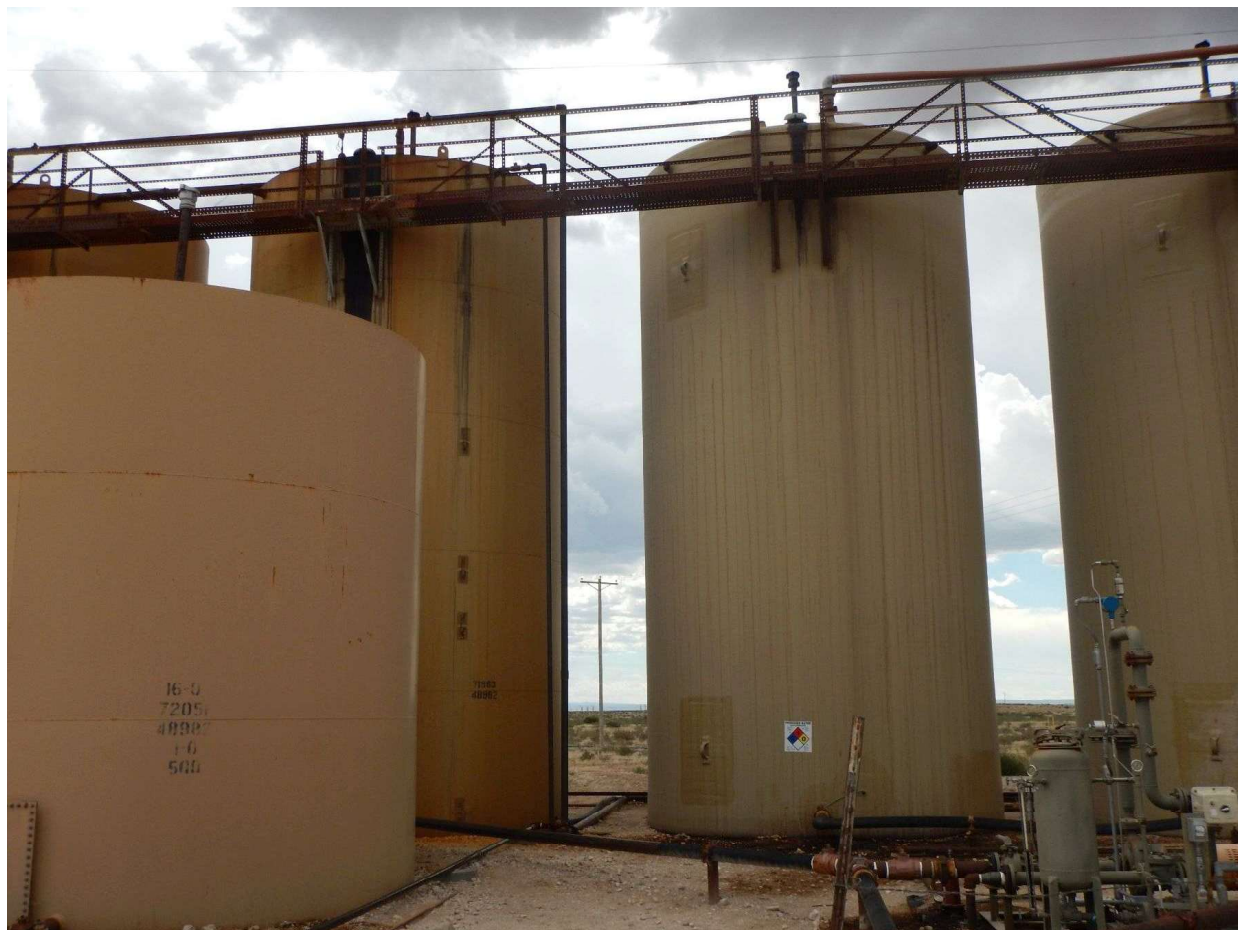
| Description: | Produced Water Storage Tank to the right of Oil Storage Tank 71963 | | |

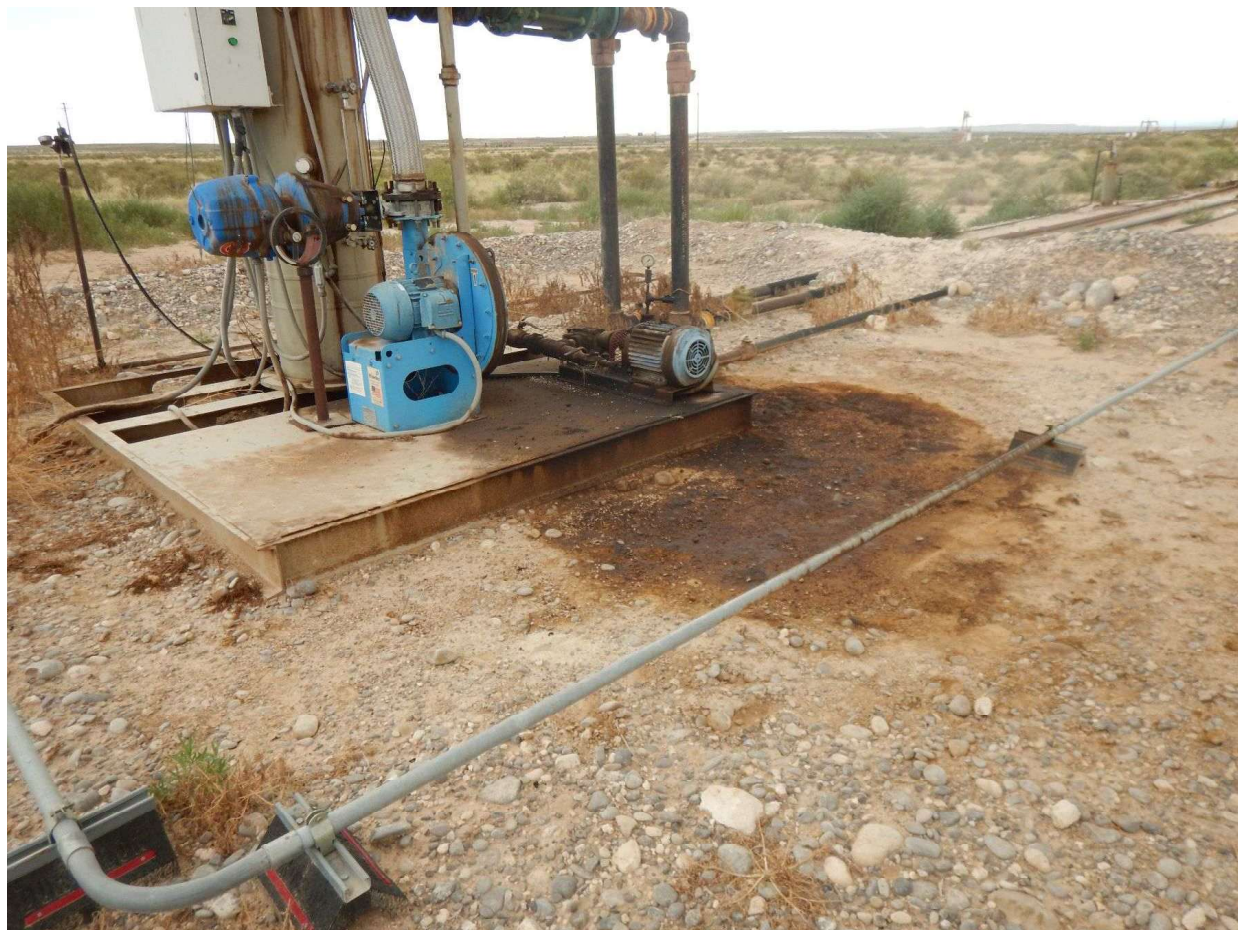
7. Un-combusted hydrocarbon emissions from a lit dual pressure flare at Goodman 22 Battery.
8. Oil residue was observed on the dual pressure flare and the soil around the flare at Goodman 22 Battery.

| Description: | Oil overflow spillage from Dual Pressure Flare | | |

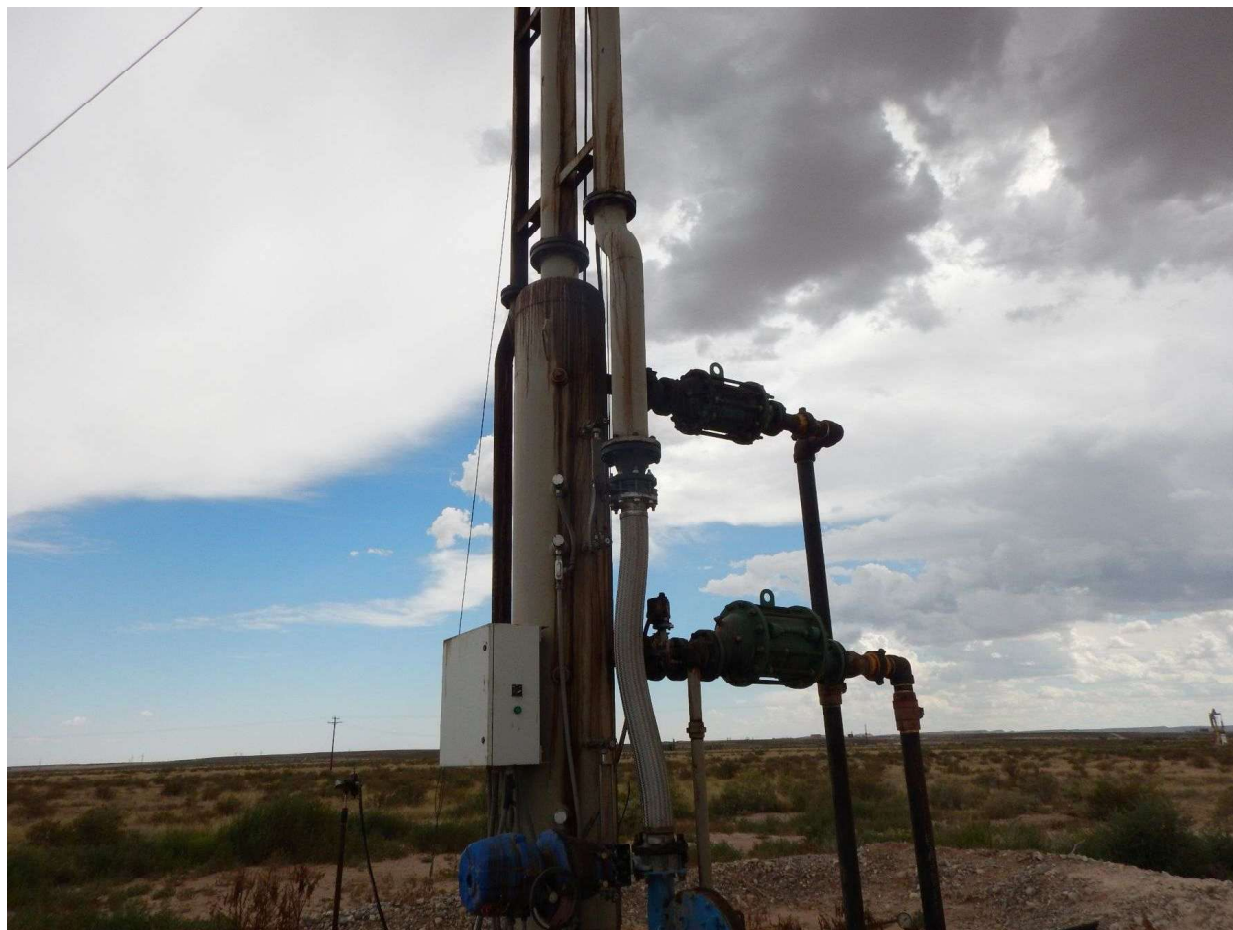
| Description: | Fluid residue on Dual Pressure Flare stack | | |

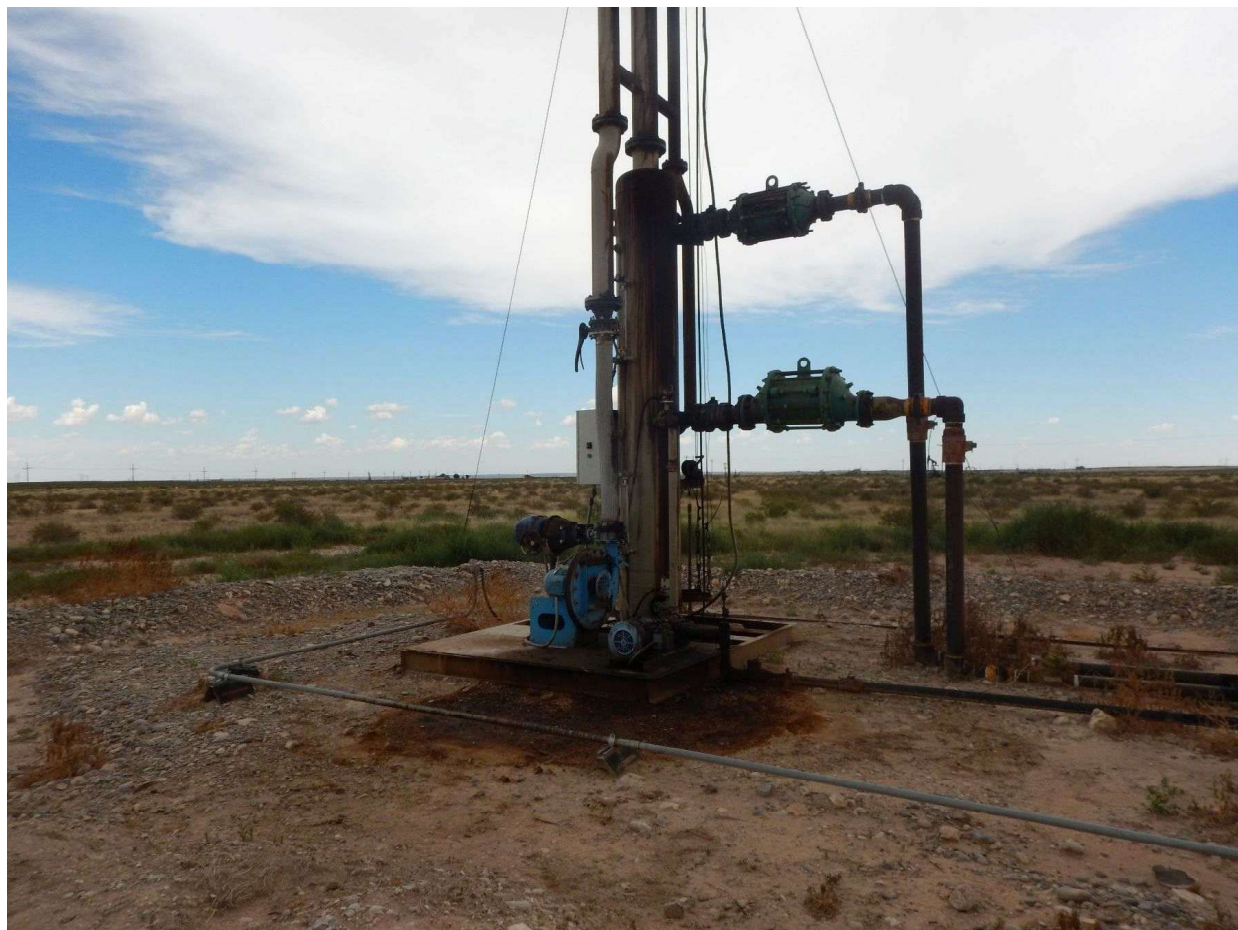
| Description: | Fluid residue from Dual Pressure Flare stack, pad, and on ground | | |

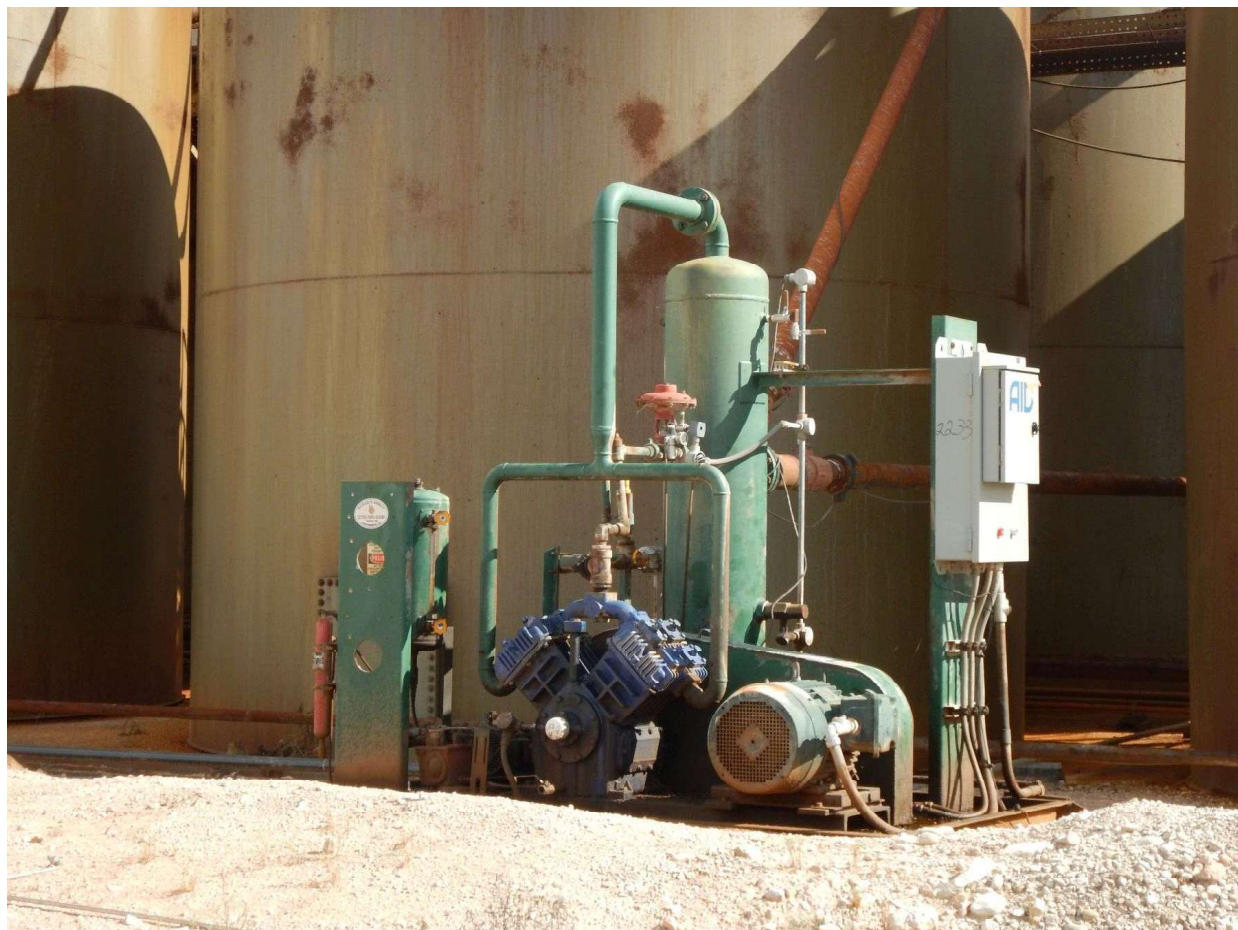
9. Hydrocarbon emissions from the VRU for oil storage tanks while it was operating at Morris Boyd State Com #5.
10. Hydrocarbon emissions from the top of the oil storage tanks at Morris Boyd State Com #5.

| Description: | Vapor Recovery Unit for Oil Storage Tanks | | |

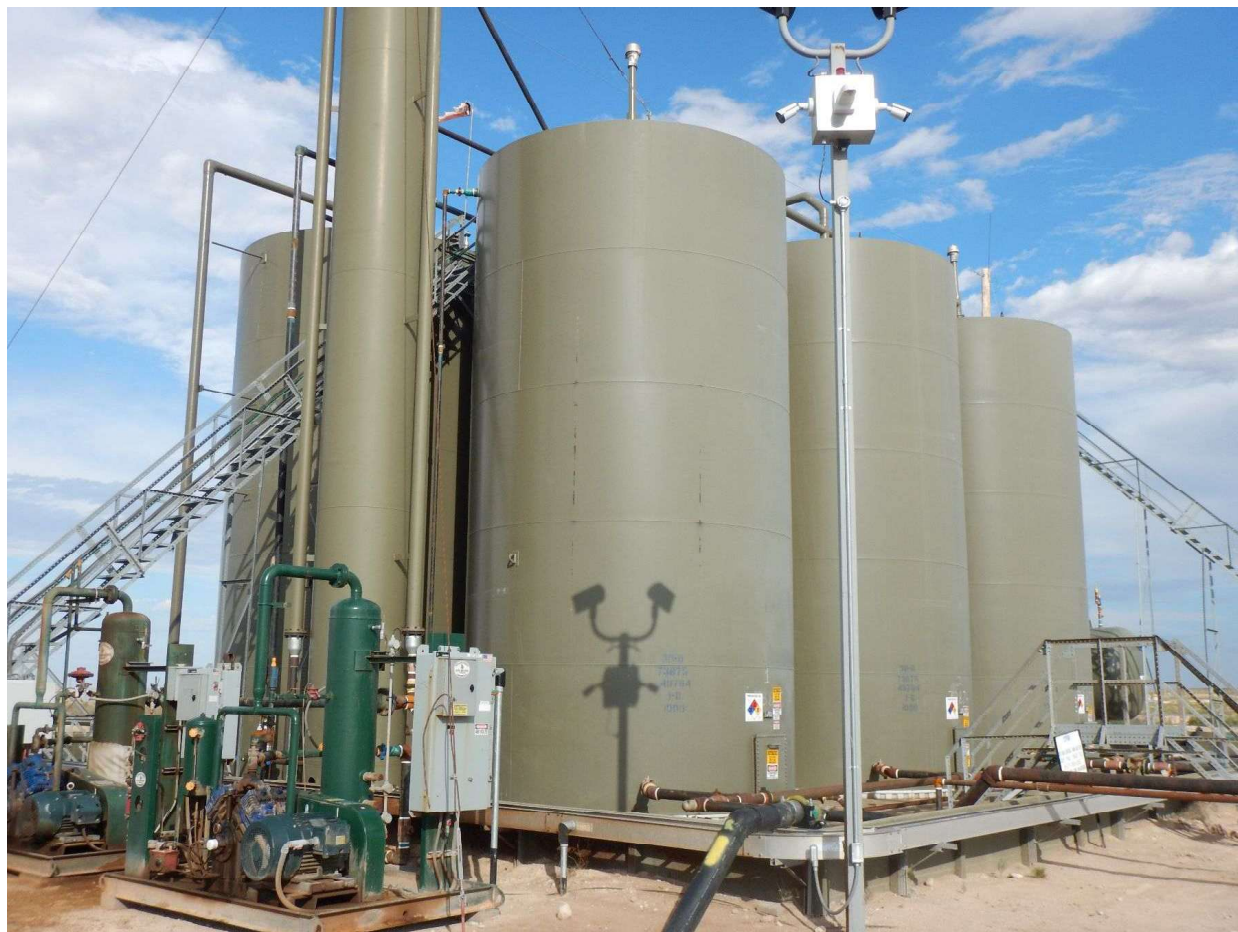
| Description: | Oil Storage Tank with hydrocarbon emissions. | | |

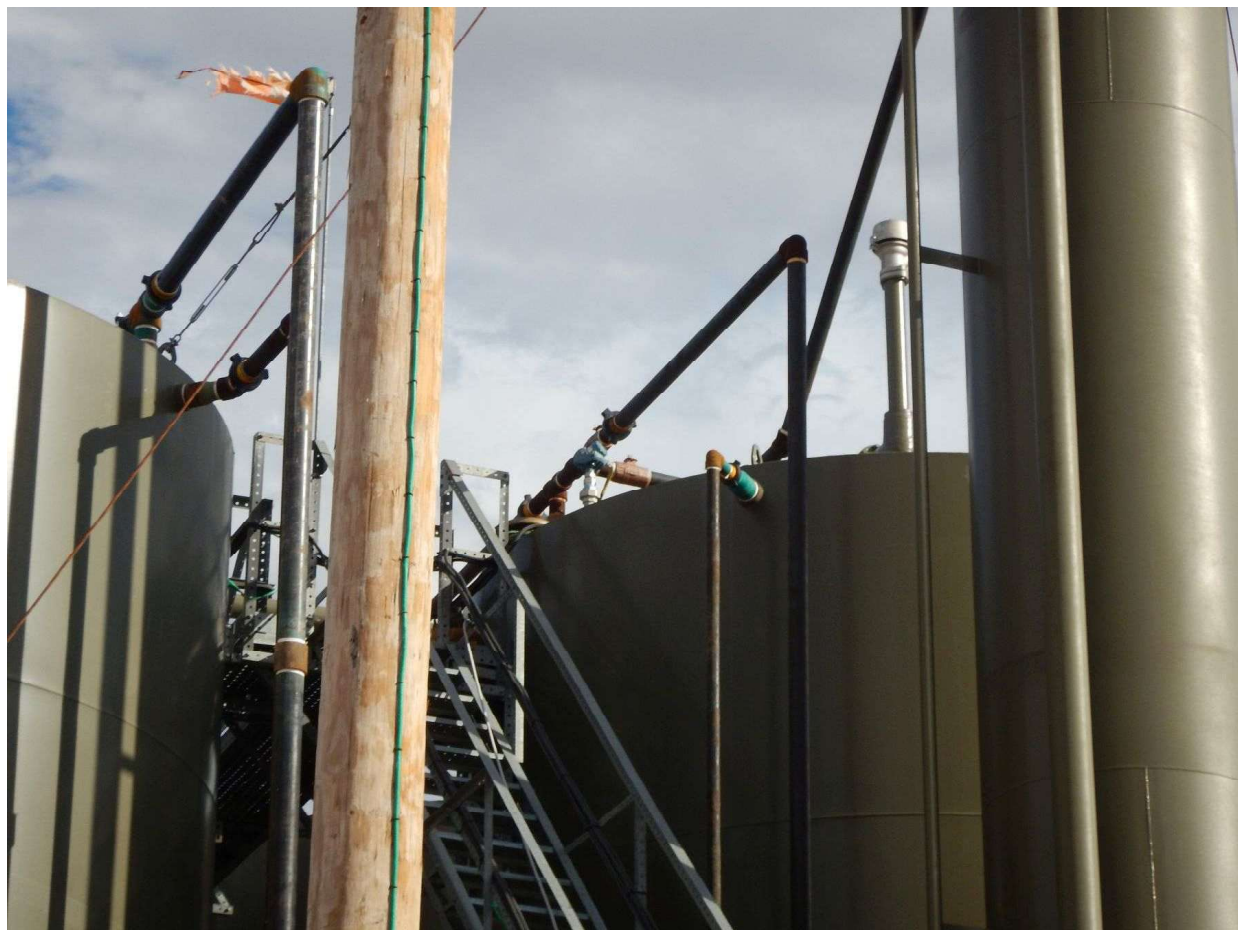
11. Un-combusted hydrocarbon emissions from an unlit dual pressure flare at Live Oak Tank Battery.
12. Hydrocarbon emissions from the thief hatch on oil storage tank 73875/OT-1 at Live Oak Tank Battery.

| Description: | Top of Oil Storage Tank 73875 | | |

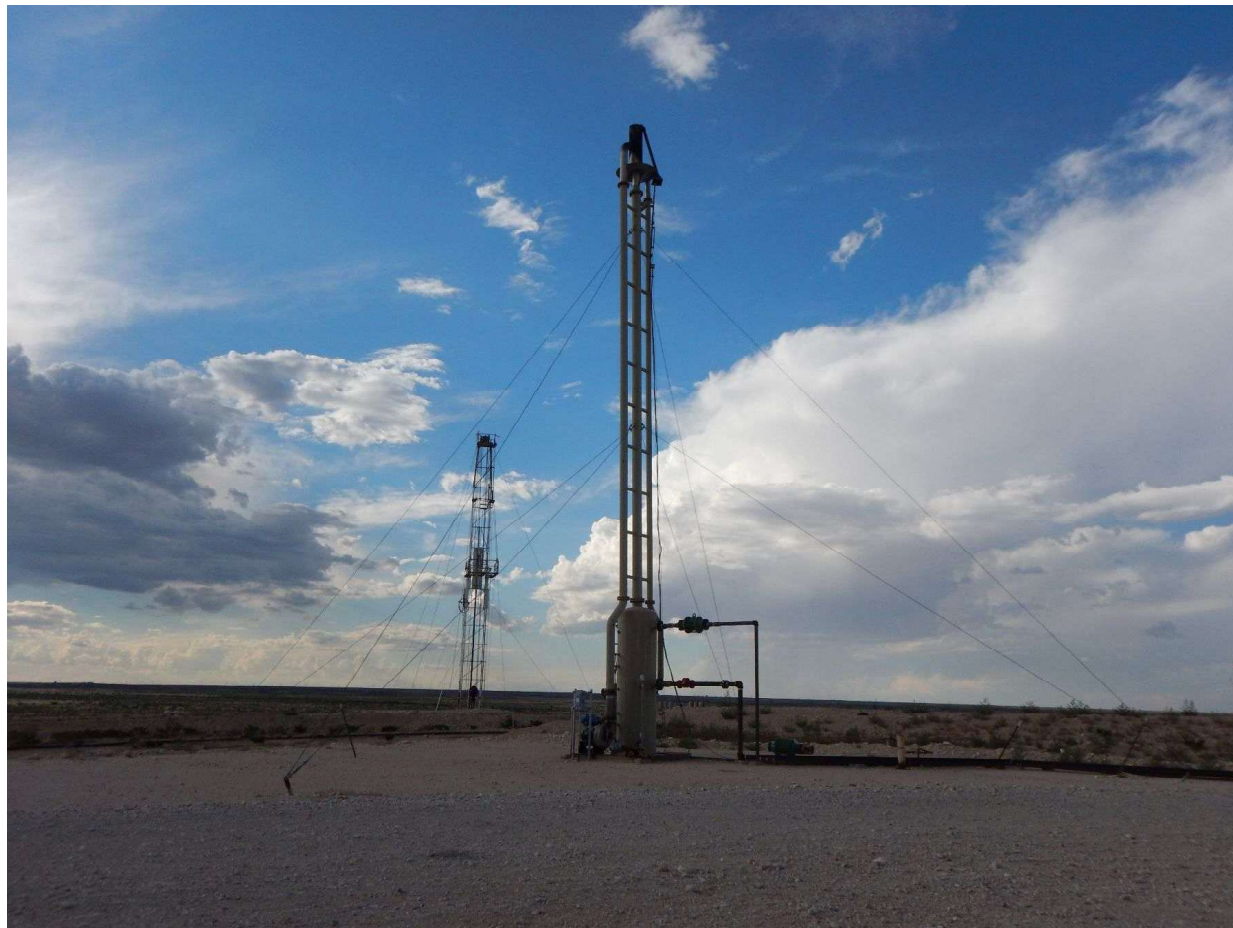
13. Un-combusted hydrocarbon emissions from an unlit dual pressure flare at Lakewood Federal Com 4H, 8H, 10H, 20H and 21H Facility.

| Description: | Unlit Dual Pressure Flare | | |
