# NPDES Compliance Inspection Report

## Ridgefield Heights Ridgefield, Washington

NPDES Permit Tracking Number  
# WAR306634

Inspection Date: 12/20/2022

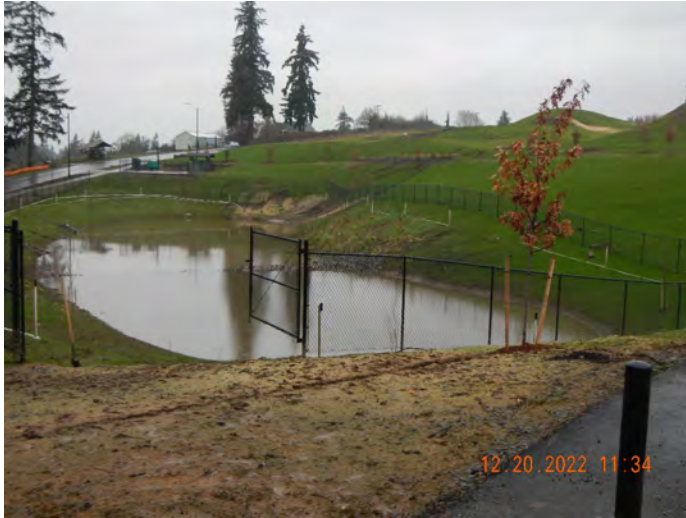
We discussed the recent erosion/sloughing issue observed along the northern hillside of Pond A (**Photo 5**). According to Mr. Searcy, erosion control blankets/matting were recently installed on the north end slope of Pond A. Straw bales and conveyance piping were also installed above the pond to help prevent erosion and improve slope stability. Straw mulch was also added to the less vegetative areas. The recent BMP corrective actions were also documented in Mr. Searcy’s most recent site inspection report. See **Attachment E**, December 14, 2022, Site Inspection Report.

Photo #:05 (DSCN3101)  
Description: Facing west, photo of Pond A.

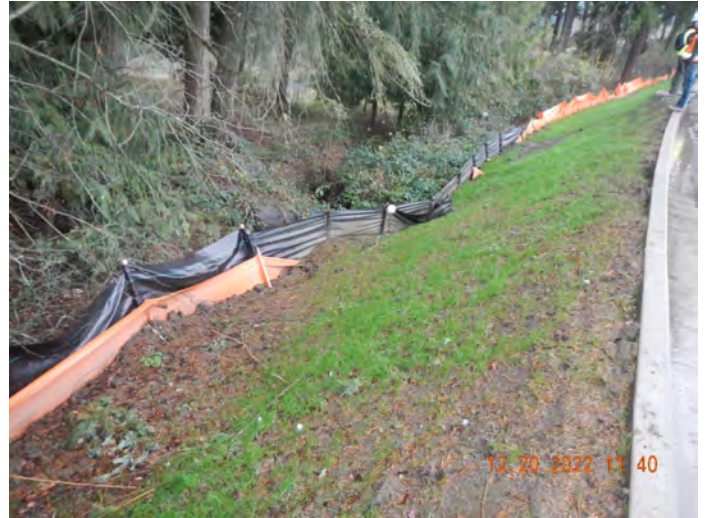
Silt fencing was observed to be installed upslope of the discharge area, along the heavily vegetated tree line. While at this area, I observed a section of secondary/perimeter silt fencing where sediment was deposited above one-third the height of the section of silt fence (**Photo 6**). We were able to observe the Pond A discharge location more clearly from the south side of the silt fence (**Photo 7**).

As discussed earlier in this inspection report, at the time of inspection during the walk-through at Ponds A & B, secondary/tertiary silt fences had been installed as a BMP. Collected sediment was observed to be contained by silt fencing. however, I observed sections of perimeter silt fencing where sediment was deposited above one-third the height (**Photo 6, & Photo 25**). The concern is that the two areas of silt fencing was in needed of maintenance based upon the written standard.

Photo #:06 (DSC3102)  
Description: Facing west, photo of silt fencing installed north of the Pond A discharge location, south of S. 10<sup>th</sup> Way. A section of perimeter silt fencing was observed to have sediment deposited above one-third the height of the section of silt fence.

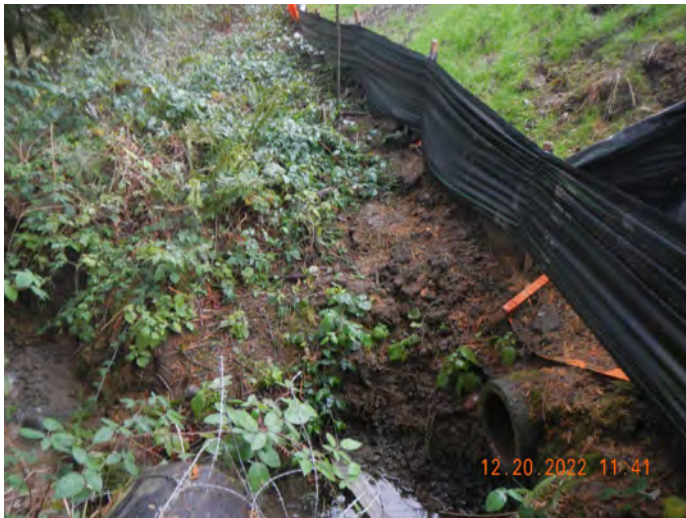
Photo #:07 (DSCN3103)  
Description: Facing west, photo of outfall pipe from Pond A.

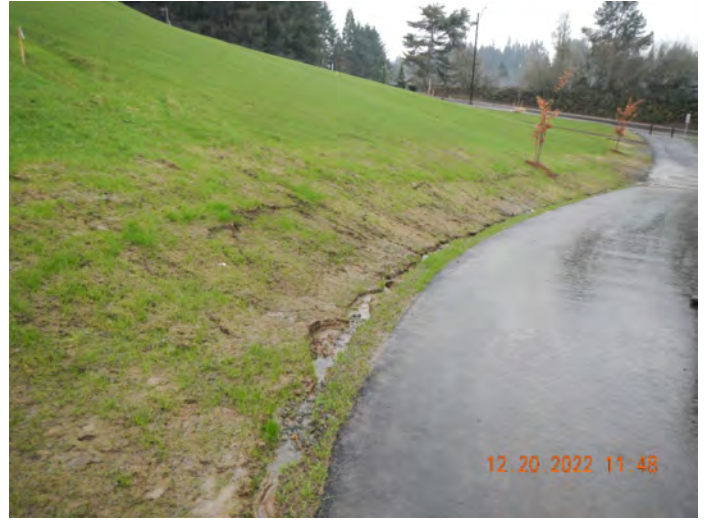
As stated earlier in this report, at the time of inspection during the walk-through near Pond A, I observed some channelized erosion along the east side of the paved footpath/road near Pond A (**Photo 10**). The concern is that the erosion could contribute to additional sediment entering Pond A.

Photo #:10 (DSC3106)  
Description: Facing south, photo of access road east of Pond A.

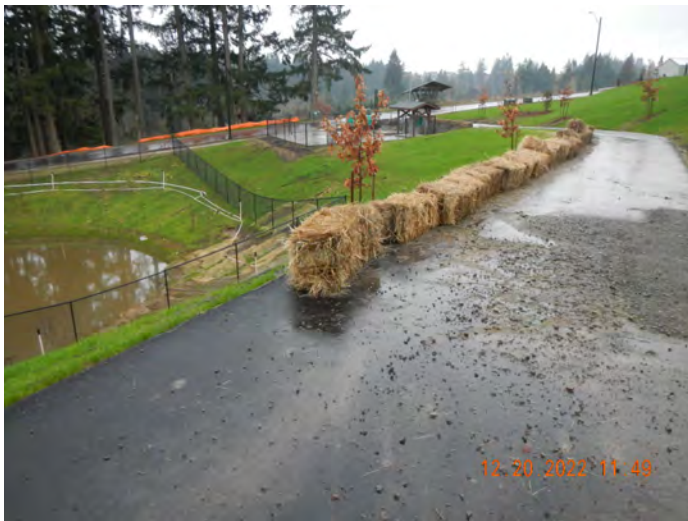
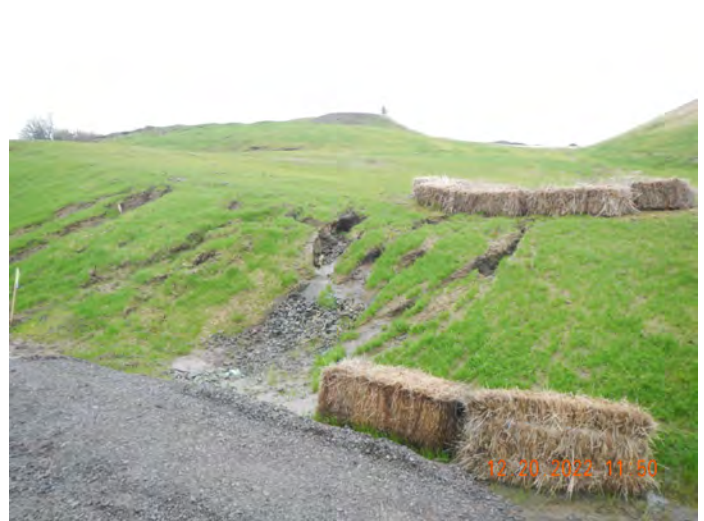
At this time, Mr. Rotschy received a phone call and had to leave the inspection to attend to a separate matter. We continued the walk-through back across S. 10<sup>th</sup> Way to Pond A and observed the erosion/sloughing at the north end of Pond A (**Photo 8 & 9**). We then traveled north along a paved access road east of Pond and discussed some channeled erosion observed along the eastern side of the access road (**Photo 10**). We arrived at the north end of Pond A and observed the straw bales and conveyance piping that had been recently installed to assist with run-on to the northern hillside (**Photo 11 & 12**).

Photo #:11 (DSCN3107)  
Description: Facing east, photo from above Pond A. Straw bales and conveyance piping installed to assist with run-on to the northern slope of Pond A hillside.

Photo #:12 (DSCN3108)  
Description: Facing west, photo from above Pond A. Straw bales and conveyance piping installed to assist with run-on to the northern slope of Pond A hillside.

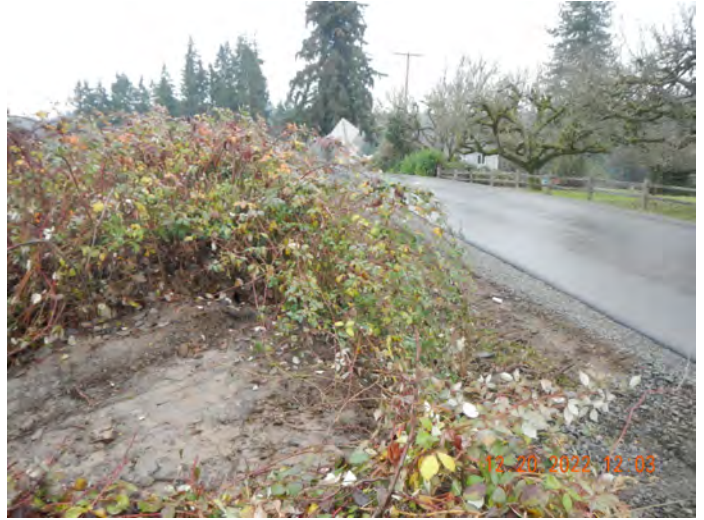
As discussed earlier in this inspection report, at the time of inspection during the walk-through at Phase 3, we observed one area east of S. 25<sup>th</sup> Place where a portion of the vegetated perimeter berm had been partially cleared and had no perimeter BMPs (**Photo 14**). The area adjacent to the partially cleared vegetative berm in Phase 3 lacked stabilization (**Photo 15**). Straw mulch was observed in some areas near the partially cleared vegetative berm as a BMP however, not to the 2” – 3” thickness application rate defined in the written standard. It was discussed that stabilization and perimeter BMPs in this area could be improved to prevent impacted stormwater from leaving this area and entering the roadside ditch along S. 25<sup>th</sup> Place.

Photo #:14 (DSC3110)  
Description: Facing south, photo of western perimeter along S. 25<sup>th</sup> Place. Vegetative berm was observed to be partially cleared.

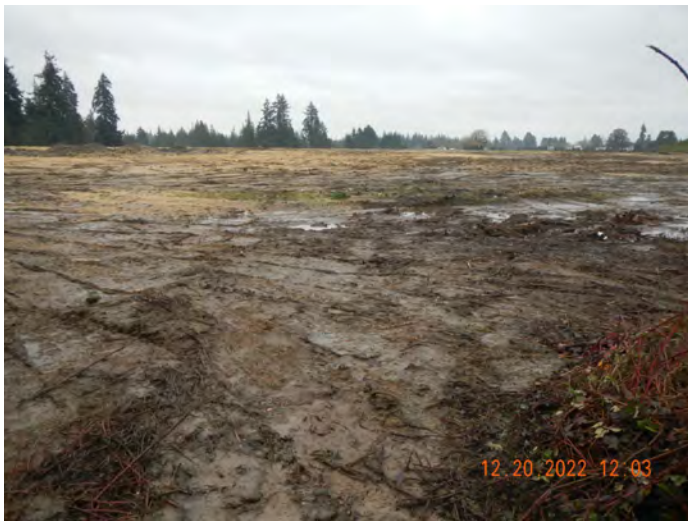
We then walked north toward the partially cleared areas of Phase 3 & 4, west of Phase 1 & 2 (**Photo 13**). We observed one area within Phase 3, east of S. 25<sup>th</sup> Place that was partially cleared, lacked stabilization, and had no perimeter BMPs (**Photo 14 & 15**). Just to the north was an area used as a construction entrance point off of S. 25<sup>th</sup> Place (**Photo 16 & 17**). Within this Phase 3 area we observed many areas with partially exposed soils.

Photo #:15 (DSCN3111)  
Description: Facing east within Phase 3, photo of the area east of the partially cleared perimeter along S. 25<sup>th</sup> Place. Area lacked stabilization.

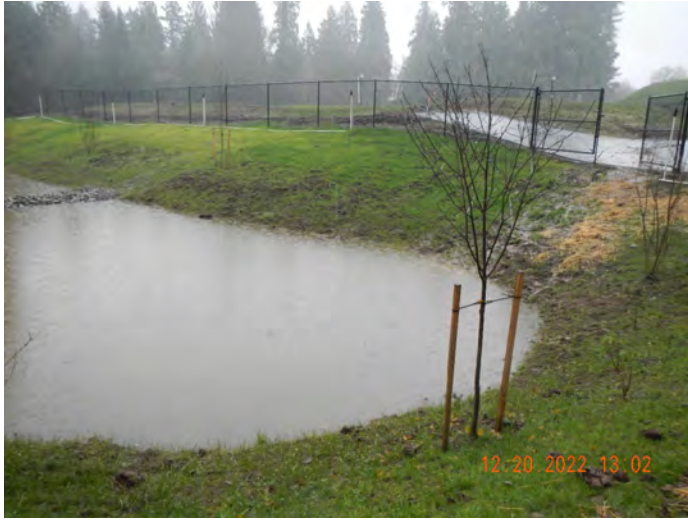
As stated earlier in this report, at the time of inspection during the walk-through at Pond B and Pond C, I observed stormwater traveling down from the paved access roads and entering the Ponds as sheet flow. Erosion was observed along the slopes where the sheet flow was entering. The concern is that the erosion could contribute to additional sediment entering the ponds.

Photo #:29 (DSCN3125)  
Description: Facing south, photo of Pond C. Erosion observed on the southwest slope.

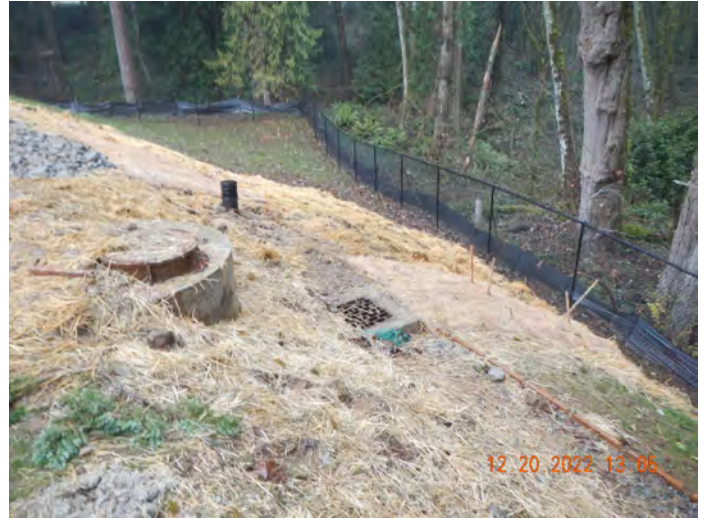
Mr. Searcy stated that prior to being repaired, similarly to Pond B the Pond C outfall was observed to be discharging via the hillside and causing some erosion and sediment to build-up within the silt fence down slope. Additional straw mulch and matting was added after the repair work was completed (**Photo 30**).

Photo #30: (DSC3126)  
Description: Facing west, photo of the Pond C outfall area.

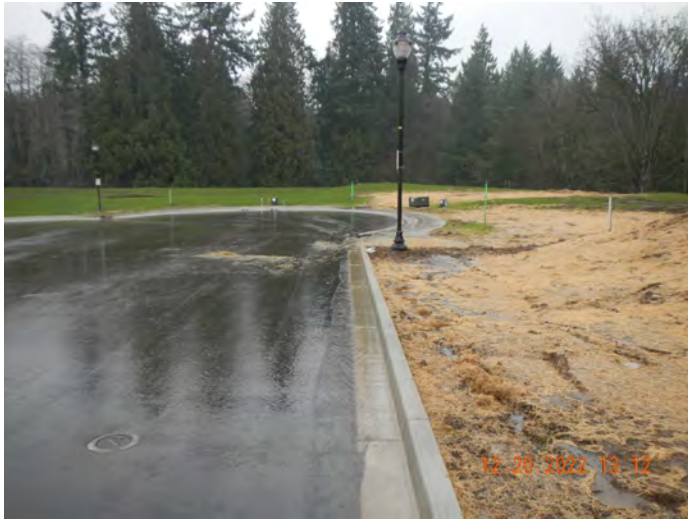
Following our time at Pond C, we traveled back to the main entrance to conclude the walk-through. During our walk, we observed one area of channelized erosion along the east side of S. 6<sup>th</sup> Way (**Photo 31**). Stormwater from this area was observed to be traveling downslope parallel to the paved road and entering a roadside catch basin discharging to Pond C.

Photo #:31 (DSCN3127)  
Description: Facing north, photo of the Phase 2 Culdesac.

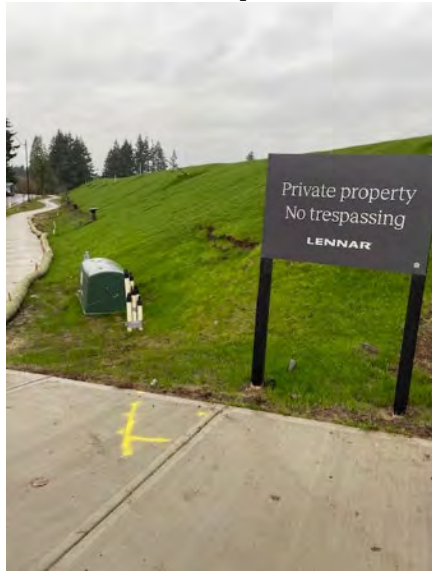
Photo 1a: Observed small slope failure at the entrance and disturbed soils where posts are installed.

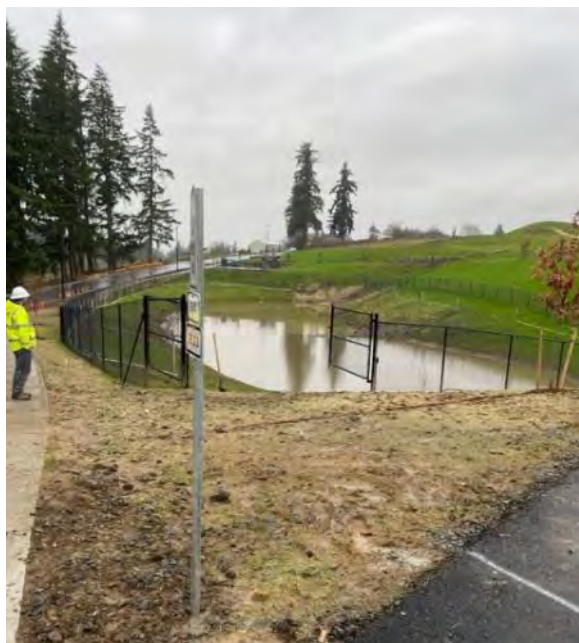
Photo 2a: Erosion observed on hillside above the pond A.

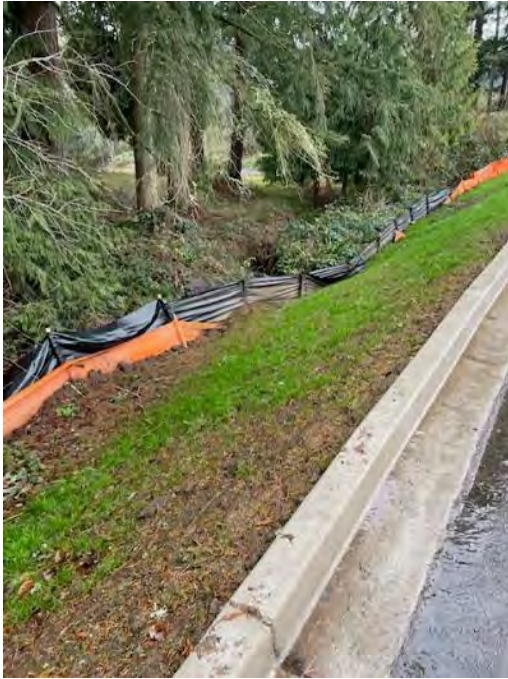
Photo 3a: Silt fence at Pond A discharge needs maintenance.

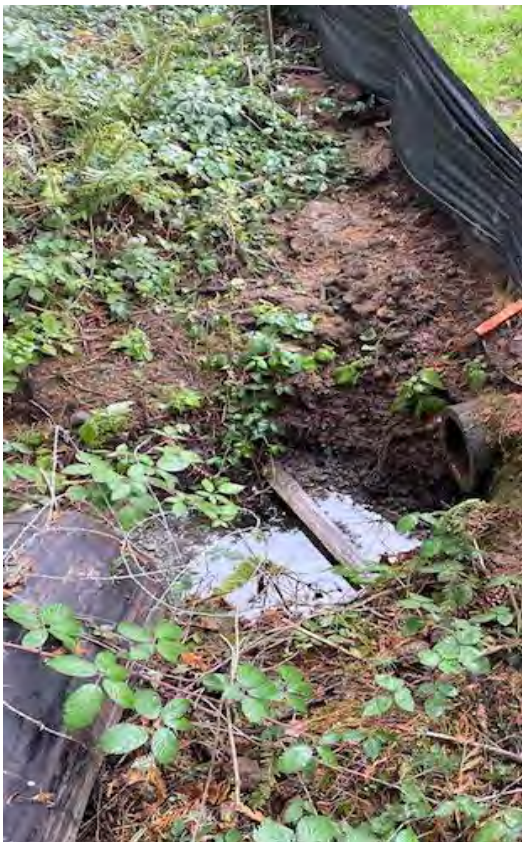
Photo 4a: Pond A discharge point needs attention.

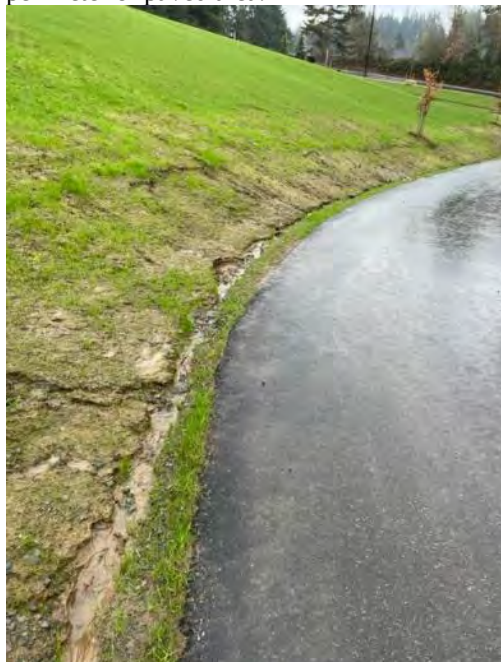
Photo 5a: Path by Pond A has some erosion along the perimeter of paved area.

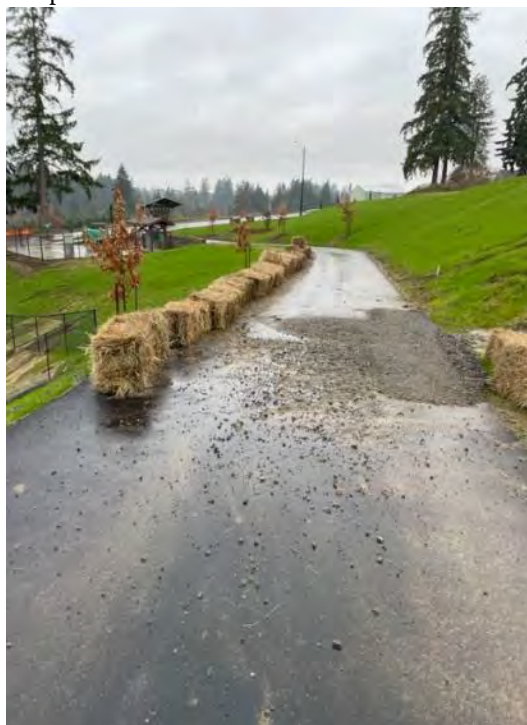
Photo 6a: Erosion observed above Pond A across paved footpath.

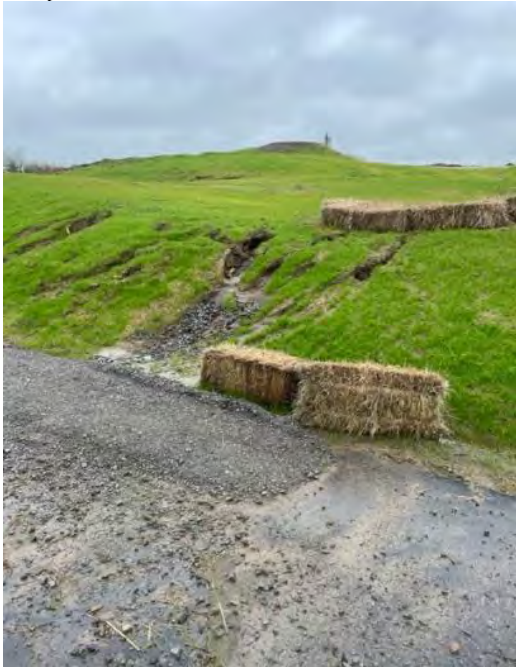
Photo 6c: Erosion observed above Pond A across paved footpath.

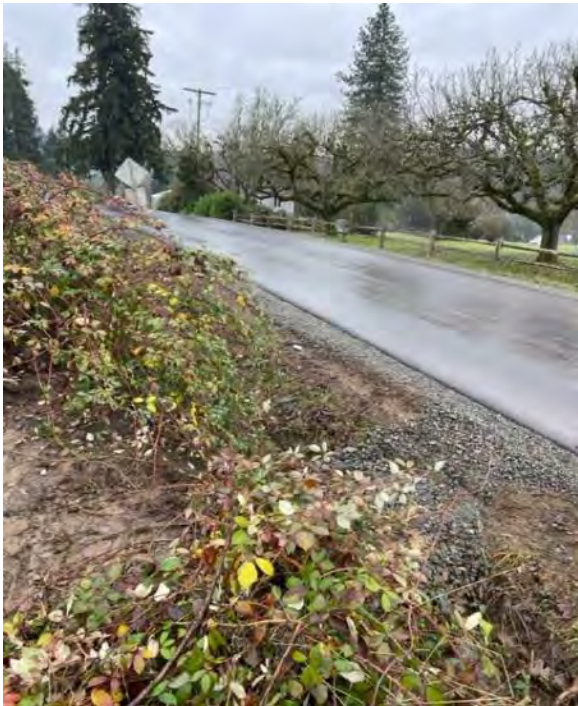
Photo 7a: Phase 3 observed break in vegetation at S. 25<sup>th</sup> Place and low point is open to roadway.

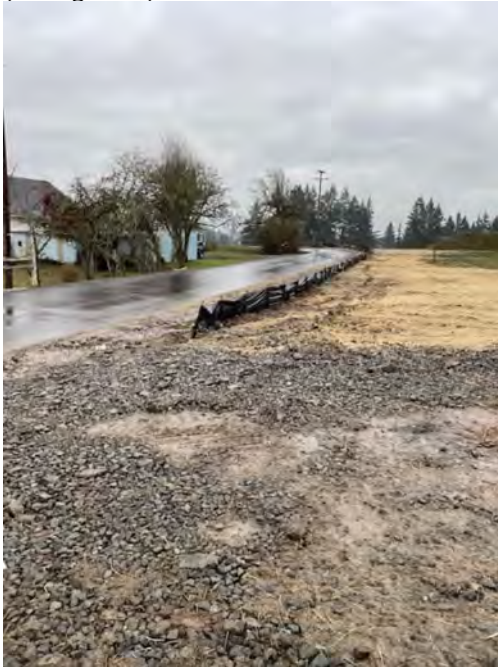
Photo 8a. West entrance to Phases 3-5 needs maintenance (Facing north).

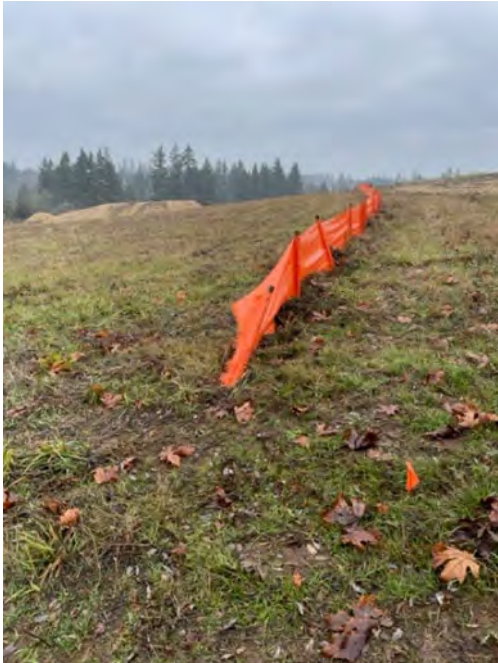
Photo 9a. West side of Phase 5 Silt fence needs to be extended.

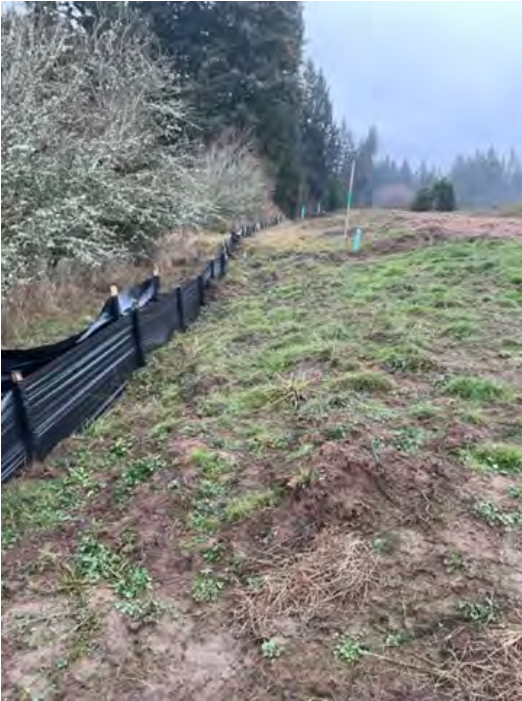
Photo 11a: Phase 5 northwest corner, silt fence needs maintenance.

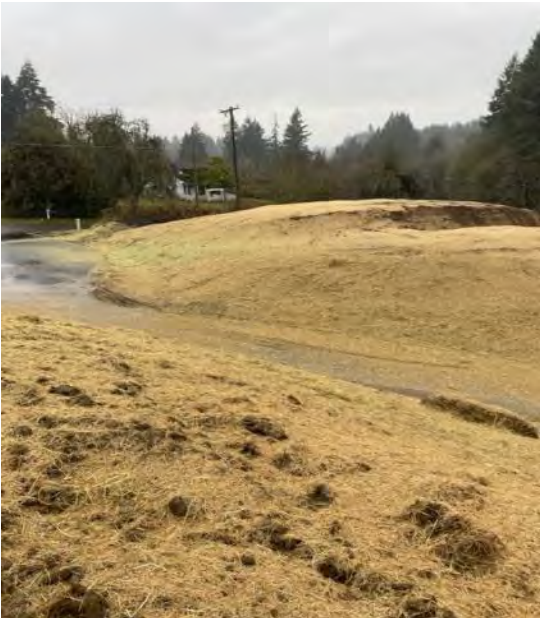
Photo 12a: Along S. 21<sup>st</sup> Place, mostly well covered with a few areas lacking enough straw mulch along the fire access road.

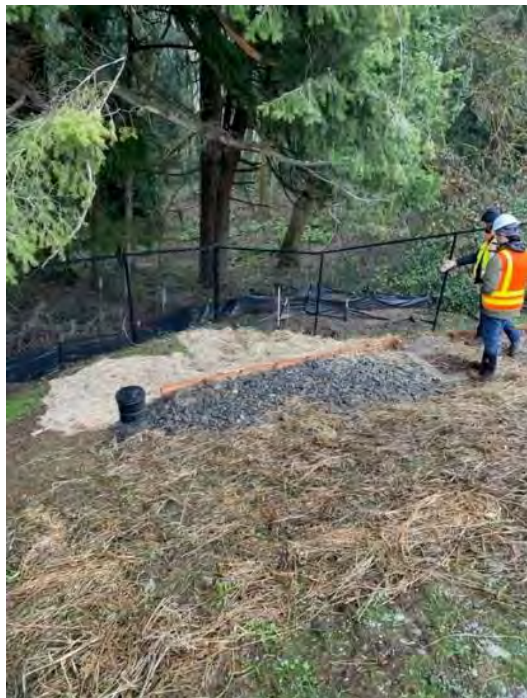
Photo 13a: Pond B silt fence needs maintenance

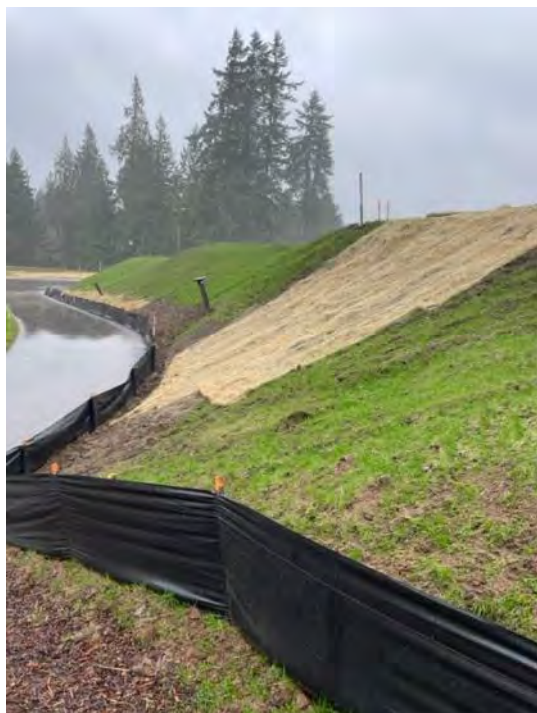
Photo 14a: North side of walking path and Pond B, silt fence needs maintenance.

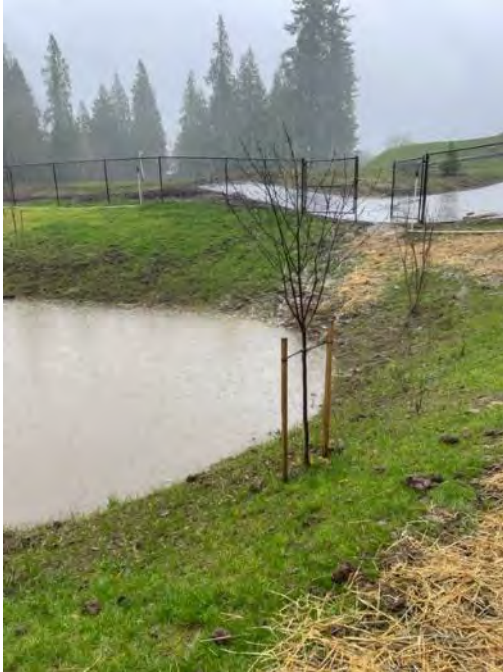
Photo 15a: Pond C entrance area needs maintenance, erosion observed.

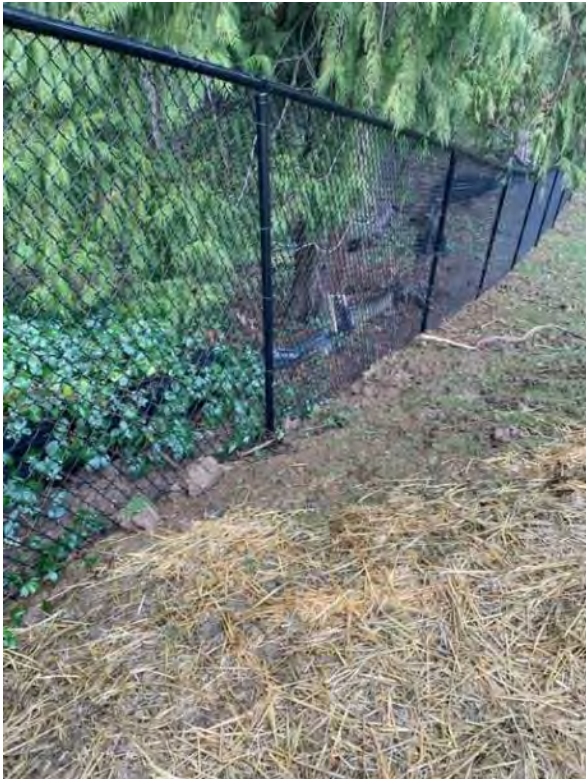
Photo 16a: Pond C silt fence needs maintenance where needed.

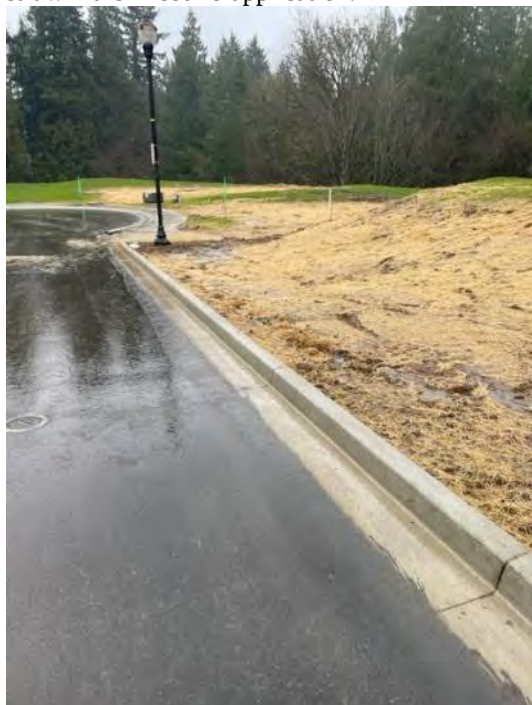
Photo 17a: Phase 2 cul-de-sac, exposed areas within straw mulch need re-application.
