**Region 6 - Enforcement & Compliance Assurance Division**  
**INSPECTION REPORT**

| Inspection Date(s): | 11/08/2024 | |
| Company Name: | <b>Pharr, Billy W (dba B Pharr Operating, LLC)</b> | |
| Facility Name: | <b>Bo Gregory #2 SWD Tank Battery</b> | |

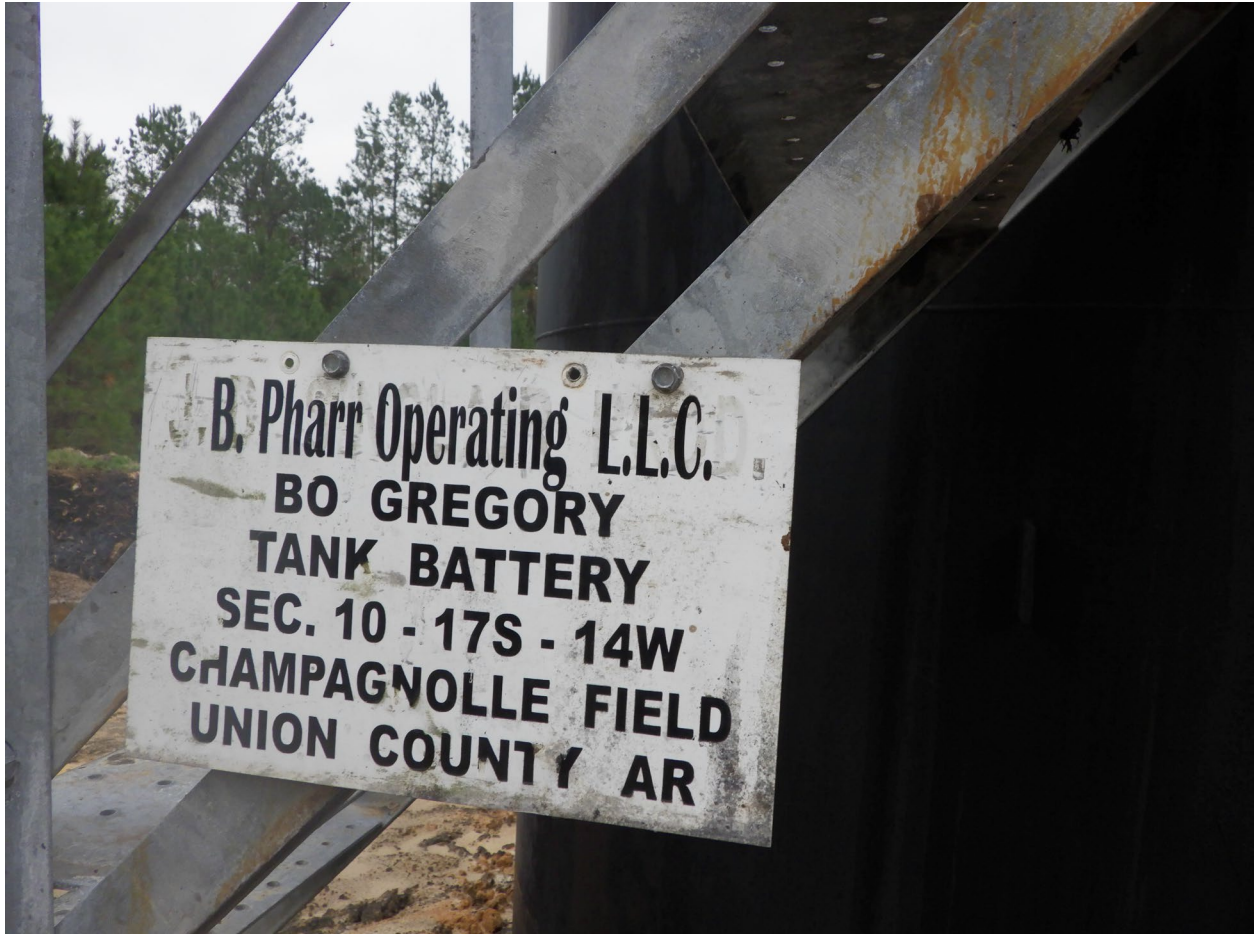
Photo No. 1

**Description:** Looking SSE, this photo shows the signage at the facility.

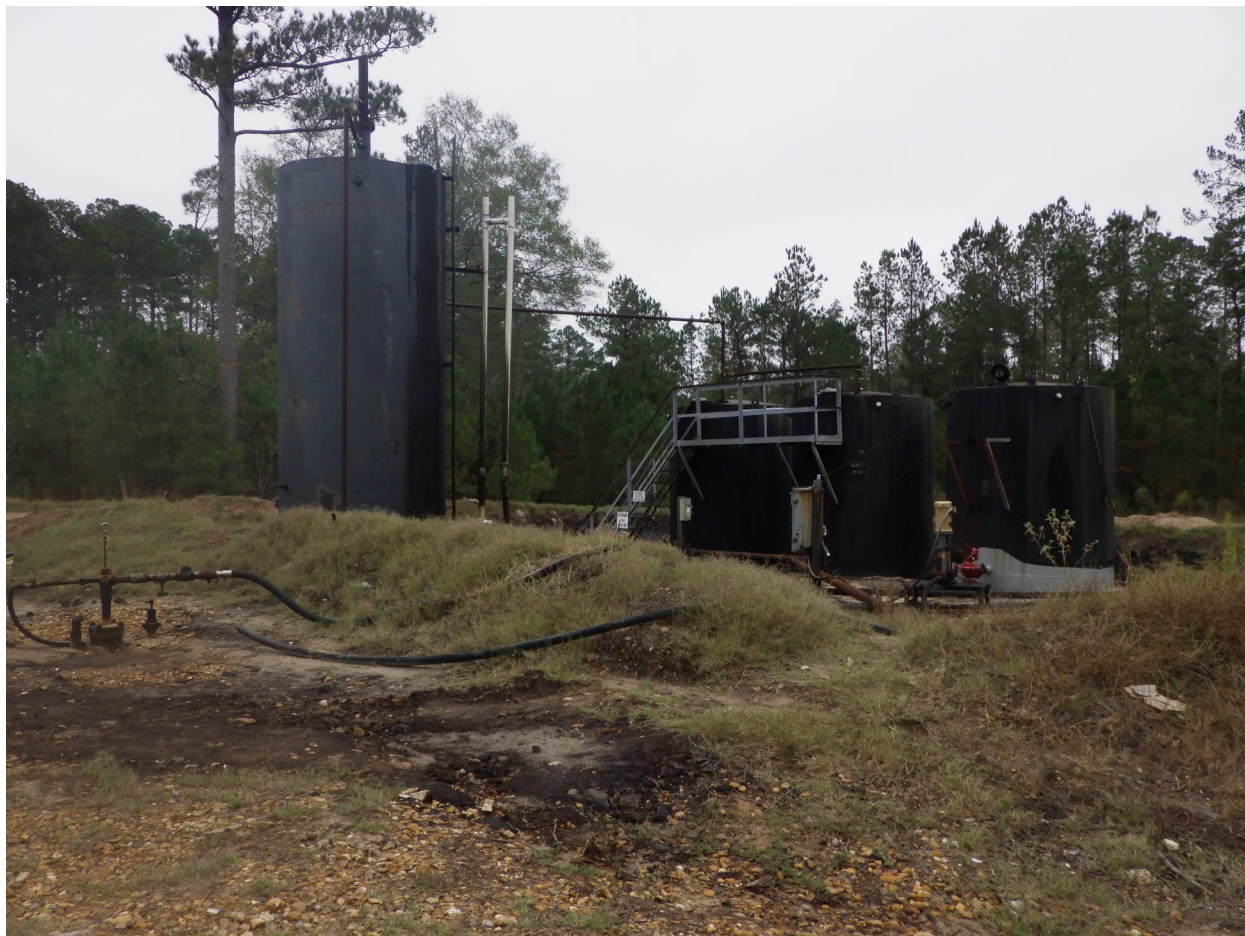
Photo No. 2

**Description:** Looking SE, this photo shows an overview of the facility.

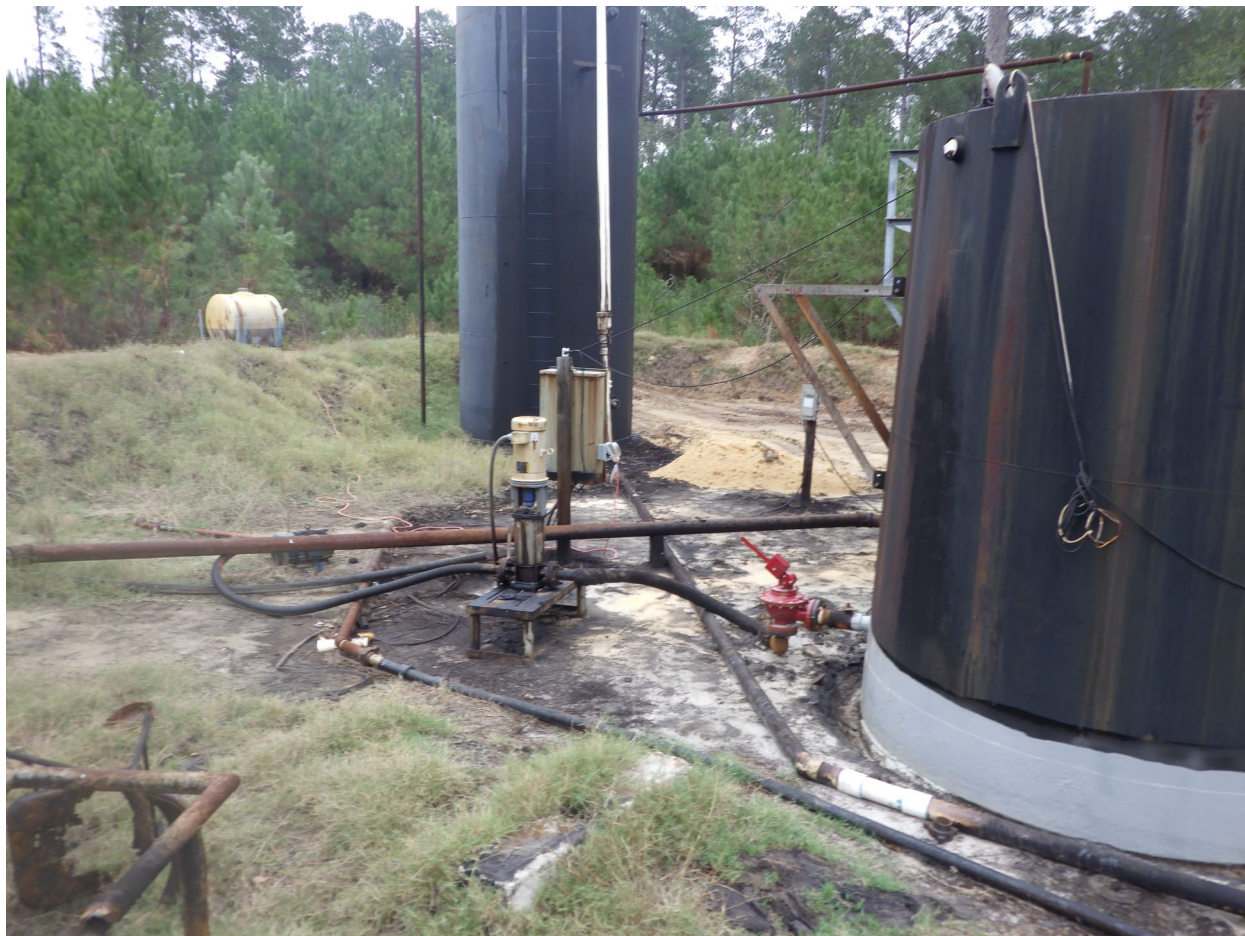
I observed loose oil inside secondary containment, see Photo No. 3 and No. 4.

**Description:** Looking E, this photo shows loose oil inside secondary containment.

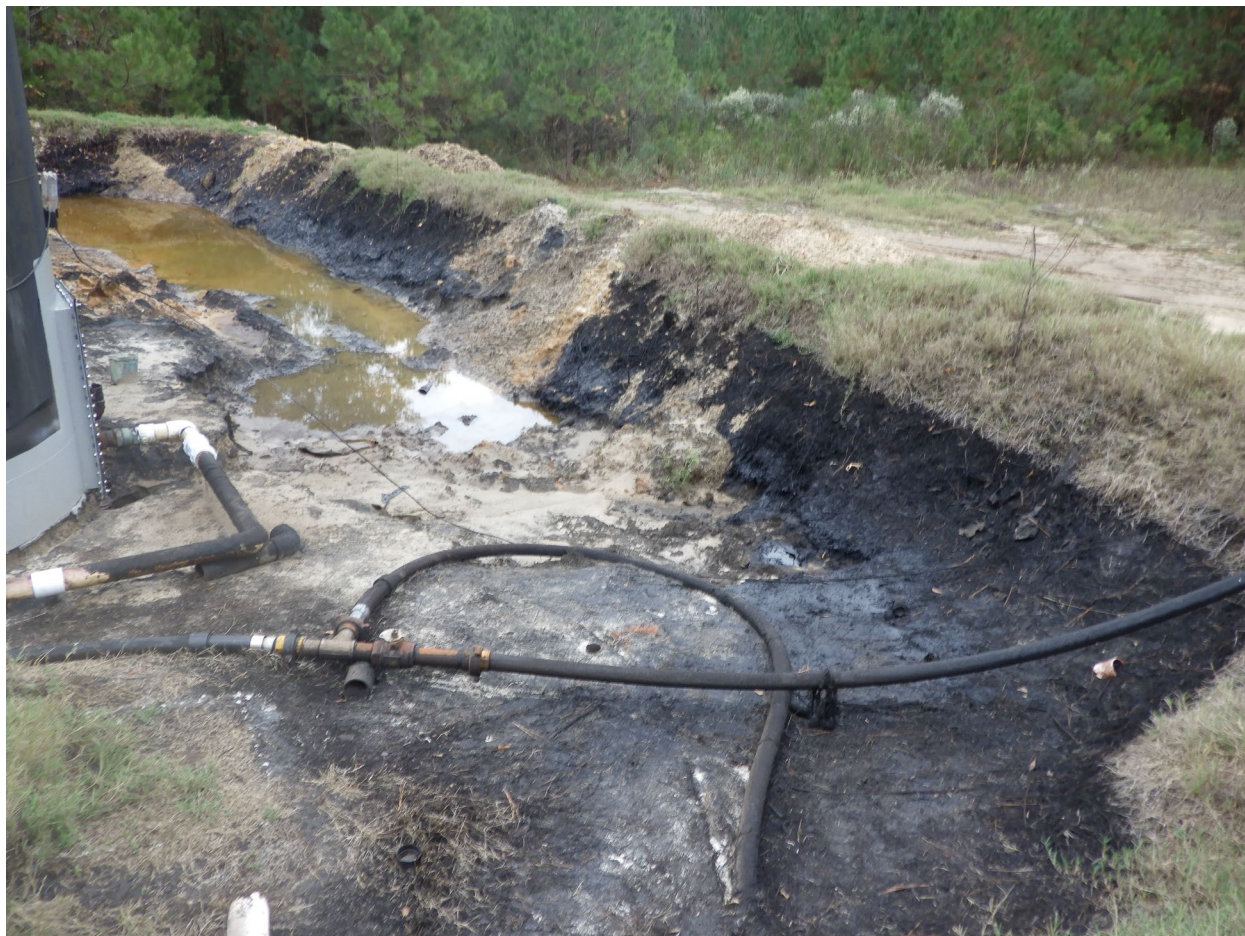
Photo No. 4

**Description:** Looking E, this photo shows loose oil inside secondary containment.

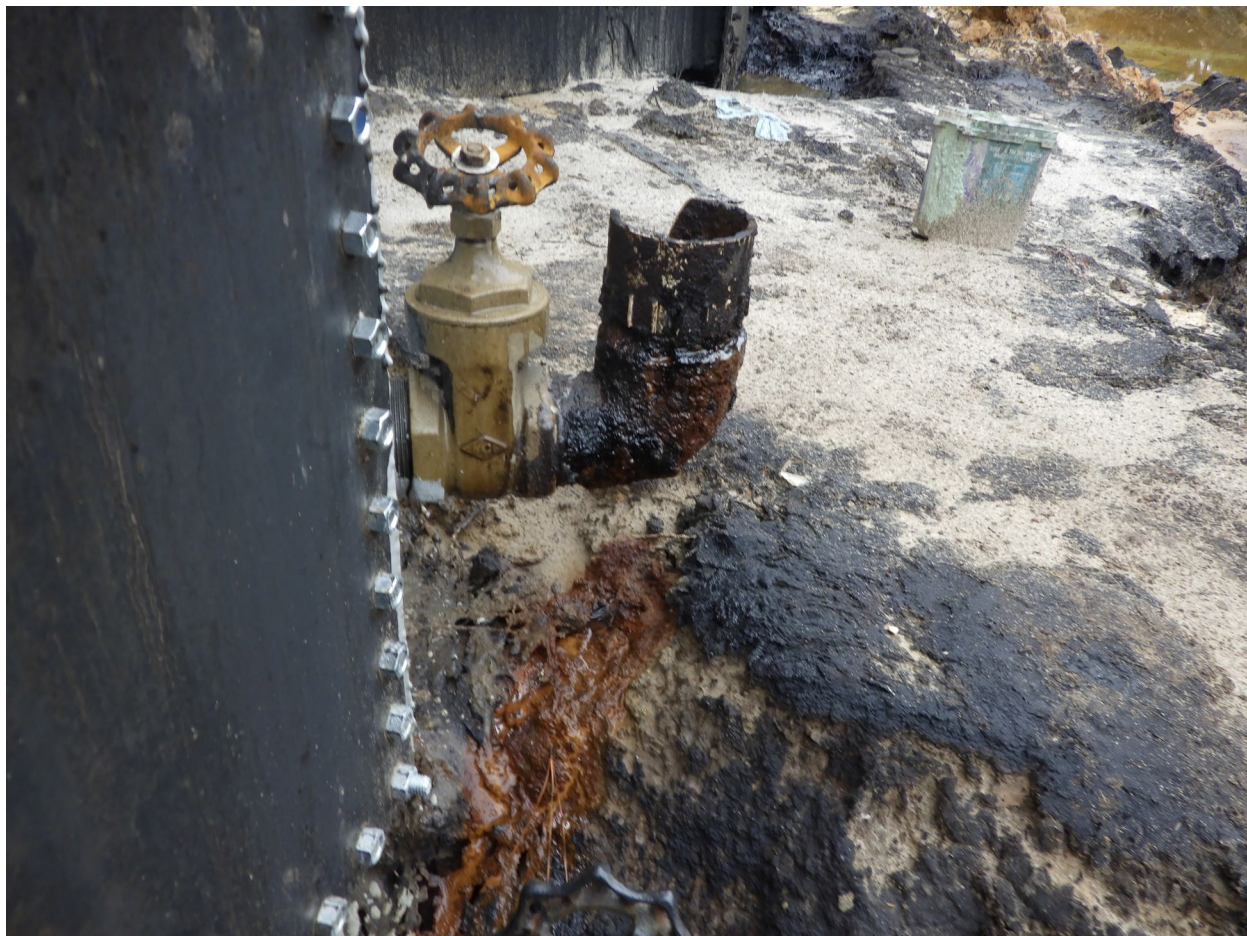
Photo No. 5

I observed an active leak of saltwater from a valve from one of the tanks inside secondary containment, see Photo No. 5.

**Description:** Looking ENE, this photo shows an active leak of saltwater from a valve from one of the tanks inside secondary containment.

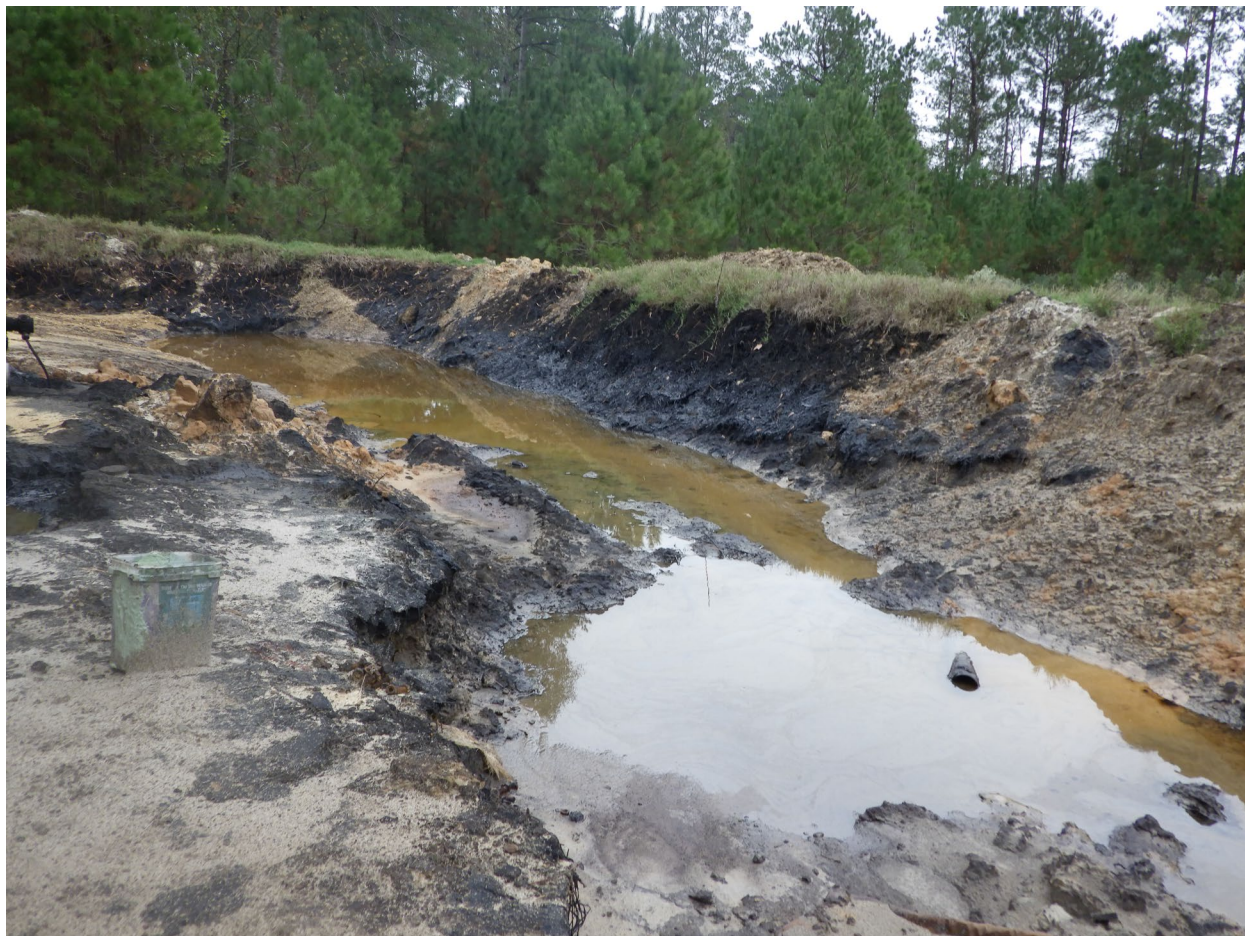
I observed loose crude oil and pooled saltwater inside the secondary containment, see Photo No. 6 and No. 7.

**Description:** Looking ESE, this photo shows loose crude oil and saltwater pooled in the sump area of secondary containment.

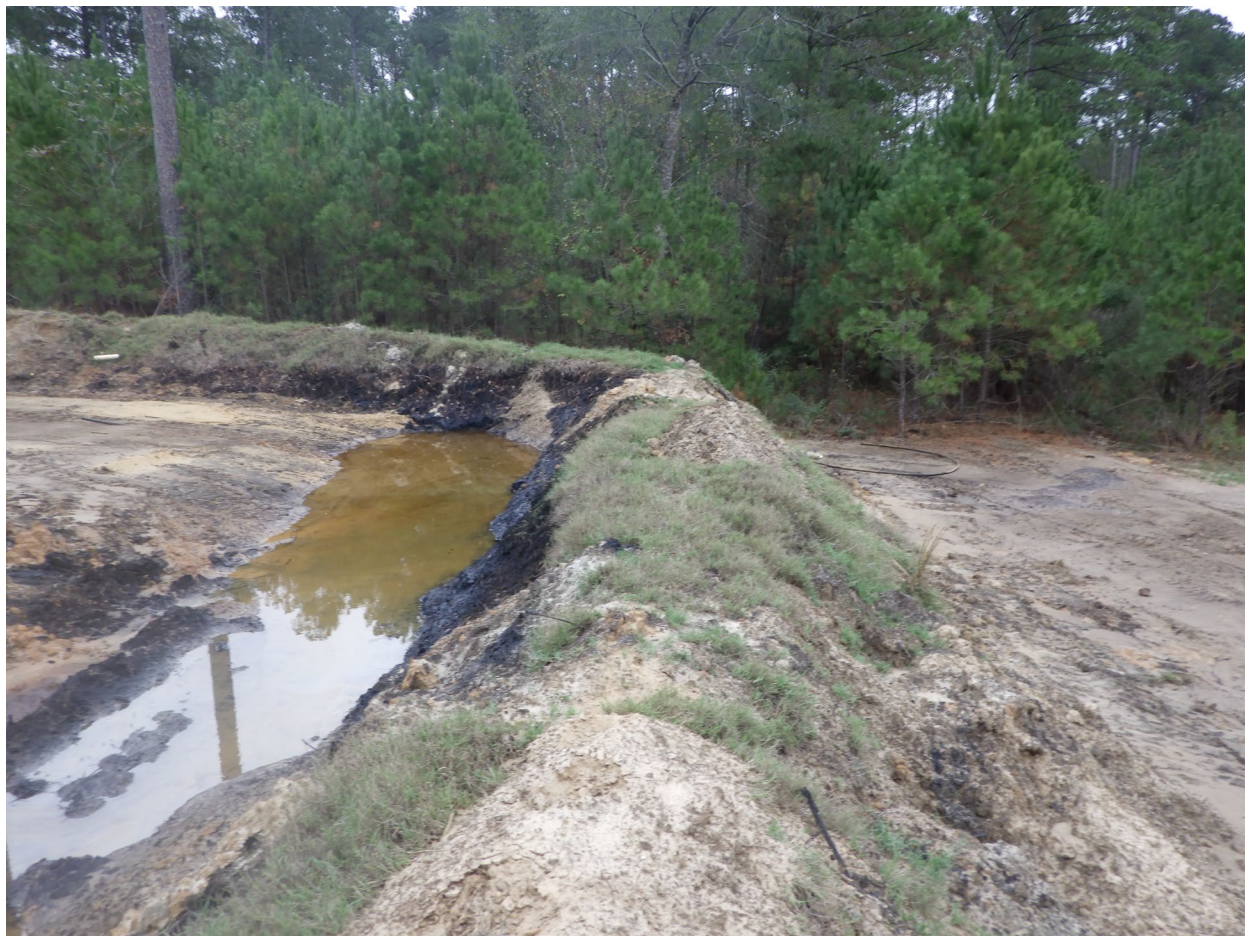
Photo No. 7

**Description:** Looking E, this photo shows an additional view from Photo No. 6.

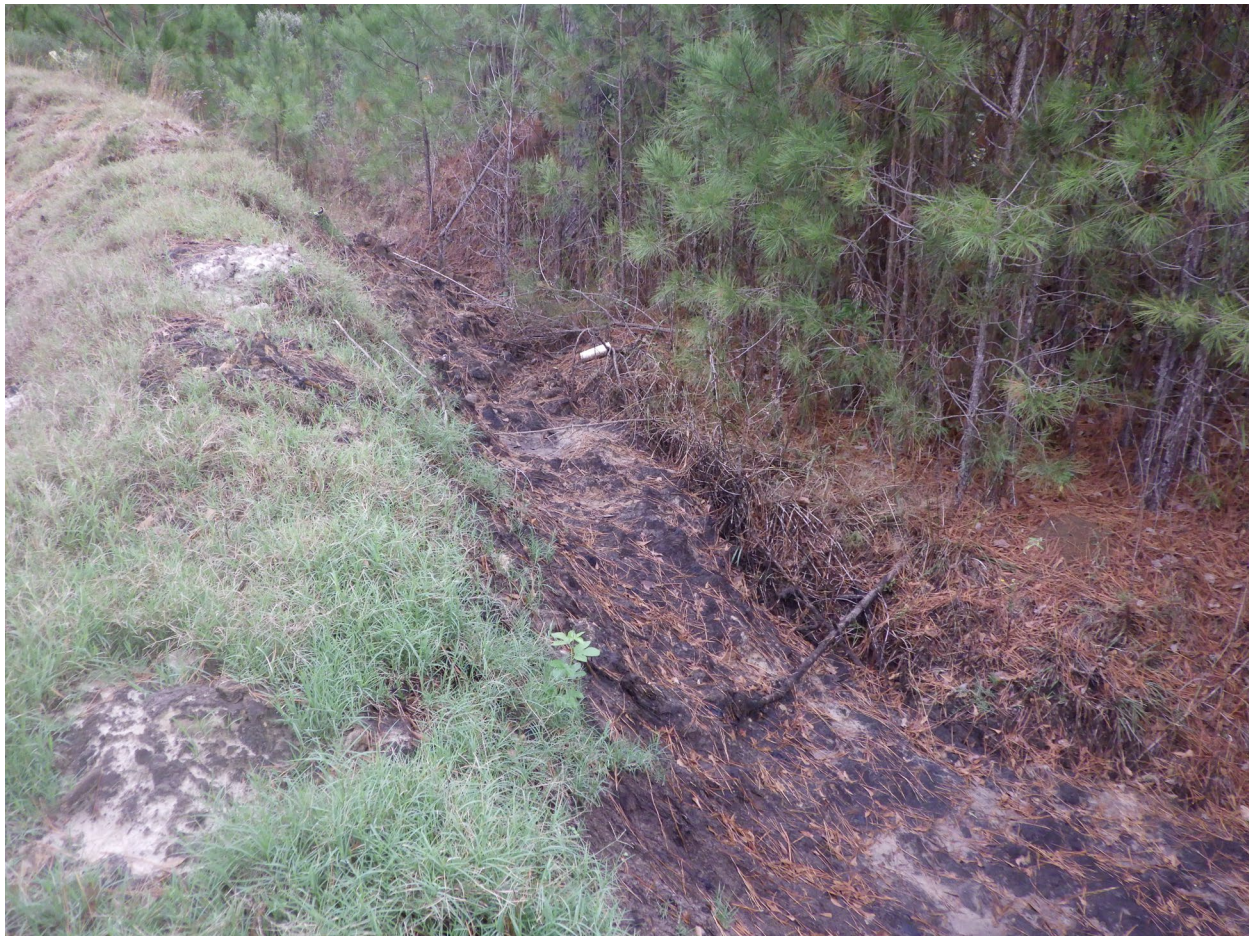
Photo No. 8

I observed residual crude oil from the overflow noted during the 10/08/2024 inspection on the outside of secondary containment, see Photo No. 8.

**Description:** Looking NE, this photo shows an area of the overflow with residual crude oil staining the outside of the secondary containment berm.

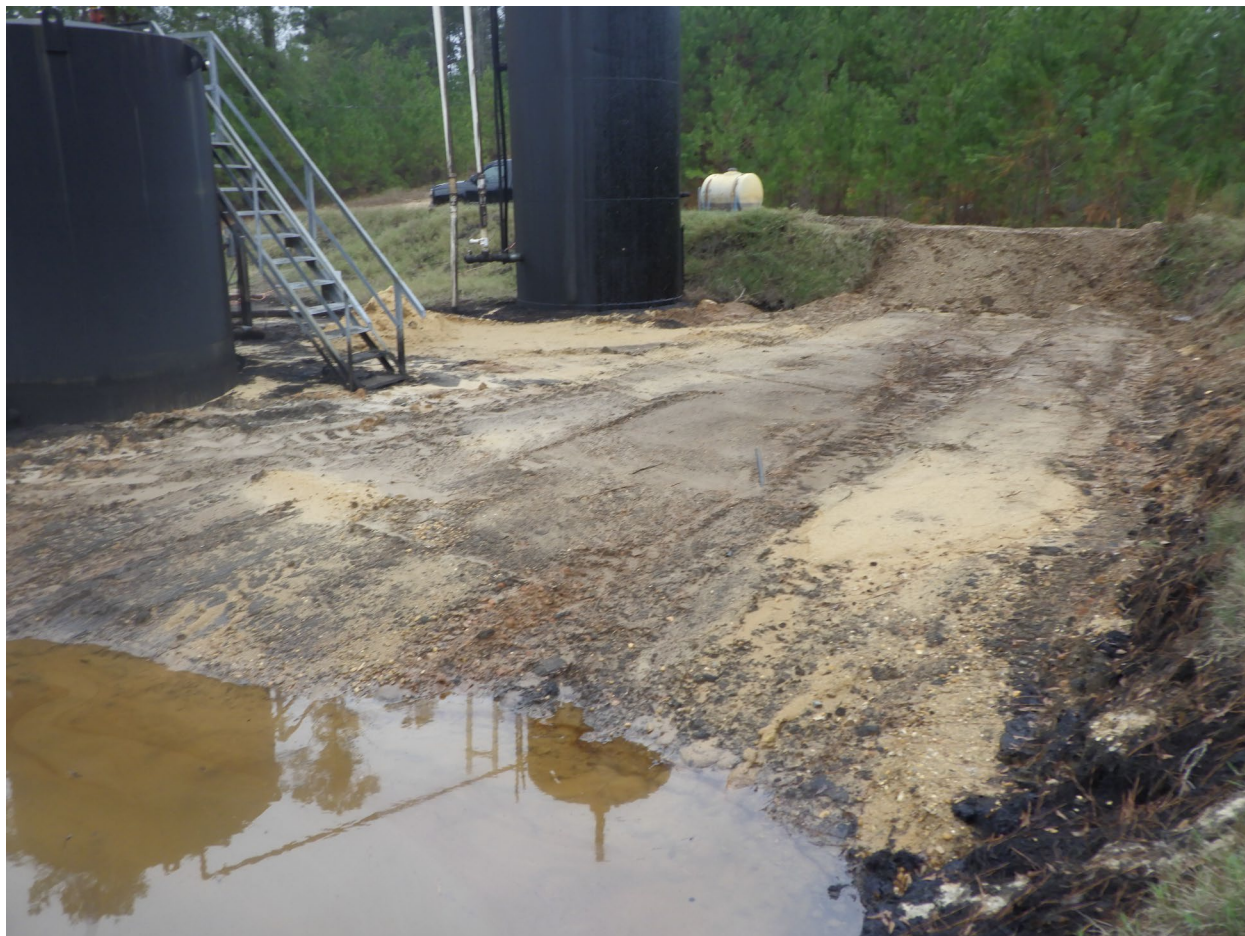
Photo No. 9

I observed an area of the secondary containment berm that had been repaired since the 10/08/2024 inspection, see Photo No. 9.

**Description:** Looking NNE, this photo shows an area of the secondary containment berm that had been repaired since the 10/08/2024 inspection.
