**Region 6 - Enforcement & Compliance Assurance Division**  
**INSPECTION REPORT**

| Inspection Date(s): | 03/1/2023 | |
| Company Name: | <b>D &amp; M Water Supply Corporation (WSC)</b> | |
| Facility Name: | <b>D &amp; M WSC</b> | |

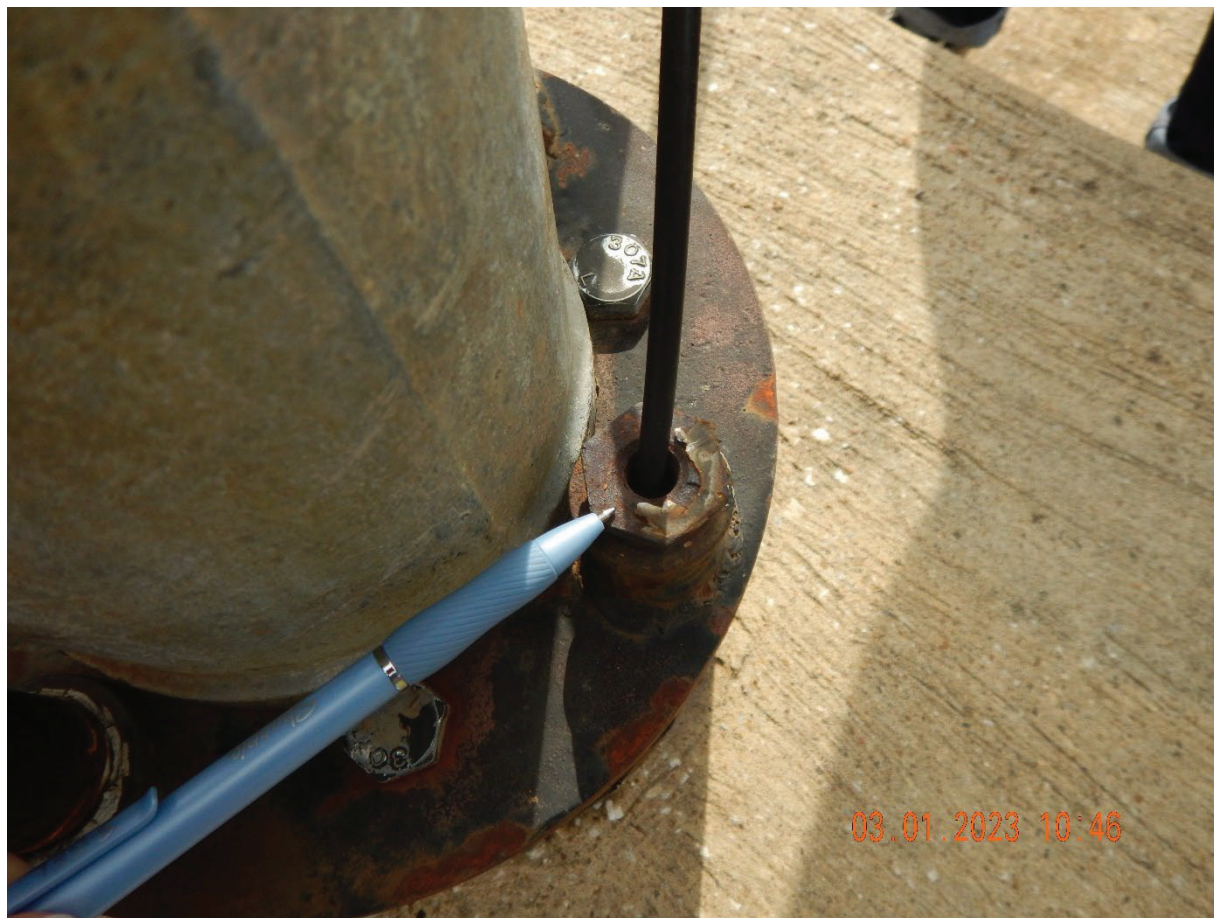
Photo No. 2

- I observed an open hole where the electrical wire enters the well (Photo 2)
- I observed open holes in the electrical conduit (Photo 3)
- The well had some area of insulation removed to access well (Photo 4)

- The electrical conduit box had four holes on the back of the panel that were open to the air
- The electrical conduit into the well was open which could be a potential path for contamination
- We were unable to confirm where hole in insulation on the side of the ground storage tank led
- Ammonia should not be stored inside of the chlorine room

Description: Hole in electrical conduit on well casing

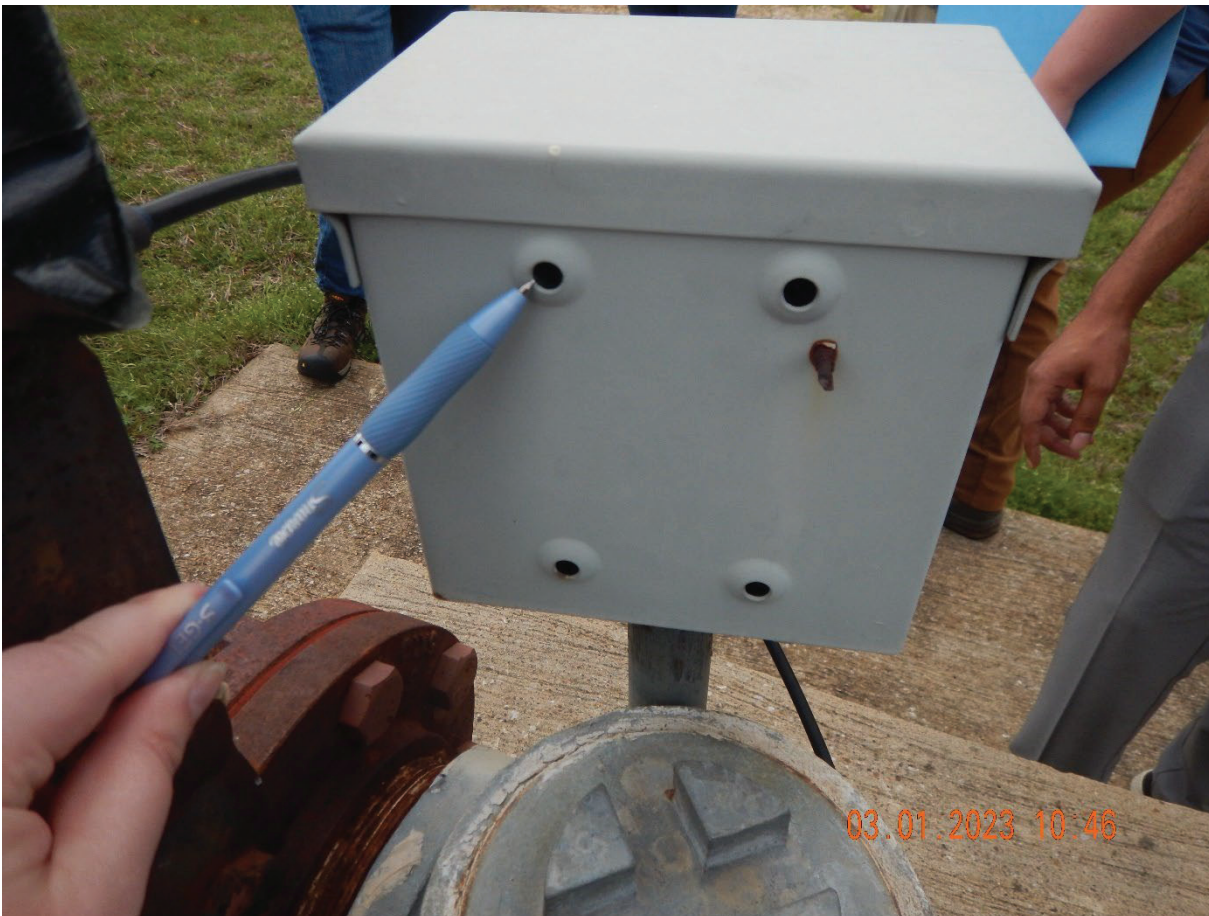
Photo No. 3

Description: Holes in electrical box

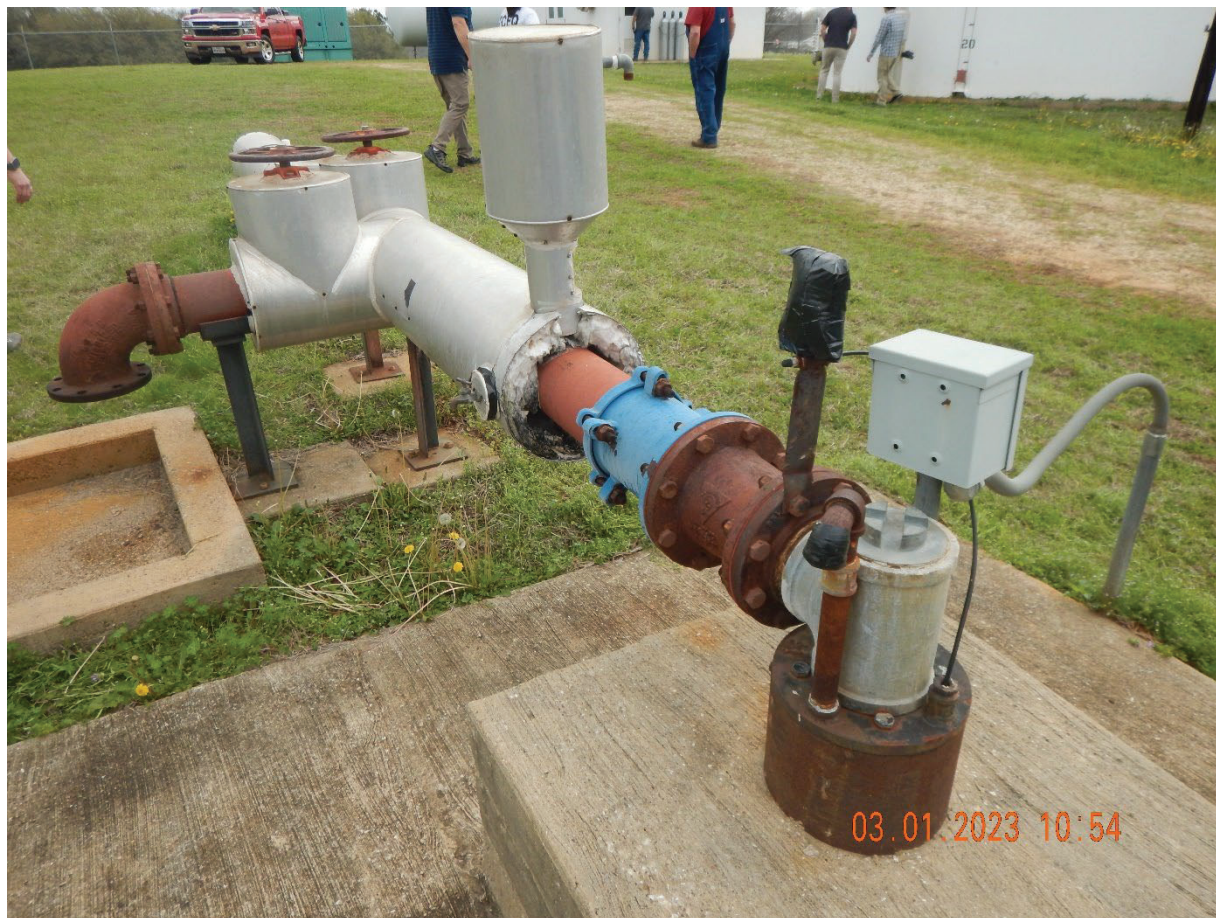
Photo No. 4

Description: Douglass Well

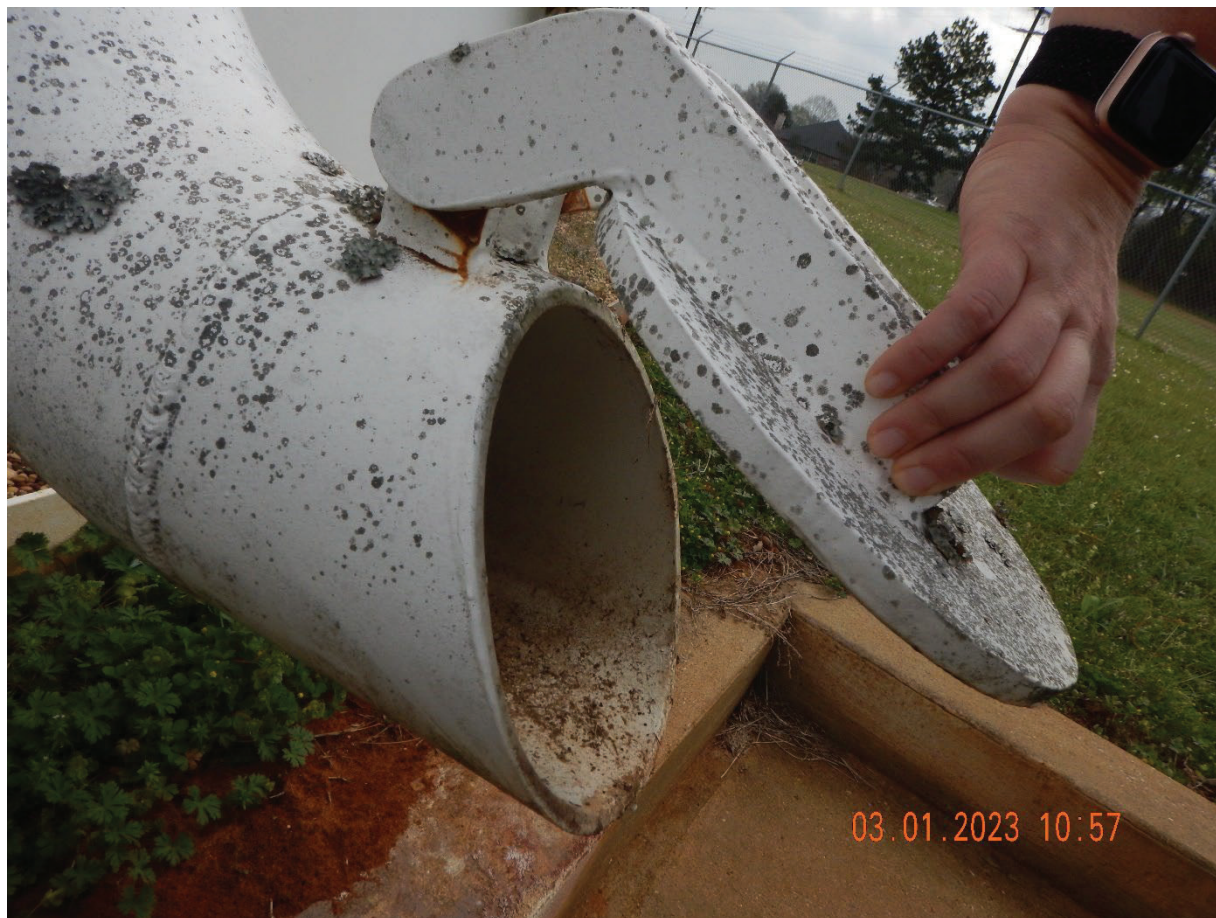
Photo No. 5

- We observed a flap style cover on the storage tank overflow. Seal appeared airtight at time of inspection, however small amount of rust and corrosion was showing (Photo 5)
- We observed a hole in the side of the insulation of the bottom of the ground storage tank. Unable to observe where hole led to (Photo 6)
- We observed ammonia being stored in the chlorine room at the treatment plant (Photo 7)
- We observed a pressure tank with a new air relief valve in the open position on the top of the storage tank (Photo 8 and 9)
- We observed a diesel generator onsite for the well. We were informed that over the last freeze the water system maintained running water through the last two heavy freezes but did have pressure issues

Description: Seal at bottom of ground storage tank overflow

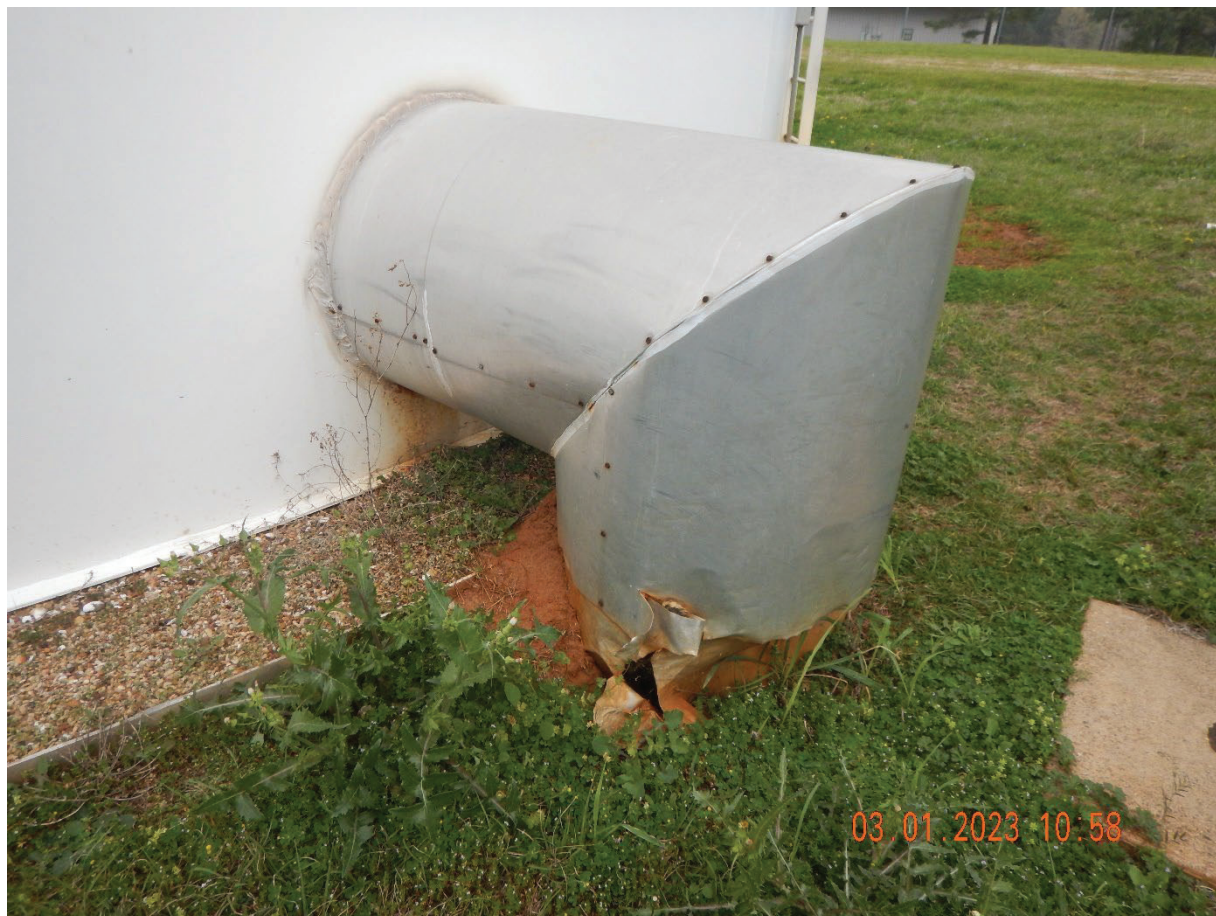
Photo No. 6

Description: Hole in insulation connected to the ground storage tank

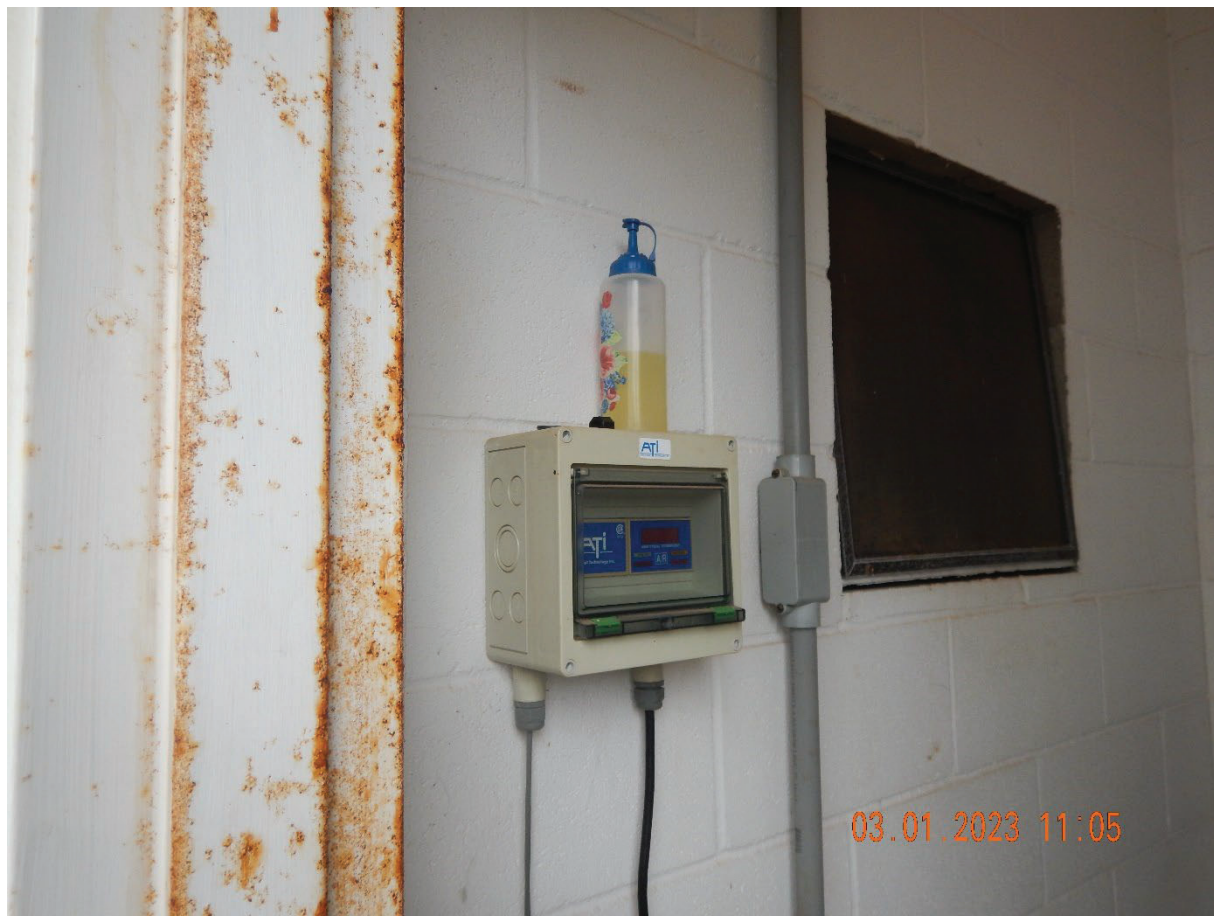
Photo No. 7

Description: Ammonia in chlorine room at water plant

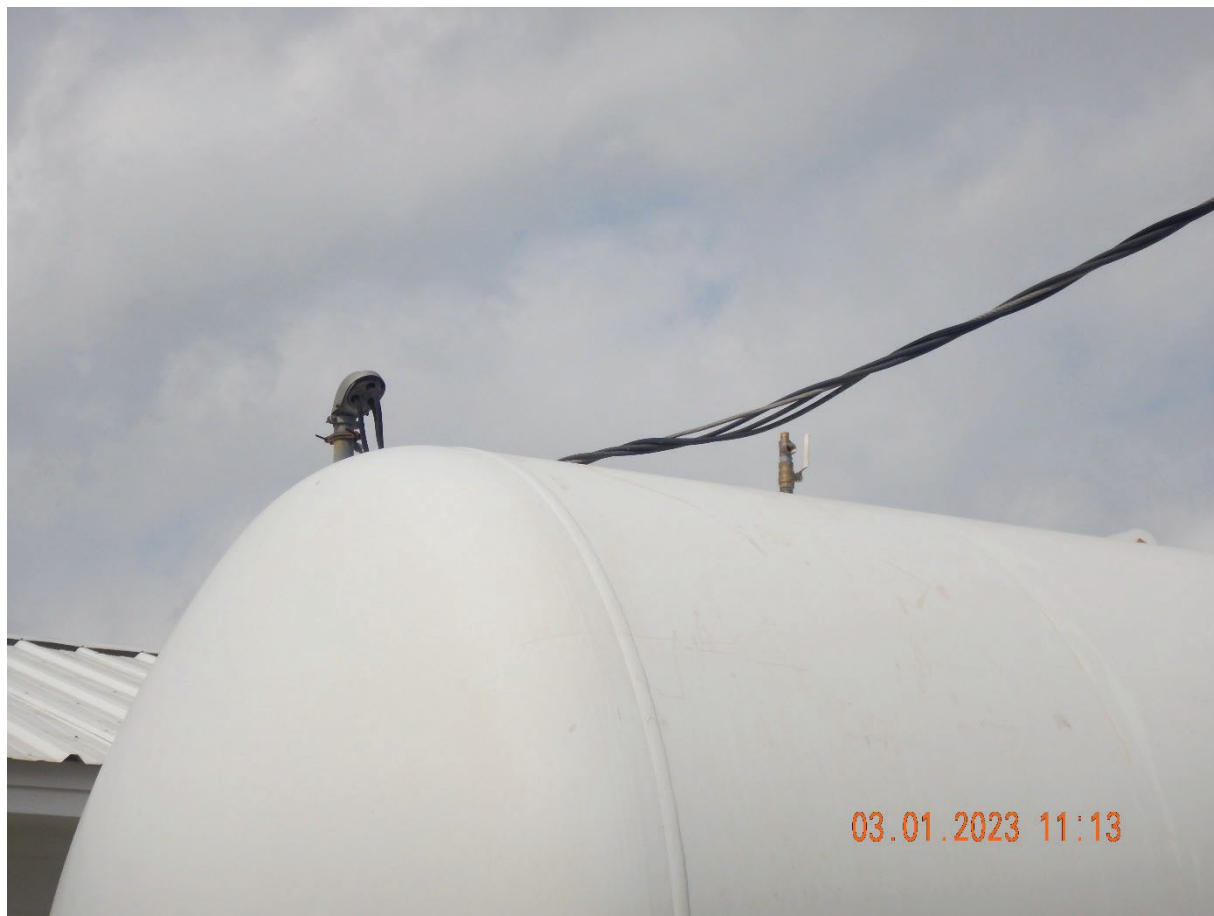
Photo No. 8

Description: Pressure relief valve at the top of the pressure tank

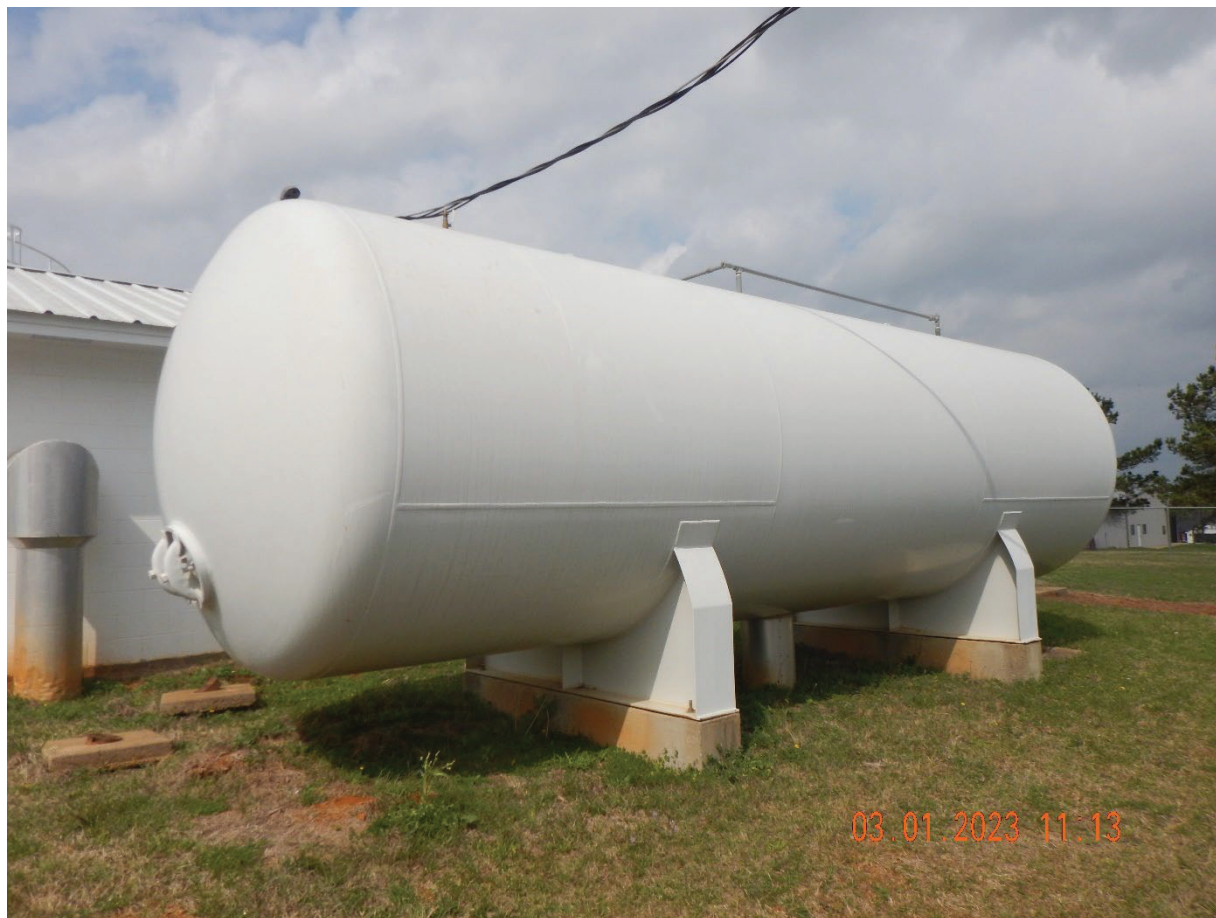
Photo No. 9

Description: Pressure tank at Douglass Plant

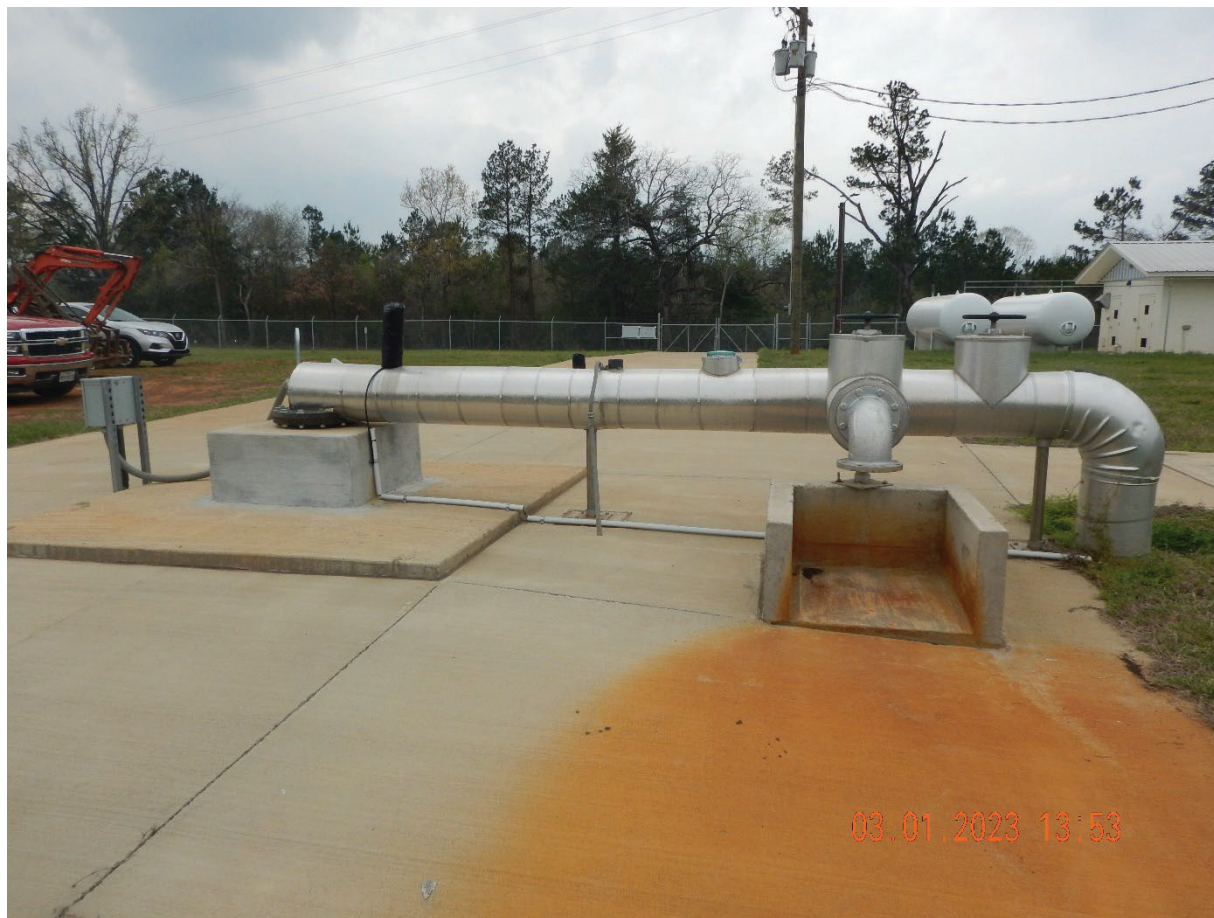
Photo No. 10

- We were informed the well at this location was two years old and was drilled following a collapse
- We observed a heavily insulated well and well pad that was consistent with recent construction (Photo 10)
- We observed the chemical injection point marked by multiple large rocks and were informed rocks were to prevent mowing accidents (Photo 11)
- We observed areas of the ground storage tank foundation being eroded (Photo 12)
- We observed staining and erosion from supporting gravel and rock from the storage tank overflow (Photo 13)
- We observed erosion of the foundation gravel around the bottom of the tank on all sides of the tank (Photo 14)
- We observed ammonia in the chlorine room of the water plant at this location
- We observed a polyphosphate tank in a secondary containment bin of unknown capacity (Photo 15)

Description: New well at Eden Plant

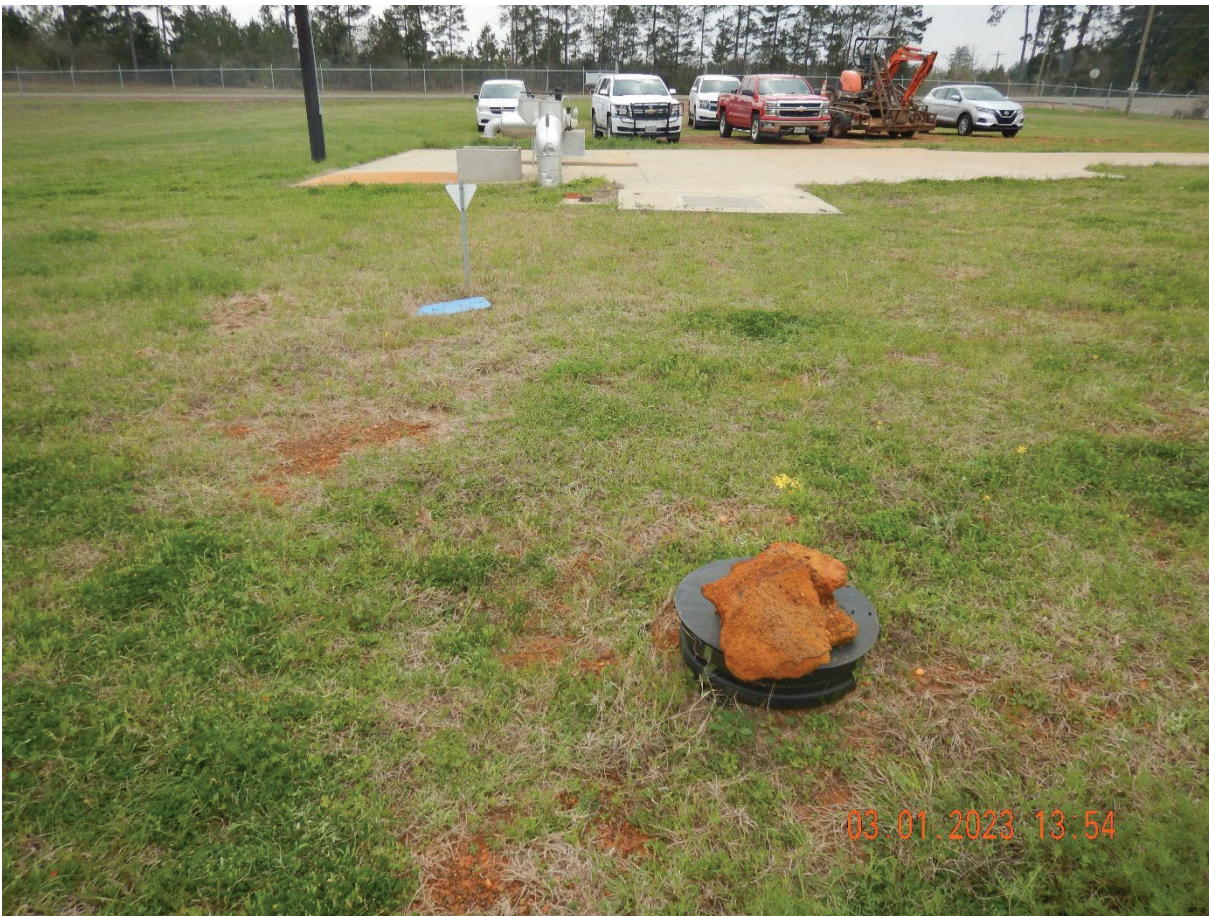
Photo No. 11

Description: Chemical feed location at Eden Plant, rocks marking location

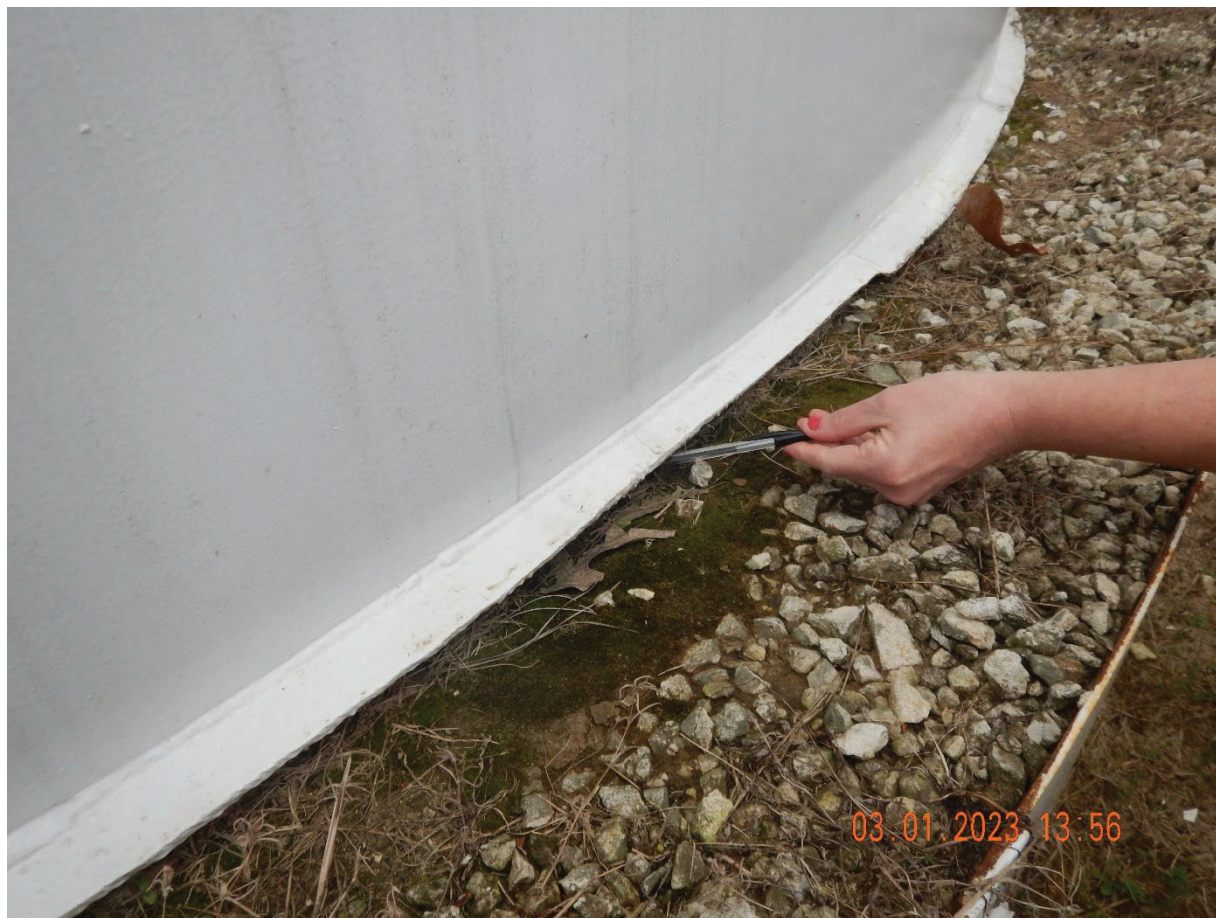
Photo No. 12

- Several areas around the base of the ground storage tank had areas where the gravel is eroding, at times under the tank at least the length of a pen
- The ammonia was stored inside the chlorine room at the plant

Description: Erosion at foundation of ground storage tank

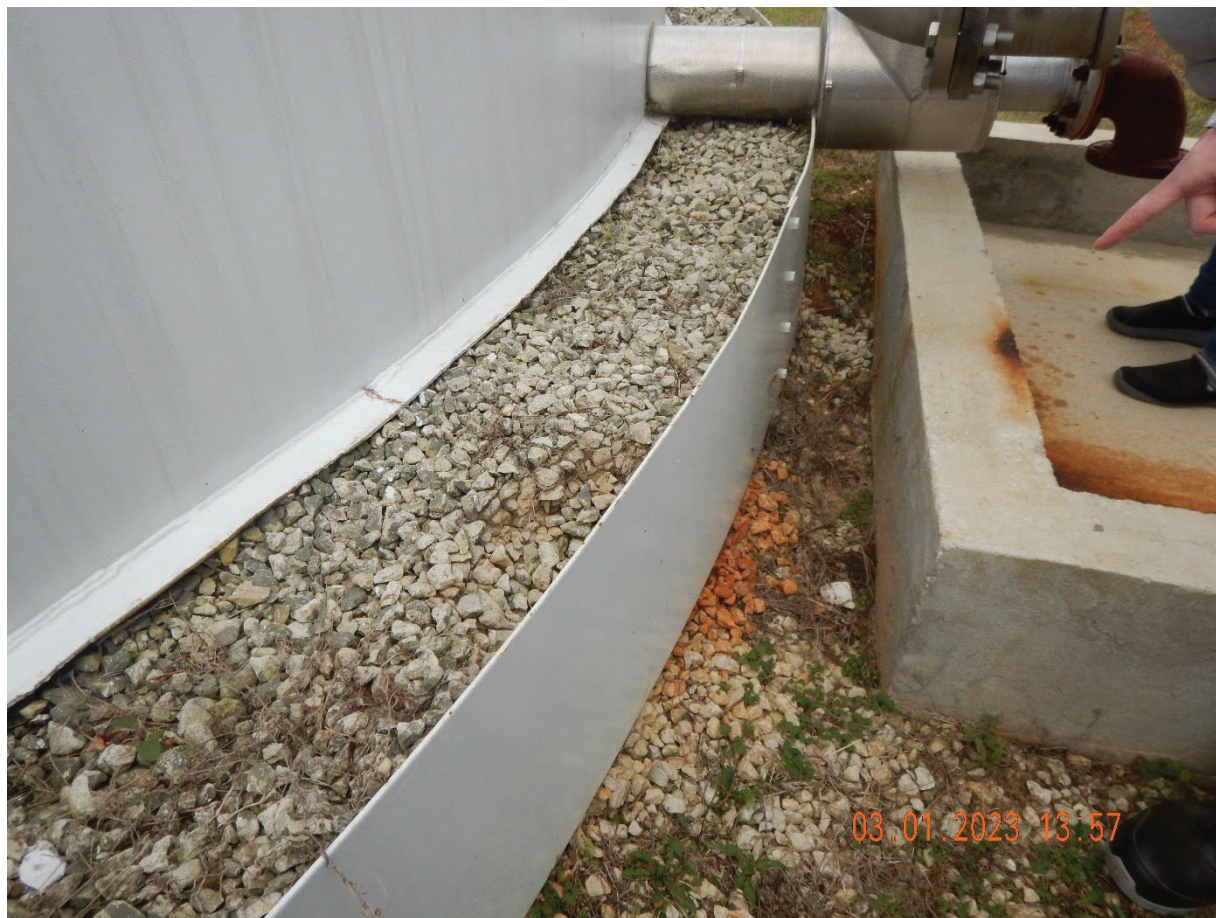
Photo No. 13

Description: Discoloration from splashing from tank overflow

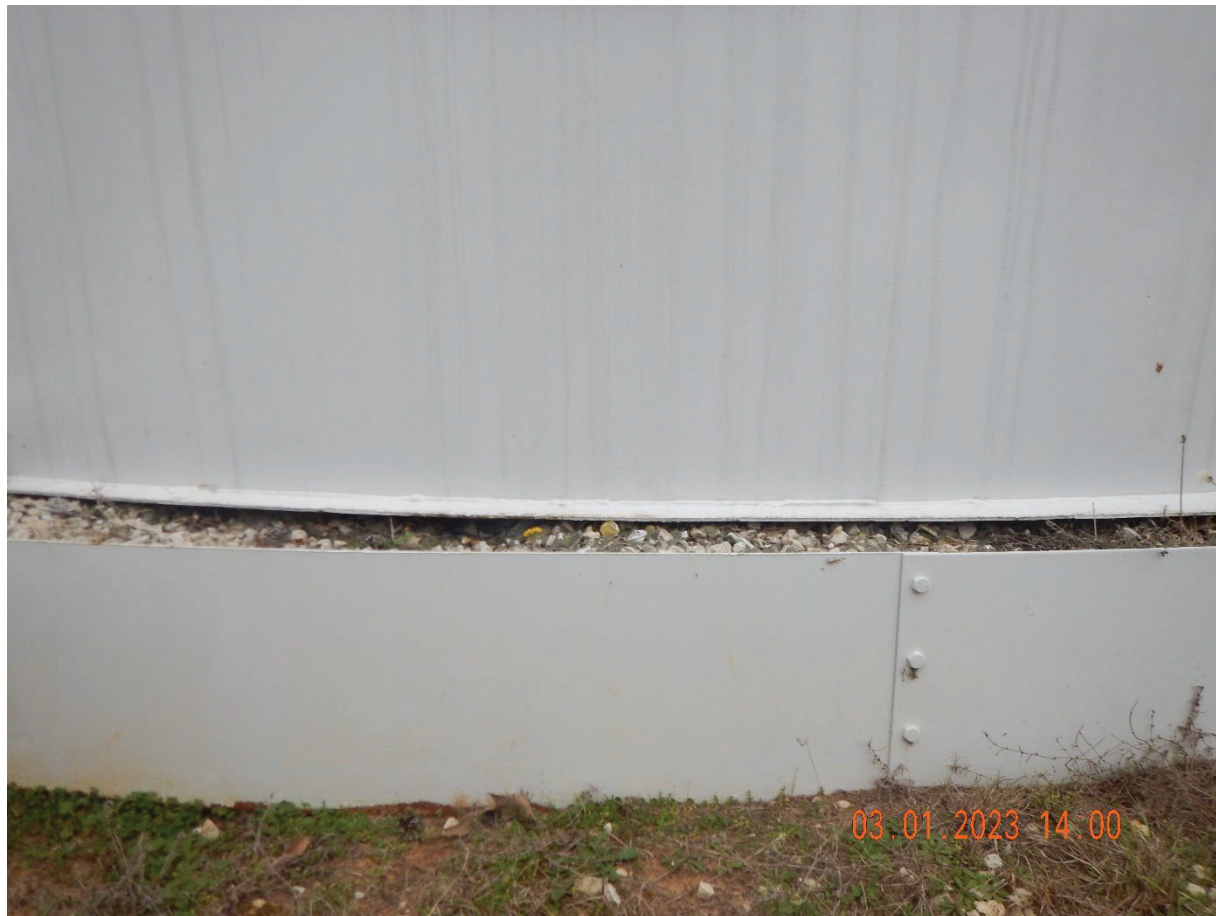
Photo No. 14

Description: Foundation erosion beneath storage tank

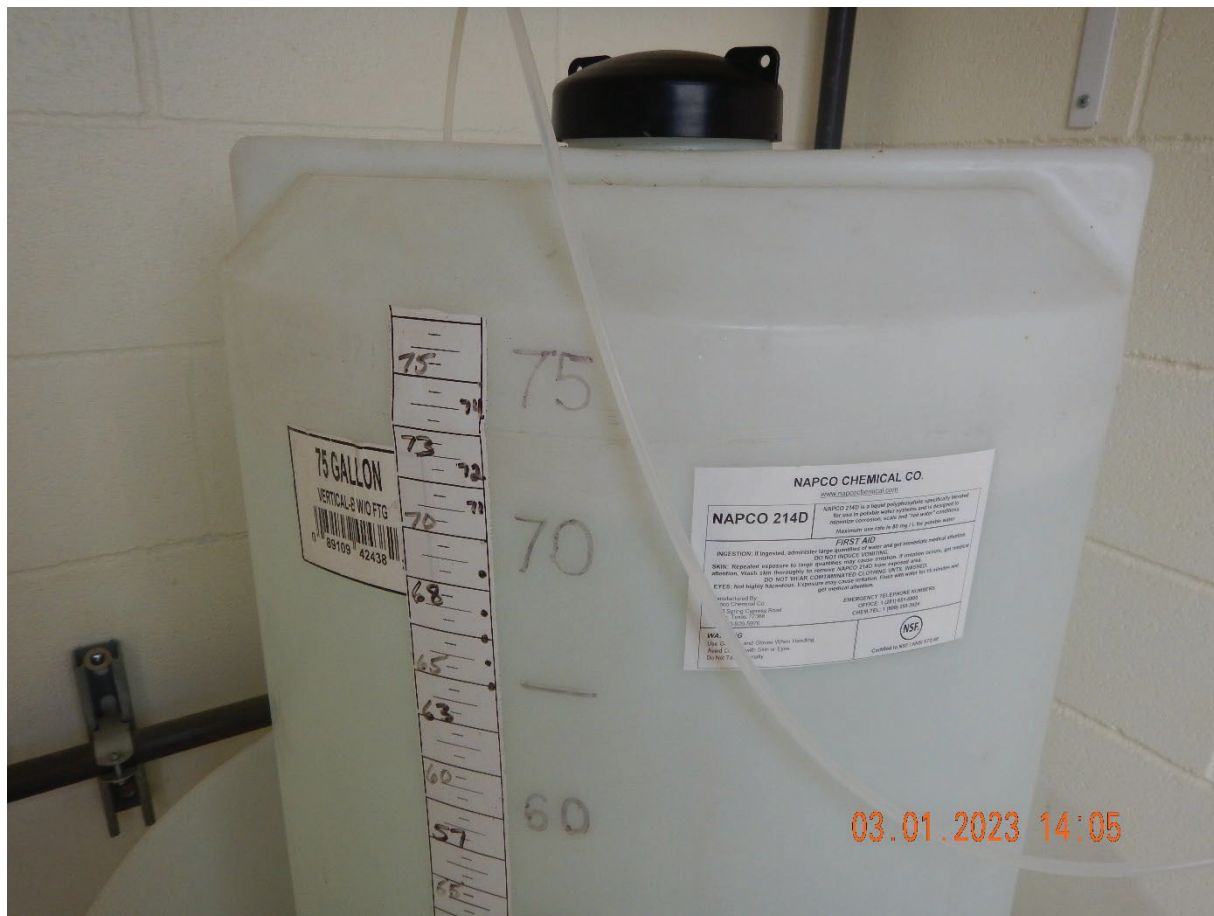
Photo No. 15

Description: Chemical storage tank in secondary containment

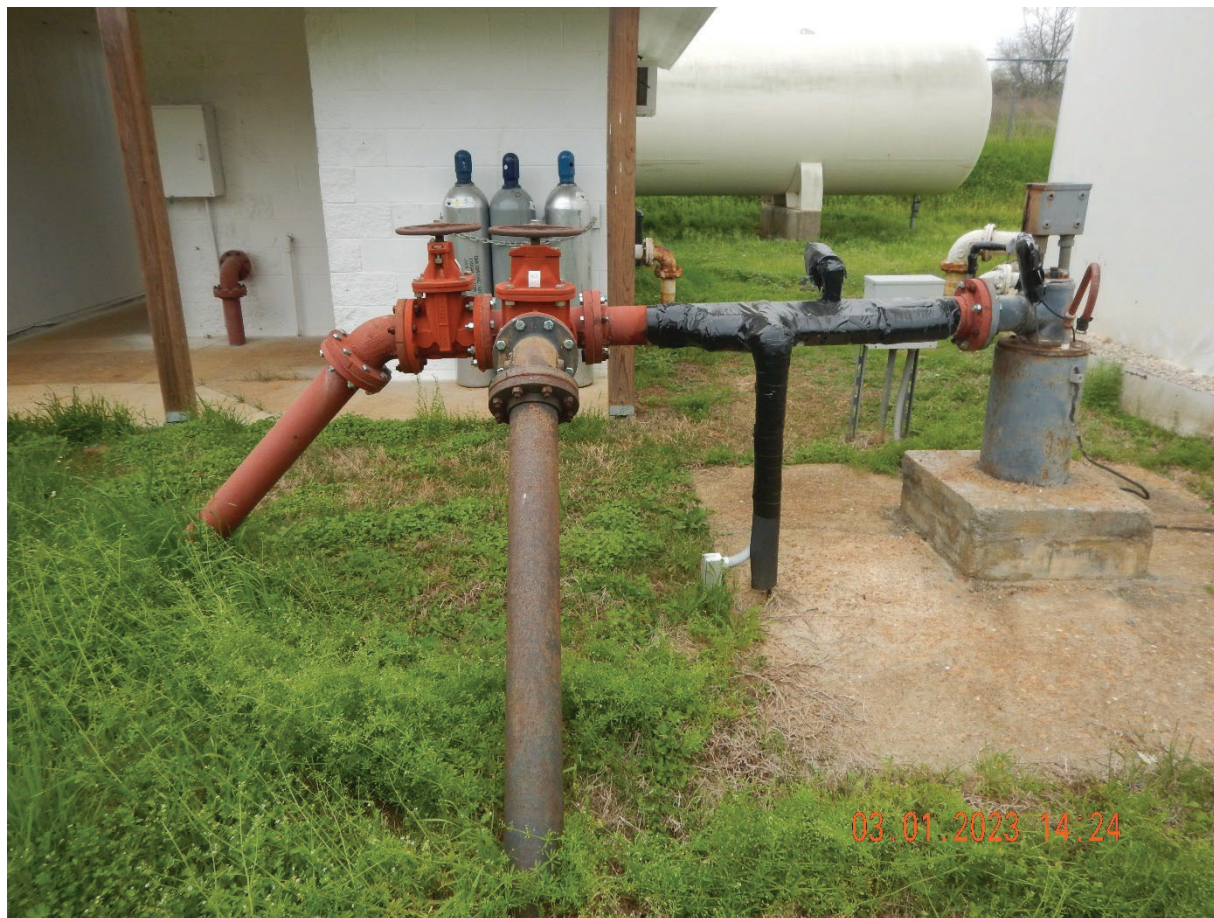
Photo No. 16

- We observed one well supplying the Alazan plant (Photo 16)
- We observed an opening around the electrical conduit on the well (Photo 17)
- We observed corrosion on the top part of the overflow of the ground storage tank where it met the pipe coming directly from the tank (Photos 18-20)

Description: Well at Alazan Treatment Plant

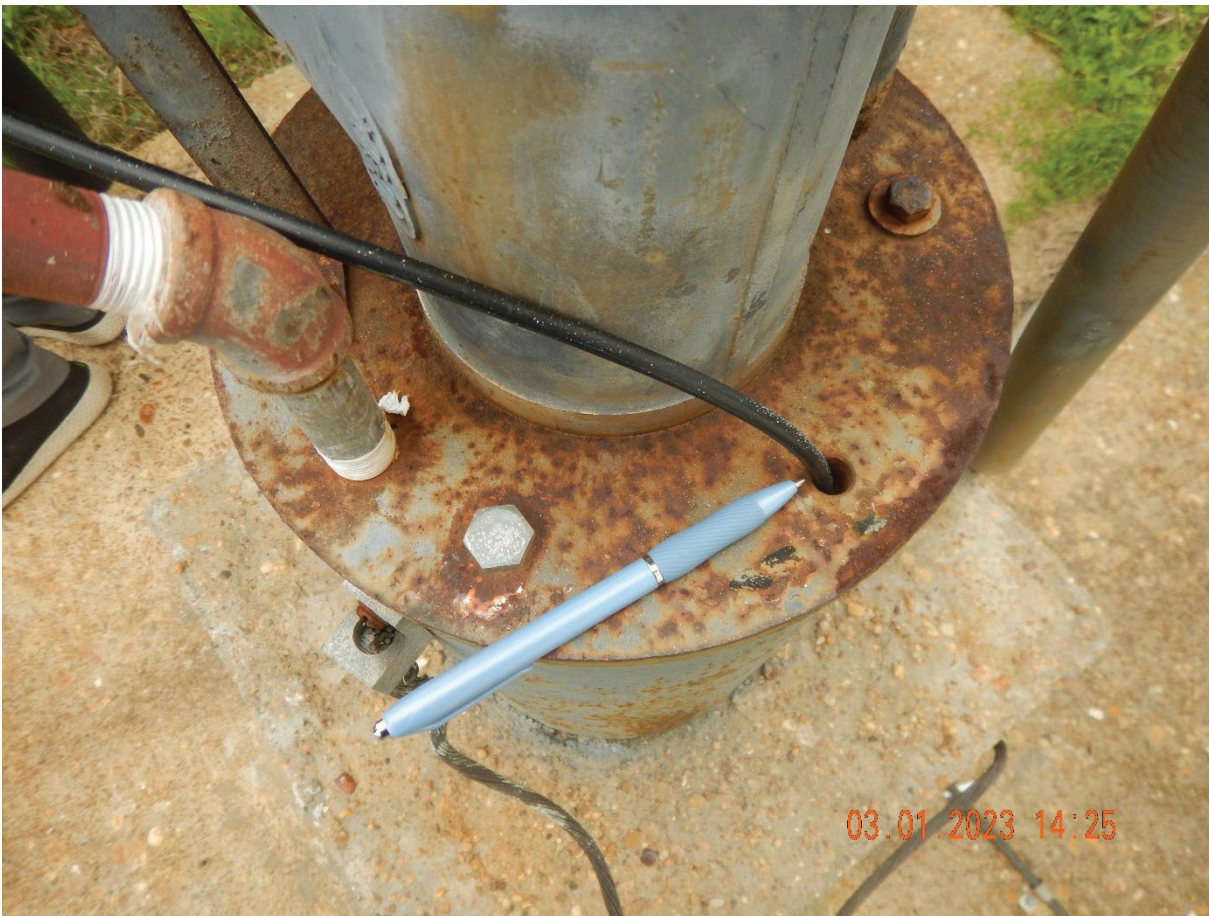
Photo No. 17

- The electrical conduit into the well was open which could be a potential path for contamination
- The overflow had significant corrosion throughout the pipe. Very significant corrosion was seen at the top of the pipe and at the outflow with numerous dead bugs in the pipe. The seal was not air/water tight since bugs were able to access the inside of the pipe.
- The exhaust fan in the chlorine room was blowing air into the room instead of pushing air out as designed. This would not clear out a potential chlorine leak
- Recording maintenance information directly onto a pump is easily lost through pump maintenance such as painting
- We were unable to determine if the secondary containment of the single walled chemical tank was sufficient
- The key in the door of the chemical room is a security concern since it has been left in the door long term

Description: Electrical conduit on well open to casing

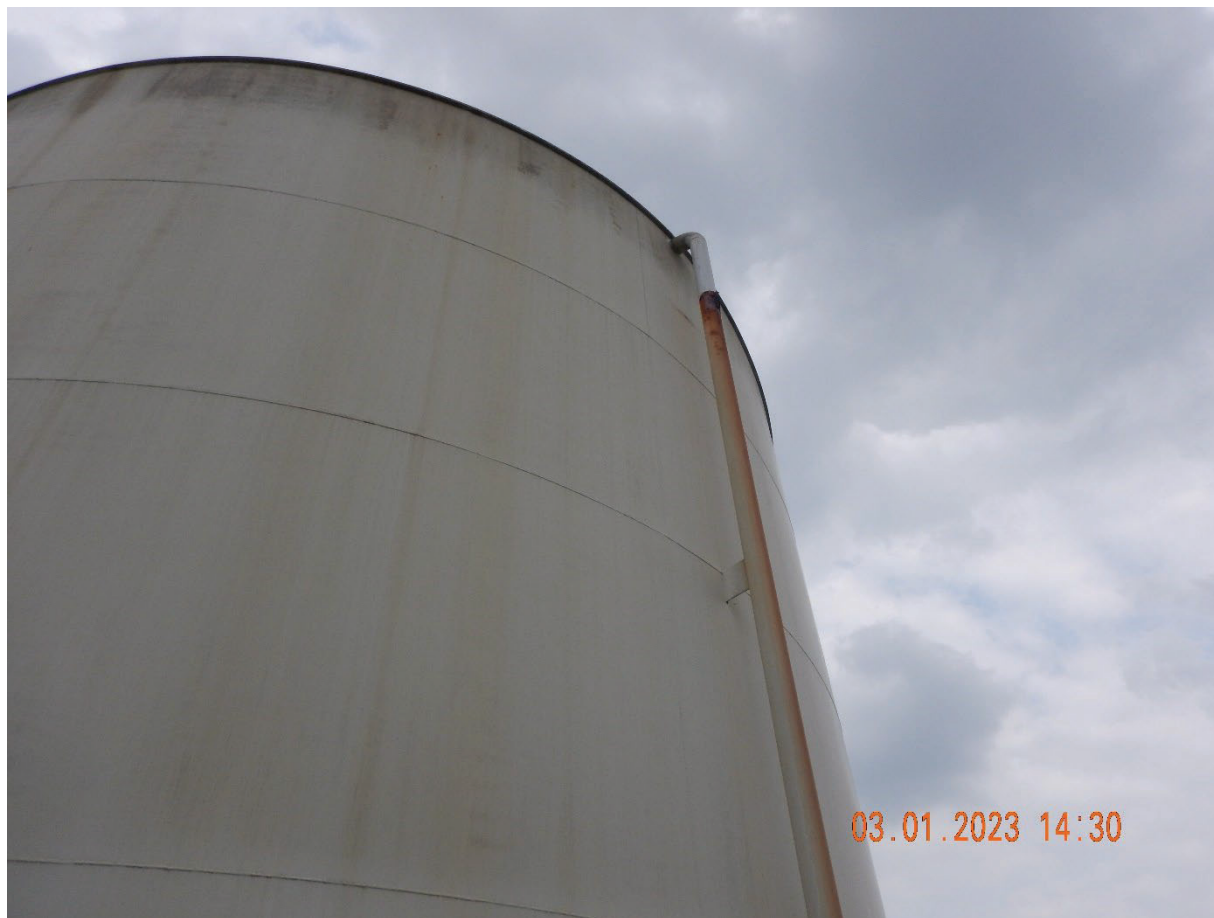
Photo No. 18

Description: Corrosion at top of overflow pipe

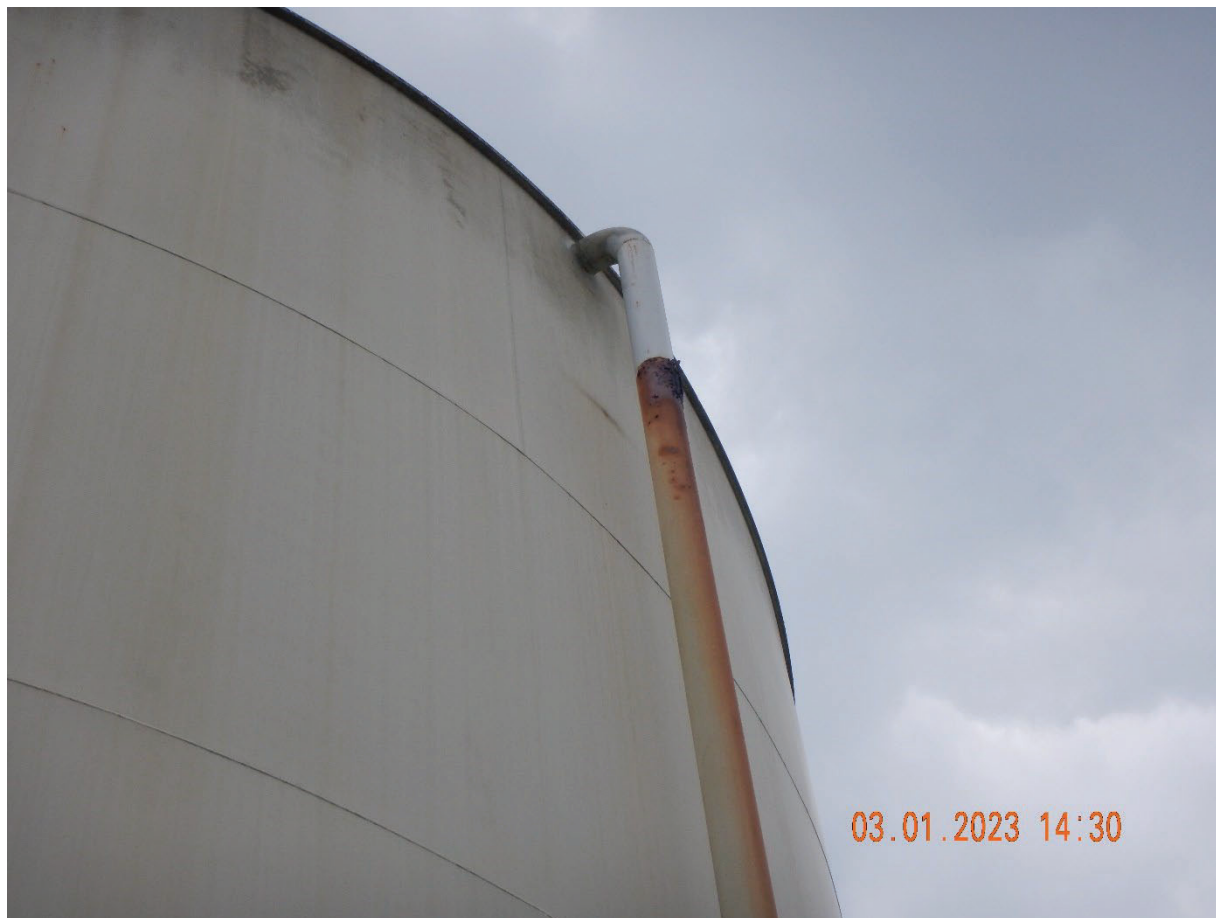
Photo No. 19

Description: Corrosion of overflow pipe

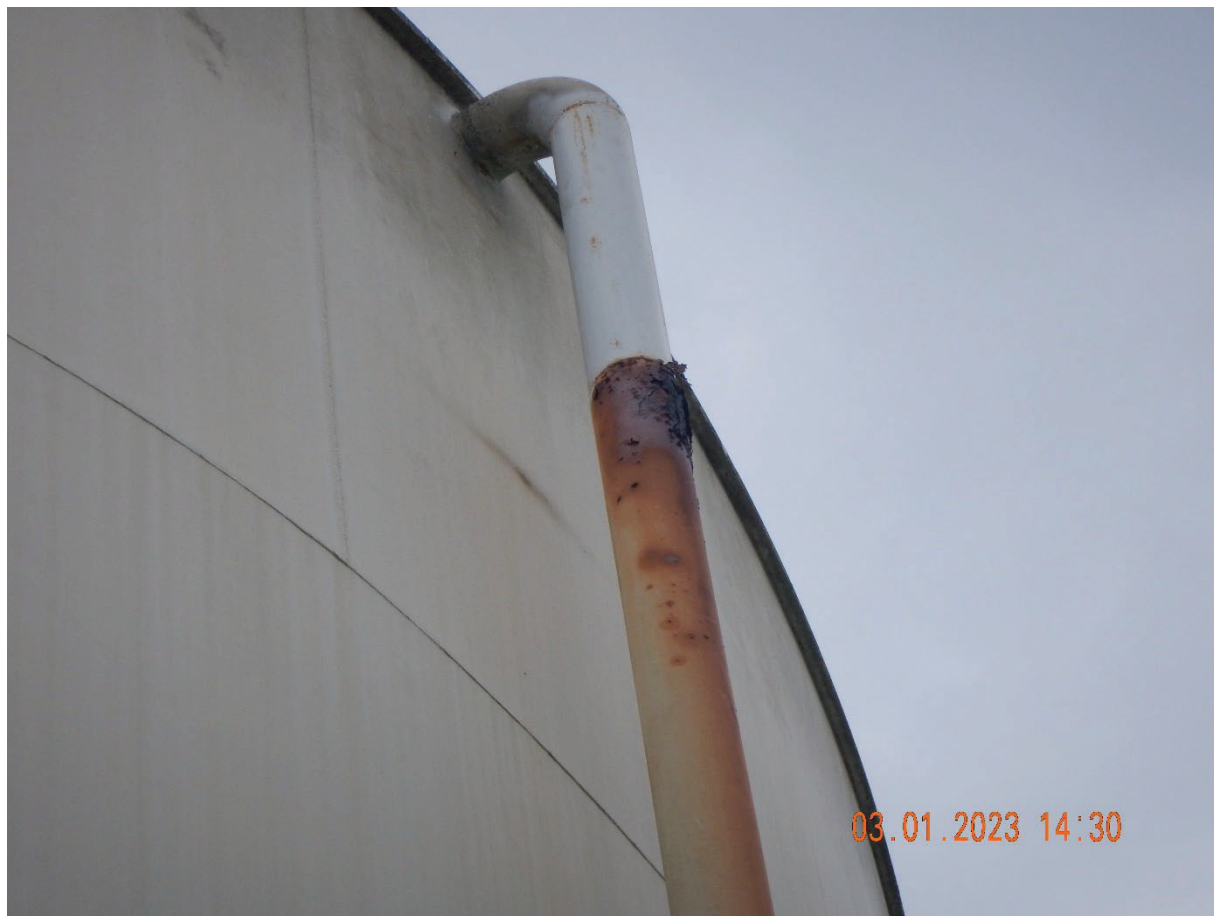
Photo No. 20

Description: Zoomed in view of corrosion at top of overflow pipe
