**Region 6 - Enforcement & Compliance Assurance Division**  
**INSPECTION REPORT**

| Inspection Date(s): | 03/1/2023 | |
| Company Name: | <b>D &amp; M Water Supply Corporation (WSC)</b> | |
| Facility Name: | <b>D &amp; M WSC</b> | |

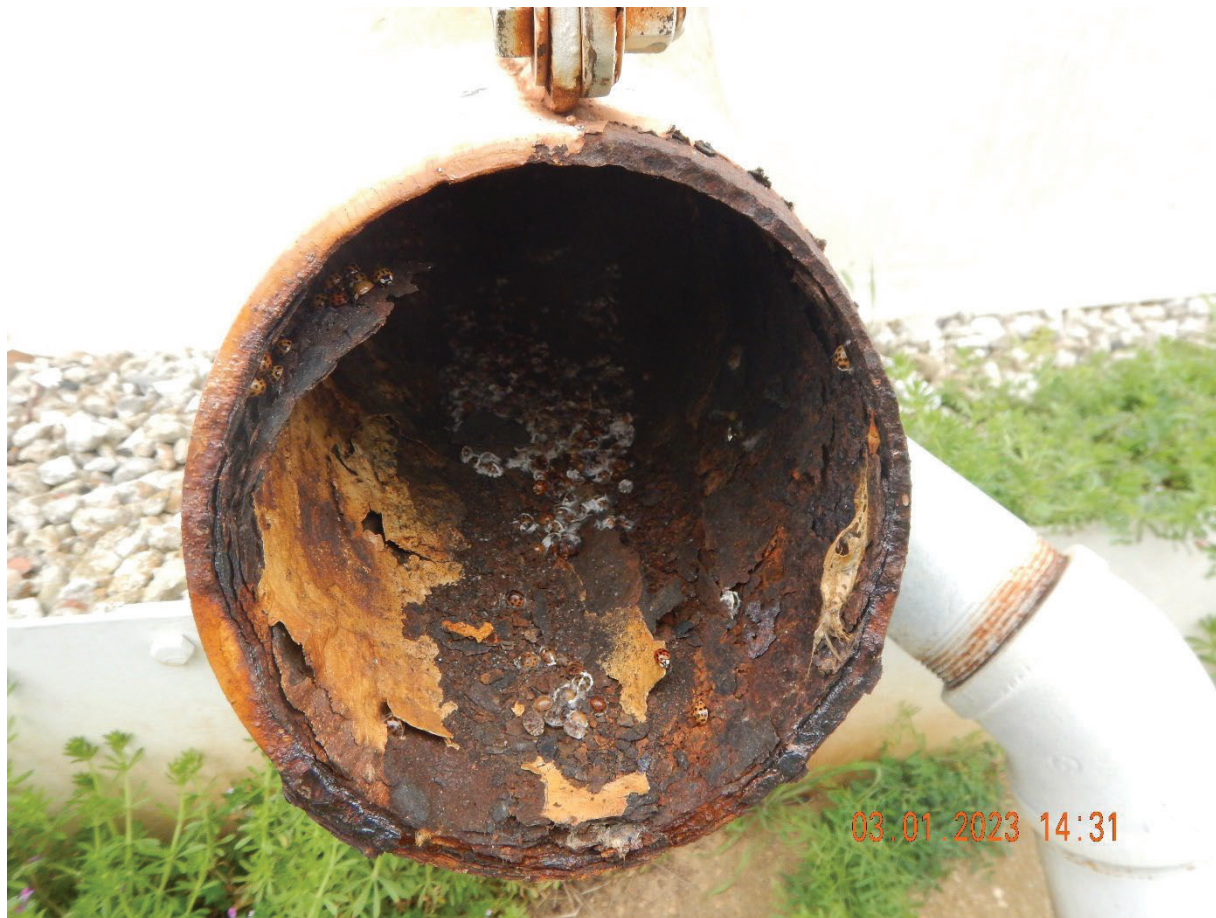
Photo No. 21

- We observed a large amount of corrosion at the base of the overflow for the ground storage tank. There were also many dead bugs in the overflow indicating the seal is not air tight (Photos 21-24)

- The electrical conduit into the well was open which could be a potential path for contamination
- The overflow had significant corrosion throughout the pipe. Very significant corrosion was seen at the top of the pipe and at the outflow with numerous dead bugs in the pipe. The seal was not air/water tight since bugs were able to access the inside of the pipe.
- The exhaust fan in the chlorine room was blowing air into the room instead of pushing air out as designed. This would not clear out a potential chlorine leak
- Recording maintenance information directly onto a pump is easily lost through pump maintenance such as painting
- We were unable to determine if the secondary containment of the single walled chemical tank was sufficient
- The key in the door of the chemical room is a security concern since it has been left in the door long term

Description: Paint peeling, rust, and biological matter seen inside overflow pipe or ground storage tank

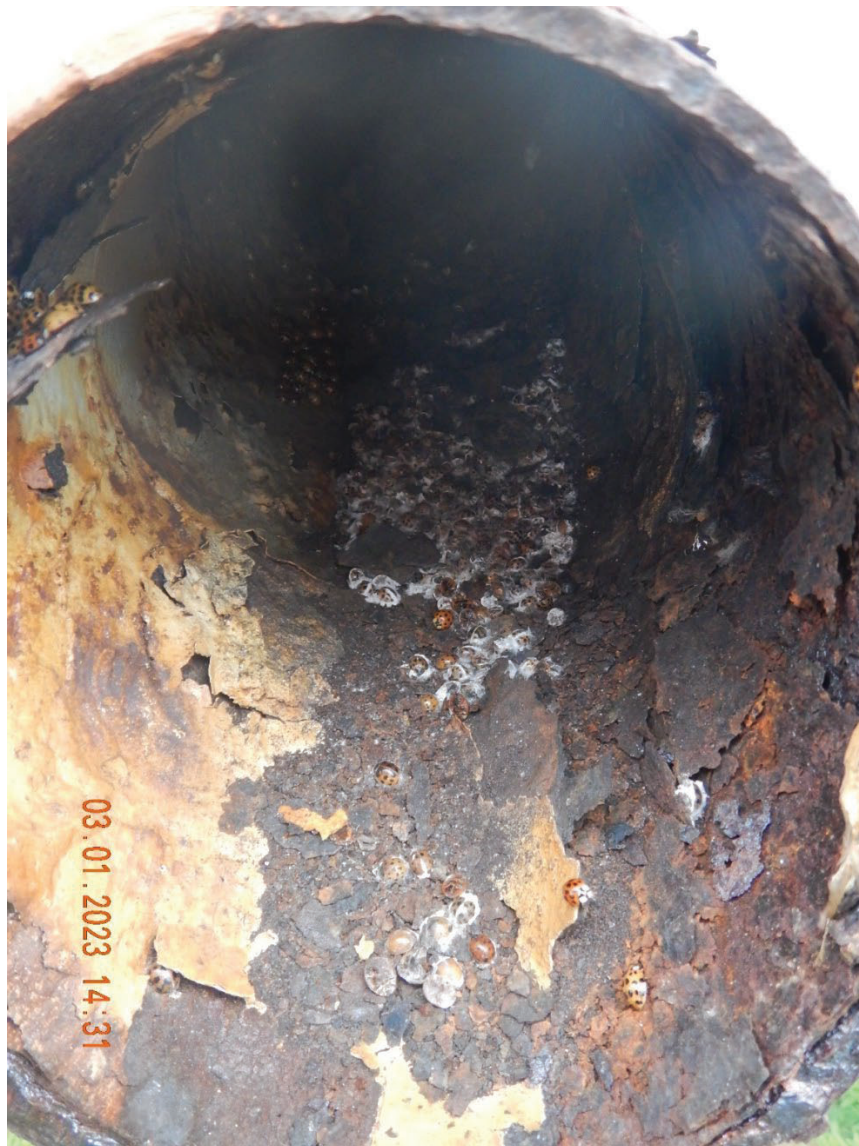
Photo No. 22

Description: Paint peeling, rust, and biological matter seen inside overflow pipe or ground storage tank

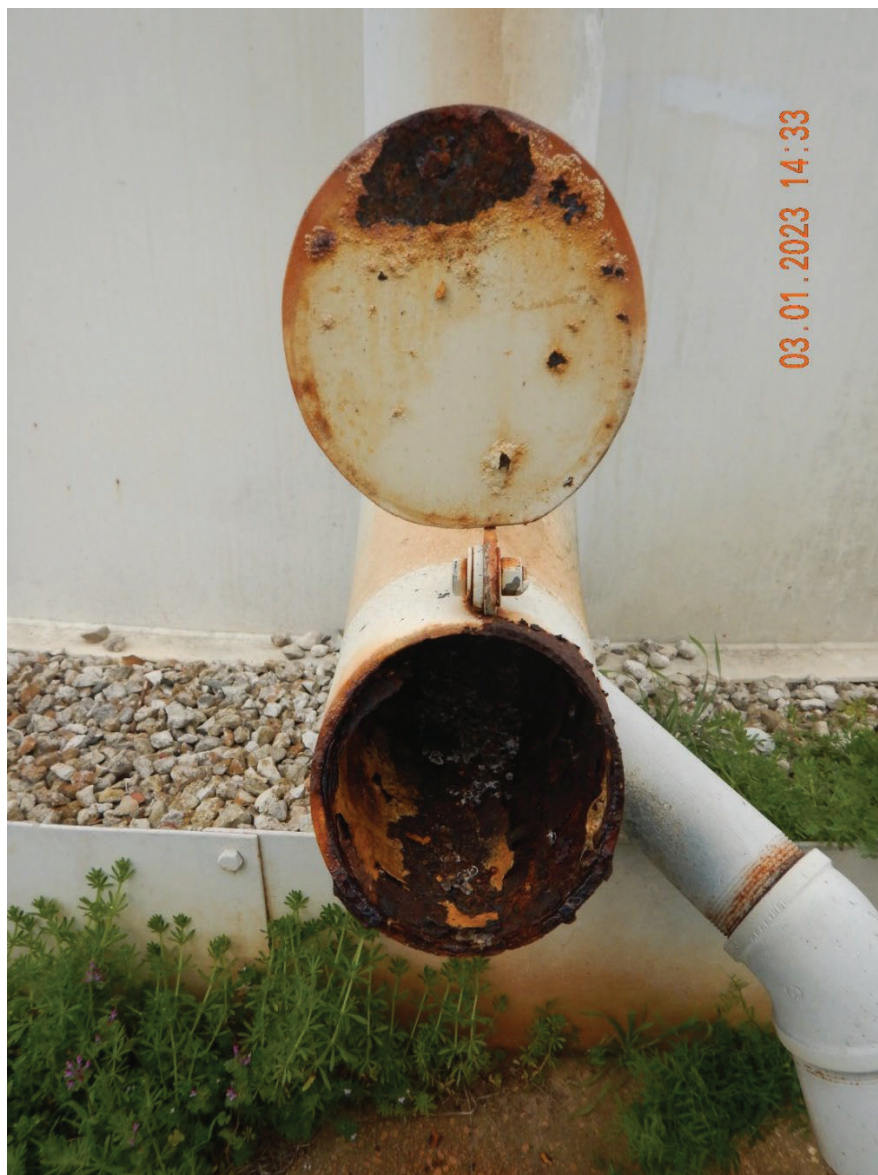
Photo No. 23

Description: Rust on lid of overflow on ground storage tank

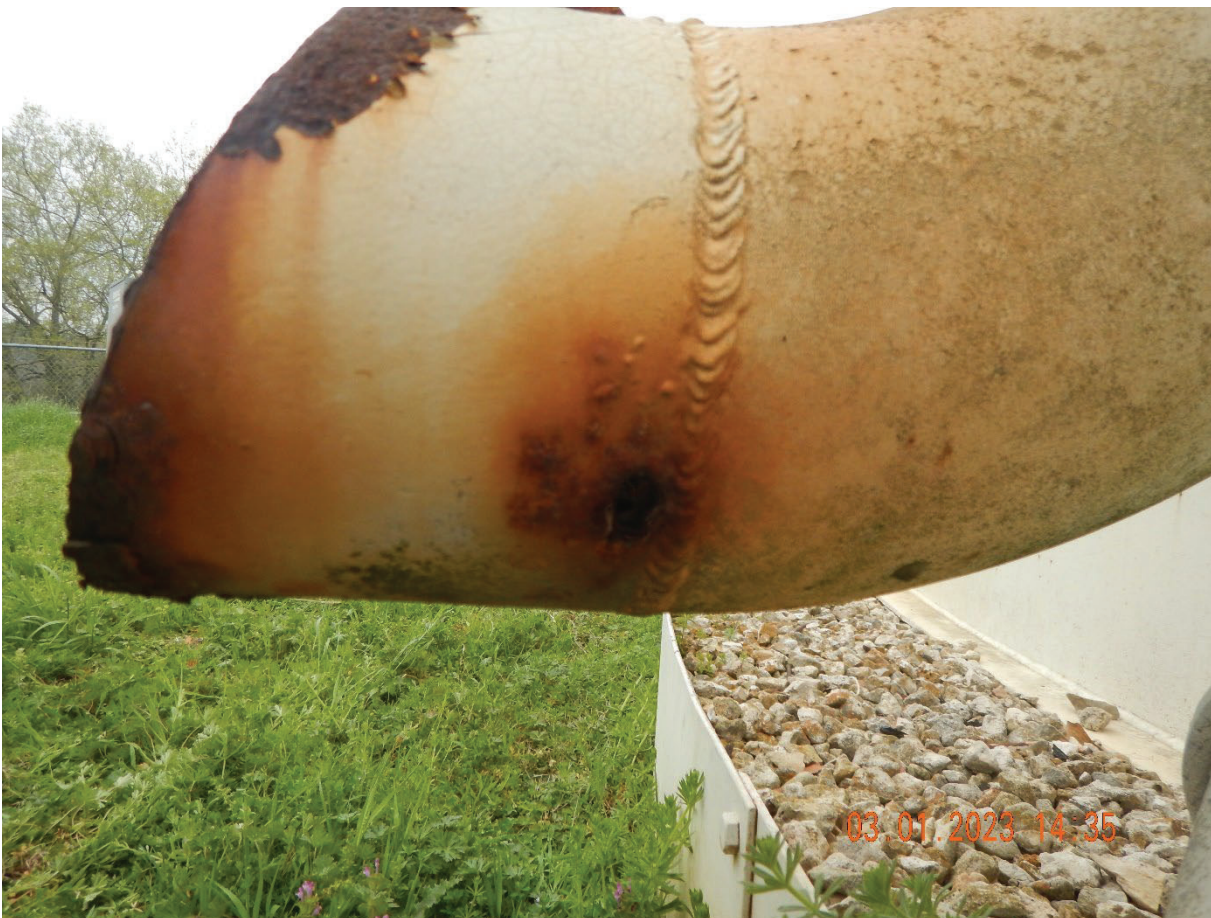
Photo No. 24

Description: Hole seen on underside of overflow pipe on ground storage tank

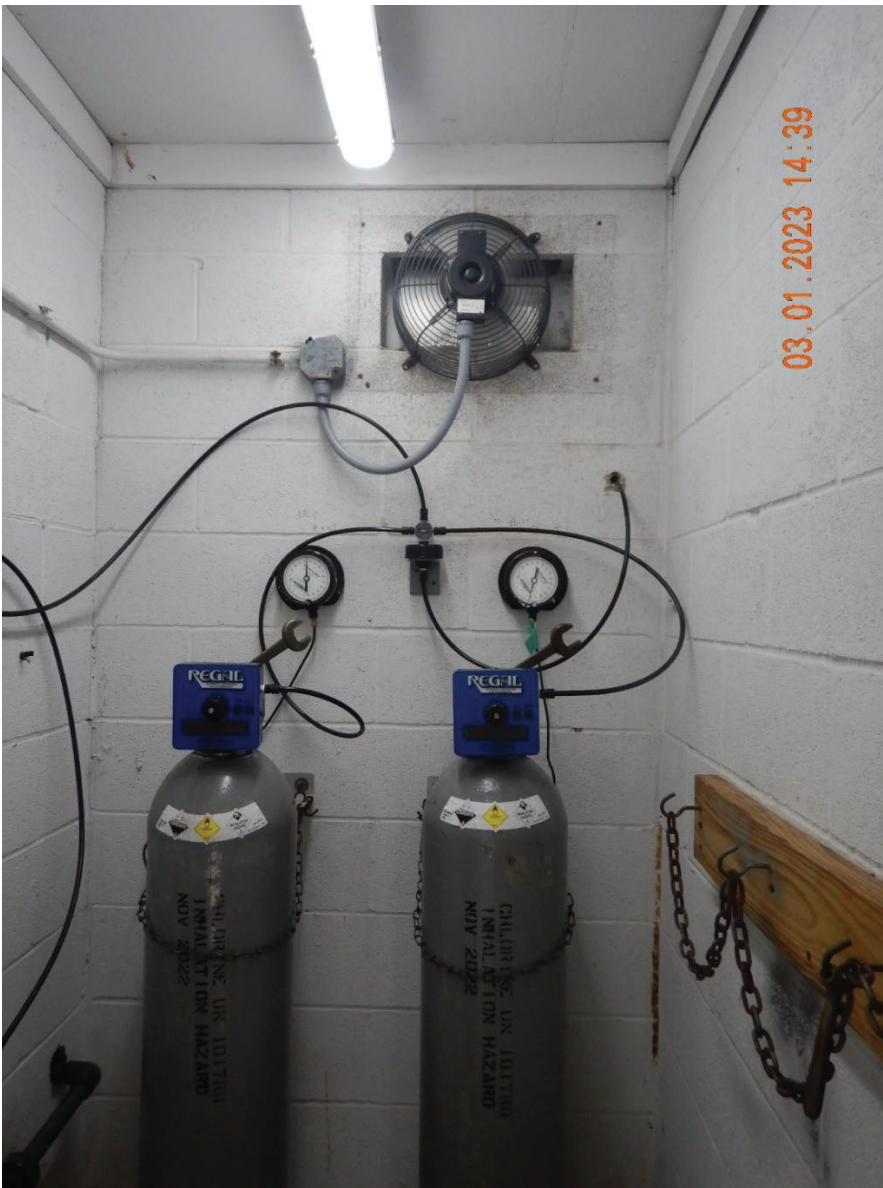
Photo No. 25

- We observed the fan in the chlorine room pulling air into the chlorine room (Photo 25)
- We observed operation and maintenance information written directly on pump (Photo 26)

Description: Exhaust fan in chlorine room

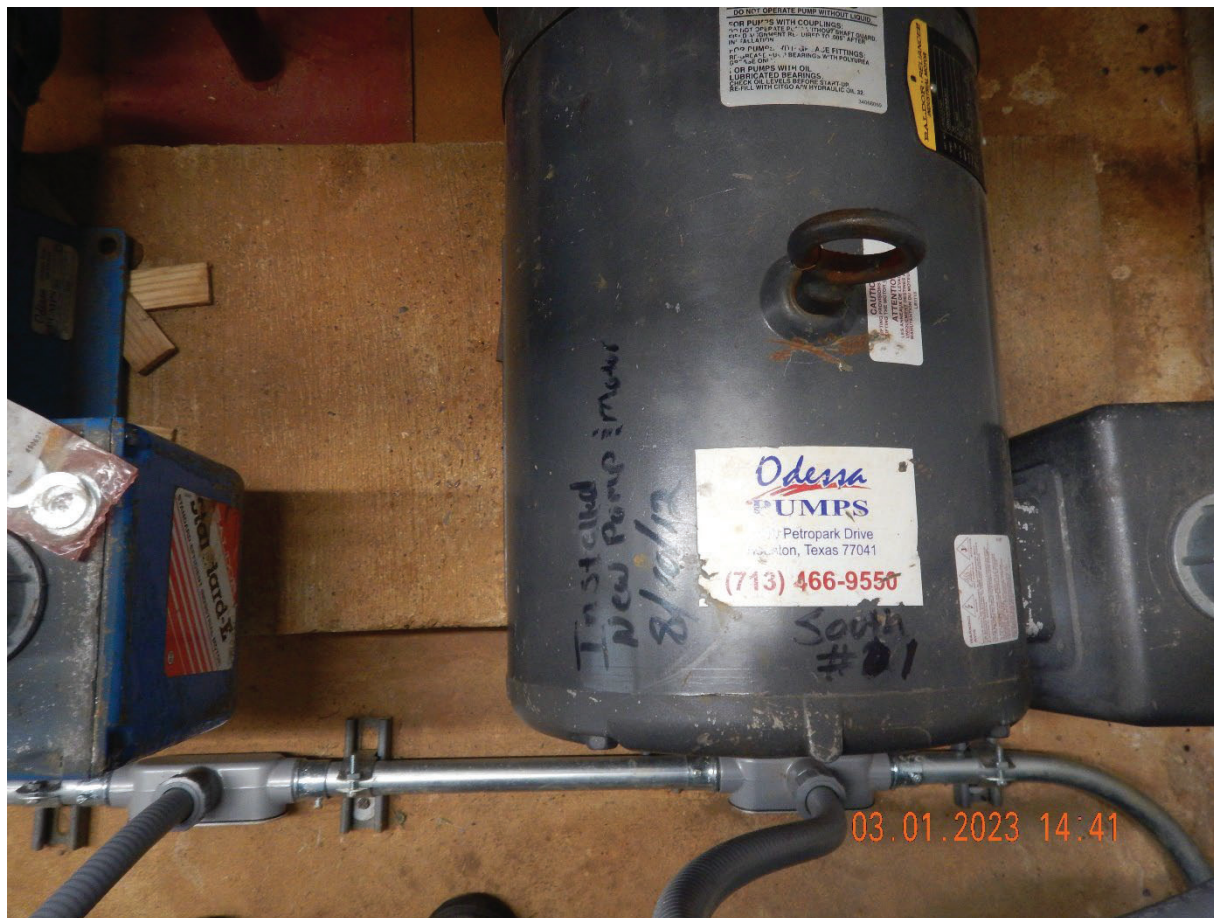
Photo No. 26

Description: Maintenance records on paint of pump

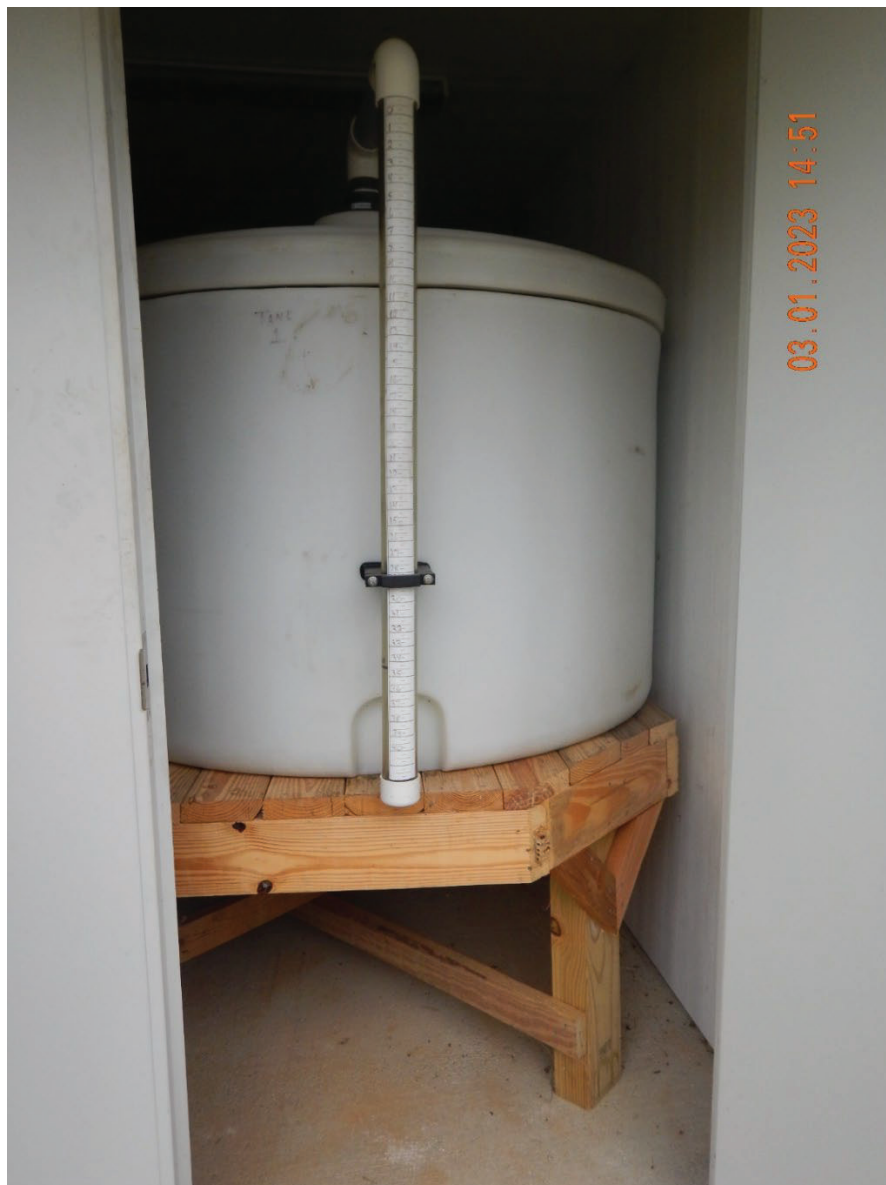
Photo No. 27

- We observed a double wall storage tank in the chemical storage room on an elevated platform (Photo 27)
- We observed a large tank in secondary containment but volume of secondary containment unknown (Photo 29)

Description: Double walled storage tank

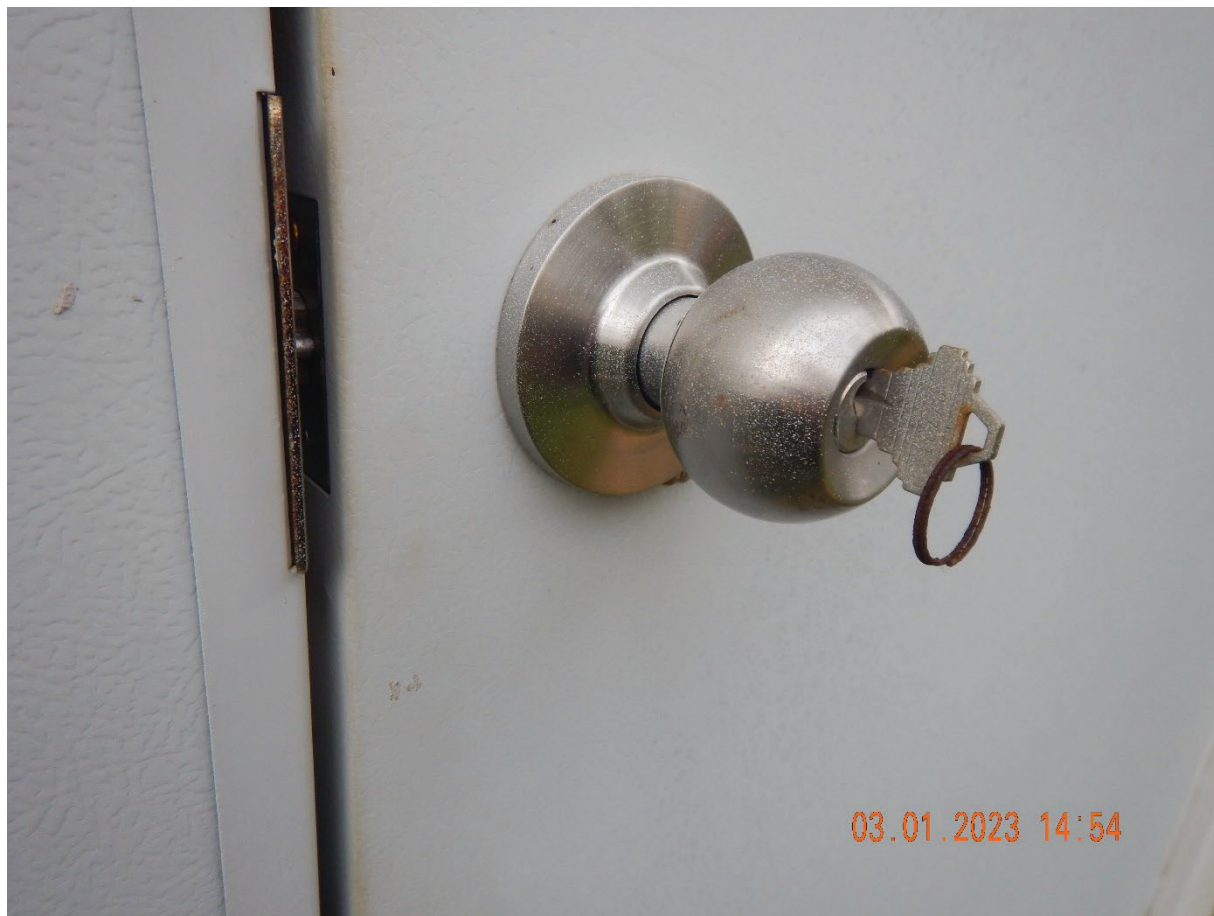
Photo No. 28

- We observed a key in the door of the chemical storage room that had been painted and rusted into the lock (Photo 28)

Description: Key permanently located in chemical storage room

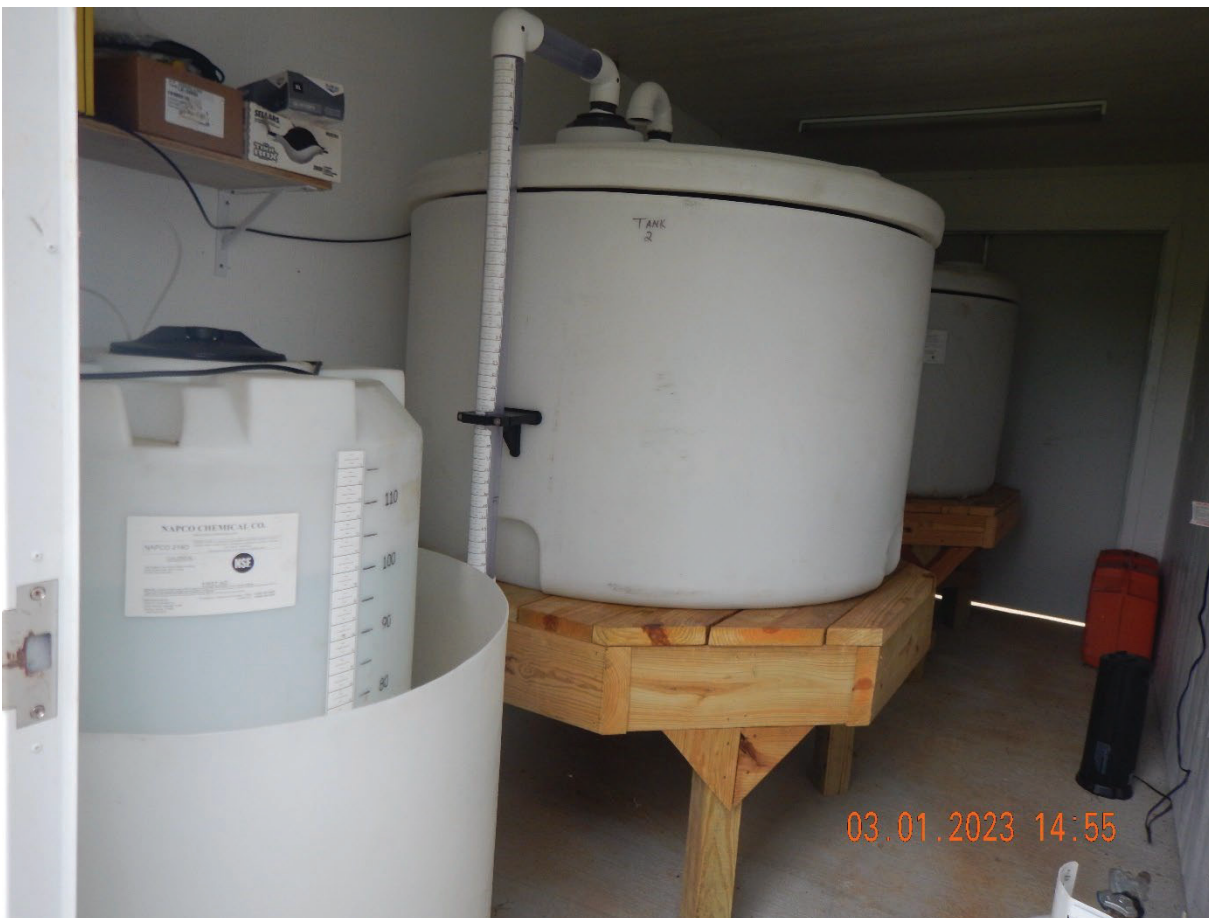
Photo No. 29

Description: Secondary containment in chemical room
