**Region 6 - Enforcement & Compliance Assurance Division**  
**INSPECTION REPORT**

| Inspection Date(s): | 03/12/2024 | |
| Company Name: | <b>Jerry Langley Oil Company, LLC</b> | |
| Facility Name: | <b>T.D. Murphy SWD Tank and T.D. Murphy Tank Battery</b> | |

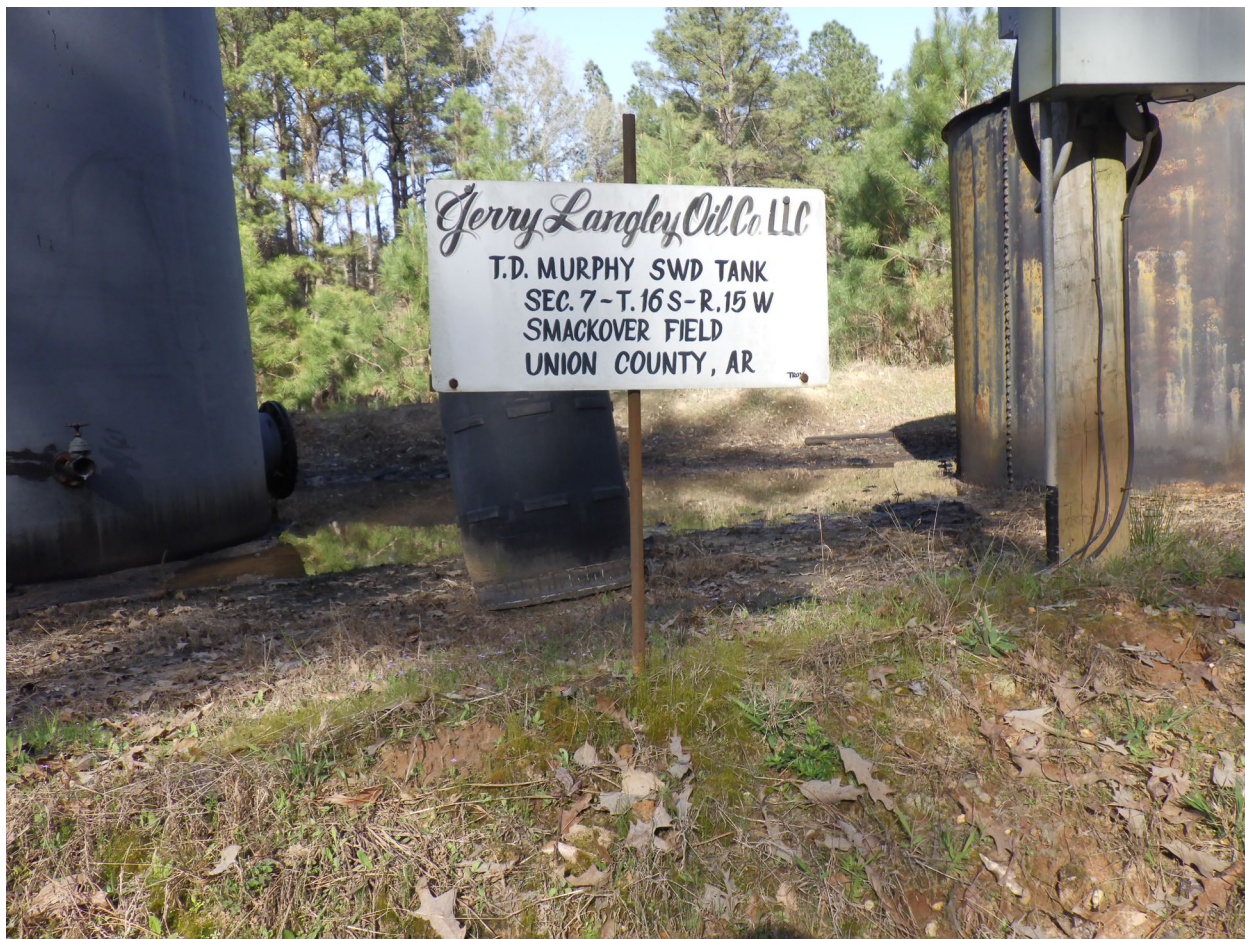
Photo No. 1

I observed the facility sign, secondary containment, pipes, valves, and tanks located at the facility; see Appendix 1 (photo log), photo No. 1 and No. 2. For additional GPS location and photo metadata, see Appendix 1.

**Photo File Name:** R0010227**Orientation:** NE**Date of Photo:** 03/12/2024**Time of Photo:** 4:34 PM**Latitude:** 33.34011**Longitude:** -92.68934**Photographer:** Uma Lad**Description:** This photo was taken looking northeast and shows the facility sign at T.D. Murphy SWD Tank.

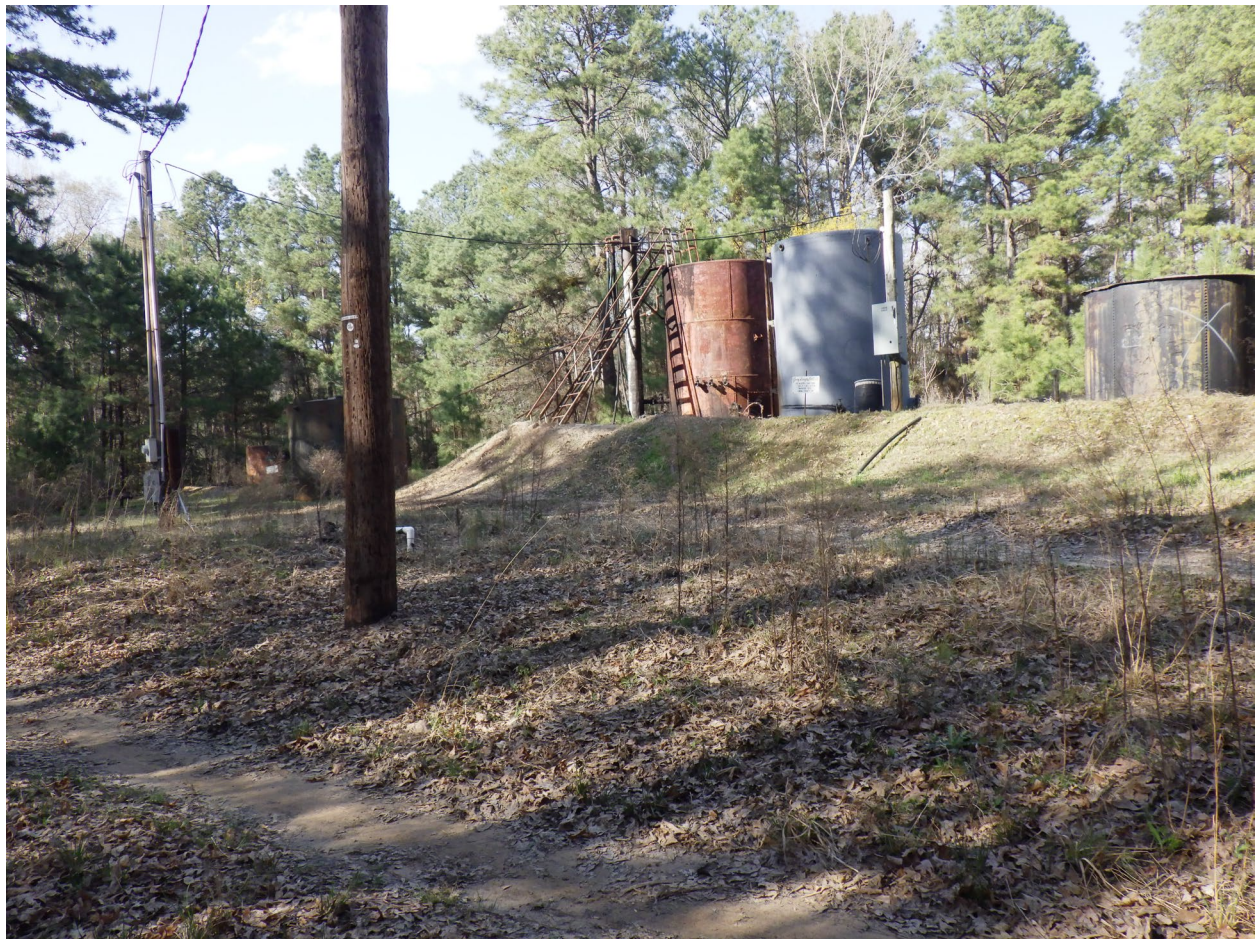
Photo No. 2

**Photo File Name:** R0010228**Orientation:** N**Date of Photo:** 03/12/2024**Time of Photo:** 4:35 PM**Latitude:** 33.33999**Longitude:** -92.68930**Photographer:** Uma Lad**Description:** This photo was taken looking north and shows an overview of the facility.

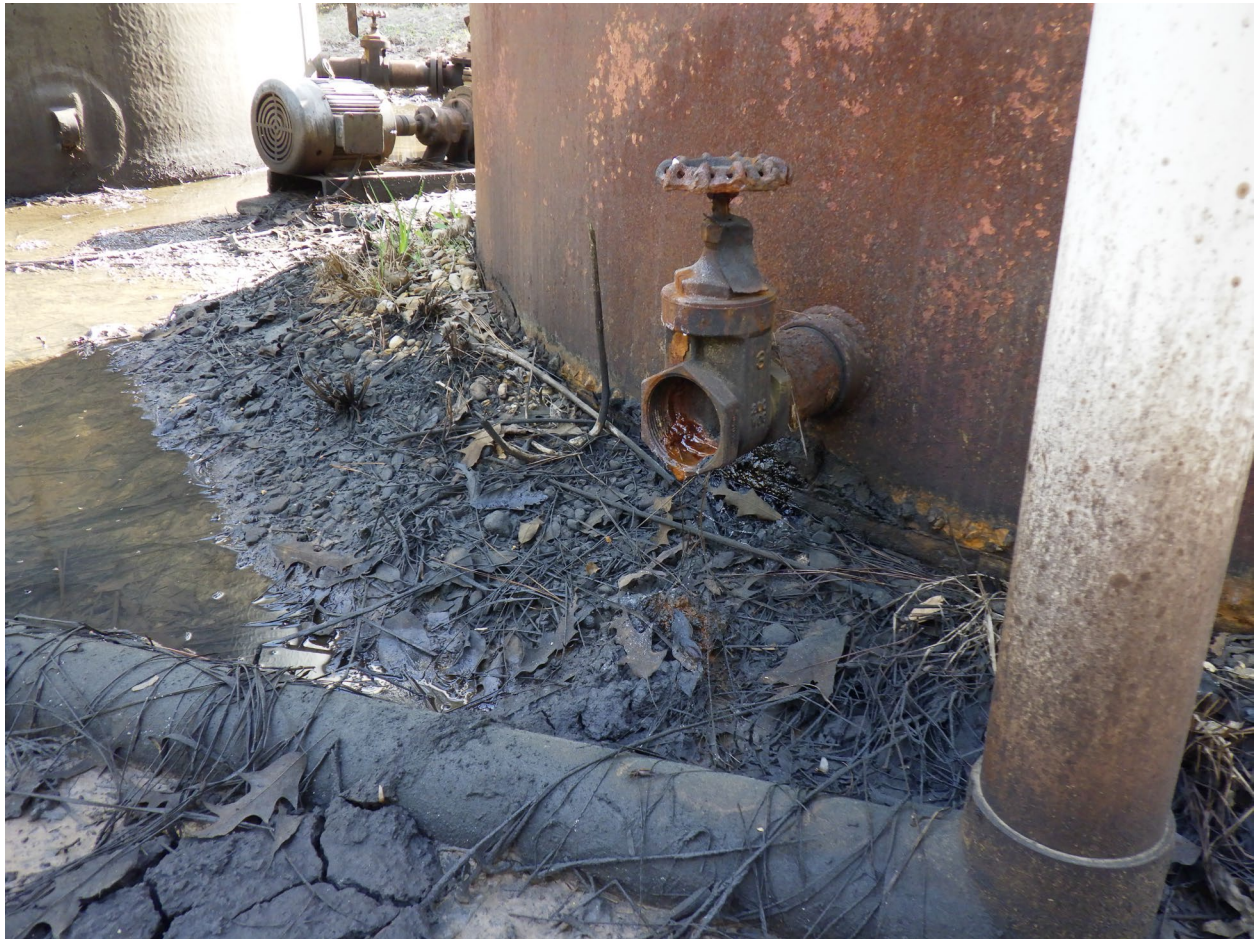
Photo No. 3

I observed a tank with a leaking valve, see photo No. 3.

Areas of concern at the time of the inspection at T.D. Murphy SWD Tank include the leaking valve at the storage tank, missing cap for the secondary containment drainage pipe, and the oil sheen in standing water outside of secondary containment.

**Photo File Name:** R0010231**Orientation:** S**Date of Photo:** 03/12/2024**Time of Photo:** 4:38 PM**Latitude:** 33.34026**Longitude:** -92.68941**Photographer:** Uma Lad**Description:** This photo was taken looking south and shows a leaking valve on a storage tank.

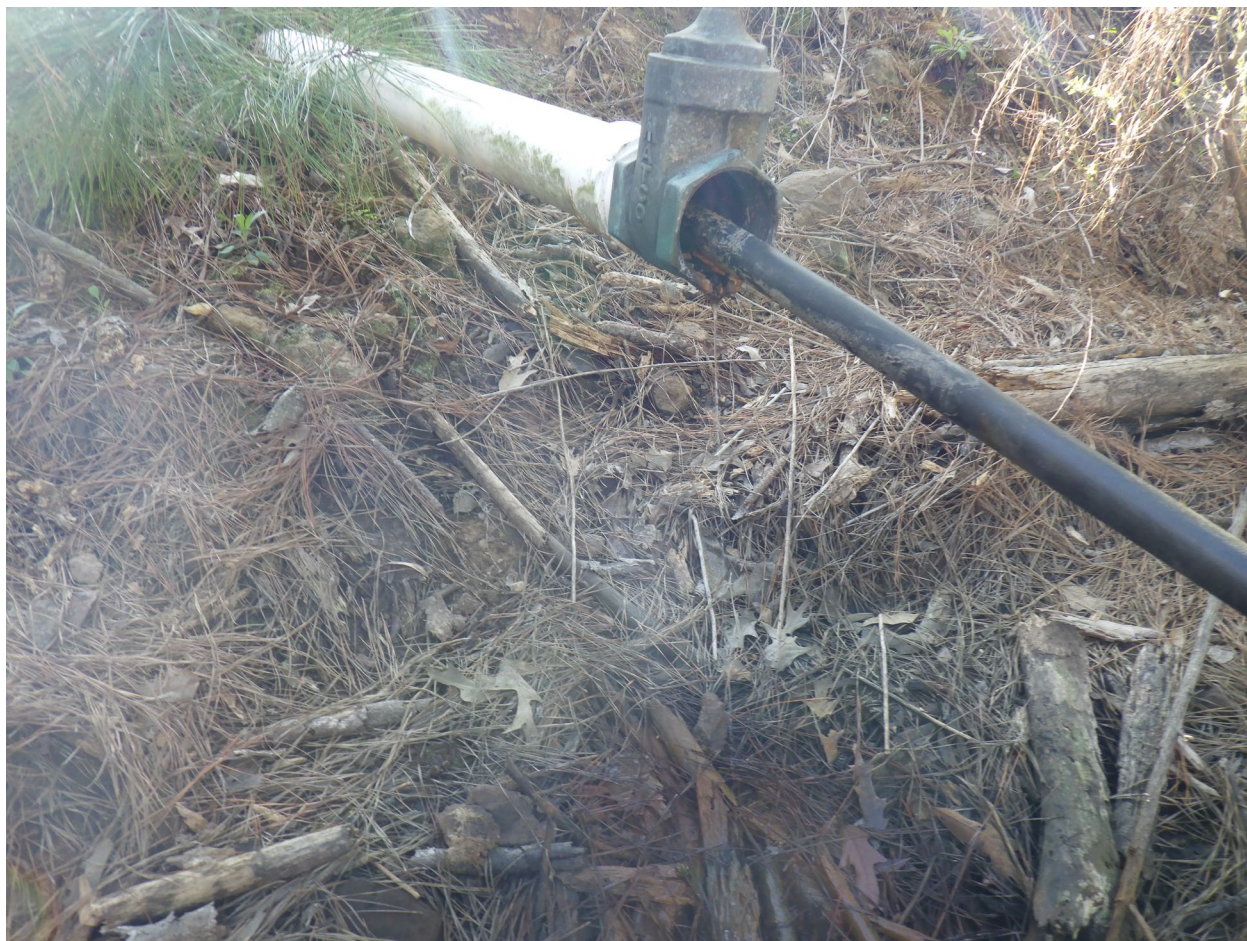
Photo No. 4

I observed an uncapped secondary containment drainage pipe containing a flowline, see photo No. 4. Outside of secondary containment, I observed standing water with an oil sheen, see photo No. 5.

**Photo File Name:** R0010229**Orientation:** W**Date of Photo:** 03/12/2024**Time of Photo:** 4:37 PM**Latitude:** 33.34024**Longitude:** -92.68936**Photographer:** Uma Lad**Description:** This photo was taken looking west and shows an uncapped and open secondary containment discharge pipe containing a flowline.

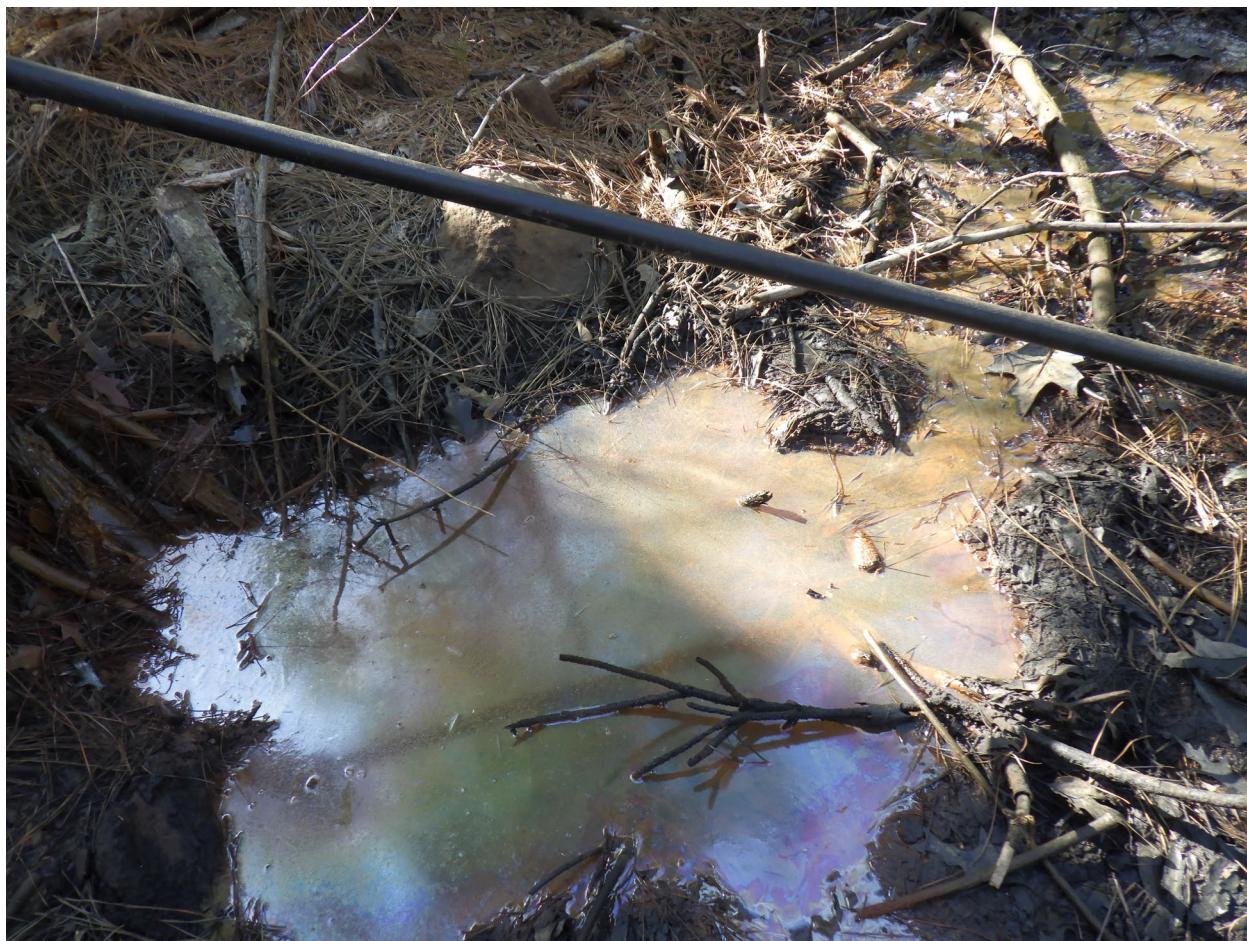
Photo No. 5

**Photo File Name:** R0010230**Orientation:** W**Date of Photo:** 03/12/2024**Time of Photo:** 4:37 PM**Latitude:** 33.34030**Longitude:** -92.68937**Photographer:** Uma Lad**Description:** This photo was taken looking west and shows standing water with an oil sheen below a flowline.

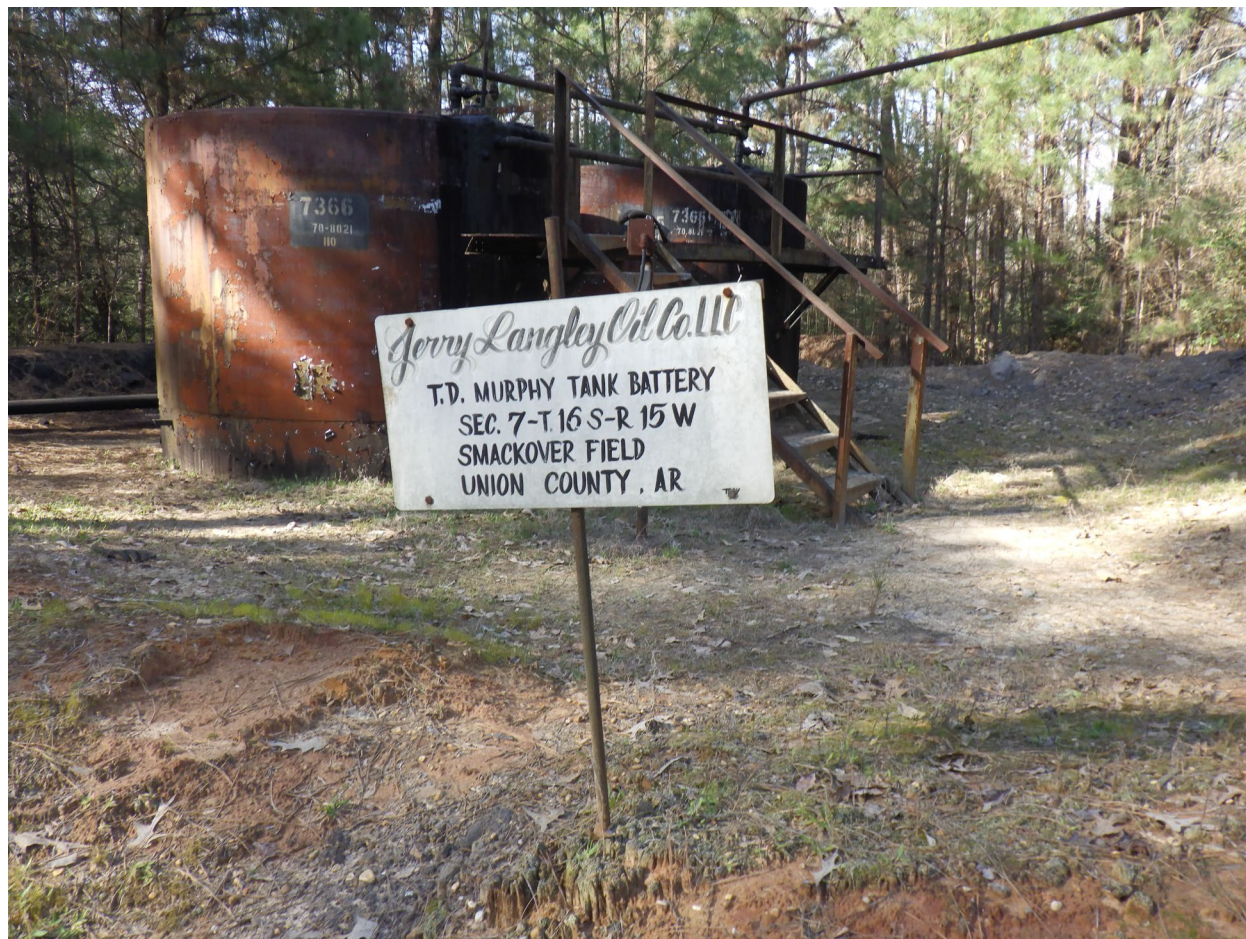
Photo No. 6

I observed the facility sign, secondary containment, pipes, valves, and tanks located at the facility, see photo No. 6.

**Photo File Name:** R0010232**Orientation:** N**Date of Photo:** 03/12/2024**Time of Photo:** 4:39 PM**Latitude:** 33.34033**Longitude:** -92.68953**Photographer:** Uma Lad**Description:** This photo was taken looking north and shows the facility sign at T.D. Murphy Tank Battery.

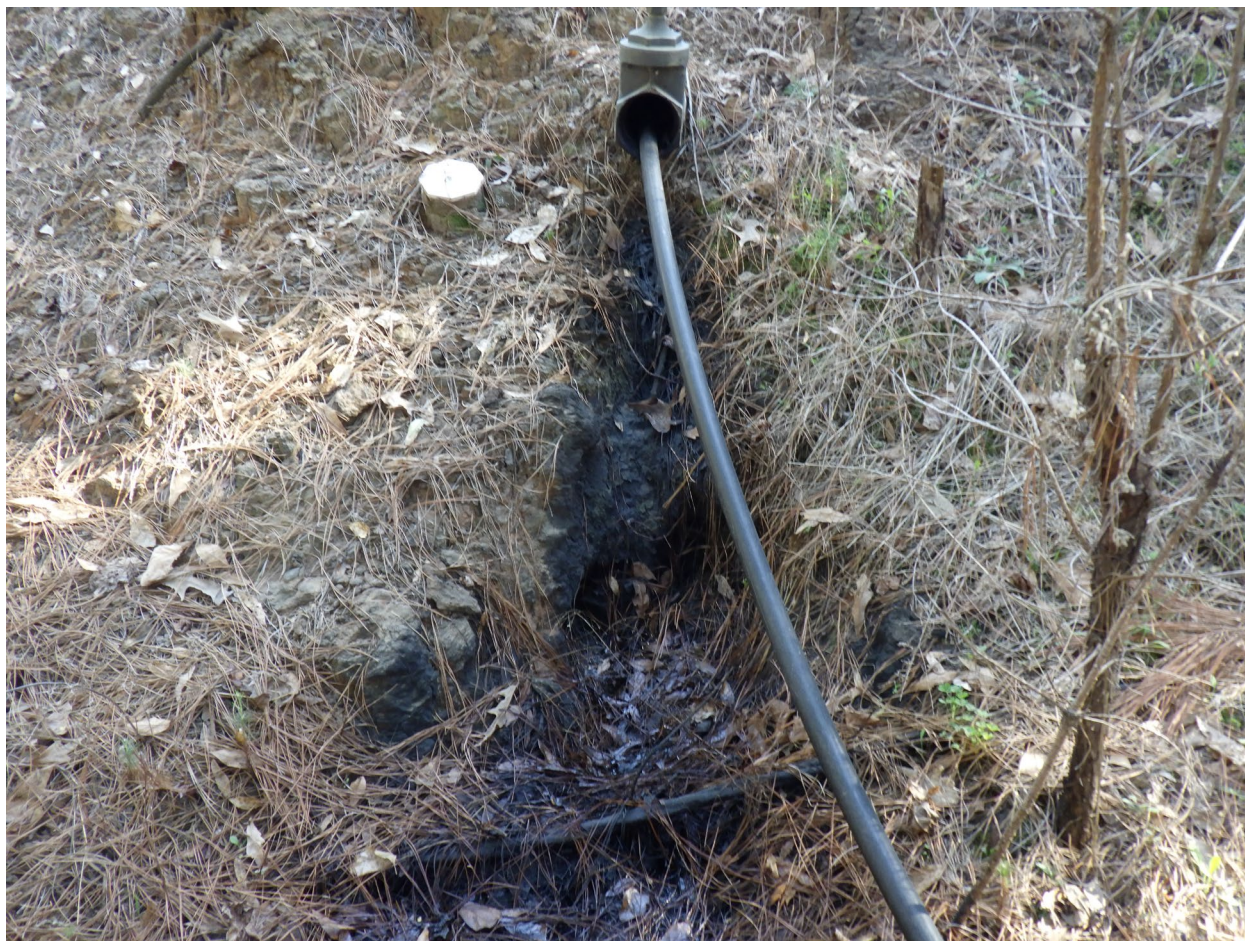
Photo No. 7

I observed an uncapped secondary containment pipe containing a flowline that was surrounded by oil-stained soil, see photo No. 7. I observed oil-stained soil around a transfer valve with no catchment, see photo No. 8.

**Photo File Name:** R0010234**Orientation:** SSE**Date of Photo:** 03/12/2024**Time of Photo:** 4:40 PM**Latitude:** 33.34041**Longitude:** -92.68948**Photographer:** Uma Lad**Description:** This photo was taken looking south-southeast and shows an uncapped and open secondary containment discharge pipe containing a flowline. Oil staining is present below the discharge valve.

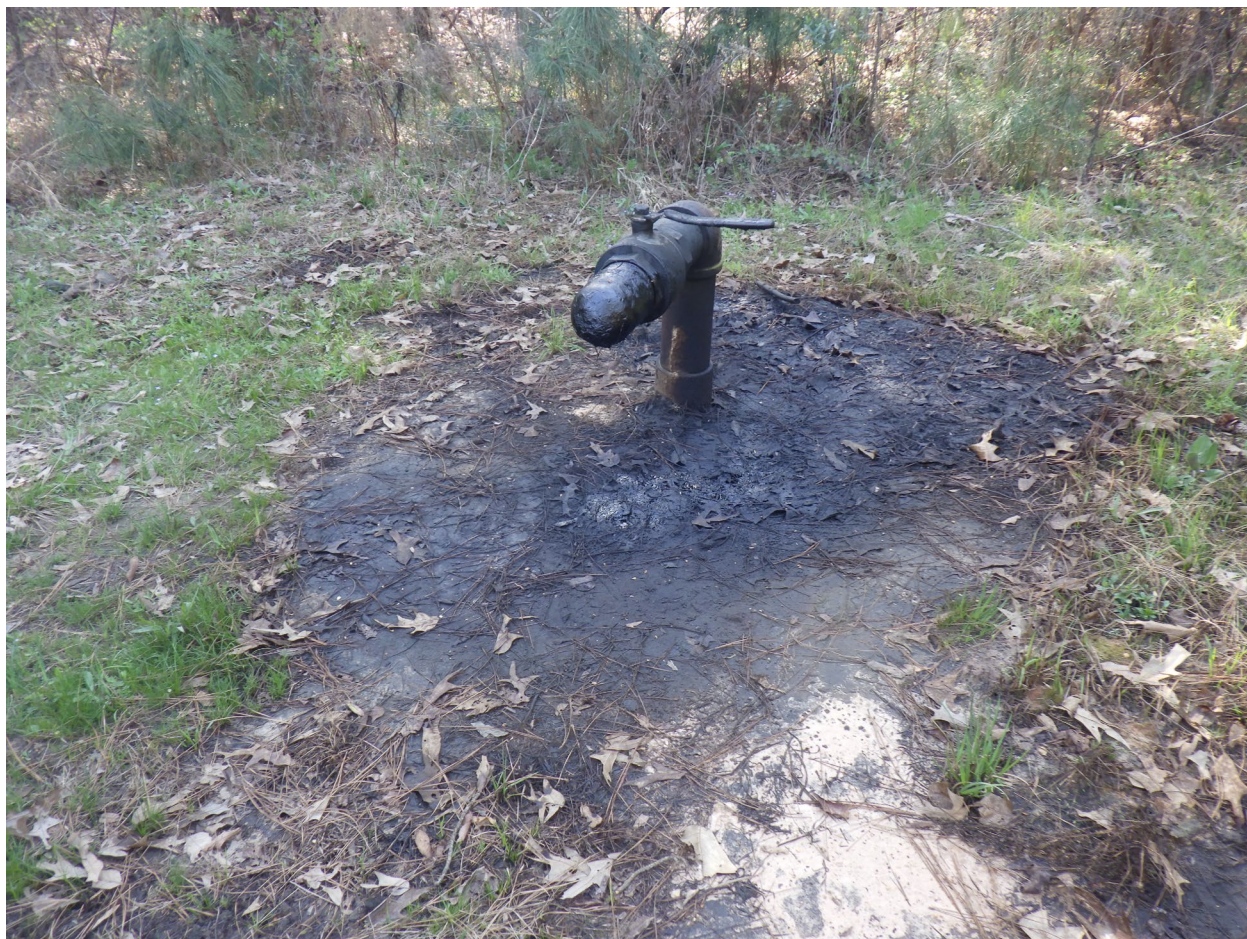
Photo No. 8

**Photo File Name:** R0010235**Orientation:** W**Date of Photo:** 03/12/2024**Time of Photo:** 4:41 PM**Latitude:** 33.34040**Longitude:** -92.68957**Photographer:** Uma Lad**Description:** This photo was taken looking west and shows a transfer pipe with no catchment. Oil-stained soil surrounds the transfer pipe.
