**United States Environmental Protection Agency Region 4**

**Compliance Evaluation Inspection Report**

Copiah County Industrial Park

NPDES Permit No. MS0032921

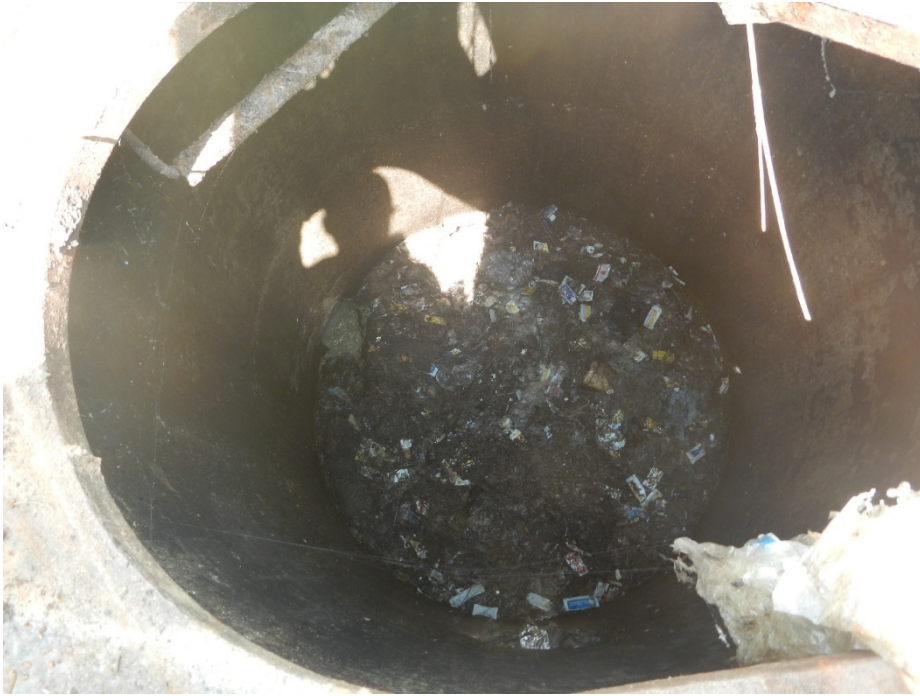
Water enters the facility through an old, now inoperable lift station (Photo 1) which, at the time of inspection, was filled with trash and debris. From the lift station the water is then screened (photo 2). EPA observed inoperable drying beds with plants overgrown (Photo 3), and water bypassed screening. Lime was injected to the water (Photo 4) before it was sent to a new pump station (Photo 5).

*Photo 1: Old Influent lift station. Inoperable and filled with trash and debris.*

- a. The headworks and the old lift station should be cleaned of debris and trash.
- b. The screening device in the headworks should be repaired as soon as possible.
- c. Plant growth on aeration tanks should be removed.
- d. Weirs on aeration tanks should be cleaned.
- e. Sludge should be removed from the chlorine contact basin.
- f. Install measurement gauge on effluent weir for accurate flow measurement and calibrate annually.

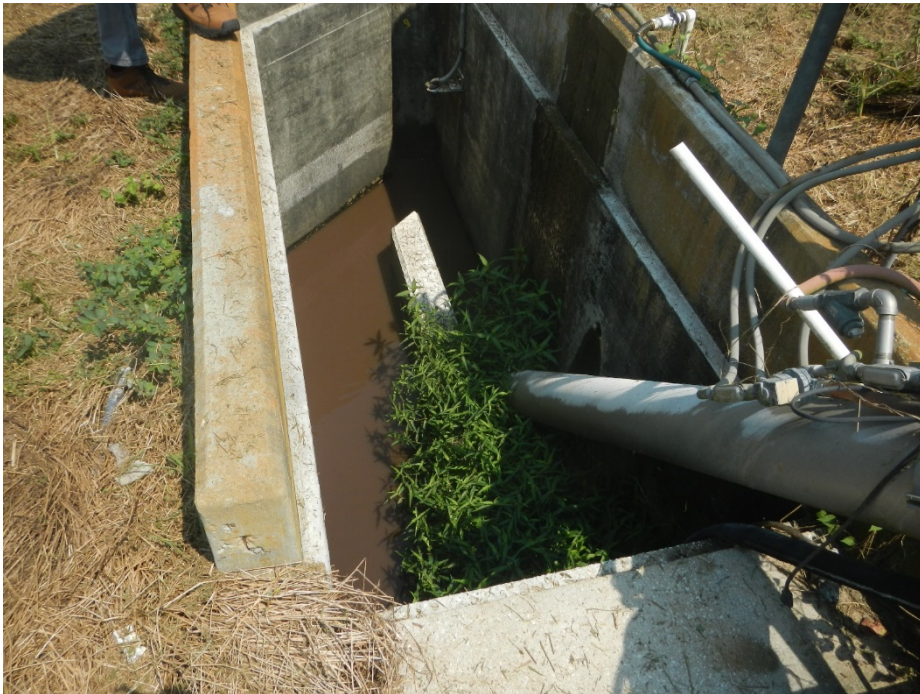
*Photo 2: Facility headworks. Area is overgrown and cleaning mechanism inoperable.*

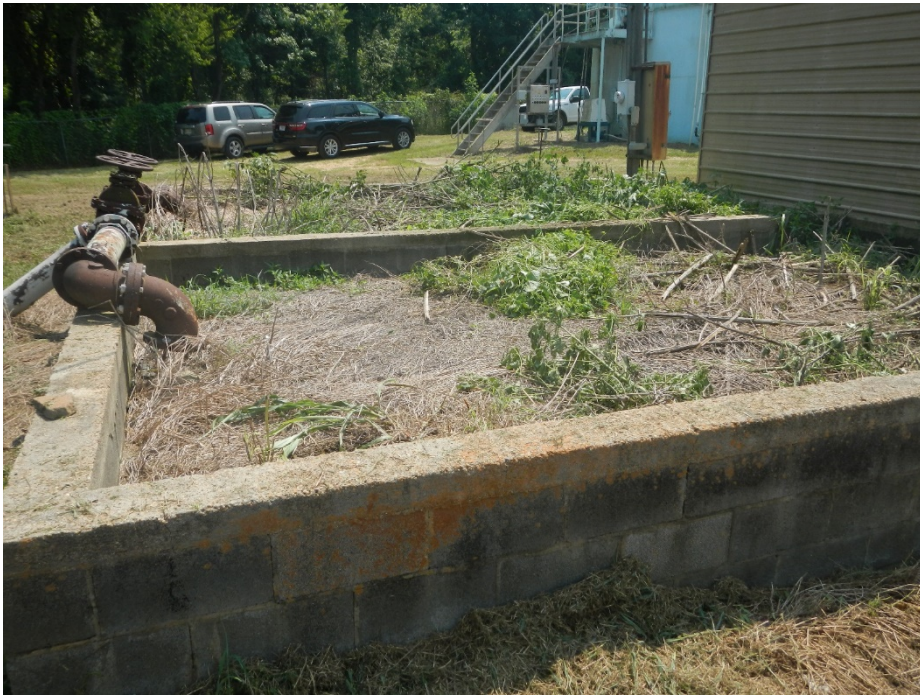
*Photo 3 :Overgrown drying beds.*

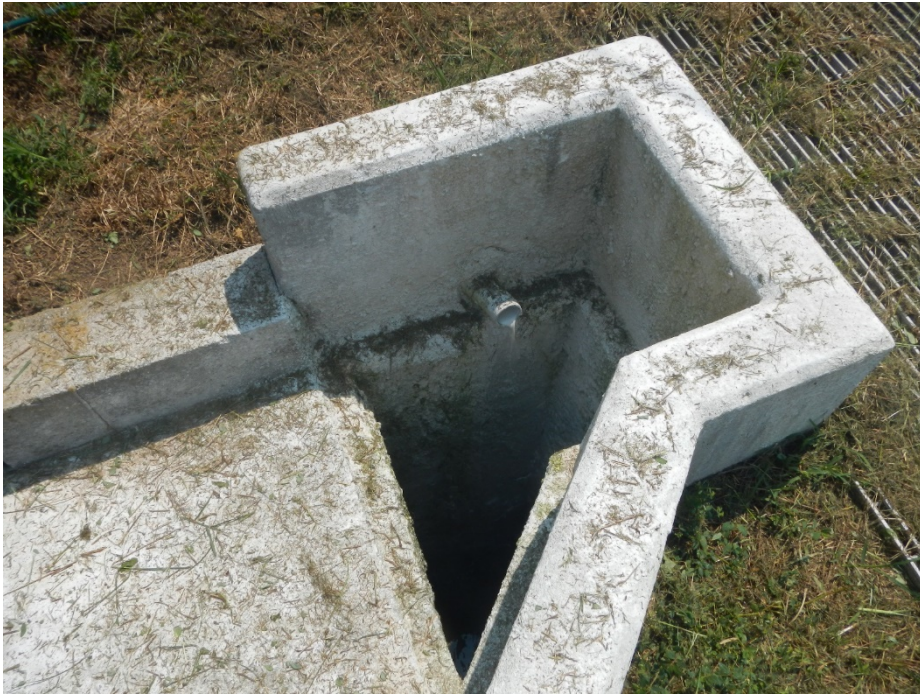
*Photo 4: Lime dosing following headworks.*

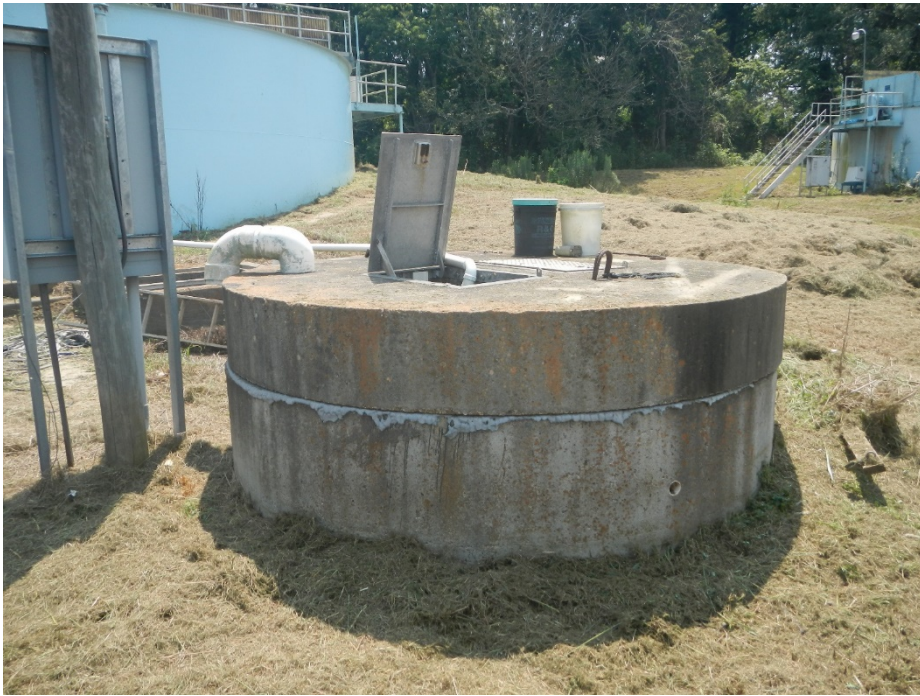
*Photo 5: New pump station.*

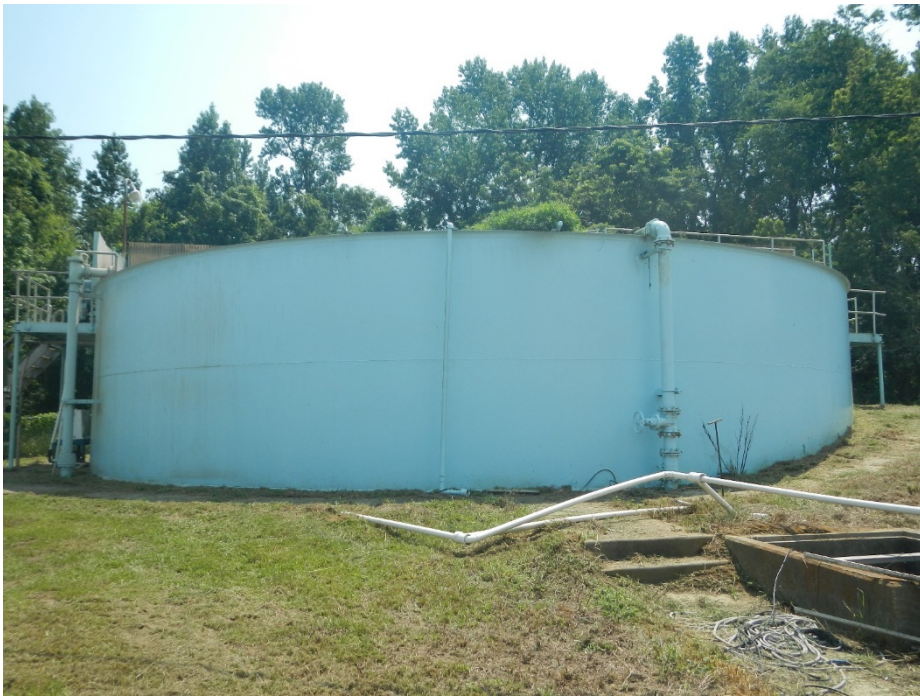
At the time of the inspection, only aeration tank 2 was operational (Photo 6). The aeration tank influent was dark reddish-brown color (Photo 7). The aeration mixer was missing paddles (Photo 8). The secondary clarifier influent had a significant amount of trash and vegetative growth (Photo 9). The clarifiers weirs were overgrown with algae. Maintenance equipment was strewn about the walkway (Photo 10).

*Photo 6: Aeration tank 2 from new pump station.*

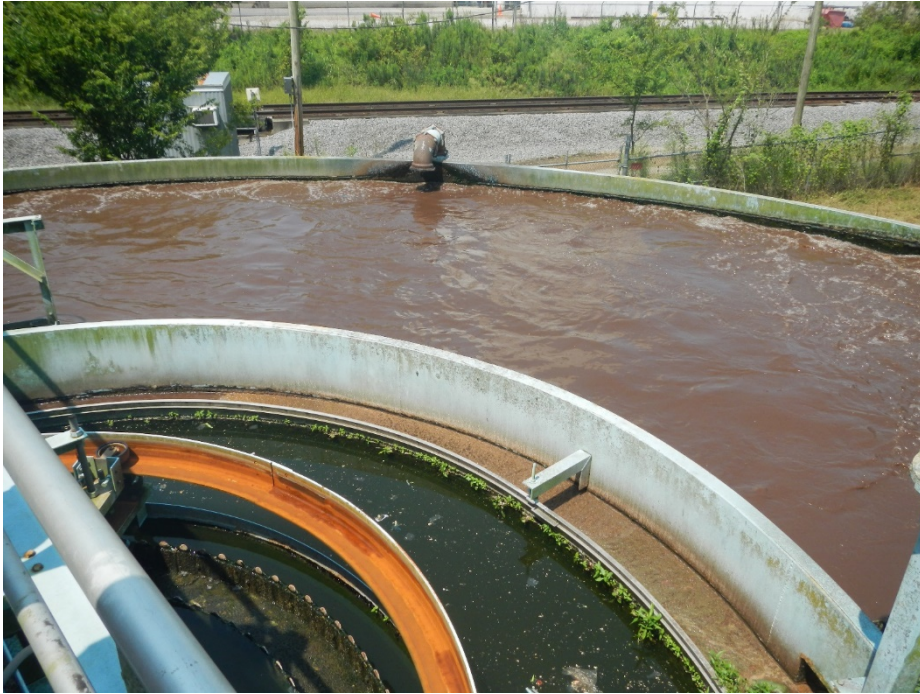
*Photo 7: Influent pipe from pump station to aeration tank 2.*

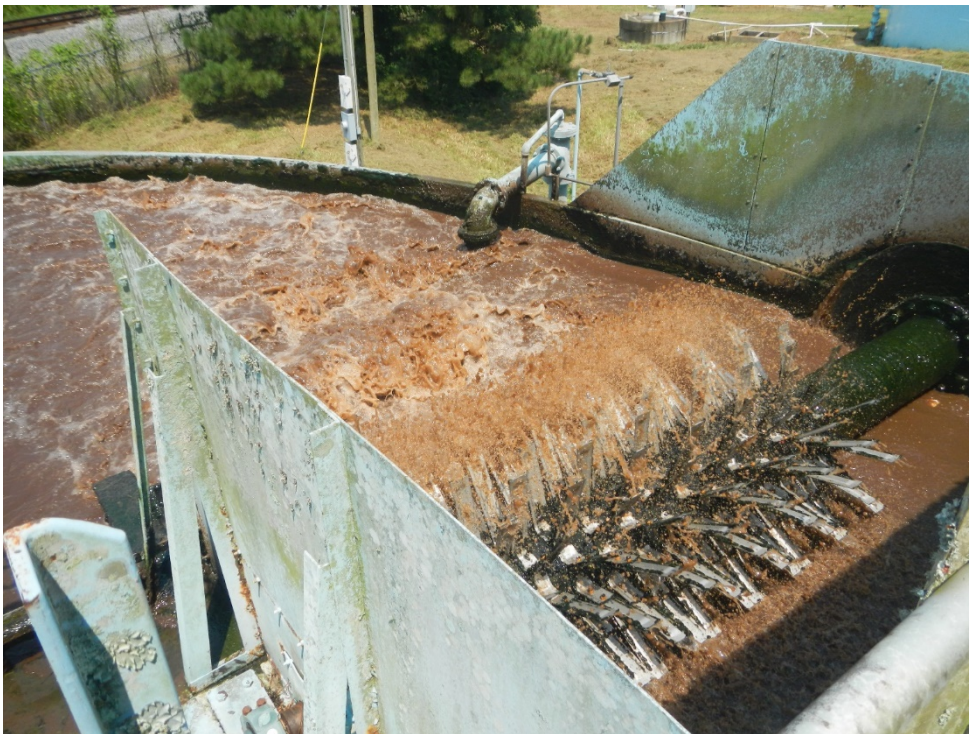
*Photo 8: Aerator in aeration tank 2. Return sludge pipe.*

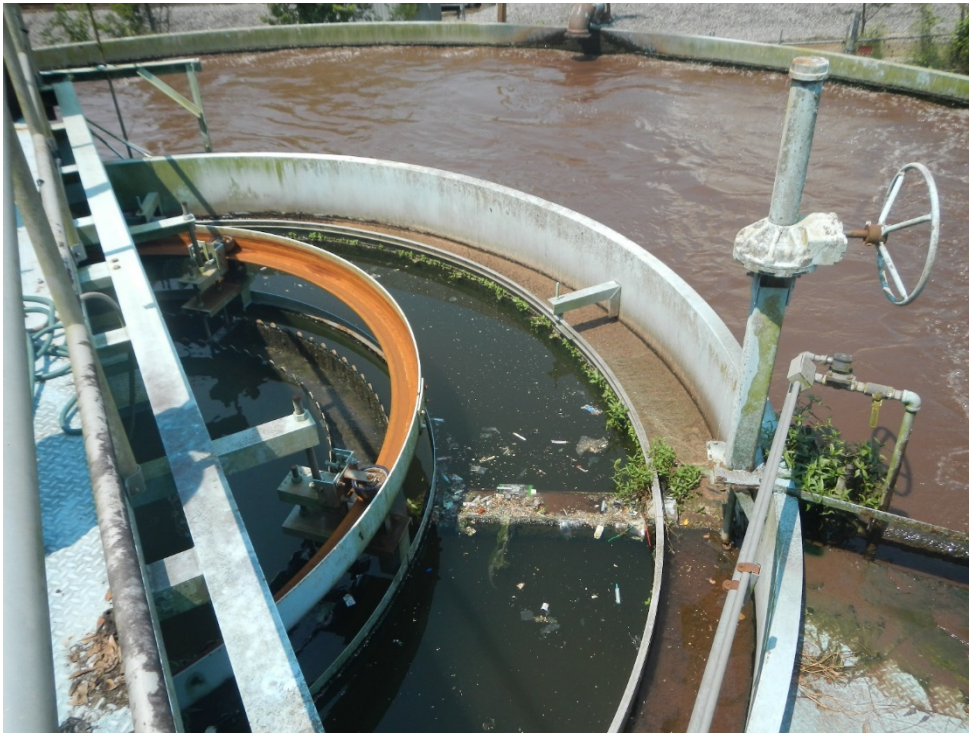
*Photo 9: Suspended trash and vegetative growth in aeration tank 2.*

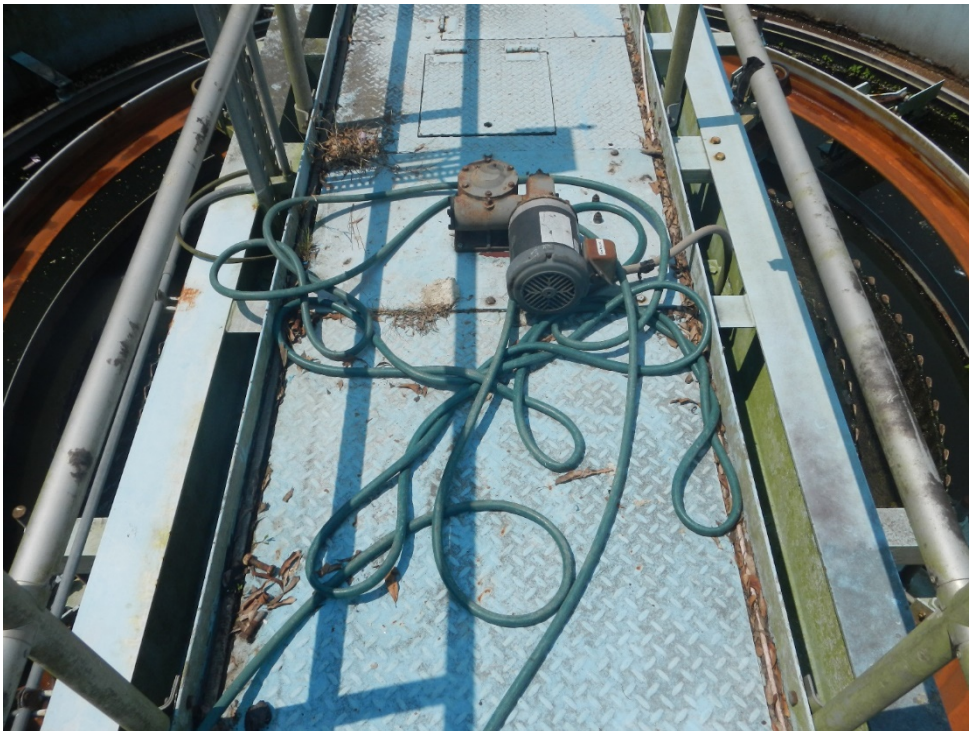
*Photo 10: Water hose laid out on aeration tank 2 walkway.*

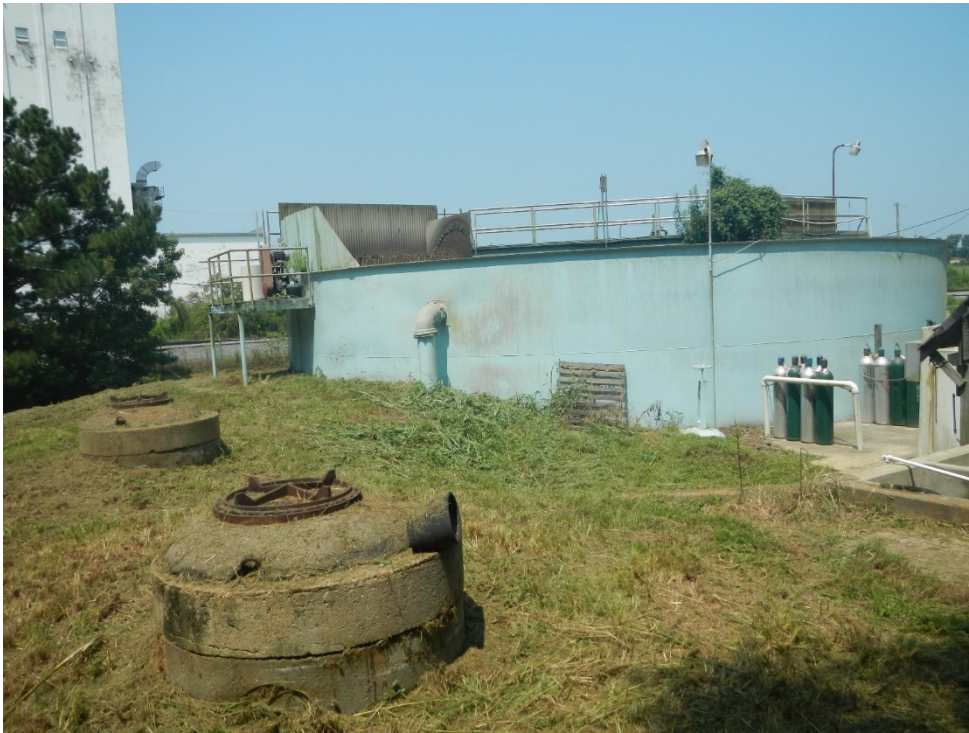
Aeration tank 1 (Photo 11) is used as storage for waste sludge from aeration tank 2. When wasting is needed sludge is routed from aeration tank 2, through the new pump station, to aeration tank 1. Water in aeration tank 1 is brown and the tank has heavy vegetative growth (Photos 12 and 13). Water in the clarifier has significant algae growth (Photo 14).

*Photo 11: Aeration tank 1 and manholes leading to chlorine contact chambers.*

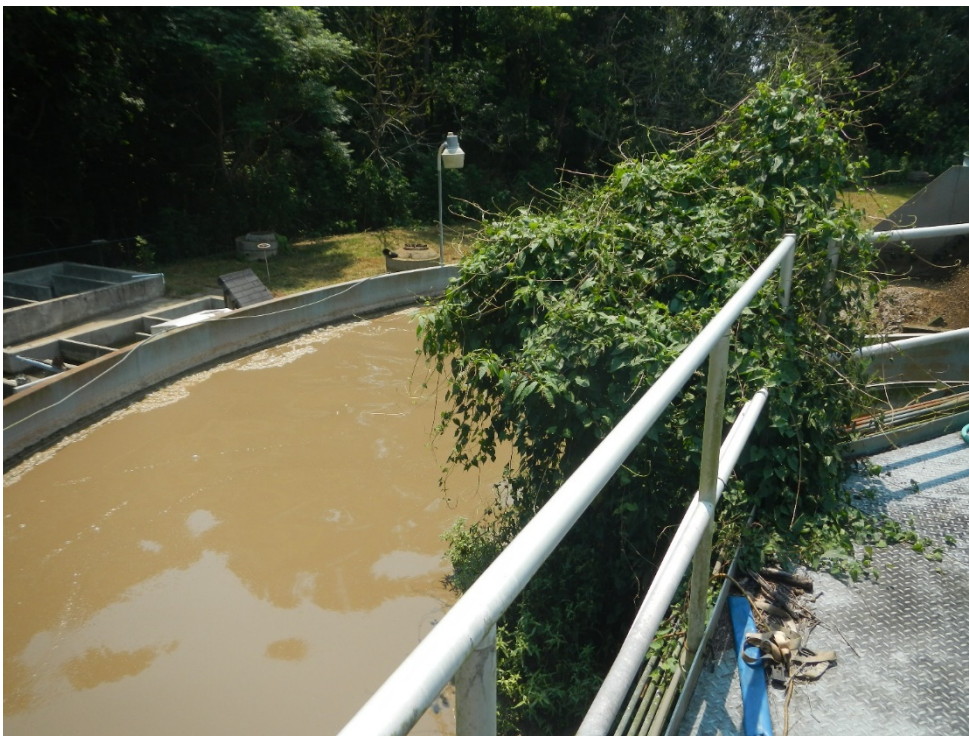
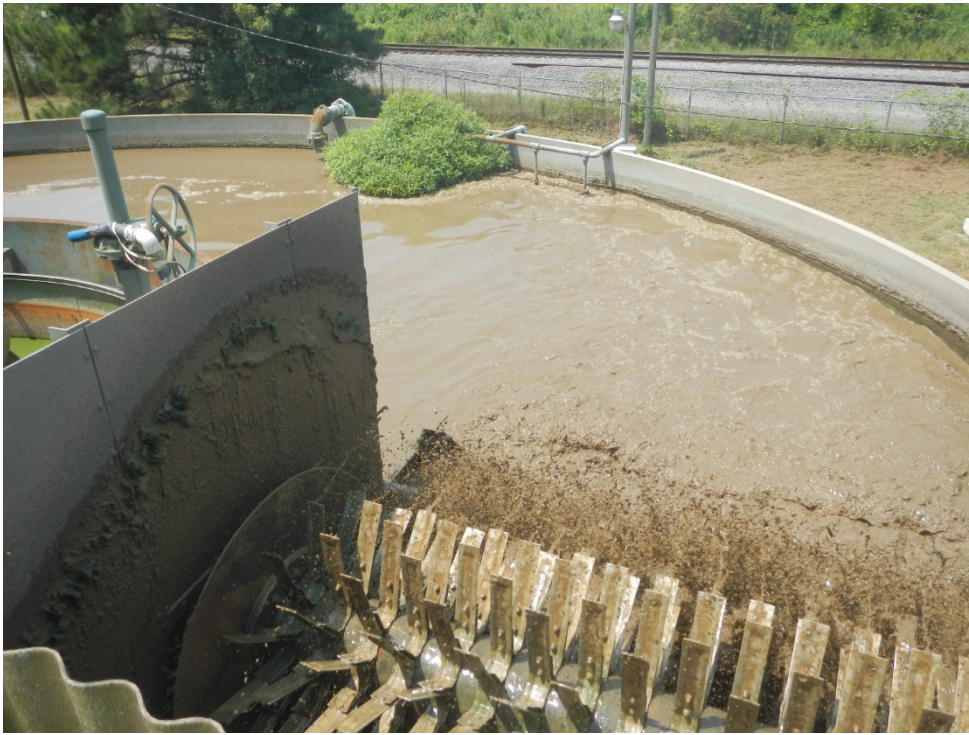
*Photo 12: Heavy vegetative growth and water coloration in aeration tank 1.*

*Photo 13: Vegetative growth and aerator in aeration tank 1.*

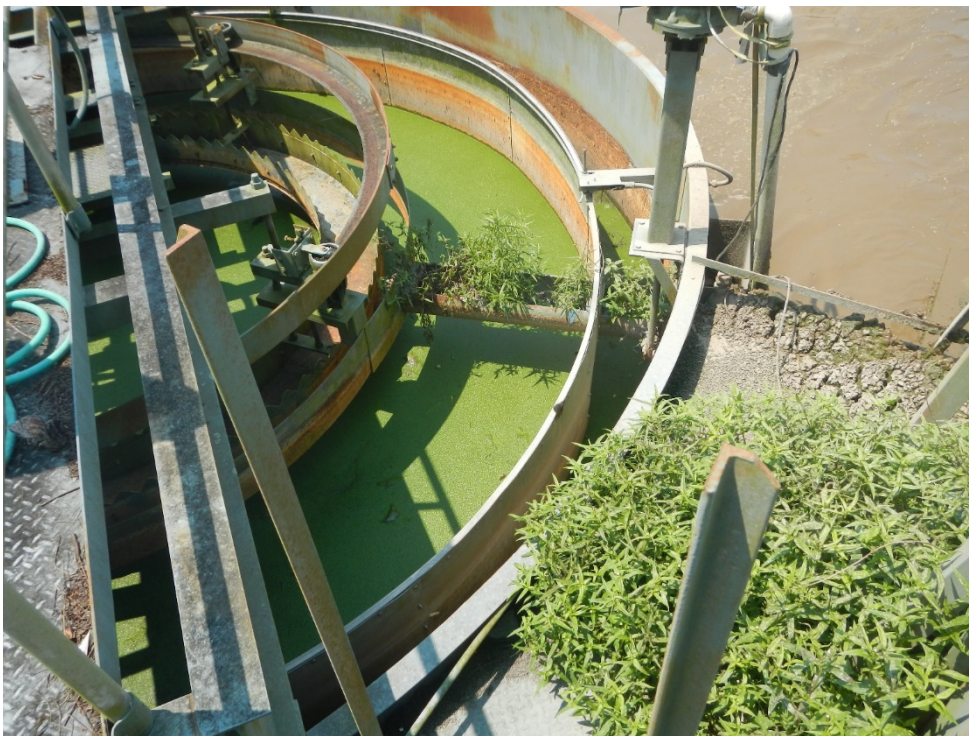
*Photo 14: Vegetative and algae growth in aeration tank 1.*

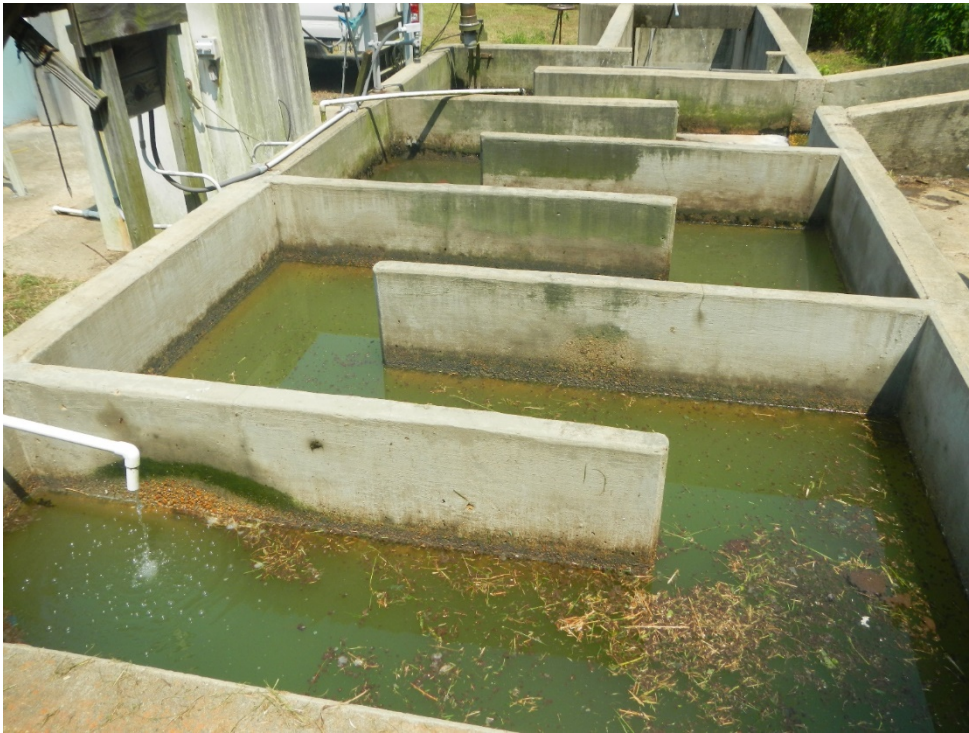
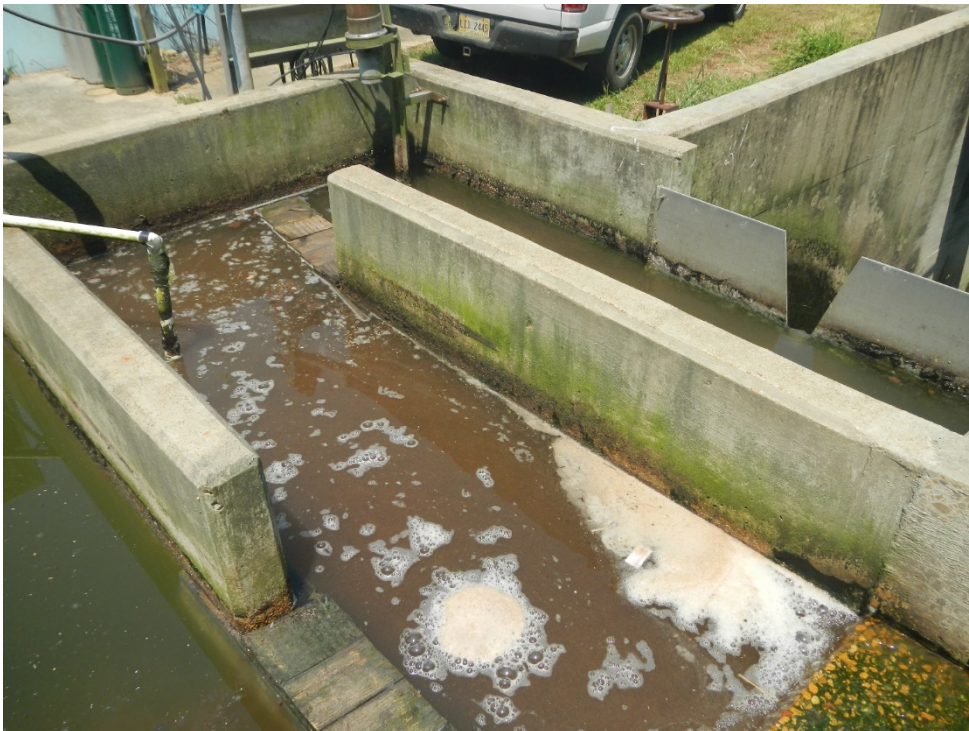
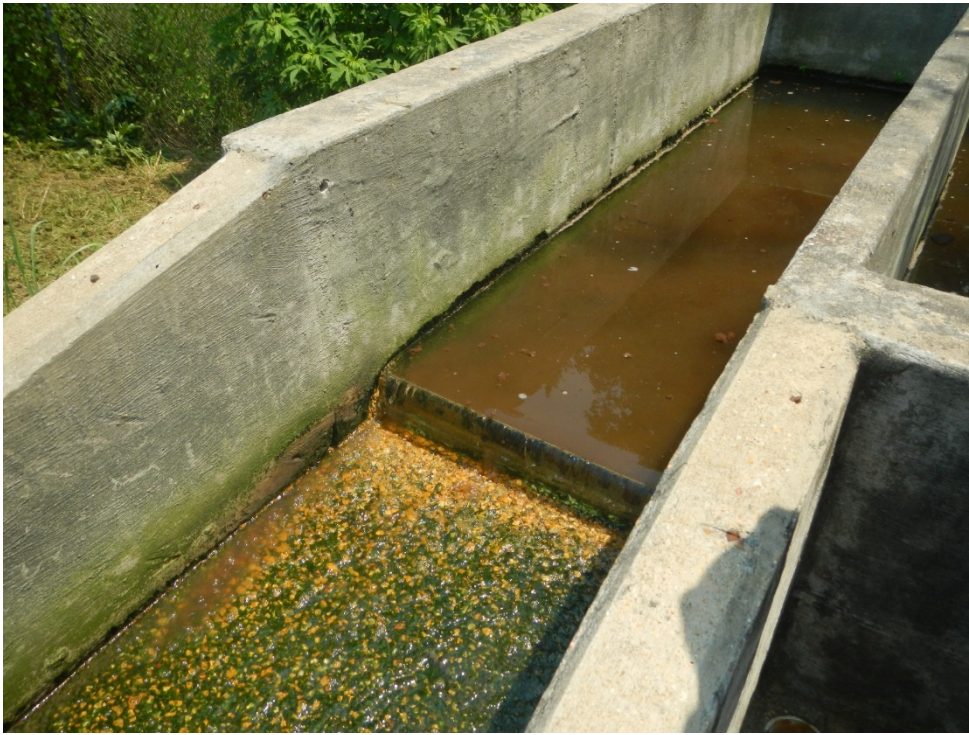
Chlorine contact chambers had significant solids and foam (Photos 15, 16, and 17). Using an on-site sludge judge the operator showed that sludge depth reached at least 2 feet in the chlorine contact chamber (Photos 18 and 19). SO<sub>2</sub> is added to the effluent for dechlorination.

*Photo 15:Chlorine contact chamber 1.*

*Photo 16: Foam and solids after chlorine contact chamber 1.*

*Photo 17: Solids after chlorine contact chamber 2.*

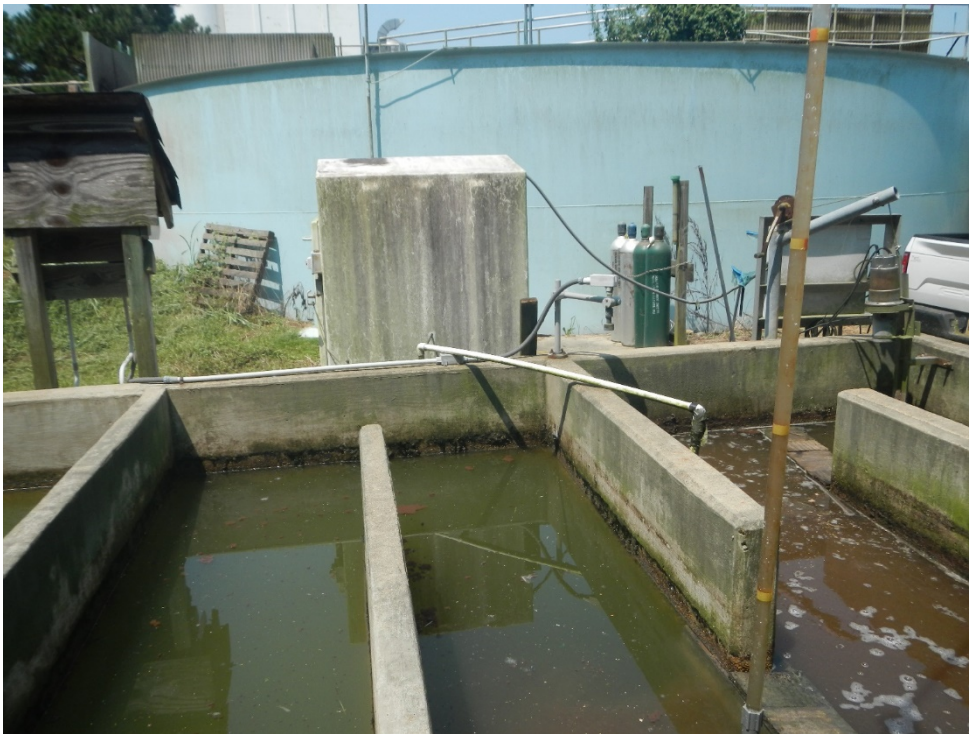
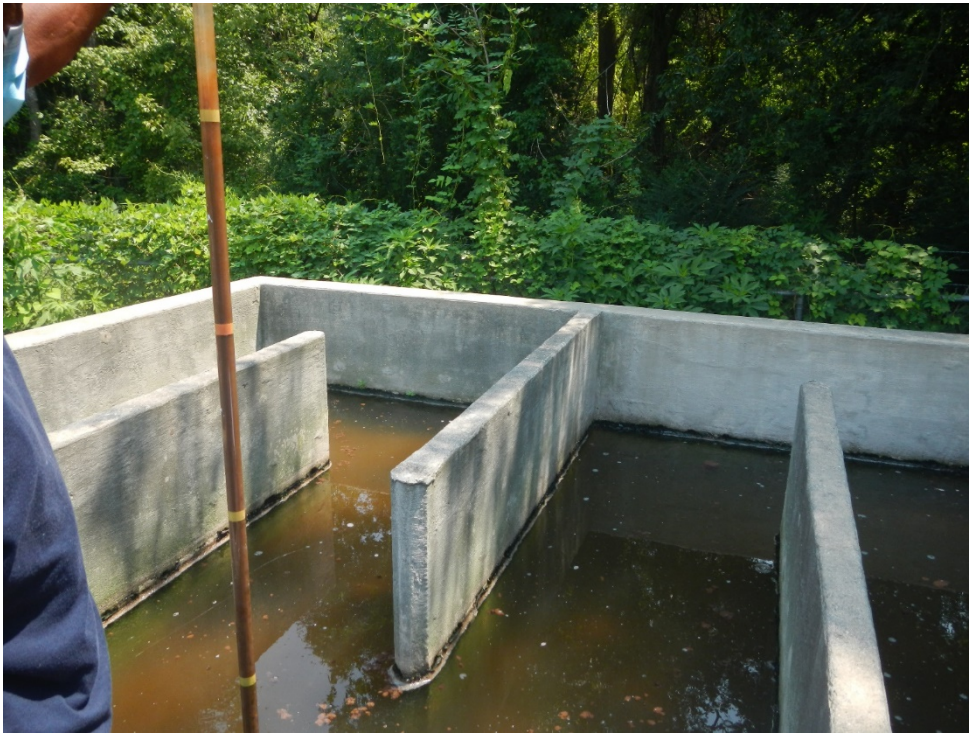
*Photo 18: Sludge judge from chlorine contact chamber 1.*

*Photo 19: Sludge judge from chlorine contact chamber 2.*

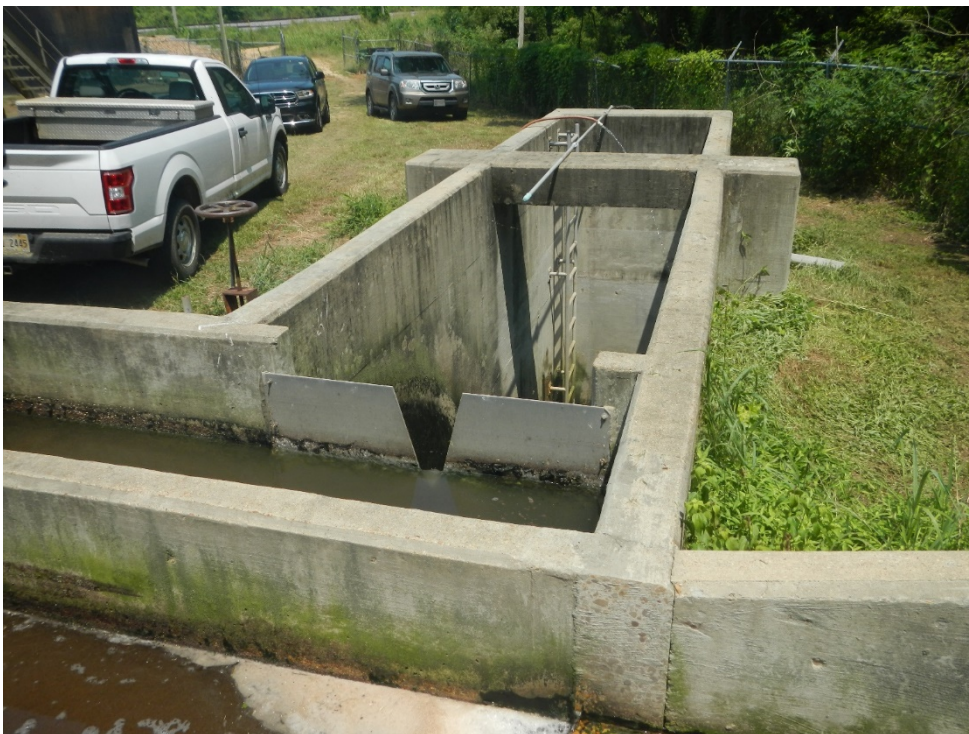
Flow is measured by a 22-1/2° V-notch weir (Photos 20). No staff gauge was available onsite for water flow measurement.

*Photo 20: Effluent v-notch weir.*

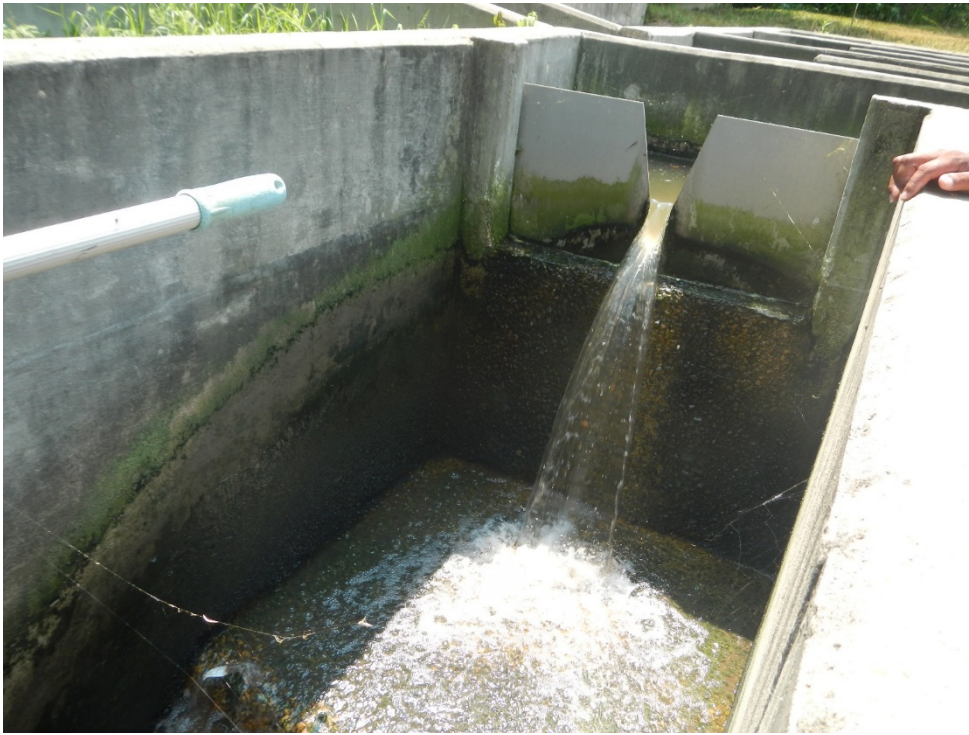
Following the plant's V-notch weir, effluent goes through cascade aeration before being discharged through outfall 001. Dark reddish-brown coloration, foam, and solids were visible in the effluent chamber (Photo 21).

*Photo 20: Effluent v-notch weir. Solids visible in effluent.*
