## Region 6 - Enforcement & Compliance Assurance Division

### INSPECTION REPORT

| Company Name: | <b>AJ Construction LLC</b> | | |
| Facility Name: | <b>NYP Pizza</b> | | |

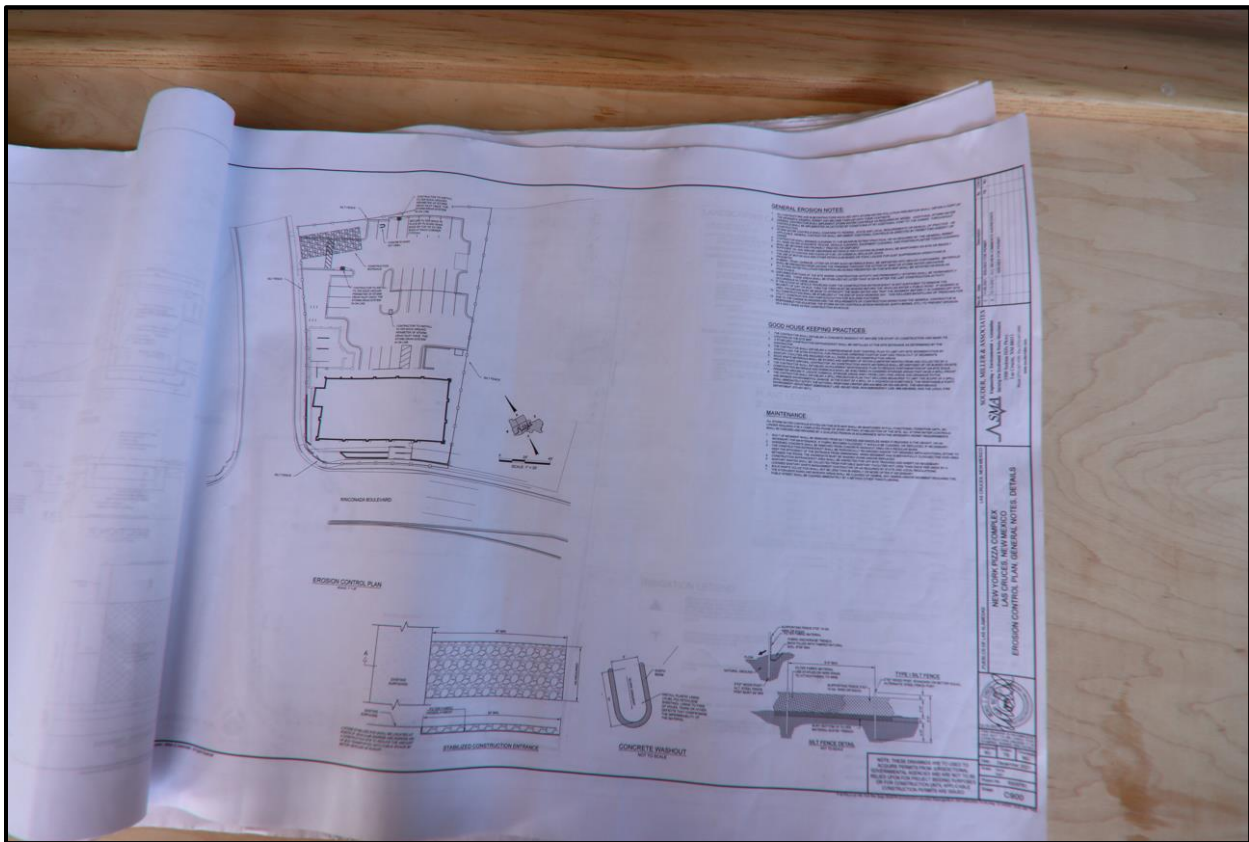
UNITED STATES ENVIRONMENTAL PROTECTION AGENCY  
**Appendix 1: Photograph Log**  
Photo No. 1

1. Mr. Hindash stated that no CGP had been obtained for the site and only provided the ECP. The NYP Pizza construction site is approximately 2.65 acres, which requires coverage under the CGP. (see Appendix 1, Photograph Log, Photo No 1); and
2. Good housekeeping practices and best management practices (BMPs) were noted in the ECP however, several AOCs were identified during the inspection (see additional details in Section III of this report).

Description: View of ECP for the NYP Pizza construction site including general erosion notes, good housekeeping practices, and maintenance.

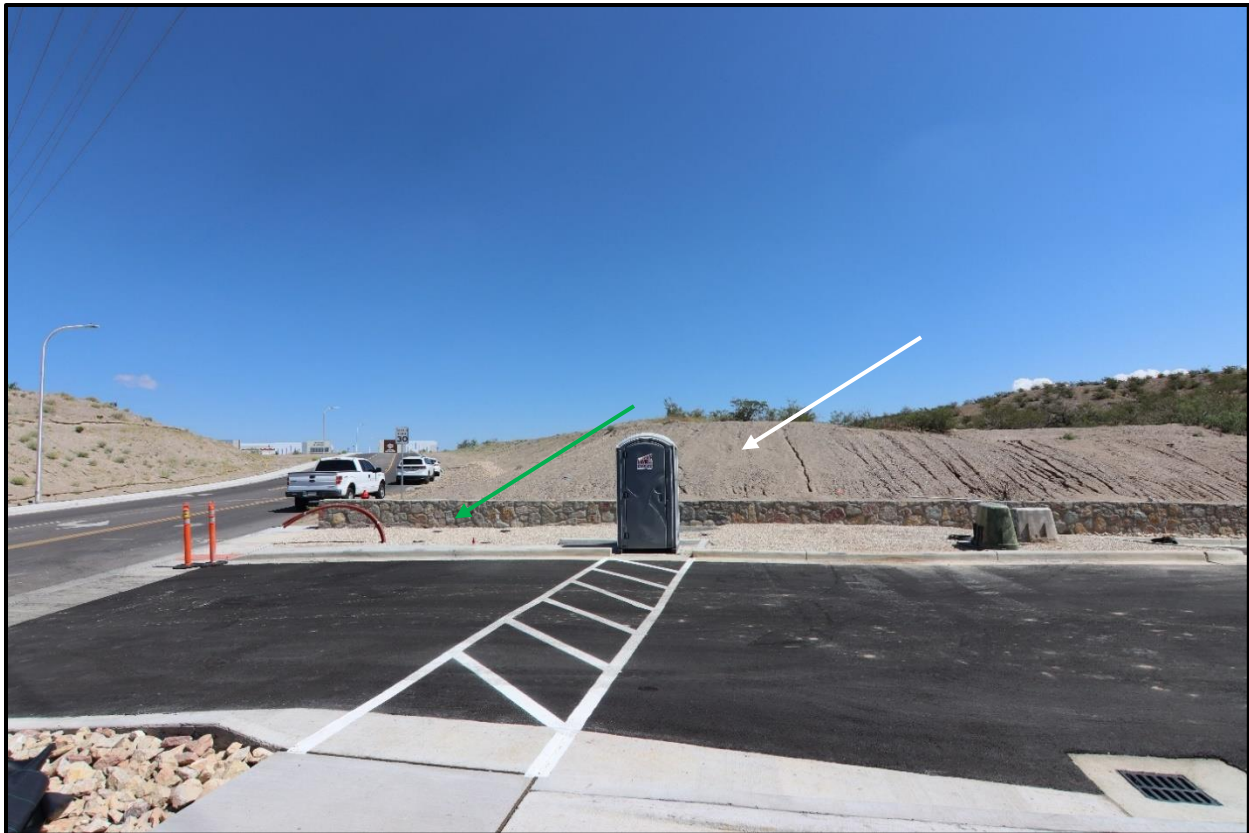
UNITED STATES ENVIRONMENTAL PROTECTION AGENCY  
**Appendix 1: Photograph Log**  
Photo No. 2

- c) Silt fences were not installed as a perimeter control BMP at the construction site, despite the ECP's specifications for their installation. As a result, sediment carryover was observed from the construction site onto the sidewalk, and roadway along Rinconada Boulevard at the southwest, south, and southeast sides. A retaining wall at the north end of the construction site was observed as a perimeter control BMP with mounds of sediment behind it. (See Appendix 1, Photograph Log, Photos Nos 2, 3, 5, 6, 7, 9, 10, & 11). **2022 CGP, Parts 2.1.3 & 2.2.3**

Description: View of the paved parking lot area of the construction site with the retaining wall (green arrow) at the north end of the site. A mound of sediment (white arrow) was observed behind the retaining wall.

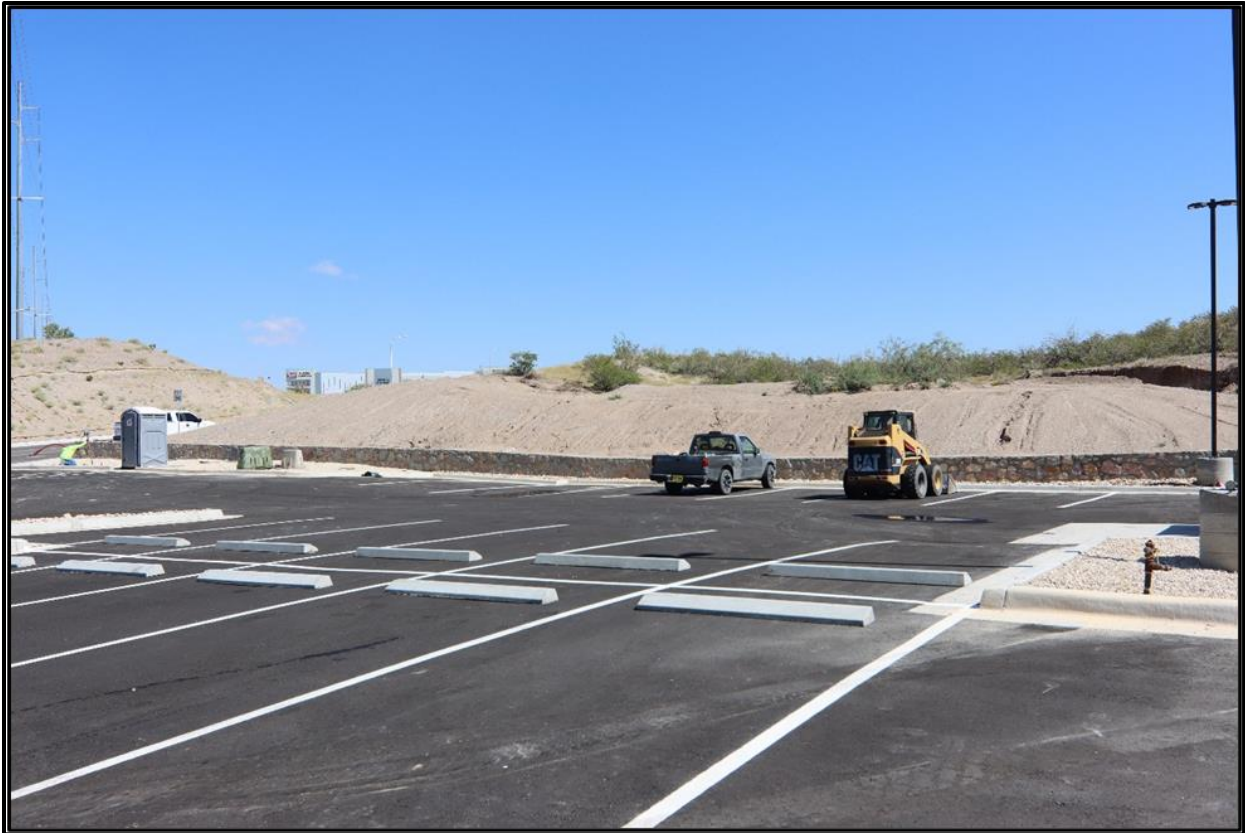
UNITED STATES ENVIRONMENTAL PROTECTION AGENCY  
**Appendix 1: Photograph Log**  
Photo No. 3

Description: Second view of the paved parking lot area of the construction site.

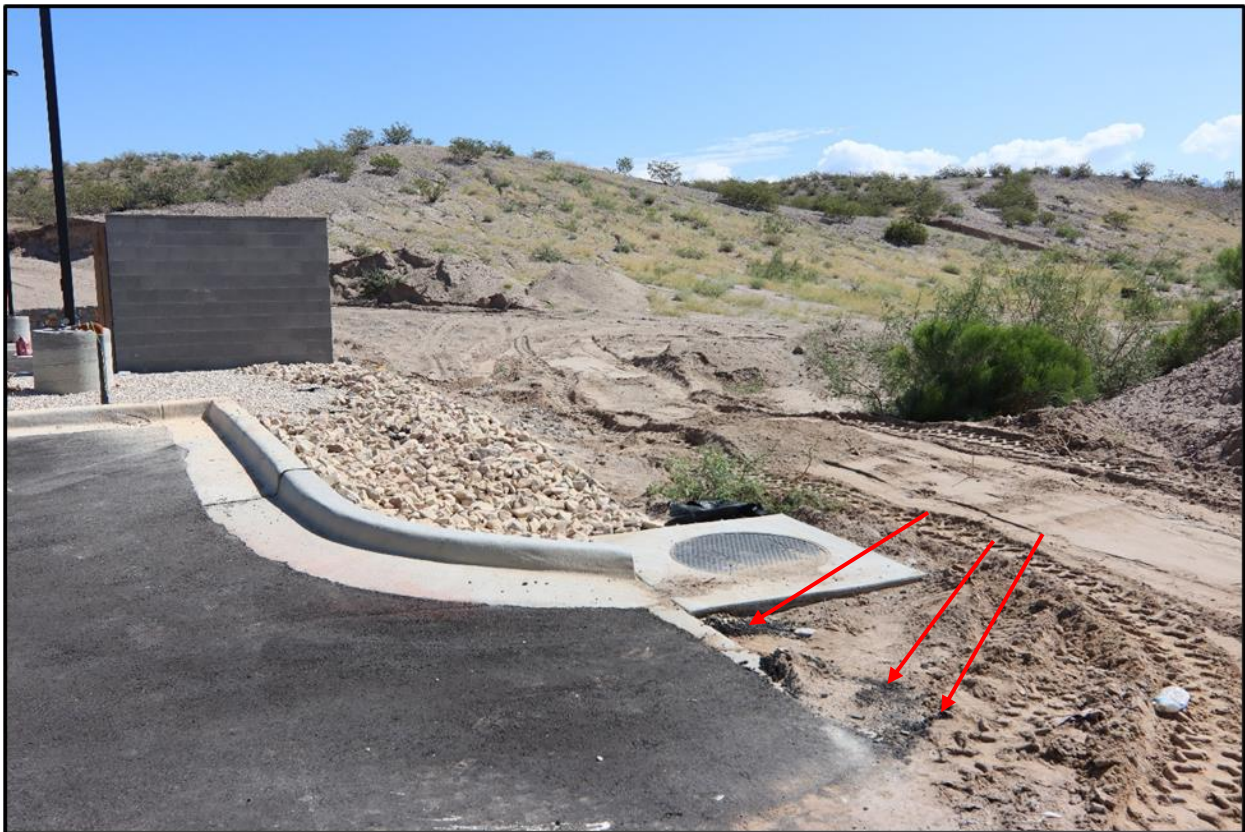
Photo No. 4

- b) Asphalt and concrete waste were improperly handled and disposed of, and debris were observed deposited directly in the sediment/ undeveloped area at the east end of the construction site. (See Appendix 1, Photograph Log, Photo Nos 4, 5, & 6). **2022 CGP, Part 2.3.3**

Description: View of asphalt deposited in the sediment/ undeveloped area at the east end of the site.

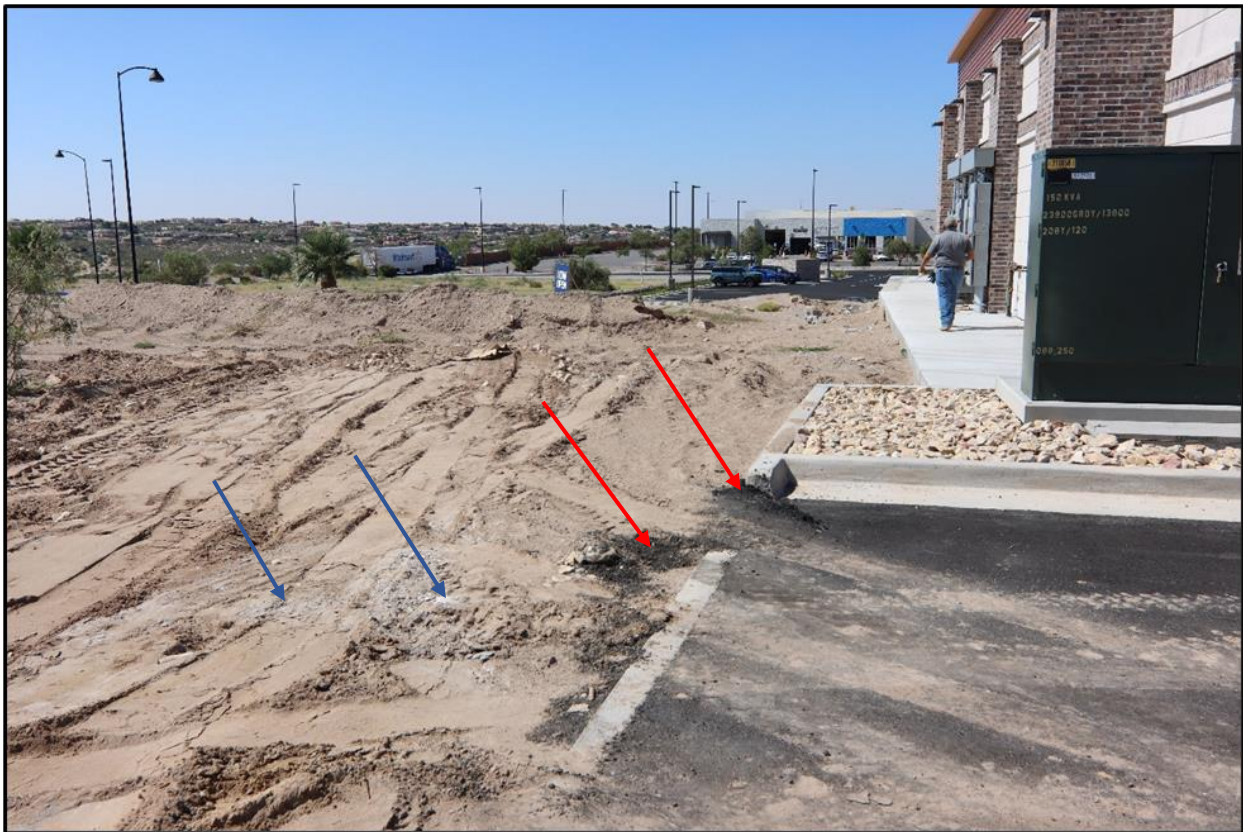
UNITED STATES ENVIRONMENTAL PROTECTION AGENCY  
**Appendix 1: Photograph Log**  
Photo No. 5

Description: Second view of the east end of the construction site, taken at the top of the slope facing downward towards Rinconada Boulevard. Asphalt (red arrow) and concrete waste (blue arrow) were observed deposited in the sediment area. During rainfall events, stormwater flows downhill from the sediment area onto the sidewalk and roadway along Rinconada Boulevard.

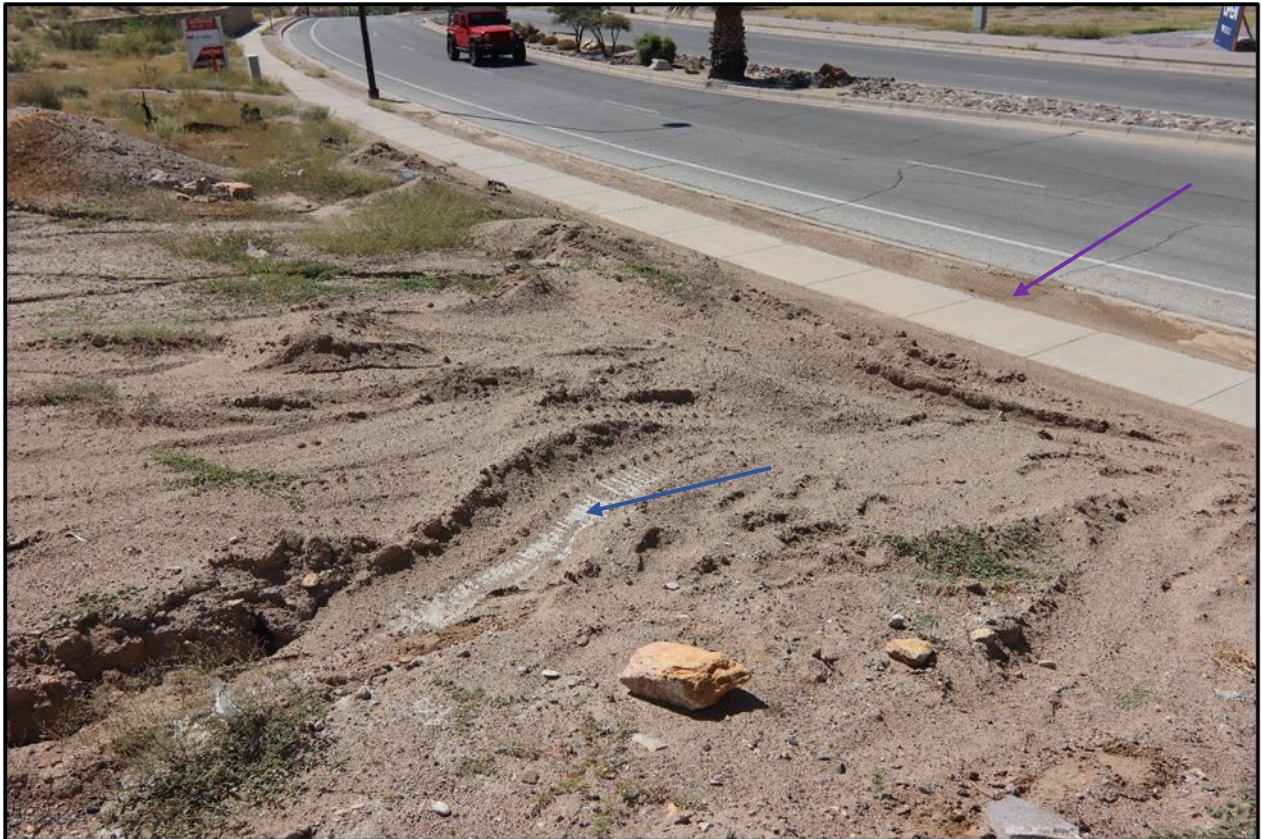
UNITED STATES ENVIRONMENTAL PROTECTION AGENCY  
**Appendix 1: Photograph Log**  
Photo No. 6

Description: View of sediment carryover (purple arrow) from the southeast end of the construction site slope onto the sidewalk along the southeast end of Rinconada Boulevard. Concrete waste (blue arrow) was observed deposited in the sediment area.

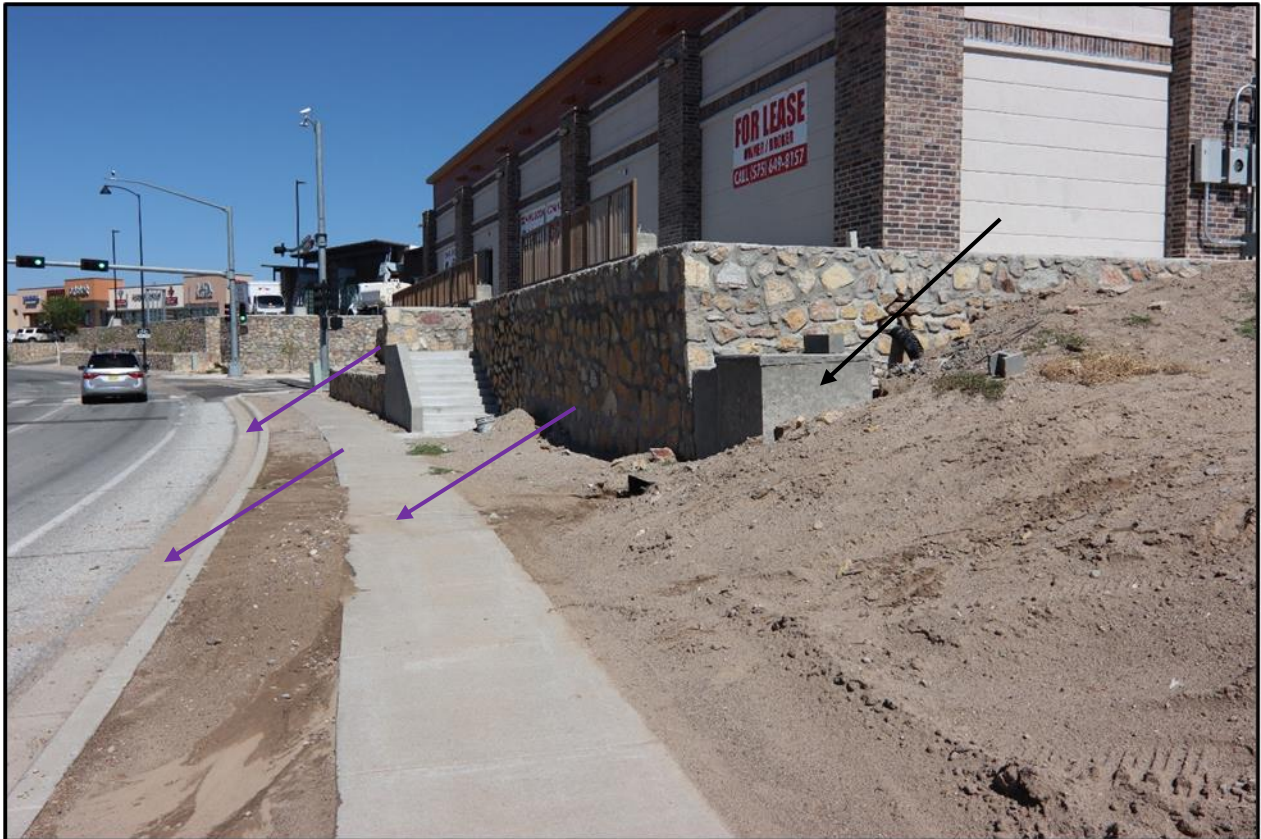
UNITED STATES ENVIRONMENTAL PROTECTION AGENCY  
**Appendix 1: Photograph Log**  
Photo No. 7

- d) The storm drain located downslope and at the southeast end of the construction site was not maintained in an effective operating manner and surrounded by eroded soil. (See Appendix 1, Photograph Log, Photo Nos 7, 9, 10 & 11). **2022 CGP, Part 2.1.4**

Description: Second view of sediment carryover (purple arrow) from the south end of the construction site onto the roadway and sidewalk along Rinconada Boulevard. Also pictured is the storm drain (black arrow).

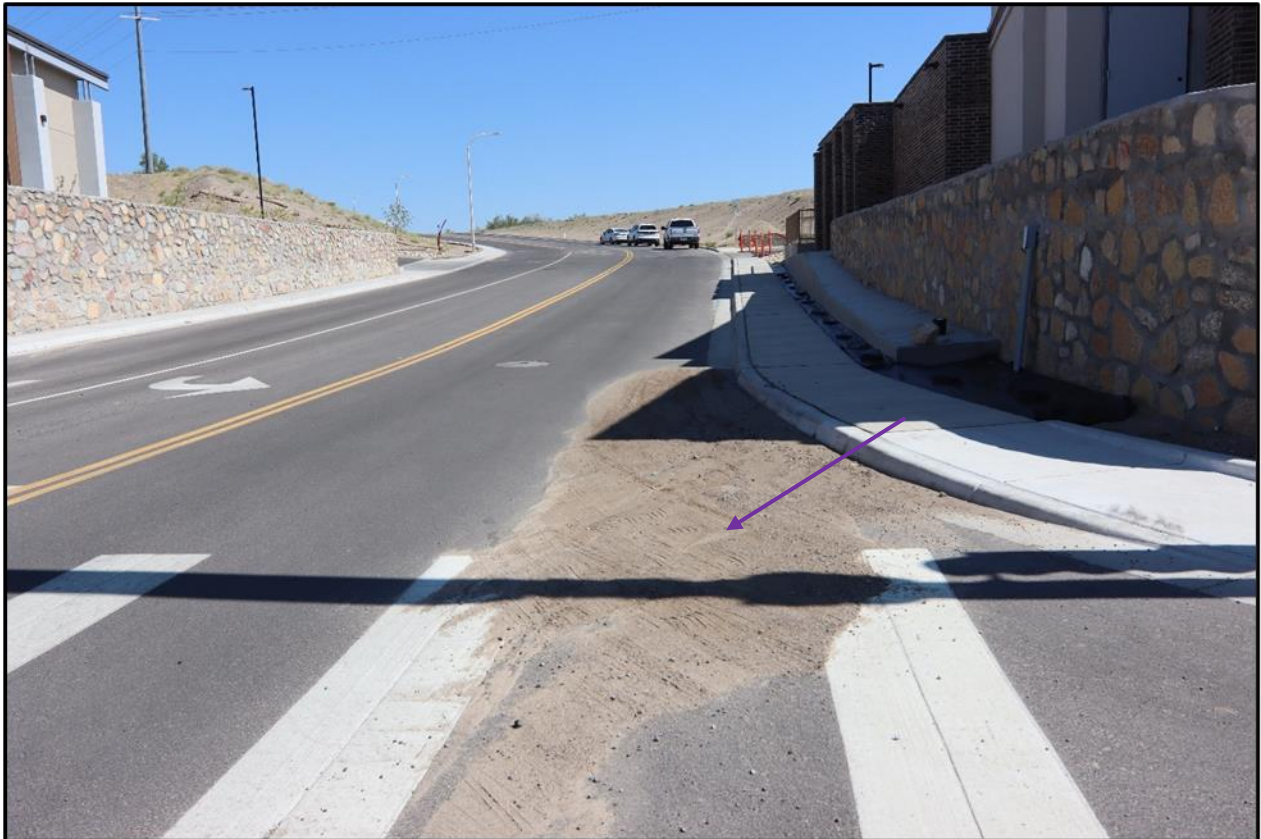
Photo No. 8

Description: View of sediment carryover (purple arrow) from the construction site onto the roadway at the southeast end of Rinconada Boulevard.

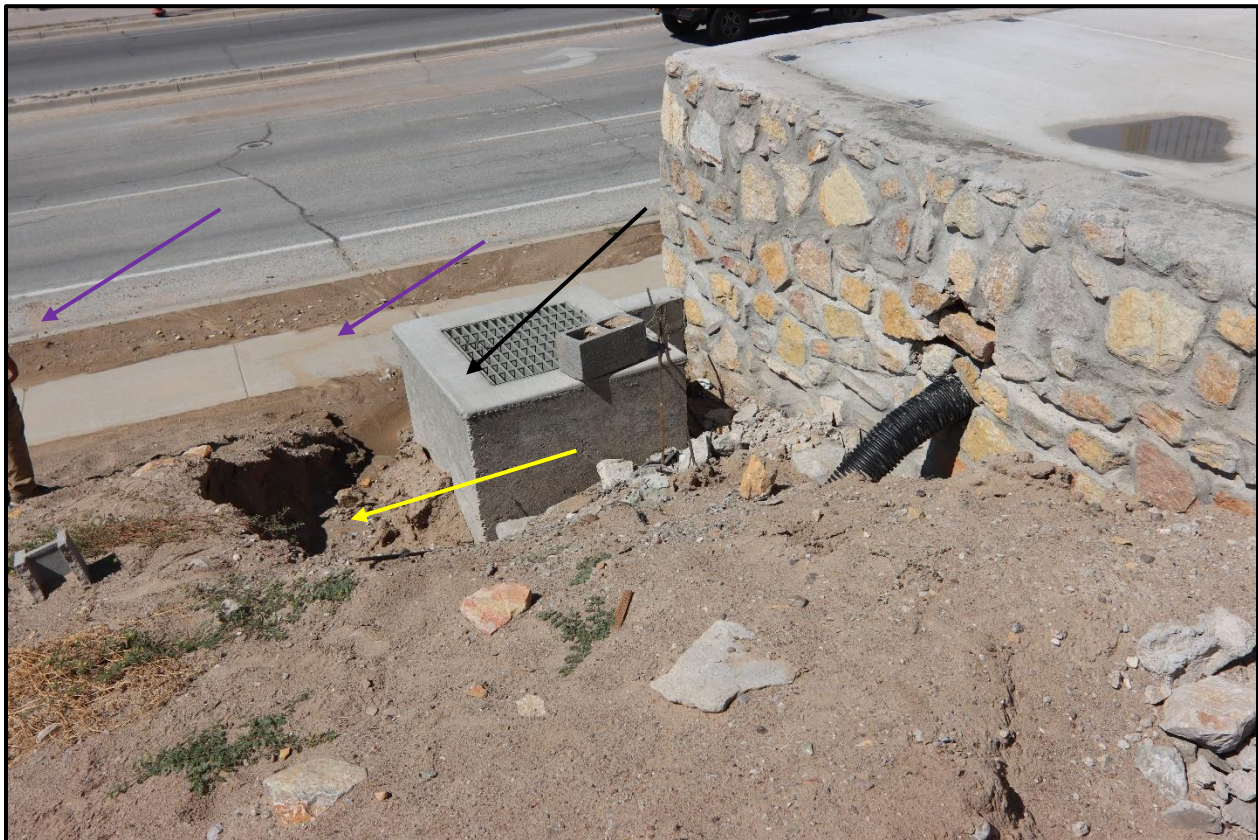
UNITED STATES ENVIRONMENTAL PROTECTION AGENCY  
**Appendix 1: Photograph Log**  
Photo No. 9

Description: View of an ineffective BMP (i.e., a storm drain (black arrow) not maintained in an effective operating manner and with the surrounding soil (yellow arrow) eroded). Sediment carryover (purple arrow) was observed from the southeast end of the construction site onto the sidewalk and roadway at Rinconada Boulevard.

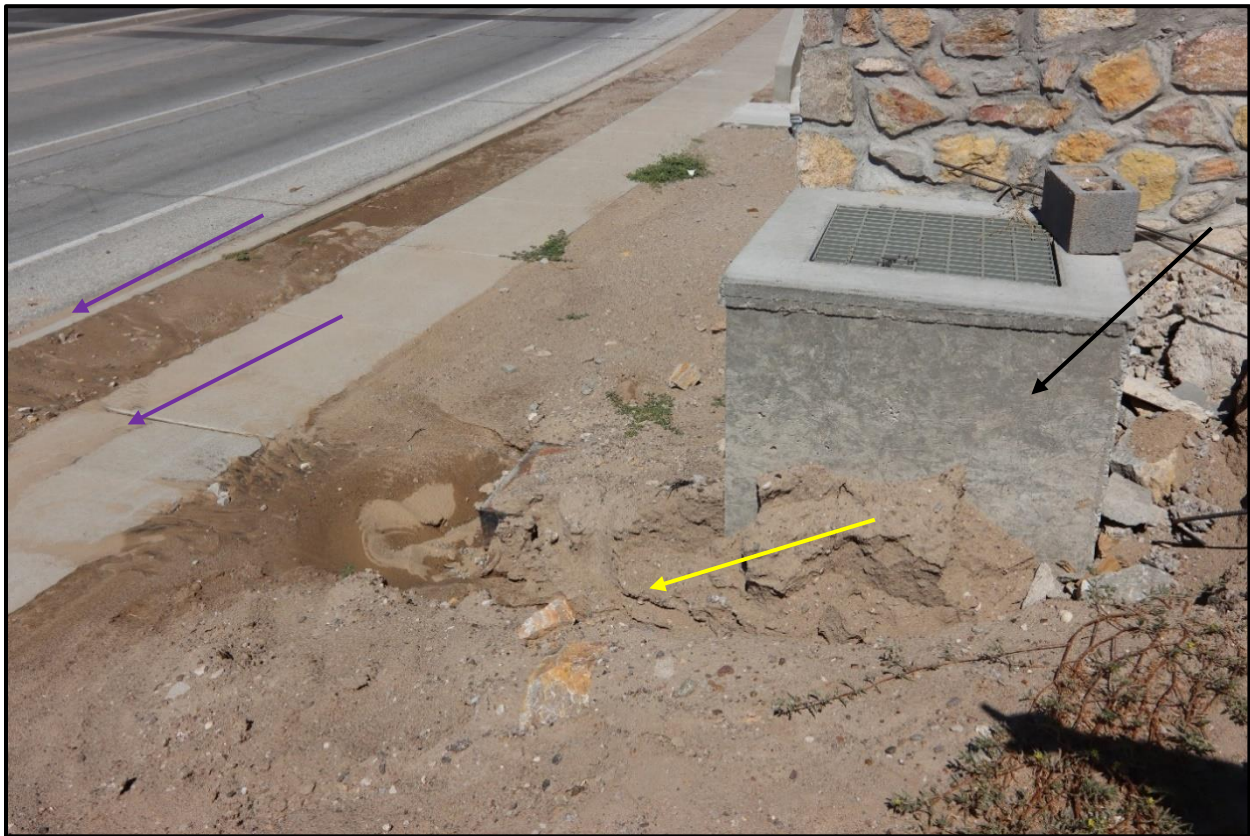
UNITED STATES ENVIRONMENTAL PROTECTION AGENCY  
**Appendix 1: Photograph Log**  
Photo No. 10

Description: A second view of the unmaintained storm drain (black arrow) with the eroded soil (yellow arrow) causing sediment carryover (purple arrow) from the southeast end/ slope of the construction site onto the sidewalk and roadway along Rinconada Boulevard.

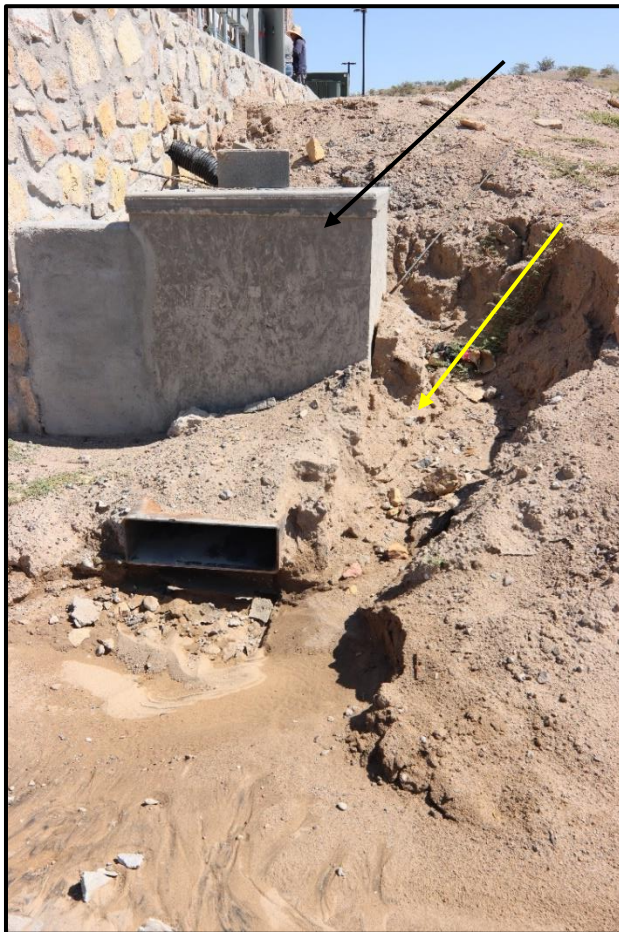
Photo No. 11

Description: A closer view of the unmaintained storm drain (black arrow) and eroded soil (yellow arrow). When the storm drain is not maintained, its ability to function adequately is compromised. As a result, water is unable to flow effectively through the drainage system leading to surface runoff and water accumulation eroding the surrounding soil and subsequent transport of sediment onto the sidewalk and roadway along Rinconada Blvd.

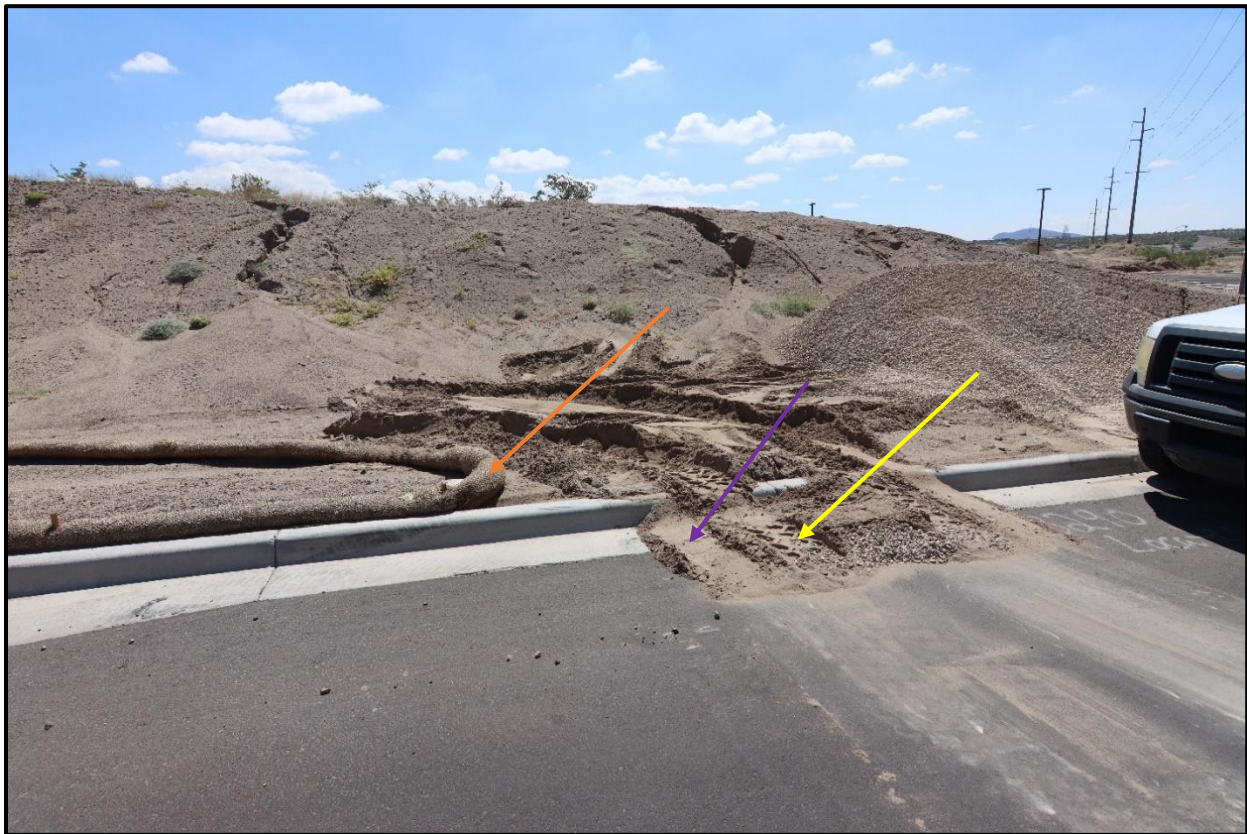
UNITED STATES ENVIRONMENTAL PROTECTION AGENCY  
**Appendix 1: Photograph Log**  
Photo No. 12

2. The BMPs identified in the site's ECP were either not implemented or not maintained in an effective operating condition:
  - a) Stabilization techniques were not provided at the designated entrance and exit point northwest of the construction site near the mounds of sediment behind the retaining wall to minimize track out despite the ECP denoting a gravel pad to be installed as a track out device. Sediment carryover and tire tracks were observed leading onto the roadway from the entrance and exit point. (See Appendix 1, Photograph Log, Photo No 12). **2022 CGP, Parts 2.1.2, 2.2.3 & 2.2.4**

Description: View of sediment carryover (purple arrow) from an entrance and exit point onto the roadway north of the construction site near mounds of sediment. Tire tracks (yellow arrow) were observed leading towards the roadway from the entrance and exit point.

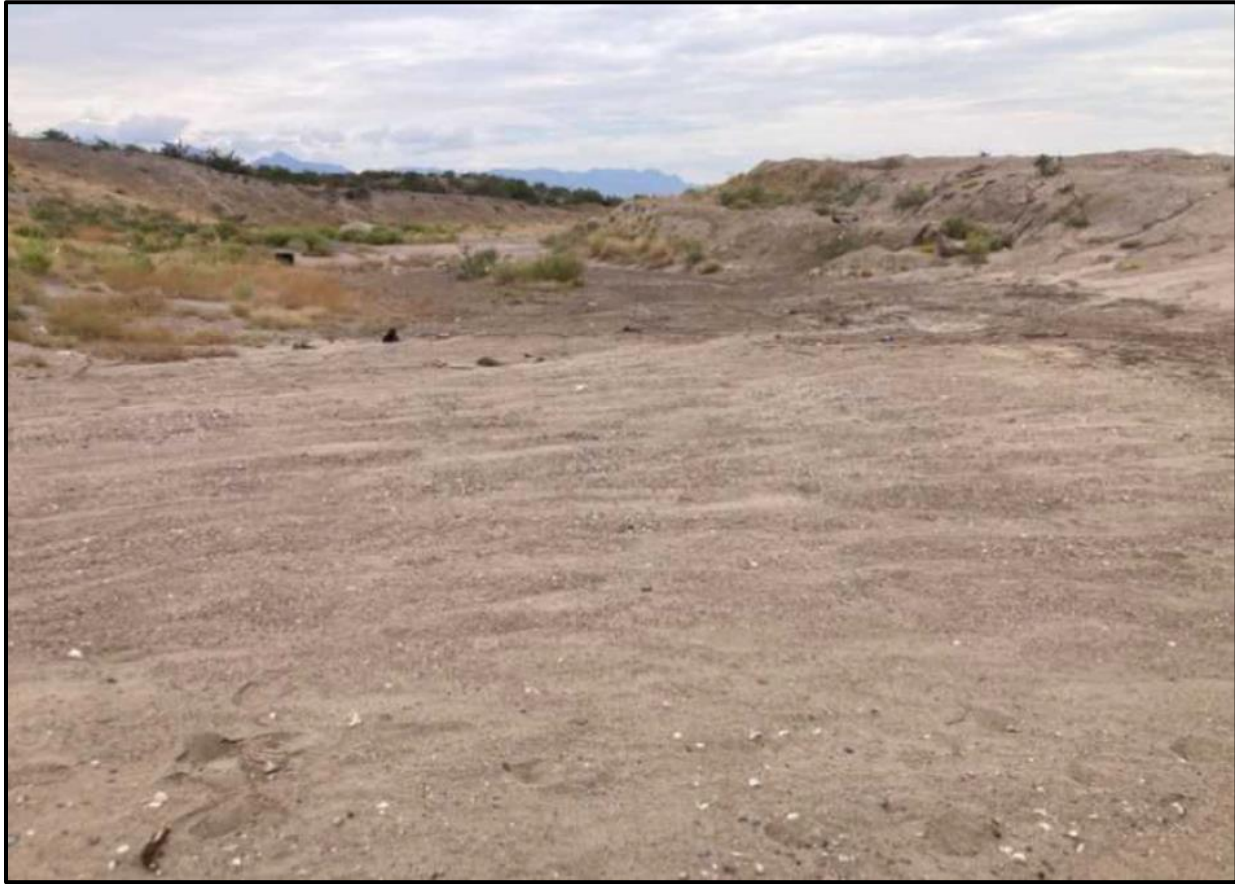
Photo No. 3

1. Mr. Hindash submitted a hand-drawn site layout along with accompanying photographs intending to demonstrate that sediment on the undeveloped lot on the eastside of the site is being diverted or prevented from transporting downslope to the sidewalk and roadway along Rinconada Boulevard. However, the documentation provided is insufficient. The hand-drawn layout is not entirely legible. The submitted photos lack directional indicators and descriptions, so the specific locations cannot be accurately identified or matched to the site layout. Only photograph number 4, 5, & 6 can be confirmed to show the east side of the construction site (See Appendix 2, Photograph Log, Photo Nos 1, 2, 3, 4, 5 & 6).

Description: View of an unknown sediment area of the construction site.

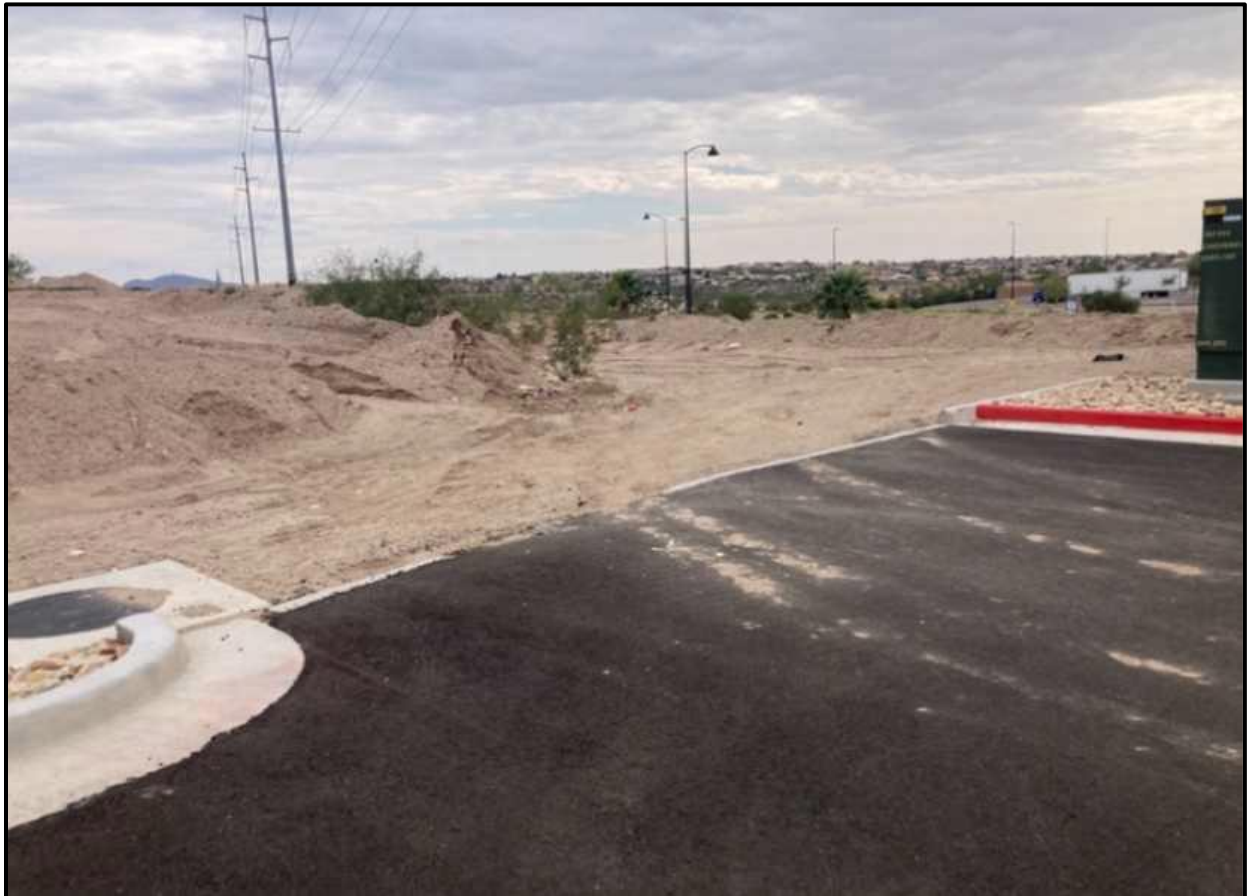
Photo No. 4

Description: View of the eastside of the construction site paved parking lot area and the adjacent undeveloped sediment area.

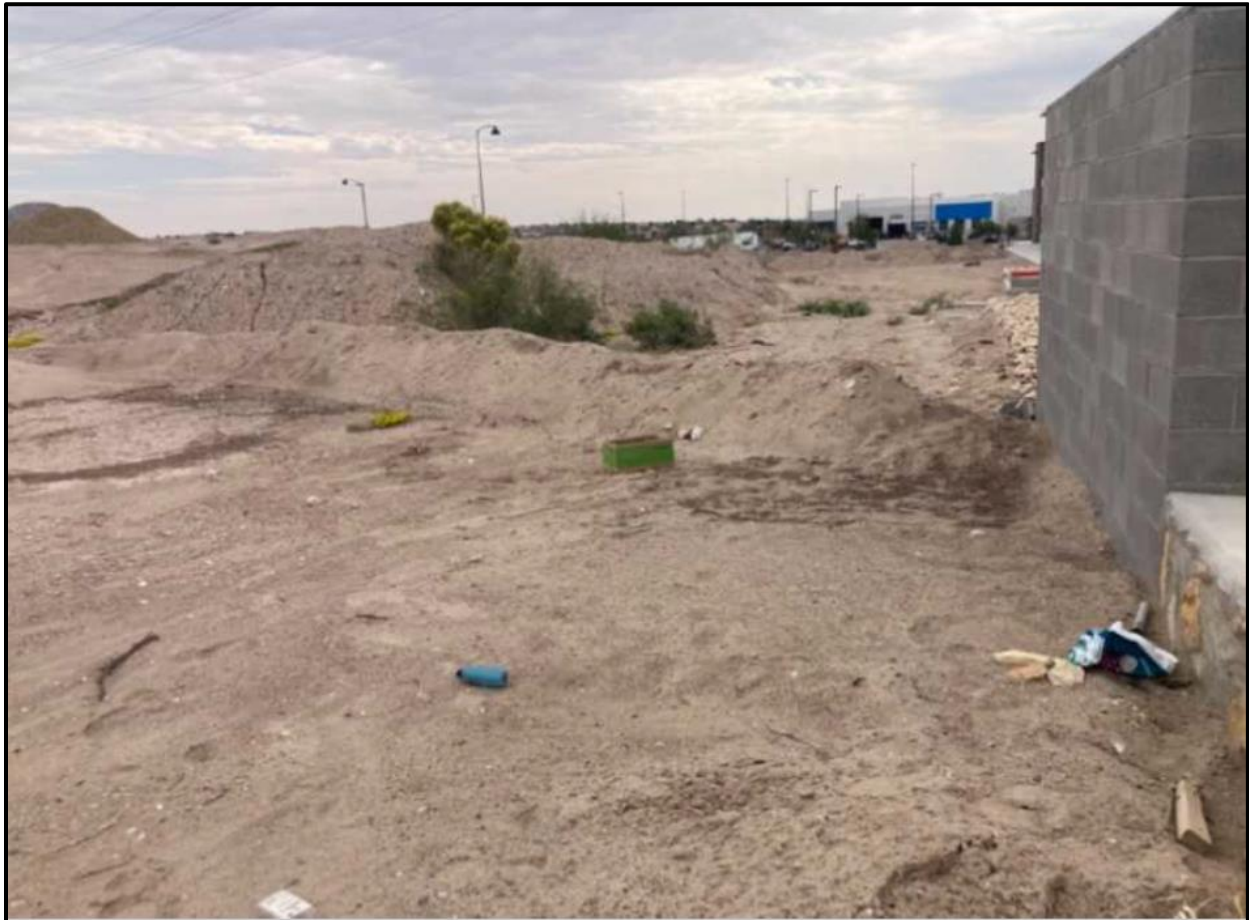
Photo No. 5

Description: View of the undeveloped sediment adjacent to the dumpster enclosure at the east end of the construction site.

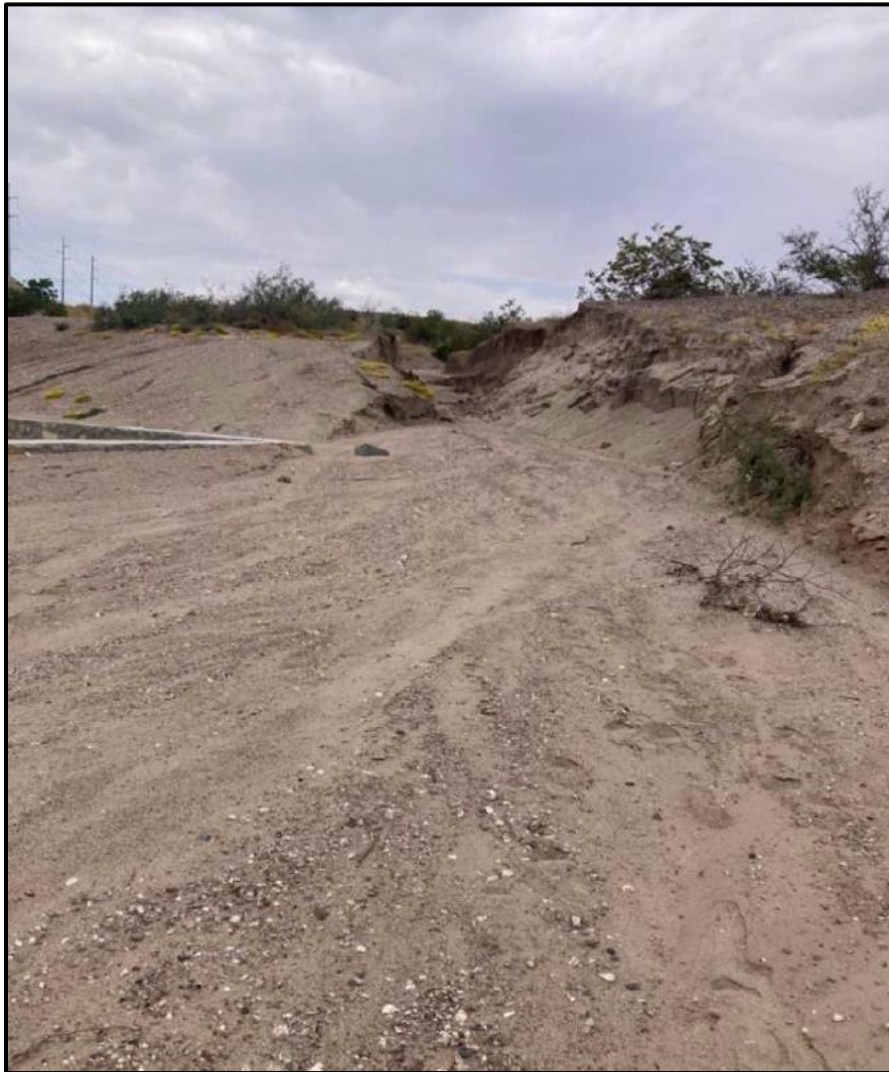
Photo No. 6

Description: View of the north eastside end of the construction site, and the adjacent undeveloped sediment area.
