INTERNAL CORRESPONDENCE

## CHEMICALS AND PLASTICS

DATE February 13, 1976

PL 700, D-16  
HAND VENT

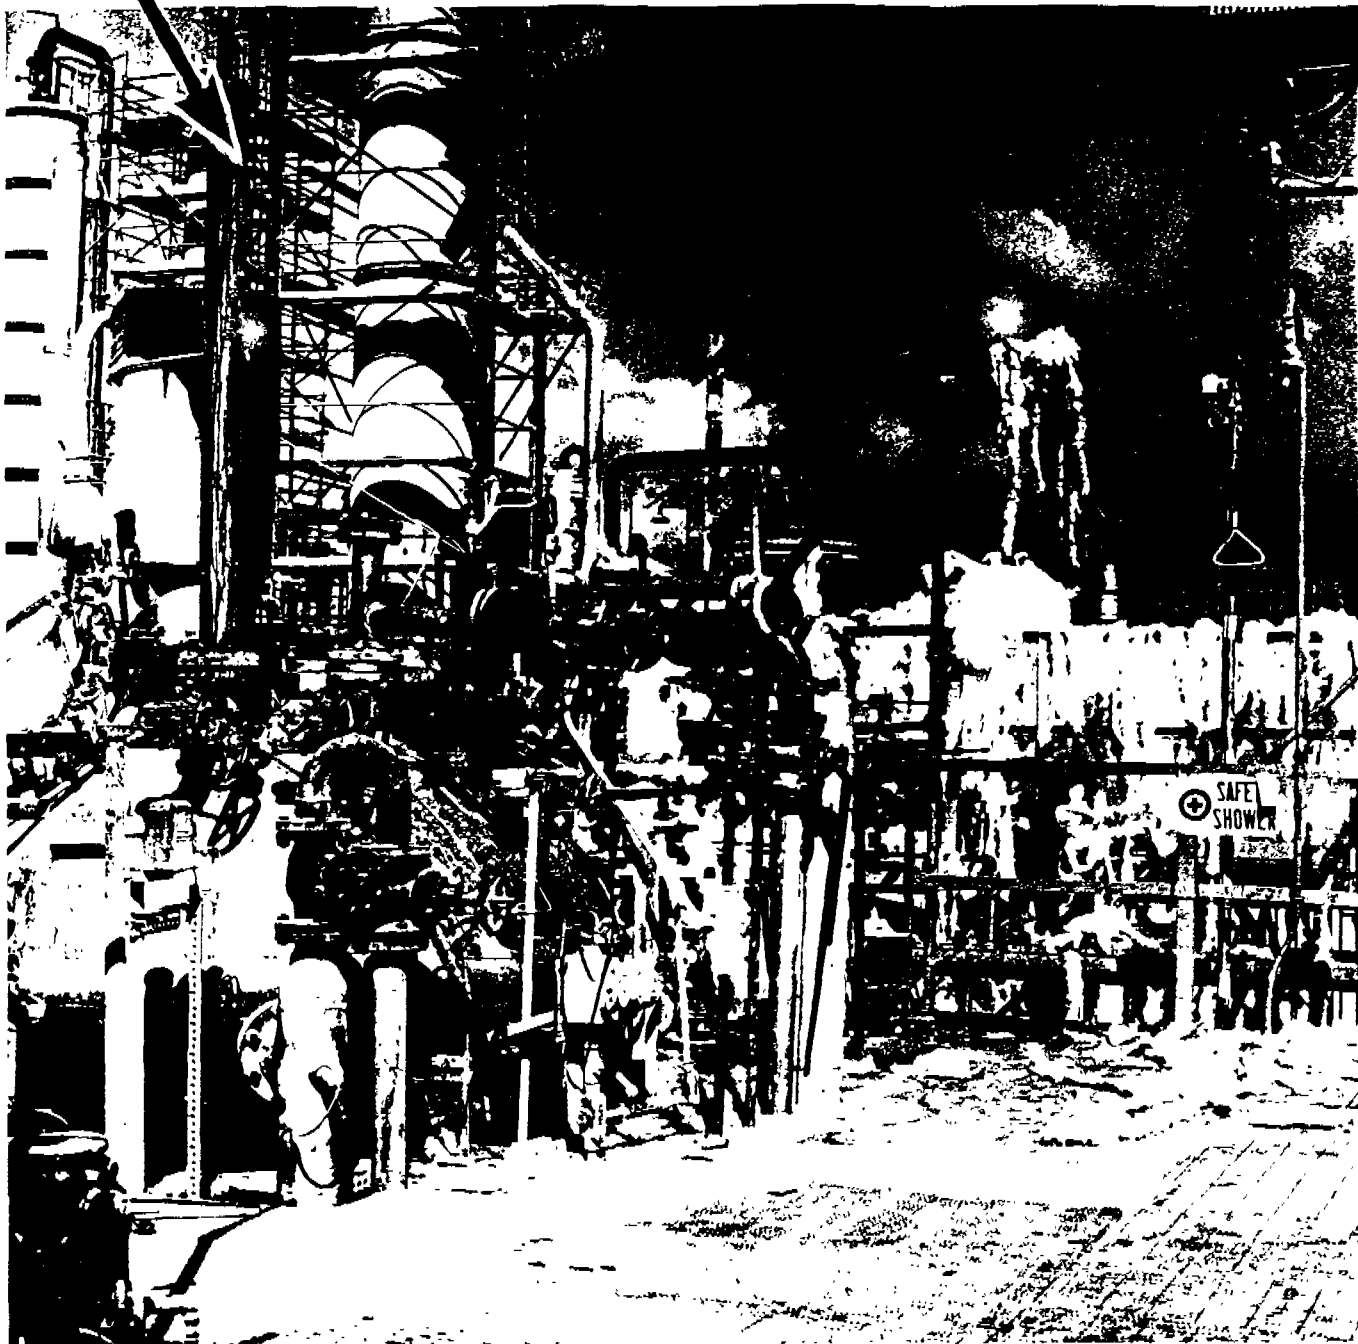
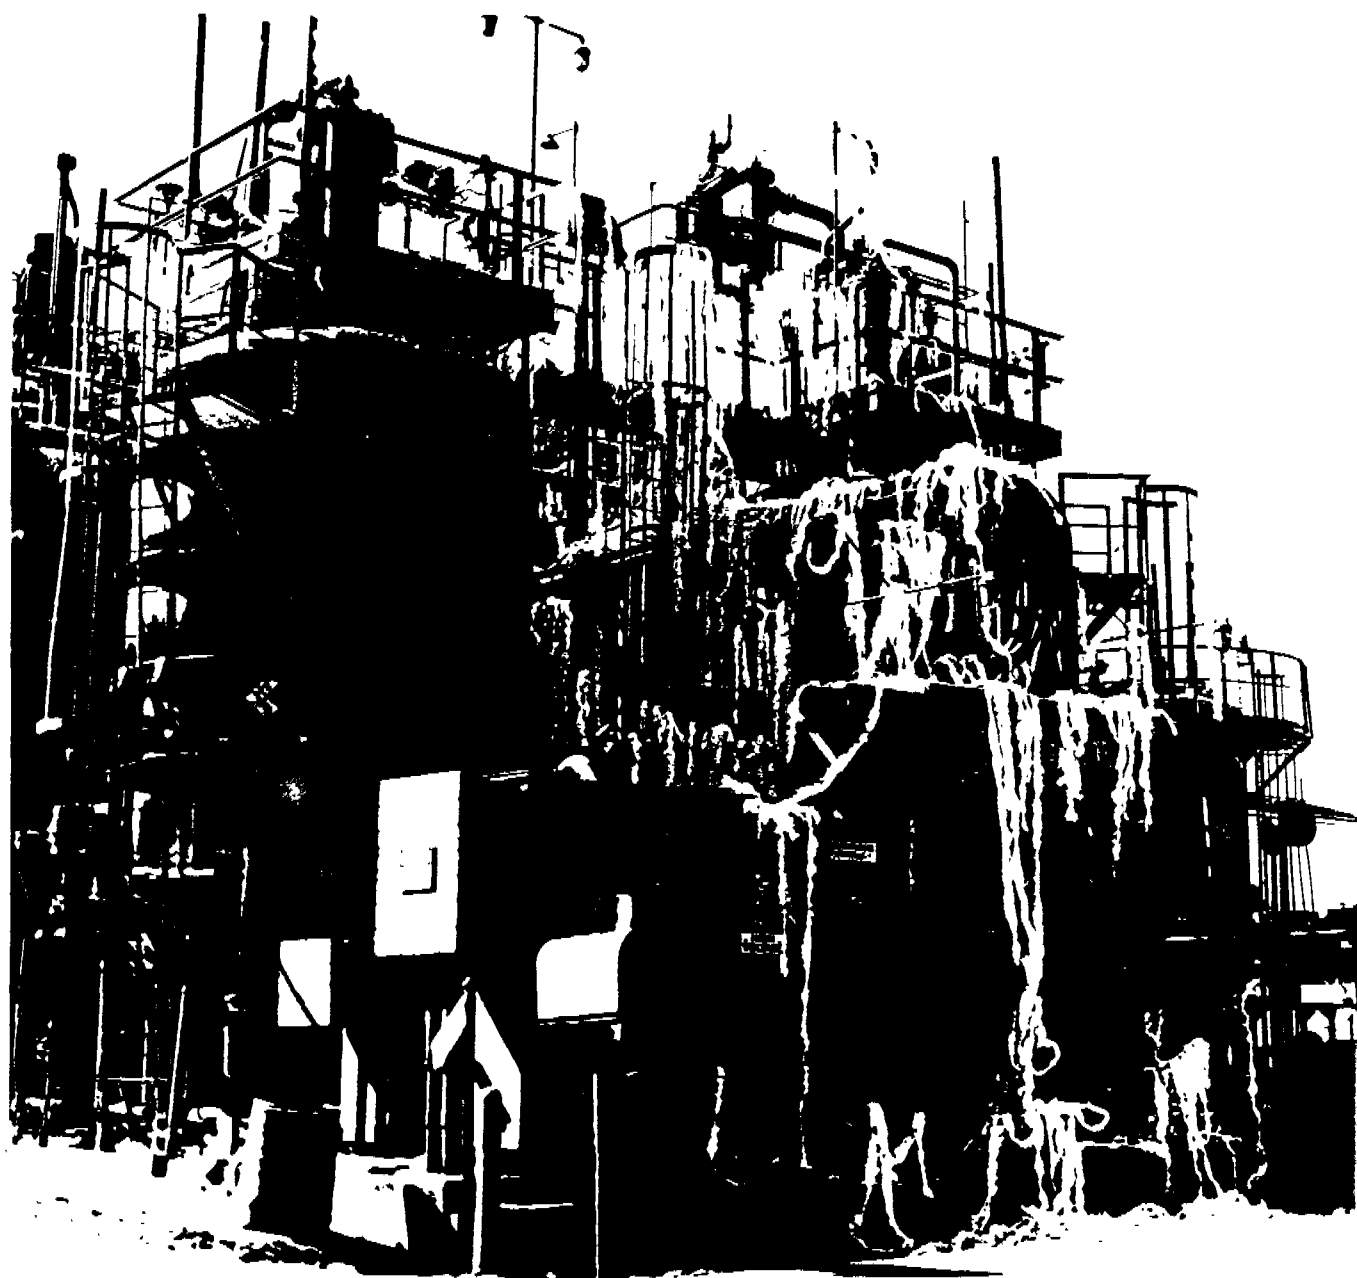
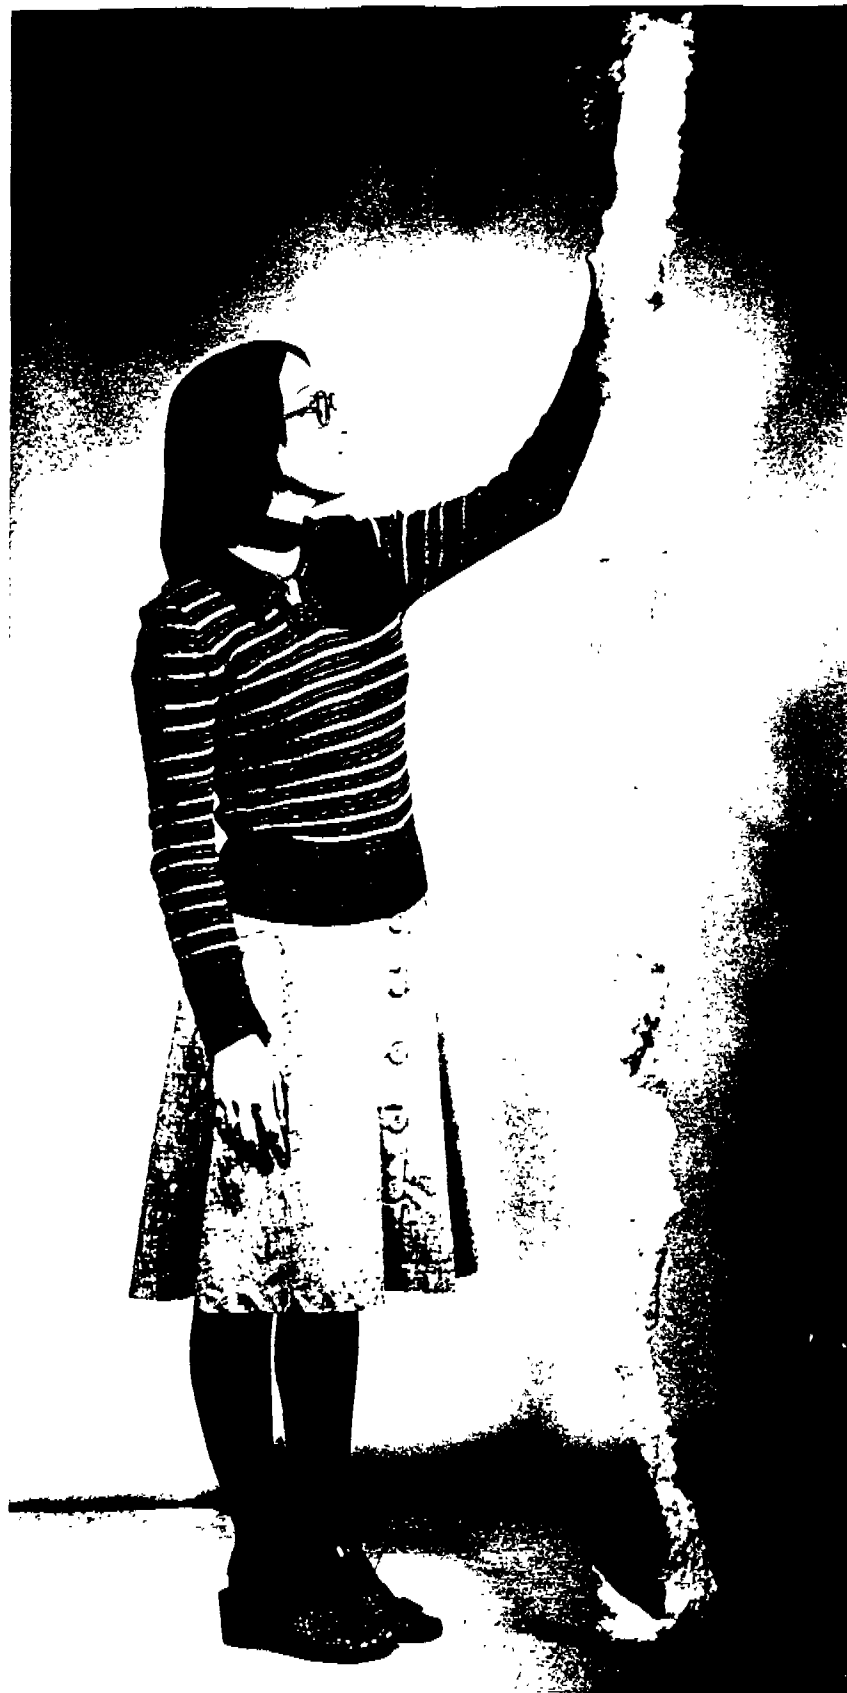
Enclosed please find the temperature/pressure recording chart for D-16 when it went out of control on the midnight shift, February 12. No inhibitor was added because the pressure reached the point where the additive system would not function. The technique for addition will be revised so that it can be added under any pressure. However, addition of an inhibitor will not always stop a reaction dead in its tracks and to assume that emergency venting can be eliminated is being naive. The rupture disk did not blow in this case, the operator opened the valve by hand to relieve the excess pressure. As you know, severe foaming always occurs under fast pressure release in a suspension autoclave and a lot of resin slurry passes out through the vent. The enclosed pictures tell the story of the resin that was released in this particular case. Under no condition would we want to try to vent in a situation like this to a gas holder. The line would plug, fouling the whole system with polymer.

We do not know why this autoclave went out of control. There was no problem immediately before or after this batch. It may have been a mischarge caused by an instrument malfunction that cannot be reconstructed.
