## Region 6 - Enforcement & Compliance Assurance Division

### INSPECTION REPORT

| Company Name: | <b>GCC Rio Grande, Inc.</b> | |
| Facility Name: | <b>Tijeras Plant</b> | |

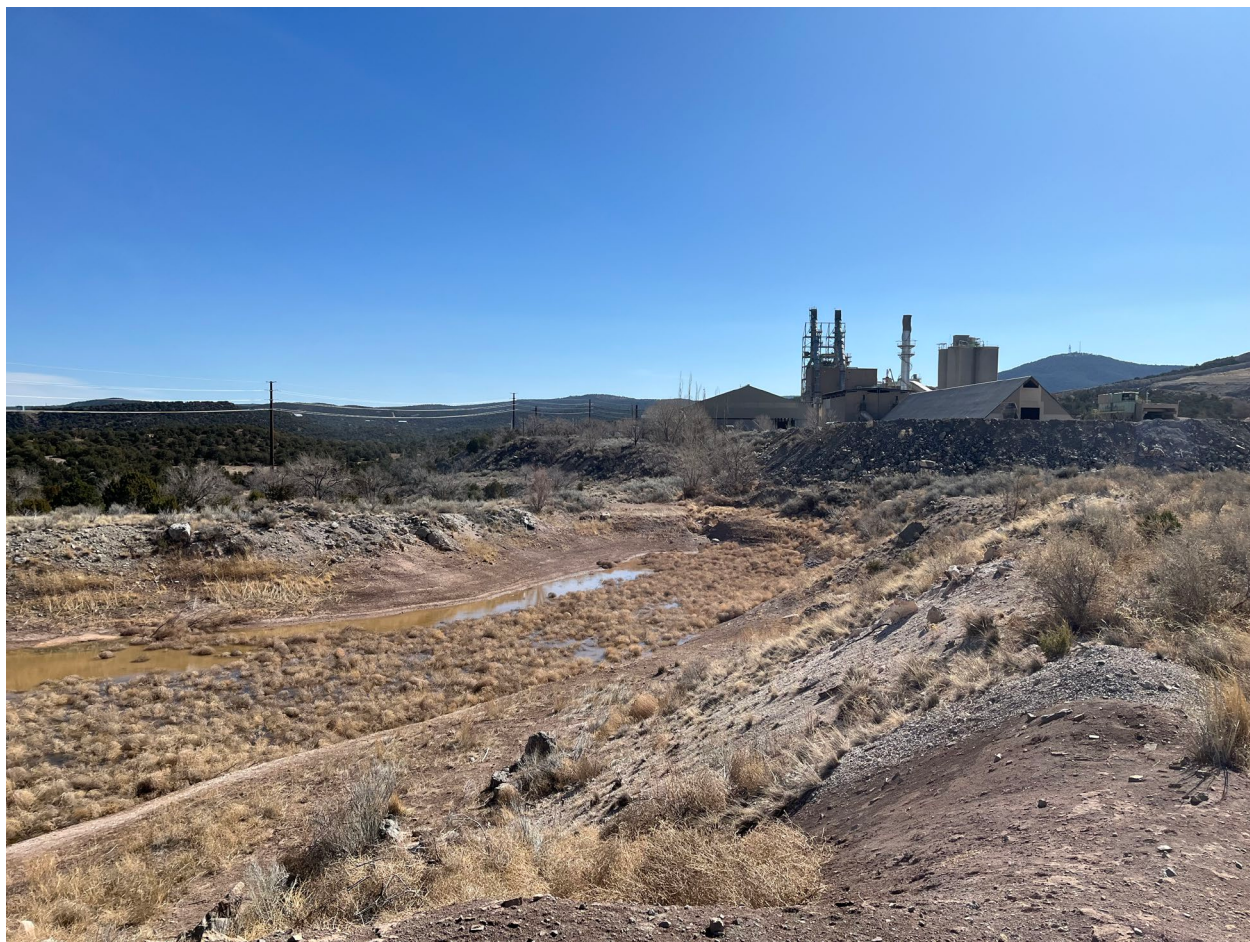
Photo No. 1

View of 4M-gallon earthen sediment pond looking approximately Southeast. (IMG\_0276). (Photographed 03/12/2025: 10:48 AM) Photographed by D. Esparza.

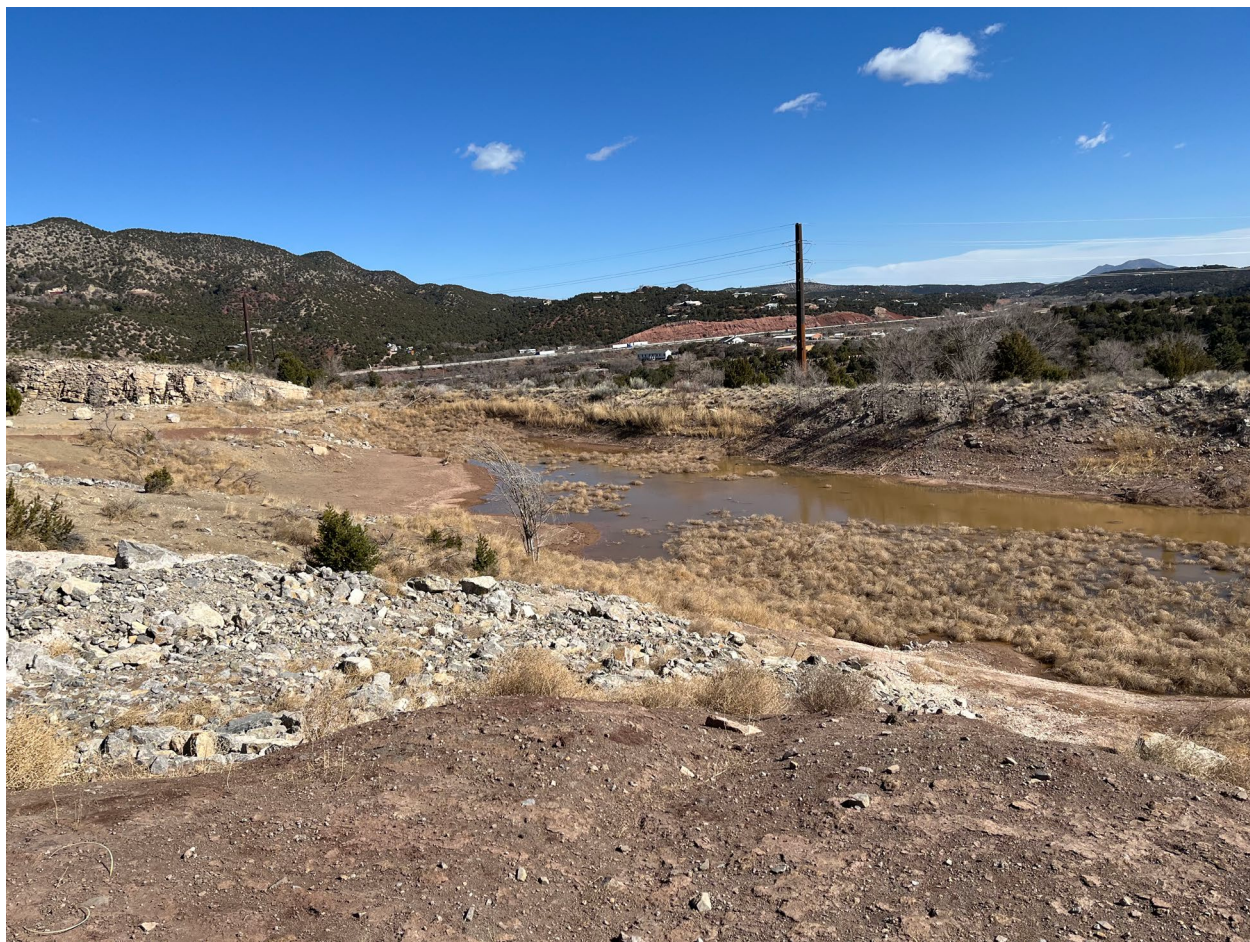
Photo No. 2

Another view of the 4m-gallon earthen sediment pond looking approximately Northeast towards Interstate-40 (I-40). (IMG\_0277). (Photographed 03/12/2025: 10:48 AM) Photographed by D. Esparza

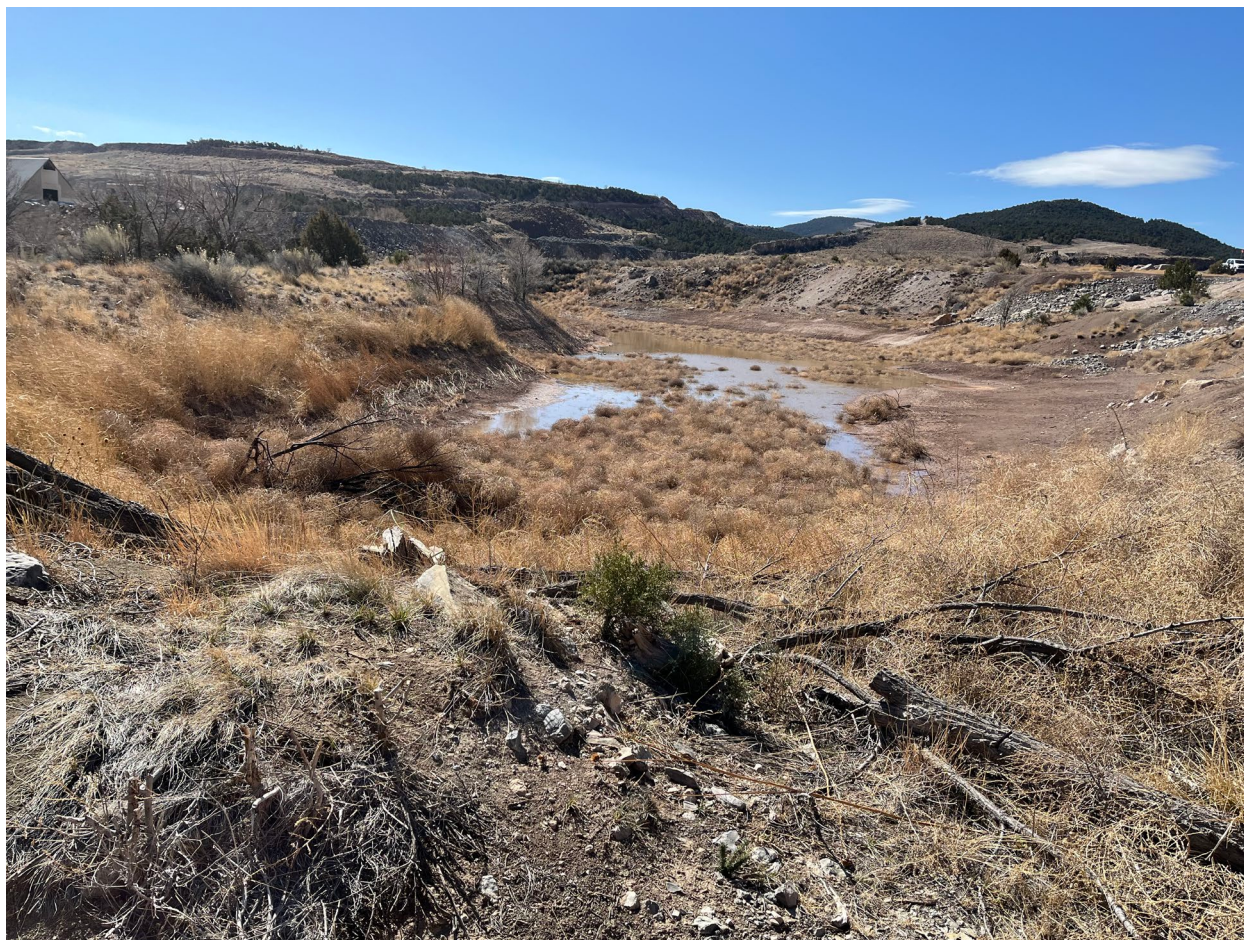
Photo No. 3

View of the 4M-gallon earthen sediment pond looking approximately Southwest. (IMG\_0278). (Photographed 03/12/2025: 10:52 AM) Photographed by D. Esparza

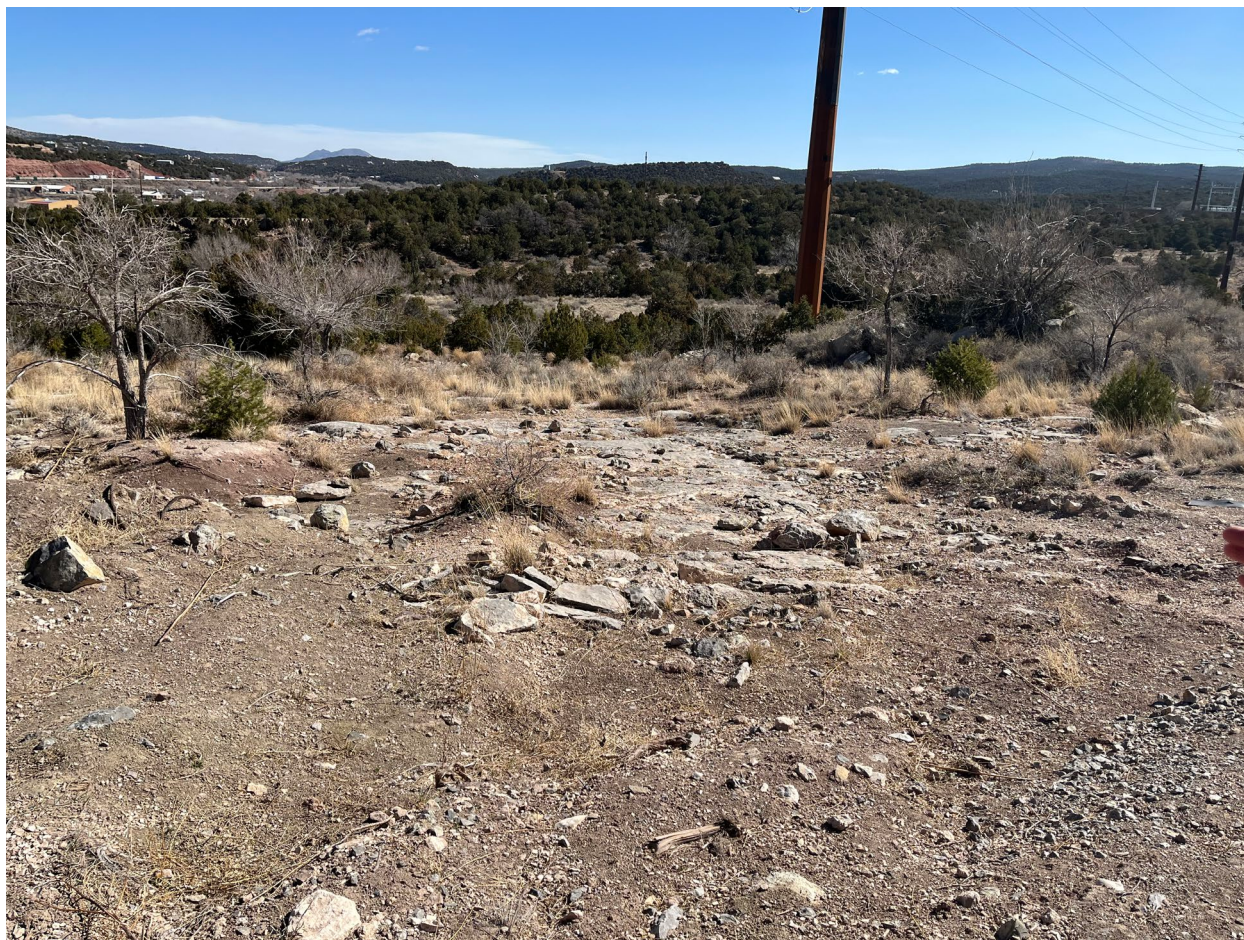
Photo No. 4

View from the berm of the 4M-gallon earthen sediment pond looking approximately Northeast towards Outfall 001 and I-40. (IMG\_0279). (Photographed 03/12/2025: 10:53 AM) Photographed by D. Esparza
