**U.S. Environmental Protection Agency  
Region 5**

**Purpose:** Clean Water Act National Pollutant Discharge Elimination System Compliance  
Evaluation Inspection

**Facility:** Hilltop Basic Resources, Inc.  
Downtown Cincinnati River Terminal  
511 W. Water Street  
Cincinnati, Ohio 45202

**Inspection Date:** May 24, 2023

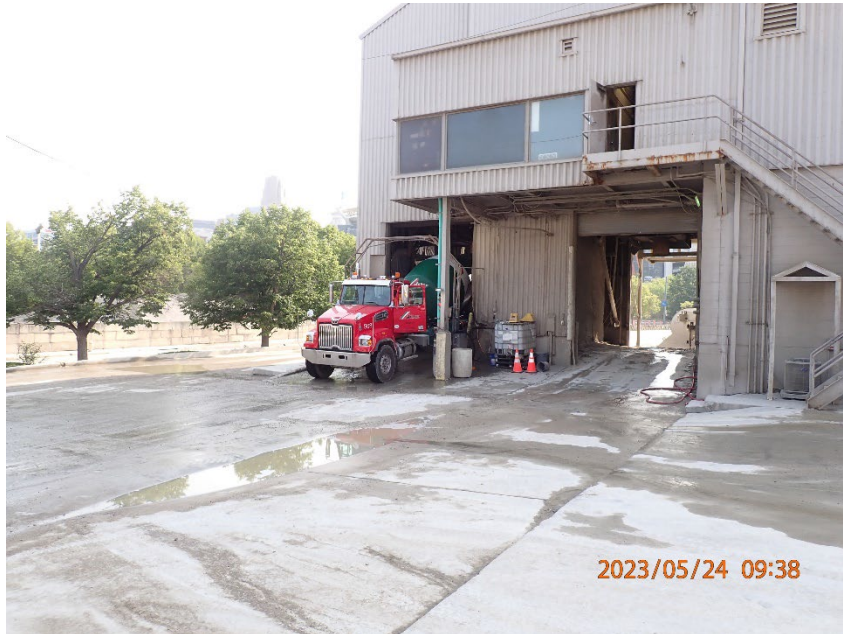
1: P5240021

- The Facility lacks stormwater and sediment controls along the front of the concrete truck loading station and the stormwater drains on Water Street. Sediment that had been rinsed off the concrete trucks had accumulated along the driveway to the loading station and around the stormwater drains (Photos 1 – 4, Photo 17).

Description: Concrete mixing truck getting washed while loaded with concrete

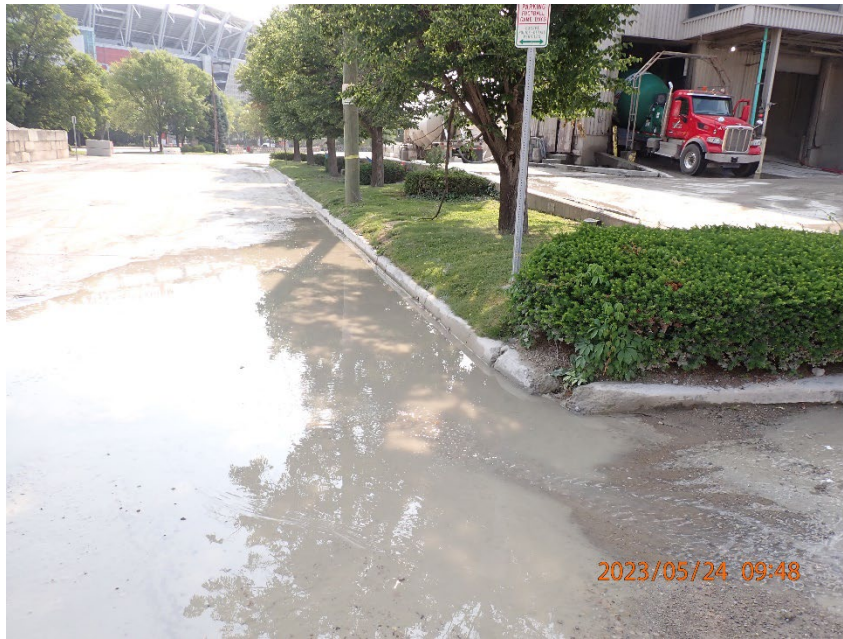
2: P5240022

Description: Runoff of water used to spray the concrete trucks

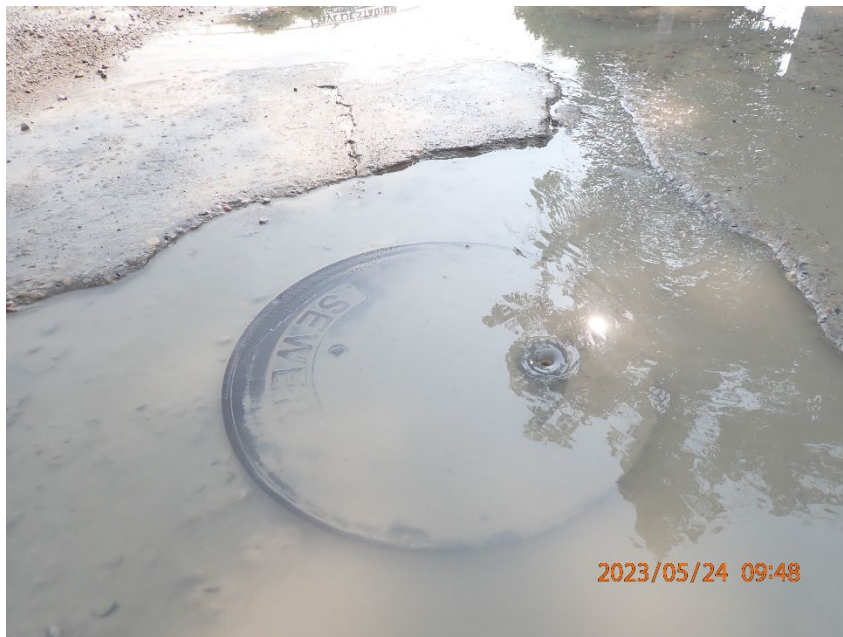
3: P5240023

Description: Truck wash runoff into the sewer manhole on Water Street

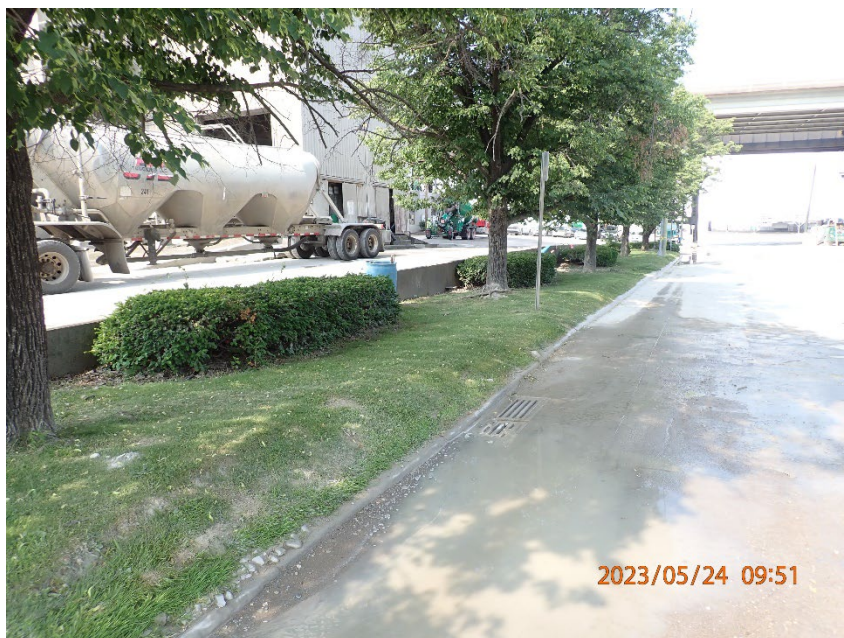
4: P5240024

Description: Runoff of water used to spray the concrete trucks, and location of where stormwater monitoring samples are taken.

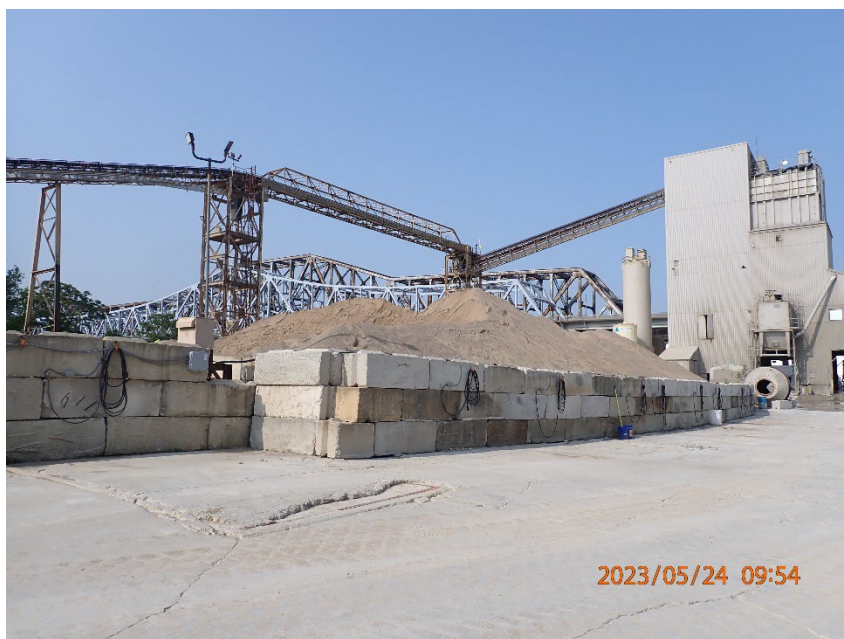
5: P5240025

Description: Sand pile behind concrete blocks

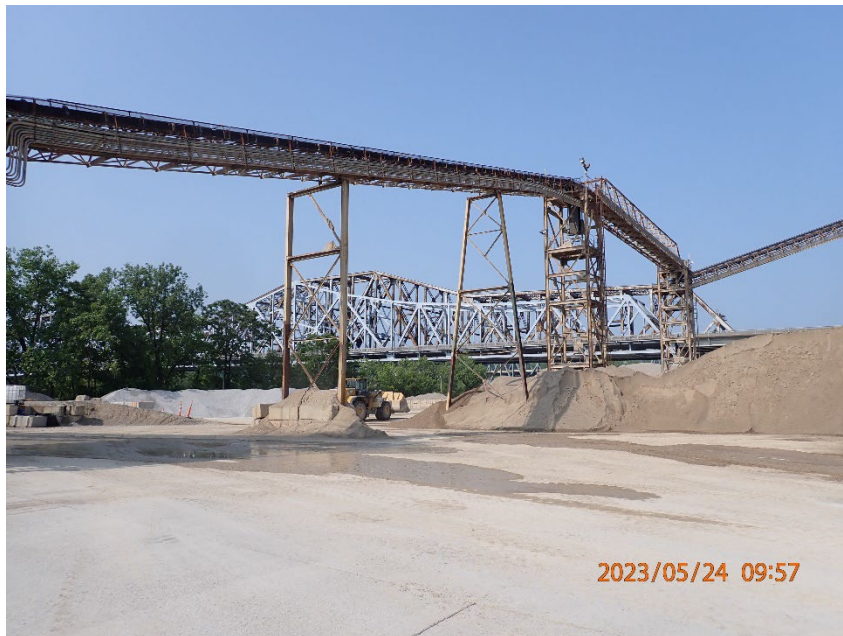
6: P5240026

Description: Stockyard and material conveyor belt

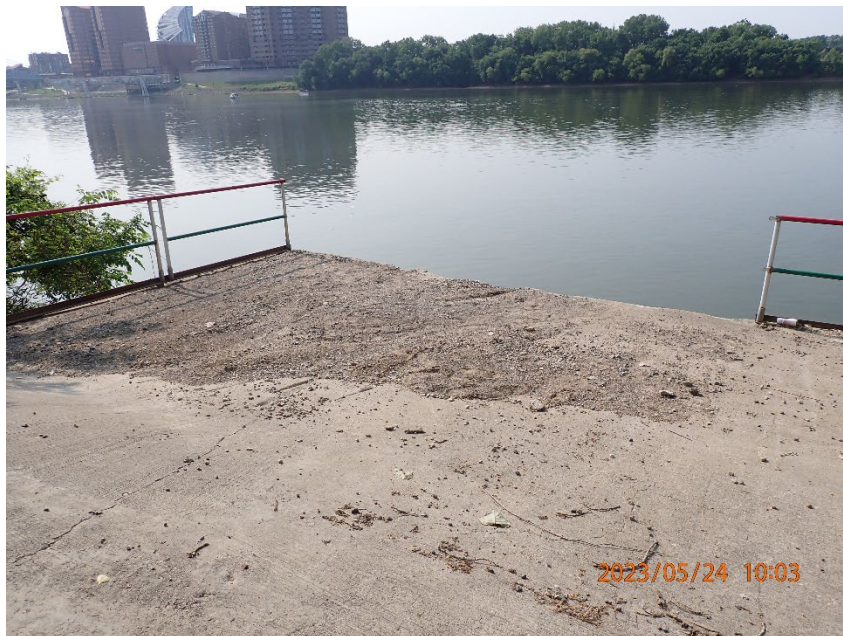
7: P5240027

- At the time of the inspection there was a pile of material spilled off the conveyor belt in the southeast corner of the Facility. According to the Facility, this excess material is removed after each barge is unloaded; however, at the time of the inspection, sediment and rock aggregate material had still accumulated in this corner (Photos 9 – 11). There were no stormwater or sediment controls to prevent this material from flowing down the ramp to the barge dock and into the Ohio River, where sediment and aggregate material had also accumulated (Photo 7 and Photo 8).

Description: Barge dock platform on the Ohio River with scraps of sand and gravel material

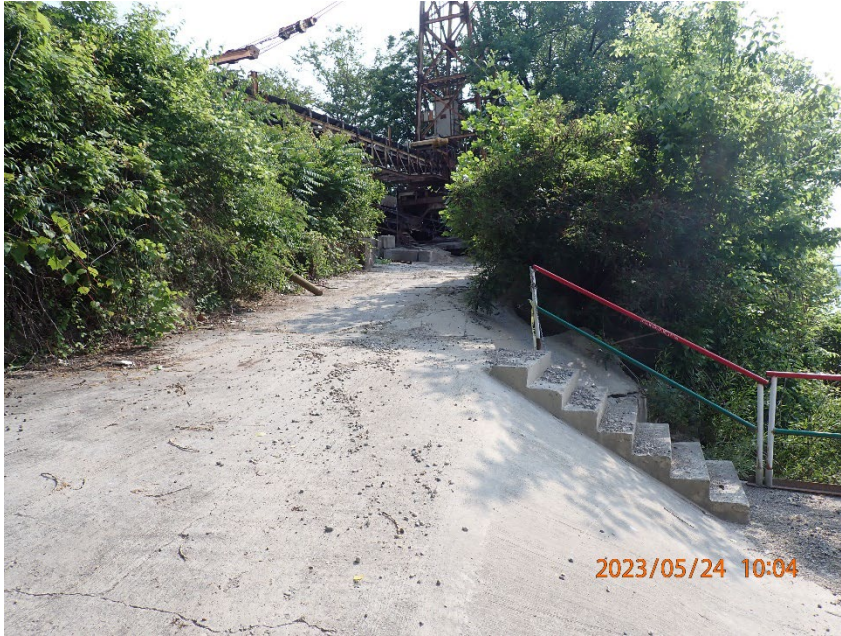
8: P5240028

Description: Ramp leading down from stockyard to barge loading platform

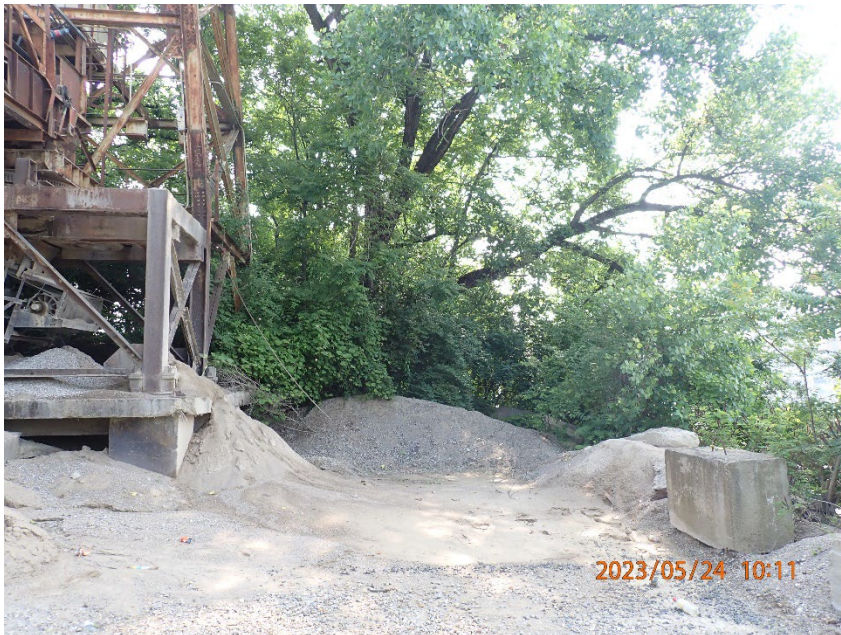
9: P5240029

Description: Corner containing piles of material spilled from the conveyor belt. Ohio River in background behind trees.

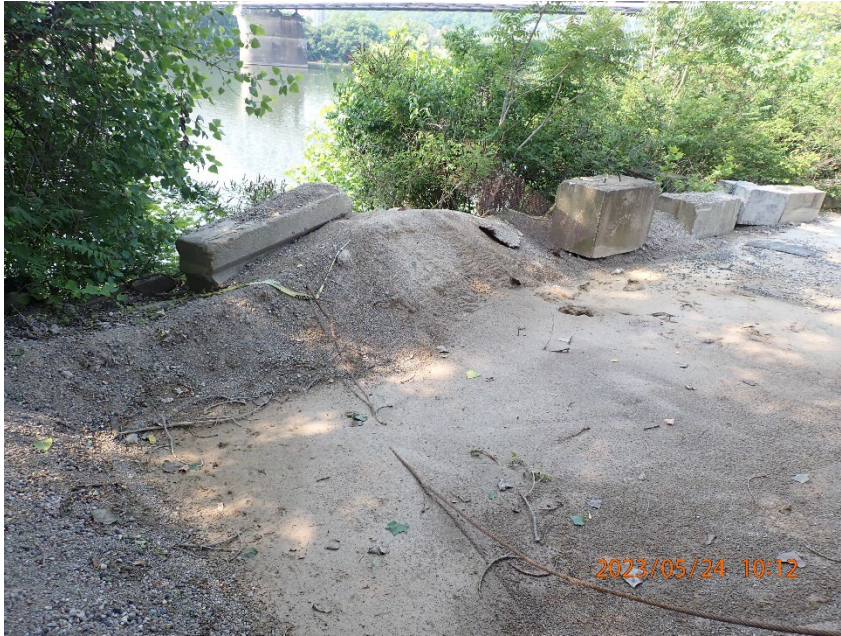
10: P5240030

Description: Spillage corner overlooking the Ohio River

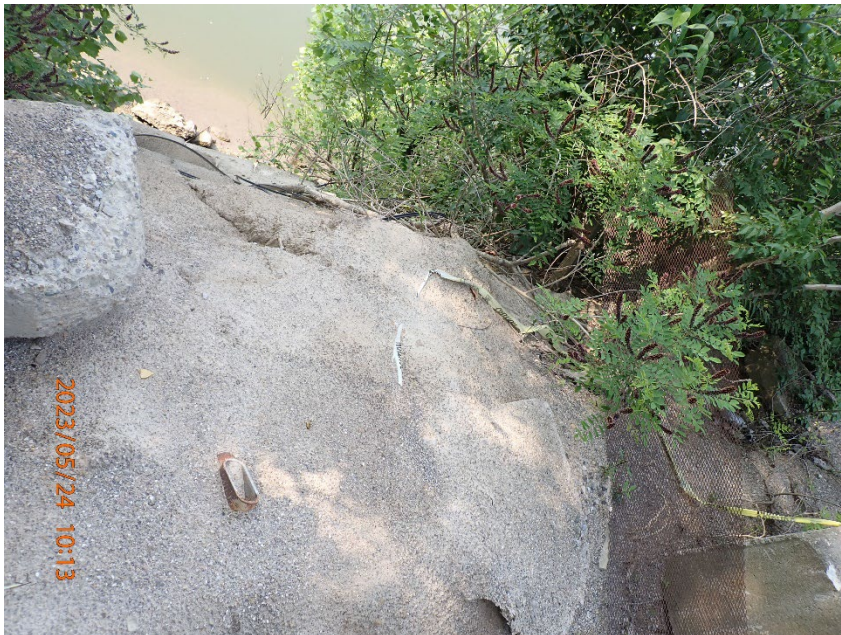
11: P5240031

Description: Edge of spillage corner directly above the Ohio River

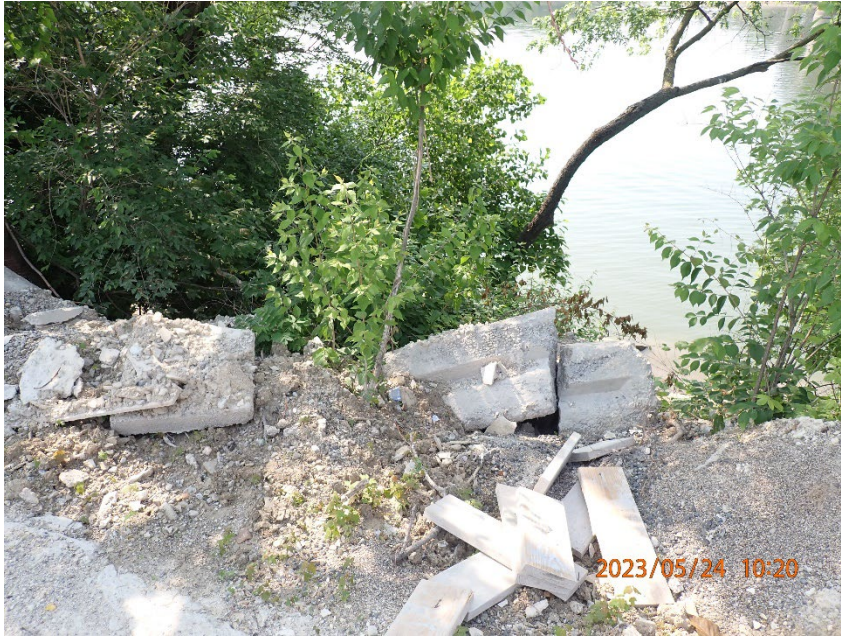
12: P5240032

- The southern edge of the Facility and the stockyard lacks stormwater control measures in several places, which allows excess material that is pushed up to the edge to fall down the steep surface leading down to the Ohio River (Photos 12 – 14).

Description: Scrap material along Southern edge of Facility directly above the Ohio River

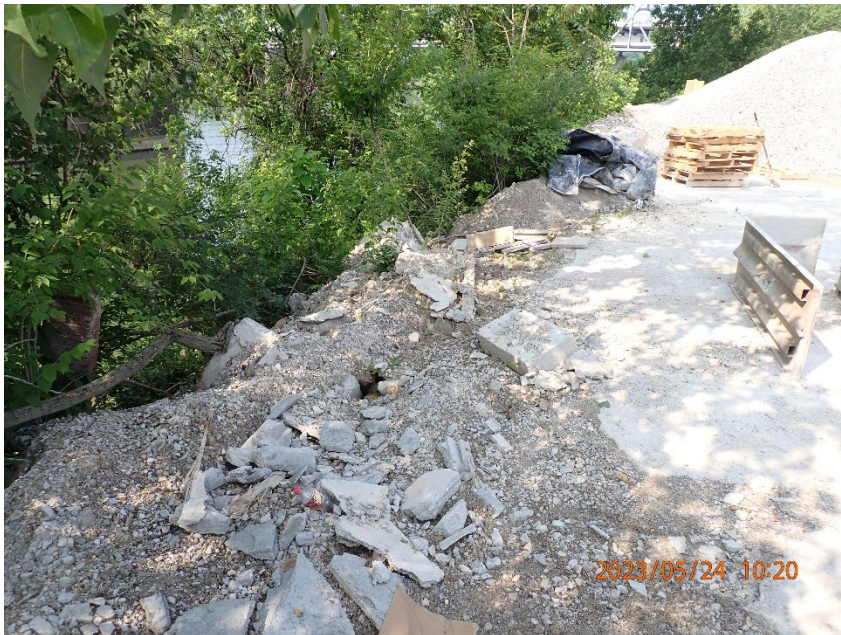
13: P5240033

Description: Scrap material along southern edge of Facility directly above the Ohio River

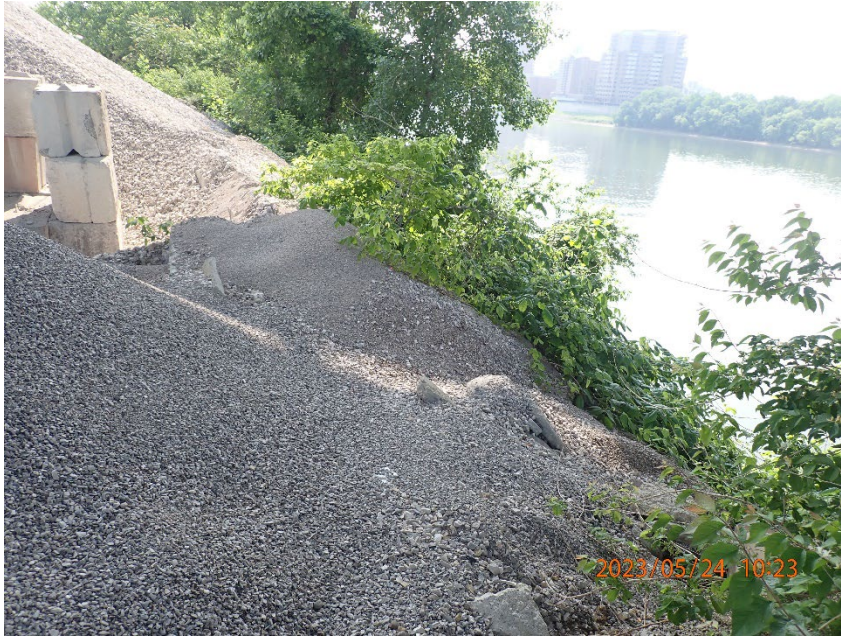
14: P5240034

Description: Edge of stockyard

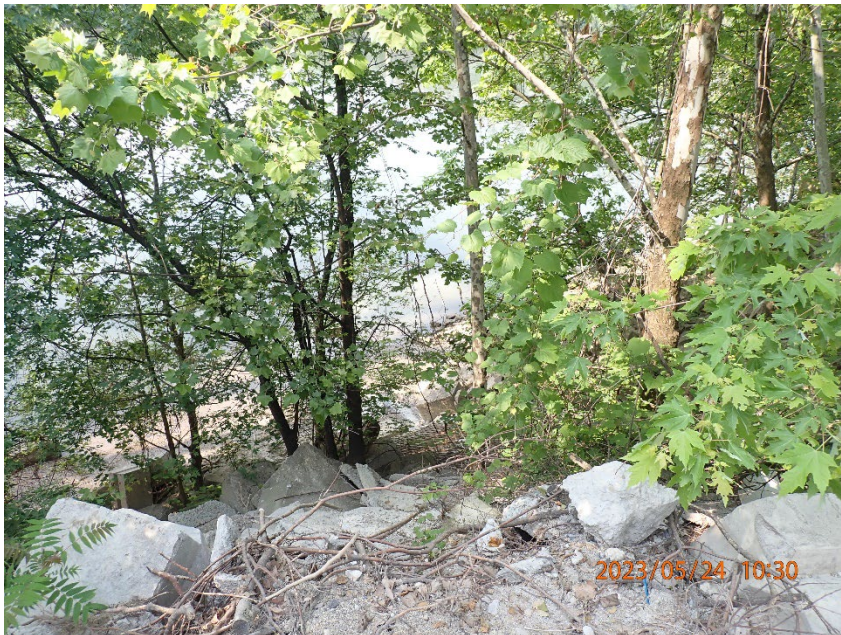
15: P5240035

Description: Unknown outfall near southwest corner of Facility

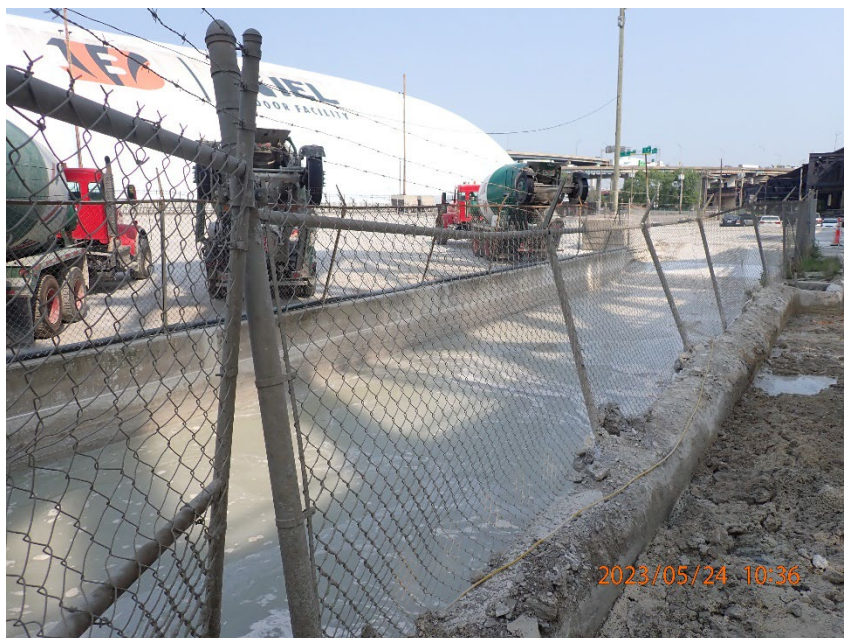
16: P5240036

- A pump house uses water to rinse out the inside of the drums of the mixer trucks. This water is contained in two pits, to be continually reused onsite for this purpose, and is not discharged (Photo 16).

Description: Mixer truck rinse water

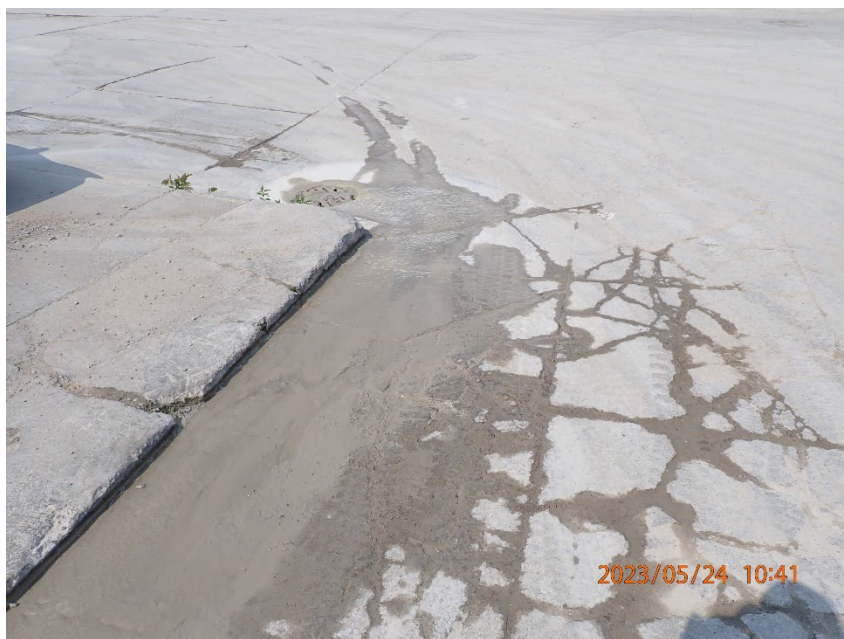
17: P5240037

Description: Truck wash runoff entering storm drain
