**Region 6 - Enforcement & Compliance Assurance Division**  
**INSPECTION REPORT**

| Inspection Date(s): | 06/27/2024 | |
| Company Name: | CapturePoint, LLC | |
| Facility Name: | North Burbank Unit (NBU) 31 Battery | |

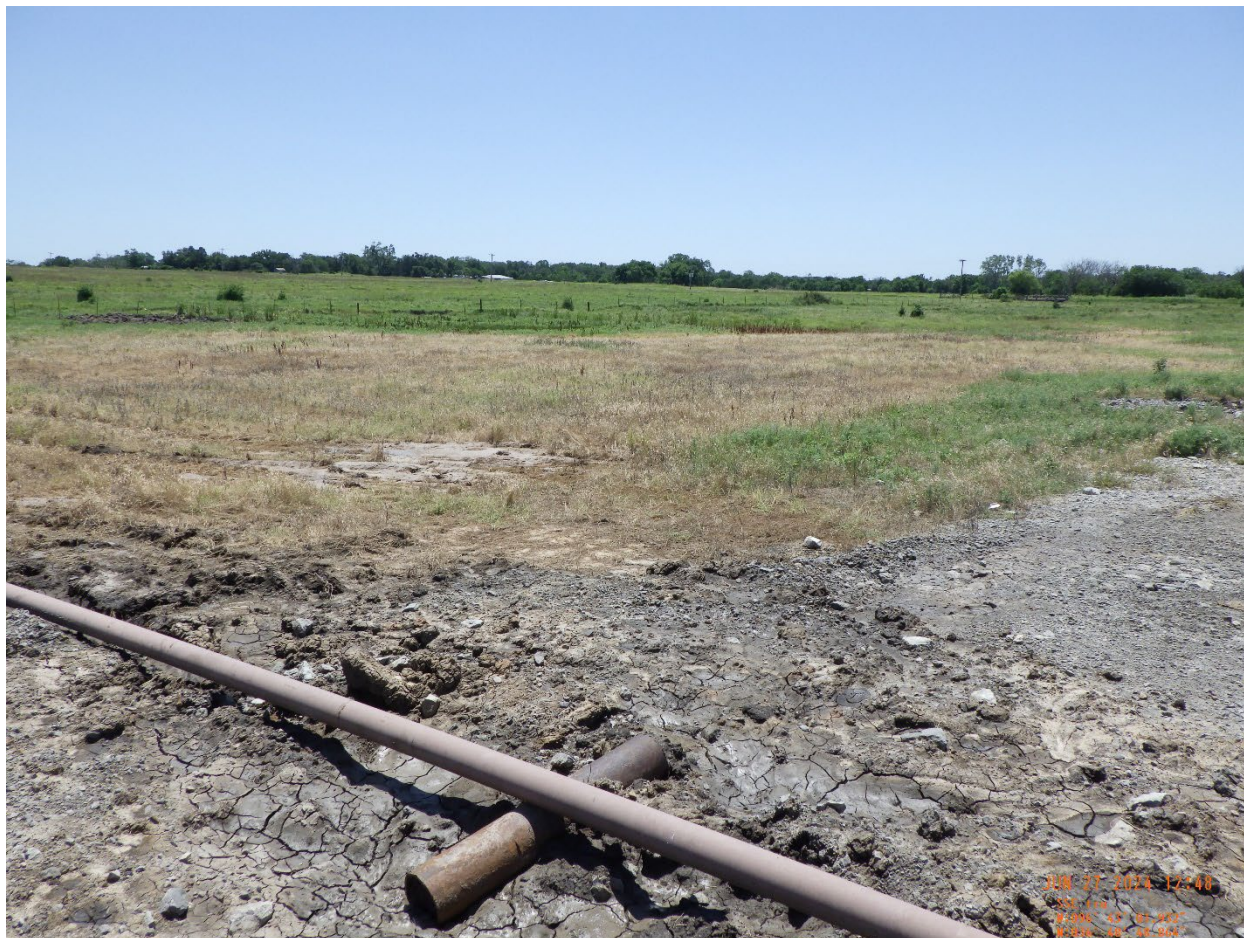
Photo No. 1

I observed the release point of the spill. At the time of the inspection, the 4-inch steel line which failed had been repaired by replacing the failed joint of pipe. I observed dead grass near the release point which extended to the southeast toward the unnamed tributary of Hay Creek. See Appendix 1, photo No. 1. For additional location information and photo metadata, see Appendix 1 (photo log).

**Description:** This was the release point of the spill. At the time of the inspection, the equipment failure had been repaired by installation of a new join of pipe. The spill release brine onto the land surface, migrating SSE to an unnamed tributary of Hay Creek.

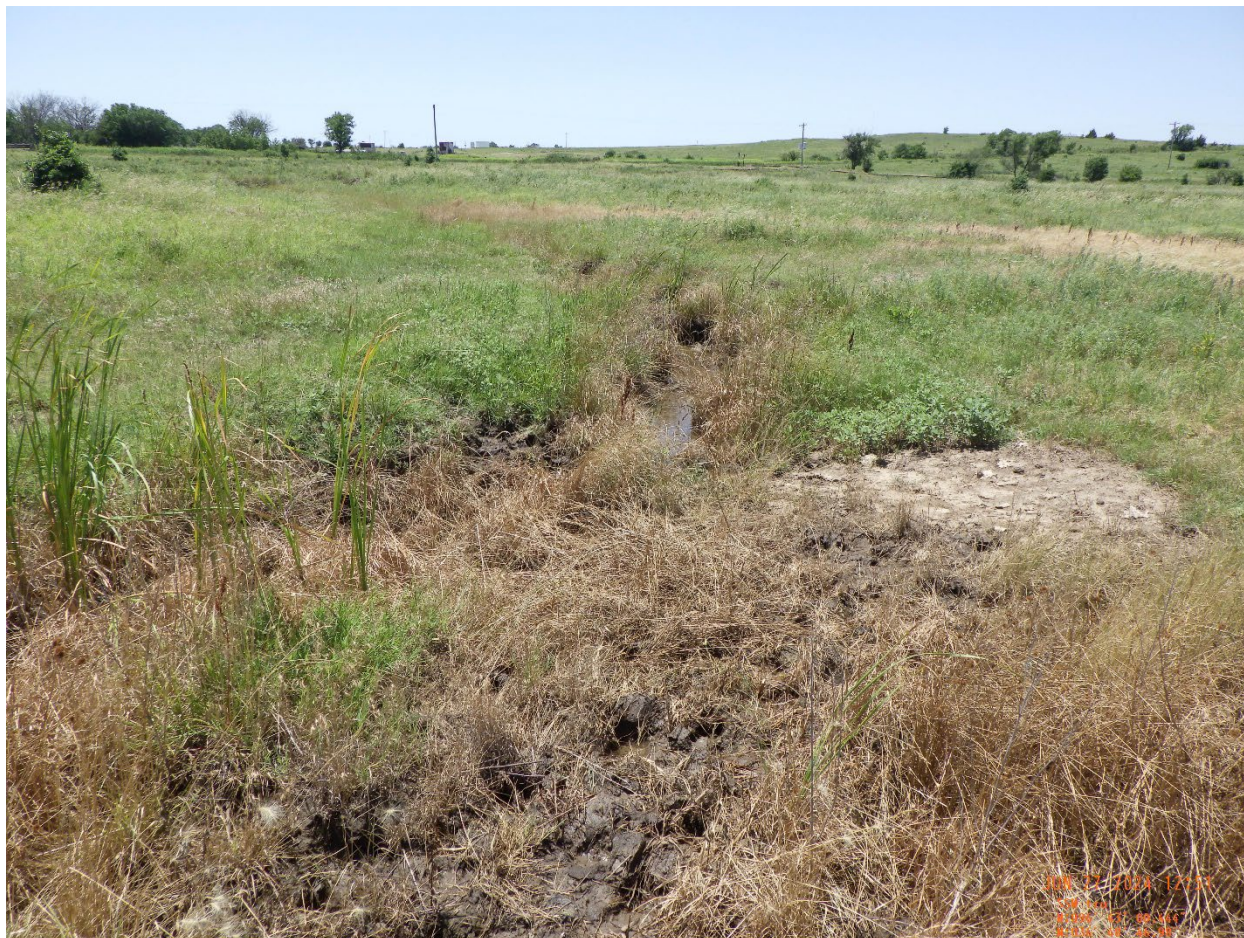
Photo No. 2

I observed the point of entry (POE) into the unnamed tributary of Hay Creek. I observed impacted vegetation near the POE and along the impacted tributary. See photo No. 2.

**Description:** This was the point of entry (POE) into the unnamed tributary of Hay Creek.

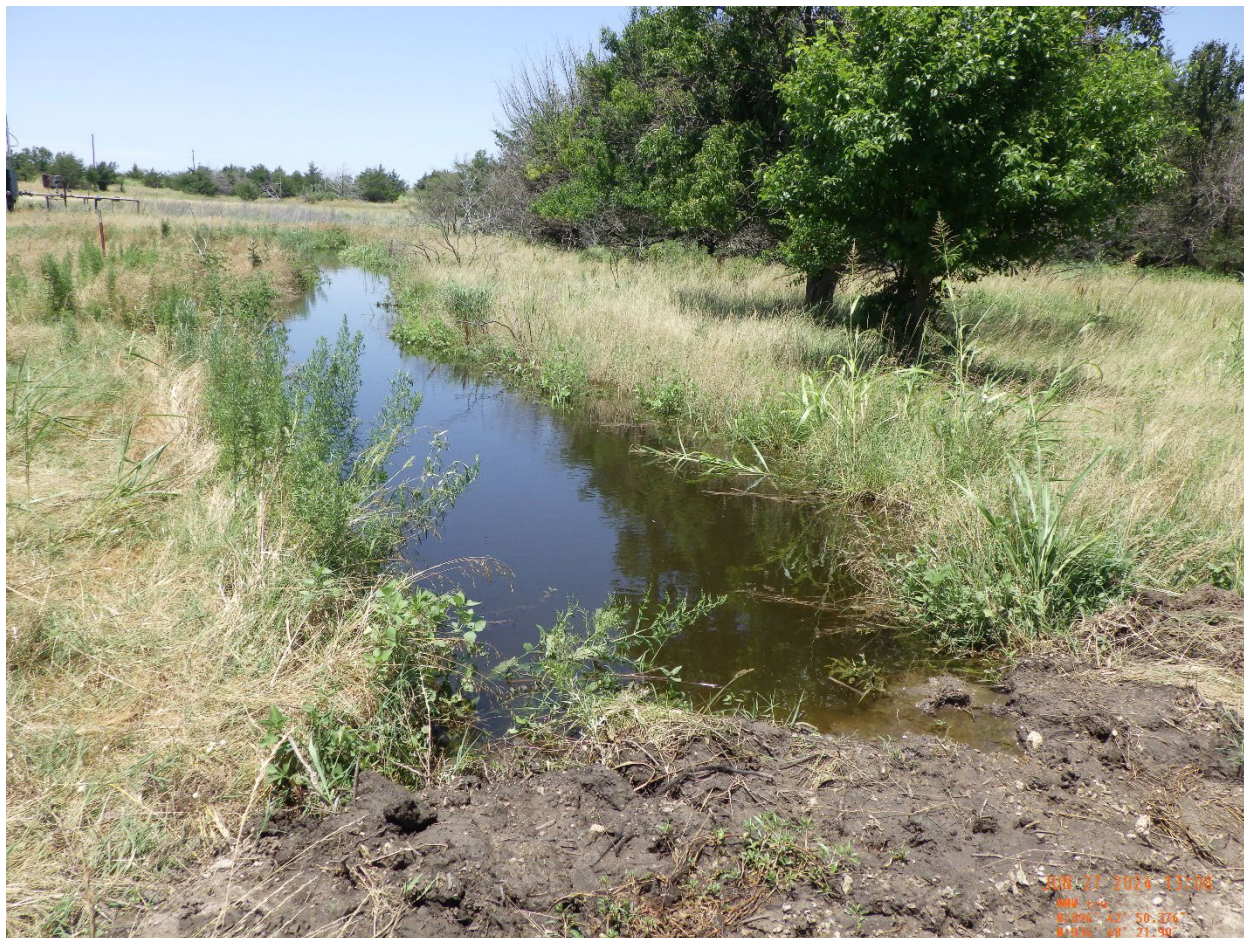
Photo No. 3

I observed the end of spill impacts and the lowermost containment dam which had been placed by the operator to prevent downstream migration of spill impacts. See photo No. 3.

**Description:** This was a temporary containment dam placed by the operator to prevent downstream migration of spill impacts. This was the end of spill impacts at the time of the inspection.
