**Region 6 - Enforcement & Compliance Assurance Division**  
**INSPECTION REPORT**

| Regulatory Program(s) | Clean Water Act – National Pollutant Discharge Elimination System | |
| Facility Name: | <b>Katie Hurst, Water Well</b> | |

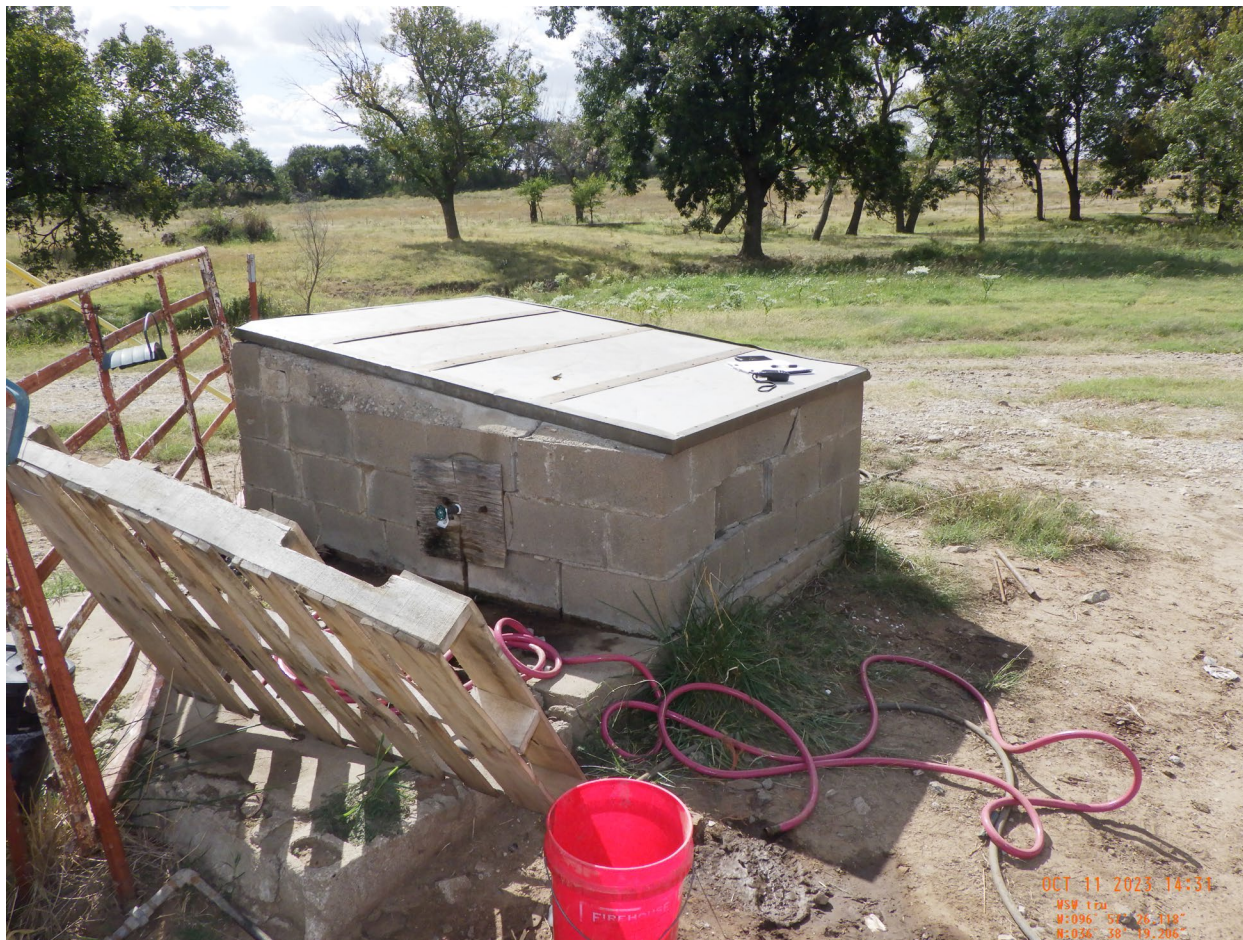
Photo No. 1

I observed the concrete and metal housing which contained the hand dug water well. The owner stated the well was approximately 5-6 feet in diameter and they were uncertain about the depth of the well. The water well structure can be seen in photo No. 1 of Appendix 1 (photo log) which is attached to this report. GPS and other metadata are also available in the photo log.

**Description:** This was a photo of the structure which housed the hand dug water well.

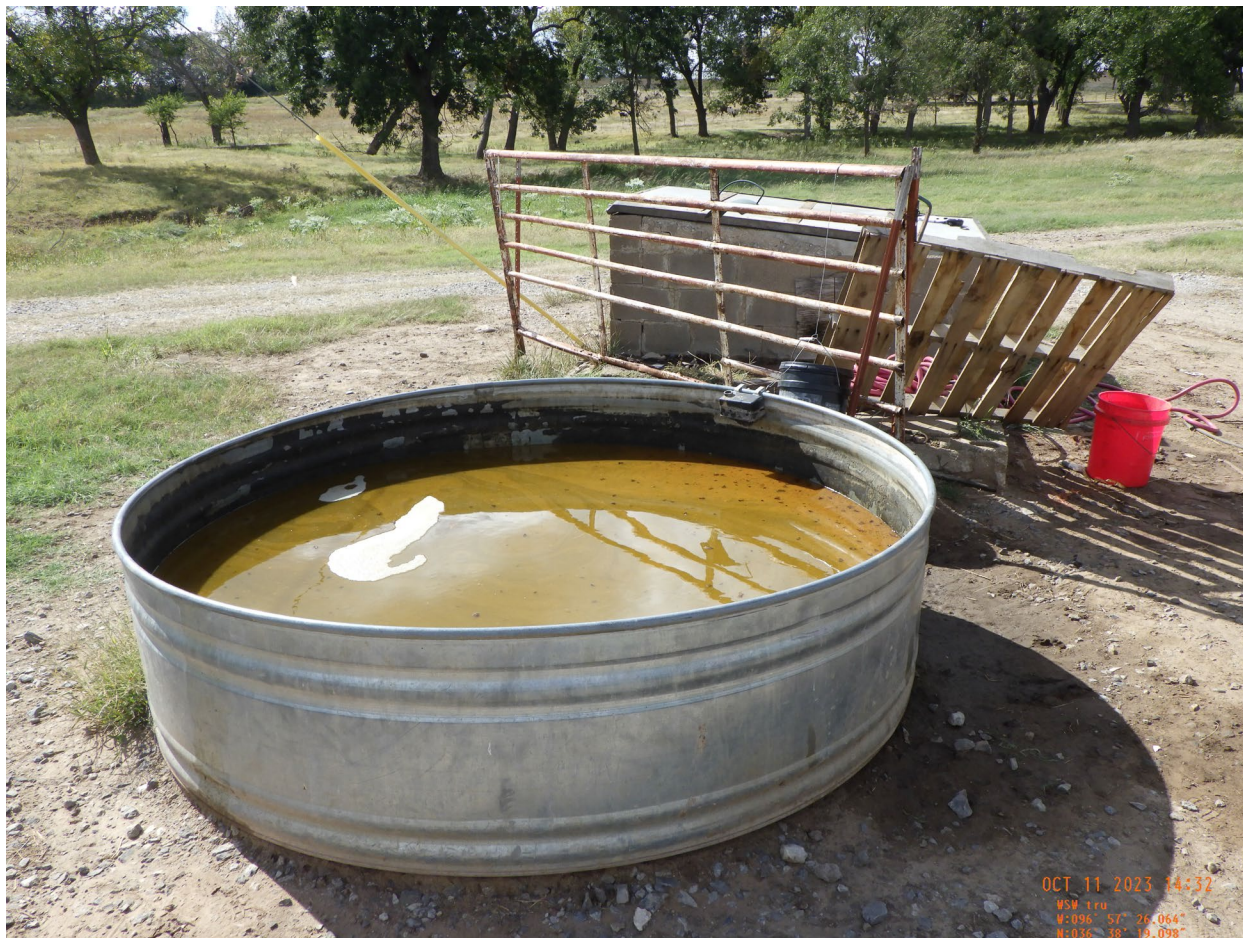
Photo No. 2

I observed a round 6–8-foot diameter water trough immediately adjacent to the water well. The landowner stated the water trough had been filled from the water well, and at the time of the inspection the water trough had a layer which looked, felt, and smelled like diesel fuel, approximately ¼ to ½ inch in depth floating atop the water in the trough. The trough and presumed diesel layer can be seen in photos No. 2 & 3.

**Description:** This was the water trough immediately adjacent to the contaminated water well. At the time of the inspection there was an estimated  $\frac{1}{4}$  to  $\frac{1}{2}$  inch thick layer which appeared to be diesel fluid floating atop the water in the trough. There was a strong smell of diesel fuel at the water tank.

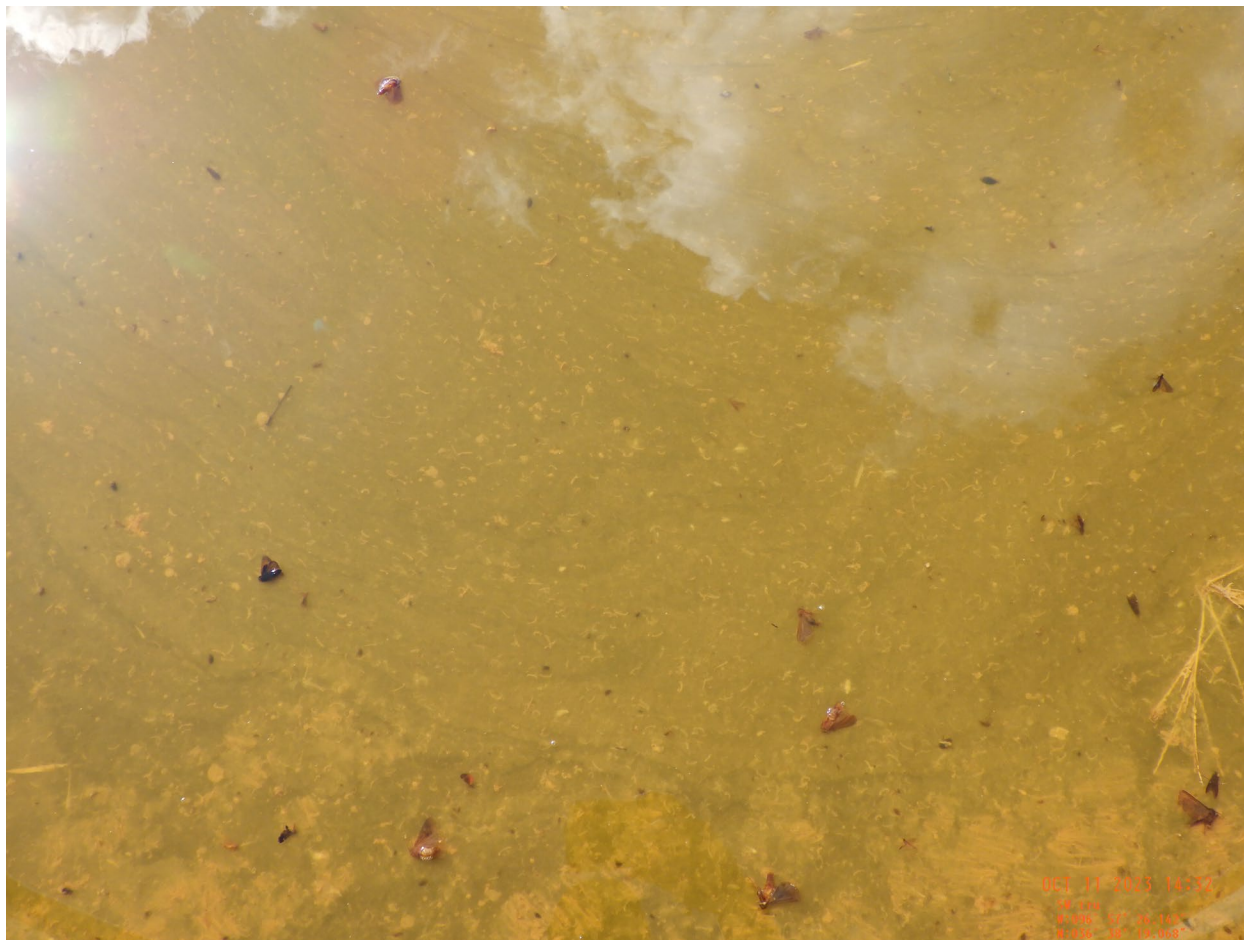
Photo No. 3

**Description:** This was a photo of the diesel-like floating in the water trough. The yellow/brown color was an emulsion layer where the water and presumed diesel fluid met in the trough. The landowner stated this layer of diesel was red at the time of discovery on October 09, 2023.
