**Region 10 Enforcement and Compliance Assurance Division**  
**1200 6th Avenue**  
**Seattle, WA 98101**  
**INSPECTION REPORT**

| <b>Site Name:</b> | Movado Subdivisions No. 5, 7, and 9 | |

*Movado Subdivision No. 5, 7, and 9*  
*Construction Stormwater Inspection Report*

*Inspection Date: February 25, 2021*

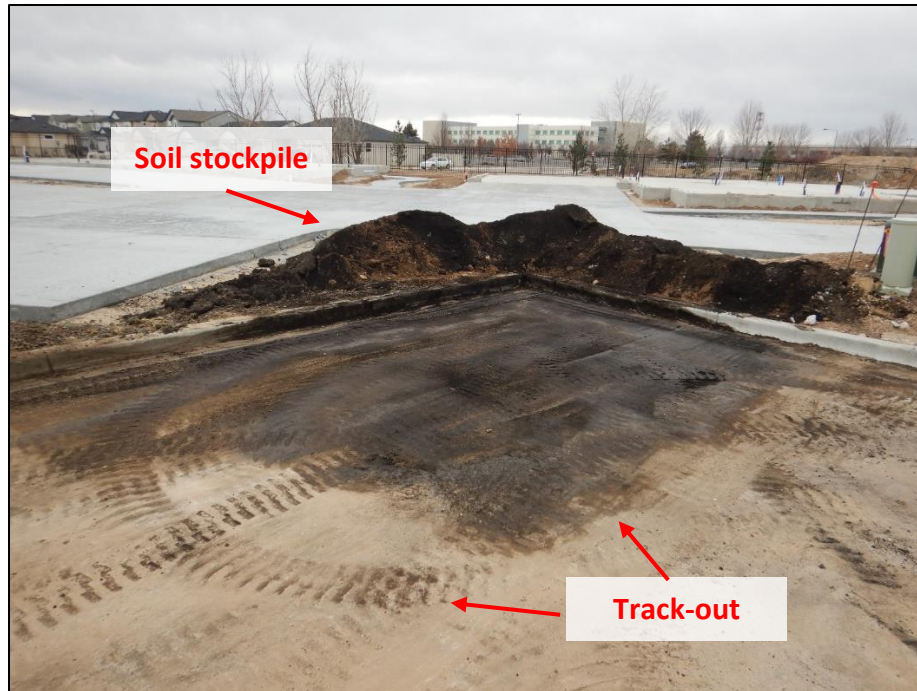
We observed an uncontained soil stockpile along the northwest perimeter of the Site in Phase 5 adjacent to an impervious area. The stockpile appeared to contribute to sediment track-out onto the pavement around it and lacked sediment barriers along the downgradient perimeter areas of the roadway (refer to Attachment A, Photograph 1).

We also observed sediment track-out around the soil stockpile located on the northwestern perimeter of Phase 5 on a roadway and the gravel and soil stockpile located on the eastern portion of the Site in Phase 7 on South Movado Way (refer to Attachment A, Photographs 1 and 3).

**Photograph 1.** View, facing southwest, of a soil stockpile located on the northwestern perimeter of Phase 5 on a roadway. The stockpile did not have a sediment barrier installed downgradient. Note the track out surrounding the soil stockpile.

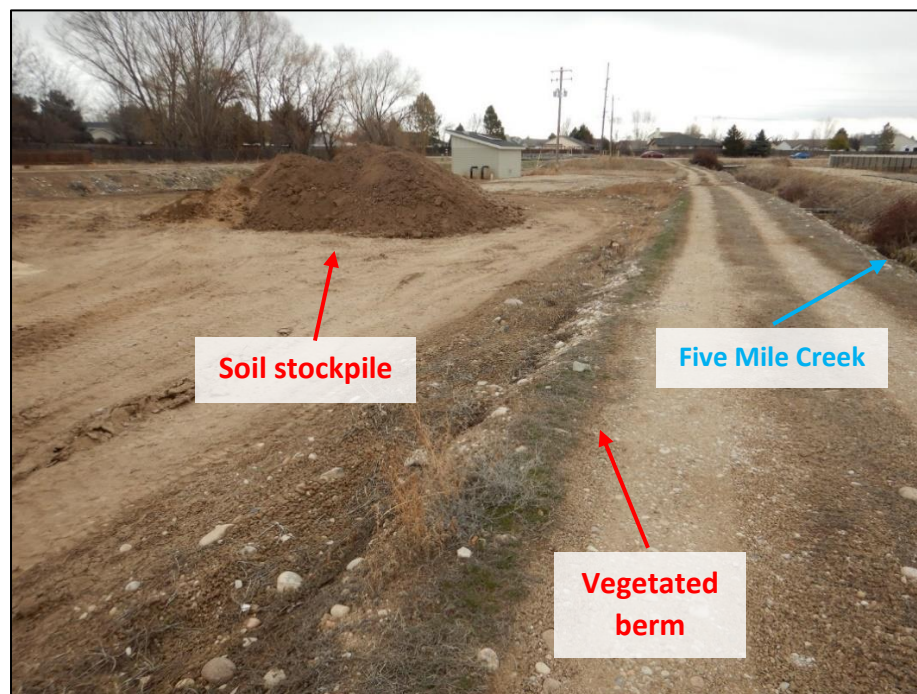
We also observed one unstabilized soil stockpile along the western perimeter of Phase 7 that was surrounded by a vegetated berm (refer to Attachment A, Photograph 2).

**Photograph 2.** View, facing south, of an unstabilized stockpile of soil located on the western perimeter of Phase 7. The soil stockpile was surrounded by a vegetated berm.

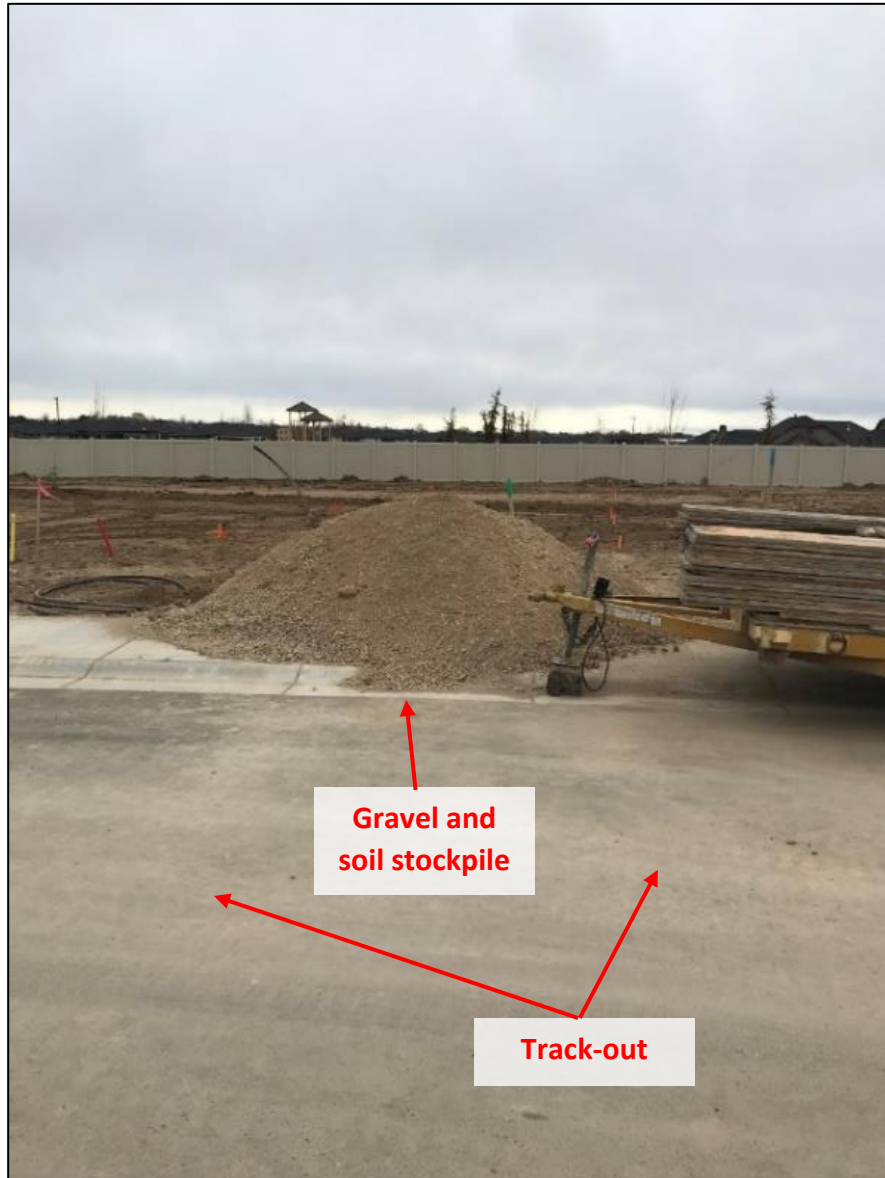
Additionally, we observed one unstabilized gravel and soil stockpile along the eastern area of Phase 7 on South Movado Way. The stockpile appeared to contribute to sediment track-out onto the pavement around it and lacked sediment barriers along the downgradient perimeter area (refer to Attachment A, Photograph 3).

**Photograph 3.** View, facing east, of a gravel and soil stockpile located on the eastern area of the Site in Phase 7 on South Movado Way. The soil stockpile did not have a sediment barrier installed on the downgradient perimeter areas on the roadway and appeared to be contributing to track-out on the surrounding roadway.

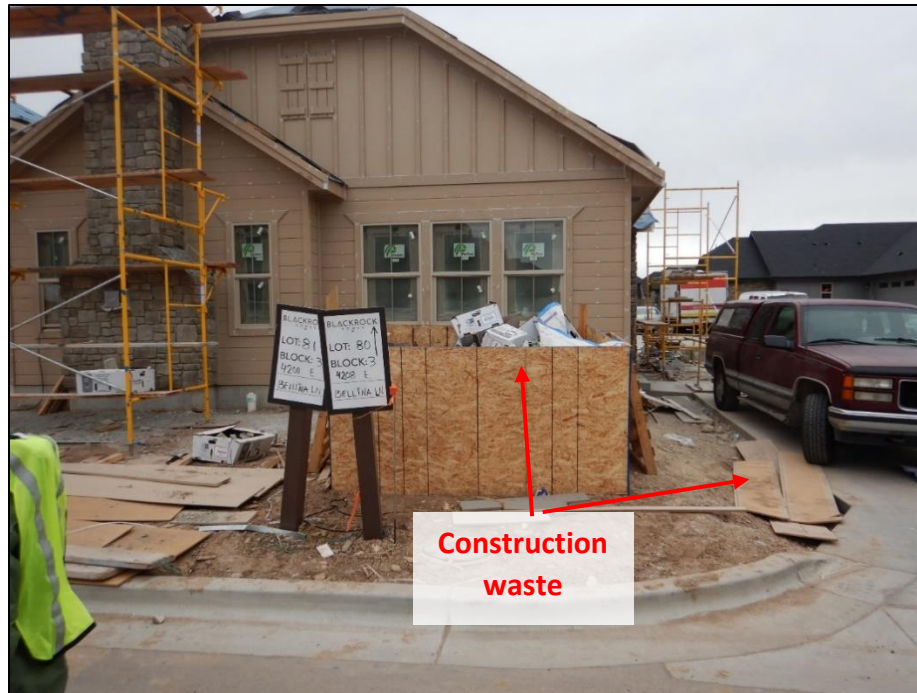
We observed construction waste and debris in an uncovered plywood container outside home building site lot 80 in Phase 5. Additionally construction waste was observed on the ground adjacent to the plywood container (refer to Attachment A, Photograph 4).

**Photograph 4.** View, facing west, of a pile of construction waste and debris in an uncovered plywood container located on the northern perimeter of Phase 5 in lot 80.

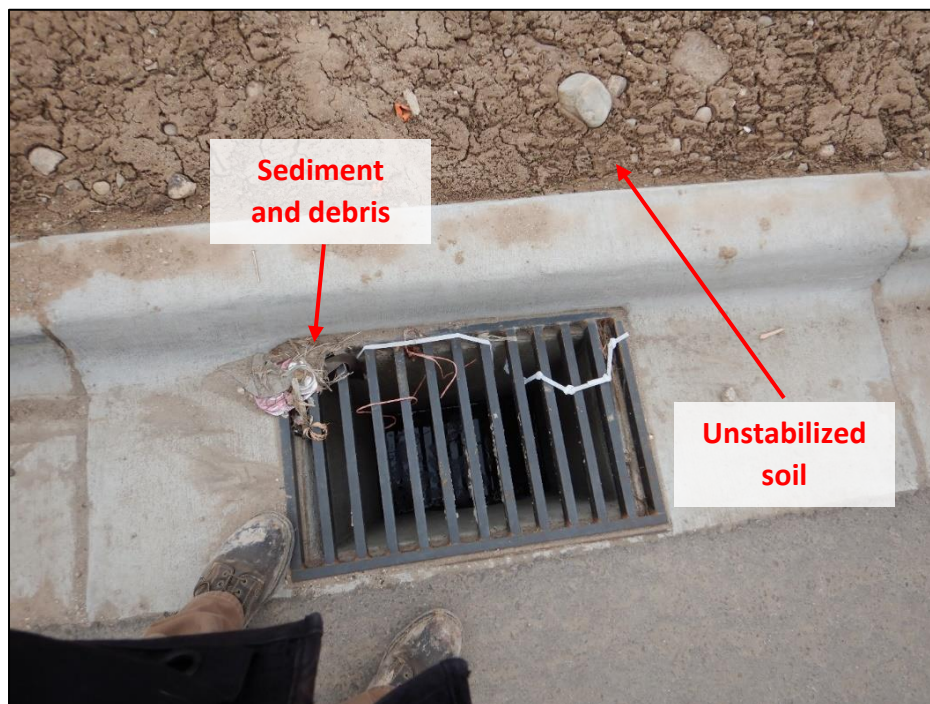
We observed sediment and debris and unstabilized soil adjacent to a storm drain inlet located on a paved roadway along the north-central perimeter of Phase 5. The storm drain inlet discharges to two seepage beds in Phase 5. We did not observe any inlet protections inside the storm drain inlet (refer to Attachment A, Photographs 5, 6, and 7).

**Photograph 5.** View of sediment and debris collected adjacent to a storm drain inlet and unstabilized exposed soil located along a roadway at the north-central perimeter of Phase 5. No BMP inside the inlet was observed. The inlet leads to two seepage beds located in Phase 5.

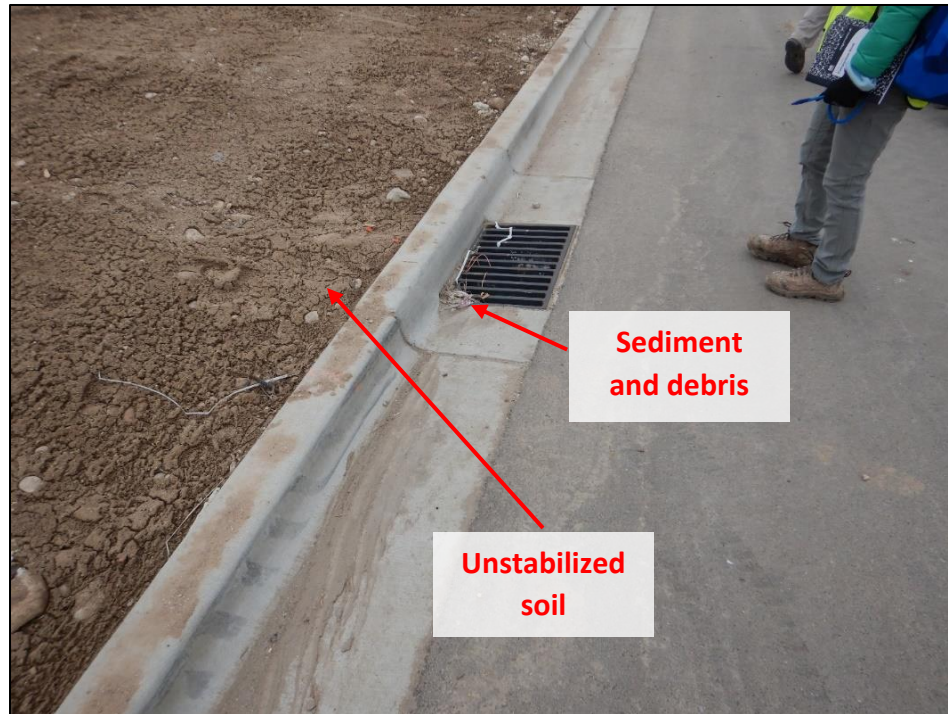
**Photograph 6.** Another view, facing south, of sediment and debris collected adjacent to a storm drain inlet and unstabilized exposed soil located along a roadway at the north-central perimeter of Phase 5. No BMP inside the inlet was observed.

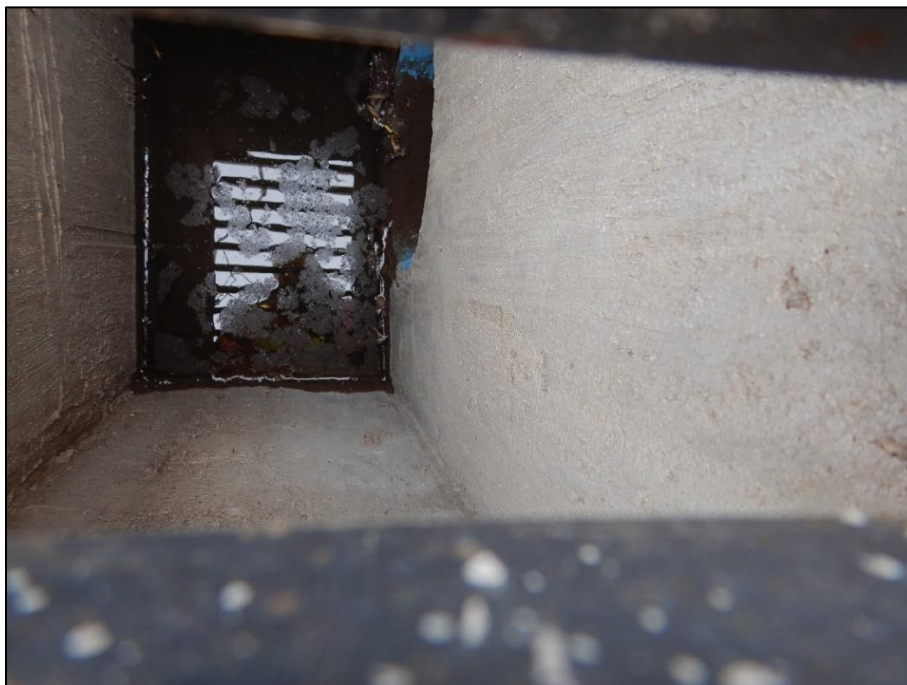
**Photograph 7.** View inside the storm drain inlet shown in Photographs 5 and 6. No BMP is located inside the catch basin. The storm drain inlet discharges to a seepage bed in Phase 5.

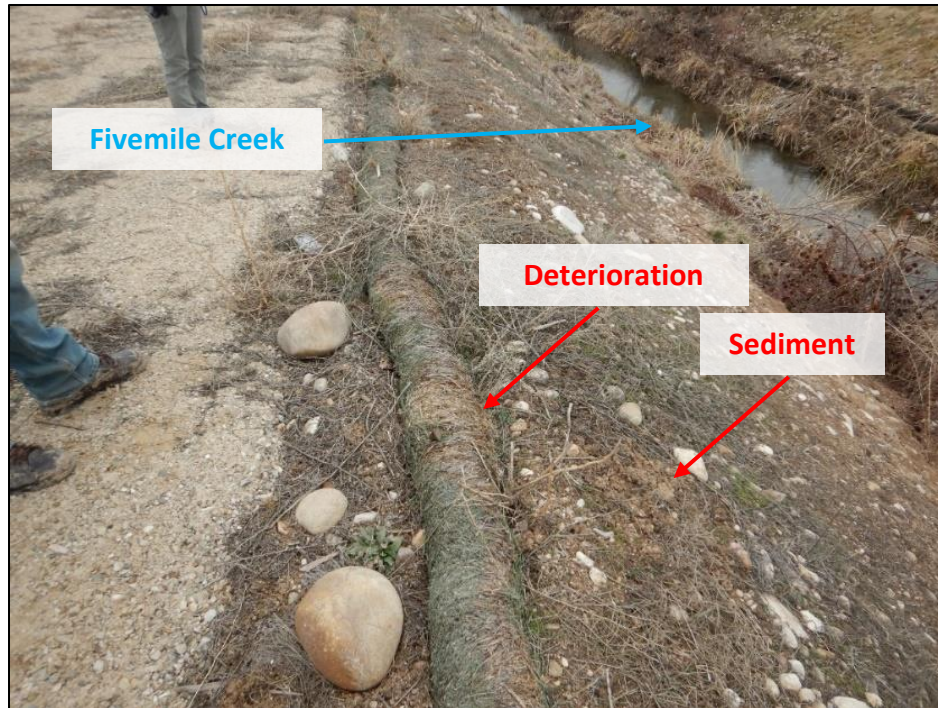
We observed a location on the fiber rolls adjacent to the Fivemile Creek in Phase 5 that showed signs of deterioration and were in need of maintenance. Additionally, sediment had been deposited on the side of the filter berm closest to Fivemile Creek without any additional sediment barriers downgradient (refer to Attachment A, Photograph 8).

**Photograph 8.** View, facing south, of a fiber roll that showed signs of deterioration. Note the sediment that was deposited downgradient of the fiber roll.

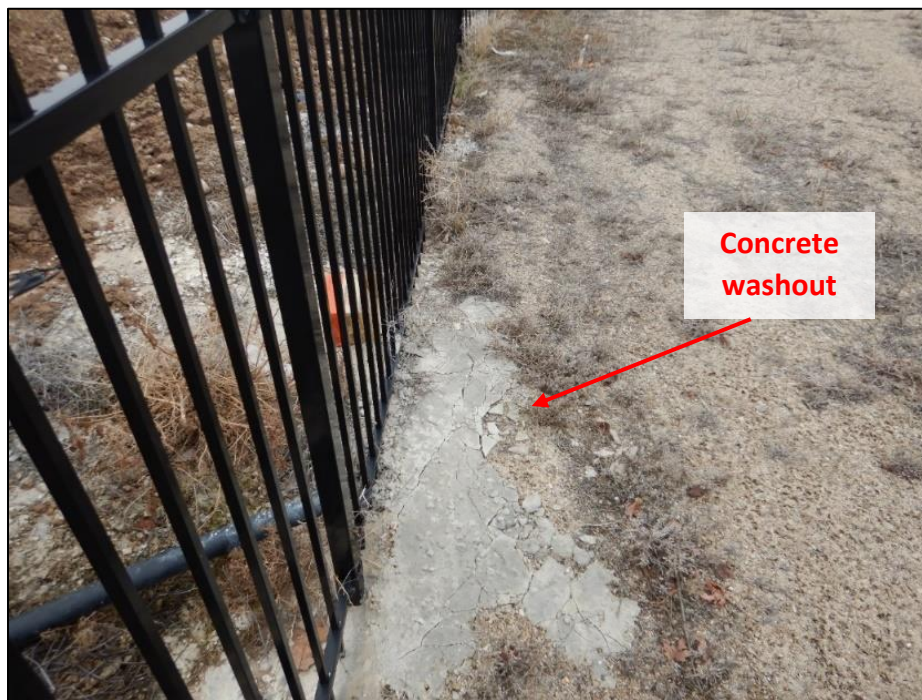
We observed a hardened puddle of concrete washout located along the western perimeter of Phase 5 roughly 20 feet from Fivemile Creek (refer to Attachment A, Photograph 9). The location is not near the concrete washout station labeled on the SWPPP map in Appendix A of the SWPPP (refer to Attachment C).

**Photograph 9.** View, facing south, of concrete washout located along the western perimeter of Phase 5 adjacent to Fivemile Creek. The location is just east of the location shown in [Photograph 8](#).

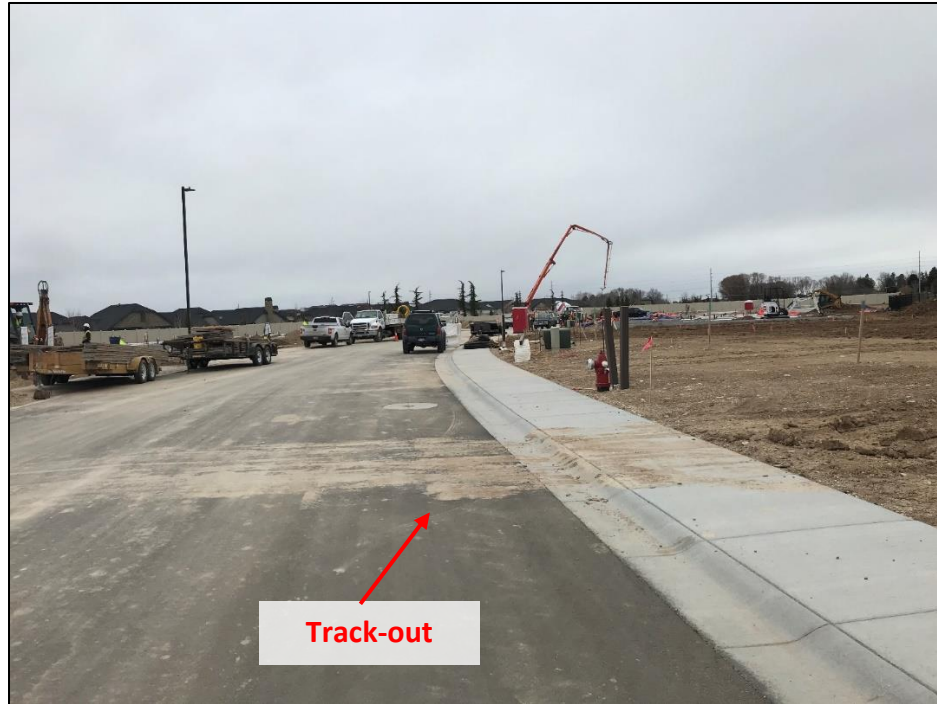
We observed that construction vehicle access had not been restricted to designated exit points in Phase 7. We observed sediment track-out on South Movado Way adjacent to the northern area of the Site. No appropriate stabilization techniques had been used at the access point (refer to Attachment A, Photograph 10).

**Photograph 10.** View, facing north, of a non-designated and unstabilized access point on South Movado Way. Note the sediment track out on to paved roadways.

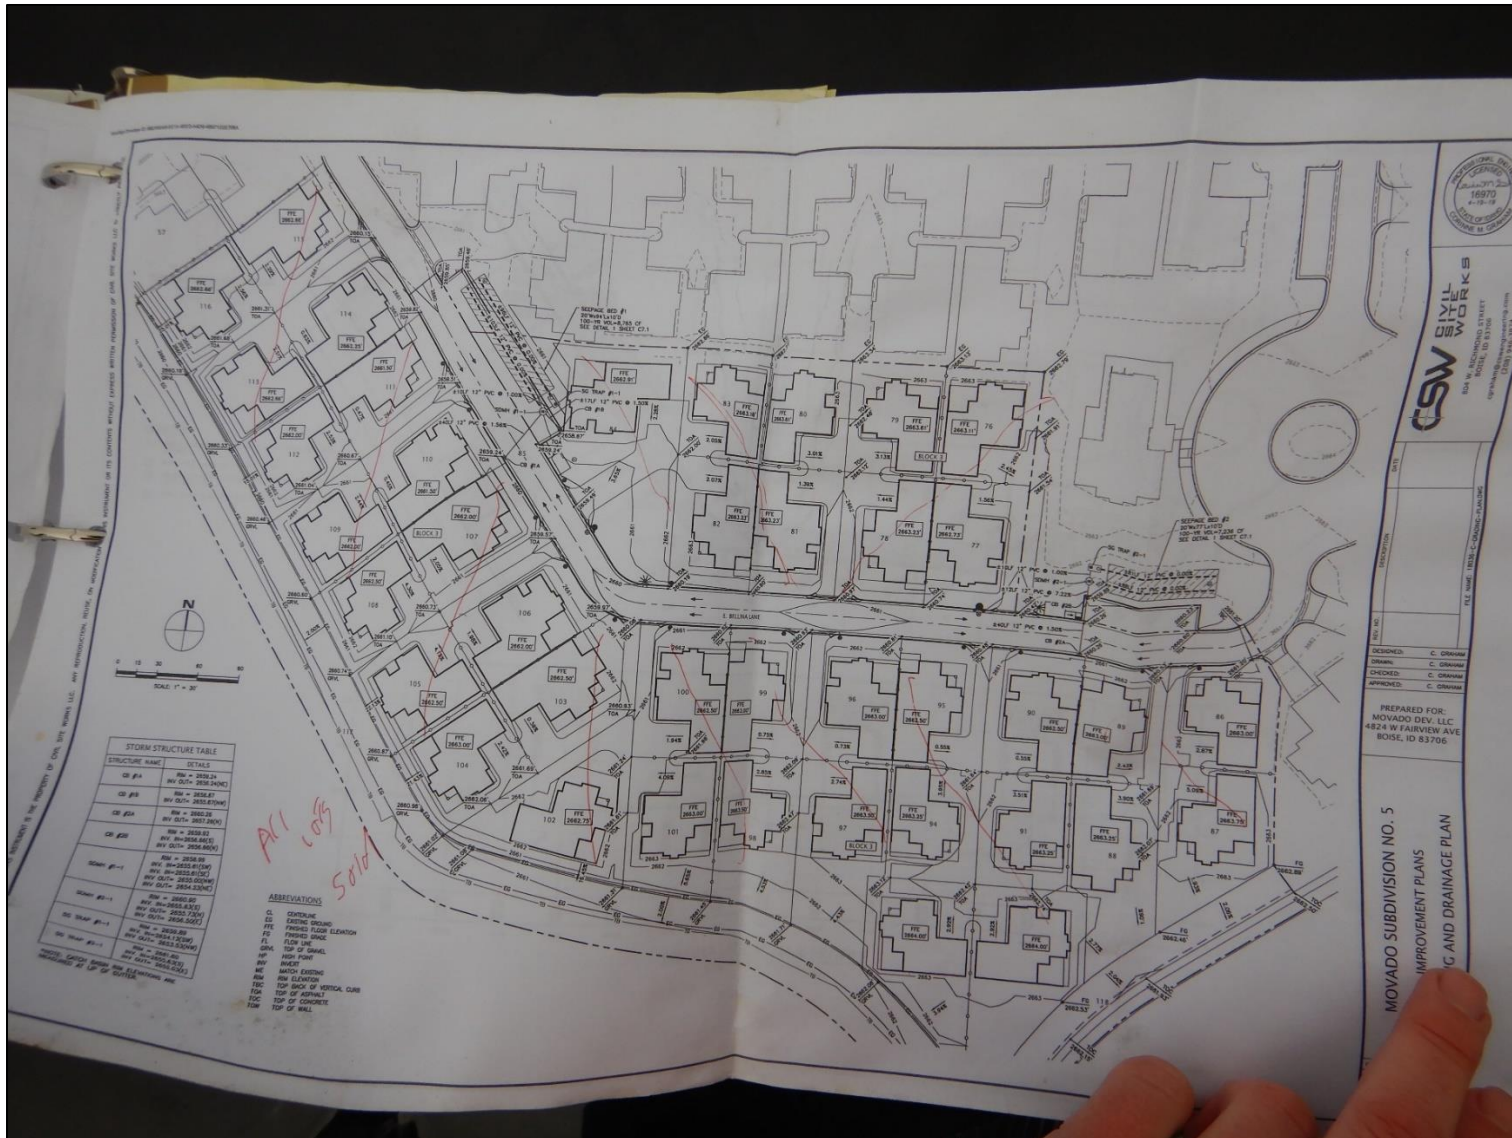
Site Representatives stated that the Site operator had adopted the practice of contractually requiring homebuilders to obtain CGP coverage for individual home lots and then internally “excluding” home lots from required inspections or other applicable BMPs (refer to Attachment B, Exhibit 2). It was unclear to the Inspection Team if individual home builders were obtaining CGP coverage for each individual lot since the Permittee did not track the CGP permits obtained by homebuilders.

**Exhibit 2.** Image of the Site map of Phase 5 provided on Site of Movado Subdivision No. 5, 7, and 9. Note that the Site map shows house lots that are sold and therefore internally “excluded” from required inspections or other applicable BMPs.

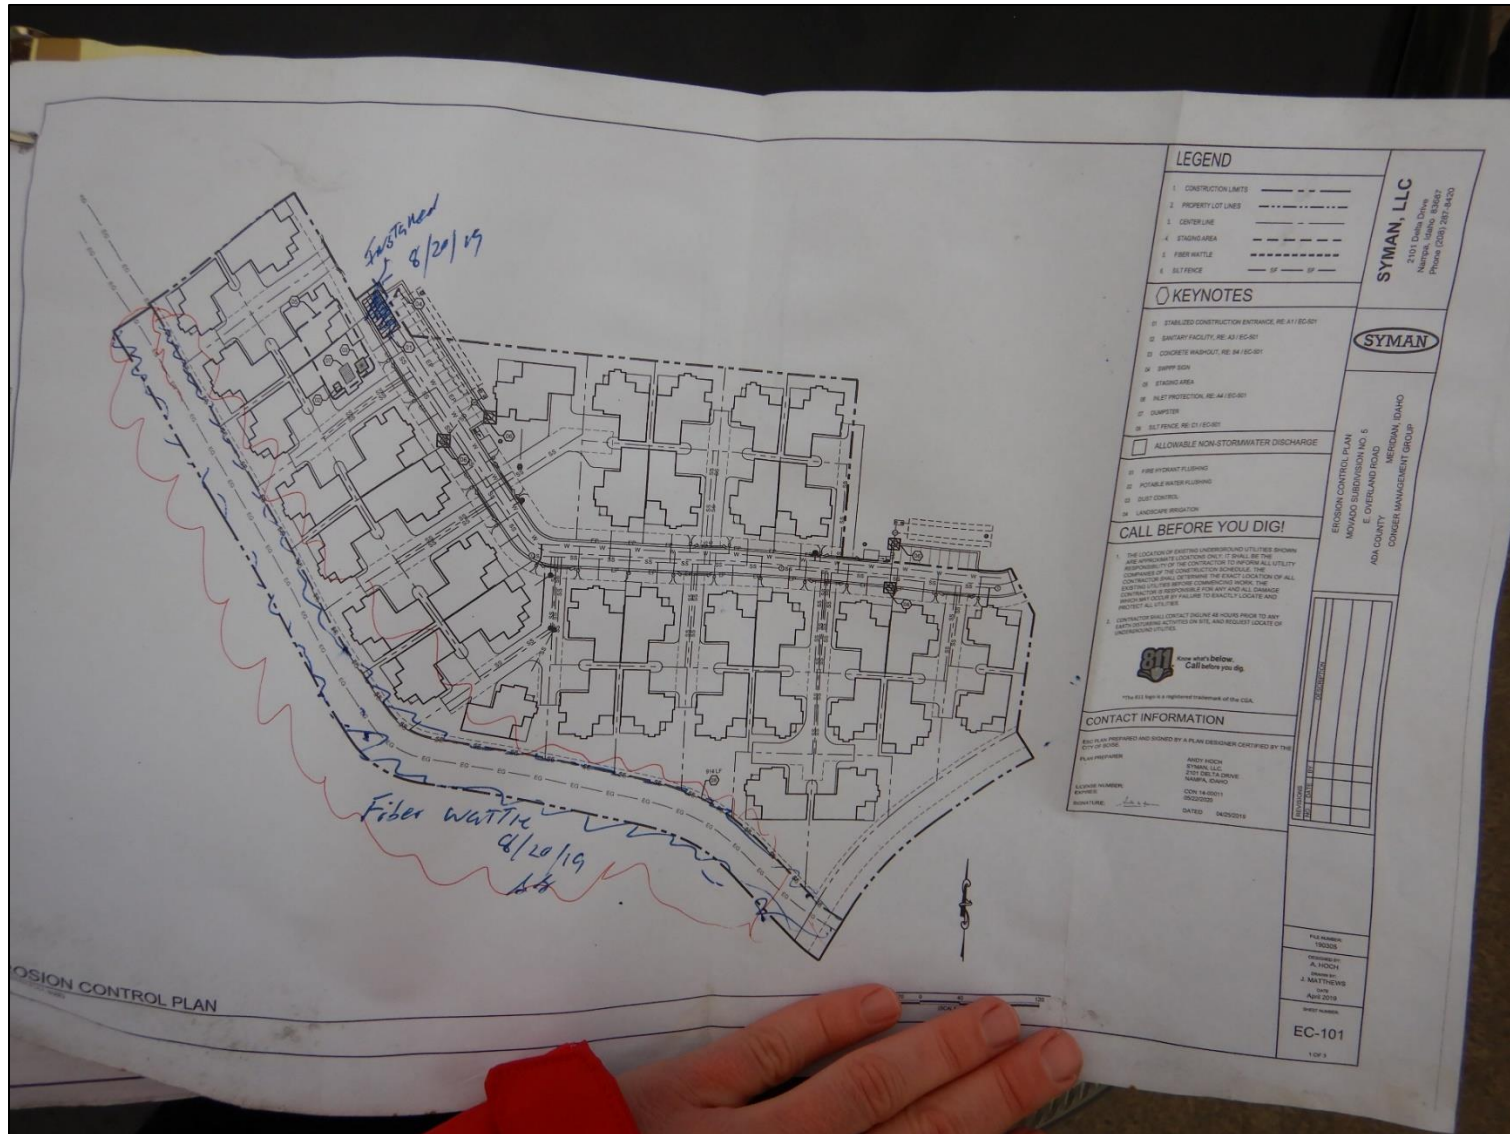
During the onsite records review, we observed that the SWPPP map presented on Site did not include every location where sediment and soil would be stockpiled as required by Part 7.2.4.b.iii of the Permit. The Site had three locations where soil and gravel were stockpiled – one at the northwestern perimeter in Phase 5, one along the western perimeter of Phase 7, and one along the eastern area of Phase 7 (refer to Attachment A, Photographs 1, 2, and 3). The onsite SWPPP map depicted an area where soil would be stockpiled, but the stockpiles were observed to be outside of that area (refer to Attachment B, Exhibit 3 and 4).

**Exhibit 3.** Image of the Site map of Phase 5 provided on Site of Movado Subdivision No. 5, 7, and 9. It was noted that the Site map does not identify all locations of stockpiles.

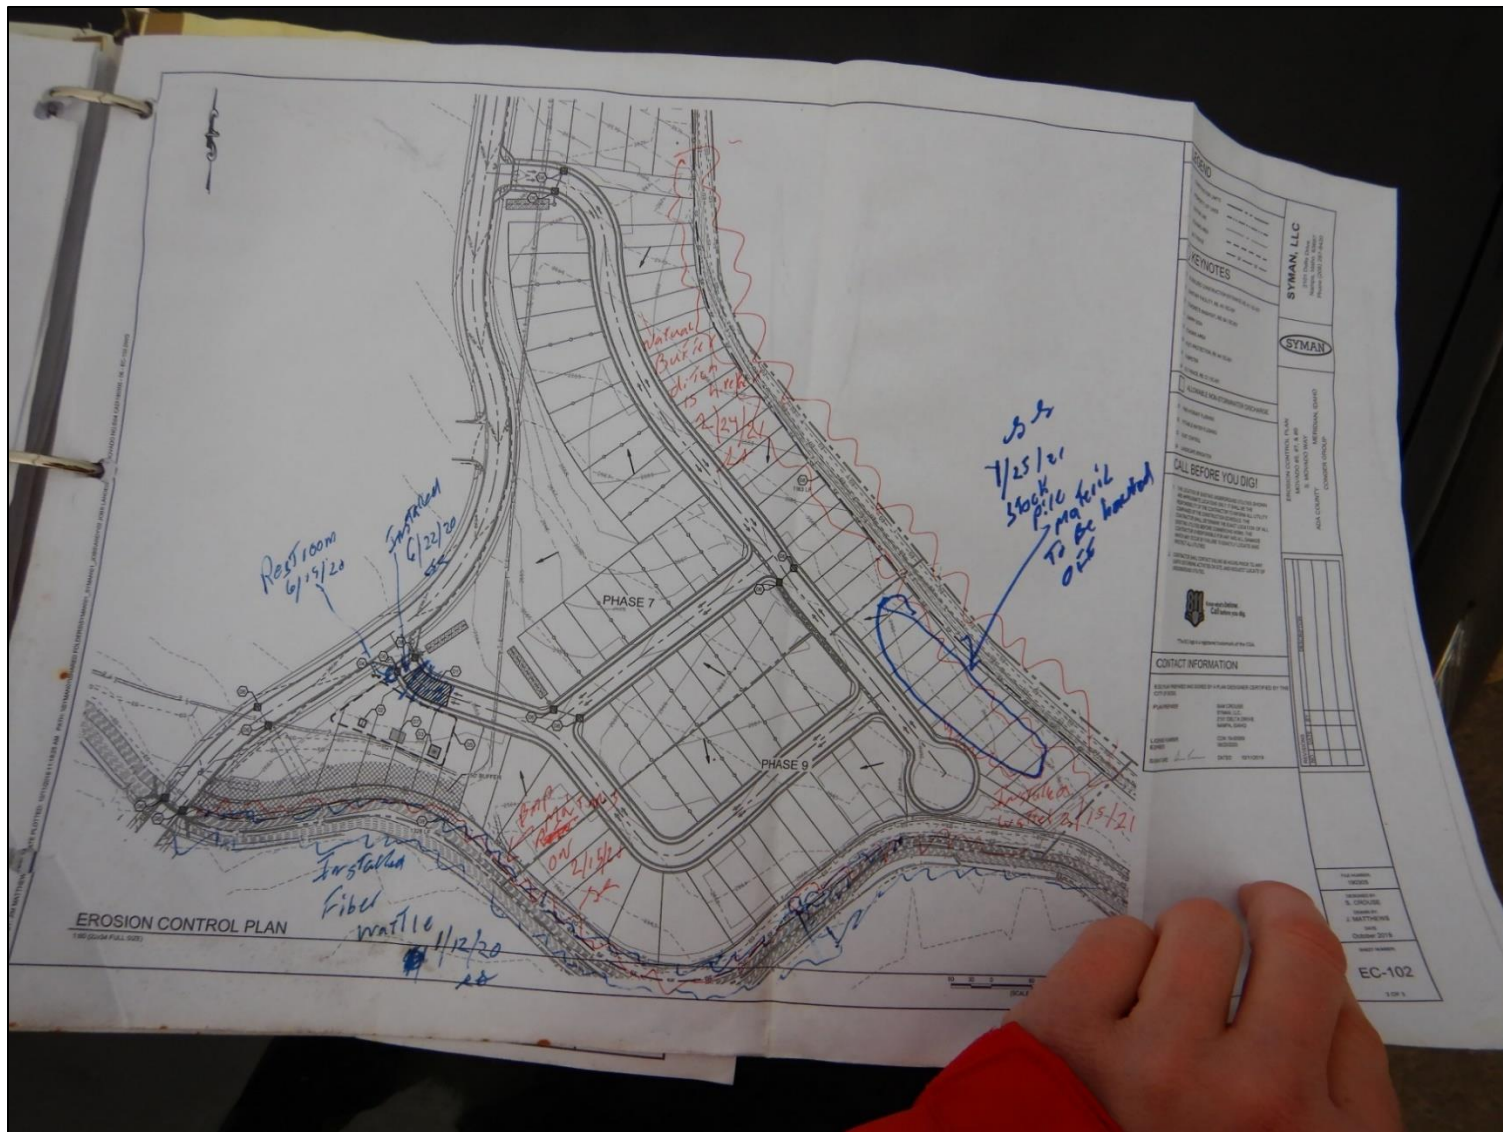
**Exhibit 4.** Image of the Site map of Phases 7 and 9 provided on Site of Movado Subdivision No. 5, 7, and 9. It was noted that the Site map does not identify all locations of stockpiles.
