### INSPECTION REPORT

| Media Program: | Water (CWA) | |
| Company Name: | <b>Merit Energy Company, LLC</b> | |
| Facility Name: | <b>Osbourne A 1-21</b> | |

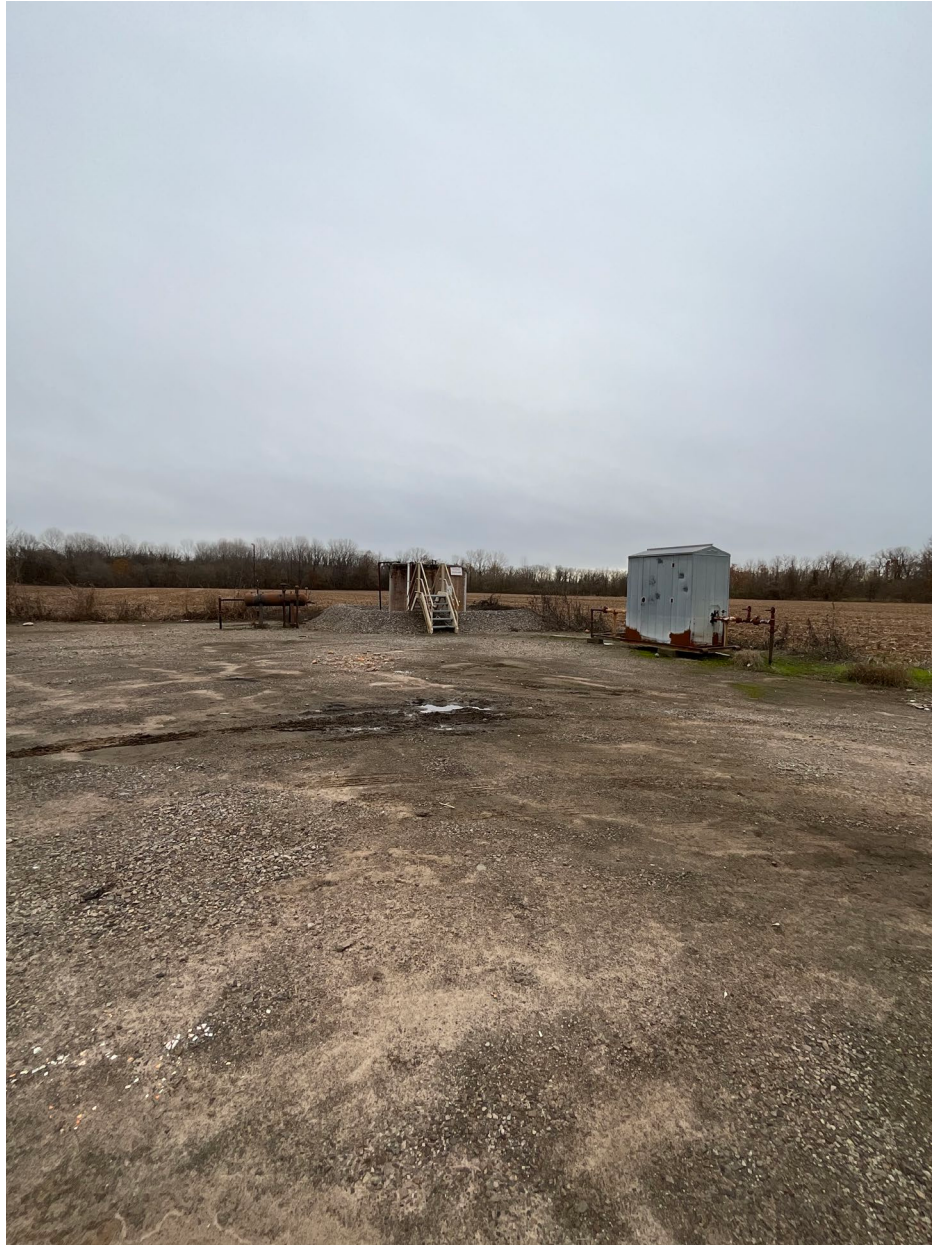
Photo No. 1

**Description:** Looking east, this photo shows an overview of the facility.

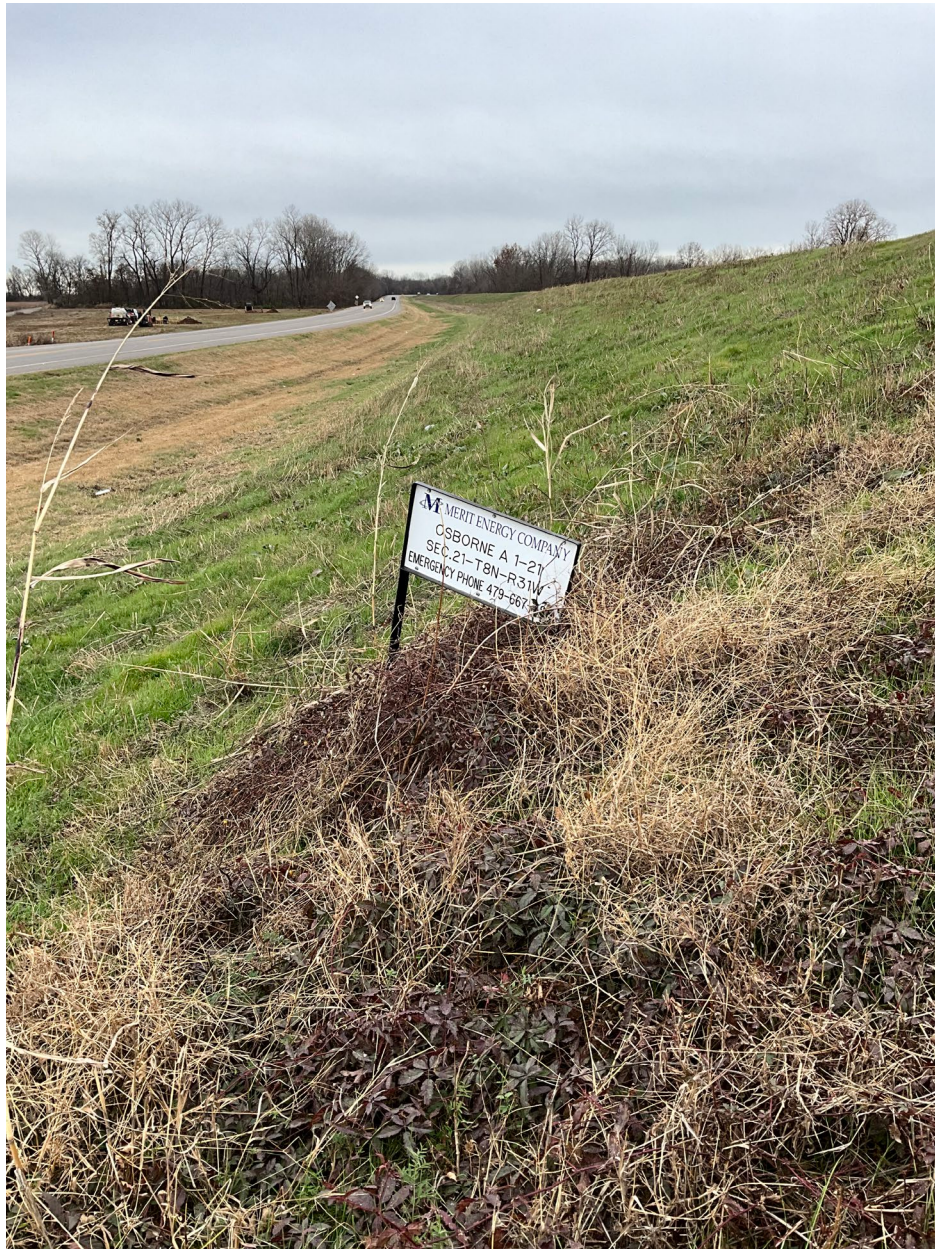
Photo No. 2

While the facility sign was observed off South Highway 59, there was no sign observed at the facility.

**Description:** Looking southeast, this photo shows the sign of the facility.
