**Region 2 Caribbean Environmental Protection Division  
Multimedia Permits and Compliance Branch**

**CAA Inspection Report**

**Inspection Date:** 5/1/2024

**Facility Name:** El Coqui Landfill

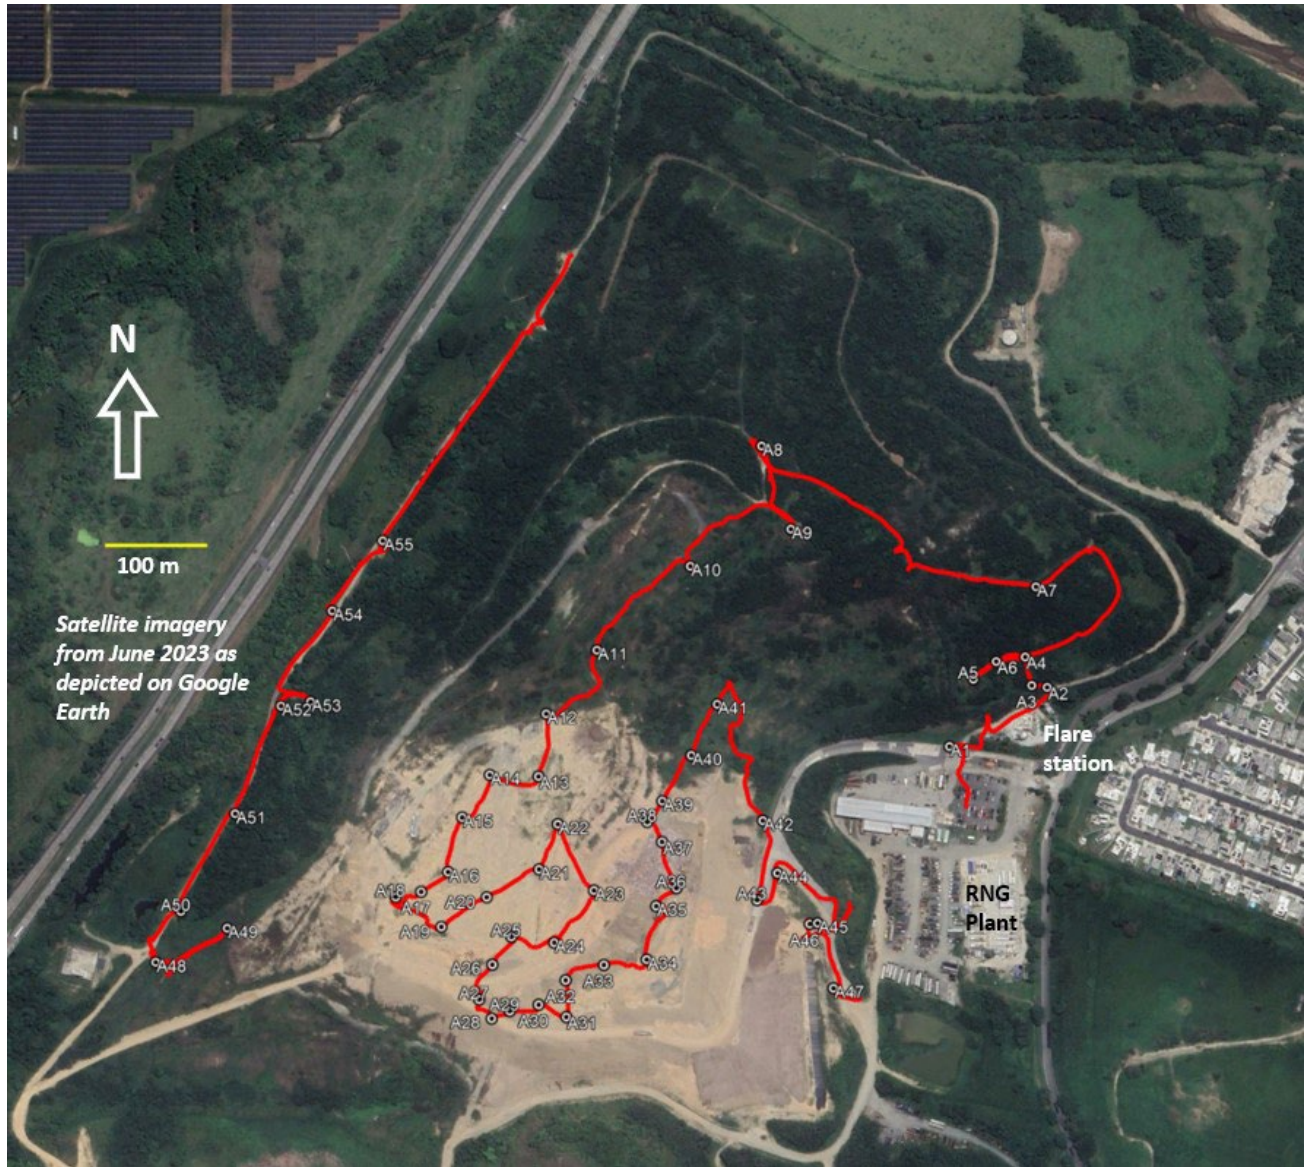
## Appendix B: Map

Red lines trace monitoring path. Exceedances are plotted and labeled as described in Appendix B. Path on western perimeter includes some stretches in vehicle driving between risers/wells. Coverage on the northern vegetated areas was primarily limited to access road/paths due to thick vegetation.

The survey covered less than 40 acres of the landfill.
